SPEEDVALE TRAIL

RETAINING WALL STRUCTURAL CONDITION ASSESSMENT REPORT

Project No. TPB165099

**Structural Retaining Wall Condition Assessment
Speed River West Retaining Wall
Guelph, Ontario**

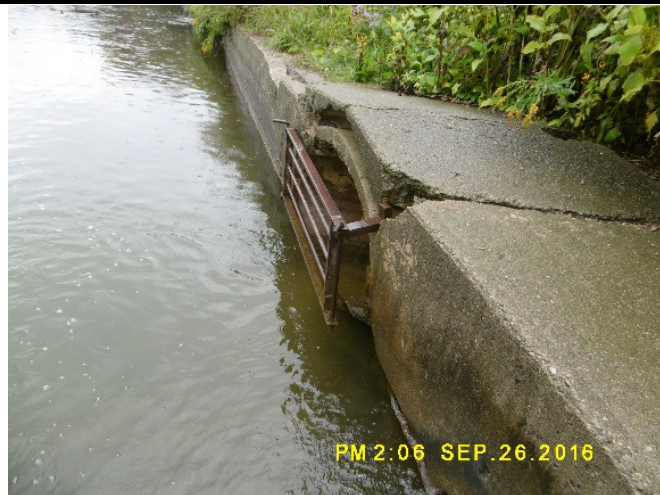
No.	Photograph	Condition Assessment
1

<p>End of the retaining wall (north side):</p> <p>North side of the investigated portion of the retaining wall ends on the storm water pipe outlet. Concrete above the pipe separated from the retaining wall and wide cracks can be observed on the both sides of the pipe.</p> <p>Medium size spalls are visible on the top end of the retaining wall.</p> <p>In overall this portion of the retaining wall is in a fair to poor condition.</p>

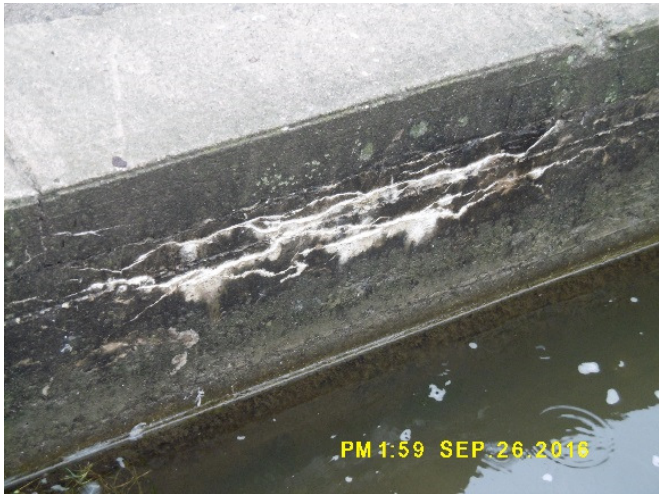
No.	Photograph	Condition Assessment
2

<p>Face of the retaining wall (north side):</p> <p>Longitudinal small to medium cracks with white efflorescence were observed on the face of the north side of the retaining wall. Cracks occur only on a limited area, and wall in this portion in overall is in a good condition.</p> <p>Rehabilitation work should be undertaken in the next 5 years to avoid concrete further deterioration.</p>
3

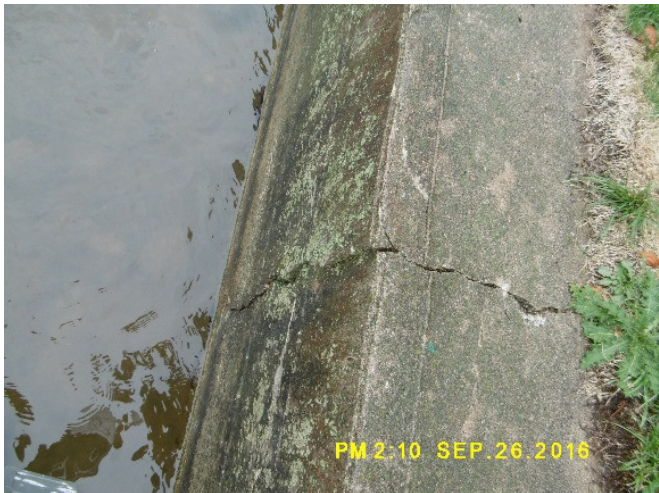
<p>Top of the retaining wall (north side):</p> <p>Medium to wide full height and depth transverse cracks were observed along the retaining wall. The cracks occur at approximately the same distance, creating a pattern.</p> <p>This type of cracks occur in a structure when no construction joints are provided, and temperature or shrinkage stresses need to be released.</p>
4

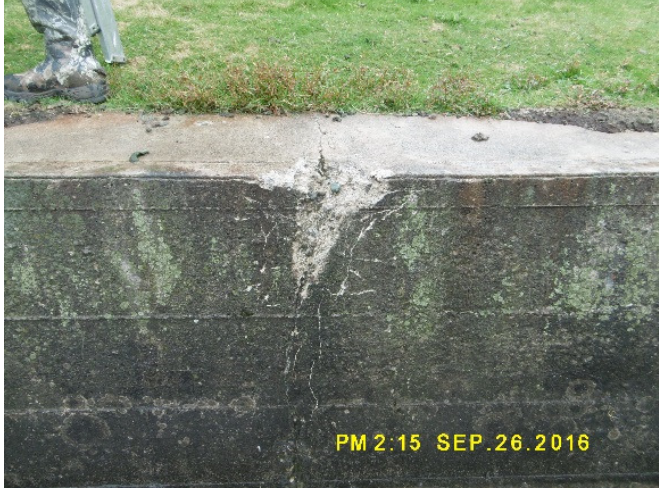
<p>Face of the retaining wall (north side):</p> <p>Occasionally, medium size spalls associated with transversal cracks were observed.</p> <p>Areas of light vegetation occur on the top of the retaining wall, partially covering its depth.</p> <p>Light mold was observed on the face of the north side of the retaining wall along the whole length</p>

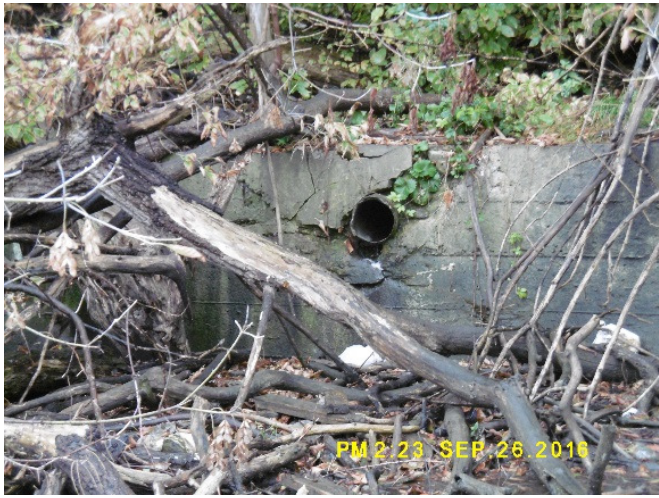
No.	Photograph	Condition Assessment
5

<p>Stormwater pipe outlet (middle portion):</p> <p>At the middle portion of the retaining wall (approximately 250 meters north of Speedvale Avenue Bridge), large spalls and delamination were observed nearby storm water pipe outlet.</p> <p>Delamination occurred at the concrete cold joint, probably due to impact load.</p> <p>This portion of the retaining wall is in a poor condition and needs to be rehabilitated in the nearest future.</p>
6

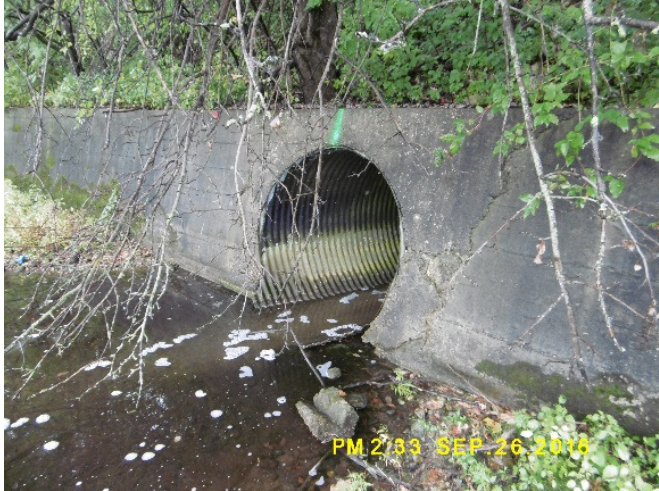
<p>Culvert outlet (middle portion)</p> <p>A round 1500mm diameter CSP pipe culvert is located at the middle portion of the retaining wall (approximately 160 meters north of Speedvale Avenue Bridge). The cold joint between the older a newer portion of the retaining wall is clearly visible, however, there are no signs of delamination and concrete in overall is in a good condition.</p> <p>Medium size mold and mass areas were observed at the bottom of the retaining wall along its length.</p>

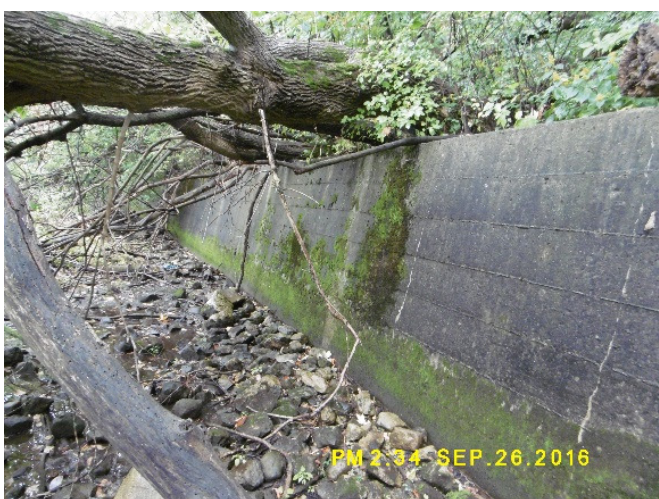
7

<p>Face of the retaining wall (middle portion)</p> <p>Large areas of the mass and mold were observed at the face of the wall in a middle section, along with the wall length.</p> <p>Heavy debris of the natural origin in form of fallen branches and entire trees were observed on the top of the retaining wall.</p> <p>There are no signs of structural distress from impact or additional dead load, however, it is recommended to clean out that area in the nearest future.</p>

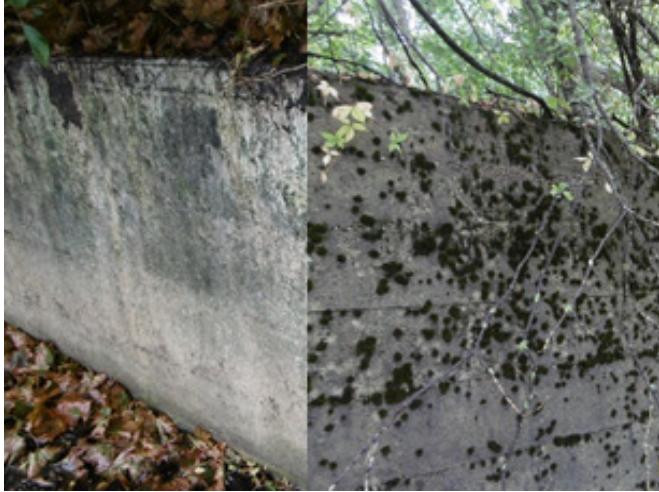
No.	Photograph	Condition Assessment
8

<p>Face of the retaining wall (south side)</p> <p>The face of the retaining wall on the south side is mostly covered in light to moderate mold and mass, causing deterioration of the concrete surface.</p> <p>Heavy vegetation covering the full depth of the retaining wall can be noticed on the top of the structure.</p> <p>In overall wall in this portion is in a good condition. Some maintenance work should be undertaken in the nearest future to prevent further deterioration</p>
9

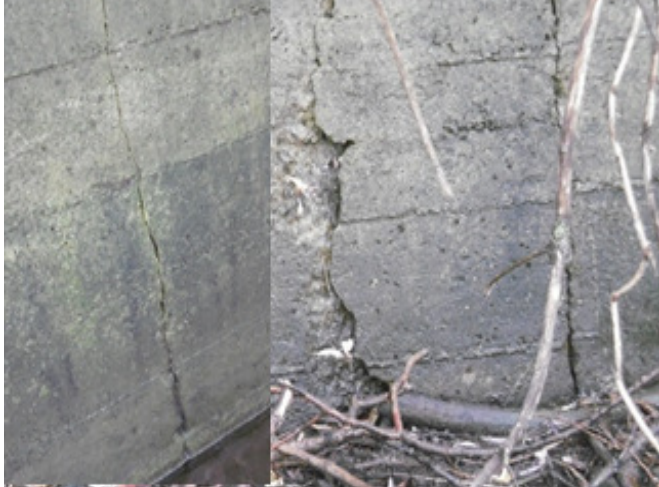
<p>Face of the retaining wall (south side)</p> <p>Characteristic transversal cracks also were observed at the south side of the retaining wall</p> <p>Occasionally, medium size spalls and concrete delamination associated with the transverse cracks were observed.</p> <p>Wall in this areas is in a fair to poor condition.</p>
10

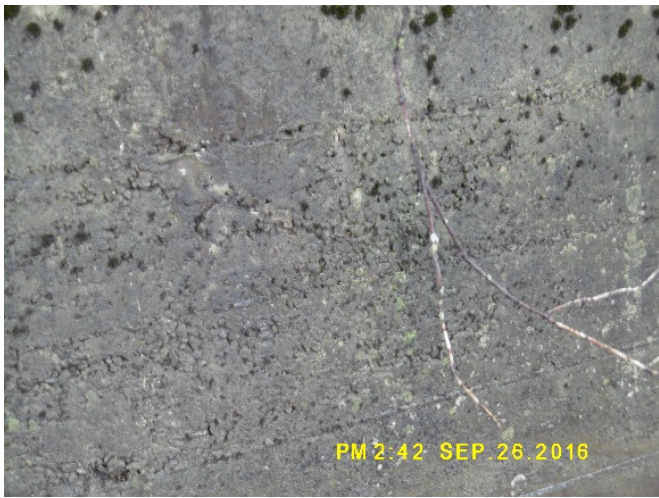
<p>Face of the retaining wall (south side)</p> <p>Light to moderate honeycombing was observed at the south side of the retaining wall.</p> <p>In overall, retaining wall in this portion is in a good condition</p>

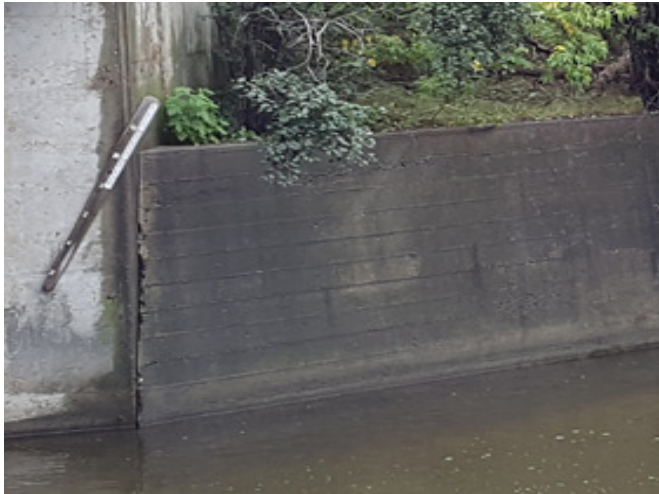
No.	Photograph	Condition Assessment
11

<p>Face of the retaining wall (south end)</p> <p>South side of the investigated portion of the retaining wall ends on the Speedvale Avenue Bridge. Medium spalling at the connection face between the retaining wall and the bridge were observed.</p>
11

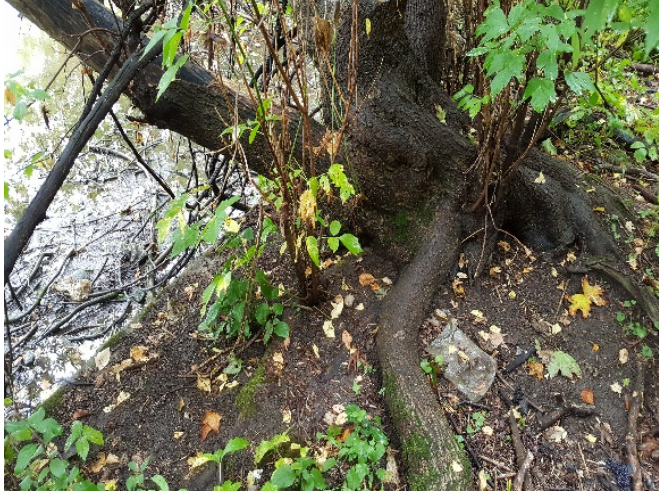
<p>Top of the retaining wall (escarpment)</p> <p>Heavy vegetation at the escarpment behind the retaining wall was observed at 70% of the total length of the wall, including fully grown trees just behind the retaining wall.</p>
12

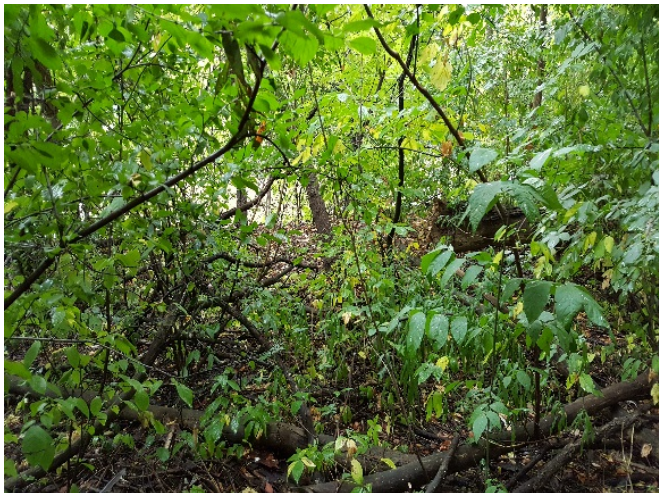
<p>Escarpment</p> <p>Approximately 270 meters of the wall retains the relatively steep and unstable, due to heavy vegetation, escarpment.</p>

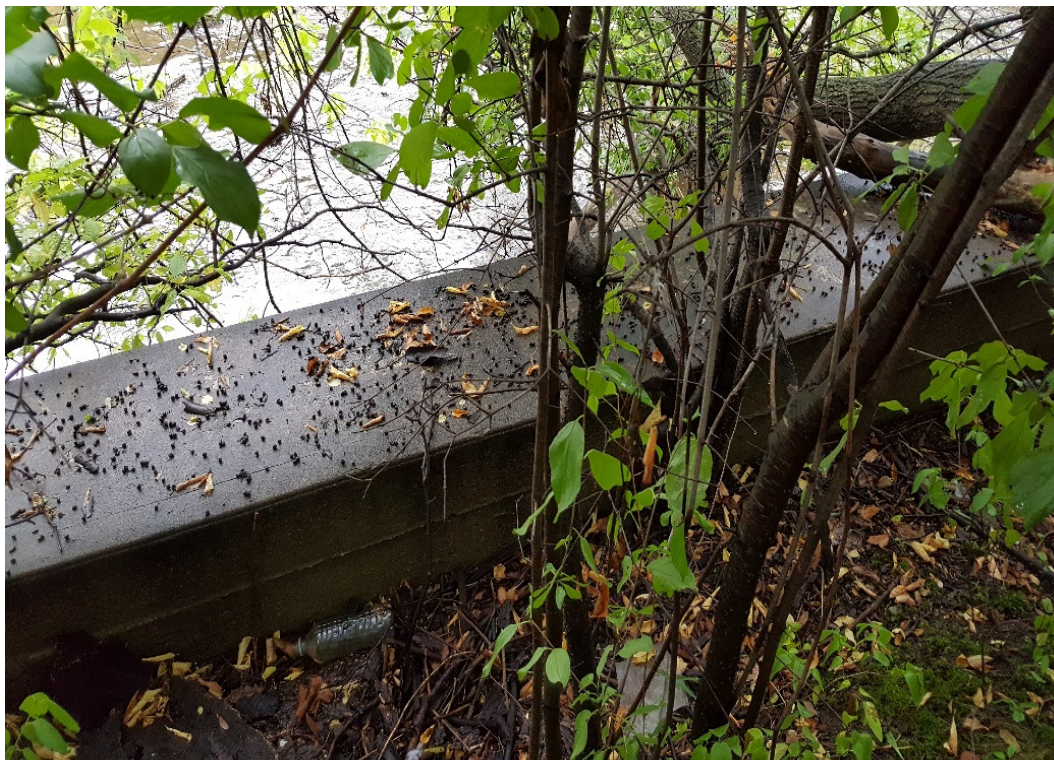
Figure 3: Top of the Retaining Wall (South End)

A heavy vegetation on top of the retaining wall, approximately on 70% of the wall length, prevented closer investigation of the top portion of the structure. The feasibility of new handrail installation was investigated based on the visual inspection of the exposed sections (refer Figure 3). In overall, the top portion of the retaining wall is in a good condition, the total width of the wall (450mm) is suitable for new handrail installation, and there was no evidence of concrete deterioration. However, further investigation should be performed to check the concrete condition under covered areas. If needed rehabilitation work should be performed prior new handrail installation.
