**LEX Project # 01050118**

**HAZARDOUS MATERIALS ASSESSMENT  
CENTENNIAL ARENA  
373 COLLEGE AVENUE WEST  
GUELPH, ONTARIO**

**Date:** March 13, 2006

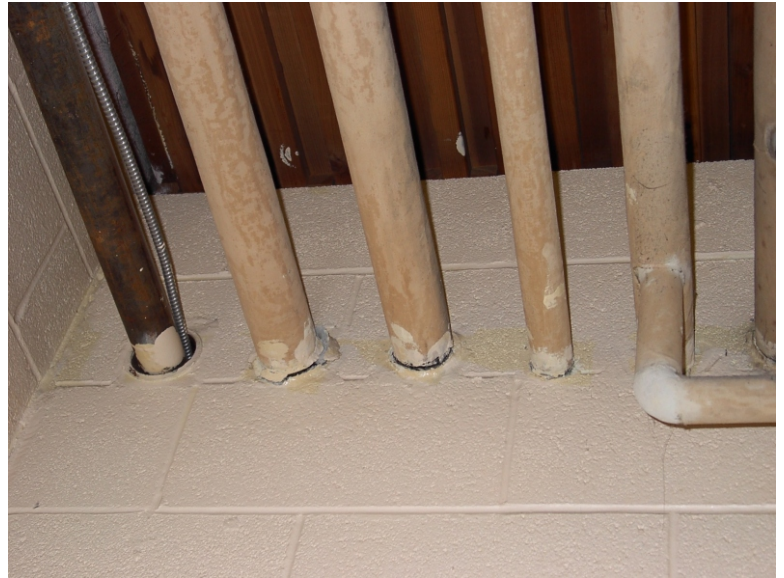
Figure 1: Centennial Arena. Guelph, ON.

- Asbestos parging filling in the gap between the heating/cooling/service water piping and the block walls was observed throughout the building. While Appendix B contains an approximate quantification of this material, it may be present in areas not already identified. This condition of this material ranged from good to poor.
- Fixed ceiling and bulkheads in bathrooms, showers, the front foyer, cafeteria, and other areas most likely contain asbestos pipe fittings. Due to the non invasive nature of this inspection, quantification of asbestos in these areas was not possible.

Parging between pipes and wall. Material contains 50% Chrysotile. This material was observed throughout the facility where piping extends through the block wall.

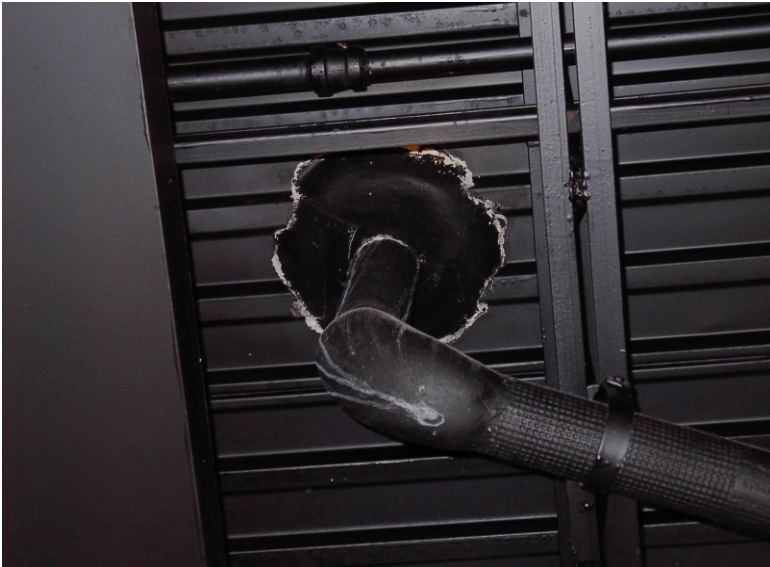
Figure 2: Centennial Arena. Guelph, ON.

4" - 8" inch transite pipe in Room 130. Parged fitting on ceiling in was inaccessible and therefore is assumed to contain asbestos.

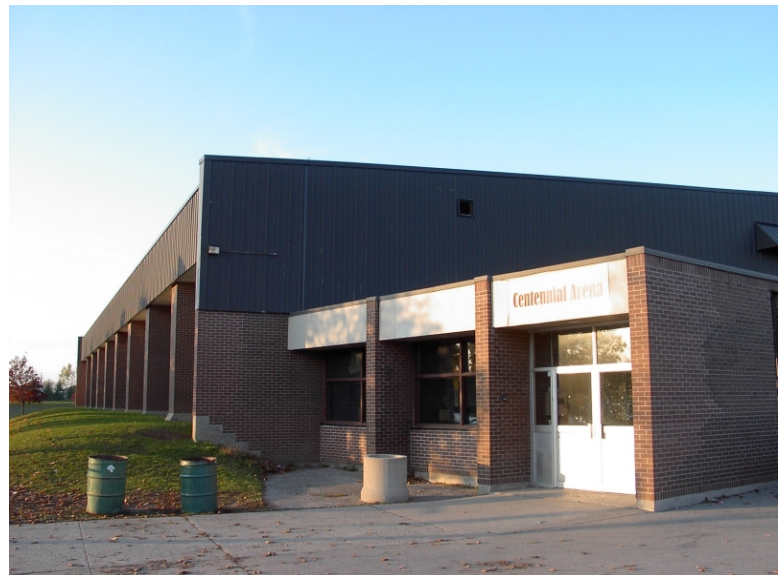
Figure 3: Centennial Arena. Guelph, ON.

- On West side of building, approximately 5 cement columns north of the front entrance, a significant amount of water was observed leaking through the transite soffit. The soffit is in fair to poor condition due to water damage. The source of the water leak is not known, nor is it known whether mould is present in the ceiling space (above the soffit).

Building soffits contain transite board.

9. It is recommended that the source of the water causing damage to the exterior transite soffit be investigated, and repaired if possible.
