## **Drawing Package for Consultant RFP**

**Fire Hall #3**

**115 Stone Rd**

## Detailed Structural Assessment Report

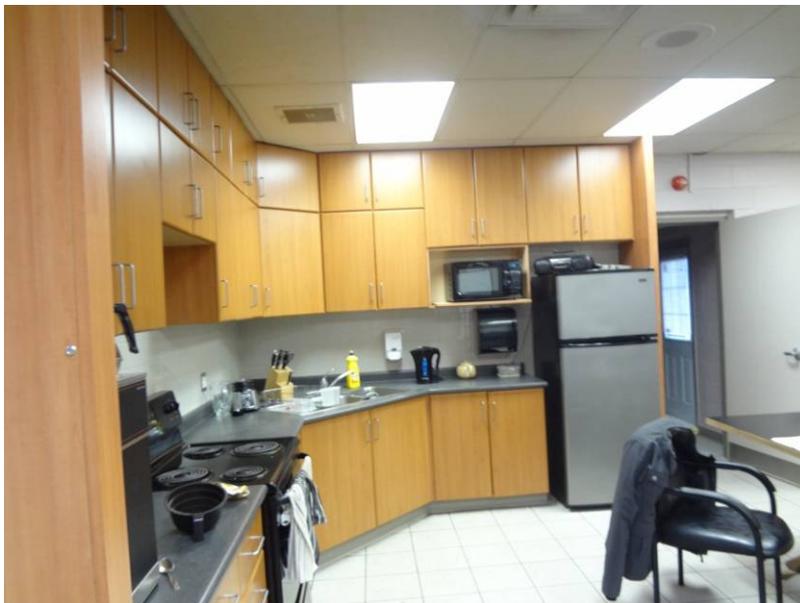
Photograph “8”  
Alterations to the Multipurpose Room

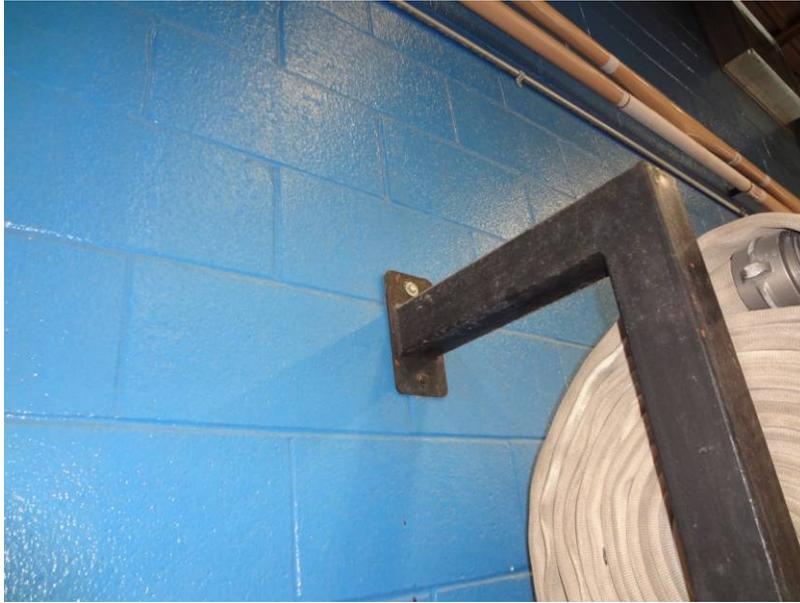
Photograph "11"  
Apparatus floor

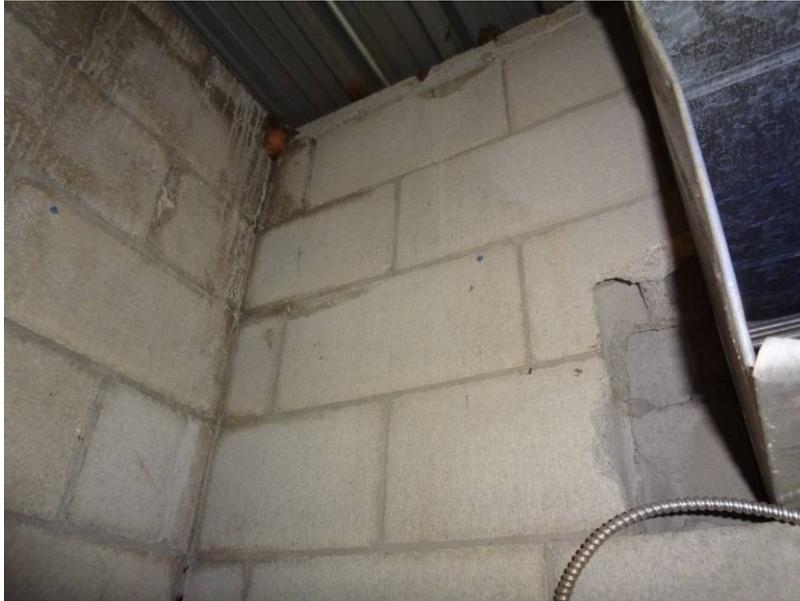
Photograph "15"  
Demising wall at gridline "2"  
Note duct penetration through the block wall with no reinforcement  
Note evidence of leakage

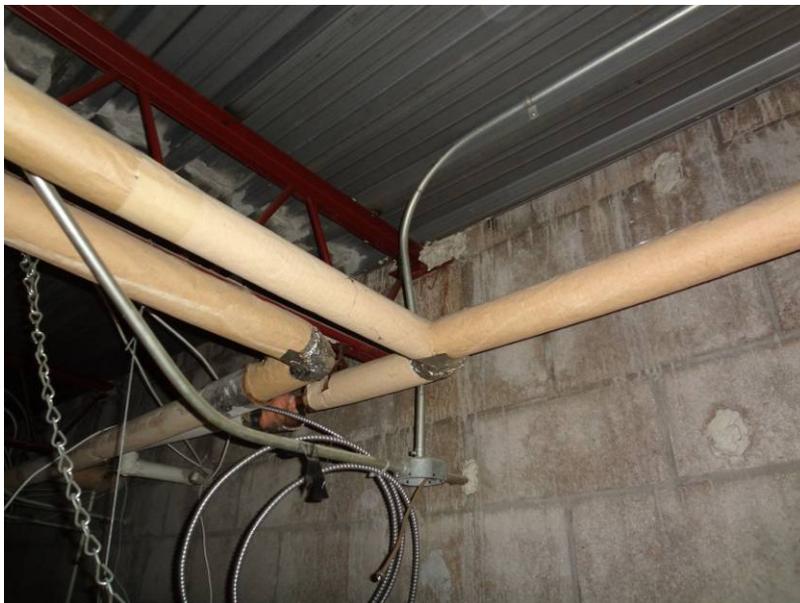
Photograph "16"  
Demising wall at gridline "2"  
Pipe penetrations through the block wall  
Note evidence of leakage

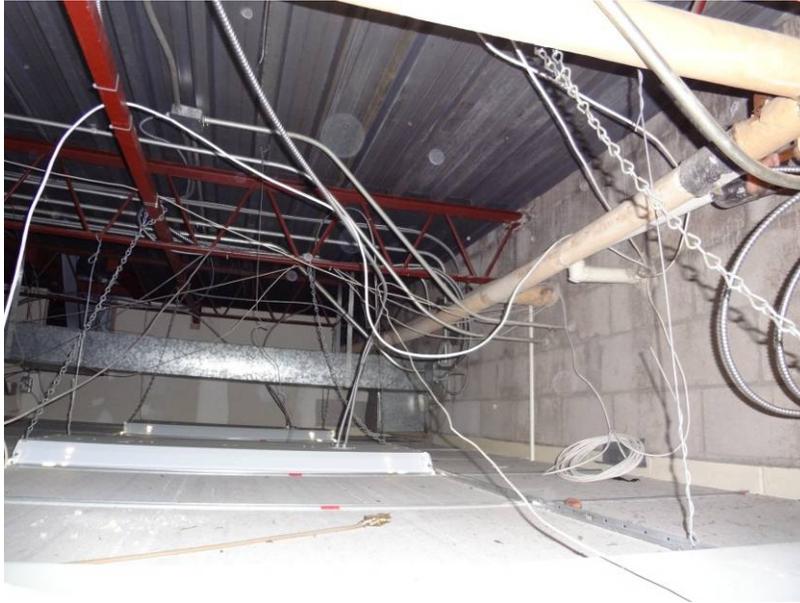
Photograph "17"  
Demising wall at gridline "2"  
Pipe penetrations through the block wall

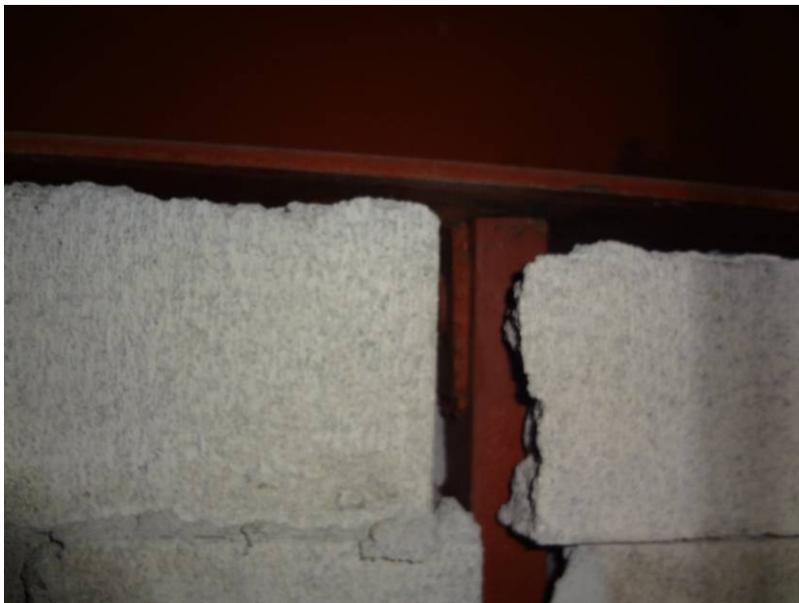
Photograph "20"

Note loose concrete blocks, unreinforced duct penetrations, laterally unsupported block wall

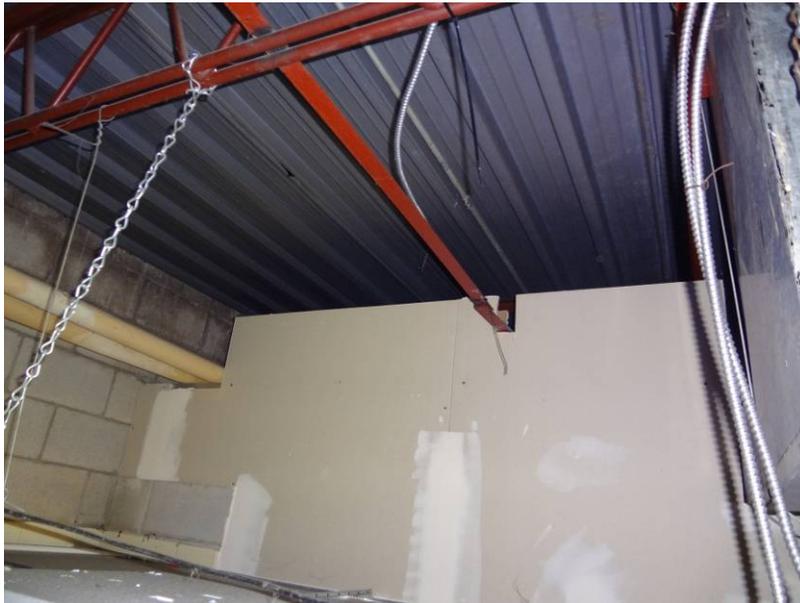
Photograph "21"  
Demising wall separating Dormitory and Multipurpose Room  
Laterally unsupported wall

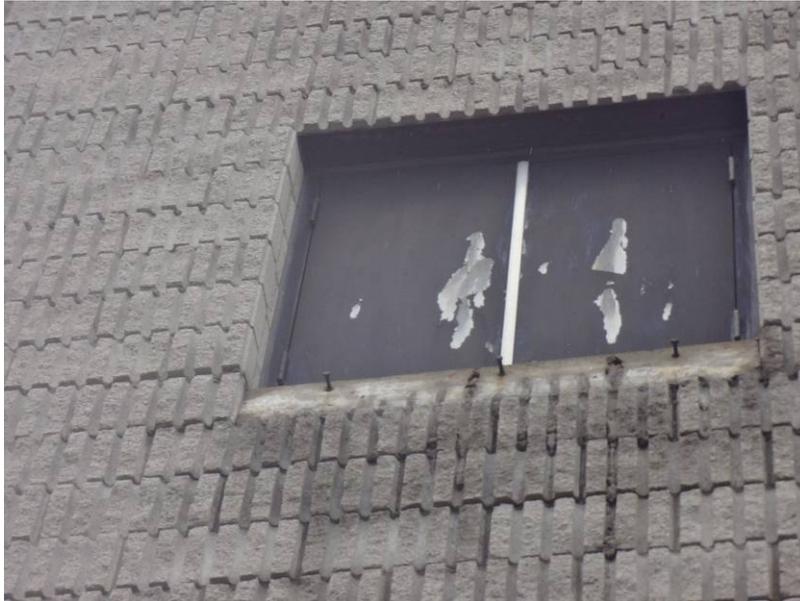
Photograph "23"  
Fire Hose Storage Tower North Elevation  
Missing sill blocking and sill flashing

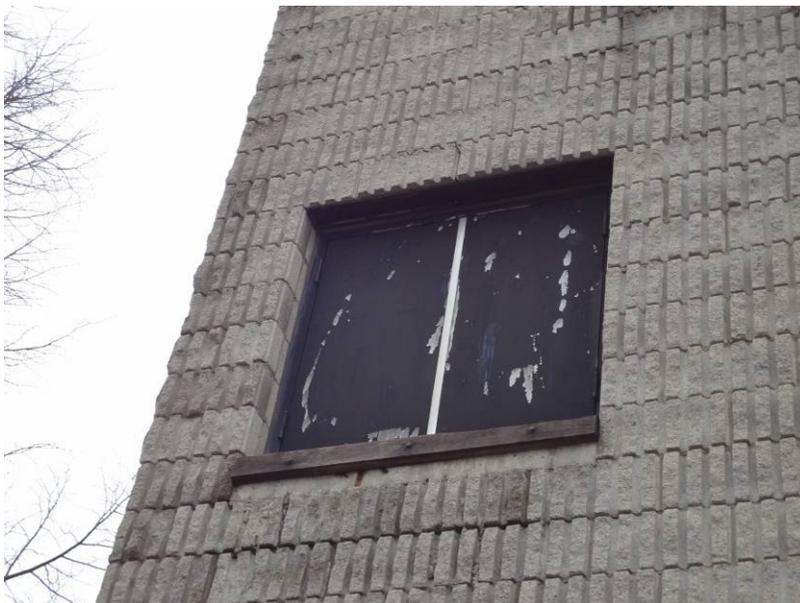
Photograph "24"  
Fire Hose Storage Tower North Elevation  
Deteriorated sill blocking and missing sill flashing

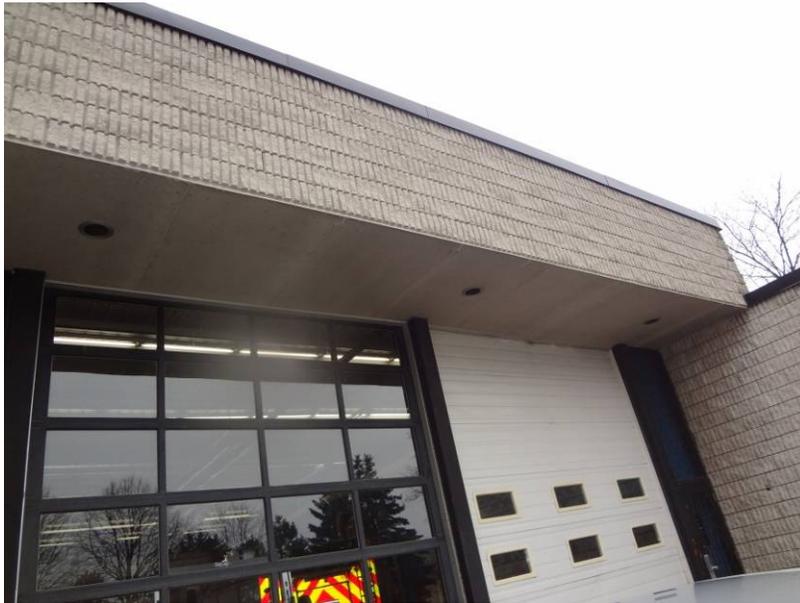
The exterior steel framing and the soffit of the cantilevered portion of the roof overhangs (canopies) are covered with transite boards (asbestos fibre cement boards) that are mechanically fastened to the supporting structure. The fastening screws are corroded. The transite boards are locally cracked and delaminated from the supporting structure at the edges. The sealant material at the edges of the suspended soffit is locally cracked and has failed.

Photograph "25"  
Roof overhang (canopy) at the north Elevation

The steel framing and the steel hangers supporting the split-faced architectural blocks are showing sign of significant corrosion. Complete soffit replacement, refurbishment of the steel framing and block repairs are recommended.

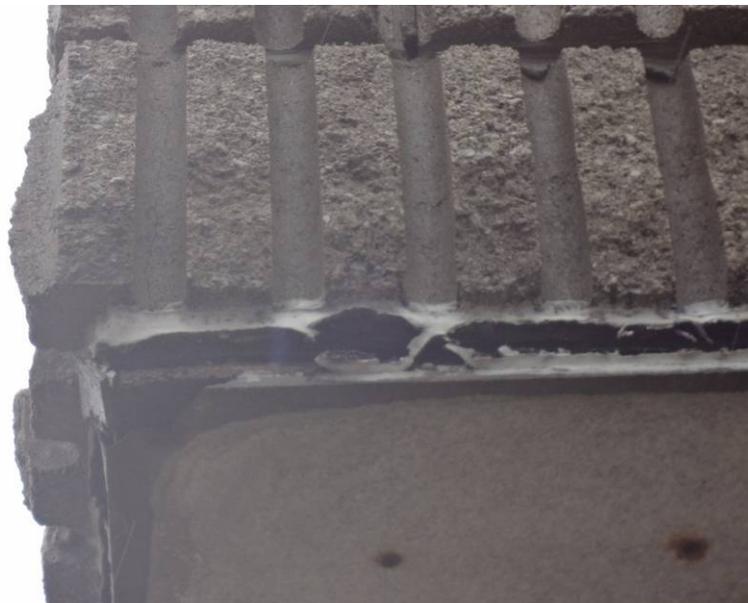
Photograph "28"

Note cracked and deteriorated sealant, delaminated transite fibre cement board

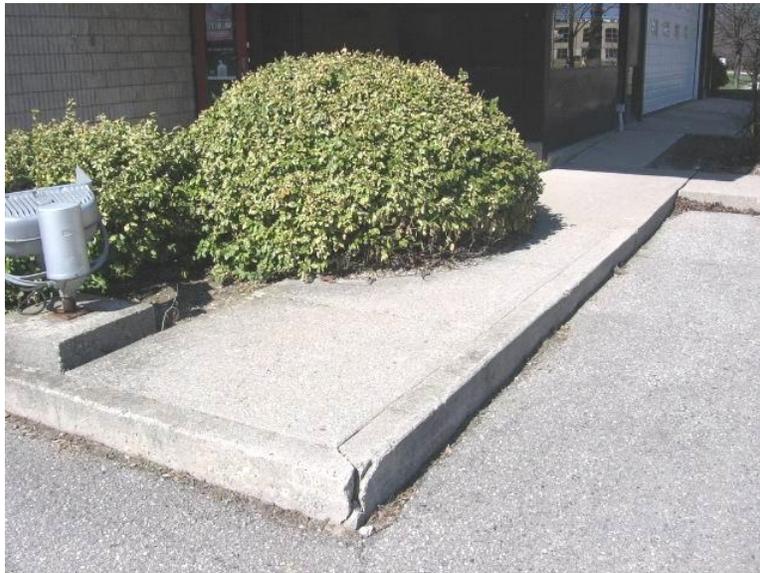
The curbs, sidewalks, and patio areas around the property were in generally fair condition at the time of the site review. Localized areas of cracked sidewalks and curbs were noted around the building, including at the front entrance.

Photo 1: Typical condition of the concrete sidewalks and curbs at the front entrance

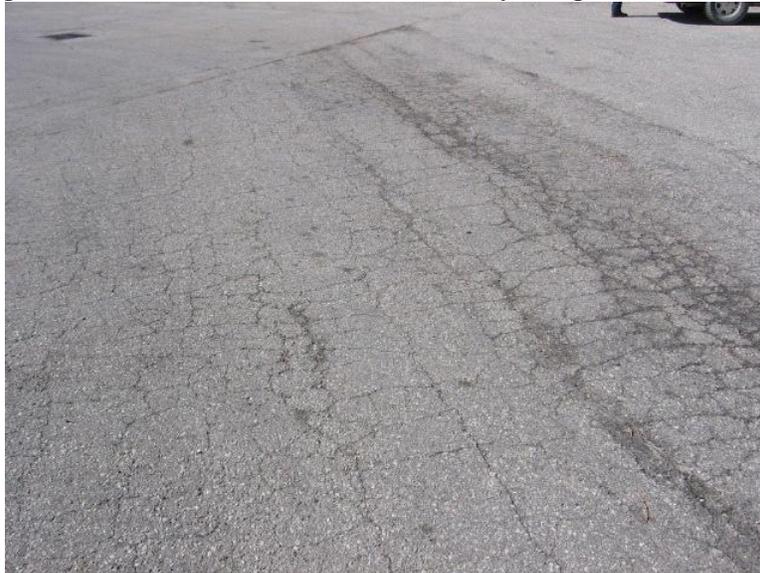
The asphalt driveways and surface parking areas were in generally fair condition, with areas of settlement, alligator cracking, and minor pot holes. There appeared to have been isolated asphalt patches conducted in the past, however this was not confirmed by site personnel.

Photo 4: Typical alligator cracking with joint of previous asphalt replacement shown

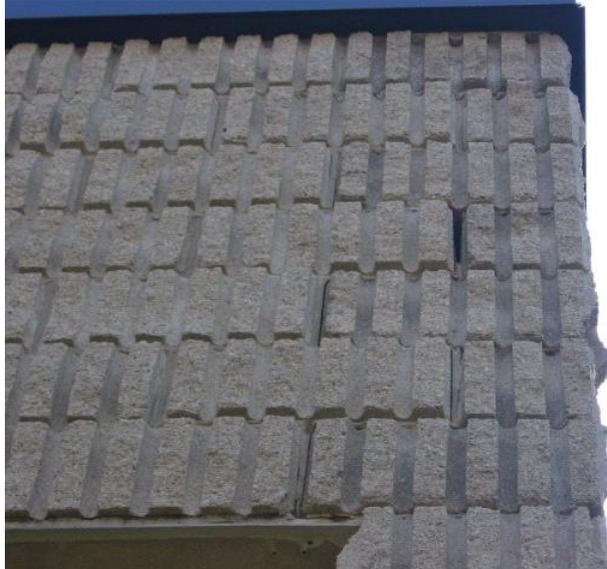
The concrete block cladding was in generally good condition with localized area of step-cracking at the southeast corner, on the east elevation.

Photo 7: Isolated location of stepcracking of the split-faced concrete blocks

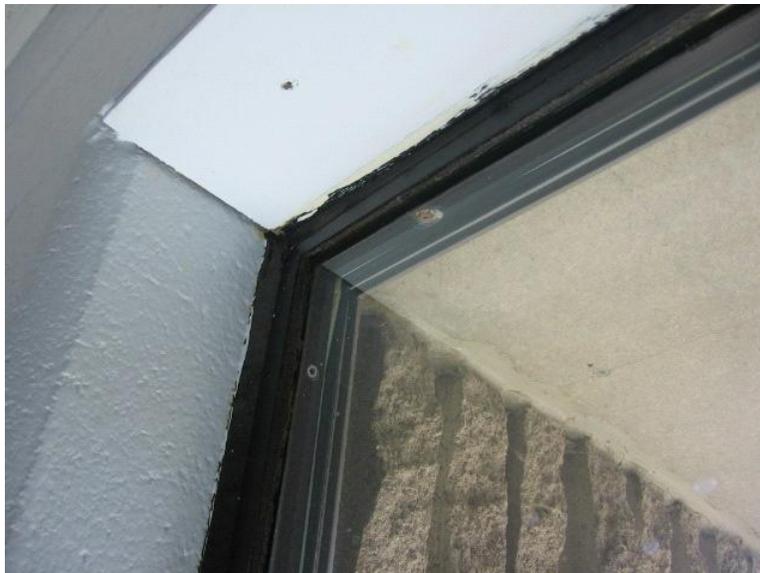
The window frames appear to be in generally fair condition. It appeared the original windows consisted of single-glazed fixed lites and were later modified by installing an additional single-glazed window on the inboard side of the window. Debris was noted within the "cavity" at most locations.

Photo 8: Typical window consisting of original single-glazed window with an additional glazing lite installed following original construction

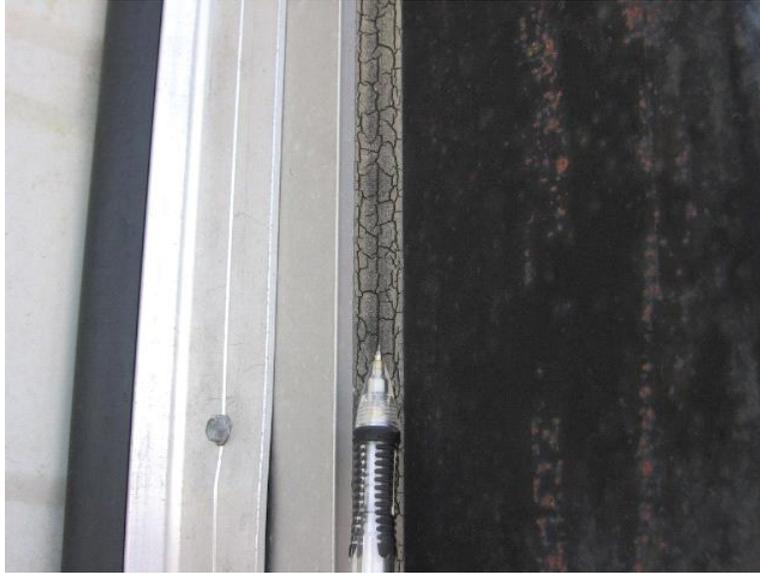
The exterior sealants were in generally poor condition at the time of the site review. Cracked, hard, unbonded, and surface alligating sealants were observed around the building perimeter. Sealants located at the various roof levels were in generally good condition and any repairs or replacements required would be covered as part of the roof repair items.

Photo 9: Typical alligator cracking of sealants around perimeter of garage glazing

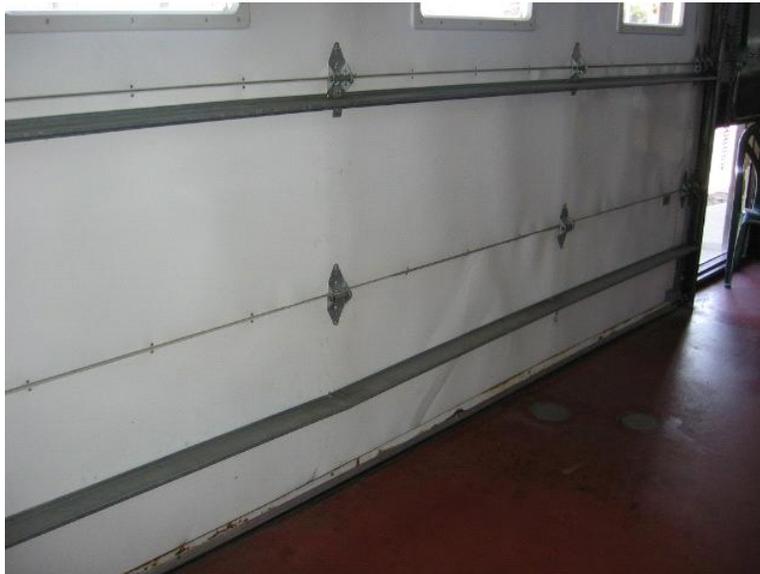
The two new overhead doors were in generally fair condition, with isolated areas of surface corrosion and impact damage noted, generally located at the base of the doors.

Photo 10: General condition of overhead doors within the garage

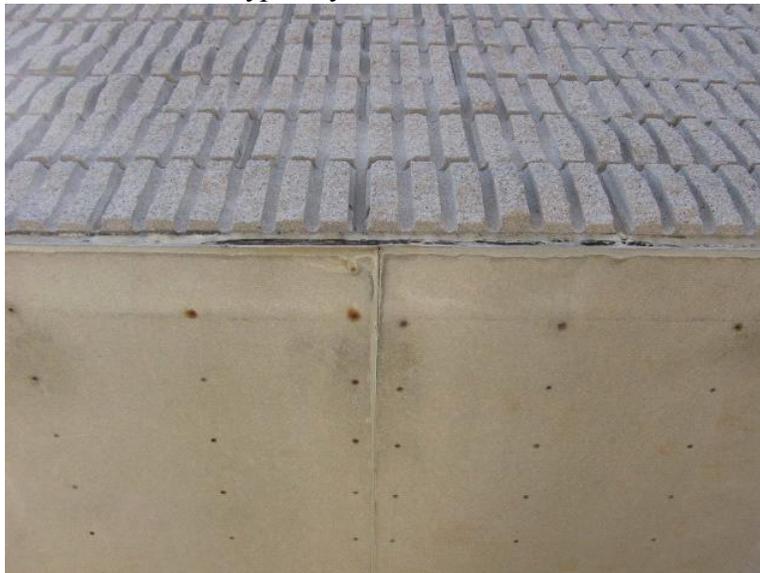
Low-severity corrosion was observed on the fasteners at canopy locations. The sealant joint between the split-faced block and the edge of the cement board was typically failed.

Photo 11: Typical finishes of cement board and fasteners at canopy locations

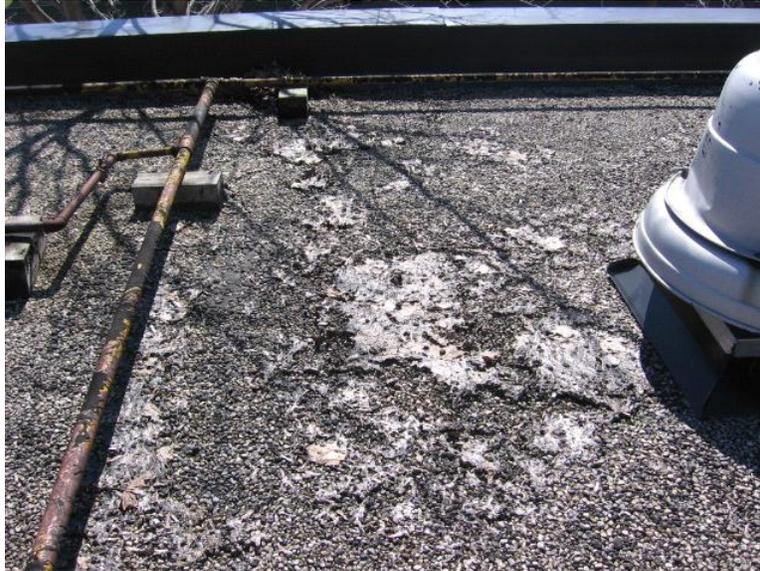
The roof areas were generally in good to fair condition. There are isolated areas of blueberries at each of the roof sections, generally concentrated around roof perimeters and roof-mounted mechanical equipment. There were areas of organic debris around the roof areas, indicating possible areas of water leakage or ponding. The roof drains were protected with plastic or metal strainer covers, which were secured and generally clear of debris with some organic debris noted. We noted there was a pitch pocket around a pipe penetration at the lower office roof that was in fair condition.

Photo 12: Typical area of organic debris showing signs of possible ponding

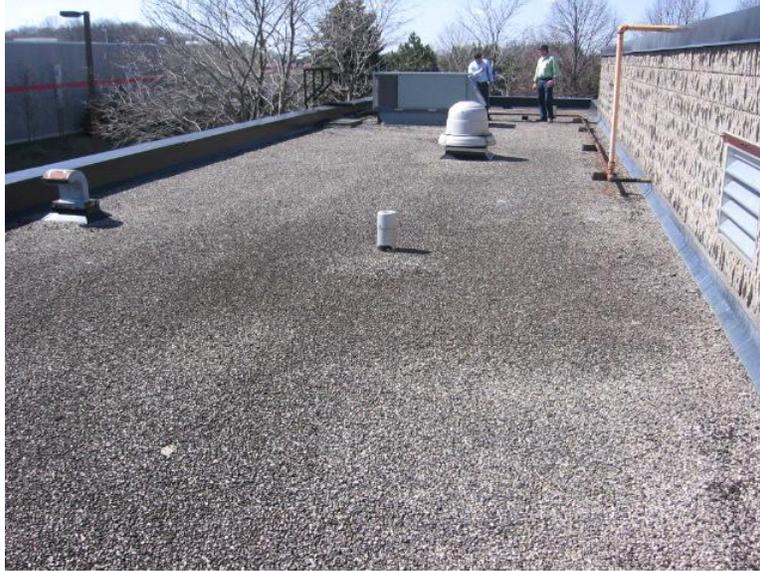
The roof cap flashing and counterflashing step flashing was in generally fair to good condition at the time of the site review. Isolated scratches were noted around the roof perimeters, with some areas of faded finishes.

Photo 13: Typical layout of roof cap flashing and counterflashing at the various roof levels

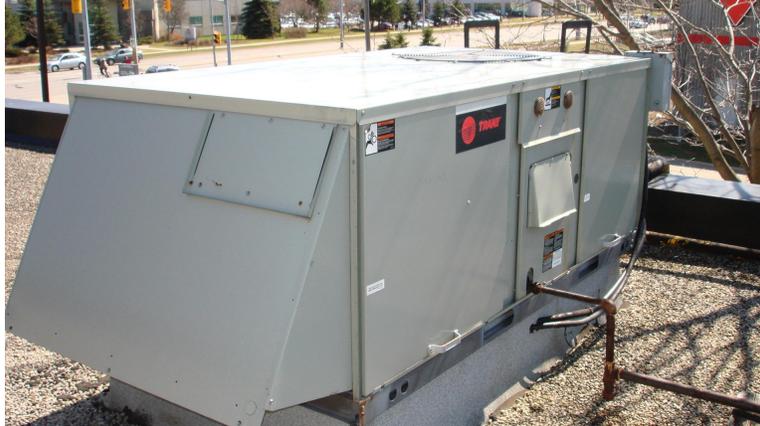
The building has one Trane roof top unit (model YCD049C3HABE), located on the roof. It is controlled by a wall-mounted thermostat, non-programmable type. The unit has a 97,200 BTU/Hr heating capacity at 81% efficiency and cooling capability using R-22 refrigerant. The unit is approximately nine years old and in fair condition.

Photo 19: Trane roof top unit, F3-AC-1

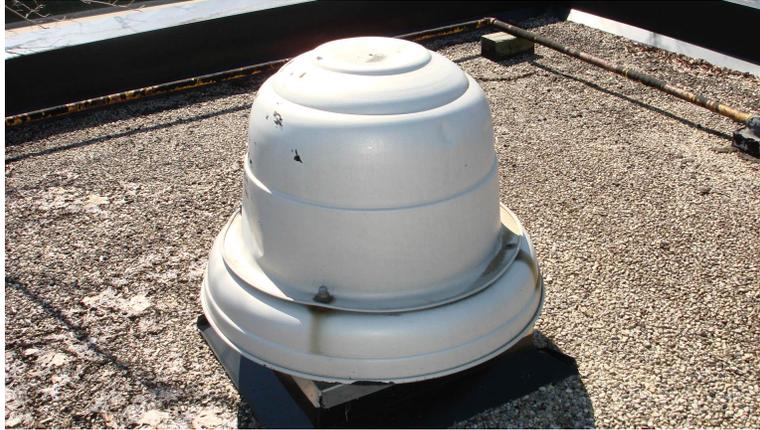
The fans F3-EF-1 and F3-EF-2 are approximately 30 years old and are in fair condition.

Photo 20: Exhaust fan, roof mounted

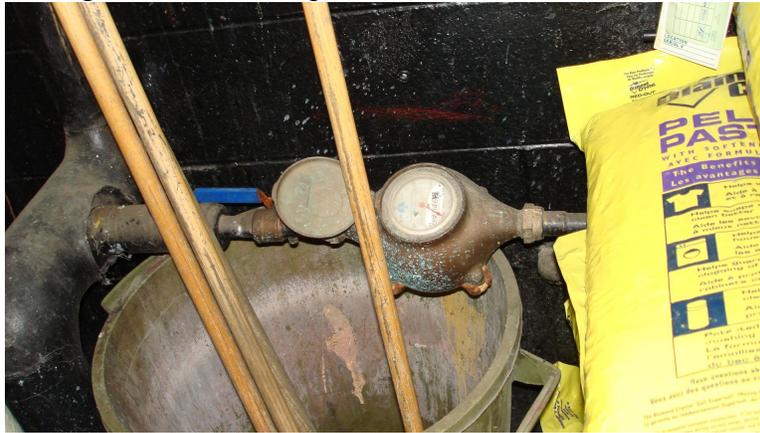
The city water is supplied on 1.5- inch copper pipe, the shut-off valve is a ball valve located in the apparatus area. The valve or meter appear to be leaking and should be replaced.

Photo 22: City water shut-off valve and water meter

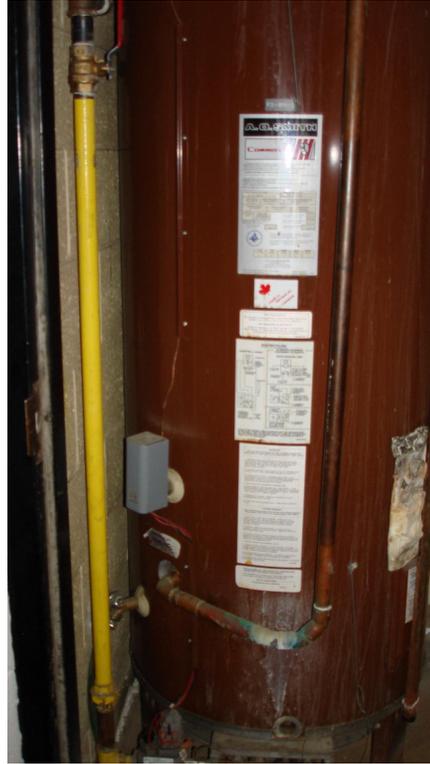
Domestic hot water is generated in a gas-fired hot water heater manufactured by A.O. Smith (model BT197-8805). The heater appeared to be approximately 12 years old and is in fair condition.

Photo 23: Gas-fired hot water heater, F3-WH-1

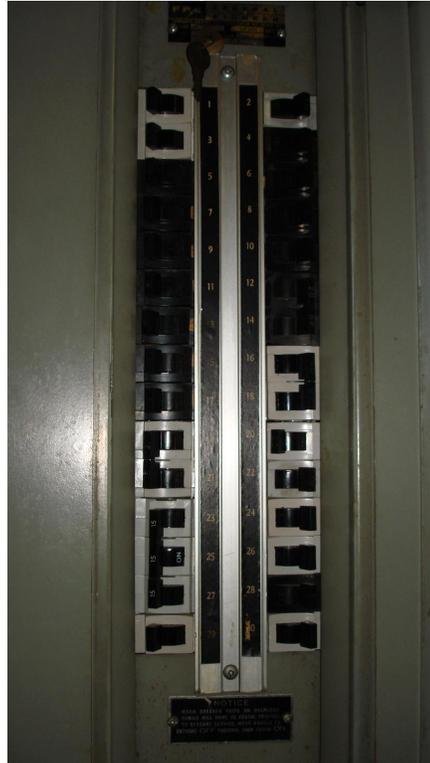
The panels are manufactured by Federal Pioneer. They are likely to be the age of the facility (31 years old), are properly labeled and appeared to be in fair condition. No power issues reported by maintenance staff or occupants of the facility.

Photo 27: Typical electrical panel

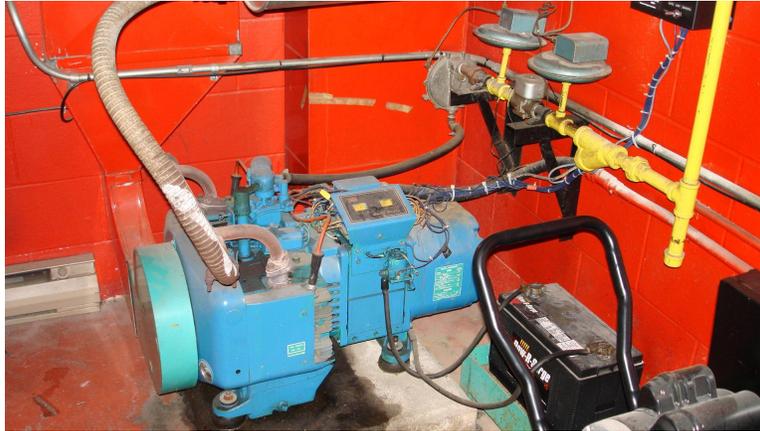
The emergency generator is an Onan Electric 5.0CCK-4R/8848R unit of estimated 5-kW capacity. The unit runs on natural gas and is located in the room adjacent to the apparatus area. It appears to be approximately 31 years old and is in fair condition.

Photo 32: Emergency generator F3-G-1, runs on natural gas

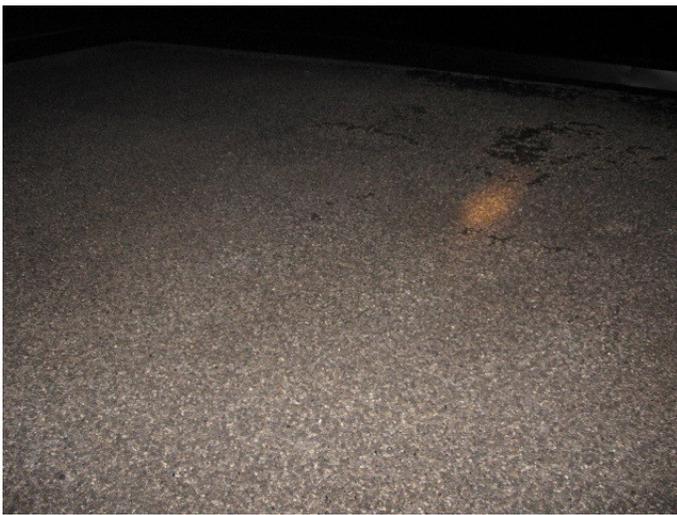
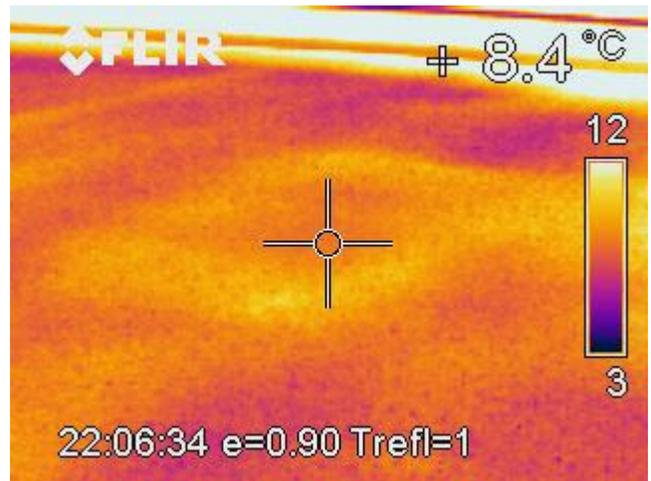
The IR survey identified a few small areas of possible wet insulation indicative of water leakage in the built-up roof areas. The roof surface appeared to be in good condition, considering its age. We were not informed of any current or previous roof leaks at or around these locations, and hence repairs are likely not warranted at this time. Aside from the roof replacement at the end of its service life indicated in the cost summary tables, no additional repairs are warranted.

**Figure 4:** Rectangular pattern of warmer area, indicative of wet insulation noted in the centre of the garage roof.
