**Heritage Guelph Meeting
12:00 noon – 2:00 pm
Monday, June 8, 2015
1 Carden St., City Hall**

CULTURAL HERITAGE CONSERVATION PLAN - STAGE 1

5 Arthur Street South, Guelph, Ontario

Issued: May 28, 2014
Revised: July 7, 2014
Revised with City Comments: May 5, 2015
Final Revision: June 2, 2015

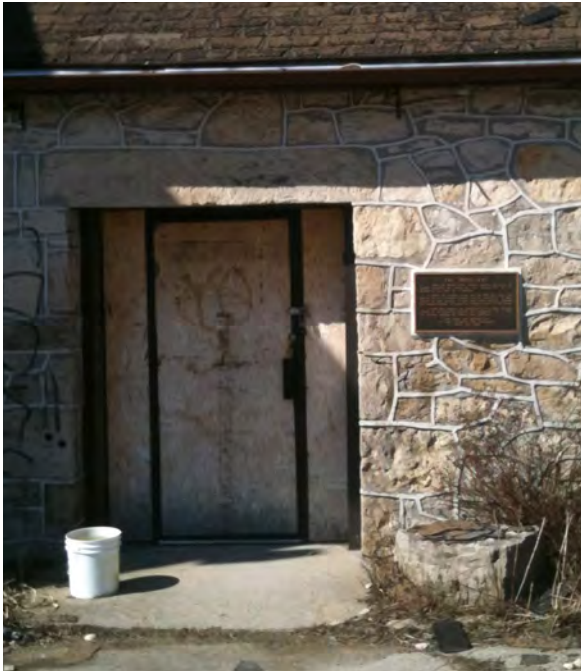
8. Building #1, door opening on East Elevation, 2014 (Source: ERA)

The building appears to be in sound condition. The accessible openings on the north and east elevation are protected with plywood and the entrance is locked. There is an eavestrough and downspout on the east elevation. There is no raingear at the west elevation.

1. No further preventative maintenance work is required for Building #1 at this time.
2. Provide no new raingear in the short-term as there is no evidence of water damage or infiltration, and access to install raingear on the west elevation is difficult due to the building's location directly adjacent to the Speed River.
3. Have a heritage building professional undertake an annual inspection of the building to ensure it remains secure and weather-tight. This is providing that ERA receives a quarterly update on any changes to the building condition and associated repairs.

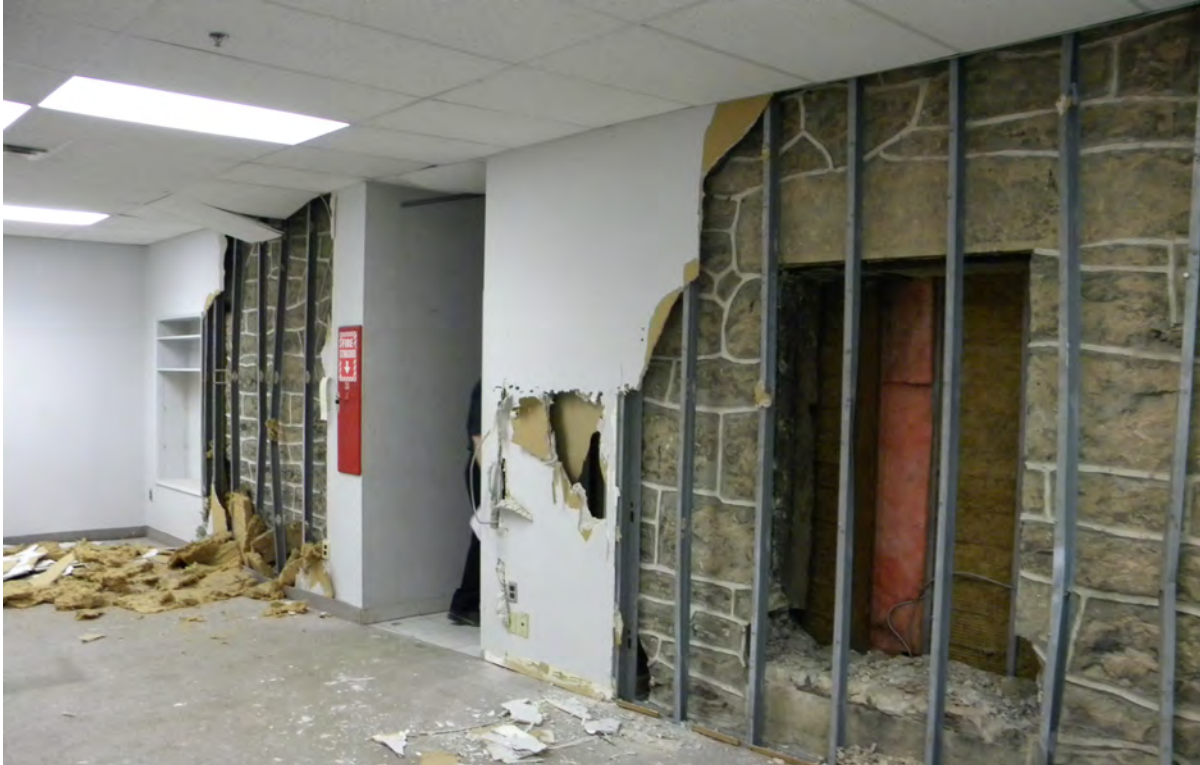
It should be noted that in undertaking the adaptive reuse or rehabilitation of the building, the removal of the brick addition at the east elevation to reveal the original exterior wall may be a reasonable removal (see figure 21). However, as the addition is meaningfully integrated with the original stone building and as the redevelopment plans have not been finalized, this Plan provides for the protection and maintenance of it.

21. Building #2a, East Elevation, original exterior wall (Source: City of Guelph)

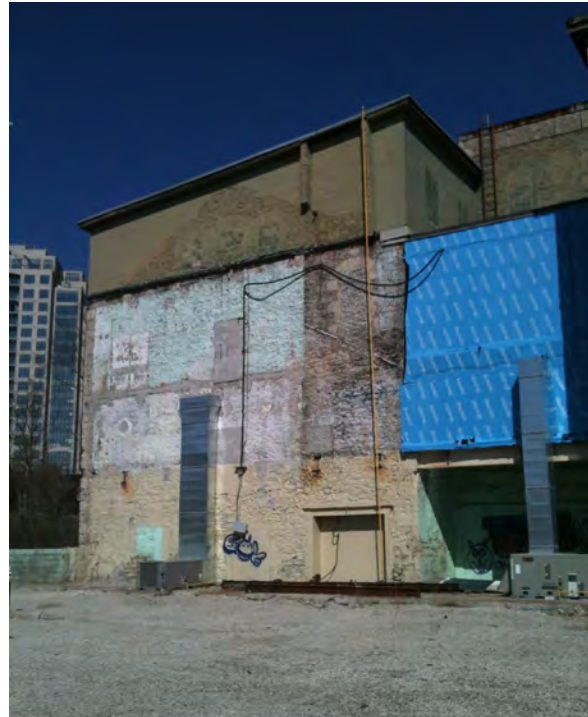
23. Building #2b, South Elevation (Source: ERA)

The building generally appears to be in sound condition. There are select areas of deteriorated mortar joints that require repair in the short-term. On the south elevation, areas suffering from

deterioration are either close to grade, at former building connection points or along cracks in the masonry (see figure 23 and the annotated drawings in Appendix 2). The accessible openings are protected with plywood and the door is locked. The building has no raingear.

1. In 2015, repoint identified areas of deteriorated mortar joints and cracks with a soft hydraulic lime-based mortar as specified by the heritage consultant and identified in the drawings.

- b) Clean out loose material in deteriorated joint and cut out to a minimum depth of $\frac{3}{4}$ " (19mm) prior to repointing.
 - c) Repoint with hydraulic lime mortar.

- d) New pointing should be finished to match the appearance of adjacent mortar joints in profile, colour and texture.
2. In 2015, repair the masonry surrounding exposed ends of steel beams as specified by the heritage consultant and identified in the drawings.

- c) Finish the rebate at the perimeter of the steel with a bead of sealant - Tremco Dymeric 240 or approved equal.
3. Provide no new raingear in the short-term as there is no evidence of water damage or infiltration, and access to install raingear on the west elevation is difficult due to the building's location directly adjacent to the Speed River.

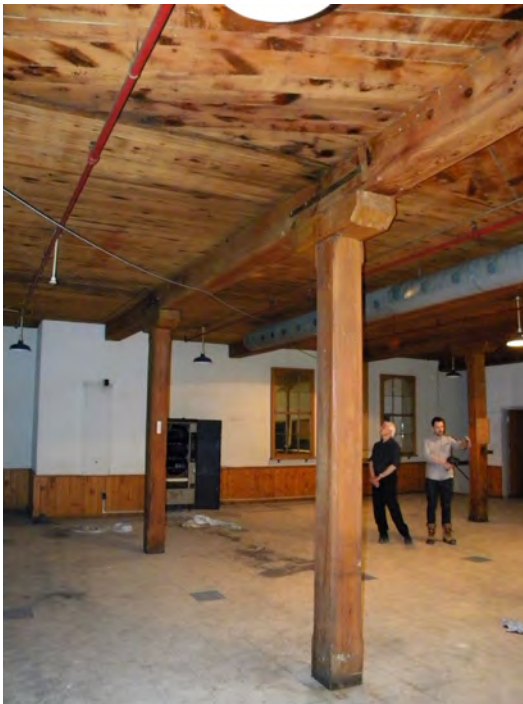
41. Building #2d, heavy timber structure. (Source: City of Guelph)

The building generally appears to be in sound condition. There are select areas of deteriorated mortar joints that require repair in the short-term. The areas of deterioration are either close to grade, at former building connection points or along cracks (as indicated on the annotated drawings). The brick chimney displays spalled bricks and deteriorated mortar joints, most notably at the upper 4'-0" (1200mm) (see figure 41). The building has limited raingear.

1. In 2015, repoint identified areas of deteriorated mortar joints and cracks with a soft hydraulic lime-based mortar as specified by the heritage consultant and identified in the drawings..
 - a) Remove paint from masonry at areas of work. Acceptable cleaning methods include a low pressure hot water wash or, if required, Peel Away Smart Strip by Dumond.
 - b) Clean out loose material in deteriorated joint and cut out to a minimum depth of $\frac{3}{4}$ " (19mm) prior to repointing.
 - c) Repoint with hydraulic lime mortar.
 - d) New pointing should be finished to match the appearance of adjacent mortar joints in profile, colour and texture.

2. In 2015, repair the masonry surrounding exposed ends of steel beams as specified by the heritage consultant and identified in the drawings.
 - a) Openings in the masonry surrounding the steel beams are to be filled with a soft mortar pack and finished with a weather joint profile.

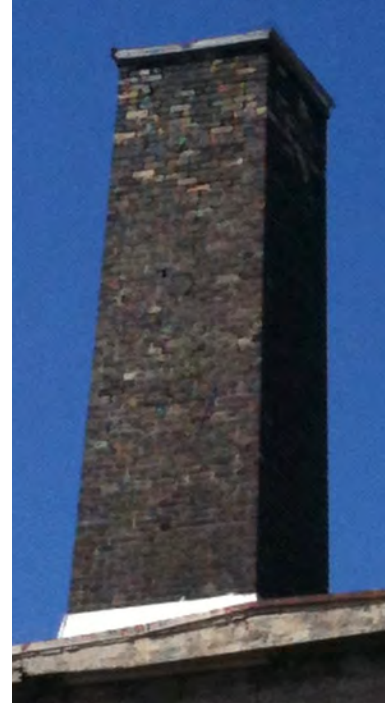
43. Building #2d, chimney (Source: ERA)

5. In 2015, document and dismantle the top 15 brick courses of the chimney, salvaging bricks for reconstruction. Repoint open brick joints in the top course from above. Provide 3/4" (19mm) exterior grade plywood with waterproof membrane with drop flashing at low edge. Provide vent with insect screen along top edge. Slope to drain on main building roof. *** Coordinate with staff if found to be 'Chimney Swift' bird habitat.

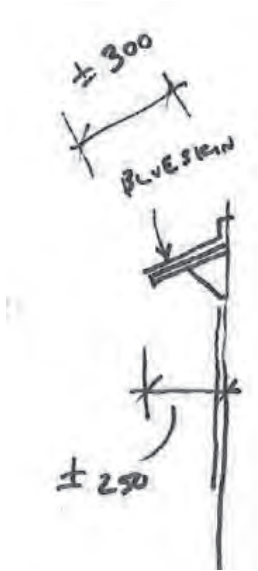
44. Section detail of temporary wood hood. (Source: ERA)

3. In 2015, provide a downspout at the eavestrough on the south elevation as the mortar joints below downspout connection are deteriorating.
4. In 2015, provide protection at "General Office" sign (see figure 44).
