**Tree Inventory and Preservation Plan  
1 Clair Road East  
Guelph, Ontario**

**SvN Architects + Planners  
110 Adelaide Street East  
Toronto, Ontario  
M5C 1L7**

29 November 2023

KUNTZ FORESTRY CONSULTING INC. Project P4032

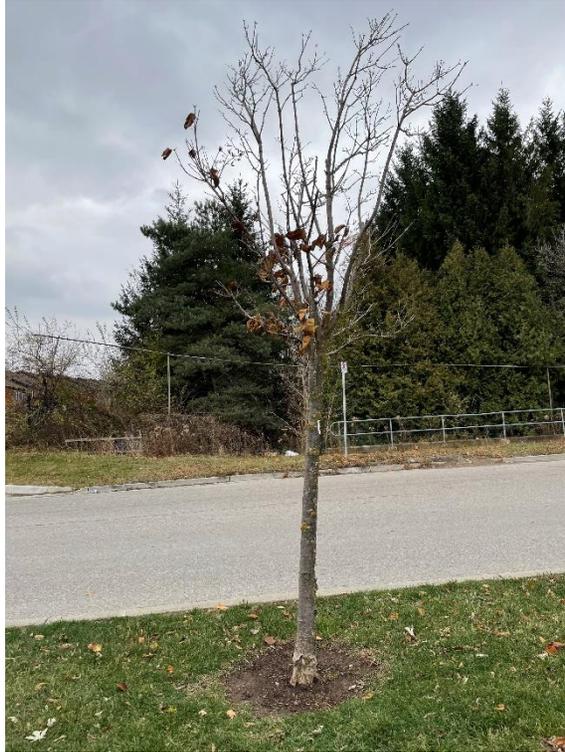
Image 14. Tree 476

476	Japanese Flowering Lilac	<i>Syringa reticulata</i>	8	P	P	P	50	1.2	1	2	Lean (M), stem wounds (H), decay (M) in trunk	City	Remove
477	Japanese Flowering Lilac	<i>Syringa reticulata</i>	10	F	F	F	20	1.8	1	2	Lean (M)	City	Remove
478	Japanese Flowering Lilac	<i>Syringa reticulata</i>	9.5	G	FG	F	10	1.2	1	2		City	Remove
479	Hackberry	<i>Celtis occidentalis</i>	13	G	G	G		1.8	1	2		Subject Site	Remove
480	Japanese Flowering Lilac	<i>Syringa reticulata</i>	11	F	FG	FG	10	1.8	1	2	Stem wounds (M) from torn out branch	Subject Site	Remove
481	Japanese Flowering Lilac	<i>Syringa reticulata</i>	11	F	F	F	10	1.8	1	2	Seam (M) with decay (L), lean (L)	Subject Site	Remove
482	Japanese Flowering Lilac	<i>Syringa reticulata</i>	11.5	FG	G	G		1.8	2	3	Lean (L)	City	Remove
483	Japanese Flowering Lilac	<i>Syringa reticulata</i>	10	P	PF	P	30	1.8	1	2	Lean (L), decay (H) in trunk	City	Remove
484	Japanese Flowering Lilac	<i>Syringa reticulata</i>	10.5	F	F	F	10	1.8	1	2	Seam (L), lean (L), epicormic branching (L)	City	Remove

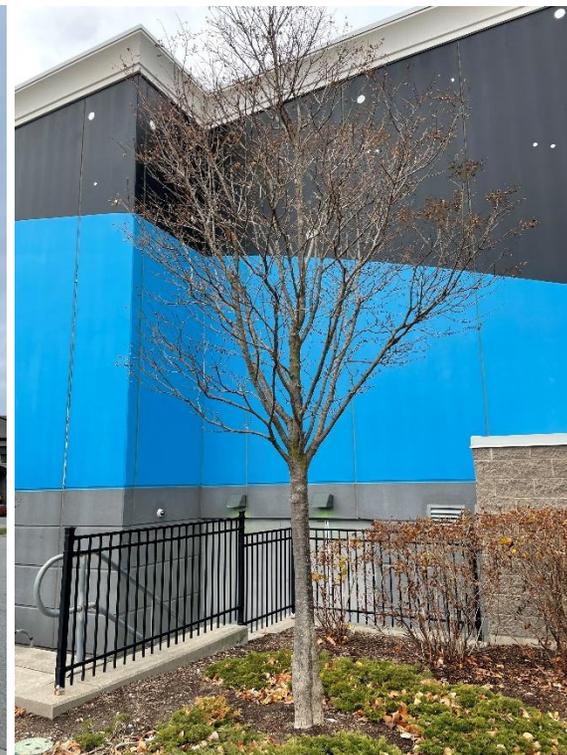
Image 22. Tree 485

485	Japanese Flowering Lilac	<i>Syringa reticulata</i>	11.5	F	G	G		1.8	1	2	Seam (M), basal swell	Subject Site	Remove
486	Japanese Flowering Lilac	<i>Syringa reticulata</i>	13	FG	F	FG		1.8	1	2	Lean (L), broken branches (M)	Subject Site	Preserve
487	Japanese Flowering Lilac	<i>Syringa reticulata</i>	11.5	G	G	G		1.8	1	2		Subject Site	Preserve (Injure)
488	Red Maple	<i>Acer rubrum</i>	12	FG	G	G		1.8	2	3	Exposed roots (L) with wounds	Subject Site	Remove
489	Red Maple	<i>Acer rubrum</i>	10	FG	G	G		1.8	2	3	Exposed roots (L)	Subject Site	Remove
490	Red Maple	<i>Acer rubrum</i>	10.5	FG	G	G		1.8	2	3	Exposed roots (L) with wounds	Subject Site	Remove
491	Red Maple	<i>Acer rubrum</i>	11	G	FG	G		1.8	2	3	Broken branches (L)	Subject Site	Remove
492	Japanese Flowering Lilac	<i>Syringa reticulata</i>	10	F	G	F		1.8	1	2	Stem wounds (M) with decay (L)	Subject Site	Remove
493	Silver Maple	<i>Acer saccharinum</i>	11.5	FG	FG	FG		1.8	2	3	Bow (L), epicormic branching (L)	Shared (Subject Site / City)	Remove

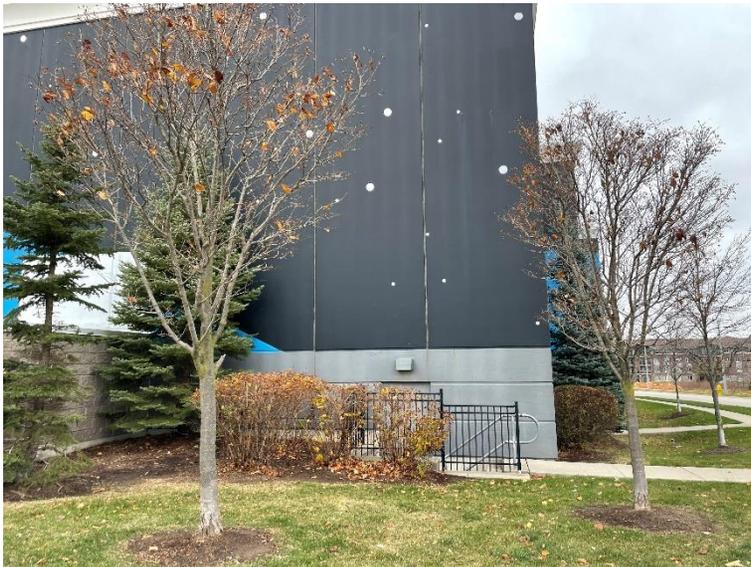
Image 23. Trees 486 (left) and 487 (right)

Minor encroachment into the mTPZ of Tree 487 will be required to install a proposed sidewalk. Tree preservation fencing has been prescribed at the anticipated limit of encroachment within the mTPZ of Tree 487. Any excavation to occur within the mTPZ of Tree 487 for the installation of the proposed sidewalk should be supervised by a Certified Arborist. Any roots exposed during the excavation process should be pruned by a Certified Arborist in accordance with Good Arboricultural Standards.

The preservation of five trees, identified as Trees 486, 487, and P – R, will be possible with the use of appropriate tree protection measures as indicated on Figure 1. Tree protection measures must be implemented prior to the commencement of the proposed work to ensure tree resources designated for retention are not impacted. Refer to Figure

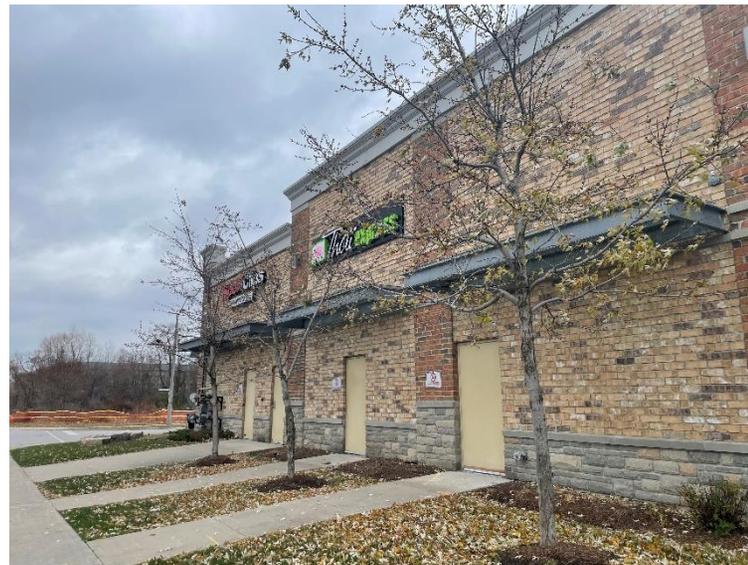
Image 29. From far to near, Trees 493 – 495

494	Silver Maple	<i>Acer saccharinum</i>	10	P	FG	PF		1.8	1	2	Lean (L), stem wounds (M) with decay (H), epicormic branching (L)	Shared (Subject Site / City)	Remove
495	Silver Maple	<i>Acer saccharinum</i>	12	FG	FG	F	10	1.8	3	4	Crook (L)	Shared (Subject Site / City)	Remove
496	Silver Maple	<i>Acer saccharinum</i>	10.5	F	F	F	10	1.8	3	4	Bow (M), asymmetrical crown (M)	Shared (Subject Site / City)	Remove
497	Silver Maple	<i>Acer saccharinum</i>	13	FG	FG	G		1.8	3	4	Bow (L), asymmetrical crown (L)	Shared (Subject Site / City)	Remove
498	Silver Maple	<i>Acer saccharinum</i>	14	G	FG	FG		1.8	3	4	Epicormic branching (L)	Shared (Subject Site / City)	Remove
499	Silver Maple	<i>Acer saccharinum</i>	13	FG	FG	FG		1.8	3	4	Bow (L), epicormic branching (L)	Subject Site	Remove
500	Silver Maple	<i>Acer saccharinum</i>	14	F	G	FG		1.8	3	4	Stem wounds (L), crook (L), basal swell	Subject Site	Remove
A	Blue Spruce	<i>Picea pungens</i>	~12	G	G	G		1.8	1	2		Subject Site	Remove

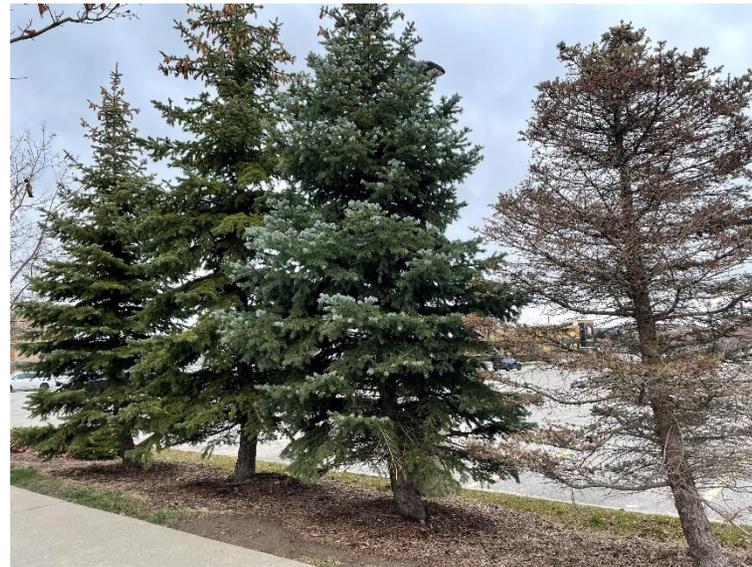
Image 36. From left to right, Trees L – O

M	Blue Spruce	<i>Picea pungens</i>	~14	G	G	G		1.8	2	3		Subject Site	Remove
N	Blue Spruce	<i>Picea pungens</i>	~14	FG	G	G		1.8	1	2	Sweep (L)	Subject Site	Remove
O	Blue Spruce	<i>Picea pungens</i>	~10	P	P	P	90	1.8	1	2	Moribund, sweep (M)	Subject Site	Remove
P	Blue Spruce	<i>Picea pungens</i>	~16	FG	G	G		1.8	1	2	Lean (L)	Subject Site	Preserve

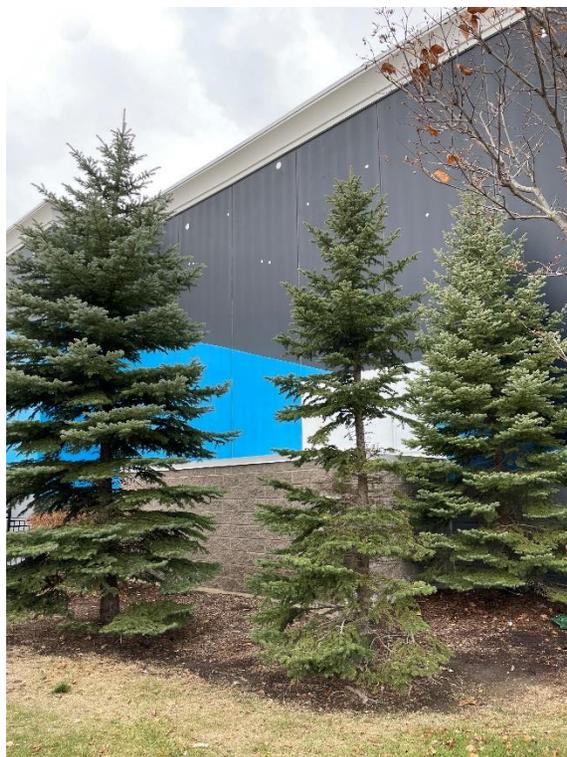
Image 37. From left to right, Trees P – R

Q	Blue Spruce	<i>Picea pungens</i>	~10	FG	PF	PF	40	1.8	1	2	Sweep (L)	Subject Site	Preserve
R	Blue Spruce	<i>Picea pungens</i>	~16	G	G	G		1.8	1	2		Subject Site	Preserve
S	Blue Spruce	<i>Picea pungens</i>	~20	G	G	G		1.8	1	2		Subject Site	Remove
T	Blue Spruce	<i>Picea pungens</i>	~14	G	FG	F	10	1.8	1	2		Subject Site	Remove
U	Blue Spruce	<i>Picea pungens</i>	~20	G	G	G		1.8	1	2		Subject Site	Remove
V	Blue Spruce	<i>Picea pungens</i>	~24	G	G	G		1.8	1	2		Subject Site	Remove
W	Blue Spruce	<i>Picea pungens</i>	~20	G	G	G		1.8	1	2		Subject Site	Remove
X	Blue Spruce	<i>Picea pungens</i>	~20	FG	G	G		1.8	2	3	Sweep (L)	Subject Site	Remove
Y	Blue Spruce	<i>Picea pungens</i>	~20	FG	G	G		1.8	1	2	Sweep (L)	Subject Site	Remove
Z	Blue Spruce	<i>Picea pungens</i>	~18	G	FG	F	10	1.8	1	2		Subject Site	Remove
AA	Blue Spruce	<i>Picea pungens</i>	~12	F	F	F	20	1.8	1	2	Sweep (M)	Subject Site	Remove
AB	Blue Spruce	<i>Picea pungens</i>	~10	FG	PF	PF	40	1.8	1	2	Sweep (L), epicormic branching (L)	Subject Site	Remove
