# Memorandum

To: Prasoon Adhikari, City of Guelph  
*B*  
Ref. No.: 11176407

**Subject: Tree Inventory and Recommendations  
Goldie Mill Ruins, Guelph, Ontario**

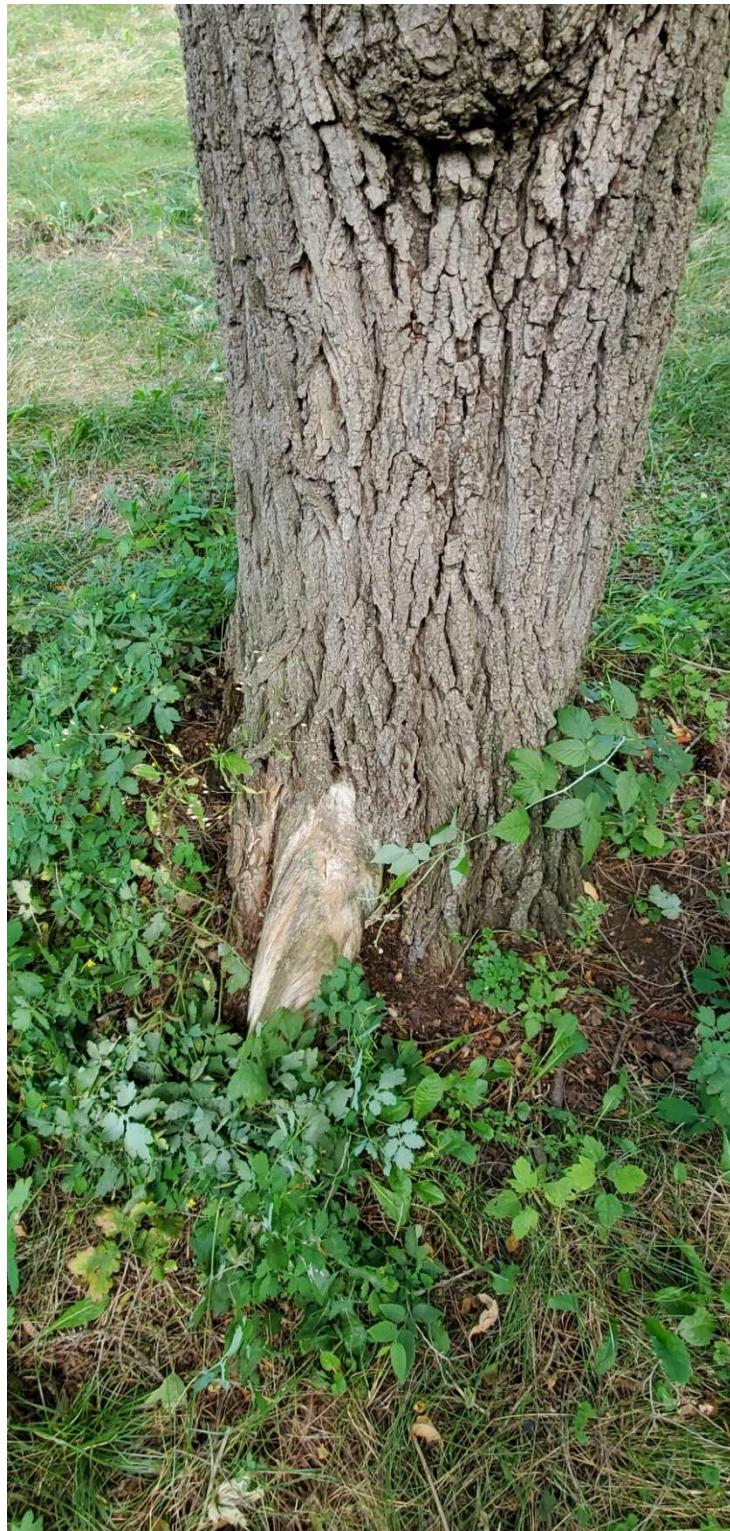
Photo 1 - Northwest-facing view of trunk of tree 704 (proposed for removal). Note dead root pointing southwards.

- Tree 704 – Siberian Elm: poor condition, anticipated poor stability and risk to building, trail and park users
- Tree 706 – Siberian Elm: poor condition, anticipated poor stability and risk to building, trail and park users
- Tree 711 – Manitoba Maple: healthy condition, anticipated poor stability and risk to building, trail and park users
- Tree 722 – Austrian Pine: poor condition and diseased, tree death anticipated
- Tree 723 – Austrian Pine: poor condition and diseased, tree death anticipated
- Tree 724 – Austrian Pine: poor condition, tree death anticipated

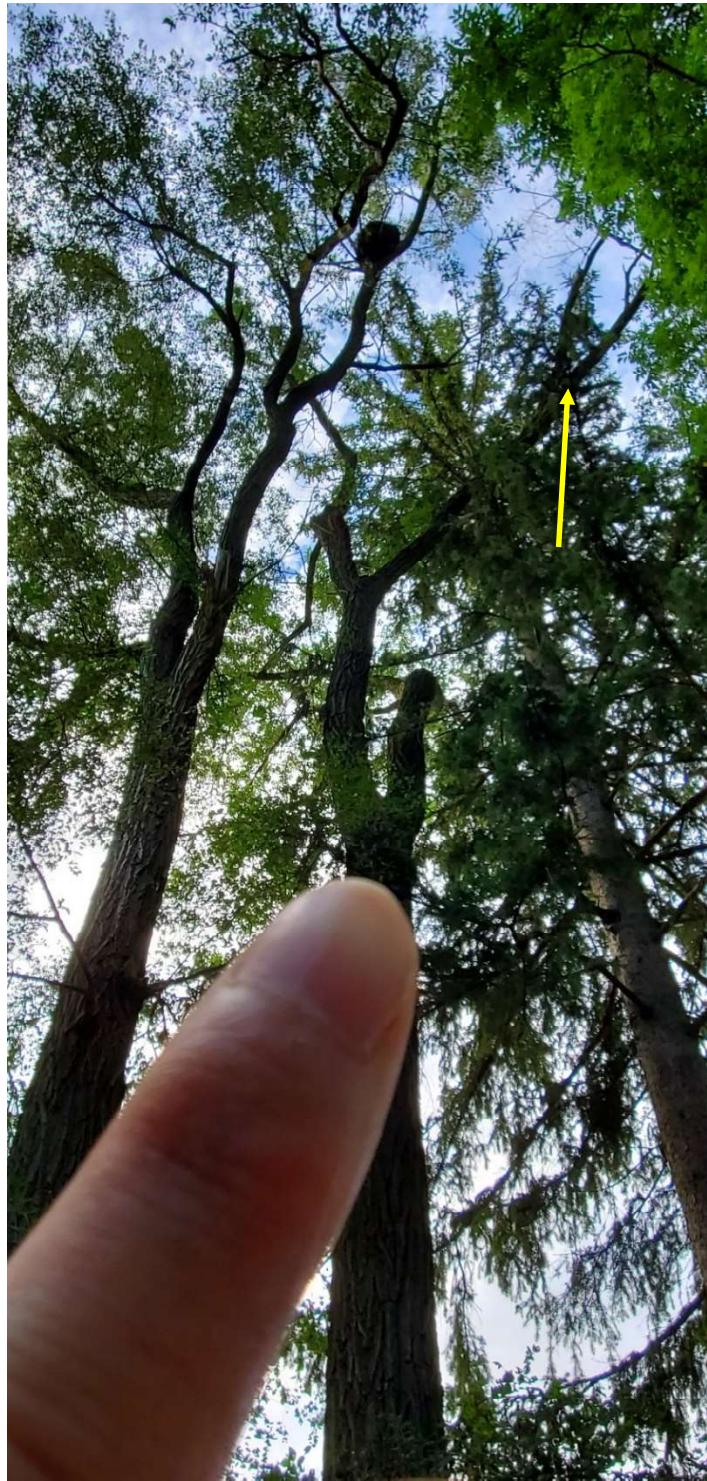
Photo 2 - South-facing view of canopy of tree 704 (proposed for removal). Note poor structure in codominant leaders and dead limb pointing northwards (yellow arrow).

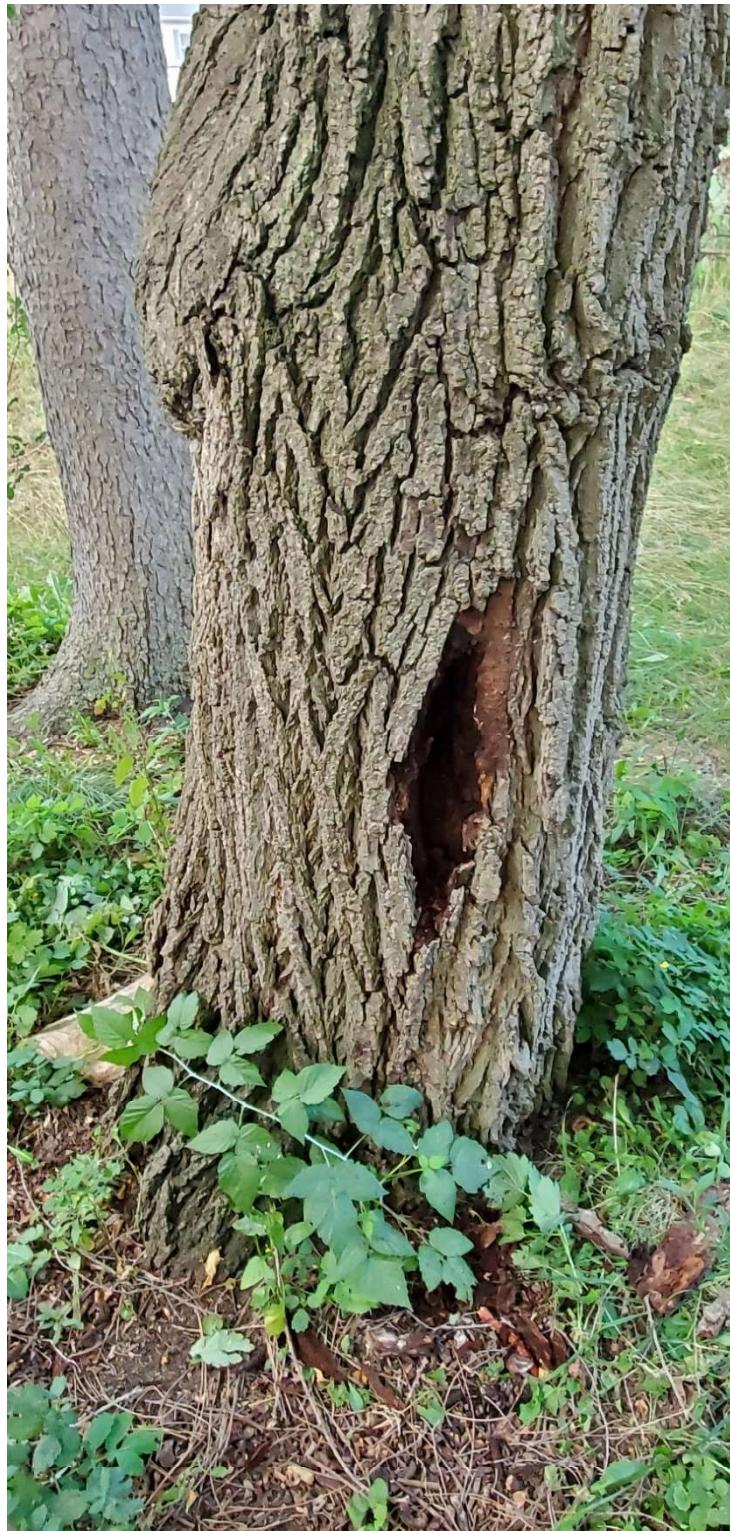
Photo 3 - West-facing view of trunk of tree 704 (proposed for removal). Note large wound that is approximately 5 cm deep.

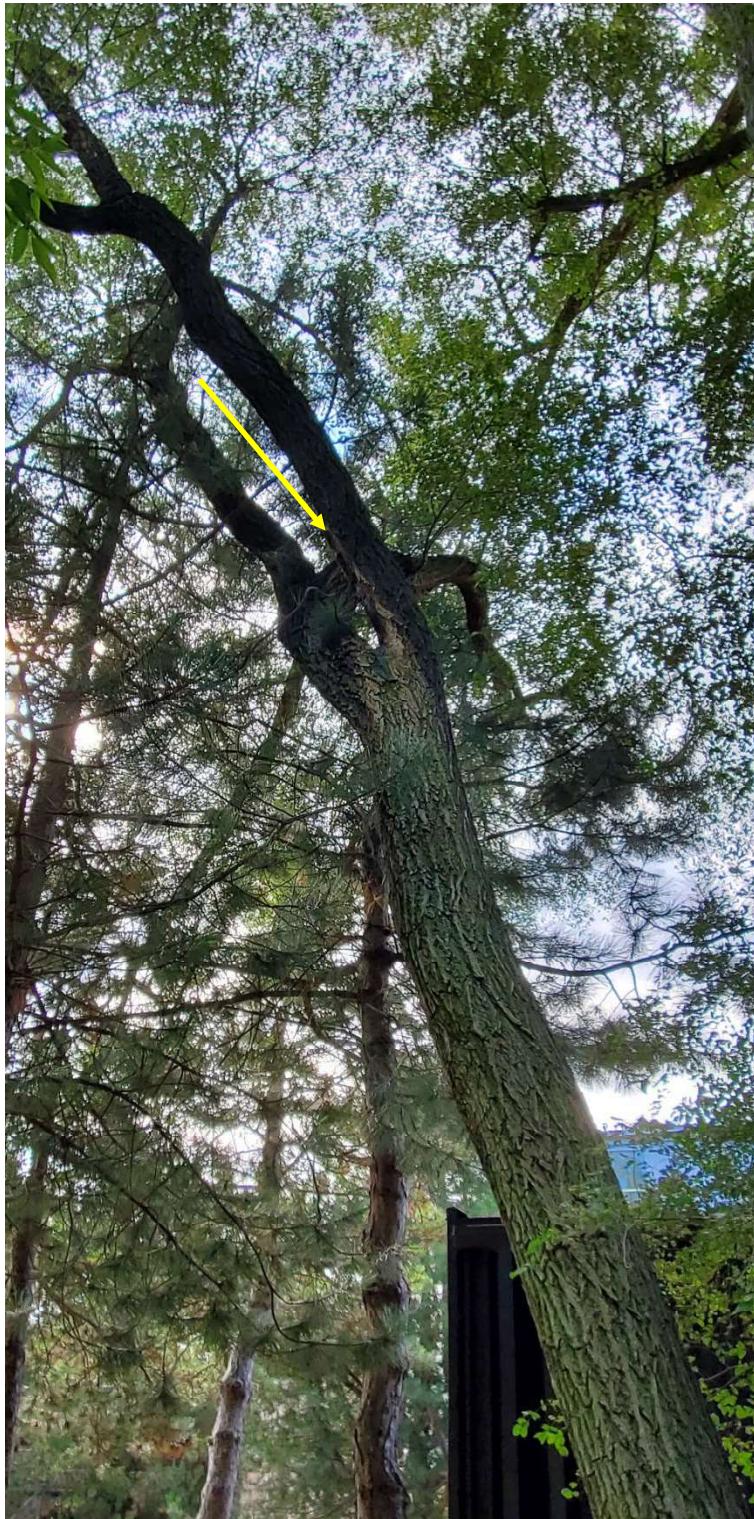
Photo 4 - South-facing view of canopy of tree 706 (proposed for removal). Note strong east lean and rot in canopy (yellow arrow).

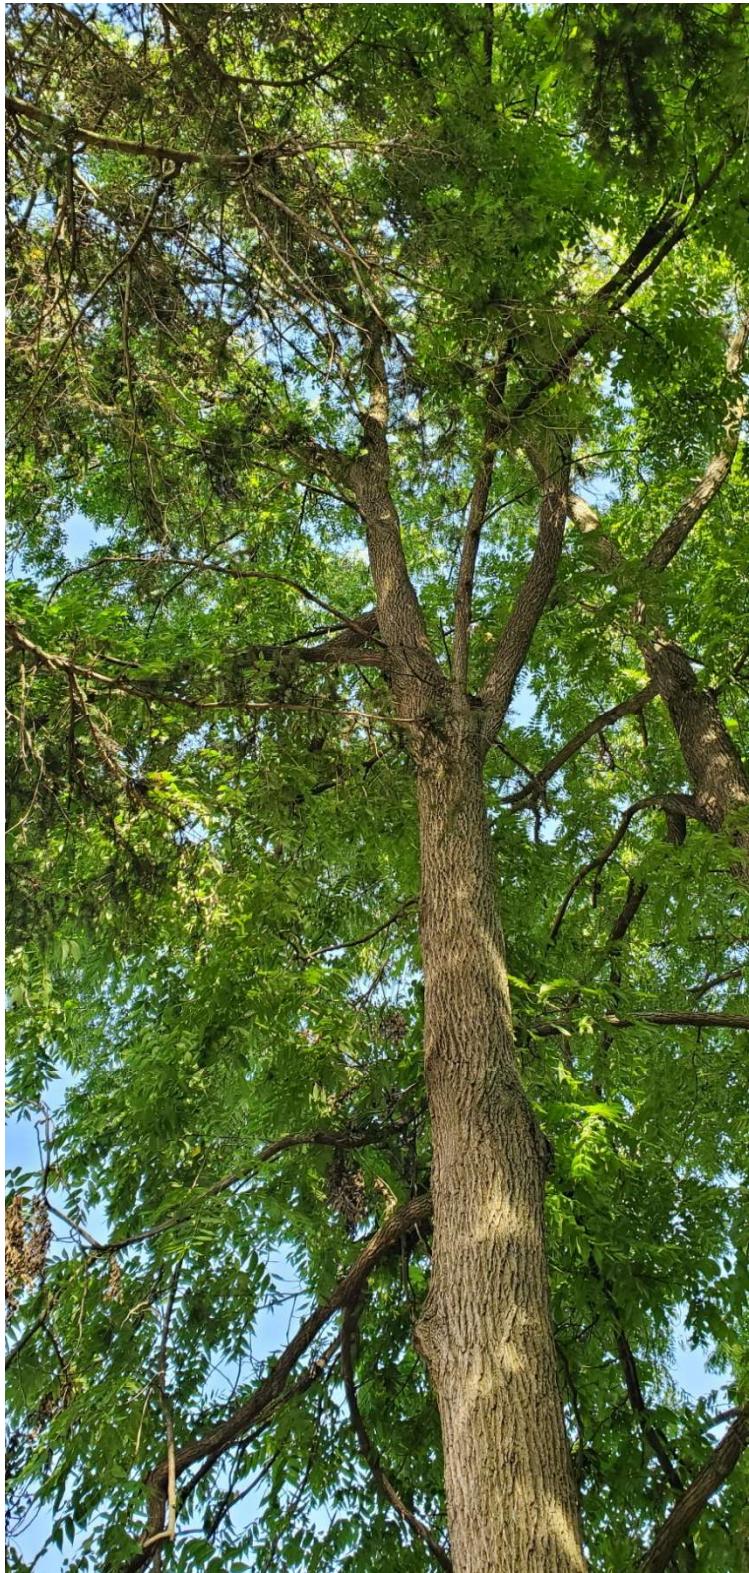
Photo 5 - Northwest-facing view of canopy of tree 708 (proposed to be retained).

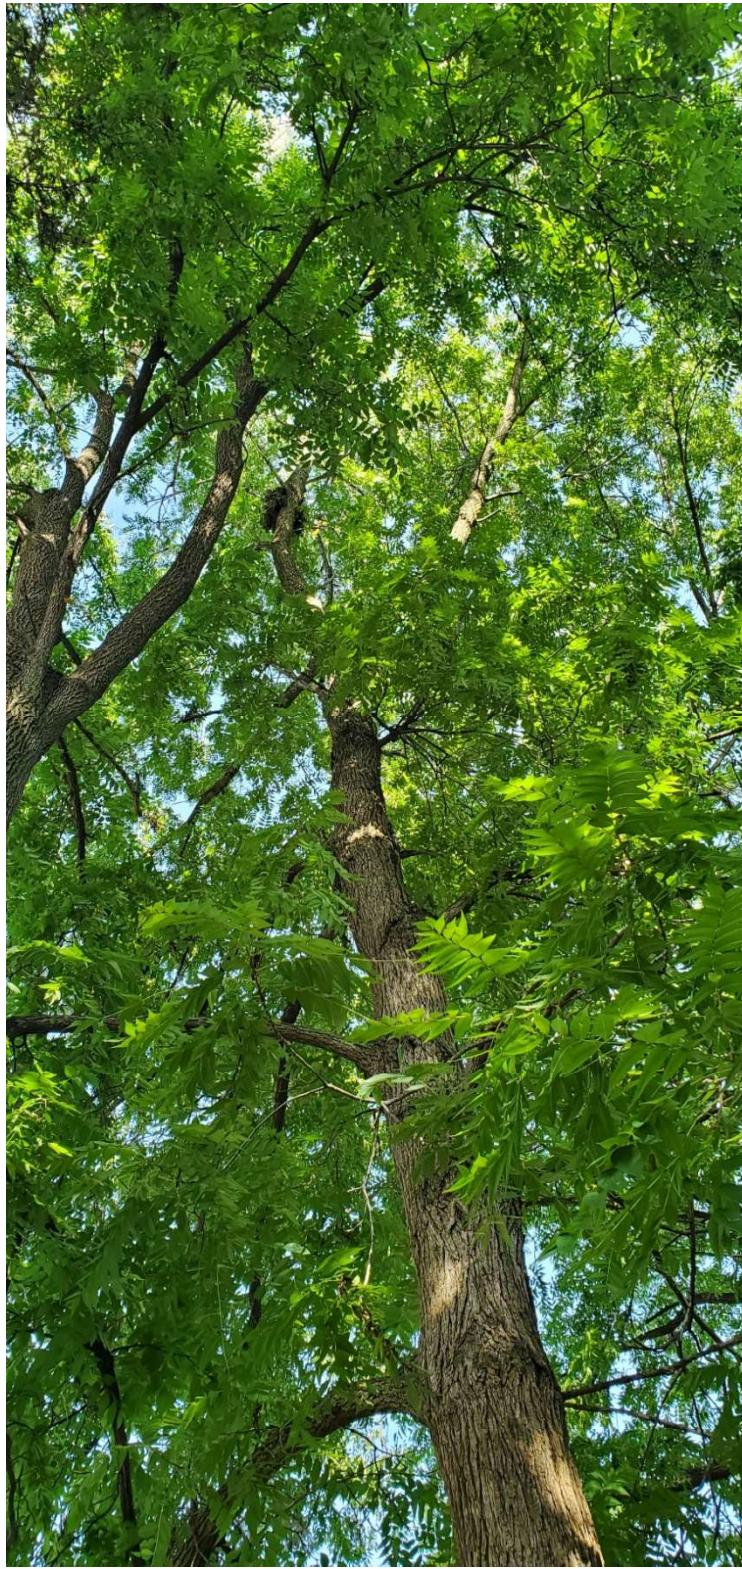
Photo 6 - North-facing view of canopy of tree 709 (proposed to be retained).

709	Black Walnut	<i>Juglans nigra</i>	40.6	5	6	Fair-Good	Fair	Fair-Good	Healthy	Preserve - Do not excavate within 1.0 m of trunk. Hydrovac or hand dig between 1.0 and 6.0 m from trunk. Work around exposed roots and do not allow roots to dry once exposed.	Tree is in sufficiently good condition to recover from recommended remediation method and taproot will provide structure during soil replacement. Approximately 60% of root system located within remediation zone, based on the tree protection zone radius.
710	Austrian Pine	<i>Pinus nigra</i>	27.2	3	4	Fair-Good	Fair-Good	Fair-Good	Healthy	Preserve - Preservation recommendations for Tree 705 and 707 will mitigate injury to this tree	Tree is in sufficiently good condition to recover from recommended remediation method and minimal injury to roots is anticipated (<5%). Approximately 5% of root system located within remediation zone, based on the tree protection zone radius.

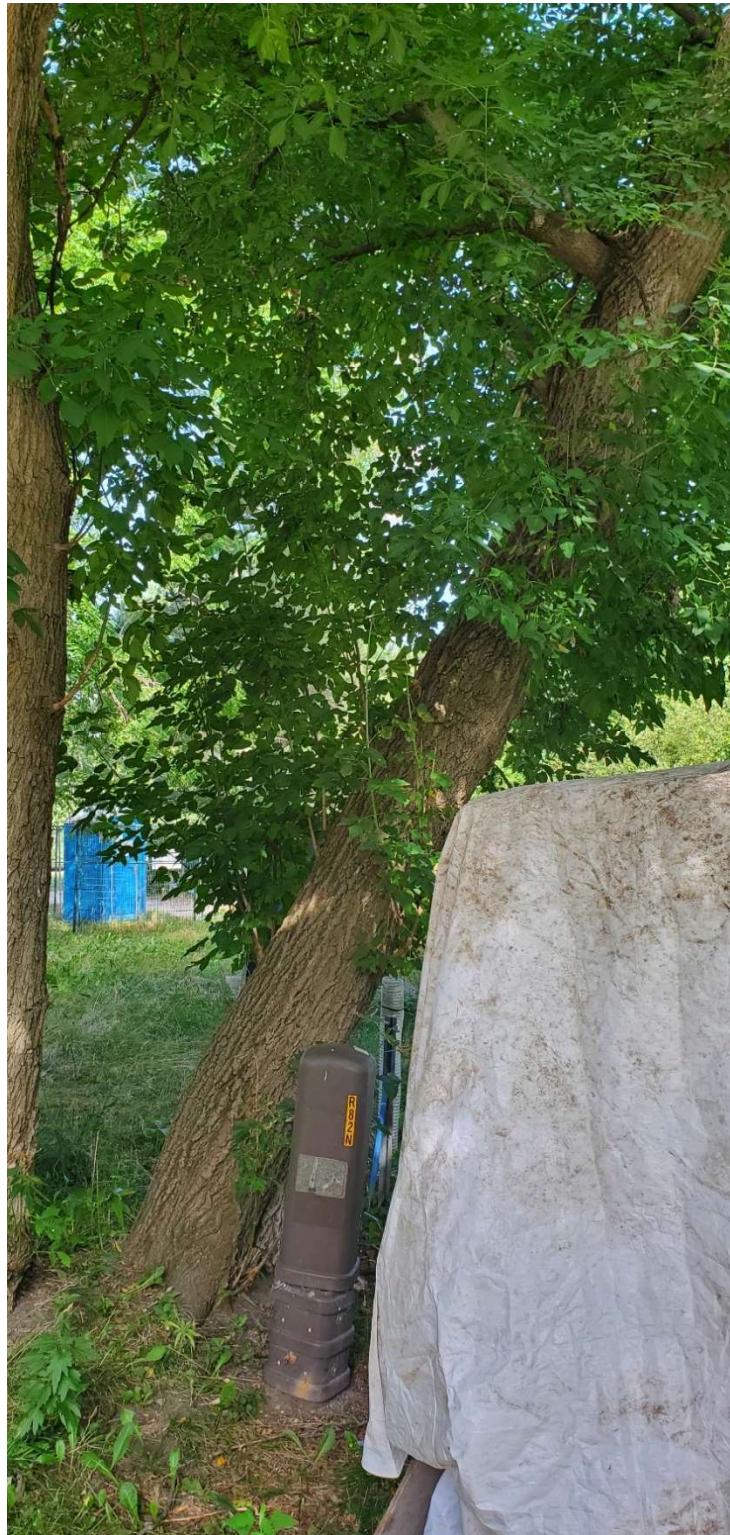
711	Manitoba Maple	<i>Acer negundo</i>	47.6, 37.2	10	11	Poor-Fair	Fair	Fair-Good	Healthy with Poor Structure	Remove	Tree has strong east-northeast lean. Removal of soil/material to the west will likely cause tree to destabilize and fail. Crown reduction may mitigate lean; however, this may result in significant epicormic growth around pruning cuts and produce poor canopy structure and increased loading. It is assumed that 80% of the root zone is within the excavation limits, based on the tree protection zone radius. Roots may have been impacted previously during installation of stone chip trail.
712	Black Walnut	<i>Juglans nigra</i>	33.1	4	5	Good	Fair-Good	Fair-Good	Healthy	Preserve - Do not excavate within 1.0 m of trunk. Hydrovac or hand dig between 1.0 and 5.0 m from trunk. Work around exposed roots and do not allow roots to dry once exposed.	Tree is in sufficiently good condition to recover from recommended remediation method and taproot will provide structure during soil replacement. Approximately 70-80% of the root system is located within the remediation excavation zone, based on the tree protection zone radius.

Photo 7 - Northwest-facing view of trunk of tree 711 (proposed for removal). Note strong lean in north stem.

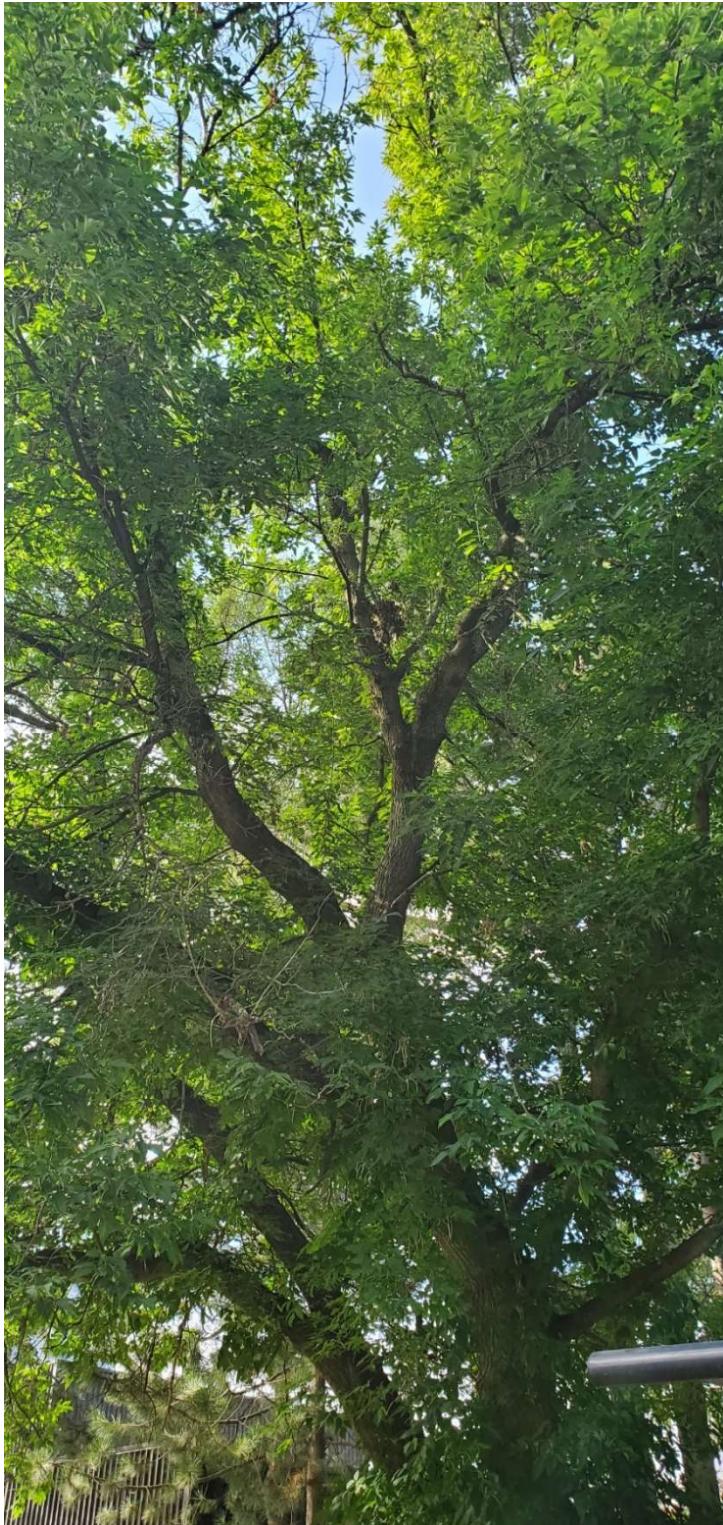
Photo 8 - Southwest-facing view of canopy of tree 711 (proposed for removal).  
Note presence of deadwood in canopy and included bark in unions.

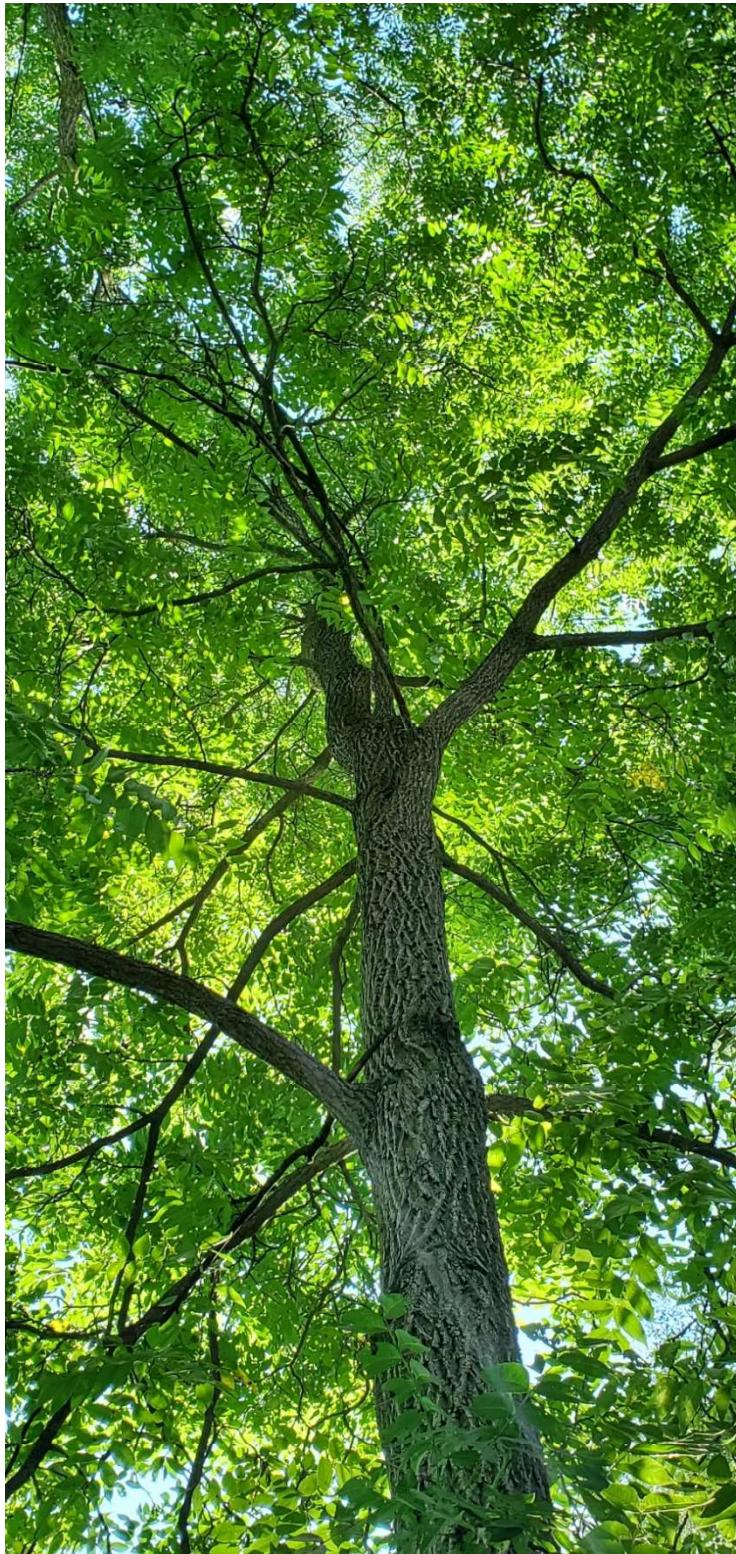
Photo 9 - North-facing view of canopy of tree 712 (proposed to be retained).

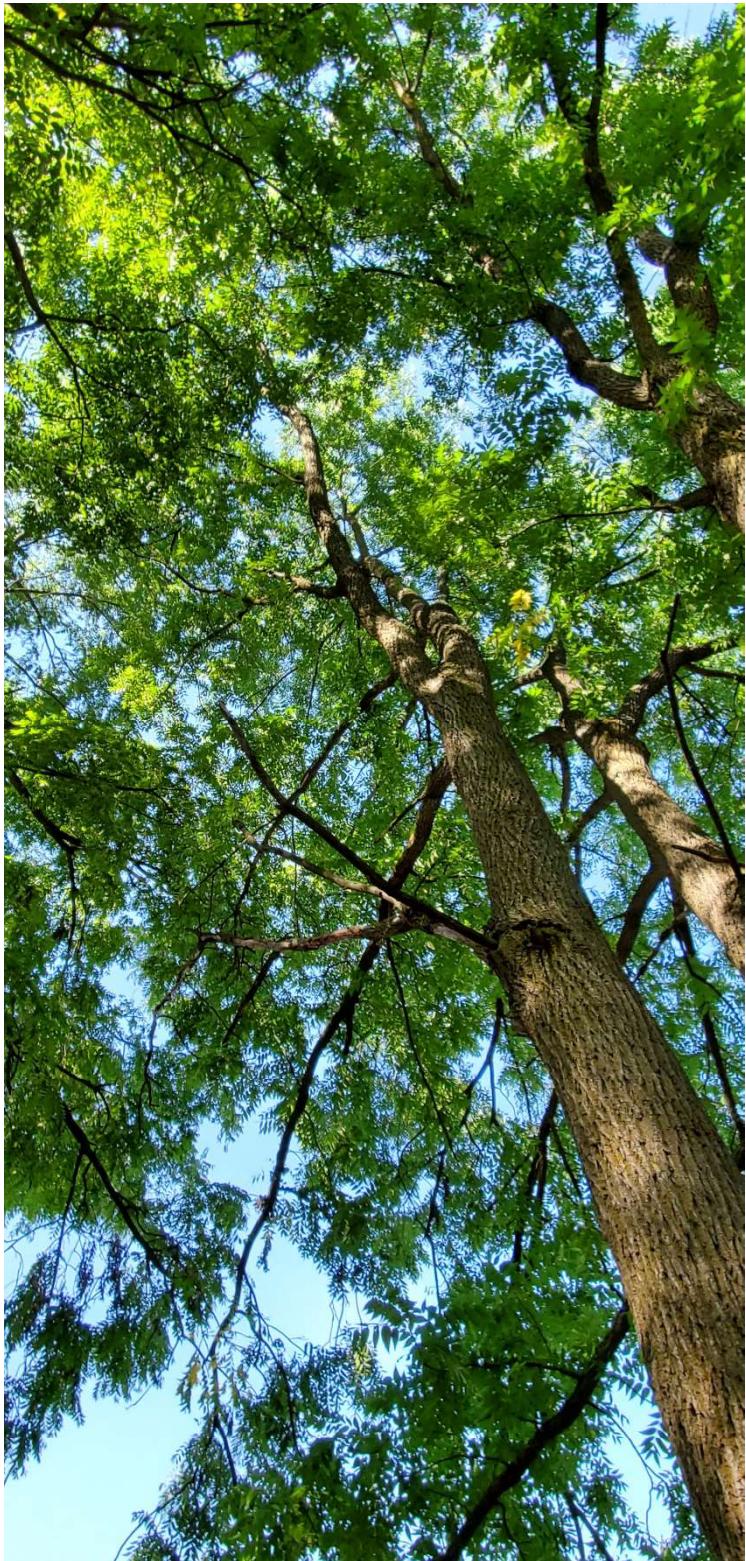
Photo 10 - North-facing view of west canopy of tree 713 (proposed to be retained).

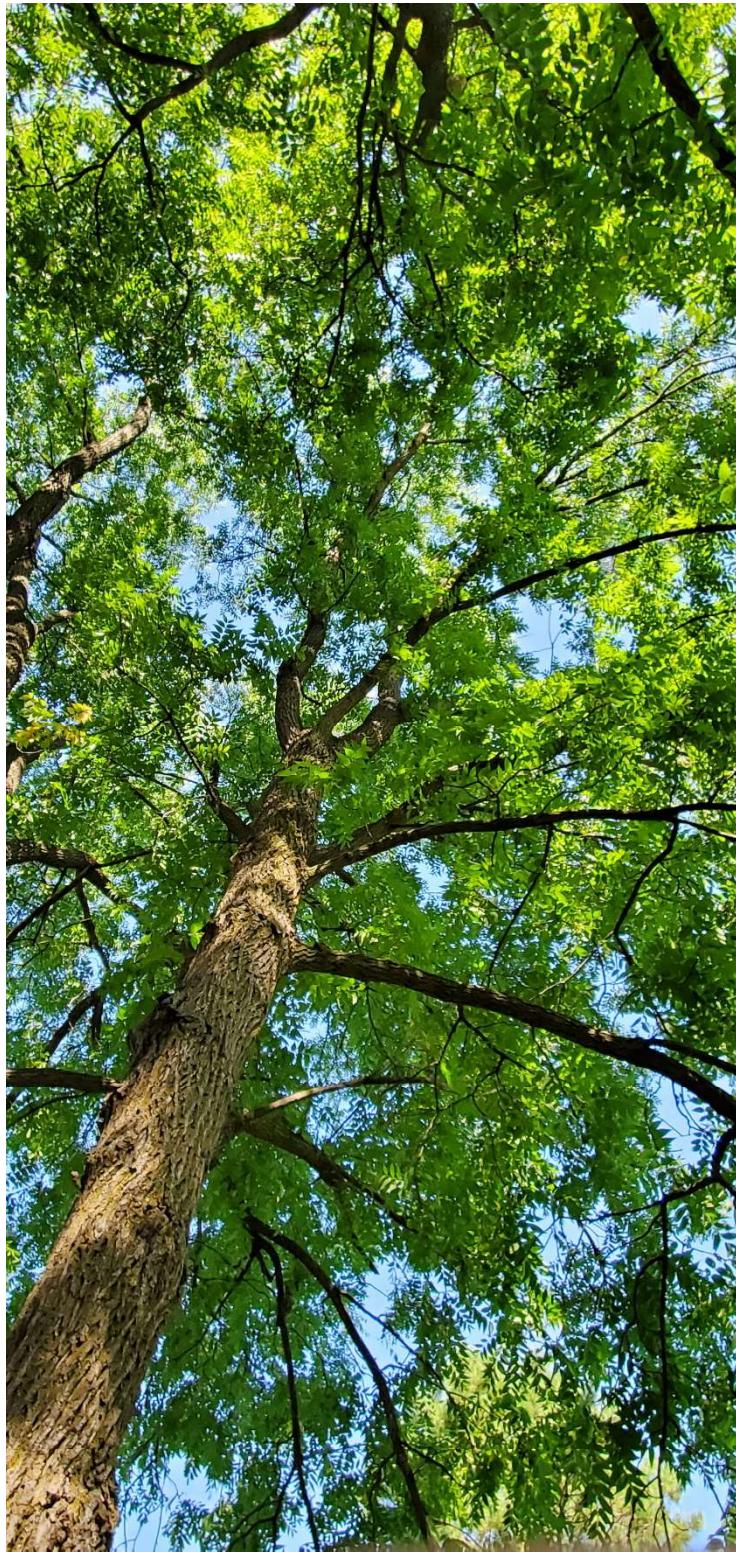
Photo 11 - North-facing view of east canopy of tree 713 (proposed to be retained).

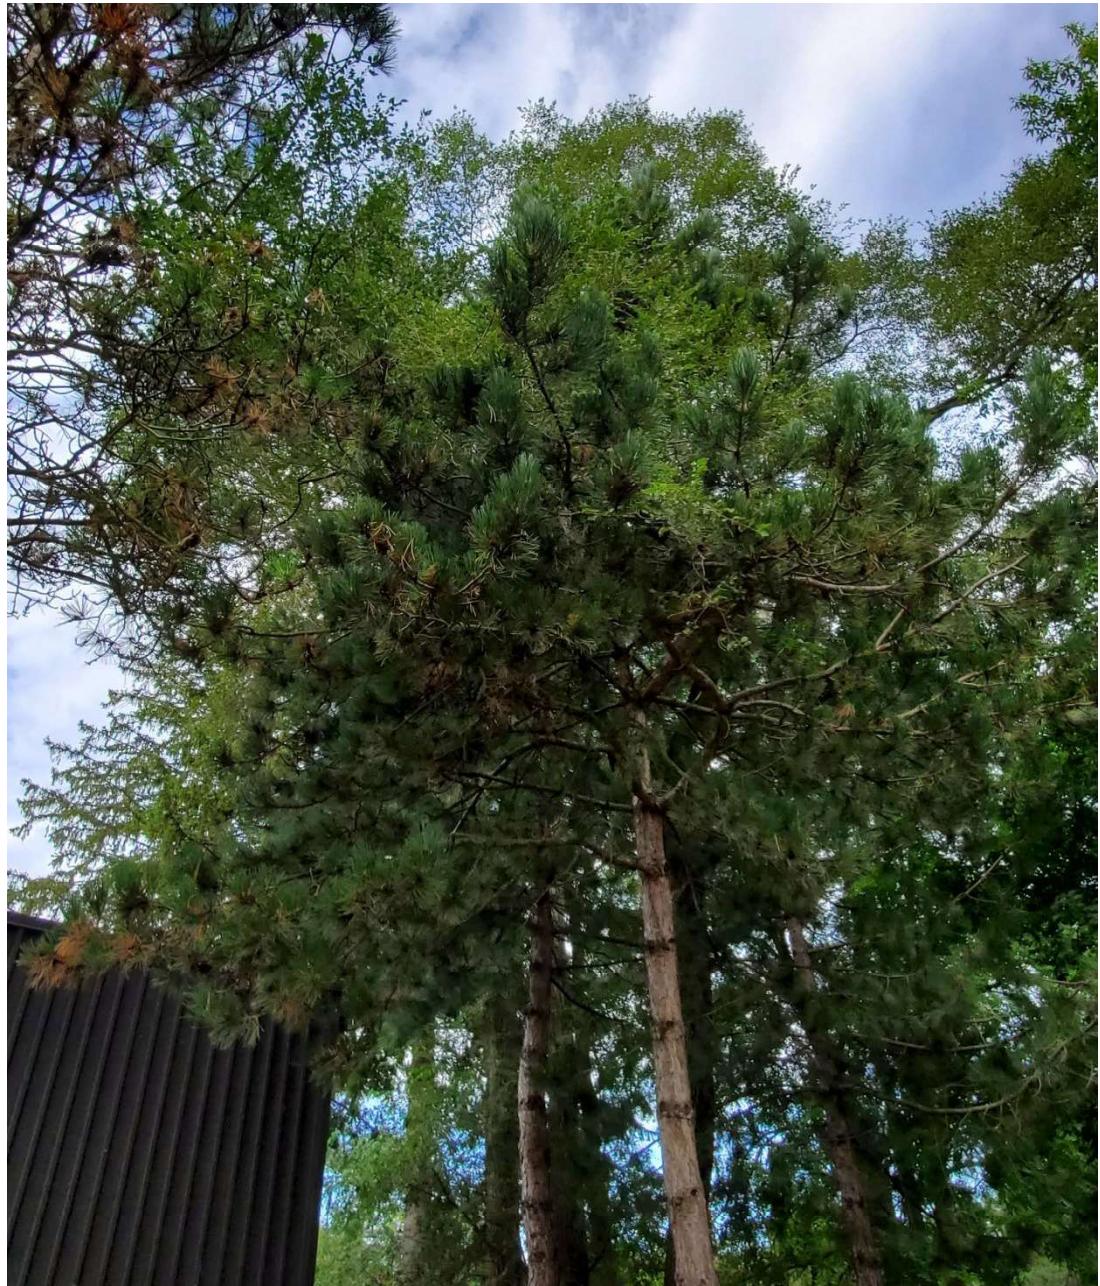
Photo 12 - Northwest-facing view of canopy of tree 714 (proposed to be retained).

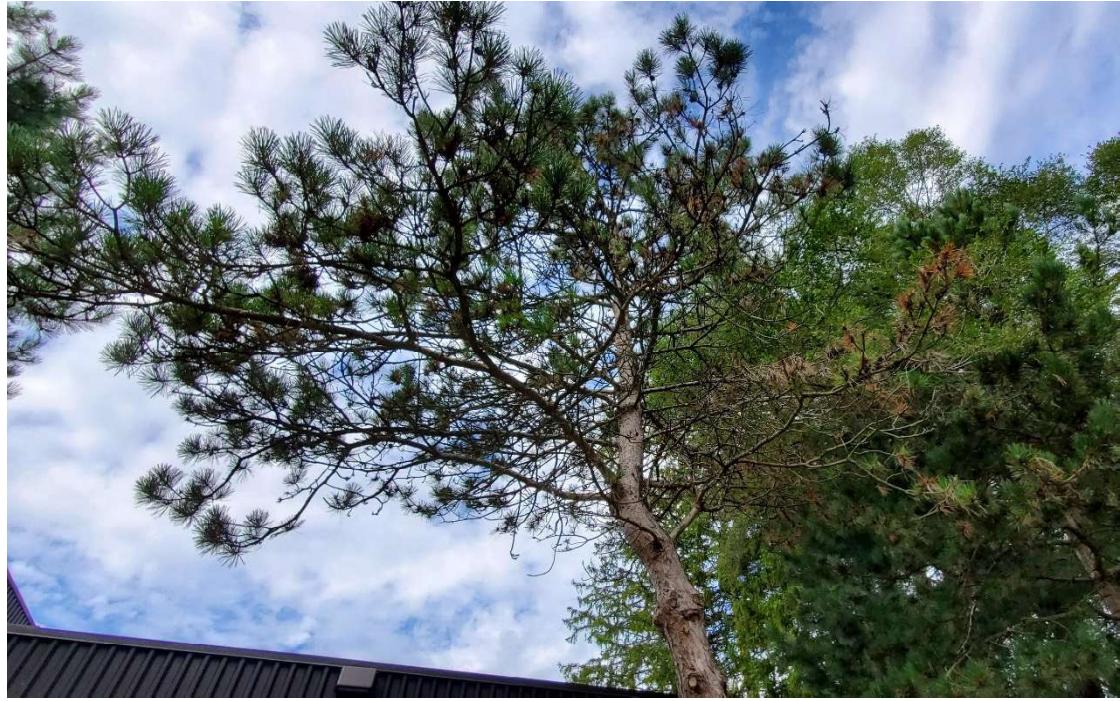
Photo 13 - West-facing view of canopy of tree 715 (proposed to be retained). Note *Diplodia* tip blight and leaf death throughout north (photo right) canopy.

715	Austrian Pine	<i>Pinus nigra</i>	31.9	4.5	5.5	Fair-Good	Fair-Good	Fair	Fair - Potential decline due to <i>Diplodia</i> tip blight	Preserve - works previously completed along path/trail	Tree to be assessed for construction-related impacts one year after completion of construction activities
716	Austrian Pine	<i>Pinus nigra</i>	46.1	5	6	Fair	Fair	Fair	Healthy	Preserve - works previously completed along path/trail	Tree to be assessed for construction-related impacts one year after completion of construction activities
717	Austrian Pine	<i>Pinus nigra</i>	22.6	3.5	4.5	Fair-Good	Fair	Poor-Fair	Poor	Preserve - works previously completed along path/trail	Tree to be assessed for construction-related impacts one year after completion of construction activities
718	Silver Maple	<i>Acer saccharinum</i>	61.1	7	8.4	Good	Fair	Fair-Good	Healthy	Preserve - works previously completed along path/trail	No anticipated impacts; tree is approximately 10.0 m from excavation limit.

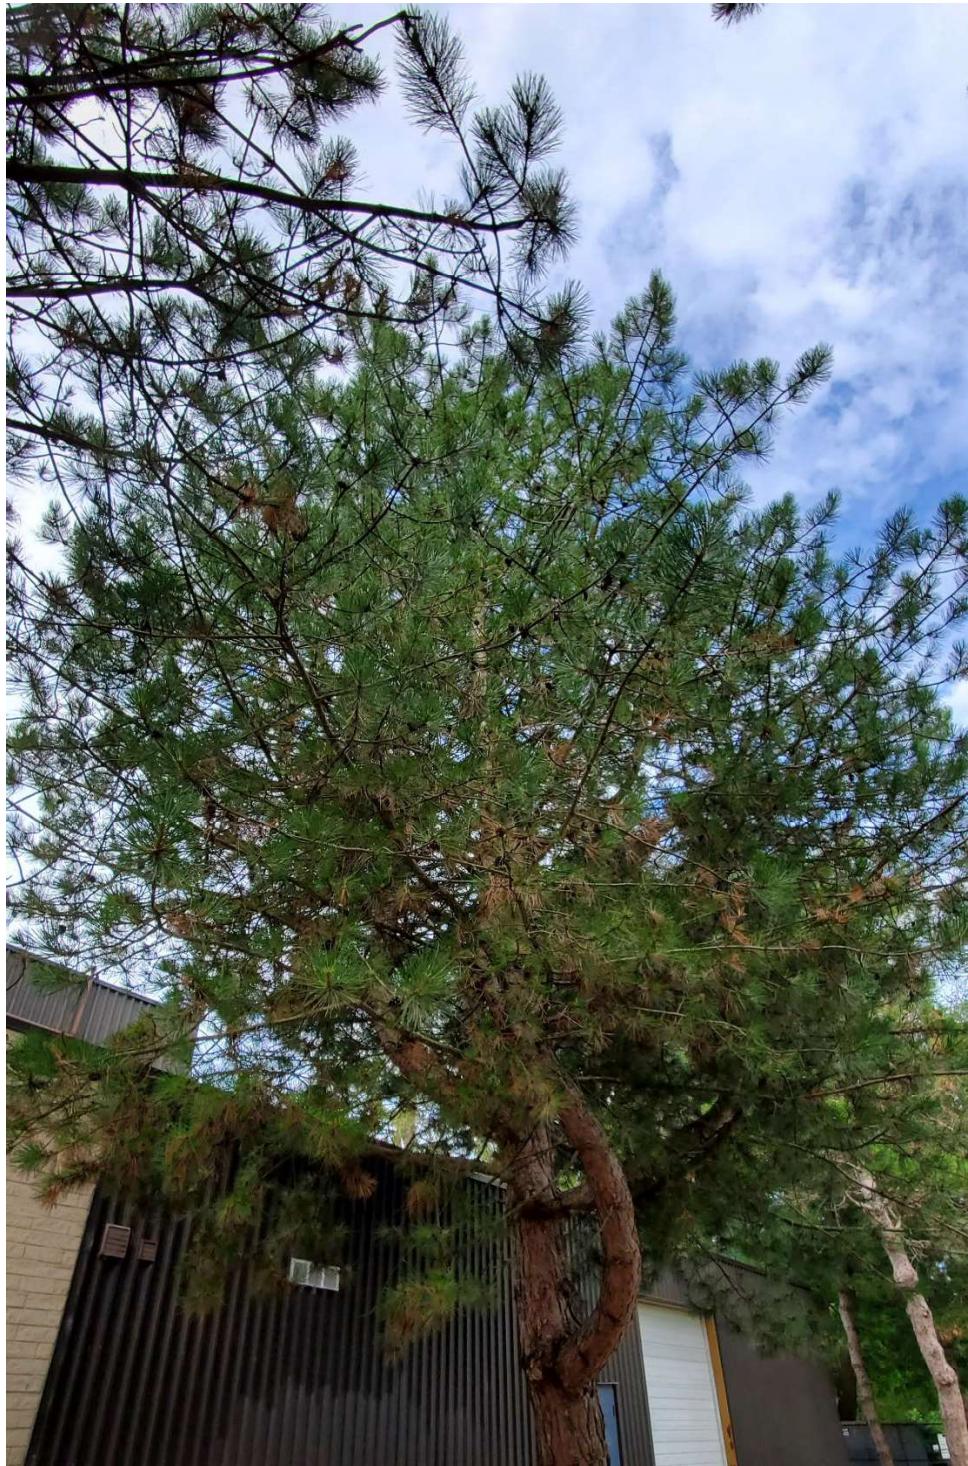
Photo 14 - West-facing view of canopy of tree 716 (proposed to be retained). Note high leaf density and relatively sparse presence of *Diplodia* tip blight in the lower canopy

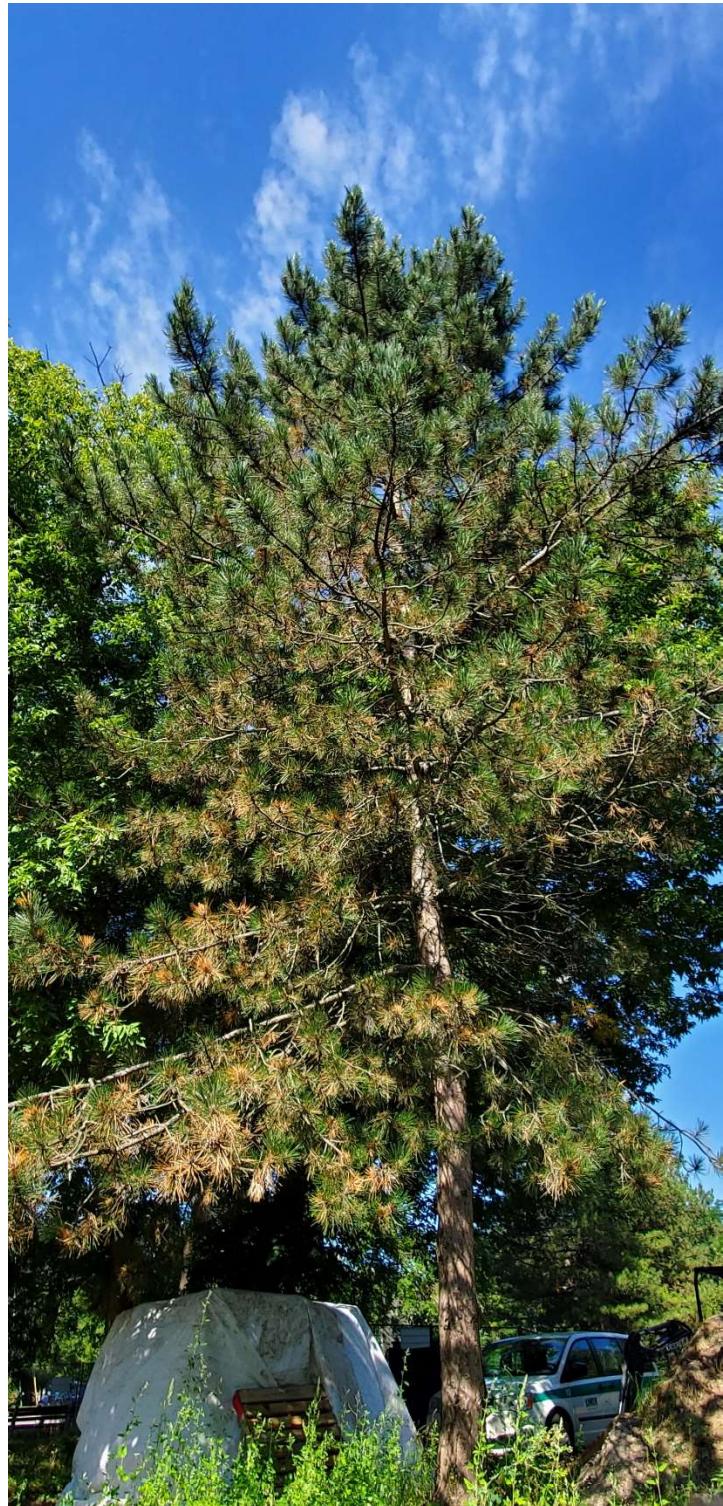
Photo 15 - Northwest-facing view of canopy of tree 722 (proposed for removal).  
Note *Diplodia* tip blight of moderate density in lower canopy.

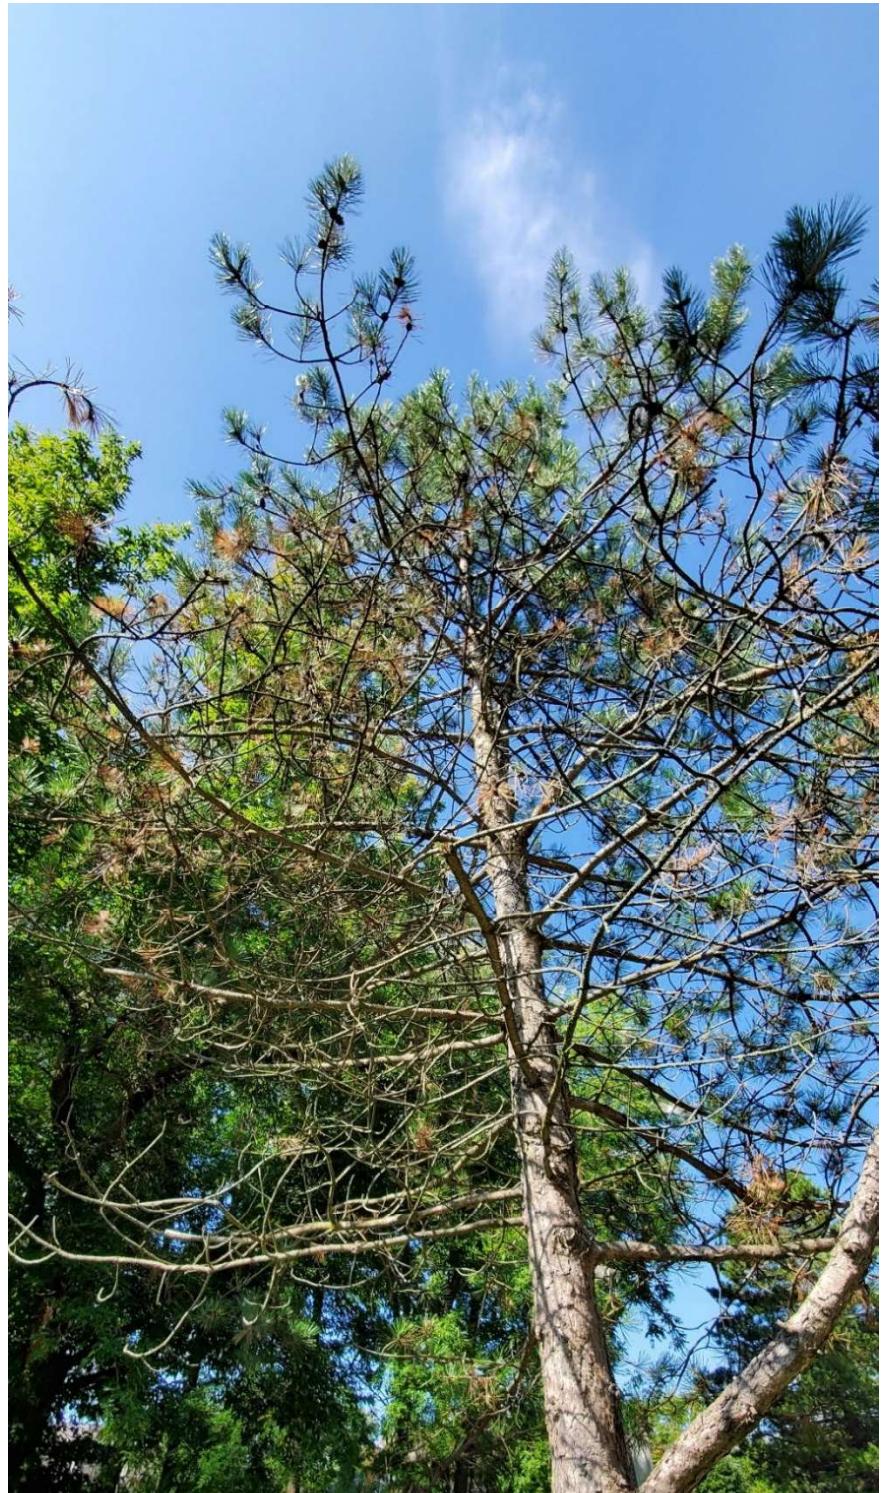
Photo 16 - Northwest-facing view of canopy of tree 723 (proposed for removal).  
Note low leaf density and presence of *Diplodia* tip blight throughout canopy.

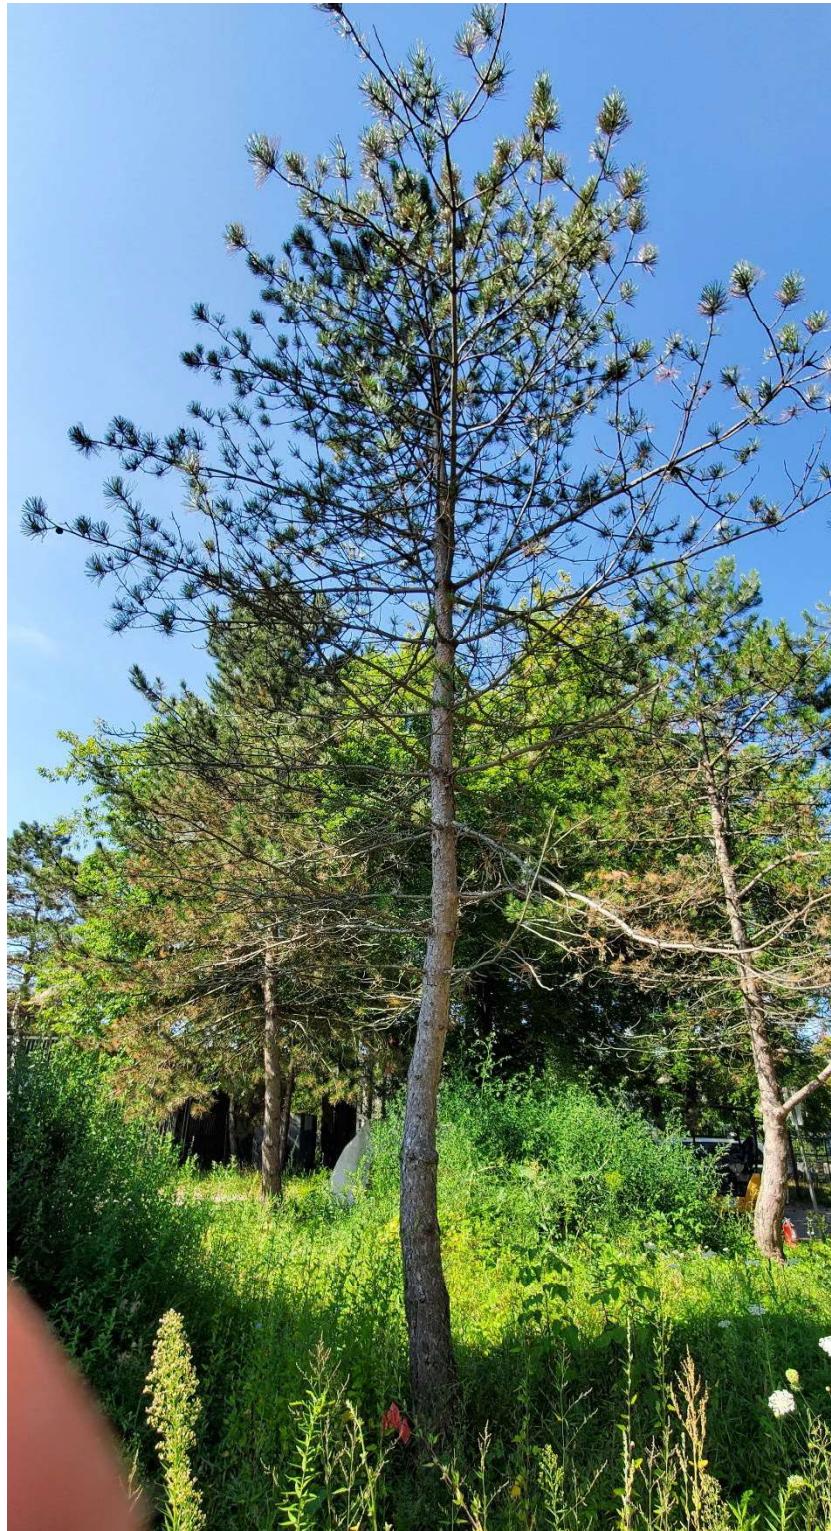
724	Austrian Pine	<i>Pinus nigra</i>	22.1	2	3.6	Fair-Good	Fair-Good	Poor-Fair	Poor	Remove	Additional stress caused by root severance may cause tree to decline further. Assumed 100% of root system located within remediation excavation area. Tree structure will likely be compromised by excavation regardless of proposed excavation method.

Photo 17 - West-facing view of canopy of tree 724 (proposed for removal). Note low leaf density throughout canopy.
