Guelph Gas Works / Coal Tar Site File Review

Summary of Findings Former Guelph Gas Works Site and Adjacent Properties  
(Area bounded by Gordon, Fountain, Wyndam and Wellington Streets) City of Guelph  
Gartner Lee Limited

Former Guelph Gas Works Site and Adjacent Property  
Full review of previous reports relating to the former Guelph Gas Works Site  
Gartner Lee Limited

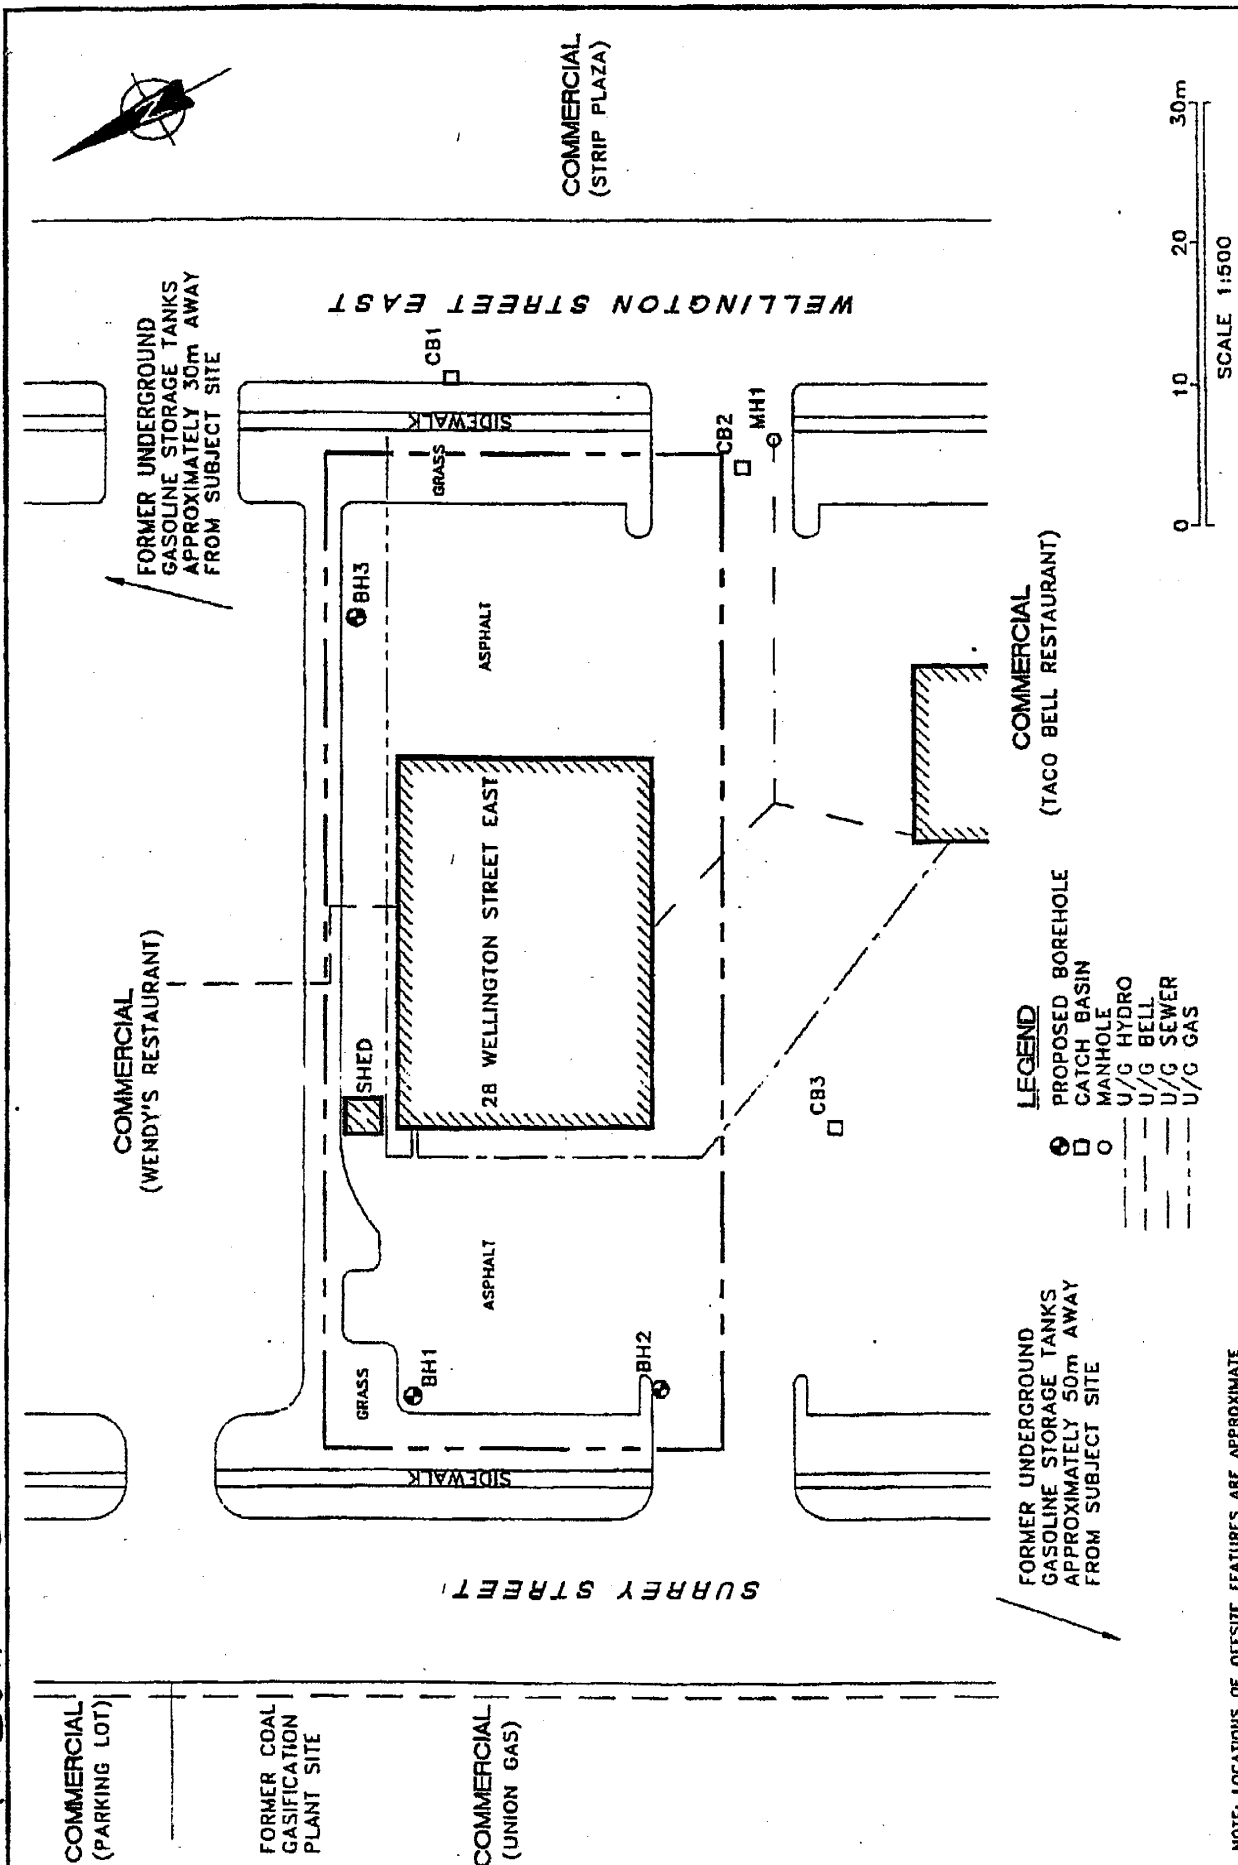
FIGURE C

**Background:** Jacques Whitford Environment Limited conducted a Phase I Environmental Investigation of the subject property in April 1997 on behalf of Peter Mitges Holdings Limited. Based on past use of this property (spring axle works/metal fabrication and vehicle repair/sales) and historical land use on adjacent properties (fuel storage and former coal gas production/storage), JWEL recommended that a Phase II Subsurface Investigation be performed. The Phase II investigation undertaken in May 1997, involved the advancement of three shallow borings, installation of two monitoring wells (in two of the borings), and the collection and analysis of soil and groundwater samples. Two of the borings referred to as JWELBH1 and JWELBH2 are located at the north end of the property immediately south of Surrey Street. Borehole JWELBH2 (west corner) appears to have been installed in the general vicinity of COGBH14. The third borehole (JWELBH3) was completed near the southeast corner of the property. A location plan from the JWEL report (Dwg. No. 2) is attached as Figure C.
