ARBORIST REPORT

ALMA Guelph Phase 2
Guelph, Ontario

Arborist Report for Development Applications

Date of Inspection:

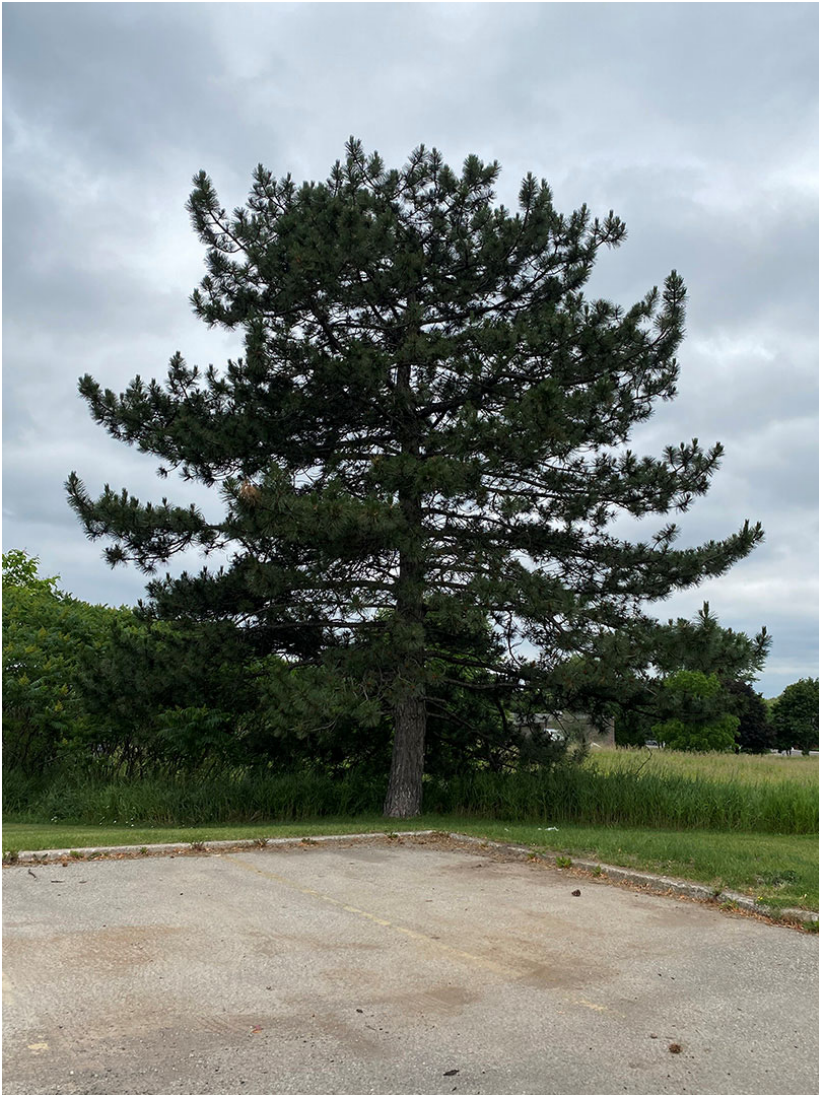
Fig. 1 - Tree T1

Tree No.	Tree Species	DBH (cm) *	TPZ (m) **	Crown Diameter (m)	Plant Condition **** Health & Structure Elements	Observations & Comments	Recommended Action (retain, relocate or Remove - Construction)	Ownership (private; on or offsite, boundary and municipal)	Compensation **** (yes or no)
1	Austrian pine <i>Pinus nigra</i>	53	6.0	10	Fair	Balanced crown form; high Live Crown Ratio (LCR); minimal pruning -crown raising: sumac grouping beside tree.	Remove - Construction	Private Onsite	Yes
2	Norway maple <i>Acer platanoides</i>	46	6.5	11	Fair	Trees 2, 3, and 4 located adjacent parking strip; surface and girdling roots present; vertical branch crack; crown pruned; balanced crown; high LCR.	Retain - Injure	Private Onsite	
3	Norway maple <i>Acer platanoides</i>	41	5.5	9	Fair	Competing crowns with trees 2 and 4; thinning inside crown.	Retain - Injure	Private Onsite	
4	Norway maple <i>Acer platanoides</i>	52	6.5	11	Fair	Surface and girdling roots; dense crown condition; balanced crown shape.	Retain - Injure	Private Onsite

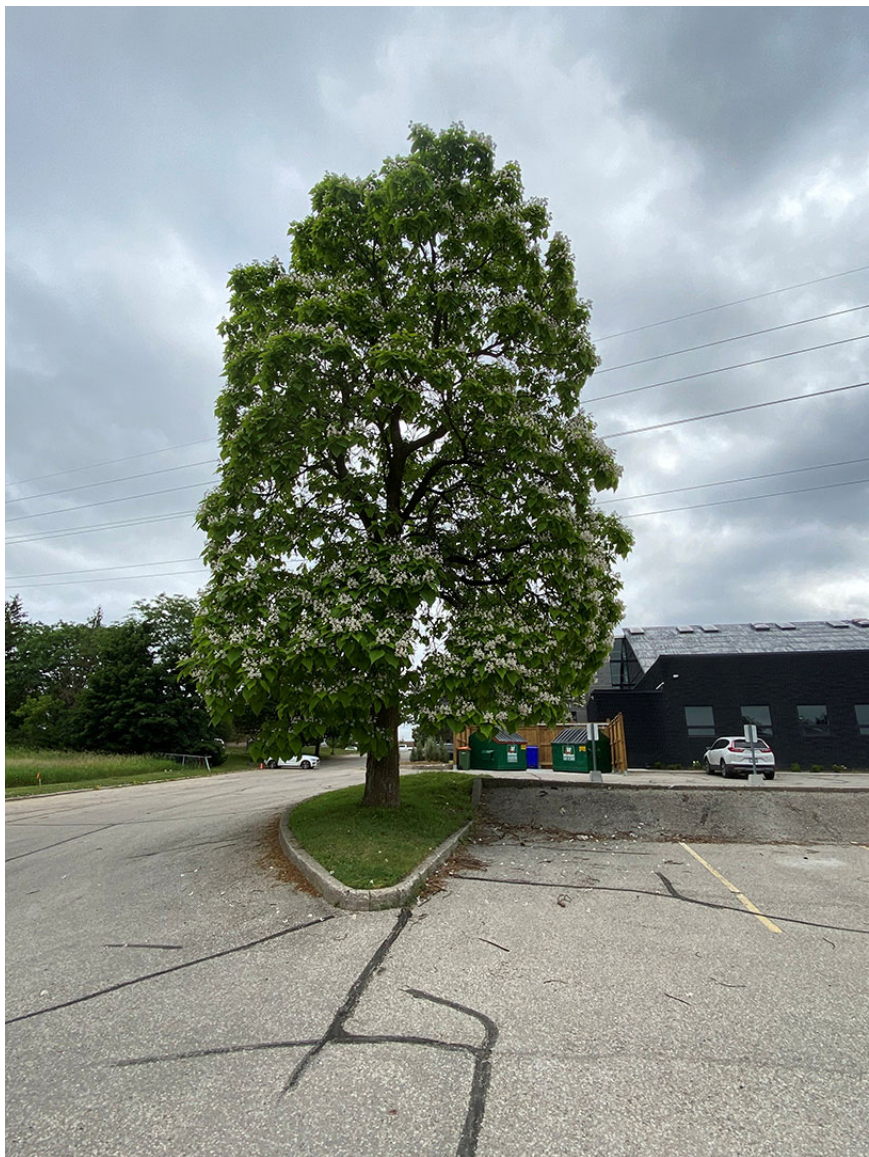
Fig. 5 - Tree T5

5	Northern catalpa <i>Catalpa speciosa</i>	52	6.0	10	Fair	Tree located in parking island; balanced crown; minimal deadwood.	Remove - Construction	Private Onsite	Yes
6	Northern catalpa <i>Catalpa speciosa</i>	52	5.5	9	Poor to fair	Large vertical trunk scars; tree beside concrete walkway and new interlocking paving patio close to building; imbalanced crown shape.	Retain - Injure	Private Onsite	
7	Northern catalpa <i>Catalpa speciosa</i>	70	6.5	11	Fair	Lower branches pruned (crown raised); generally balanced crown form; basal cavity with rot and ant frass.	Retain - Injure	Private Onsite	
8	Austrian pine <i>Pinus nigra</i>	39	4.5	7	Poor	Tree located very close to building on slope; imbalanced crown form; crown deadwood; crown pruned.	Retain - Injure	Private Onsite	
9	Norway maple <i>Acer platanoides</i>	39	5.5	9	Poor to fair	Surface roots present; crown competing with tree 10; minimal deadwood; thinning inside crown condition.	Retain - Injure	Private Onsite

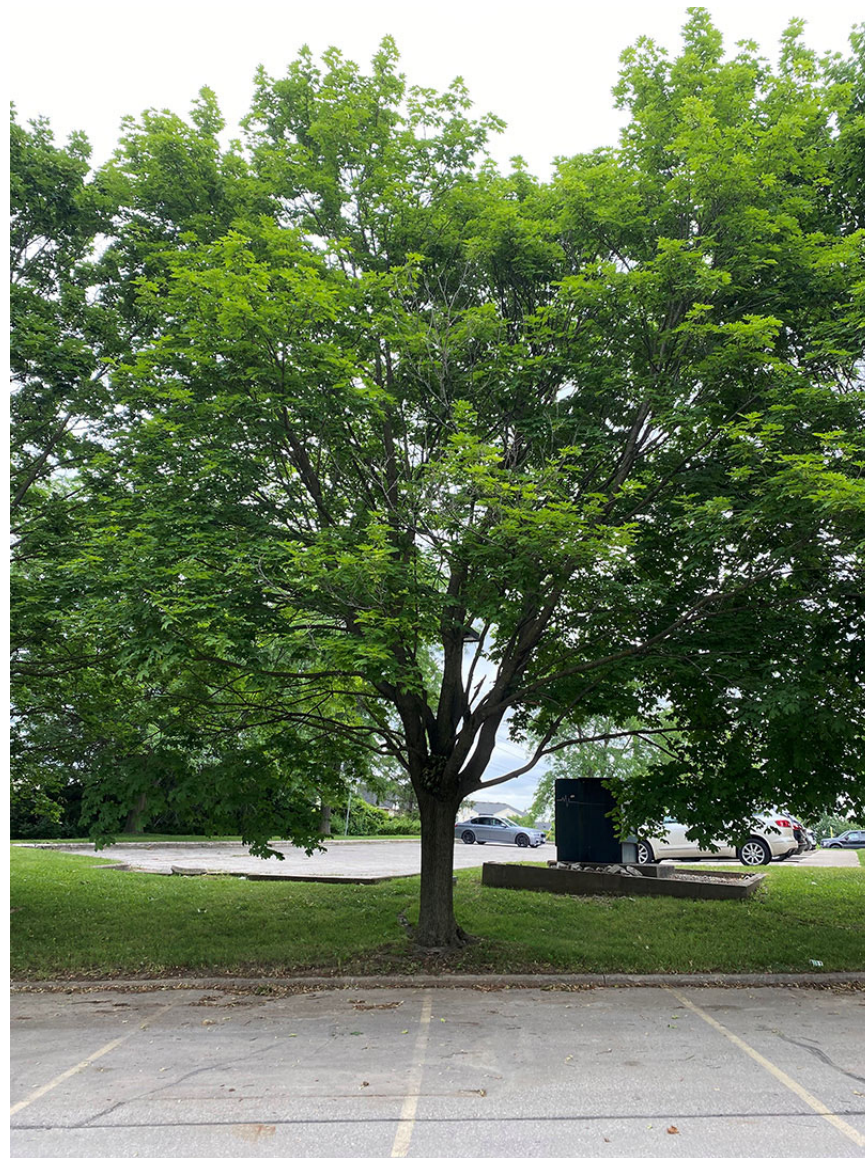
Fig. 12 - Tree T10

Tree No.	Tree Species	DBH (cm) *	TPZ (m) **	Crown Diameter (m)	Plant Condition **** Health & Structure Elements	Observations & Comments	Recommended Action (retain, relocate or Remove - Construction)	Ownership (private; on or offsite, boundary and municipal)	Compensation **** (yes or no)
10	Norway maple <i>Acer platanoides</i>	46	6.5	11	Fair	Surface and girdling roots; competing crown with tree 8 and 11; crown deadwood; foliage is chlorotic.	Retain - Injure	Private Onsite	
11	Norway maple <i>Acer platanoides</i>	45.5	6.0	10	Poor	Poor crown form with deadwood in upper crown section; broken branches.	Retain - Injure	Private Onsite	
12	Silver maple <i>Acer saccharinum</i>	46.5	7.0	12	Poor to fair	Defined trunk flare; trunk splits at 1.8m into 2 branches; large branch cut at 1m with centre rot; deadwood on south side; dense crown condition.	Remove - Construction	Private Onsite	Yes
13	Silver maple <i>Acer saccharinum</i>	13, 21	3.0	4	Very poor	Surface roots; trunk with split; 2 stems at 0.5m; significant crown deadwood.	Retain	Private Onsite

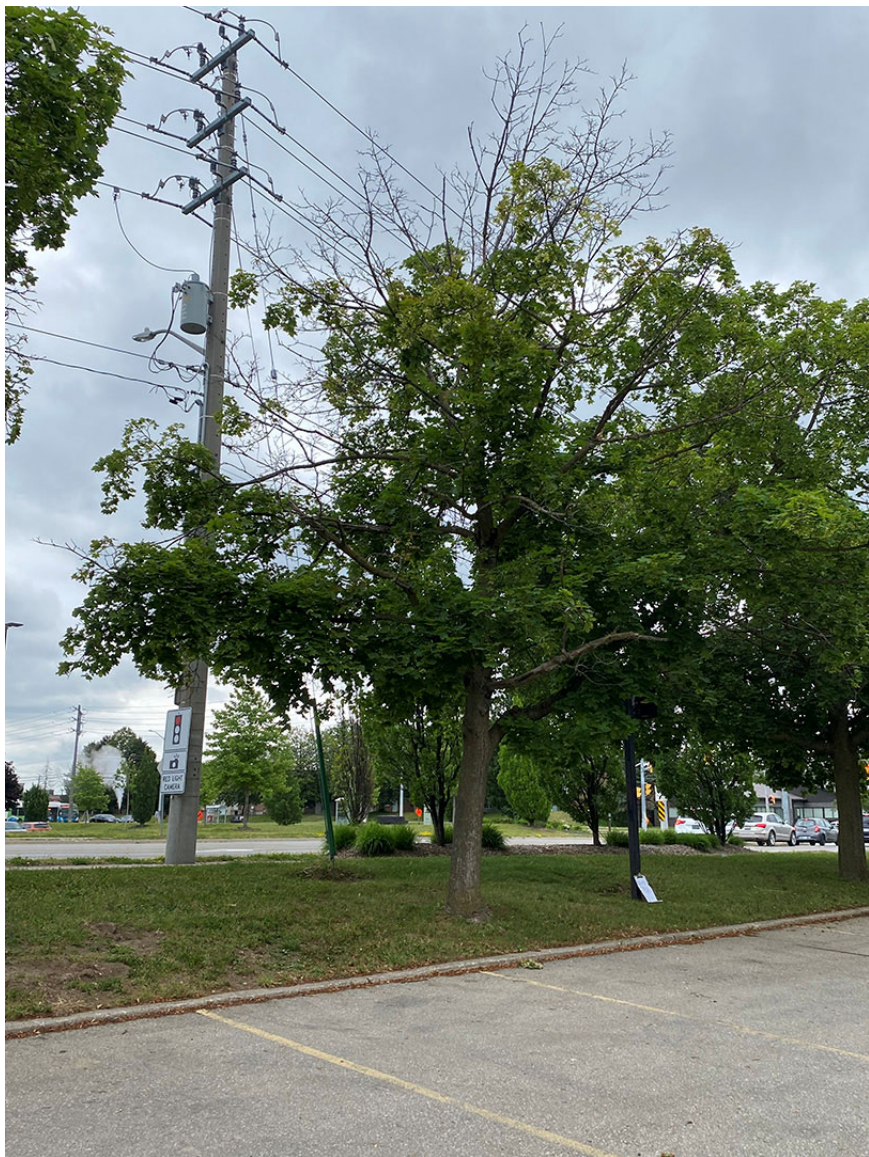
Fig. 25 - Tree T20

20	Norway maple <i>Acer platanoides</i>	30	5.0	8	Very poor	Girdling root; significant crown mortality.	Retain	Private Onsite

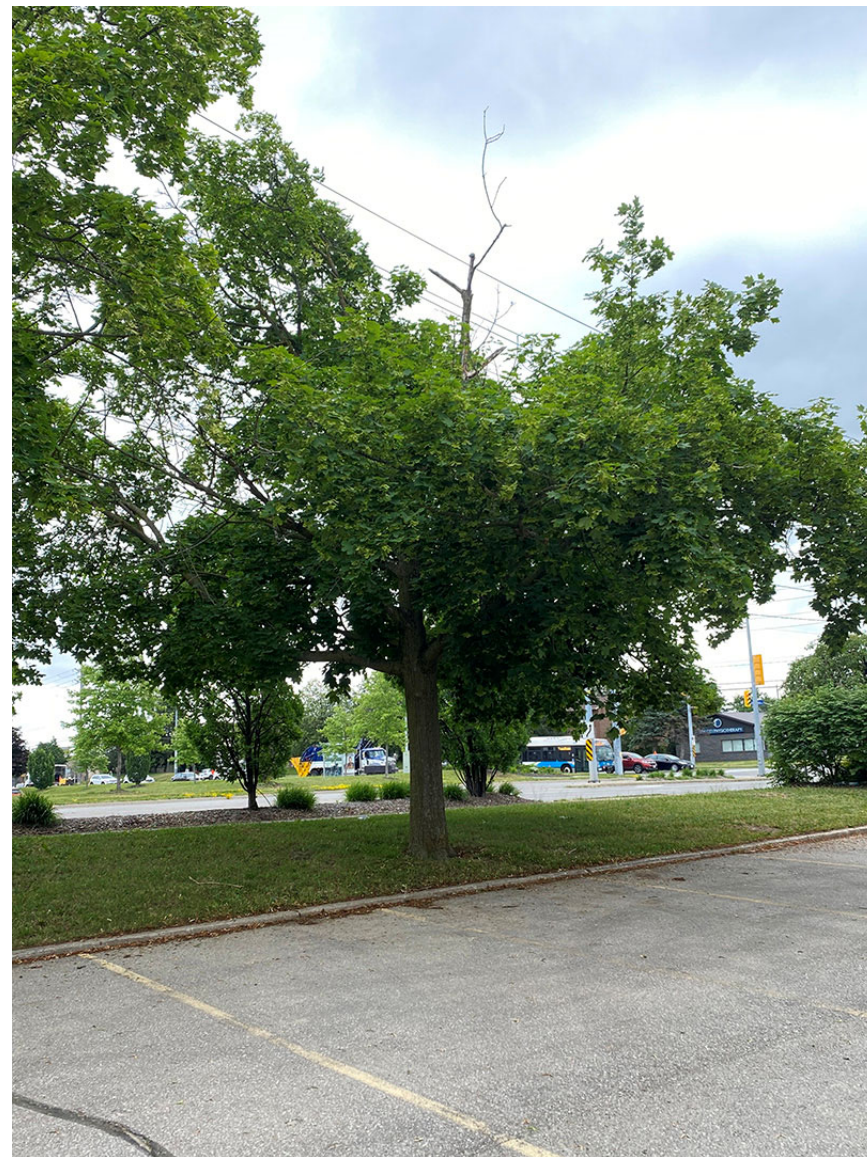
Fig. 26 - Tree T21

Tree No.	Tree Species	DBH (cm) *	TPZ (m) **	Crown Diameter (m)	Plant Condition **** Health & Structure Elements	Observations & Comments	Recommended Action (retain, relocate or Remove - Construction)	Ownership (private; on or offsite, boundary and municipal)	Compensation **** (yes or no)
21	Norway maple <i>Acer platanoides</i>	37.5	6.0	10	Poor	Surface roots; flat section on lower trunk area; crown deadwood; dead terminal portion of crown.	Retain	Private Onsite	
22	Pyramidal English oak <i>Quercus robur</i> 'Fastigiata'	Multi-stemmed (1-10cm)	2.5	3	Fair	Tree located between concrete sidewalk and curb with Hydro lines above crown; Mulch surrounding tree; balanced crown form.	Remove - Construction	Municipal	Yes
23	Pyramidal English oak <i>Quercus robur</i> 'Fastigiata'	Multi-stemmed (1-8cm)	2.0	2	Fair	Tree located between concrete sidewalk and curb with Hydro lines above crown; thinning crown on west side – competing with Norway maple crown.	Remove - Construction	Municipal	No

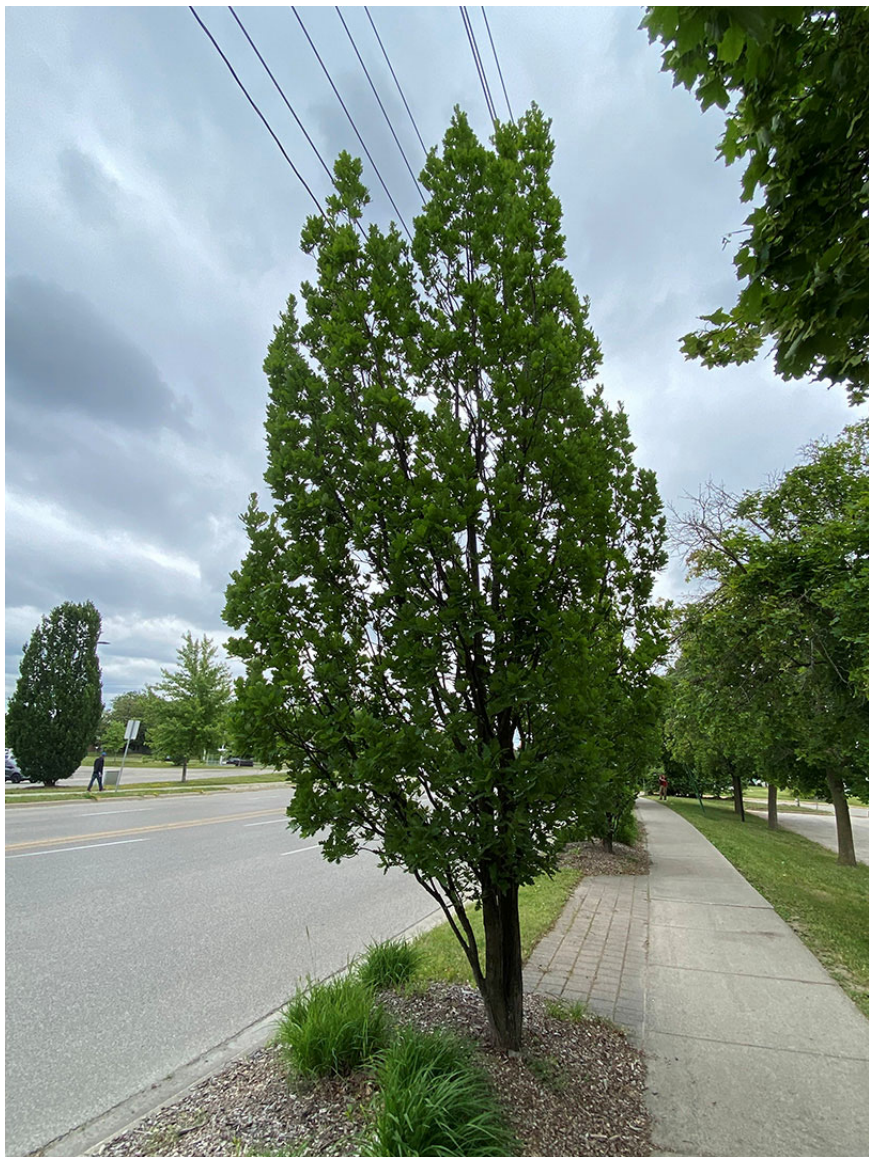
Fig. 29 - Tree T24

24	Pyramidal English oak <i>Quercus robur</i> 'Fastigiata'	Multi-stemmed (1-8cm)	2.5	3	Fair	Tree located between concrete sidewalk and curb with Hydro lines above crown; thinning crown on west side – competing with Norway maple crown.	Retain	Municipal	
25	Pyramidal English oak <i>Quercus robur</i> 'Fastigiata'	Multi-stemmed (1-12cm)	2.5	3	Fair	Tree located between concrete sidewalk and curb with Hydro lines above crown; thinning crown on west side – competing with Norway maple crown; thinning crown condition.	Retain	Municipal	
26	Pyramidal English oak <i>Quercus robur</i> 'Fastigiata'	Multi-stemmed (1-8cm)	2.0	2	Poor to fair	Tree located between concrete sidewalk and curb with Hydro lines above crown; thinning crown on west side – competing with Norway maple crown; thinning crown condition; poor crown form.	Retain	Municipal	
27	Pyramidal English oak <i>Quercus robur</i> 'Fastigiata'	Multi-stemmed (1-12cm)	2.0	2	Poor to fair	Tree located between concrete sidewalk and curb with Hydro lines above crown; thinning crown on west side – competing with Norway maple crown; thinning crown condition; poor crown form.	Retain	Municipal

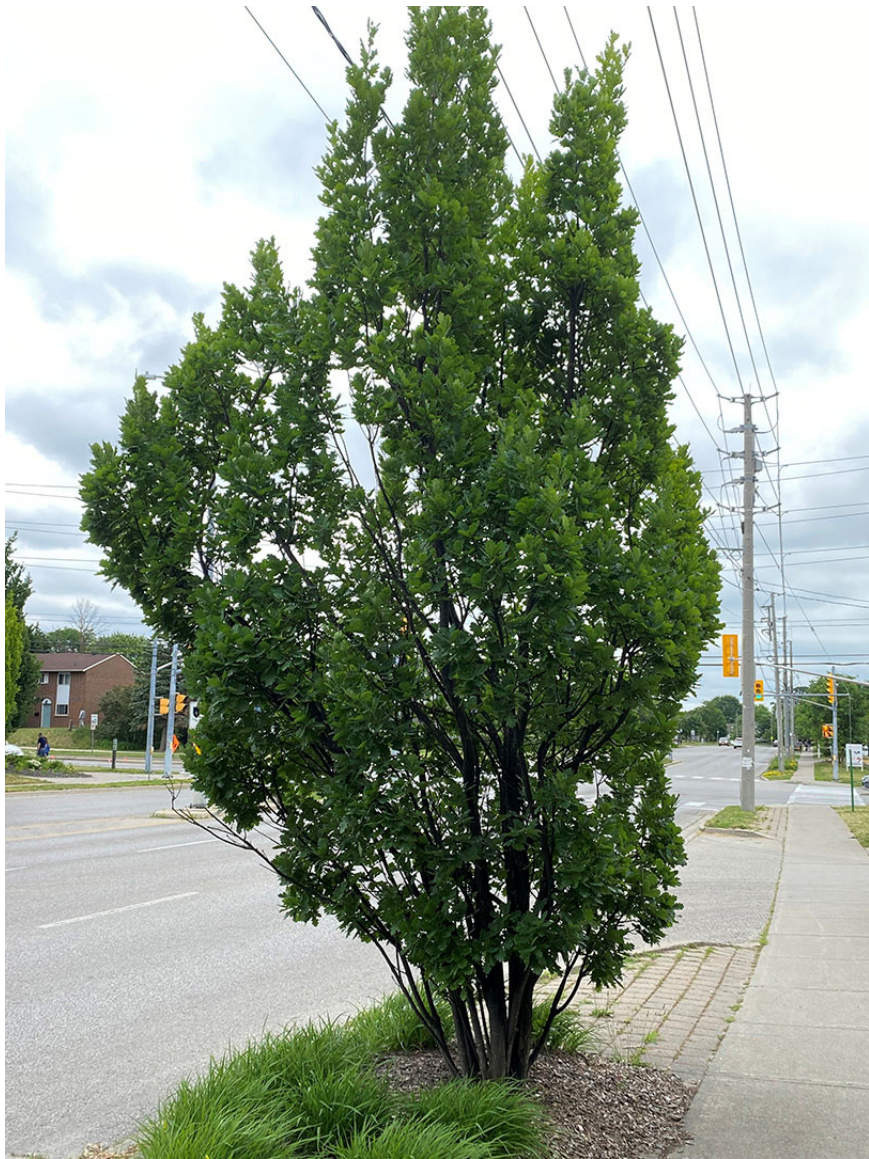
Fig. 35 - Tree T30

30	Pyramidal English oak <i>Quercus robur</i> 'Fastigiata'	Multi-stemmed (1-8cm)	2.25	2.5	Fair	Tree located between concrete sidewalk and curb with Hydro lines above crown; dense crown condition; competing with Norway maple crown.	Retain	Municipal	
31	Weeping cherry variety <i>Prunus pendula</i> var.	16	3.0	4	Fair	Short stature tree with light standard positioned in crown; dense and balanced crown condition; minimal internal crown deadwood.	Retain	Private Onsite	
32	Weeping cherry variety <i>Prunus pendula</i> var.	14.5	3.0	4	Fair	Short stature tree with light standard positioned in crown; dense and balanced crown condition; minimal internal crown deadwood.	Remove - Construction	Private Onsite	Yes
33	Thornless honey locust <i>Gleditsia triacanthos</i> var. <i>inermis</i>	30	5.5	9	Fair	Trunk with no visible major defects; imbalanced crown form; minimal crown deadwood; crown pruned on building side.	Retain	Private Onsite

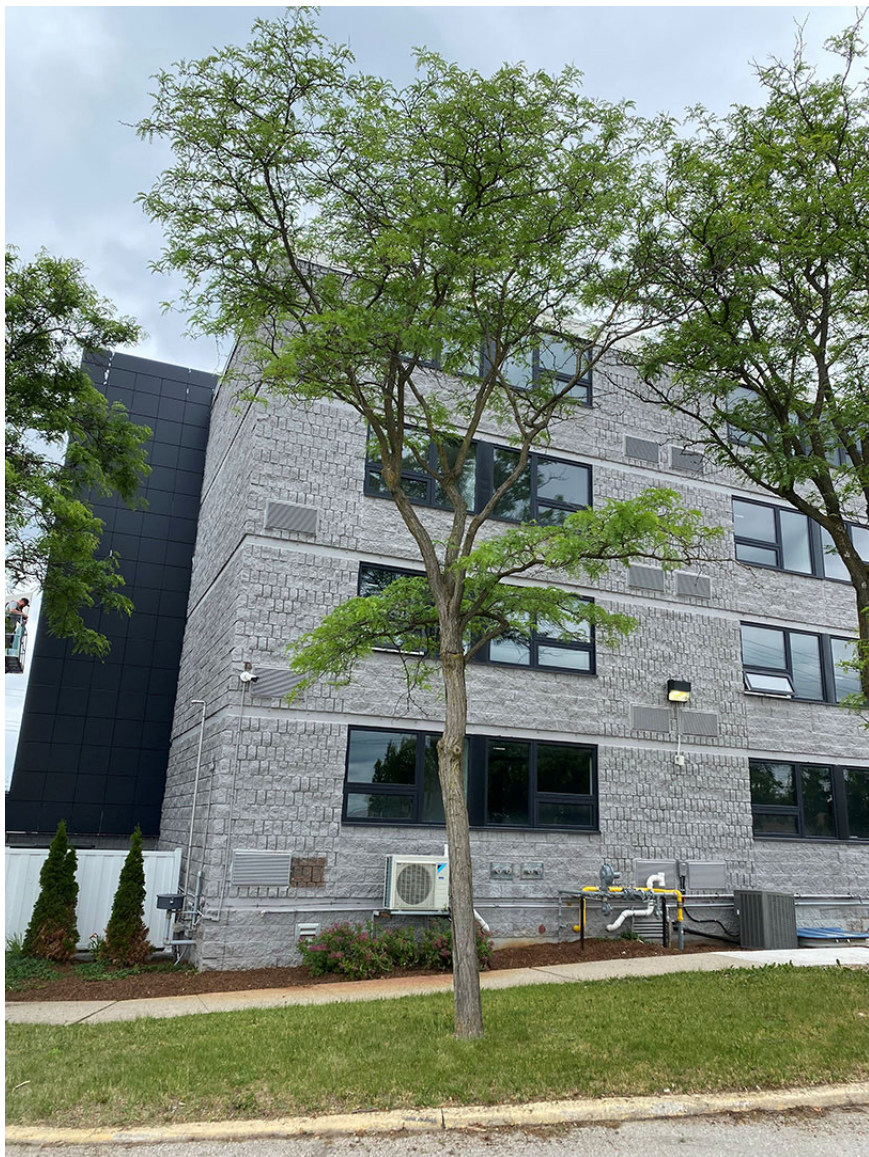
Fig. 41 - Tree T34

34	Thornless honey locust <i>Gleditsia triacanthos</i> var. <i>inermis</i>	21	3.5	5	Poor to fair	Trunk damage at 3m; thinning crown; crown pruned; crown deadwood.	Retain	Private Onsite

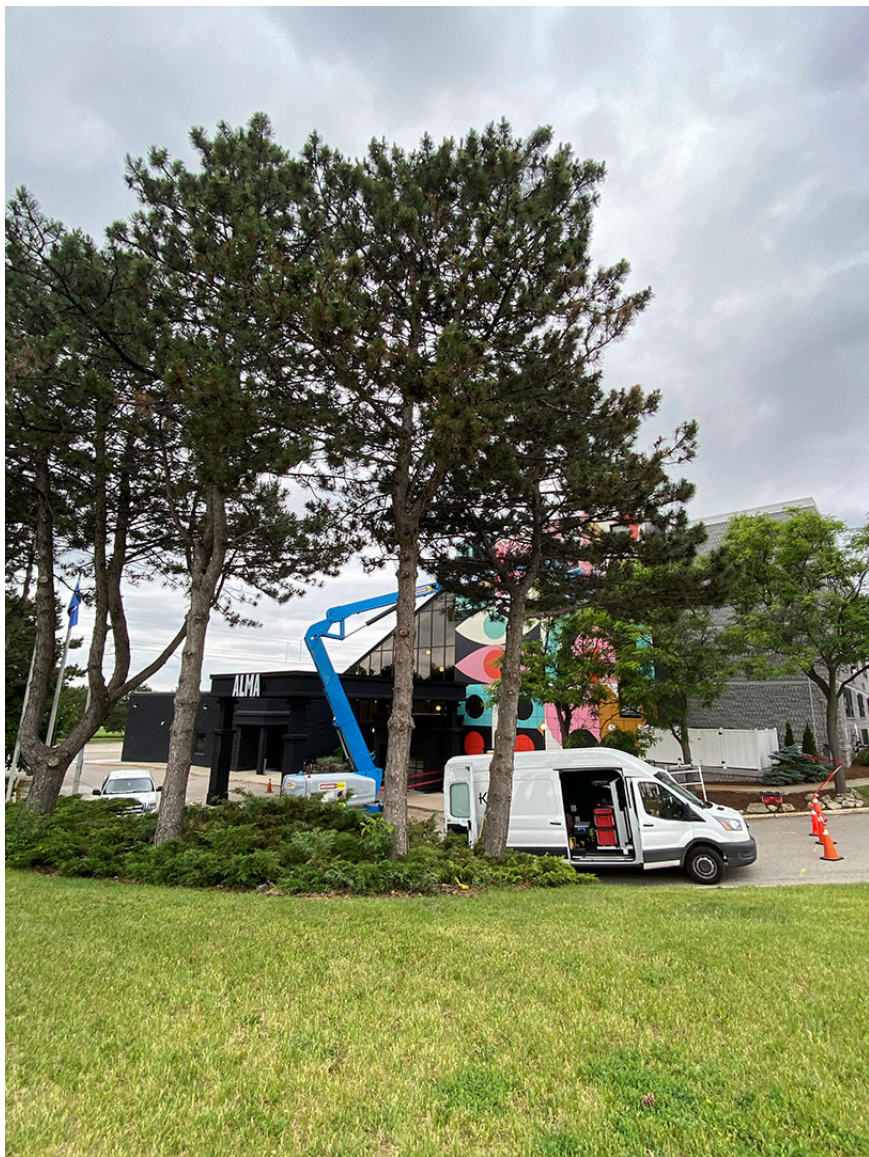
Fig. 45 - Trees T41, T40, T39, T38

38	Austrian pine Pinus nigra	43	4.0	6	Very poor	Trunk with lean; very poor crown form – competing with adjacent tree; crown raised; trees 38 through 47 all with competing crowns with inside branches sometimes dead.	Remove - Construction	Private Onsite	No
39	Austrian pine Pinus nigra	37	4.0	6	Poor	Crooked upper branching form; crown raised; very poor crown form.	Retain - Injure	Private Onsite	
40	Austrian pine Pinus nigra	35	3.0	4	Poor	Trunk with co-dominant stems at ~5m; poor crown form; crown raised; thinning crown.	Retain	Private Onsite	
41	Austrian pine	50	3.5	5	Very poor	Trunk with 3 upper branches at ~1.5m; crown raised; thinning crown; poor crown form.	Retain	Private Onsite	
42	Austrian pine Pinus nigra	37	3.5	5	Very poor	Very low live crown present; crown raised.	Retain	Private Onsite	
43	Austrian pine Pinus nigra	42	4.0	6	Very poor	Very poor crown form; low live crown volume.	Retain	Private Onsite

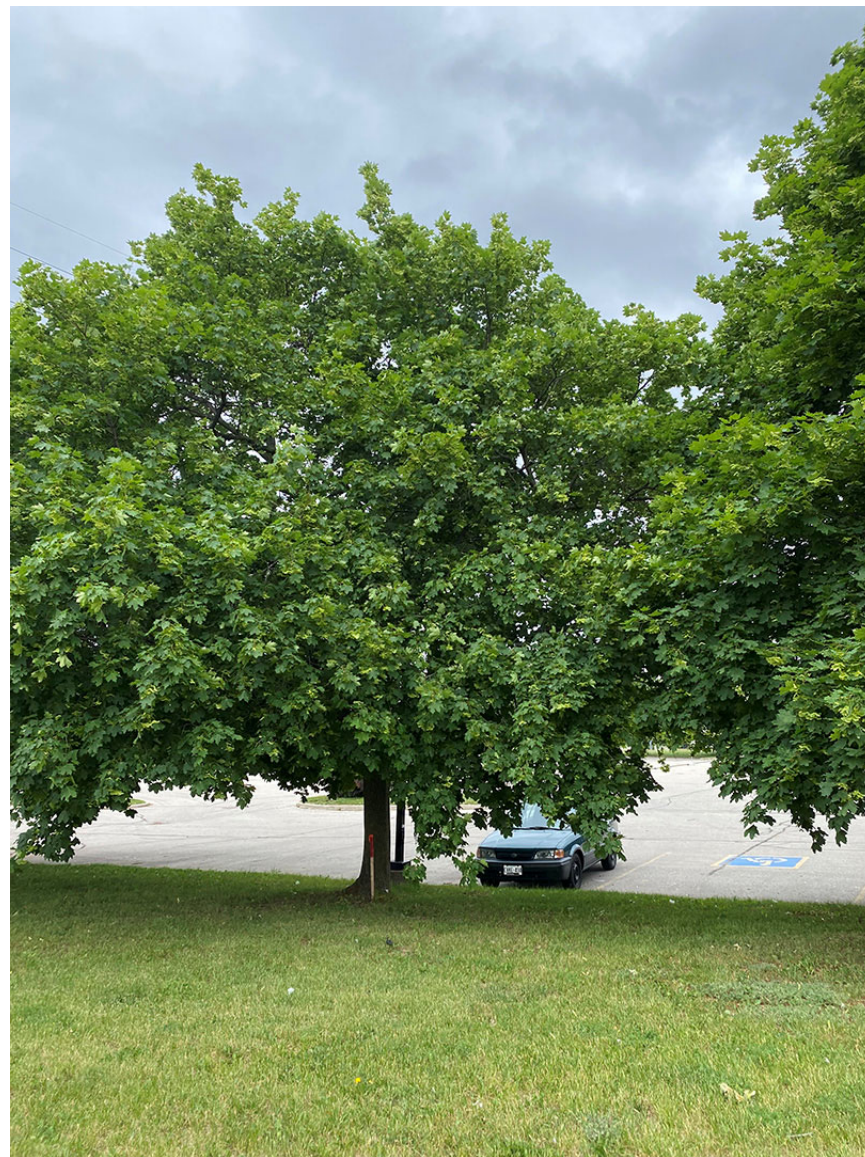
Fig. 52 - Tree T51

51	Norway maple Acer platanoides	40	5.5	9	Fair	Surface and girdling roots; balanced crown; thinning inside crown.	Retain - Injure	Private Onsite	
52	Norway maple Acer platanoides	49	7.5	13	Fair	Surface and girdling roots; balanced crown; thinning inside crown; broken branch end.	Retain - Injure	Private Onsite	
53	Norway maple Acer platanoides	48	6.0	10	Fair	Defined root flare; surface and girdling roots; balanced crown; thinning inside crown; broken branch end.	Retain - Injure	Boundary	
54	Norway maple Acer platanoides	50	6.5	11	Fair	Defined root flare; surface and girdling roots; balanced crown; thinning inside crown; broken branch end.	Retain - Injure	Private Offsite	
55	Norway maple Acer platanoides	22.5	2.5	3	Very poor	Small very poor formed tree in parking island; crown deadwood; vertical trunk scar; low live crown volume.	Remove - Construction	Private Onsite	No
56	Austrian pine Pinus nigra	36	4.0	6	Fair to poor	Trunk with no visible major defects; thinning crown; low live crown volume; crown deadwood.	Retain - Injure	Private Offsite

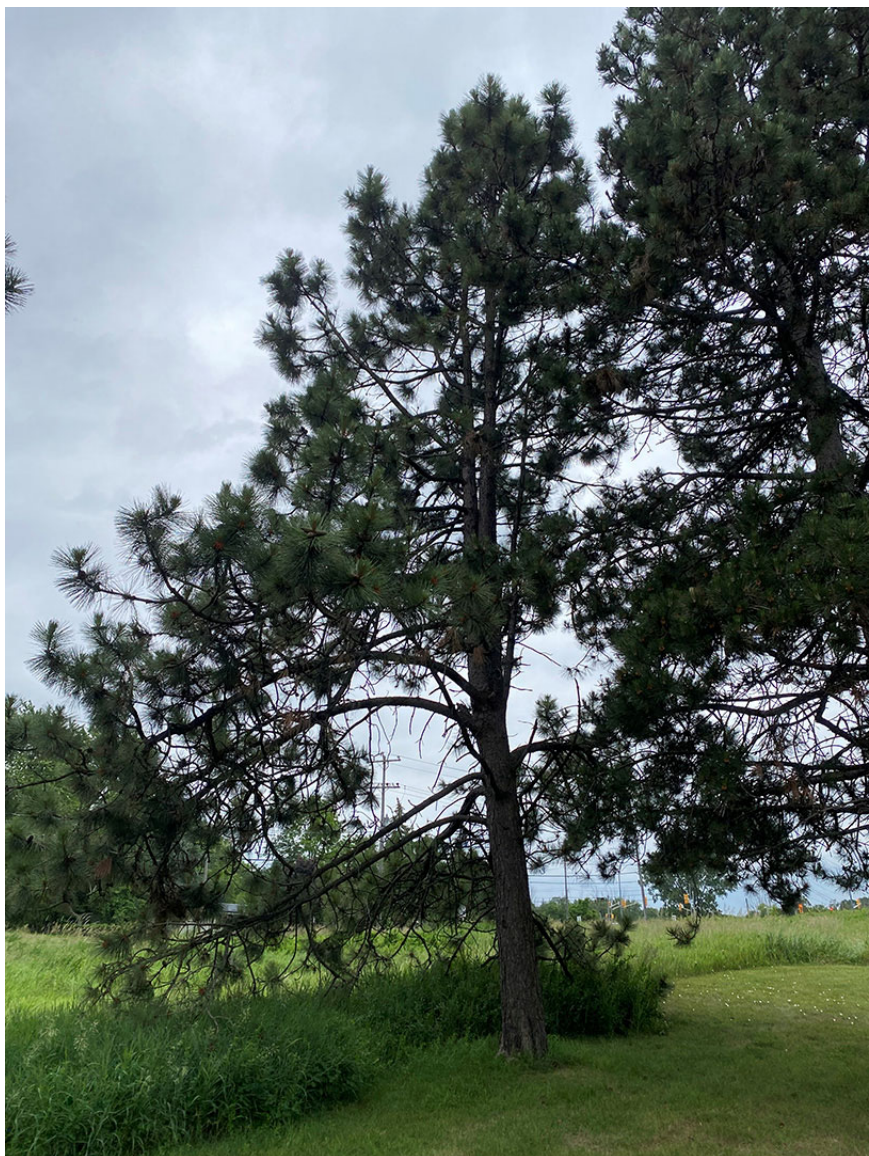
Fig. 59 - Tree T57

57	Austrian pine Pinus nigra	42	4.0	6	Fair to poor	Trunk with no visible major defects; thinning crown; low live crown volume; crown deadwood; competing tree crowns.	Retain	Private Offsite	
58	Austrian pine Pinus nigra	60.5	5.5	9	Fair	Trunk with 2 stems (co-dominant) at ~2.2m; crown pruned.	Remove - Construction	Private Onsite	Yes

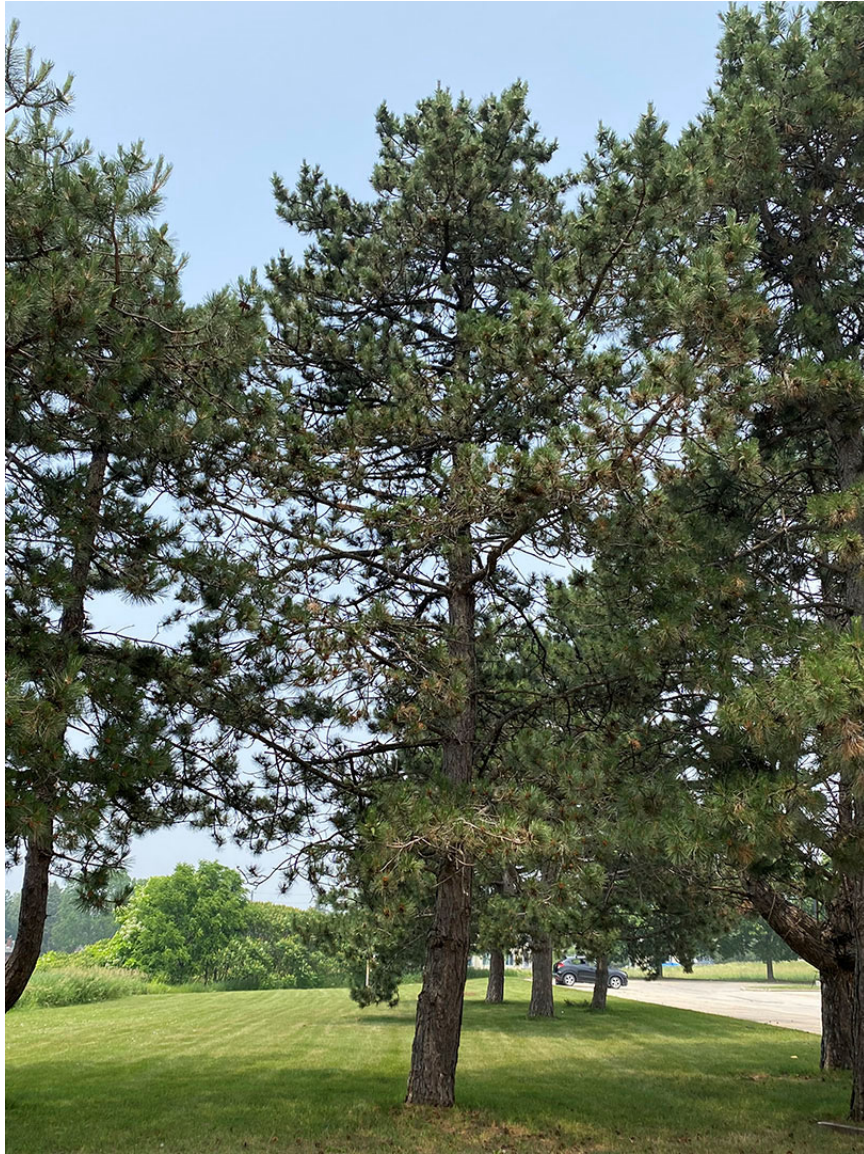
Fig. 66 - Trees T63, T64

63	Austrian pine Pinus nigra	41	4.0	6	Poor	Poor form to trunk and crowns; thinning crown condition; crown deadwood; trunk lean.	Remove - Construction	Private Onsite	No
64	Austrian pine Pinus nigra	53	4.0	6	Very poor	Very poor formed tree; large scaffold branch; thinning crown.	Remove - Construction	Private Onsite	No
65	Austrian pine Pinus nigra	50	5.0	8	Poor	Poor formed tree; crown deadwood; crown raised.	Remove - Construction	Private Onsite	No
66	Austrian pine Pinus nigra	32	4.5	7	Poor	Poor formed tree; trunk lean; crown deadwood; crown raised.	Remove - Construction	Private Onsite	No
67	Austrian pine Pinus nigra	49	6.0	10	Fair	Trunk with no major visible defects; balanced crown form.	Remove - Construction	Private Onsite	Yes
68	Black walnut Juglans nigra	19 @ 1m	4.5	7	Good to fair	High LCR; dense crown condition; balanced crown form; somewhat crooked trunk form.	Remove - Construction	Private Onsite	Yes

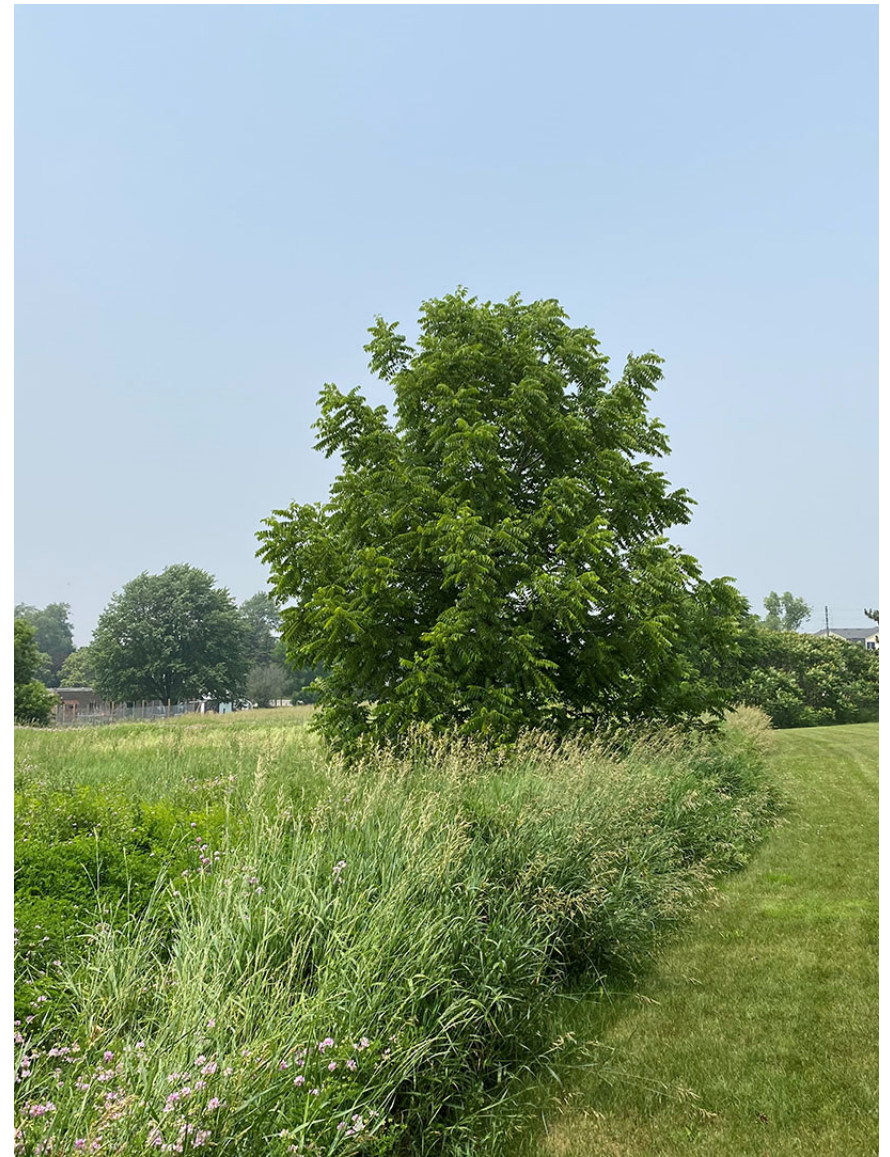
Fig. 72 - Tree 69

69	Black walnut Juglans nigra	17.5	4.5	7	Good	High LCR; dense crown condition; balanced crown form.	Remove - Construction	Private Onsite	Yes
Tree group #1	2 black walnuts, 4 Northern catalpas Juglans nigra, Catalpa speciosa (6 trees)	average 10cm	7.0	12	Fair	Closely grouped trees with lack of live inside crowns; sumac vegetation abutting tree grouping.	Remove - Construction	Private Onsite	Yes
