City Of Guelph

Structure 112 Mcdonell Street Soffit Inspection Report

GMBP File: 123117

February 29, 2024

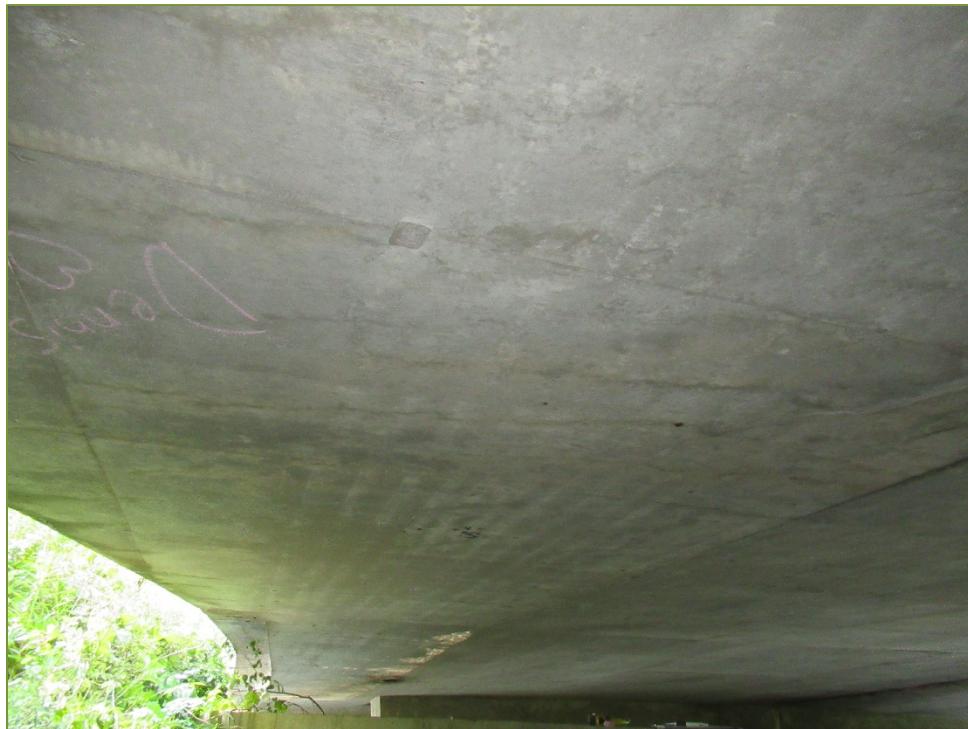
Photo P10 Soffit between West Abutment and Pier (fair condition - cracks, spall, delamination and wet area) note, Inaccessible

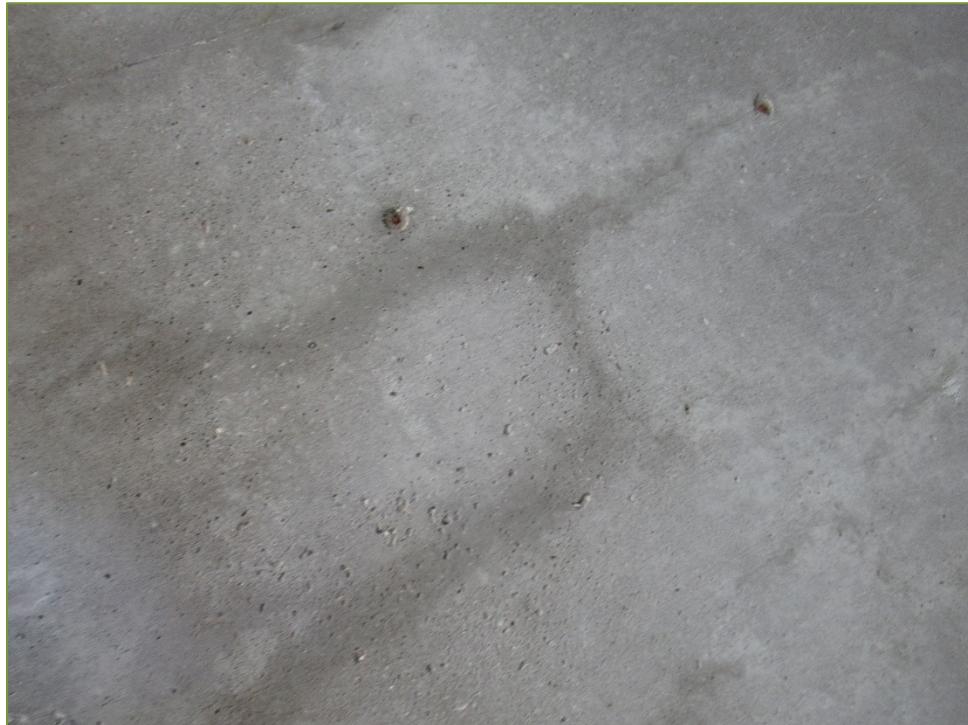
Photo P11 Soffit between East Abutment and Pier (fair condition – cracks, spall, delamination, light scaling, and wet area)

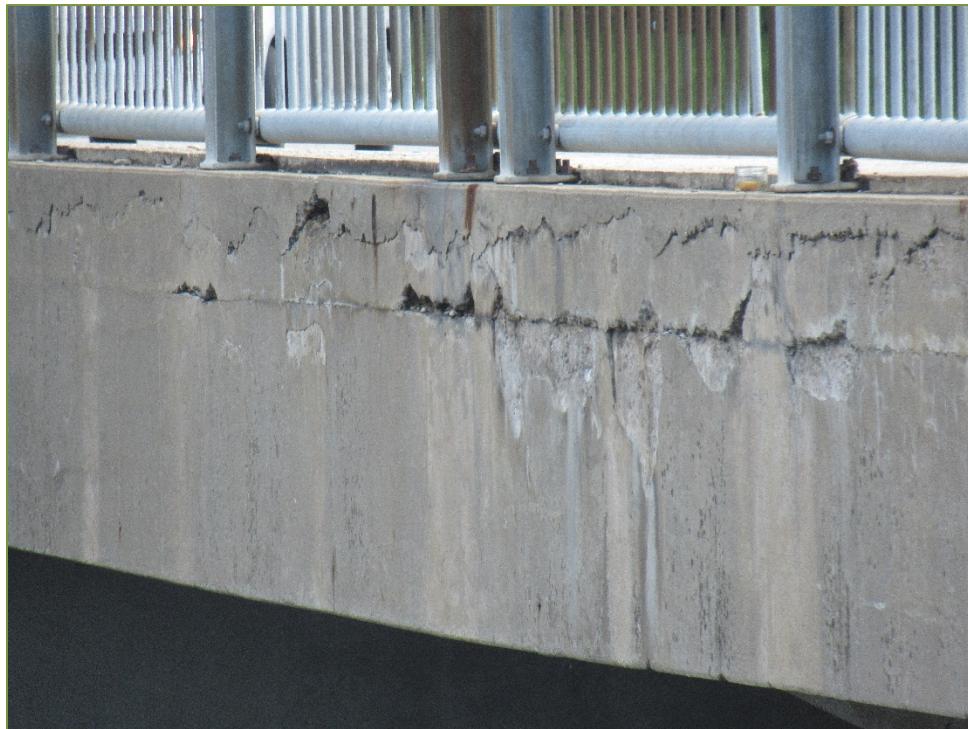
Photo P22 North Elevation – Fascia (wide cracks, spall and delamination) note, exposed rebar

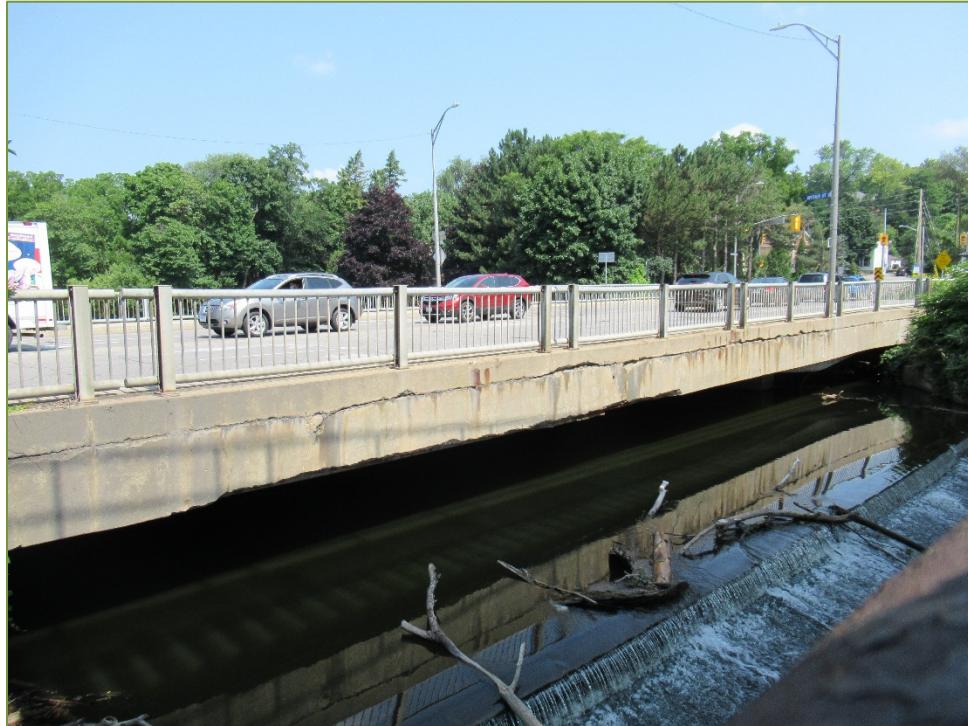
Photo P23 North Elevation – Fascia, east span (wide cracks, spall and delamination)

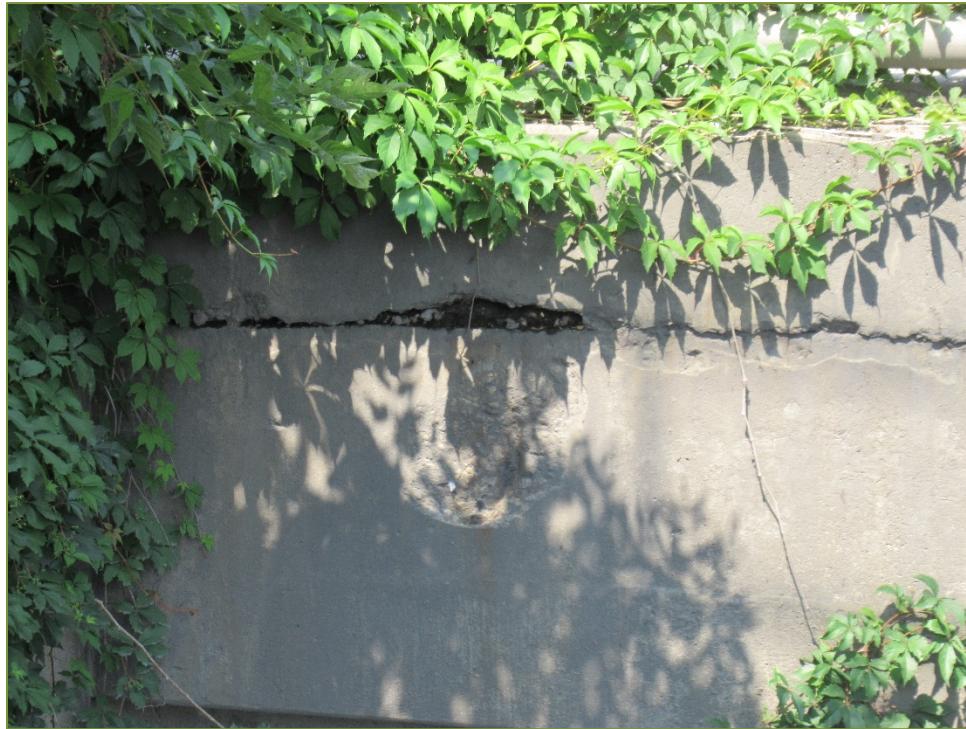
Photo P24 South Elevation – Fascia (wide cracks, spall and delamination)

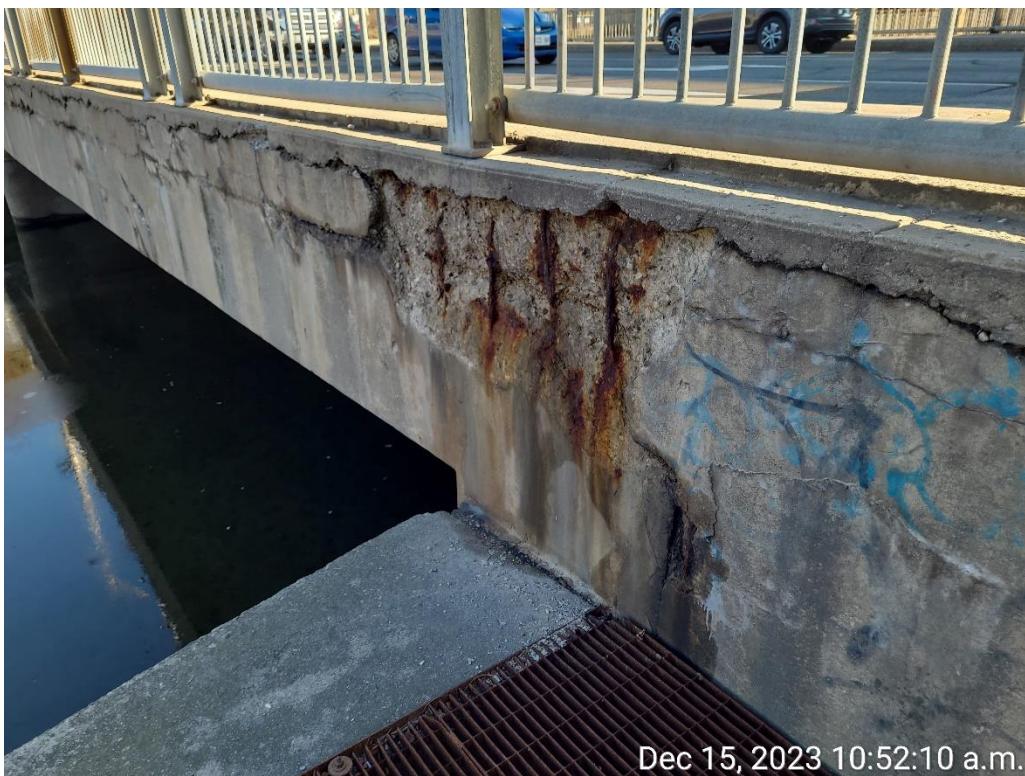
Photograph 2: North soffit exterior showing severe delamination and exposed corroded rebar

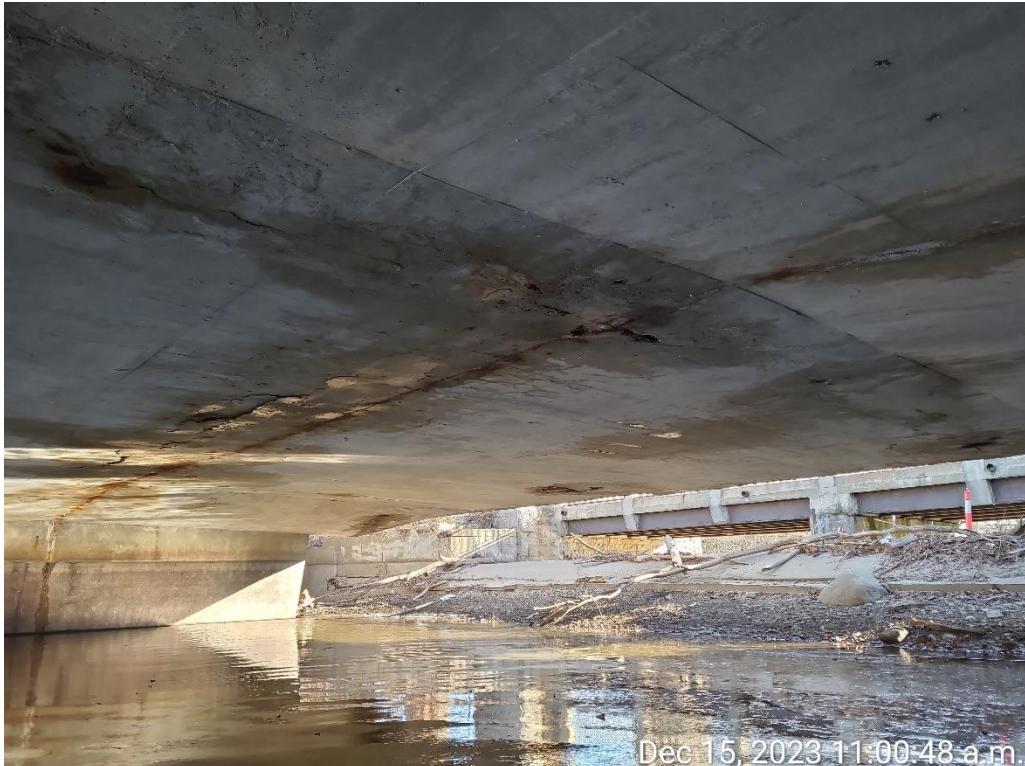
Photograph 3: West span soffit interior showing longitudinal wide crack along centerline

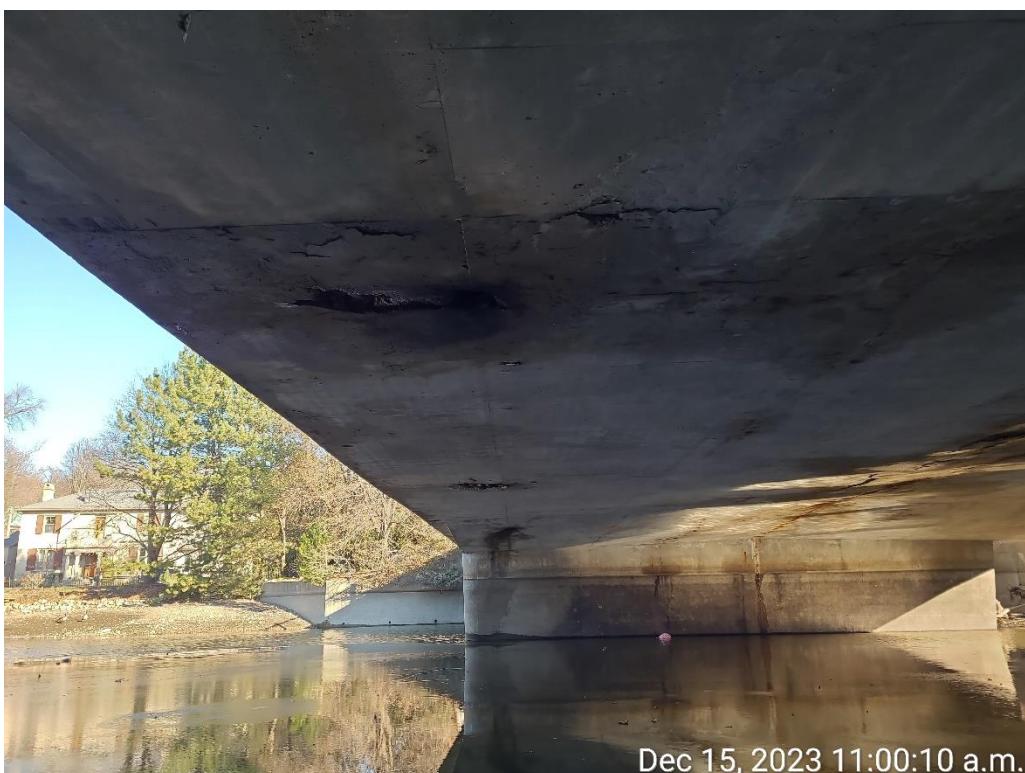
Photograph 4: Northwest deck drain hole showing delamination and spalls

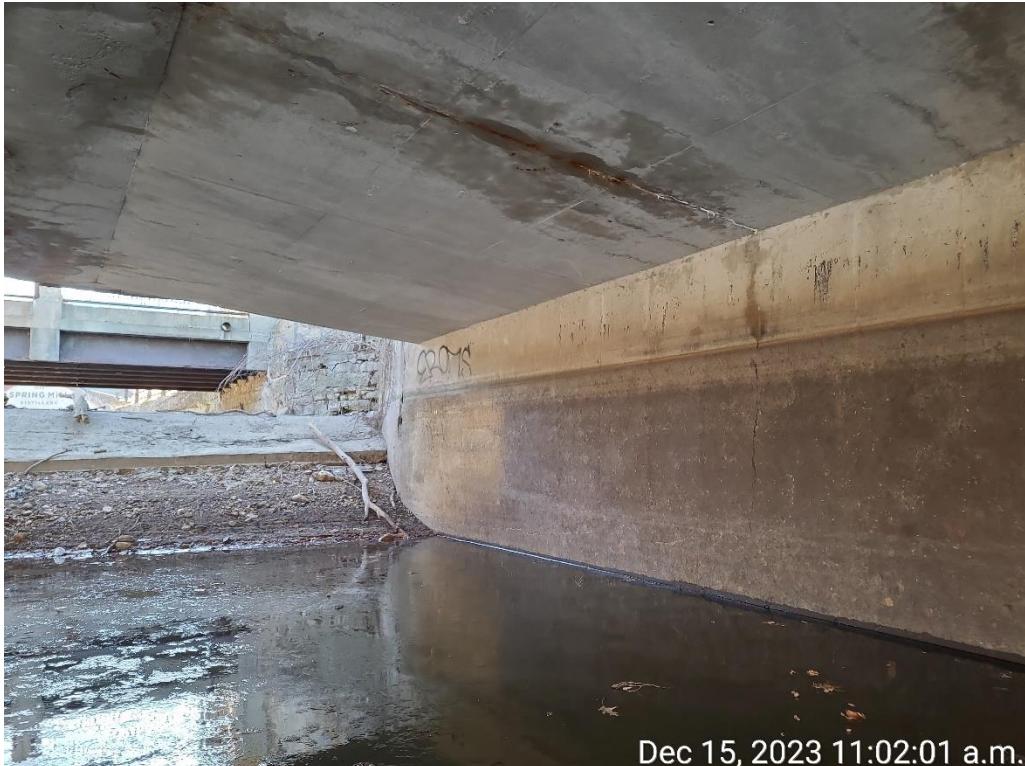
Photograph 5: Wide crack with rust staining and efflorescence continuing into north abutment

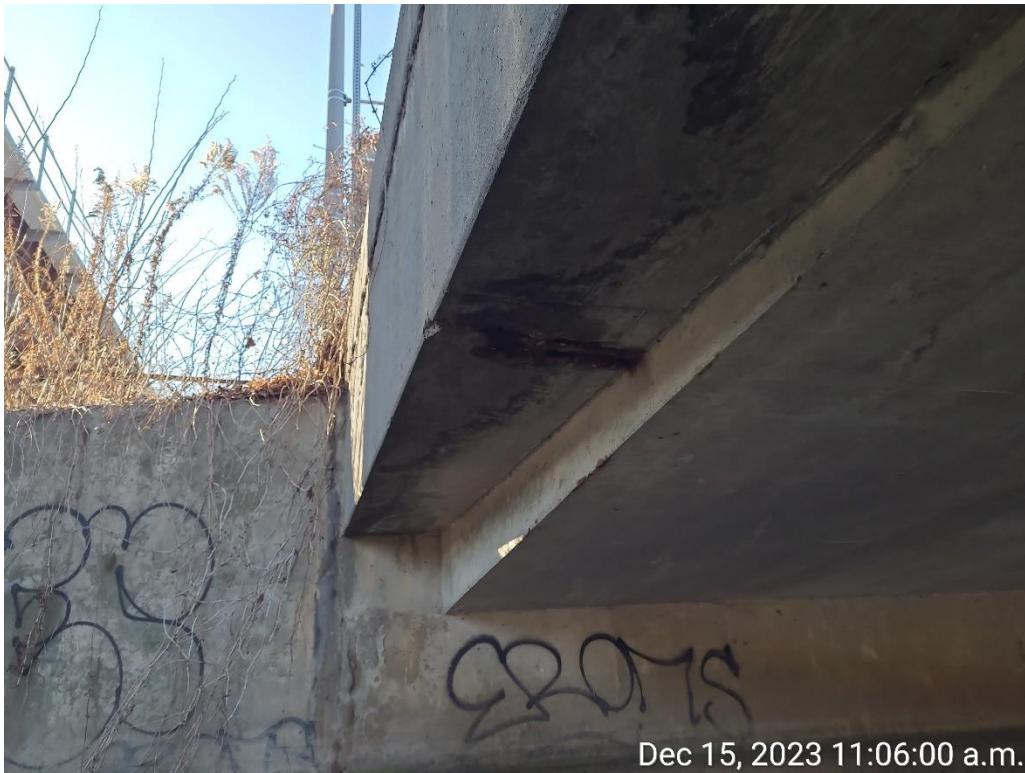
Photograph 6: Underside of southwest fascia showing delamination, spalls and exposed corroded rebar

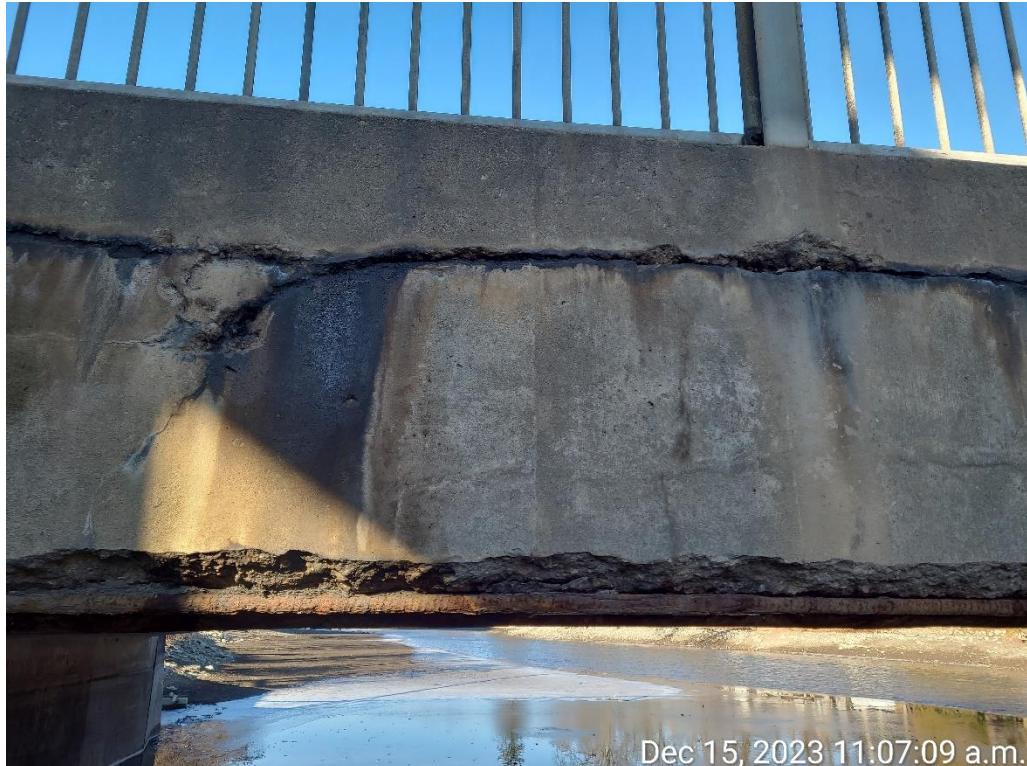
Photograph 7: South fascia showing severe spalls and exposed corroded rebar

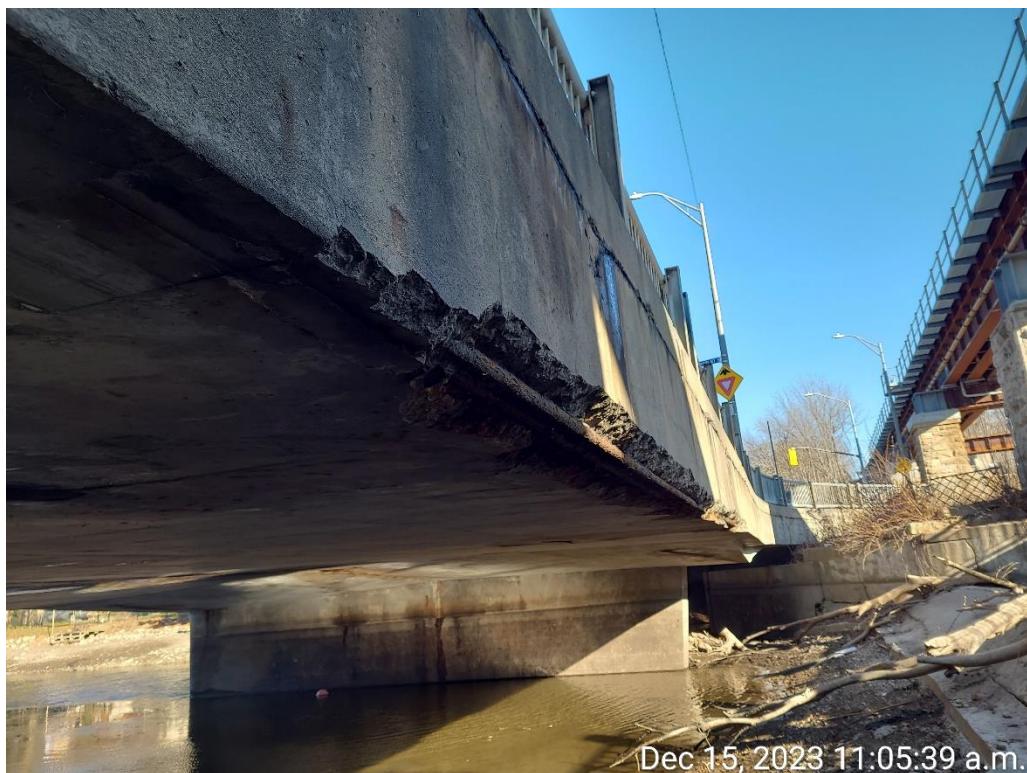
Photograph 8: South fascia showing severe spalls and exposed corroded rebar

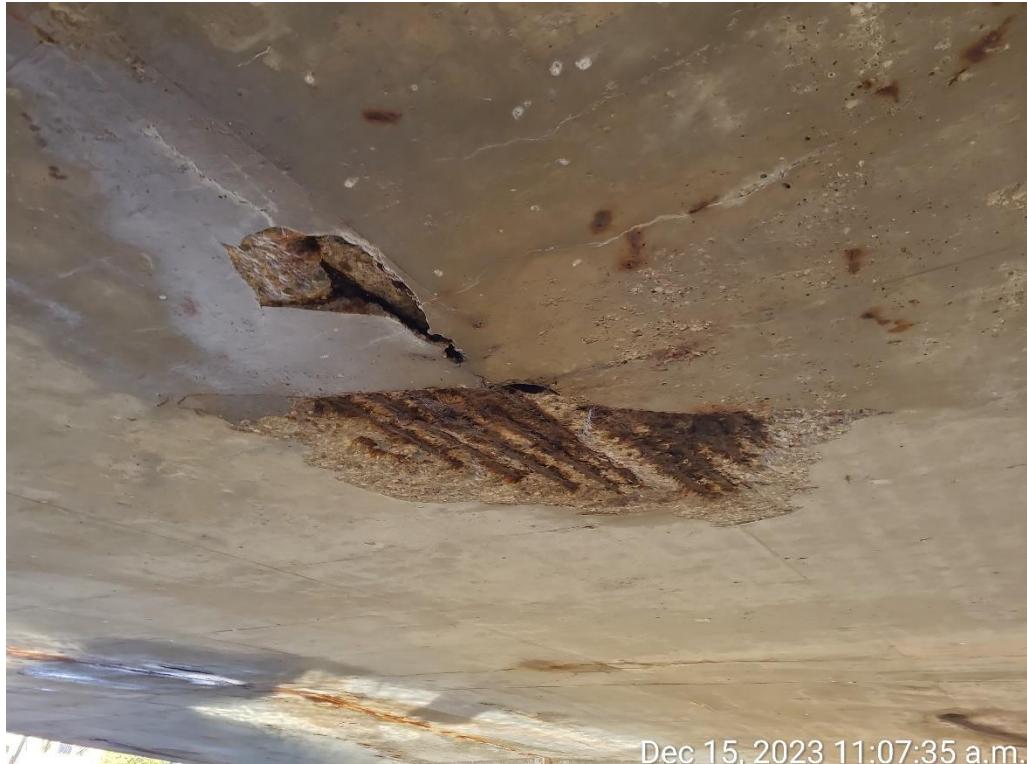
Photograph 9: South soffit interior showing spalls and exposed corroded rebars

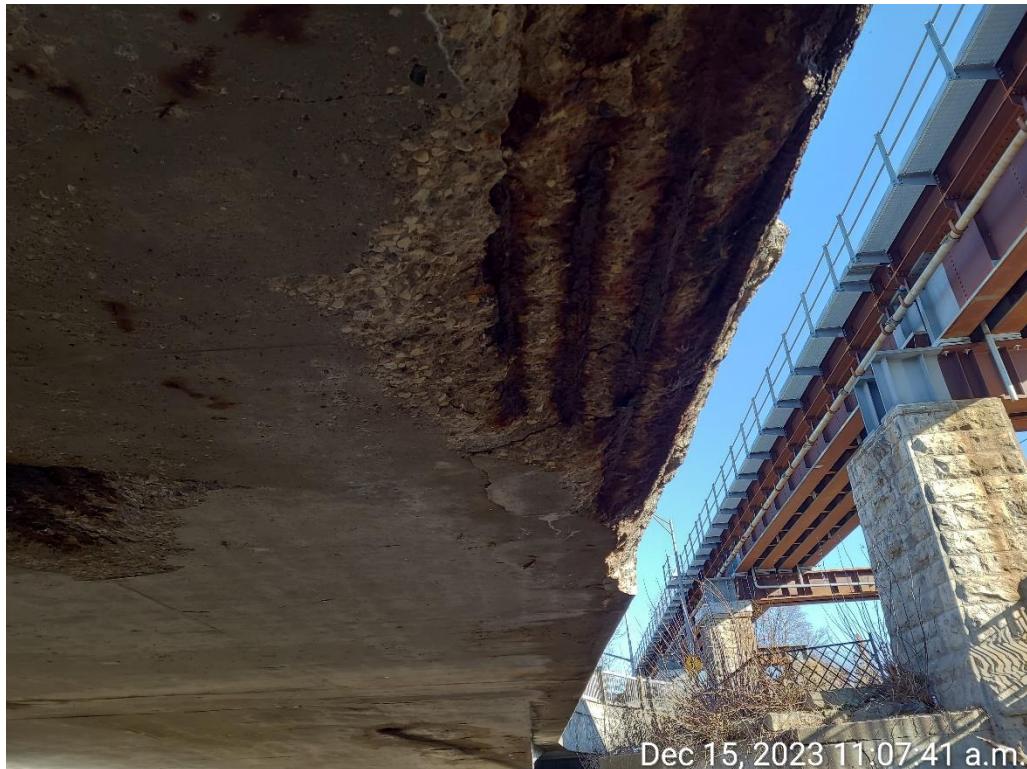
Photograph 10: Southwest soffit interior showing spalls and corroded rebars near bottom edge of fascia

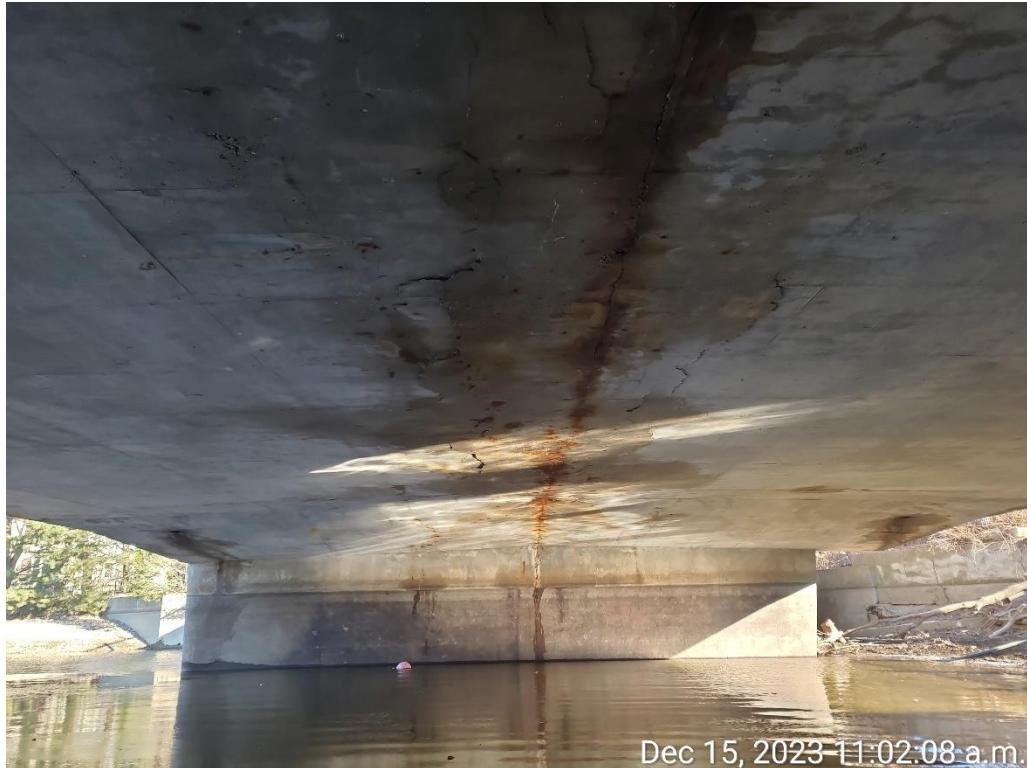
Photograph 11: Centerline wide cracking w/ efflorescence and rut staining along western span deck soffit

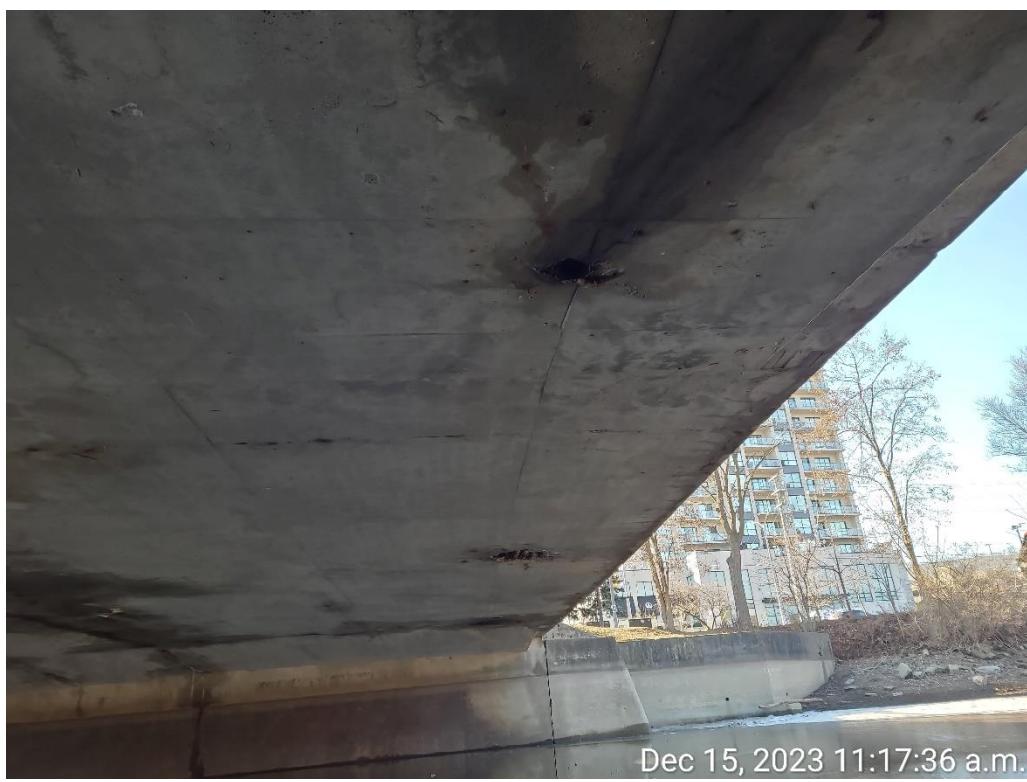
Photograph 12: Northeast drain on west span showing delamination and moisture staining around opening

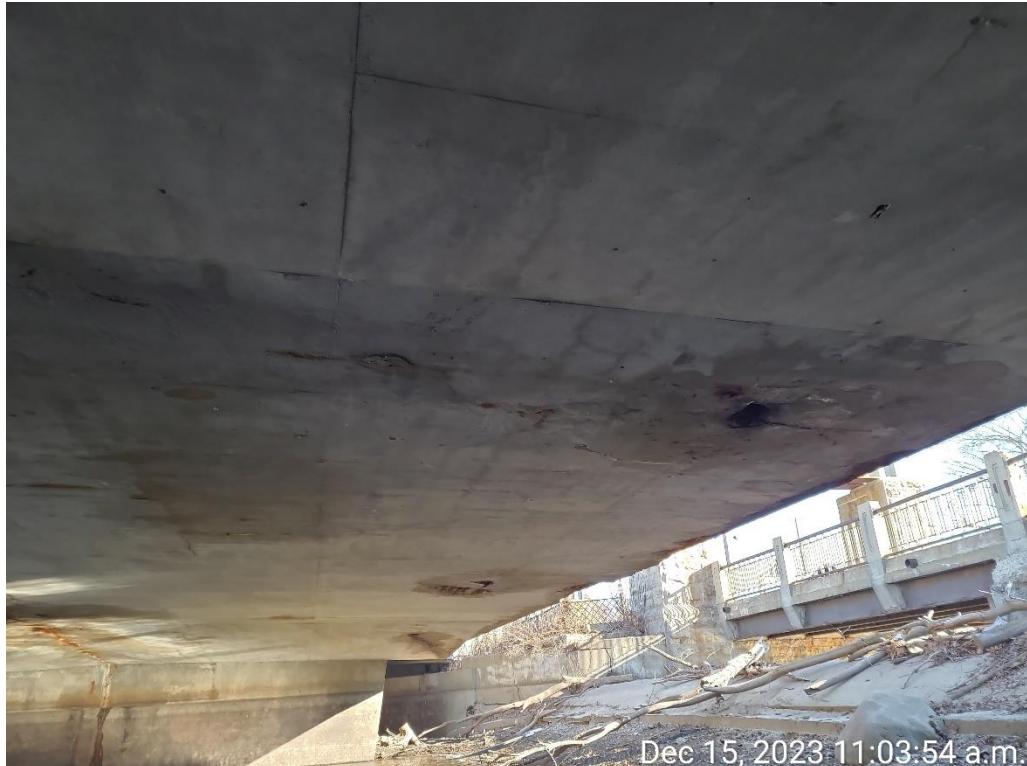
Photograph 13: Southwest drain hole showing spalls around opening

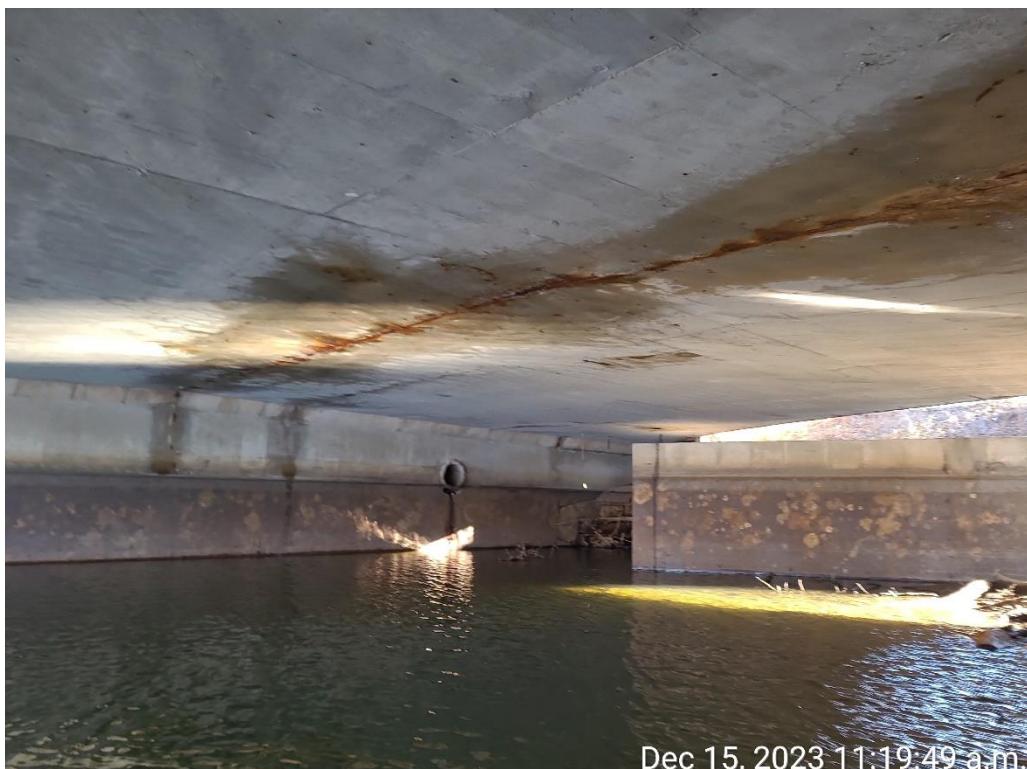
Photograph 14: East span soffit showing wide crack w/ efflorescence, rust and moisture staining along centerline

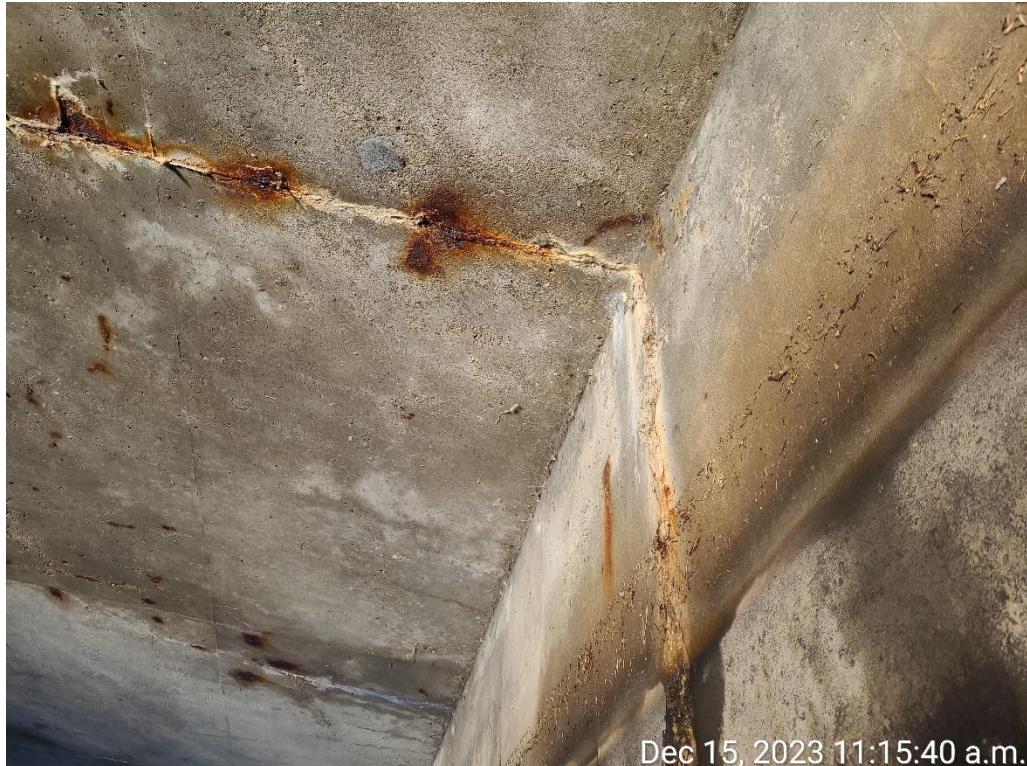
Photograph 15: East span centerline crack continue into east abutment wall

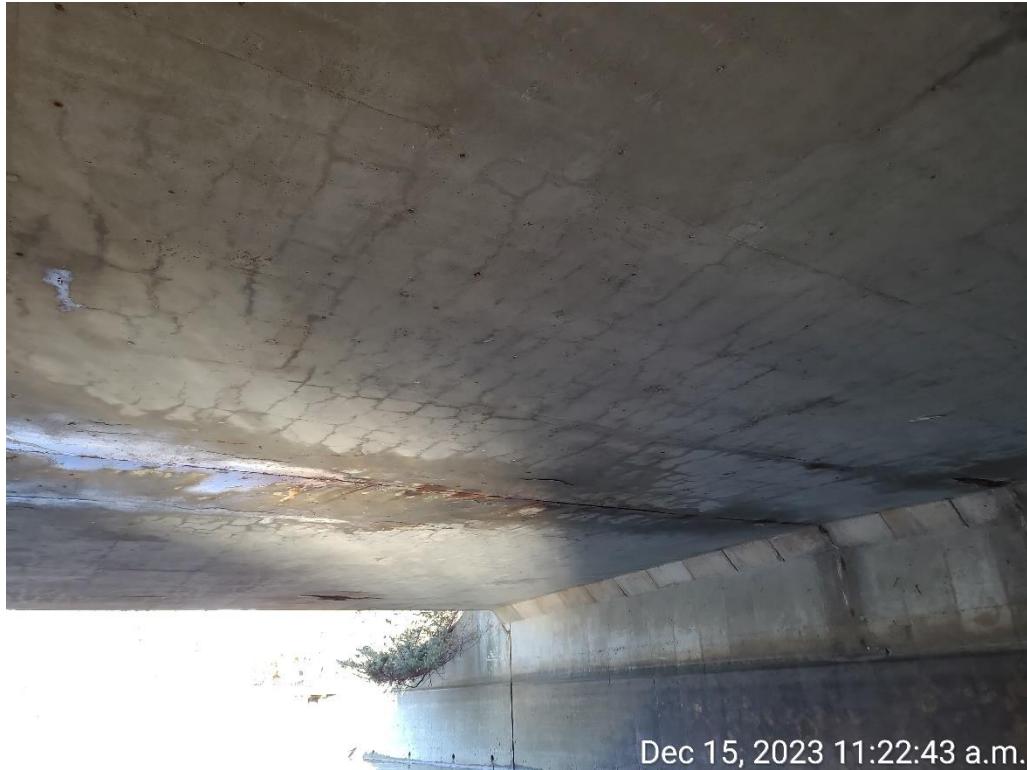
Photograph 17: East span soffit showing pattern cracking near midspan

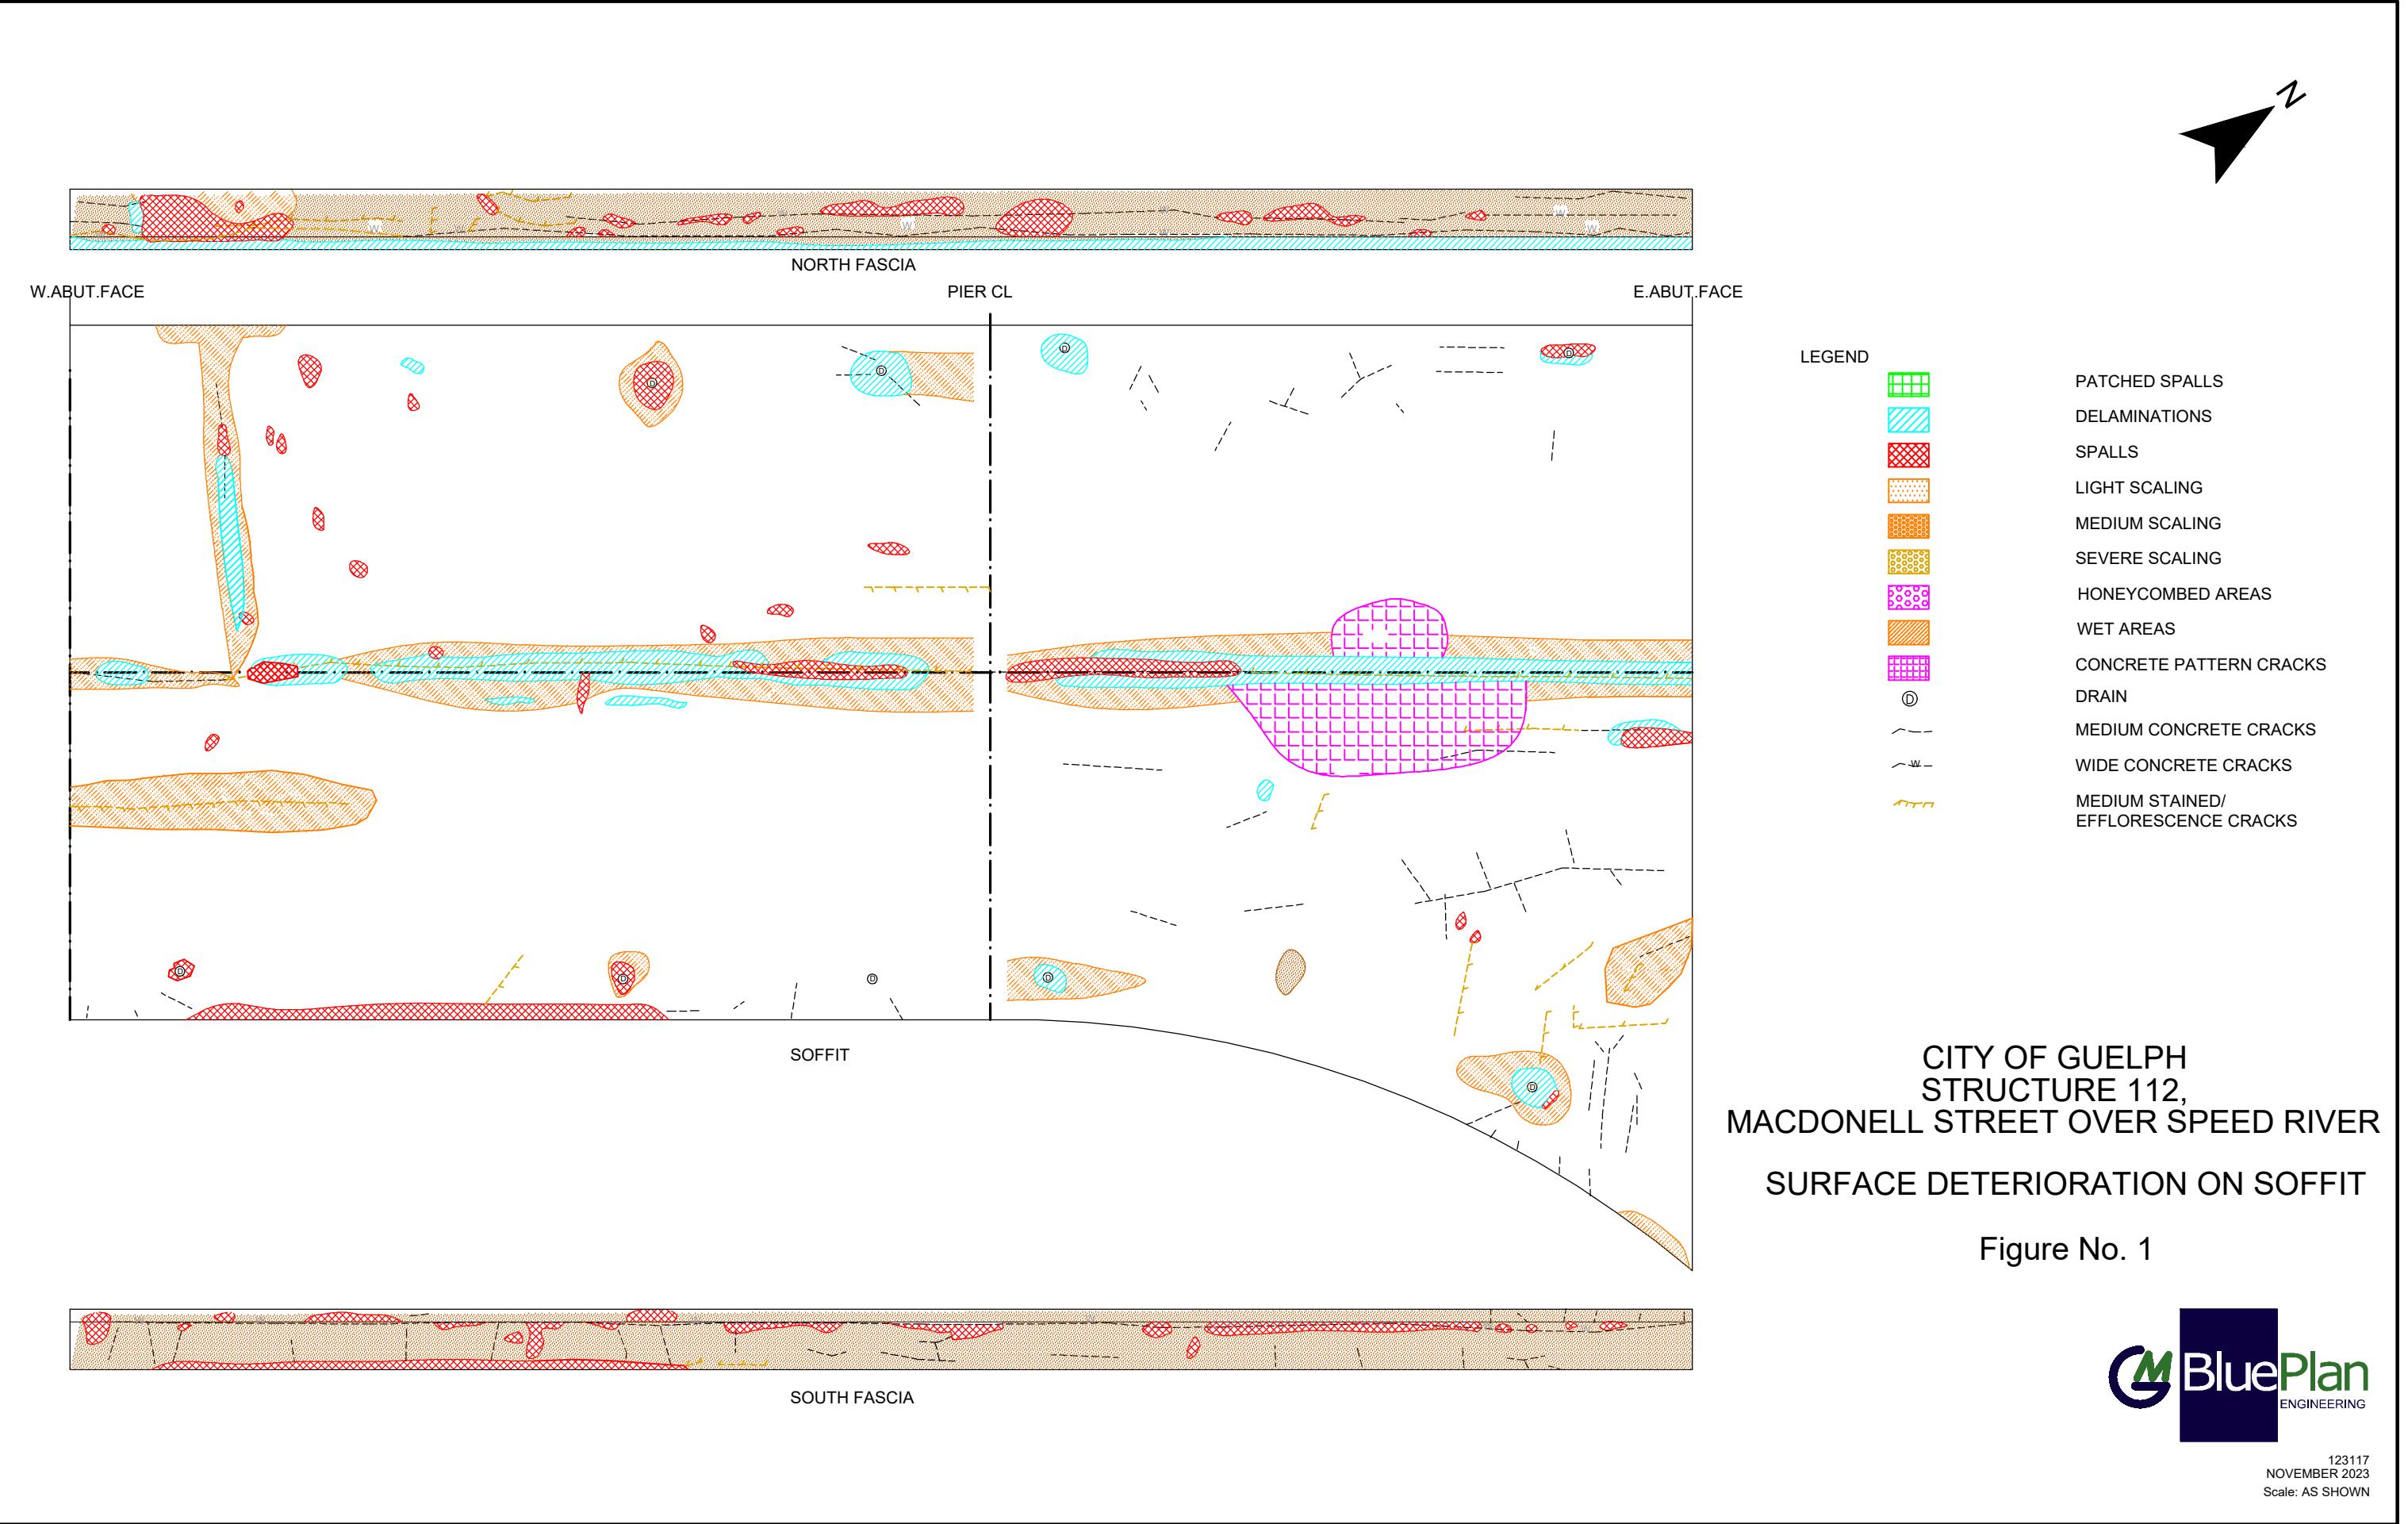
DECK SOFFIT SURFACE DETERIORATION FIGURE

- Wide longitudinal and pattern cracking with active leakage, rust staining and efflorescence;
- Severe spalls near the mid span;
- Narrow to wide cracking throughout with moisture staining; and,
- Severe delamination, with some spalling, surrounding all deck drains.

- Longitudinal wide crack with active leakage, rust staining and efflorescence along the centerline of the deck soffit continuing into pier wall;
- Longitudinal wide crack with moisture staining and efflorescence near centerline continuing into west abutment wall;
- Severe delamination near north fascia continuing transversely into the centerline near west abutment face; and,
- Severe delamination surrounding all deck drains.

It is recommended that the deck soffit of Structure 112 continues to be monitored for signs of advancing deterioration until the structure is replaced. GMBP is scheduled to return in November/December of 2024 to conduct an OSIM inspection as well as a detailed visual inspection of the deck soffit. The deterioration figure included in **Appendix C** shall be used as a baseline to compare against any future deterioration of the soffit.
