DETAILED CONDITION SURVEY REPORT

Structure ID 112, Macdonell Bridge, Guelph, ON

BCC Project No.: BCC21015
Report Date: March 25, 2025

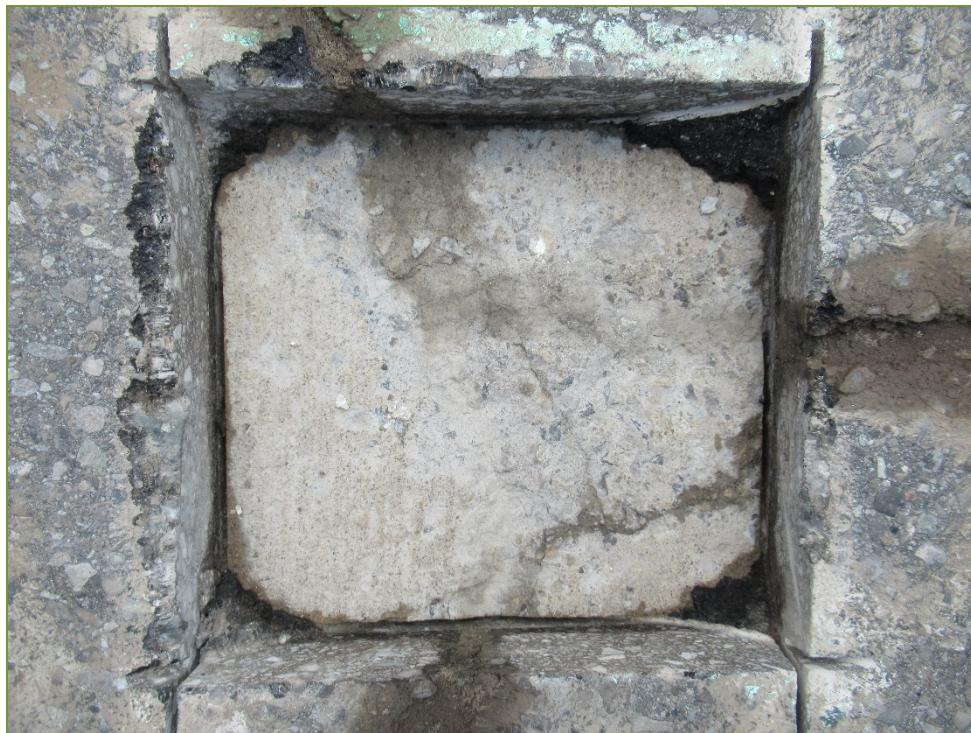
Photo S9 – Sawn Sample SS9 (delamination, and severe scaling)

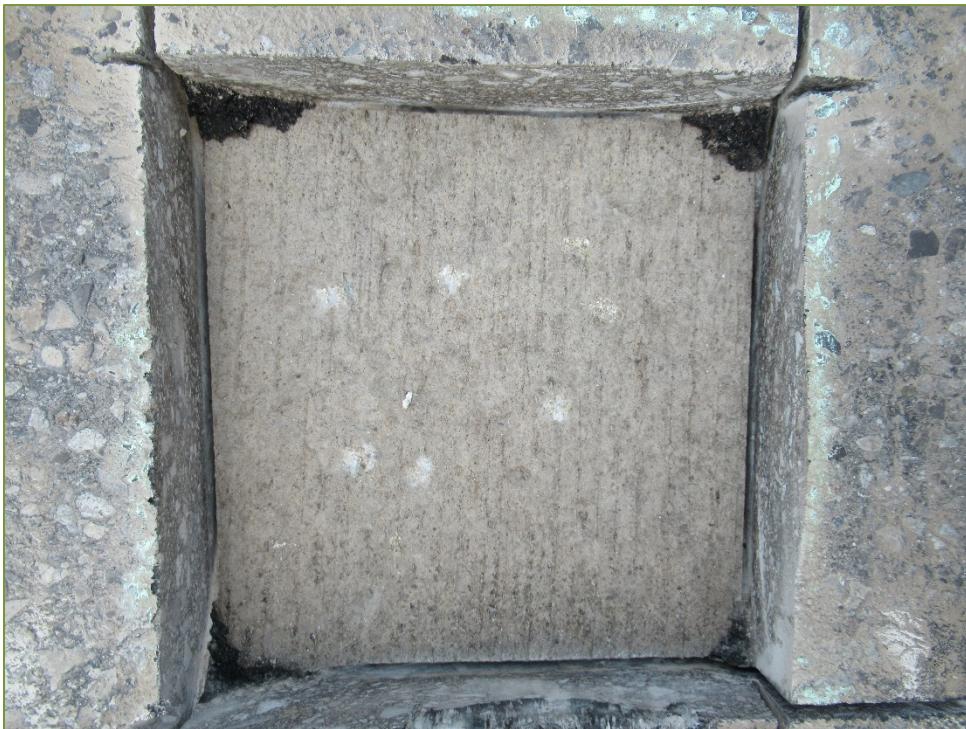
Photo S10 – Sawn Sample SS10 (crack, and medium scaling)

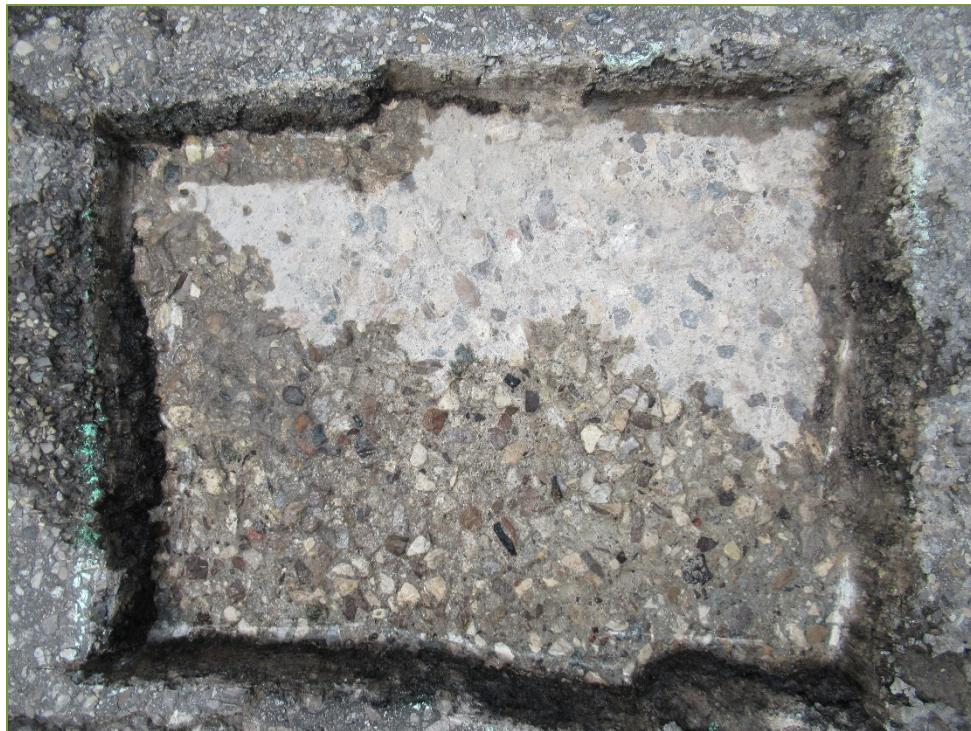
Photo S16 – Sawn Sample SS16 (cracks, delamination, and severe scaling)

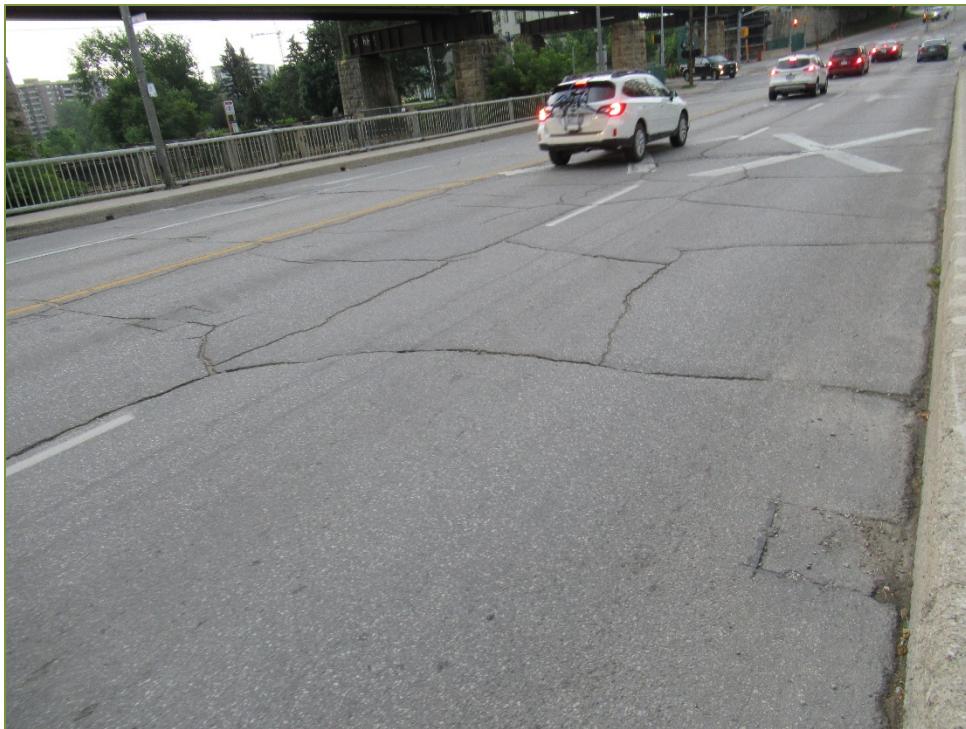
Photo P5 Deck Wearing Surface (fair to poor condition – unsealed cracks, alligator cracks, pot holes, ravelling and rutting)

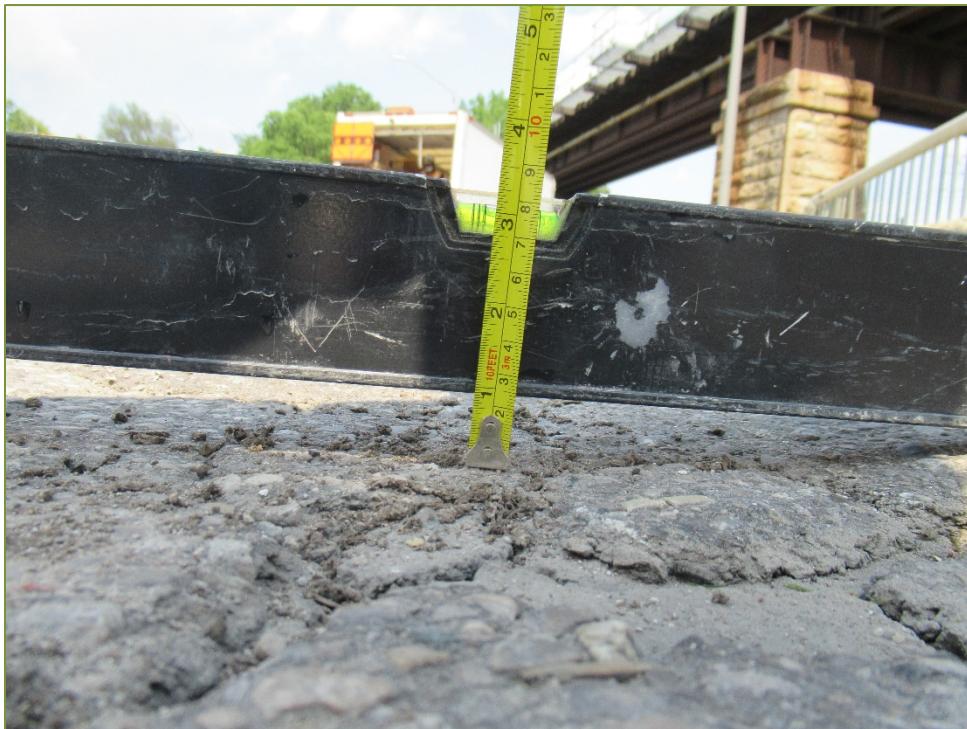
Photo P9 Deck Wearing Surface at East Abutment, south side (rutting)

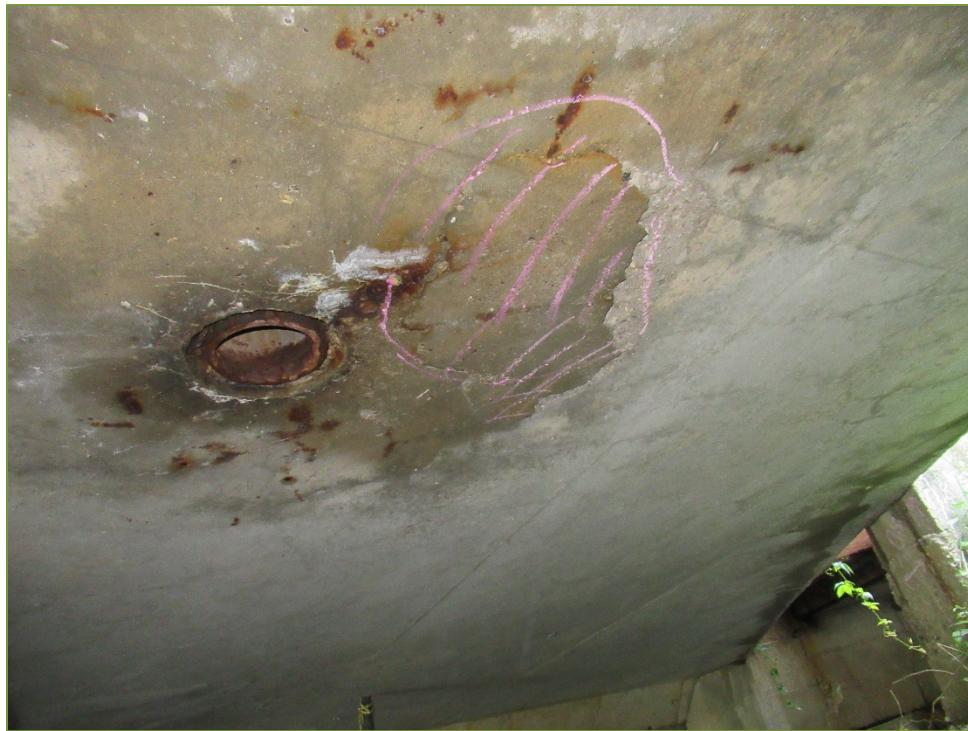
Photo P17 Soffit between East Abutment and Pier, south side (cracks, spall, delamination, and wet area) note, drain is discharging directly onto soffit

A total of eight steel drain pipes were located on bridge deck, each having a 100 mm diameter and a 350 mm length. The drain pipes need to be extended so that they do not discharge drain water on the soffit surface. Catch basins were found at all four quadrants outside structure limits (Photos P28 to P32).

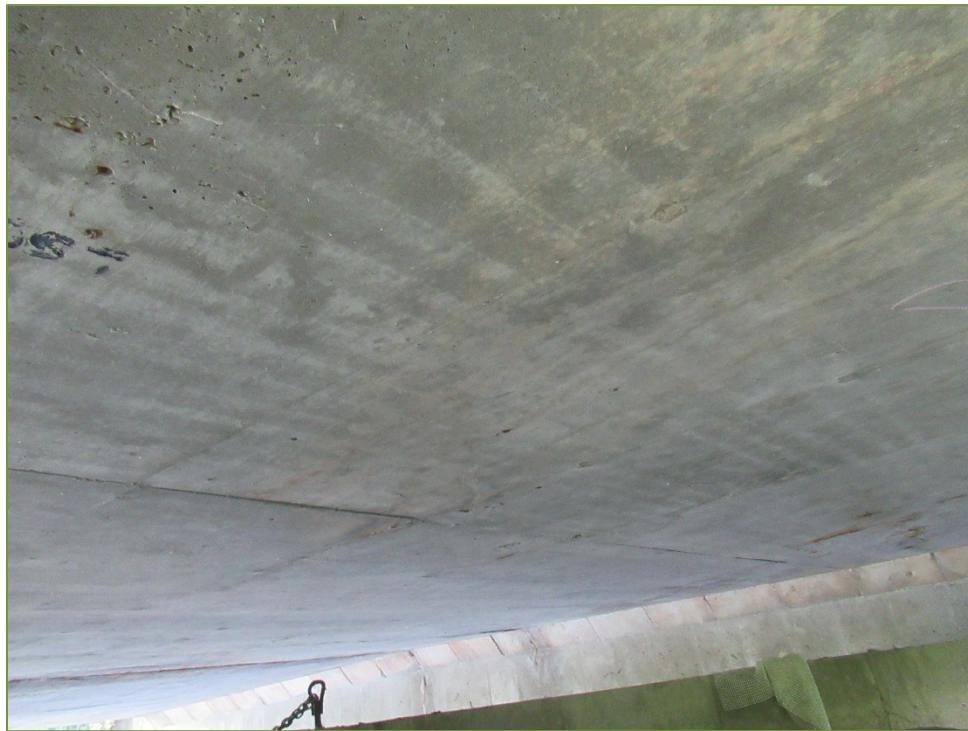
Photo P19 Soffit between East Abutment and Pier, south side (cracks)

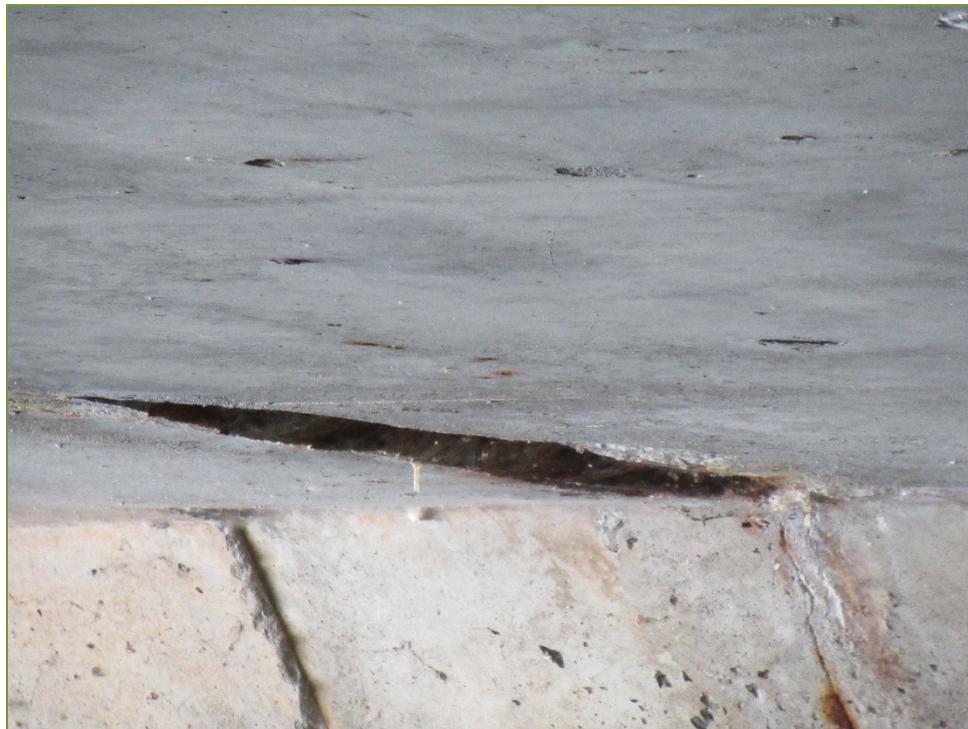
Photo P21 Soffit at East Abutment (cracks, and spall)

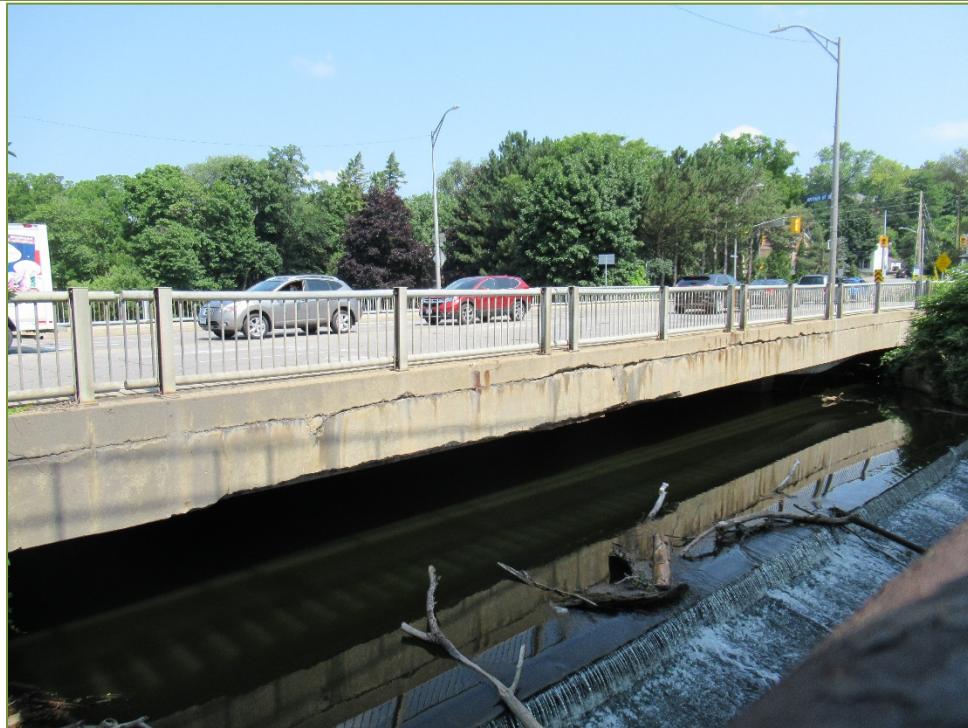
Photo P23 North Elevation – Fascia, east span (wide cracks, spall and delamination)

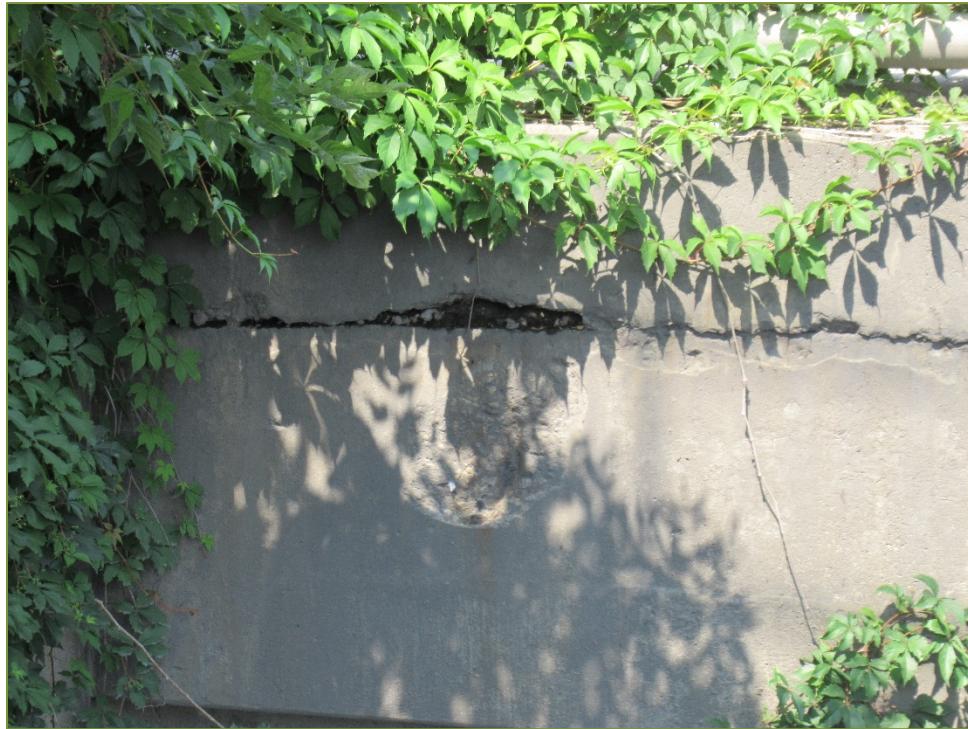
Photo P25 South Elevation – Fascia (wide cracks and spall)

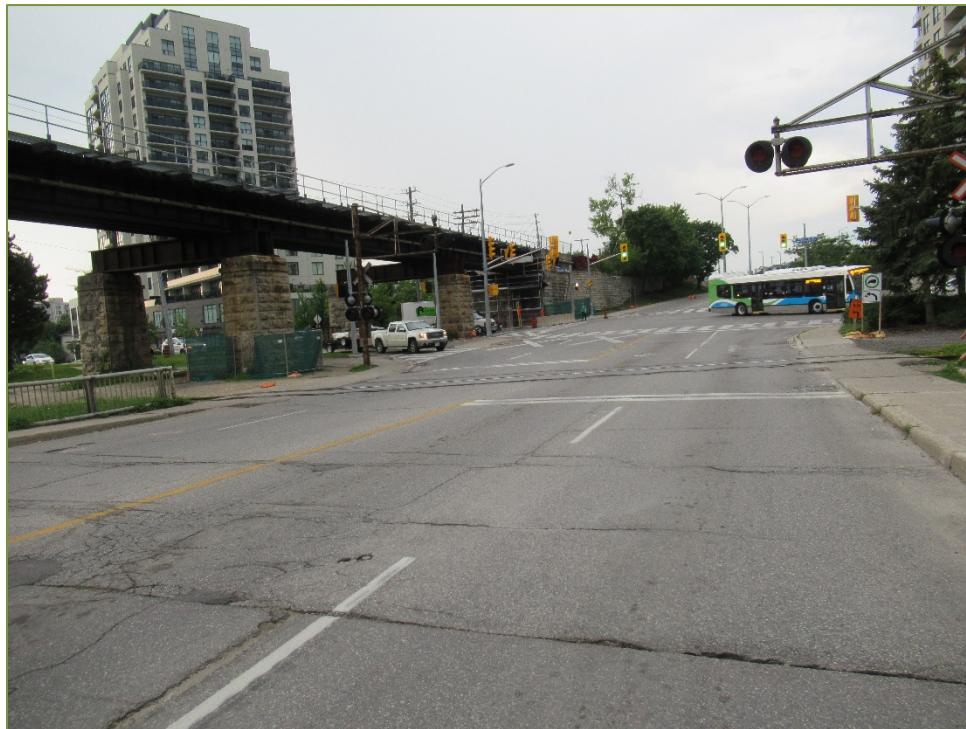
Photo P26 East Approach Wearing Surface (fair condition - unsealed cracks, and pot holes)

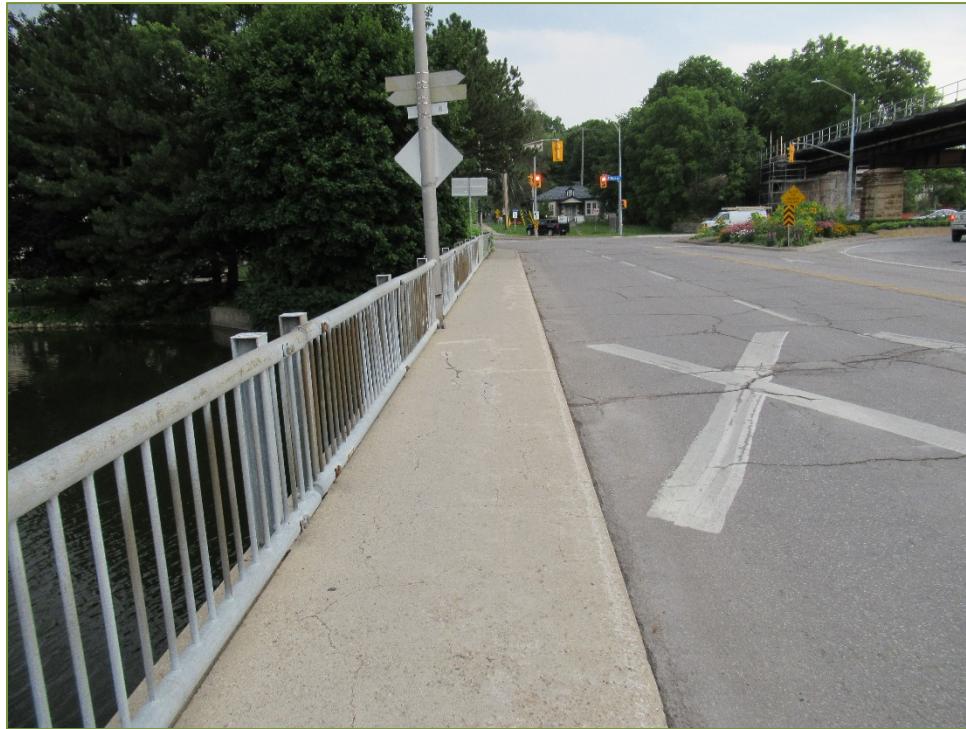
Photo P36 North Sidewalk (fair to poor condition - cracks, spall, delamination, and light to severe scaling) **and Handrail** (fair condition - light corrosion)

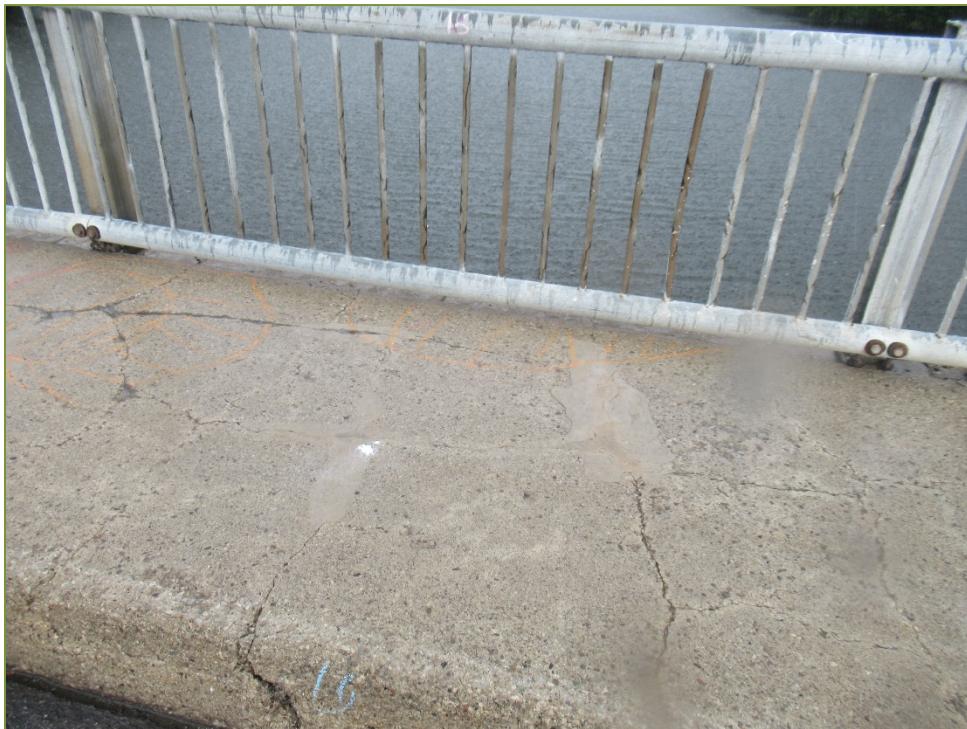
Photo P41 North Sidewalk (cracks, spall, delamination, and severe scaling) and Handrail (light corrosion)

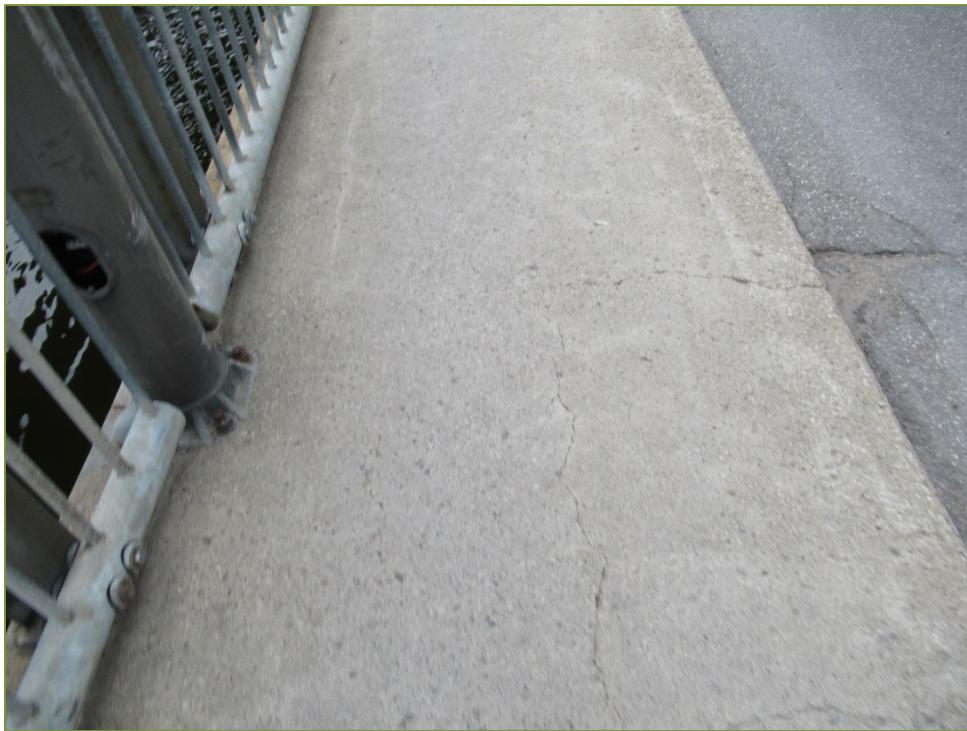
Photo P42 South Sidewalk (fair condition – wide cracks and light to medium scaling) and Handrail (fair condition - light corrosion)

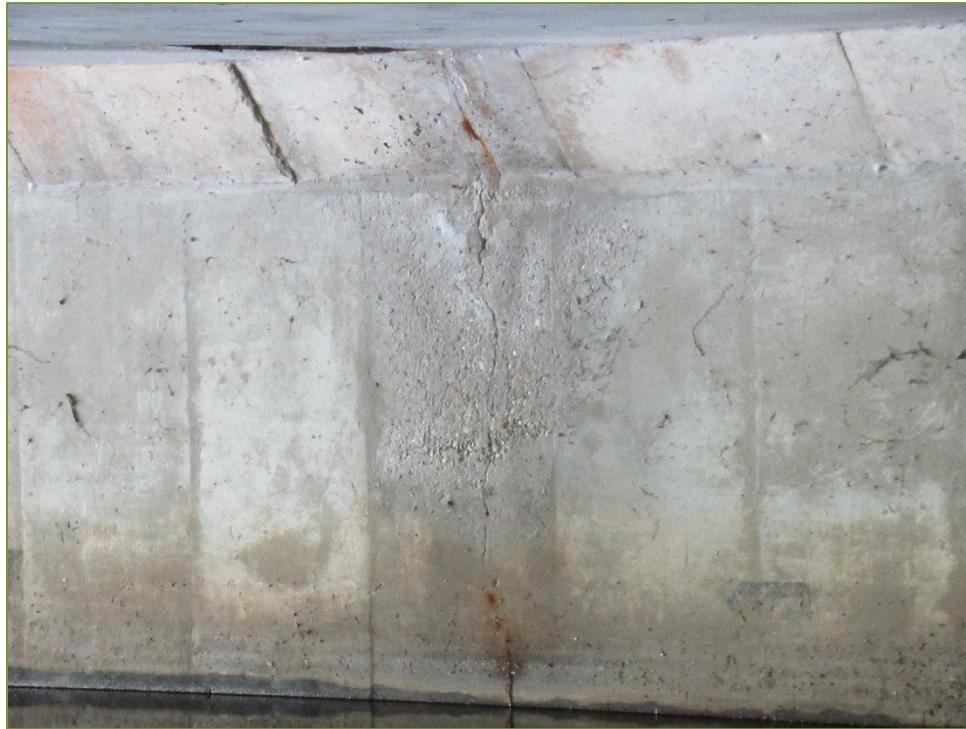
Photo P46 East Abutment (fair condition – cracks, spall, light to medium scaling, and wet area)

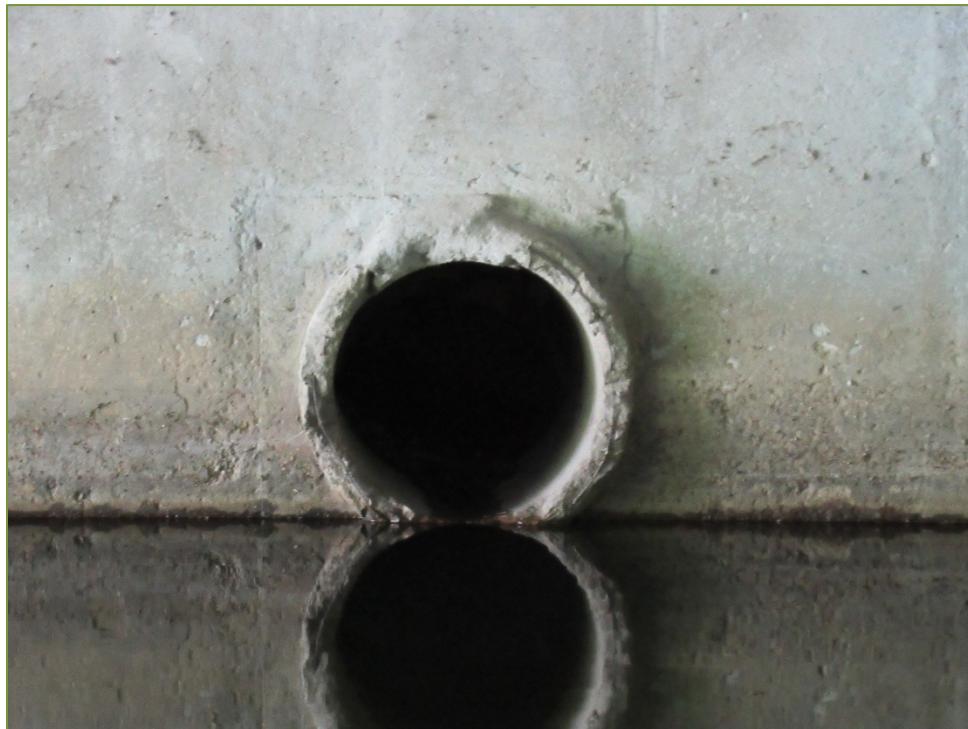
Photo P49 East Abutment (cracks, and medium scaling) note, drain

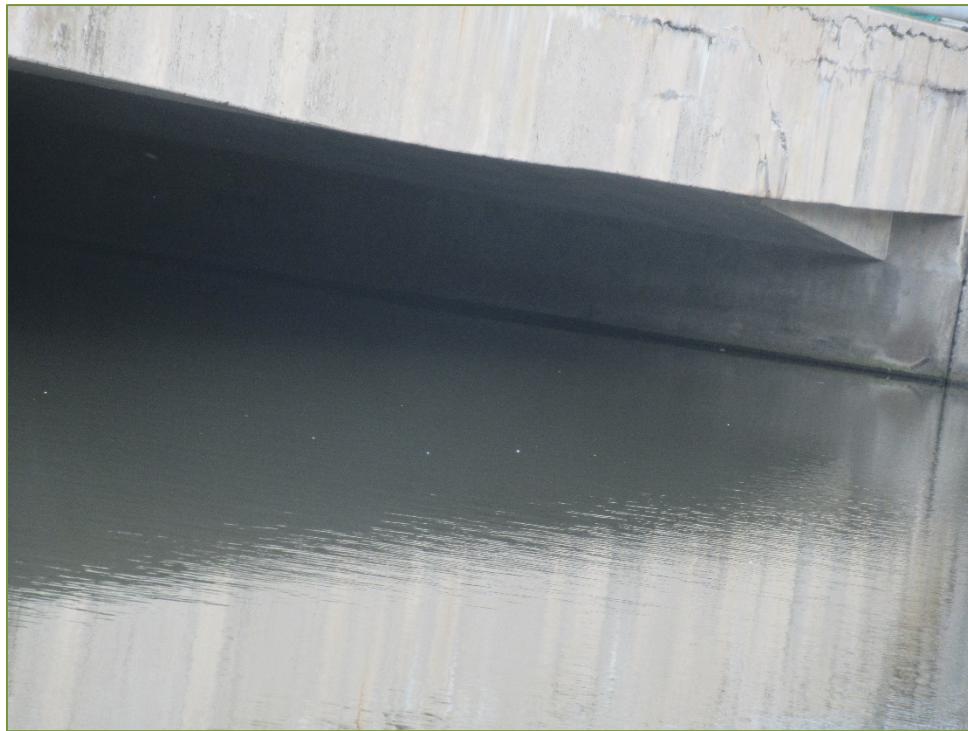
Photo P51 West Abutment (cracks)

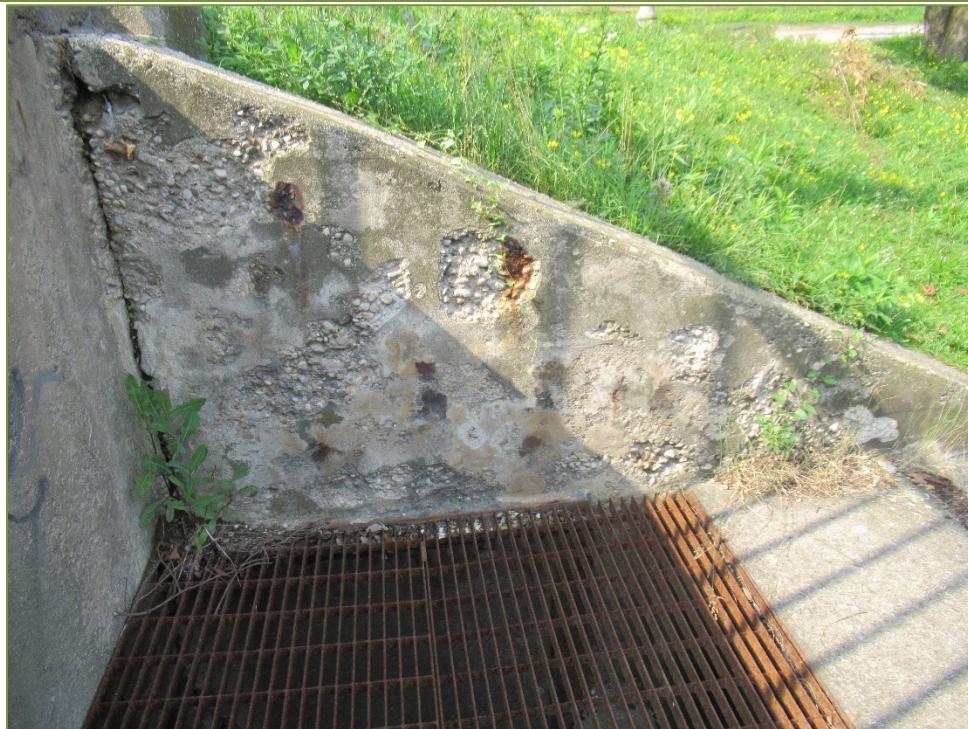
Photo P53 Northwest Retaining Wall (fair condition – cracks, spall and light to severe scaling)

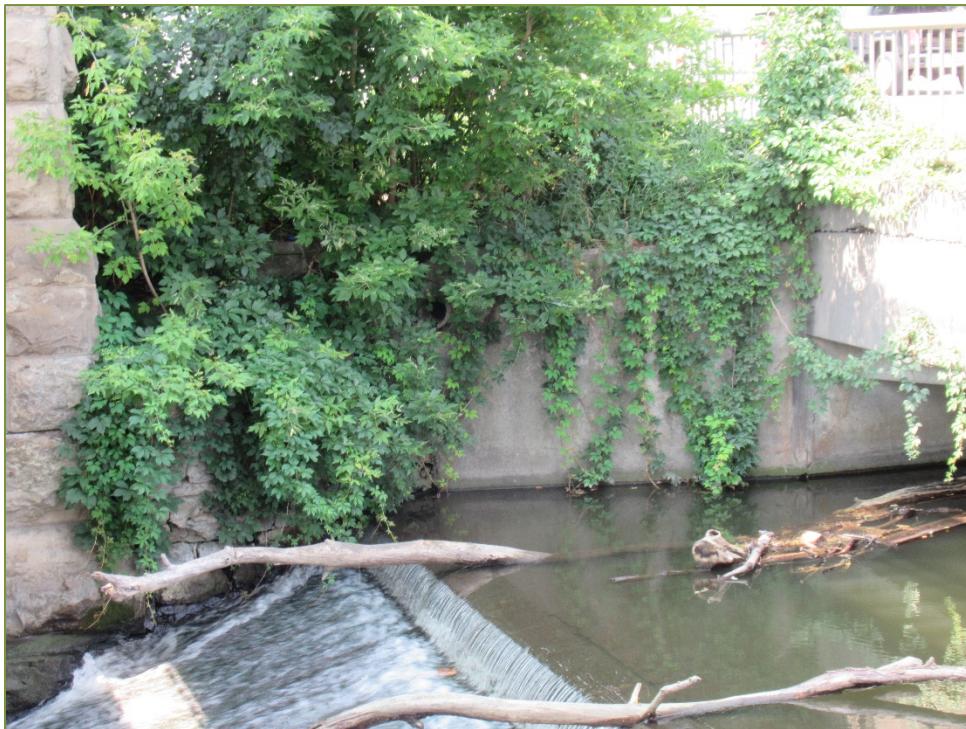
Photo P55 Southwest Retaining Wall (good condition - cracks and light scaling)

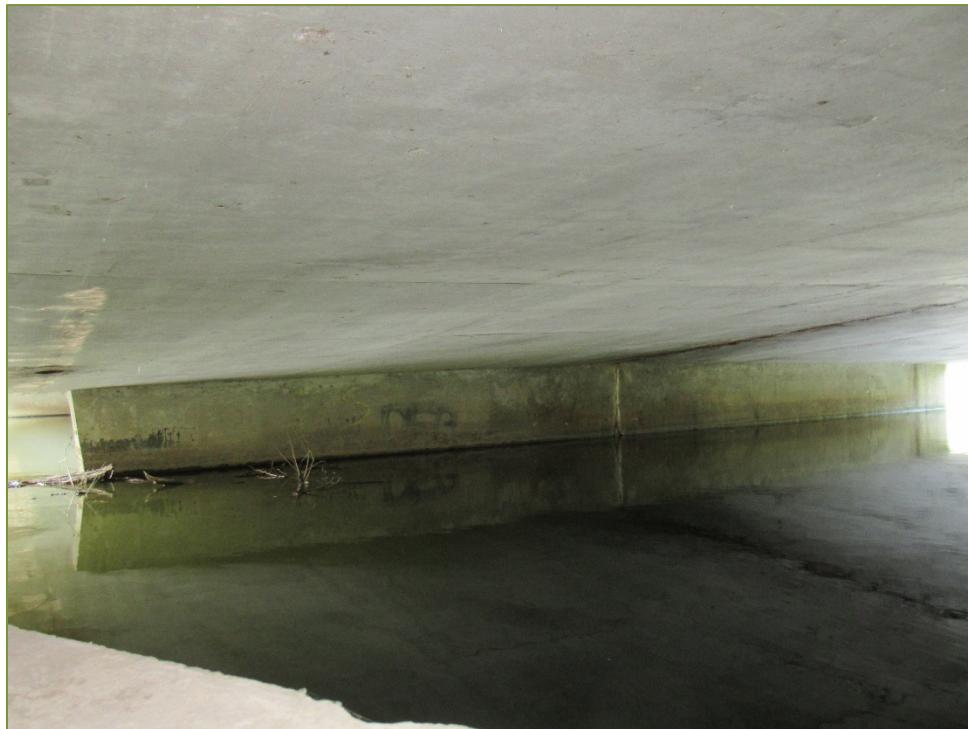
Photo P57 Pier - East Face (fair to good condition - crack and light scaling)

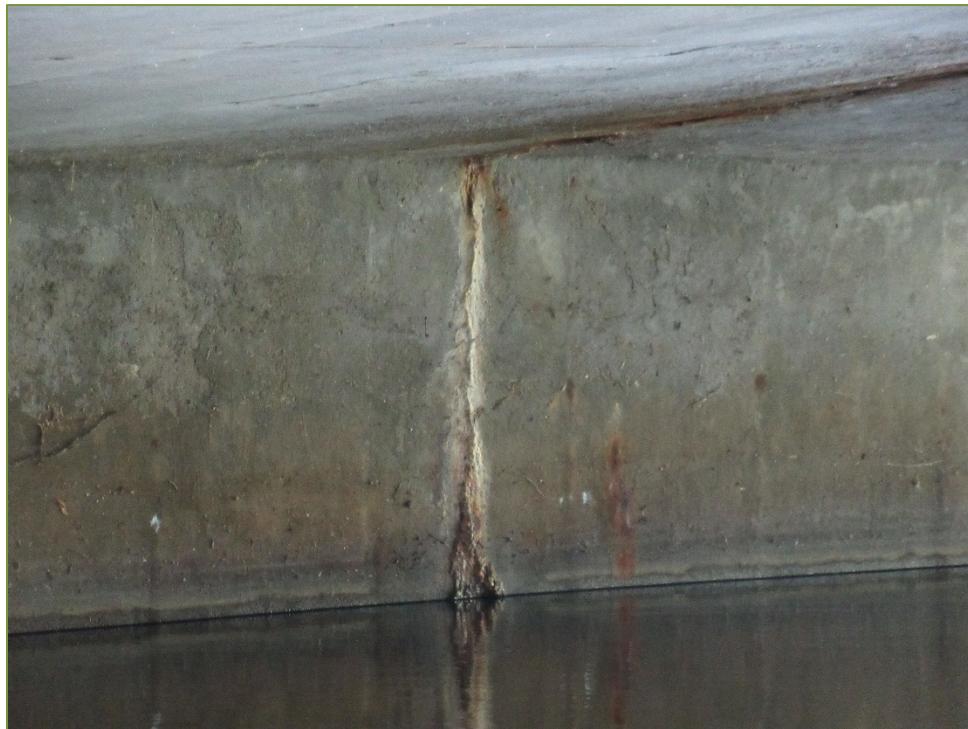
Photo P59 Pier - East Face (cracks, spall, and wet area)

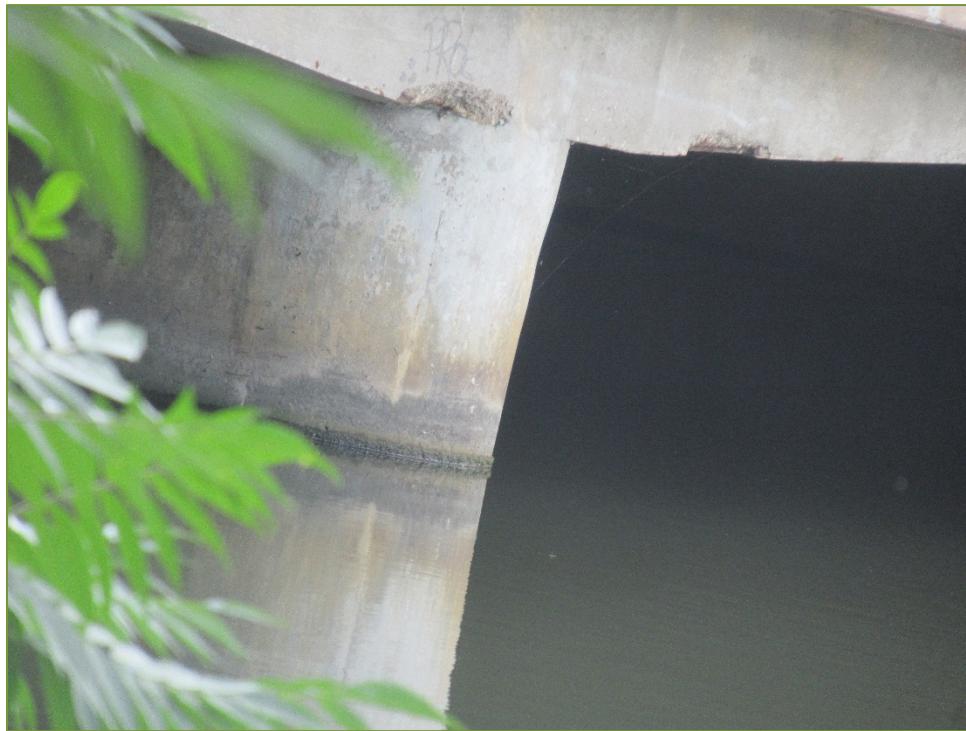
Photo P61 Pier - North Face (crack)

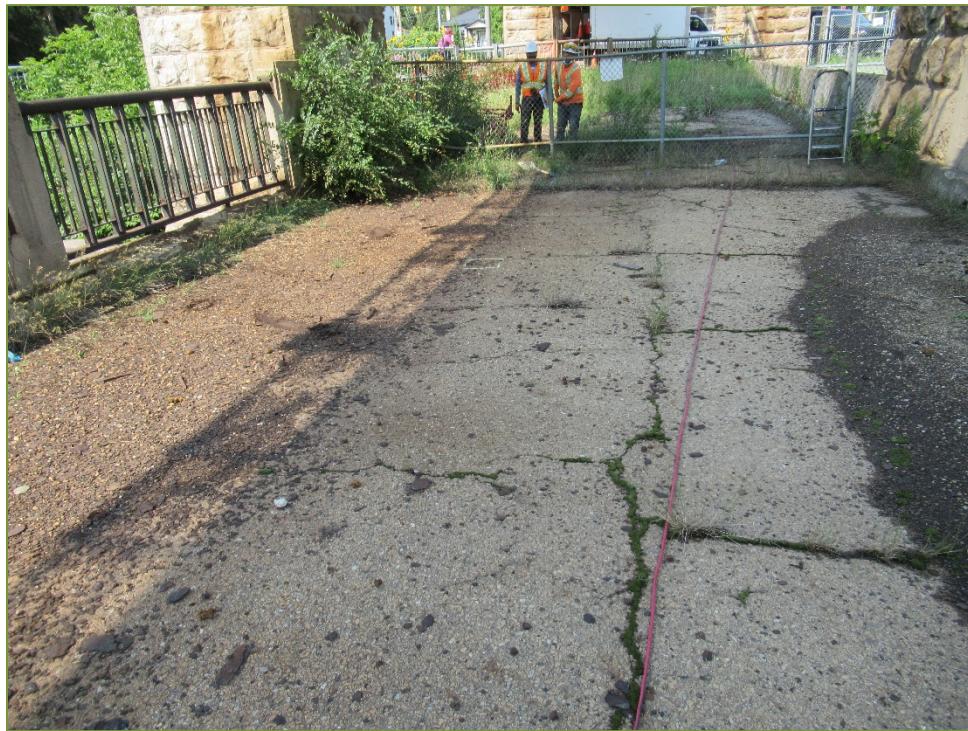
Photo P5 Deck Wearing Surface (poor condition – unsealed cracks, and ravelling) note vegetation growth and debris

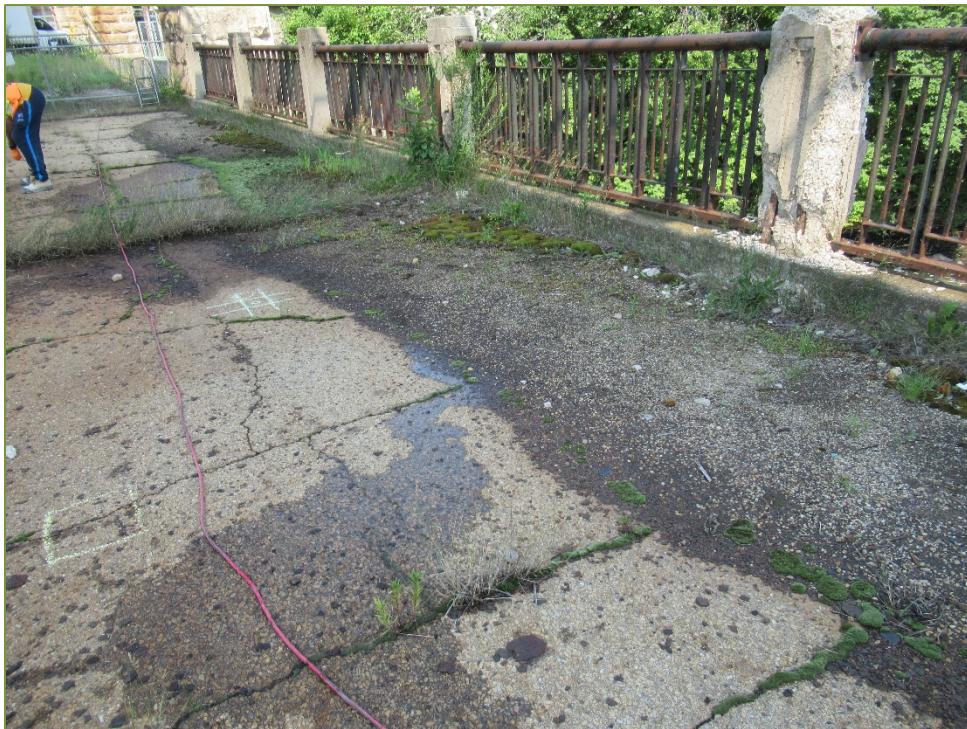
Photo P7 Deck Wearing Surface (unsealed cracks, and ravelling) note vegetation growth and debris

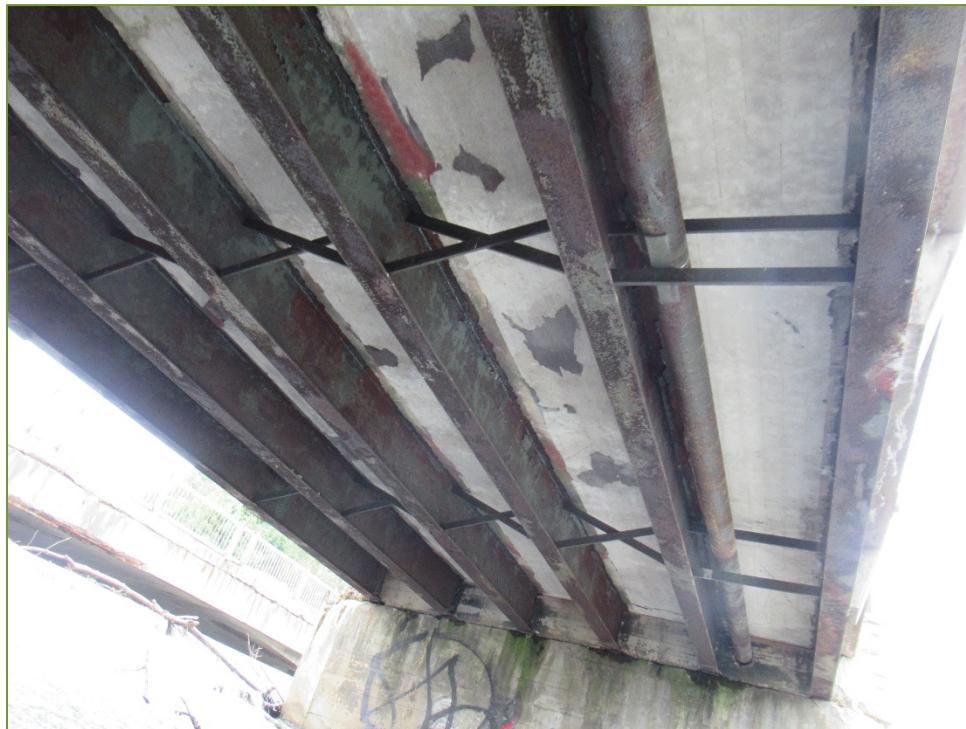
Photo P9 Soffit between West Abutment and Pier, looking east (fair condition – cracks, spall, delamination and light scaling) and **Girders** (fair condition – light to severe corrosion)

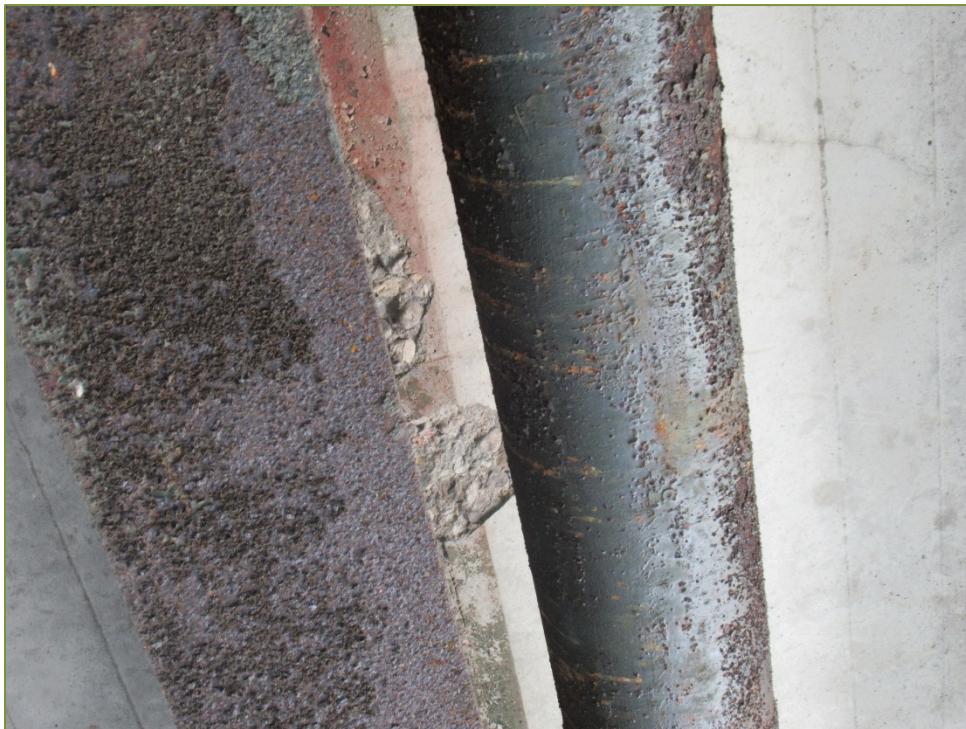
Photo P11 Soffit at West Abutment, south edge (spall, and delamination) and Girder (light corrosion)

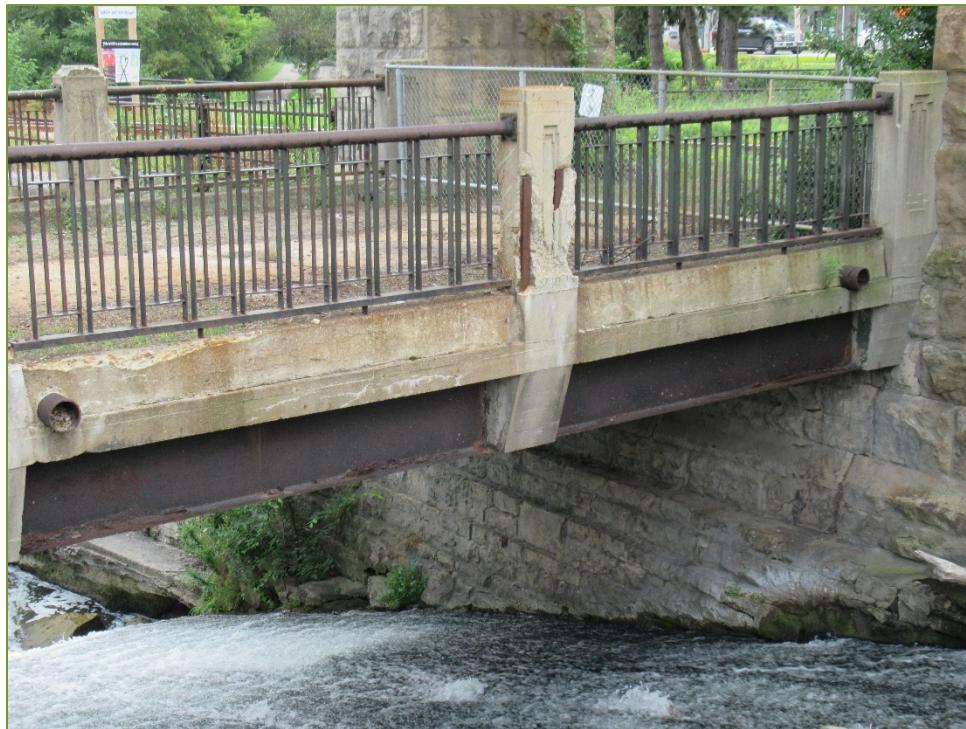
Photo P41 North Elevation – Fascia (cracks, spall, delamination, and light scaling)

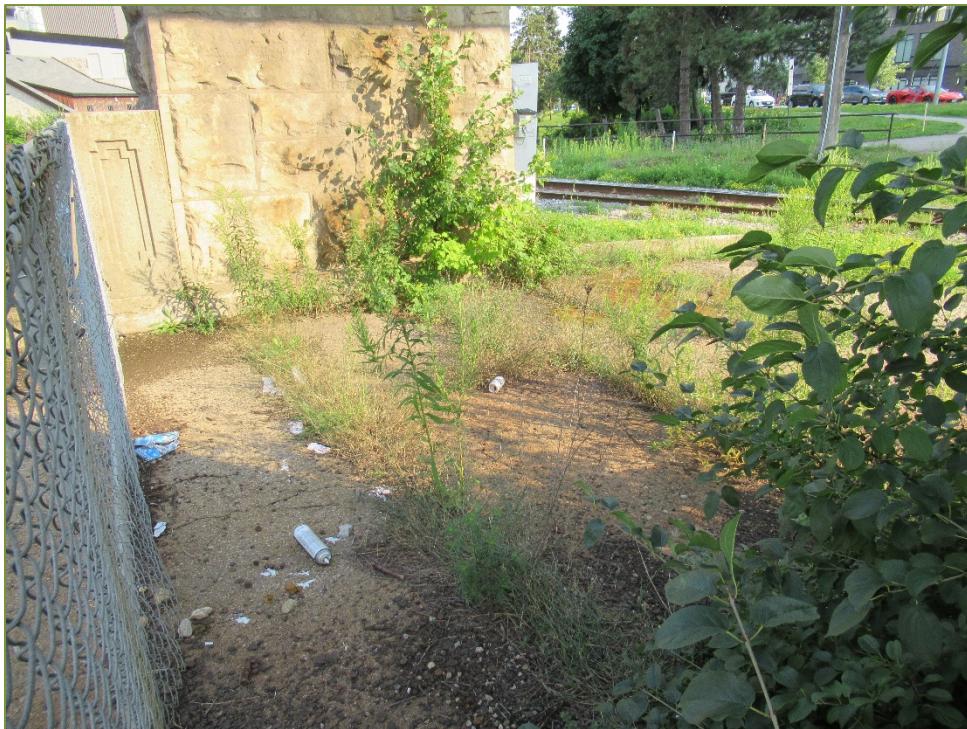
Photo P45 West Approach Wearing Surface (fair condition – unsealed cracks, and ravelling)
note, vegetation growth

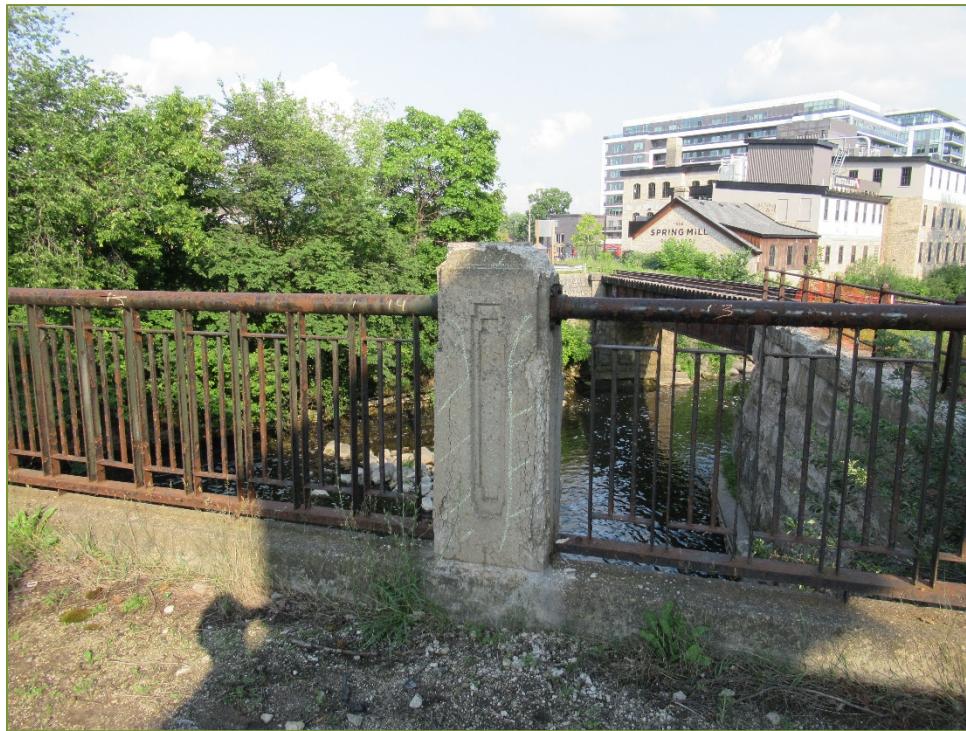
Photo P51 **South Curb** (medium scaling) **Concrete Posts** (cracks, spall, delamination, and light scaling) **and Handrail** (light corrosion)

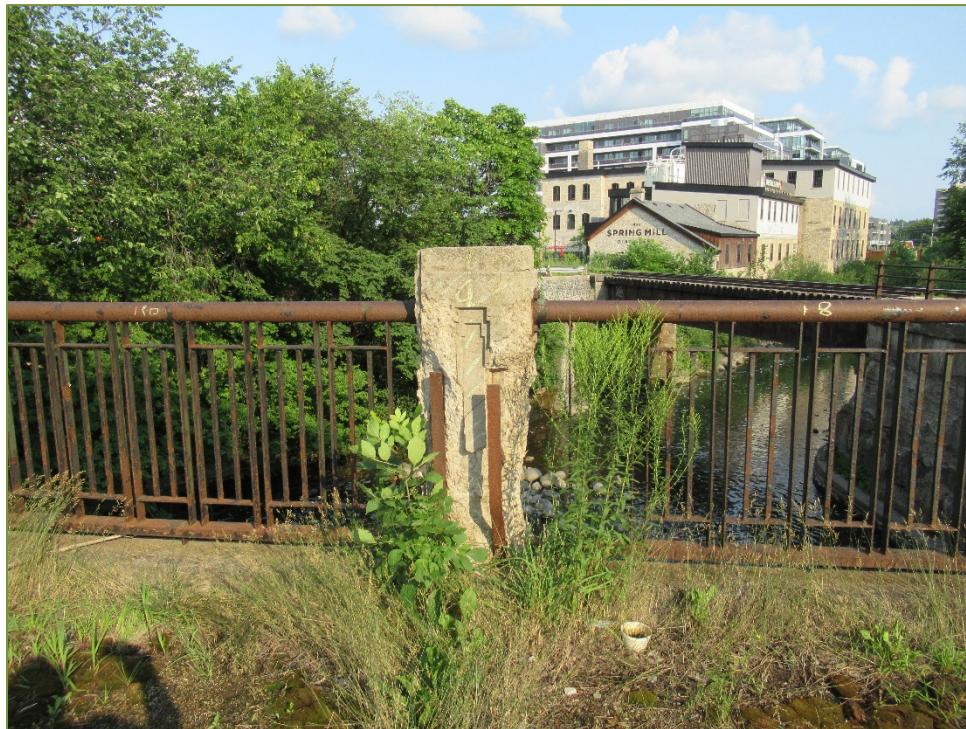
Photo P53 **South Curb** (medium scaling) **Concrete Posts** (cracks, spall, delamination, and light scaling) **and Handrail** (light corrosion)

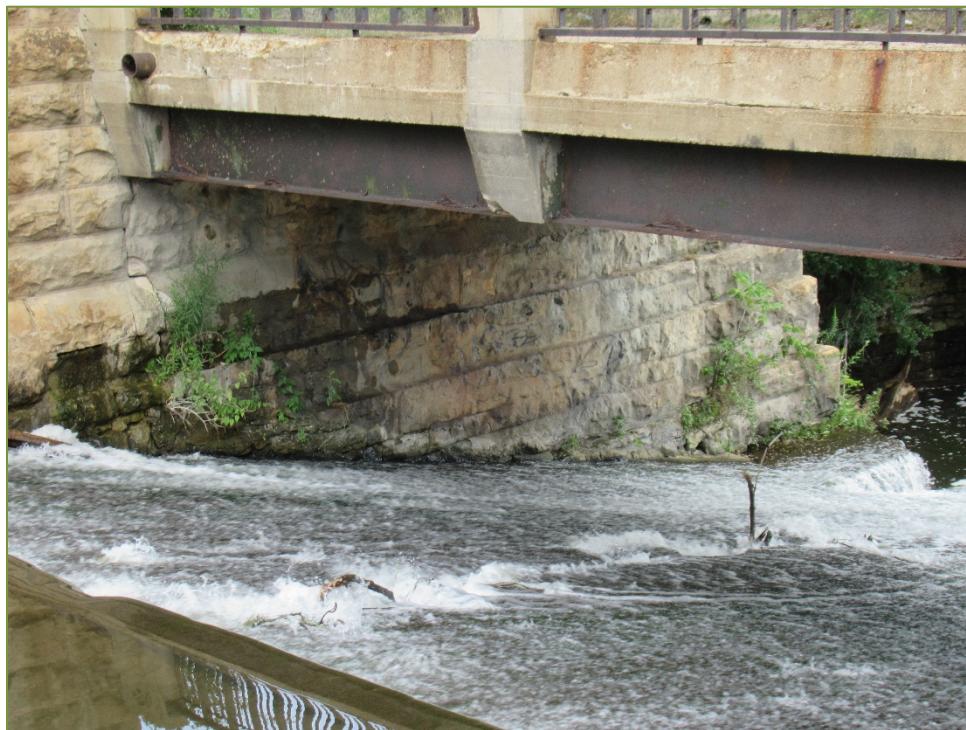
Photo P54 **East Abutment – Masonry Wall** (cracks, spall and wet area)
