DETAILED CONDITION SURVEY REPORT

Structure ID 112, Macdonell Bridge, Guelph, ON

BCC Project No.: BCC21015
Report Date: March 25, 2025

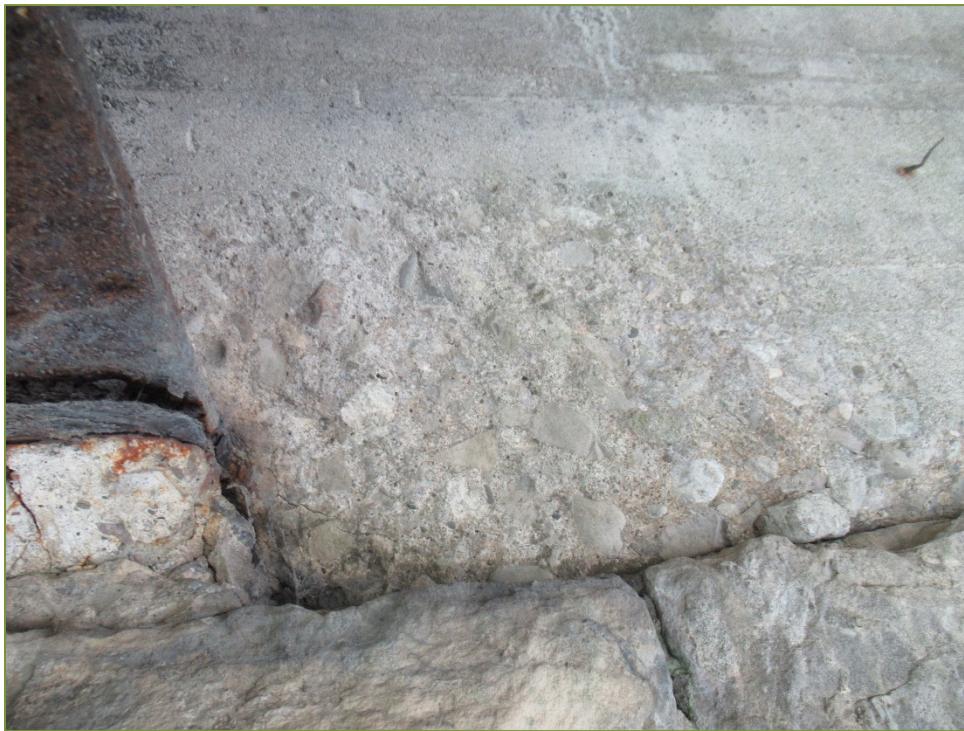
Photo P61 West Diaphragm (spall)

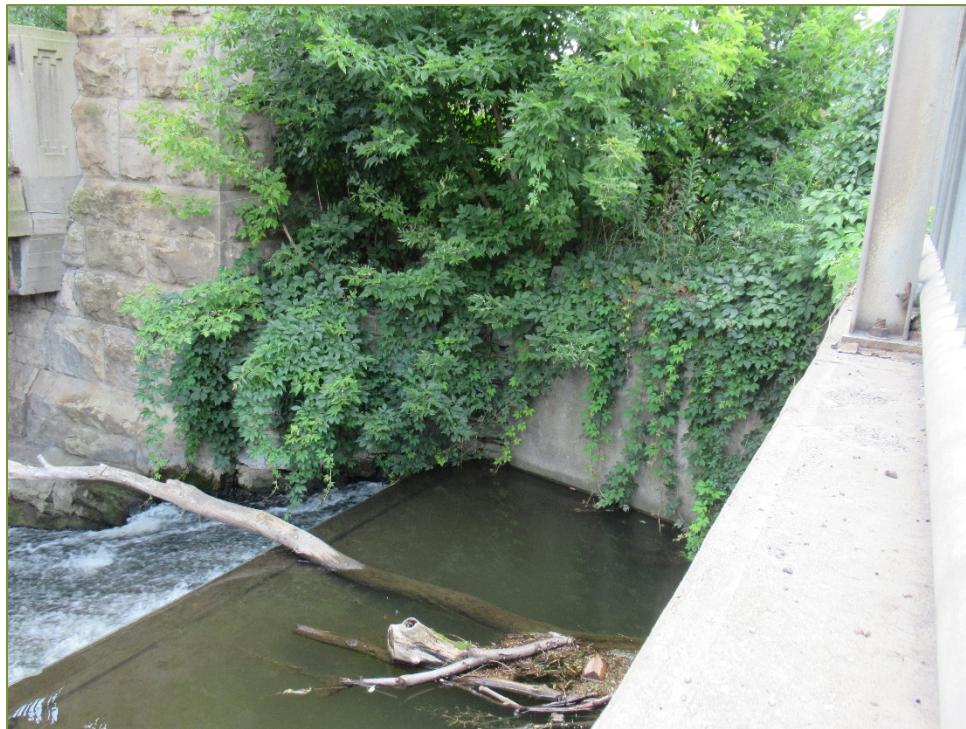
Photo P67 Northwest Retaining Wall (fair to good condition – cracks, and light scaling)

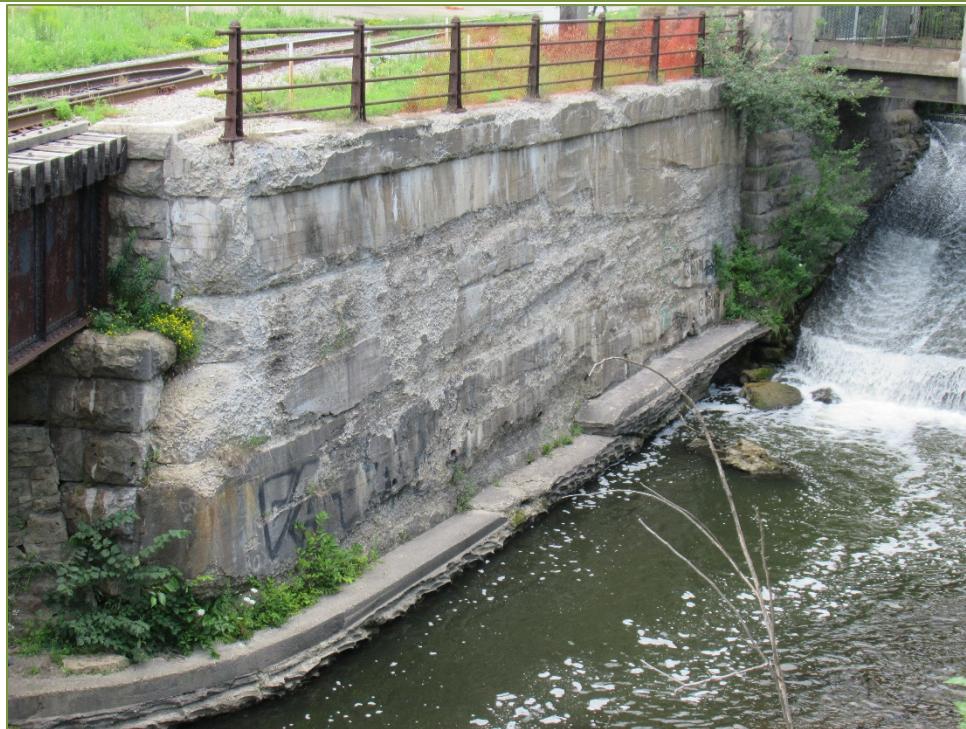
Photo P68 Southwest Retaining Wall (spall and severe scaling)

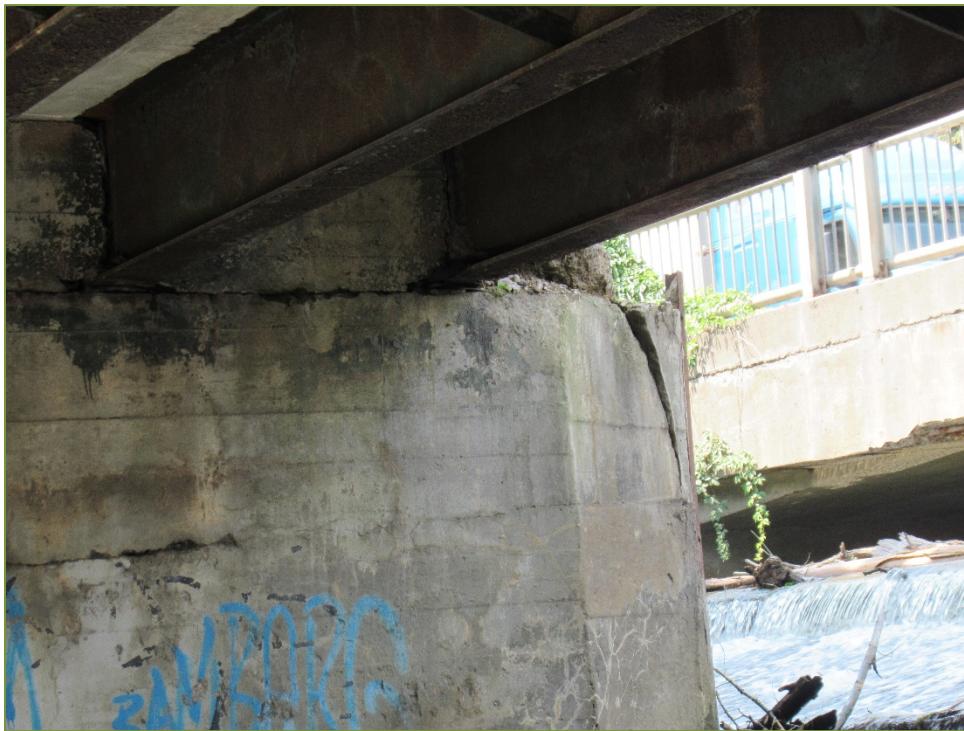
Photo P71 Pier - East Face, north side (cracks, spall, delamination, light to medium scaling, and wet area)

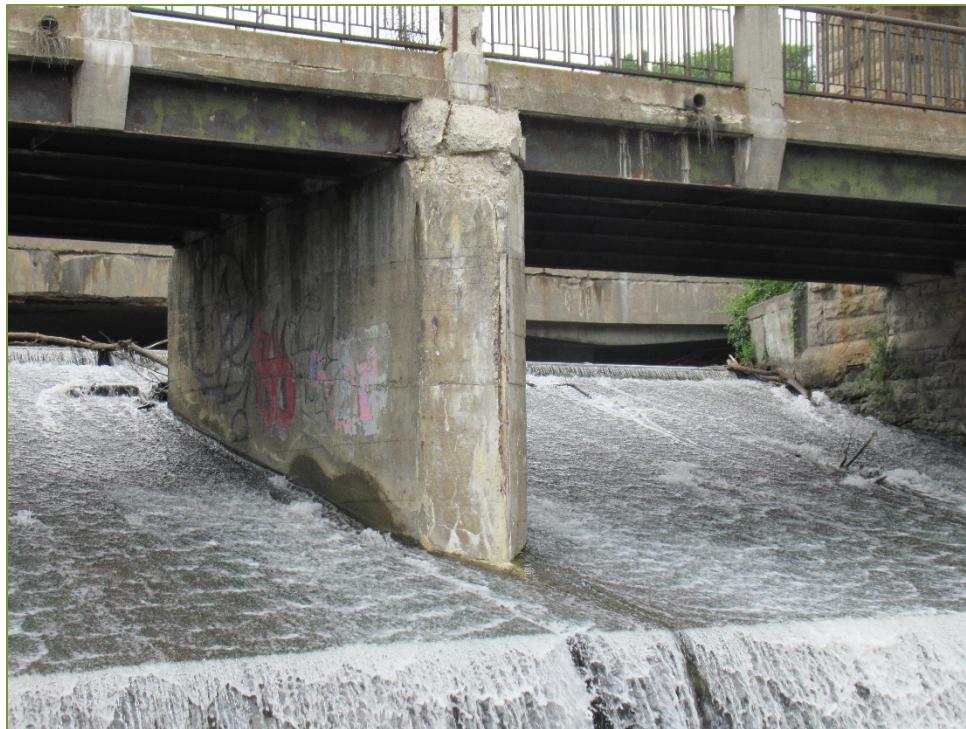
Photo P73 Pier – East Face, south side (cracks, spall, delamination, light to medium scaling, and wet area)

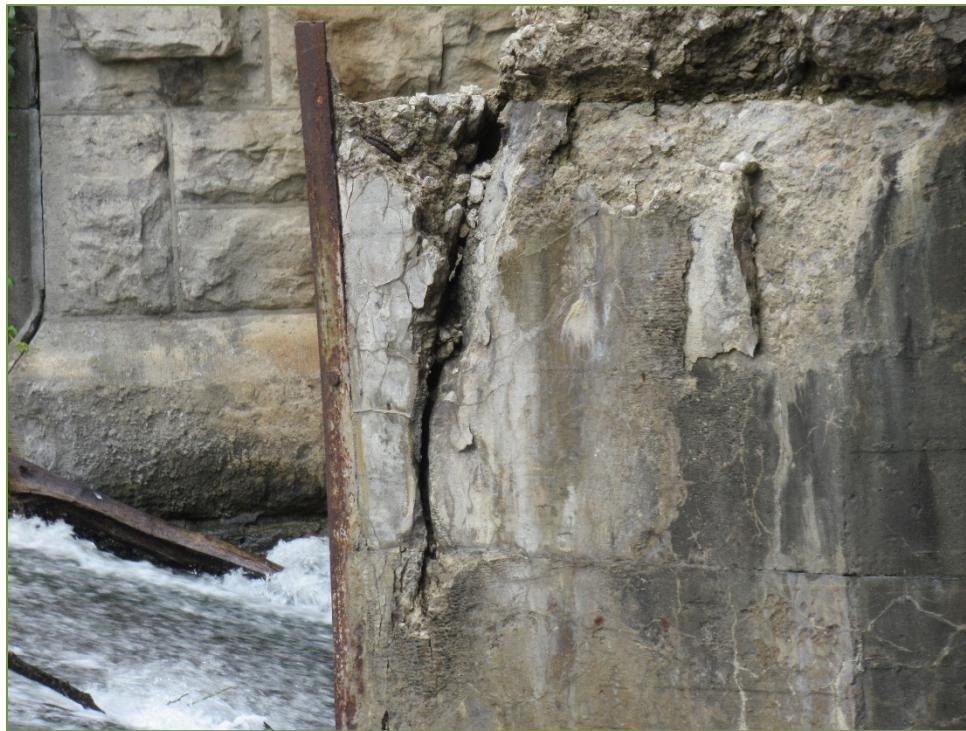
Photo P77 Pier - West Face, north side (cracks, spall, and delamination) note, exposed rebar)

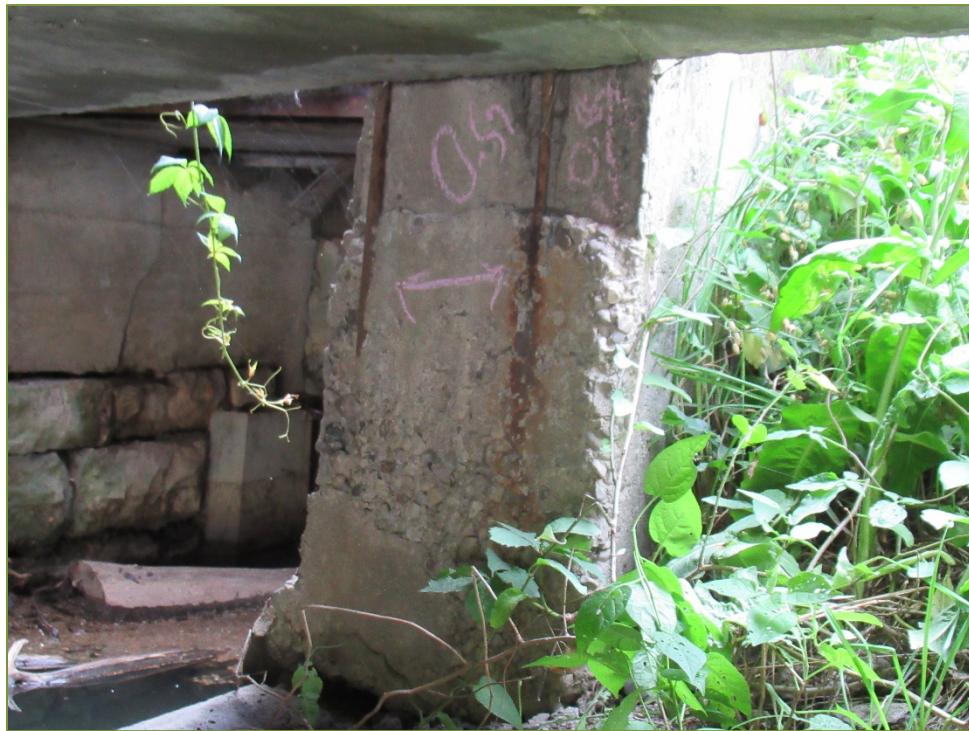
Photo P3 Inlet – North Elevation, West Wall (spall, and delamination) note, exposed rebar

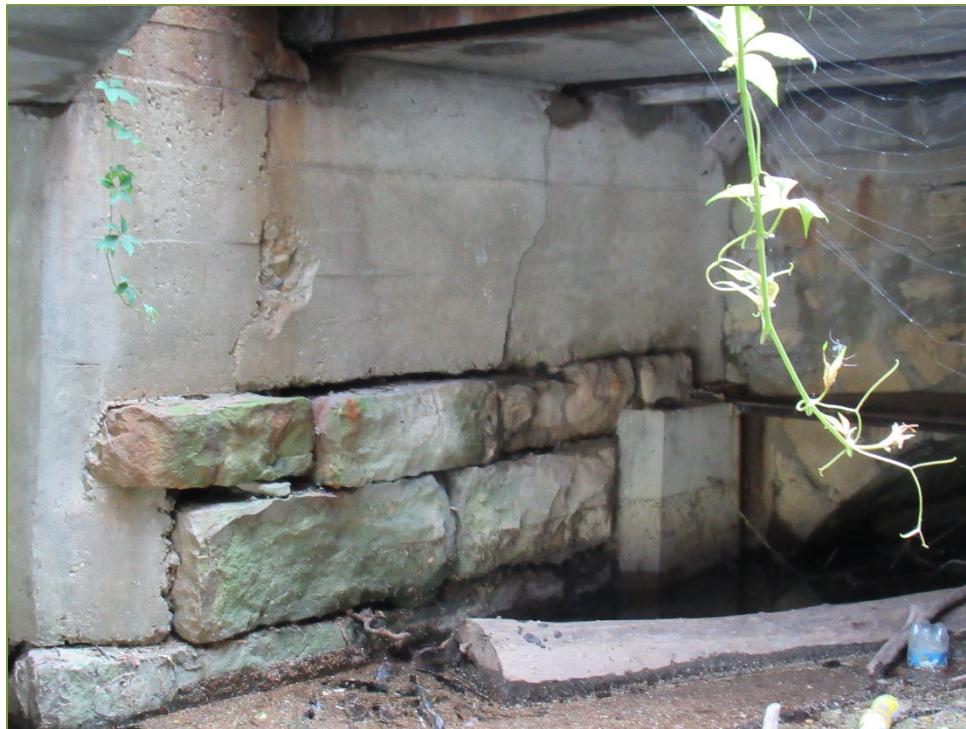
Photo P5 Inlet – East Wall (wide crack, spall, delamination, and light to medium scaling)

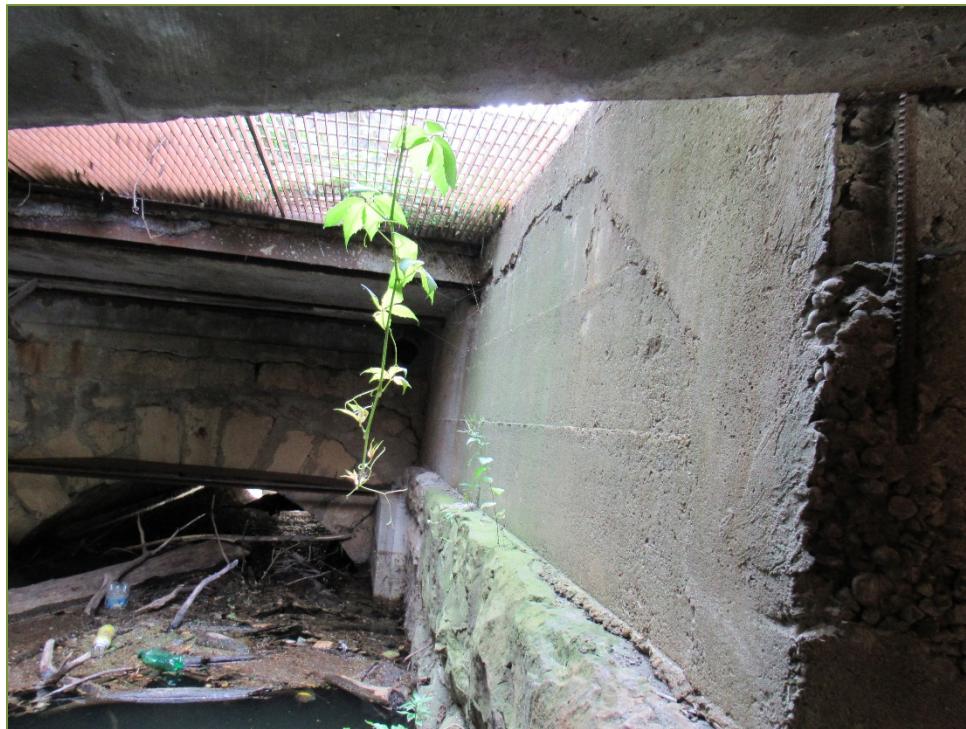
Photo P7 Inlet- West Wall (wide crack, spall, delamination and medium scaling)

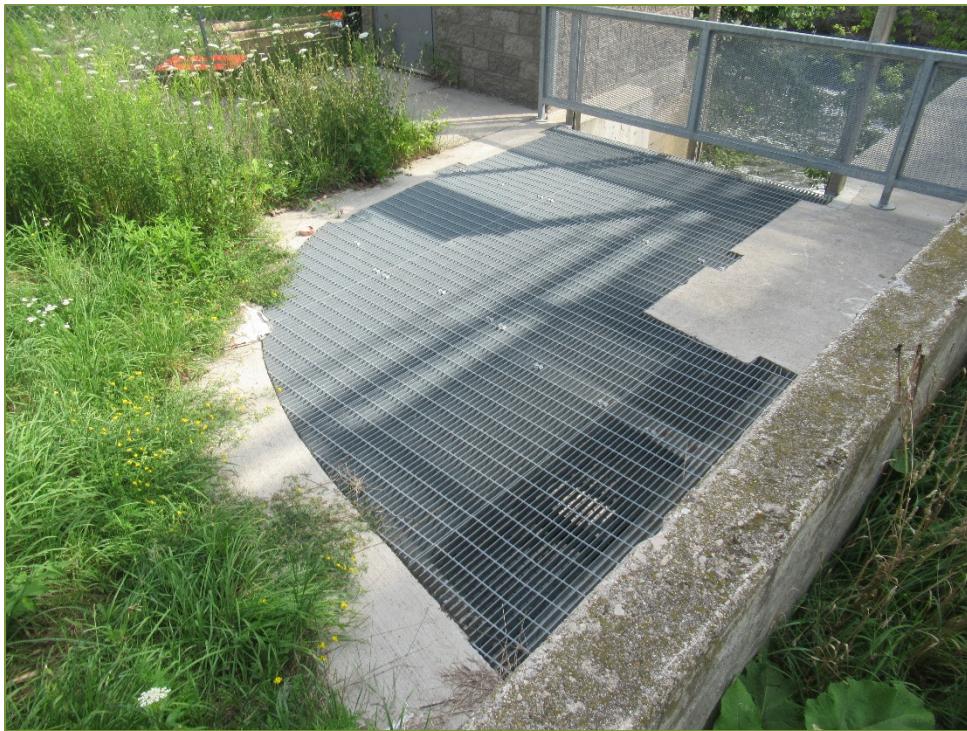
Photo P11 **Outlet – Top Surface** (cracks, spall, and medium scaling)

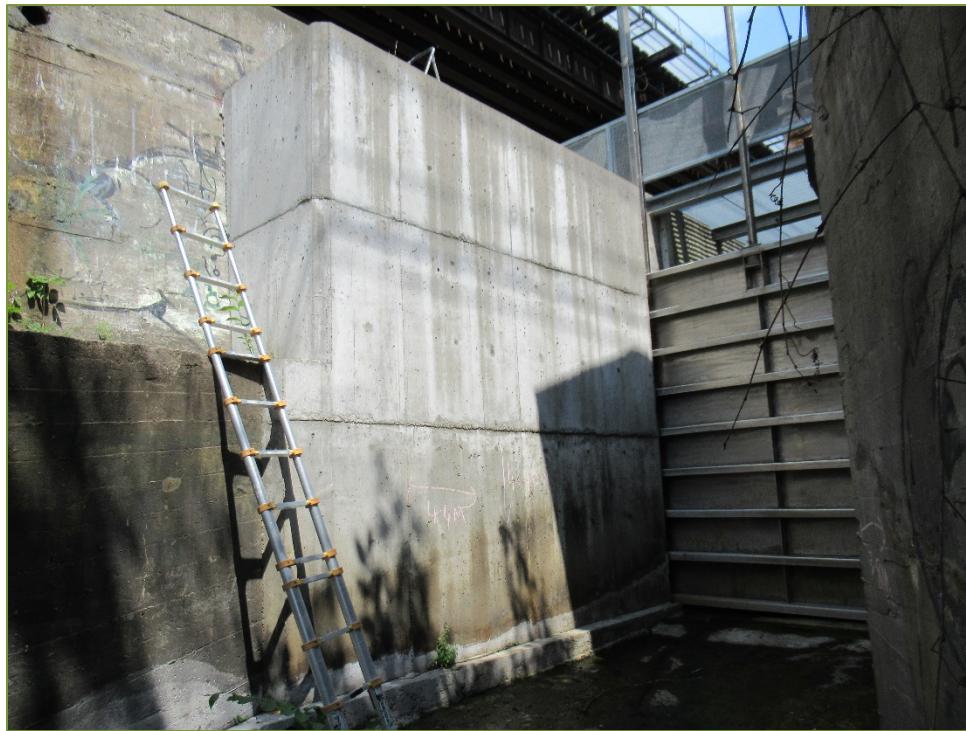
Photo P13 Outlet – North Wall, new structure (cracks, and light scaling)

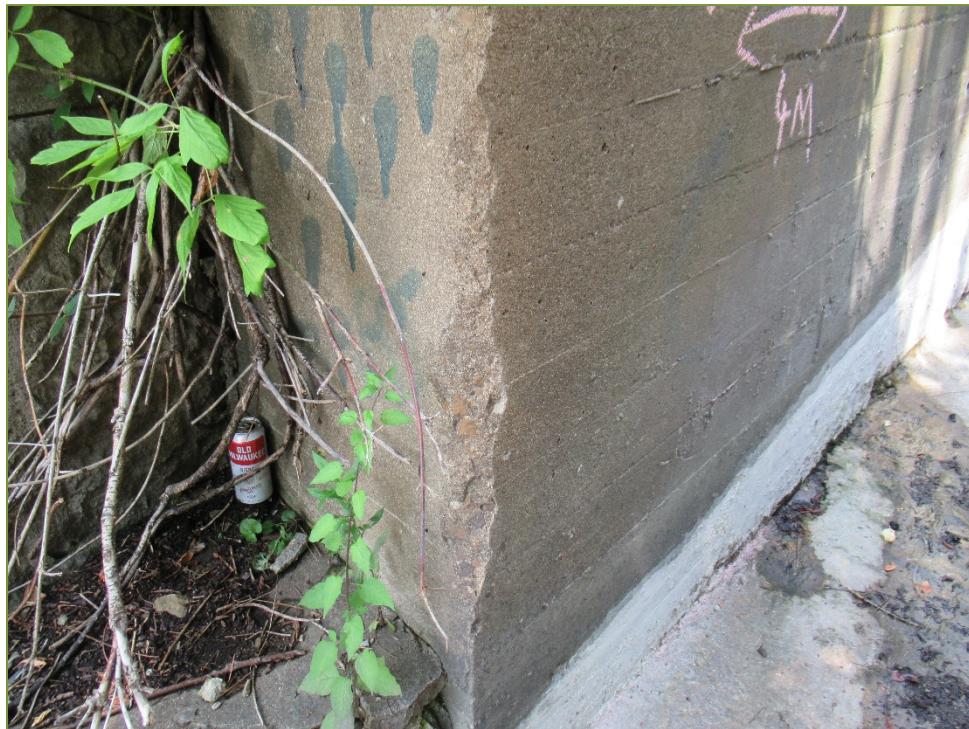
Photo P15 Outlet – North Wall, old structure (spall)

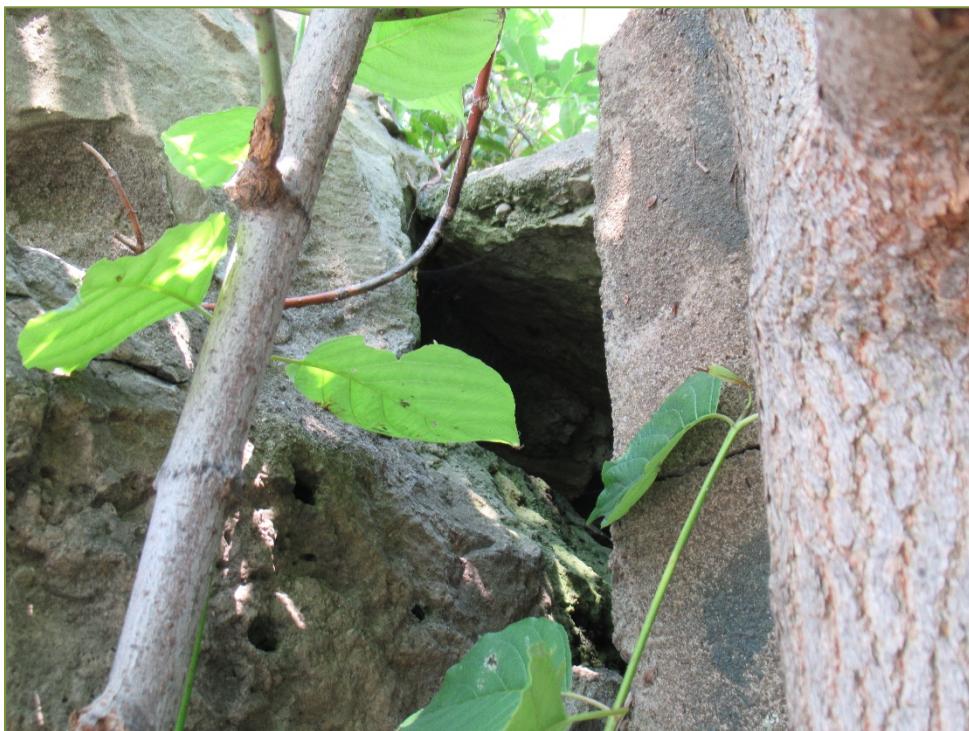
Photo P16 Outlet – North Wall, old structure note, void at the end of the wall
