**City of Guelph**

## **Stormwater Management Master Plan**

## Appendix H: Stormwater Management Facility Maintenance Inspection Summary

Prepared by:  
**Aquafor Beech Ltd.**

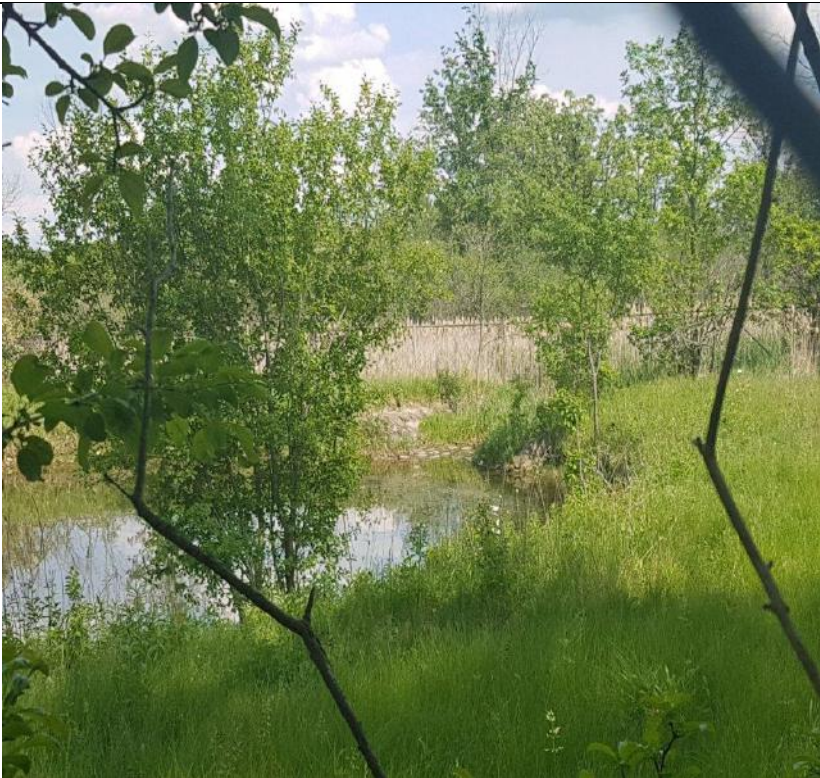
A. Outlet weir with sediment deposition

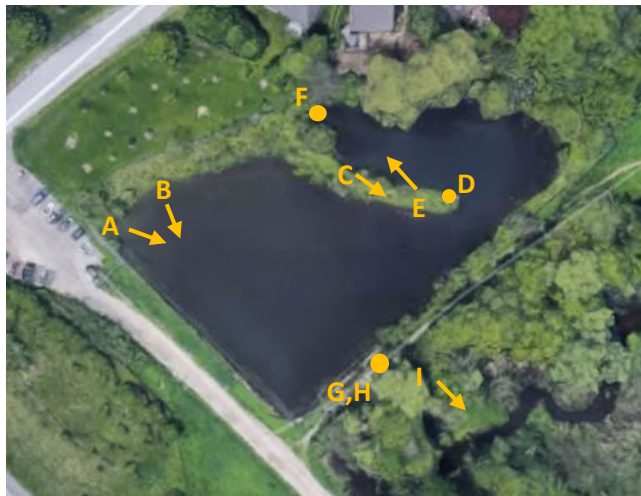
Inspection Summary Table		
Immediate	Moderate	Low
<ul style="list-style-type: none"> <li>Pond has high levels of permanent standing water (Photo B.)</li> <li>450mm riser 90% buried and surrounded by vegetative overgrowth and sediment accumulation (Photo D.)</li> </ul>	<ul style="list-style-type: none"> <li>Outlet spillway has concrete fractures and features sediment and vegetative accumulation (Photo G,H,I)</li> </ul>	<ul style="list-style-type: none"> <li>Early stages of algae growth in pond (Photo B.)</li> <li>Poor access to pond/structures due to dense vegetation</li> <li>Buckthorn present in facility</li> </ul>

<div>A. Infiltration cell with permanent standing water</div>

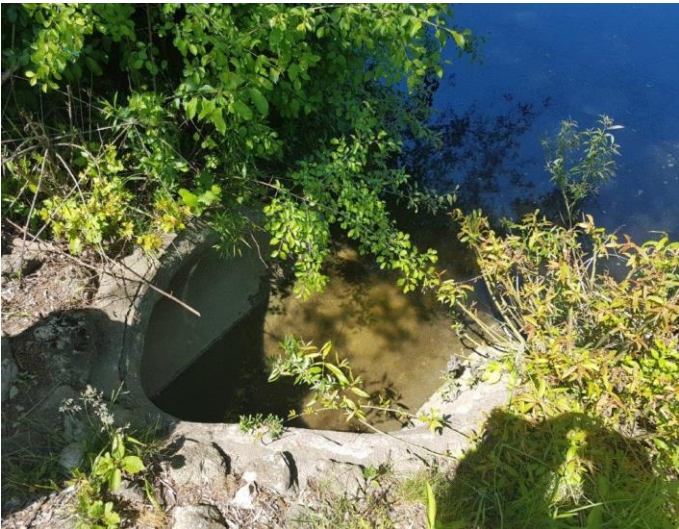
A. Concrete inlet pipe and outfall into forebay basin

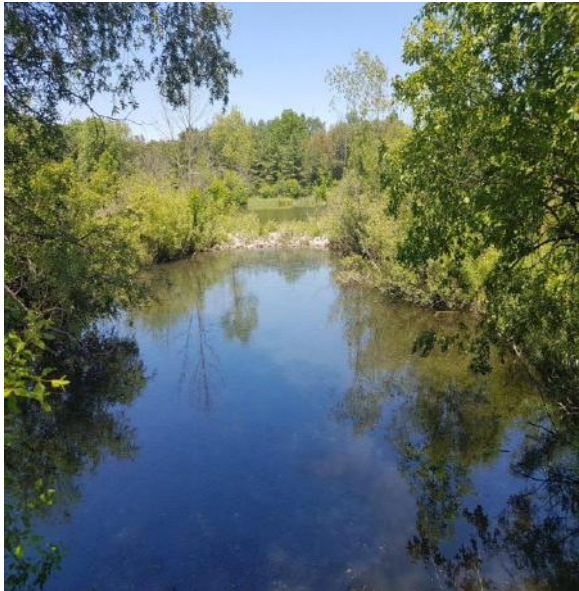
B. Forebay overview and overflow weir into main cell in fair condition

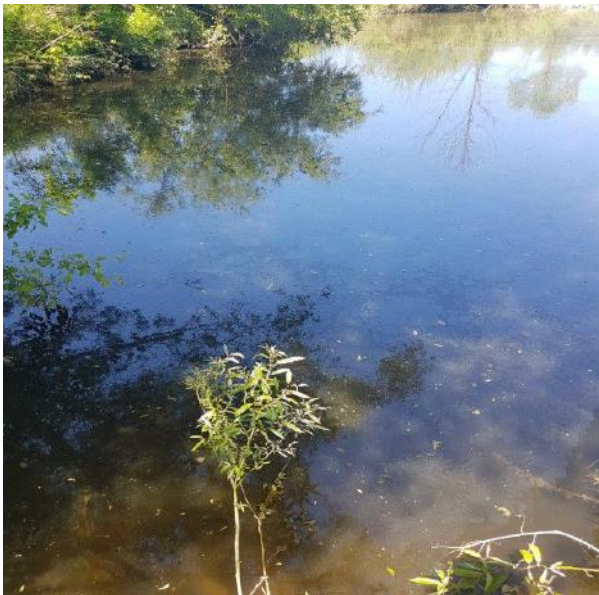
C. Oily Sheen on Forebay

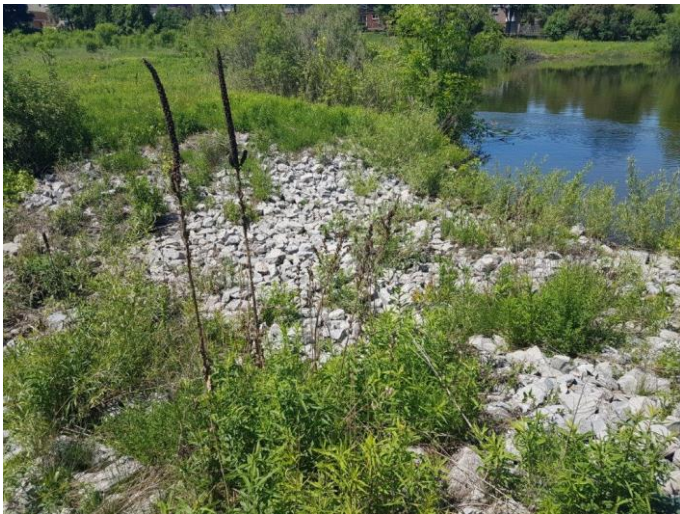
D. Spillway between forebay and main cell with minor vegetative overgrowth (replaced in 20\_\_)

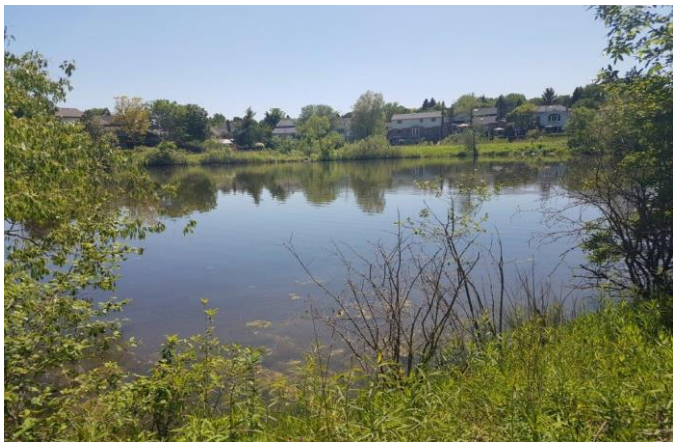
Inspection Summary Table		
Immediate	Moderate	Low
<ul style="list-style-type: none"> <li>Recharge pond cell has high levels of permanent standing water (Photo E.)</li> </ul>	<ul style="list-style-type: none"> <li>Water in forebay found with oily sheen (Photo C.)</li> <li>Weedy undergrowth in permanent water (Photo. F)</li> </ul>	<ul style="list-style-type: none"> <li>Residents with ladder access (Photo G.)</li> <li>No facility signage</li> <li>Buckthorn and dense shrubs growing around perimeter</li> <li>Forebay spillway showing minor vegetation establishment (Photo D.)</li> </ul>

E. Recharge basin with high permanent water level

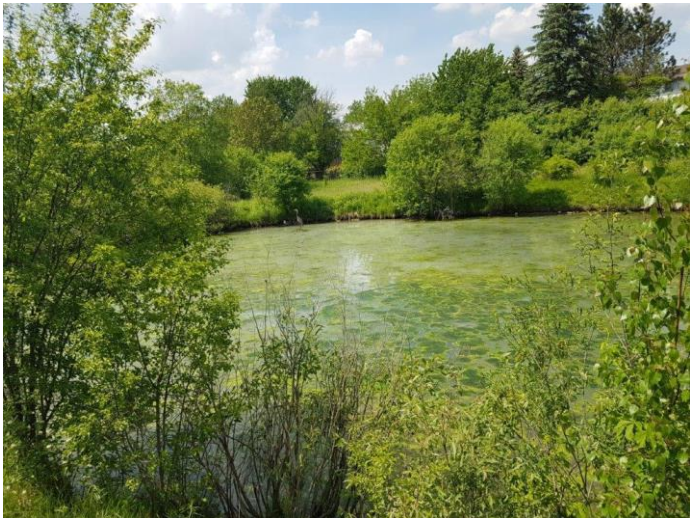
A. Forebay overview showing dense algae growth

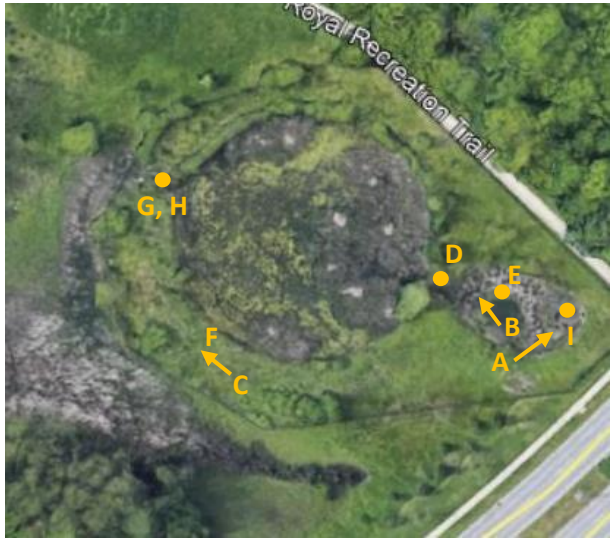
A. Looking at Inlet structure on forebay

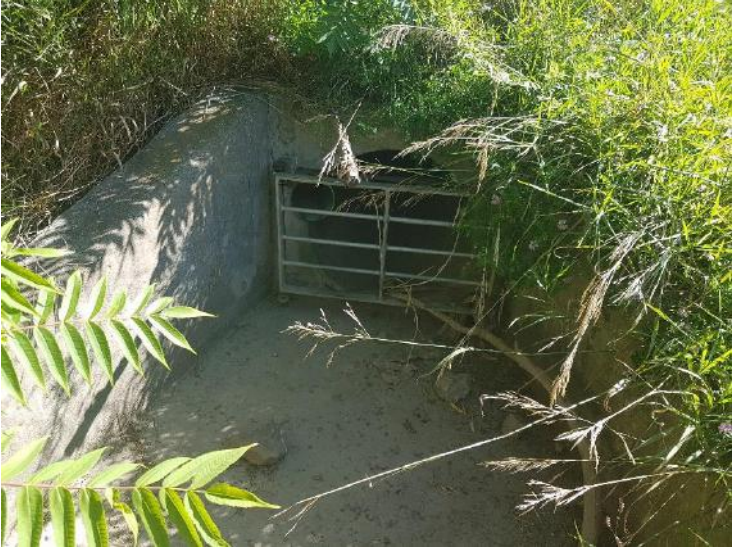
<p>M. 600mm Concrete outlet pipe outfall featuring trash grate and headwall in good condition. Several pieces of riprap were found in the outfall structure</p>

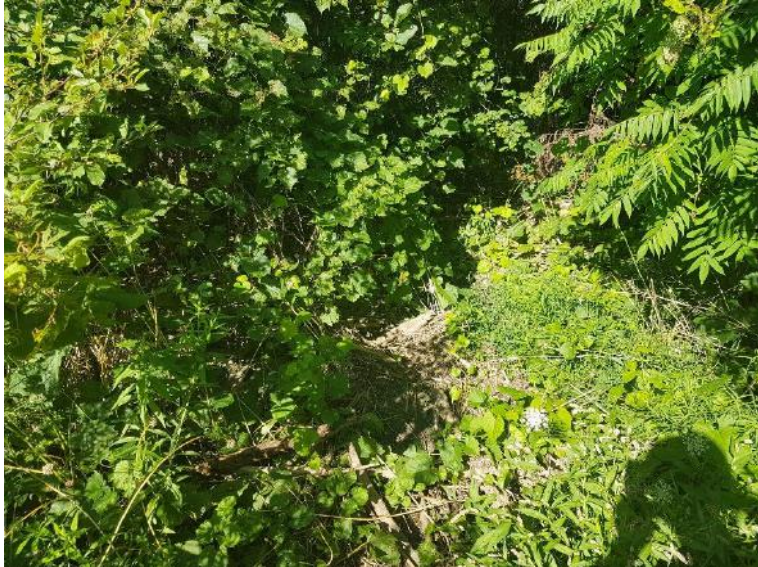
<p>N. Receiving channel downstream of pond outlet pipe showing dense vegetation and minor sediment accumulation</p>

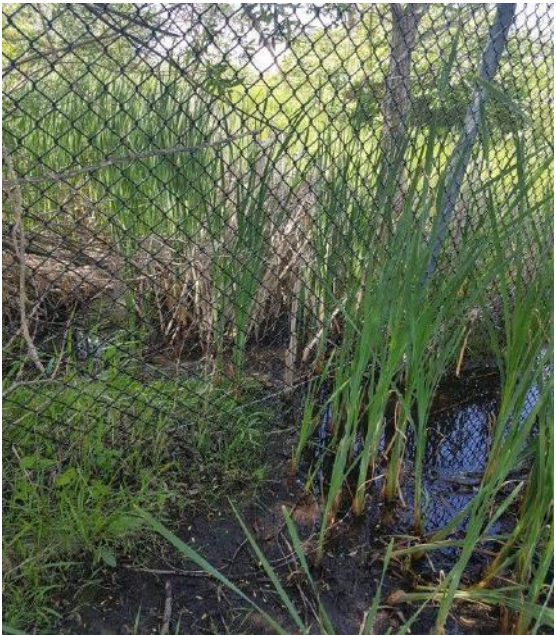
A. Outlet channel with sediment

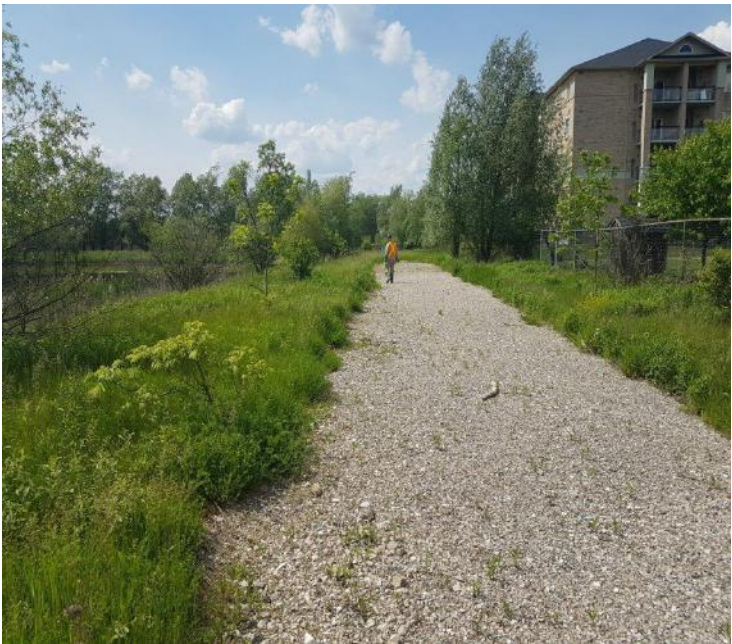
B. Access path in good condition

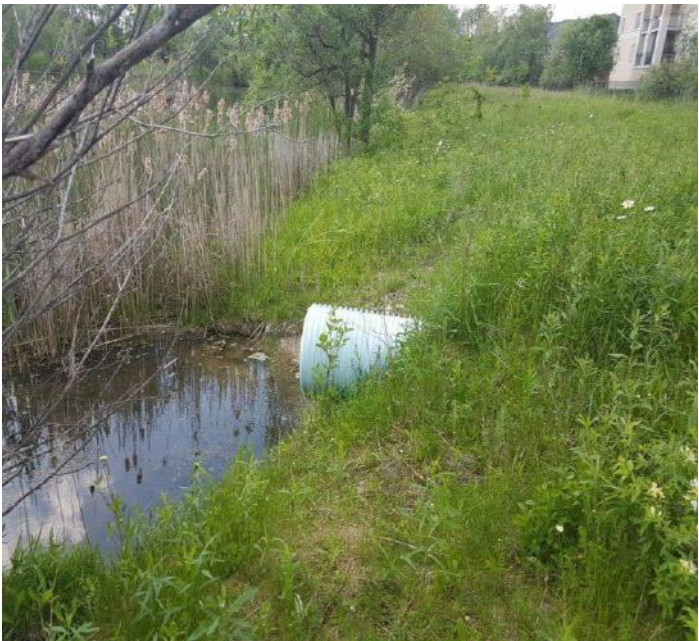
C. PVC pipe inlet in East corner of main cell

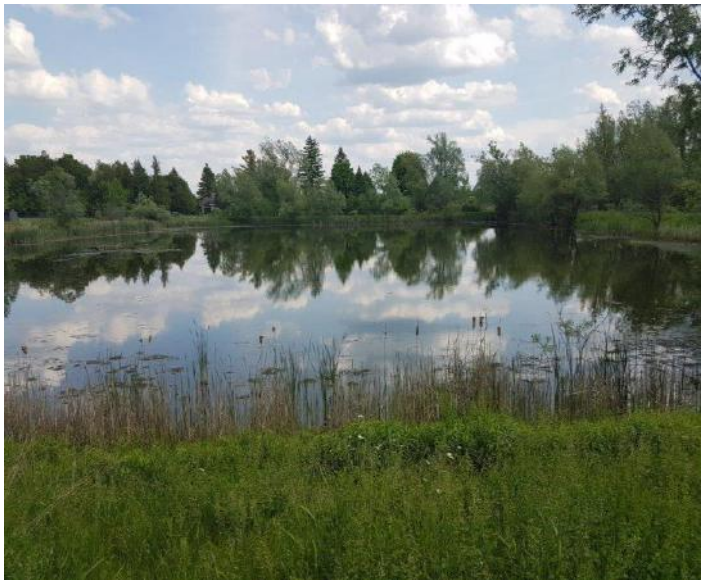
Inspection Summary Table		
Immediate	Moderate	Low
<ul style="list-style-type: none"> <li>Pond has high levels of permanently standing water at as much as 0.5m deep (Photo I.)</li> </ul>	<ul style="list-style-type: none"> <li>Outfall channel has sediment accumulation and vegetation overgrowth nearby outlet pipe (Photo A.)</li> <li>450mm storm inlet pipe blocked by an estimated 15% from a riprap channel (Photo G.)</li> </ul>	<ul style="list-style-type: none"> <li>Vegetation deadfall found</li> <li>Outlet headwall 1 m drop with no railing</li> <li>Debris found in downstream channel</li> <li>Key did not work on lock</li> <li>Large hole in fence</li> </ul>

<p>I. Infiltration pond with high levels of standing water</p>

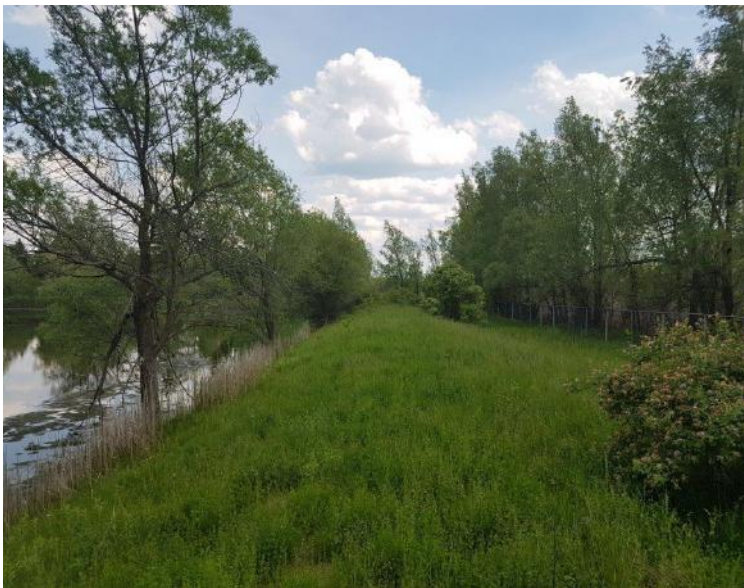
<p>J. Embankment at South end with healthy vegetation</p>

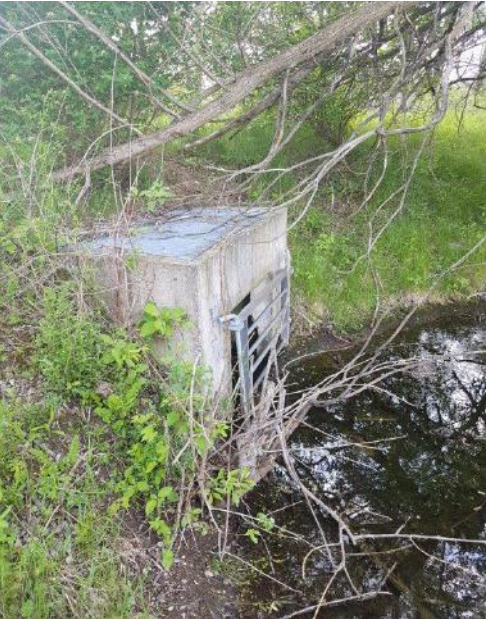
<p>L. Outlet structure with damaged grate over 755mm side opening and vegetation growth around structure</p>

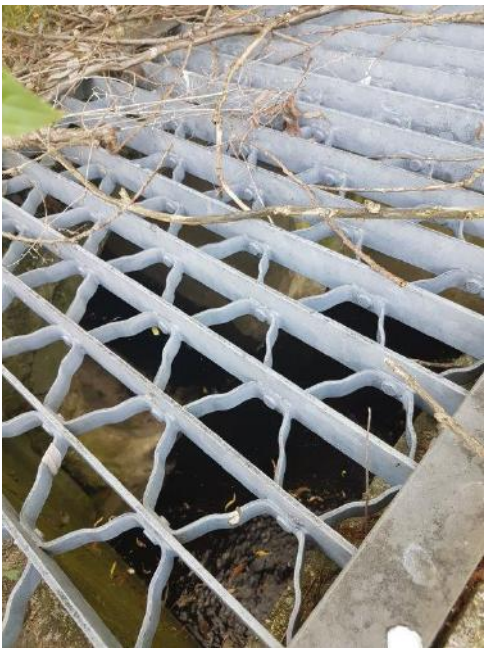
<p>M. Outlet structure grate in good condition</p>

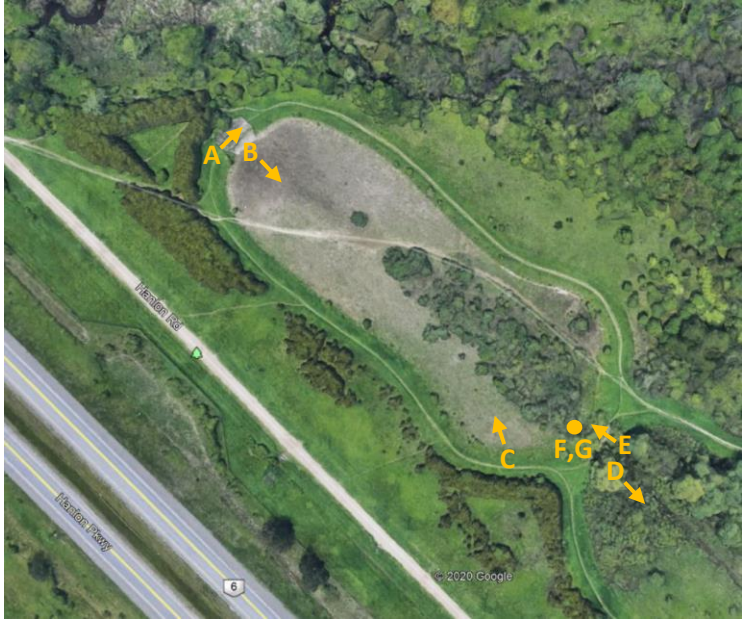
<div data-bbox="1081 727 1662 848">A. Emergency overflow spillway out of infiltration basin showing early grass growth in small cracks</div>

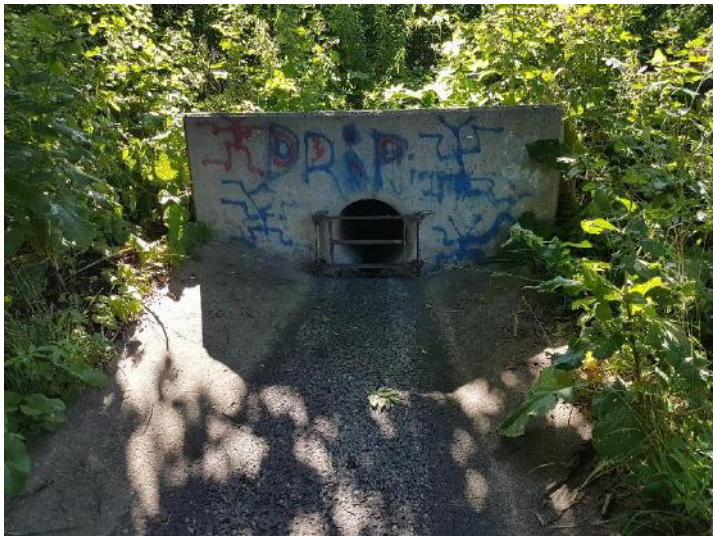
H. South inlet pipe and headwall. Note headwall covered in graffiti.

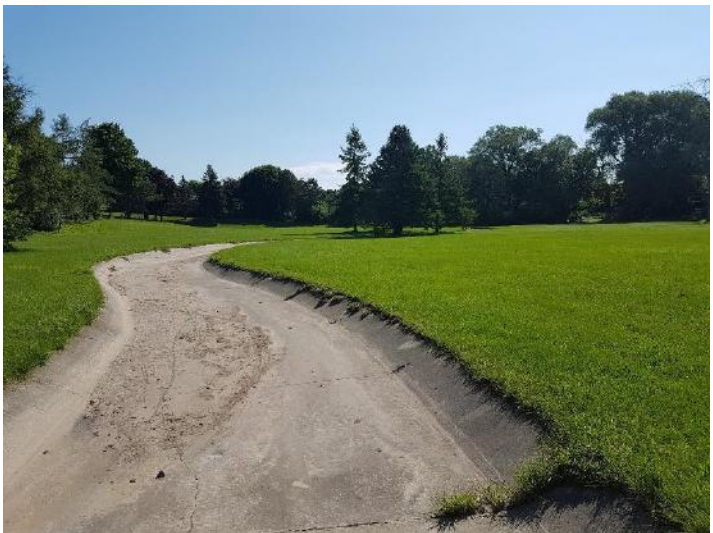
N. Basin overview from near outlet structure.

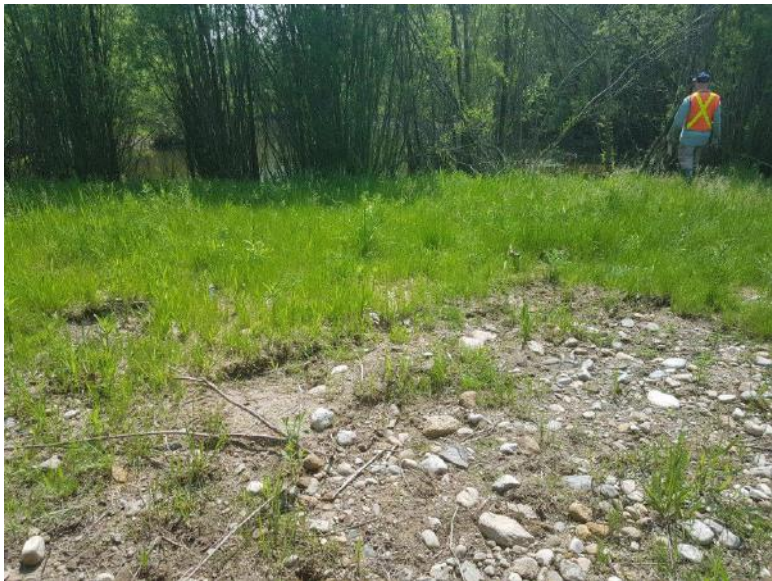
A. Berm between East inlet pond and dry pond

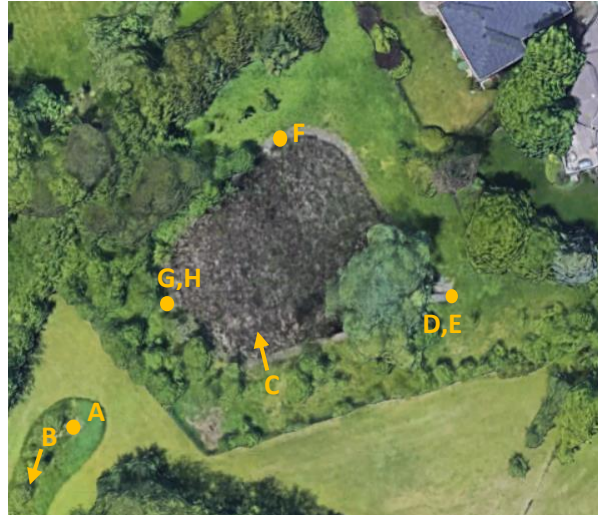
<p>A. Concrete pond outlet pipe at downstream end.</p>

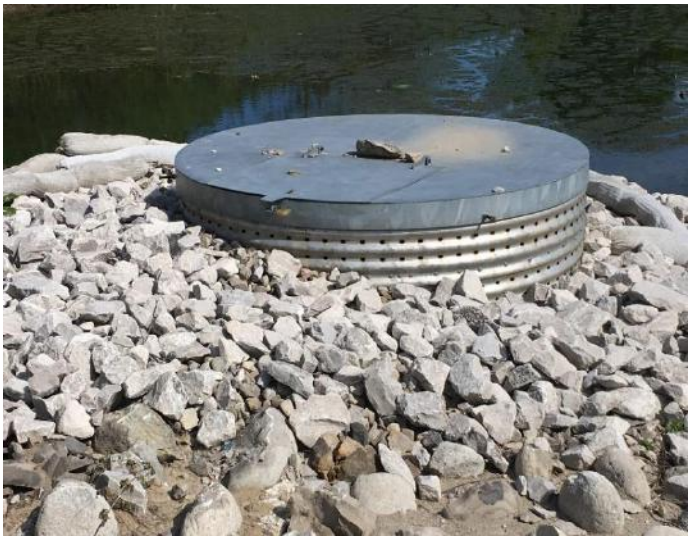
C. Hickenbottom structure with riprap base in good condition

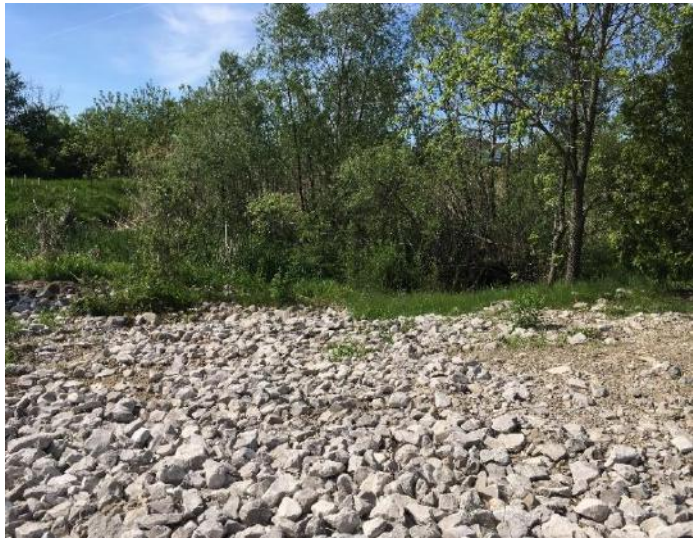
D. Riprap overflow/looking at dry pond

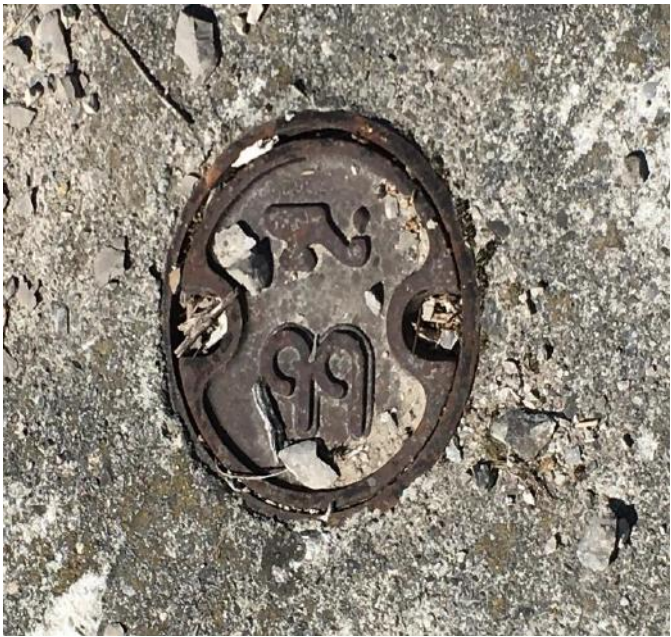
A. Valve on overflow weir

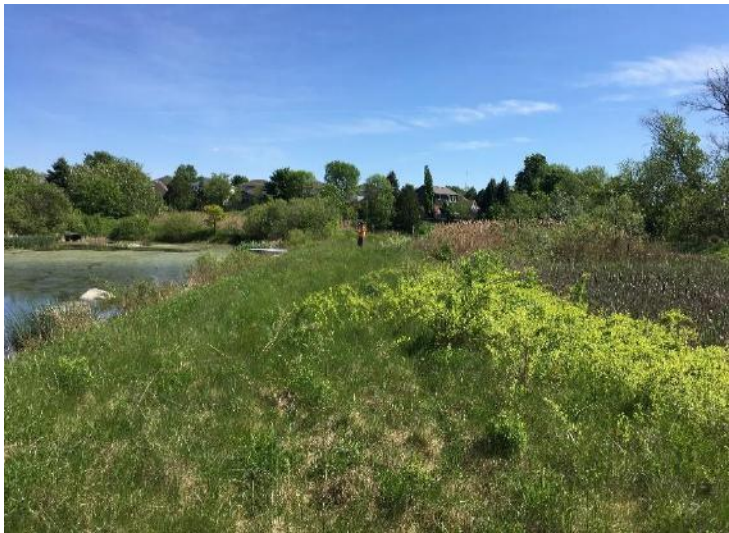
F. Dry Pond/overflow berm in good condition

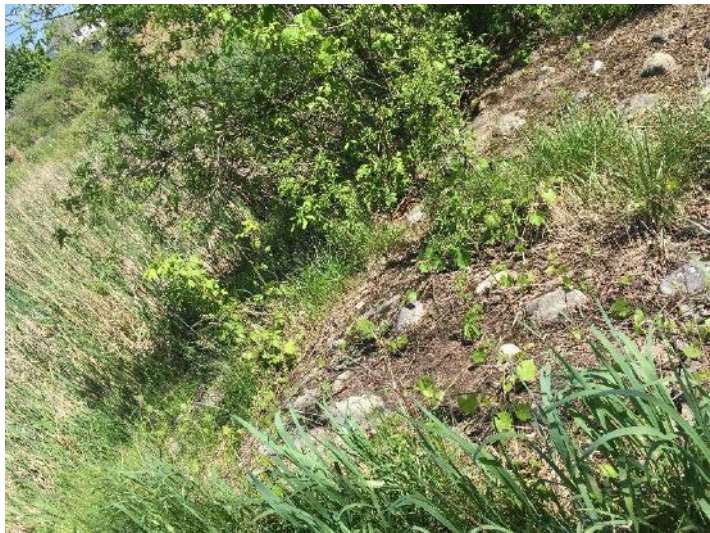
G. "First flush" weir between cells showing sediment deposition

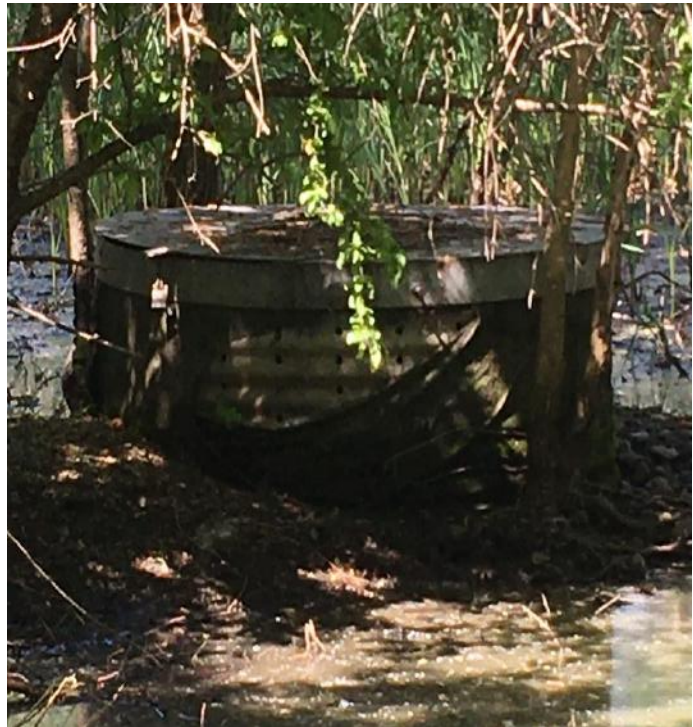
C. Perforated riser outlet structure with torn sediment cloth and missing 50mm clear stone jacket as noted in design drawings

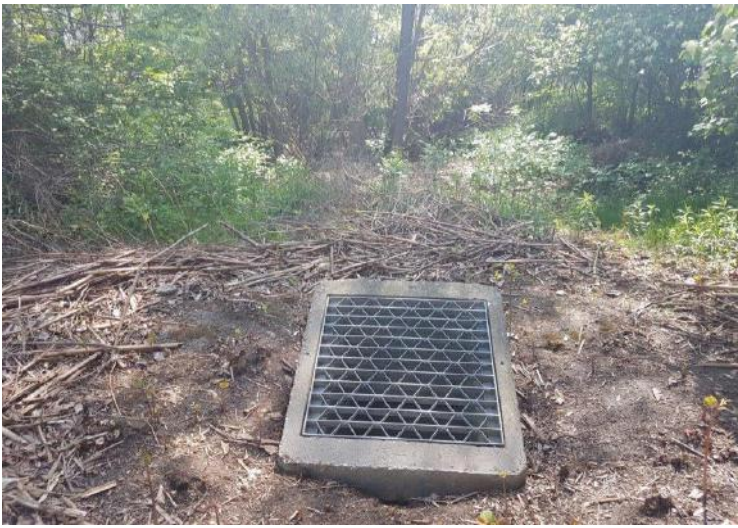
G. Ditch inlet catchbasin to infiltration trench in good condition

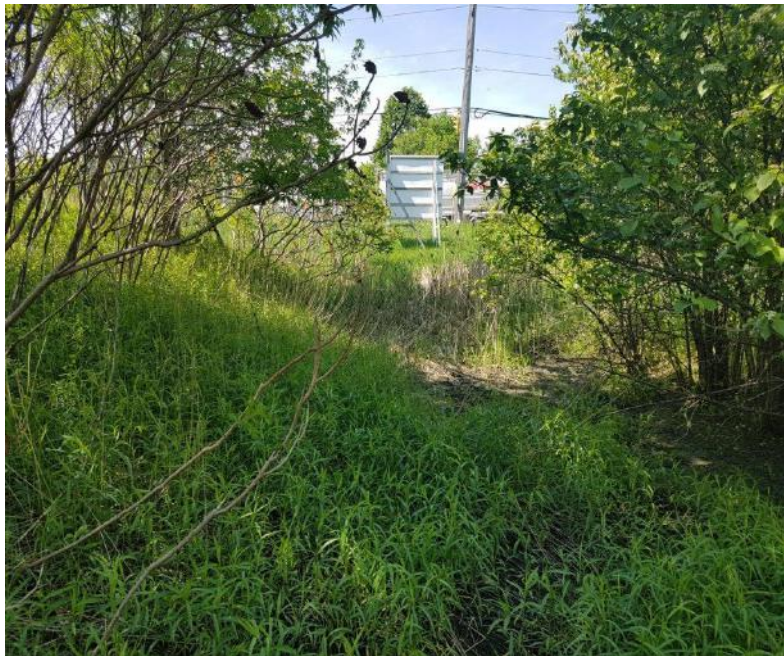
A. Infiltration facility looking towards Victoria Road

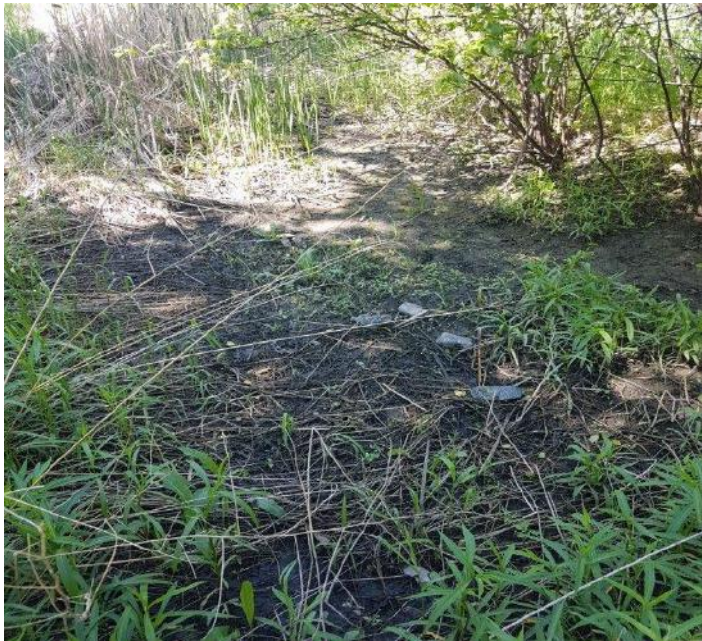
B. Ditch with sediment deposition overtop sand filter layer

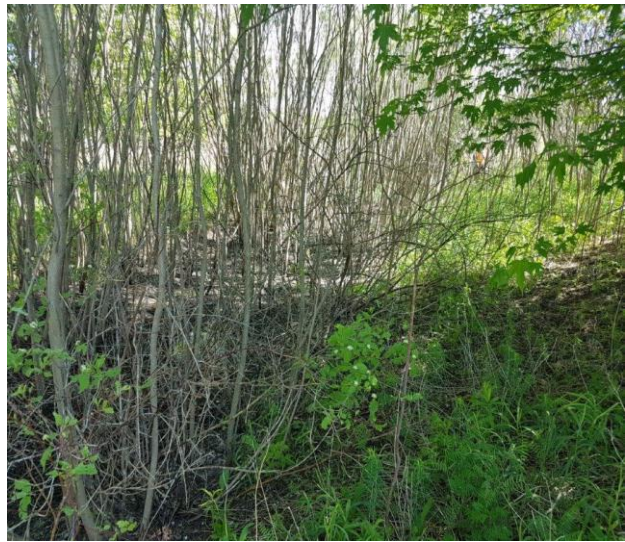
D. Dense stand of willow trees in infiltration facility

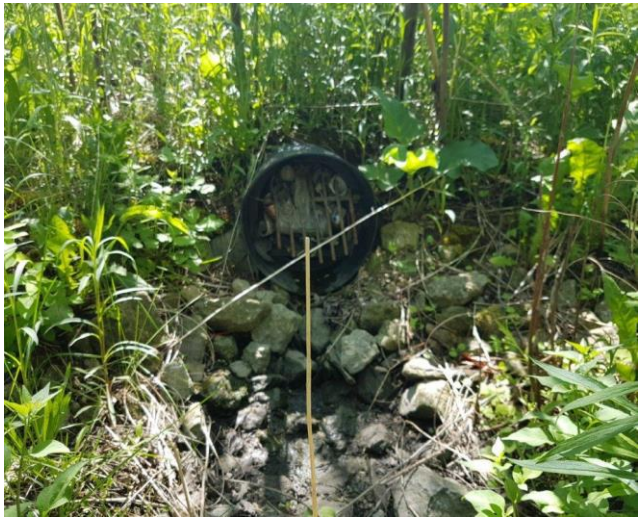
E. 300mm inlet pipe with damaged grate and 40% clogged with trash

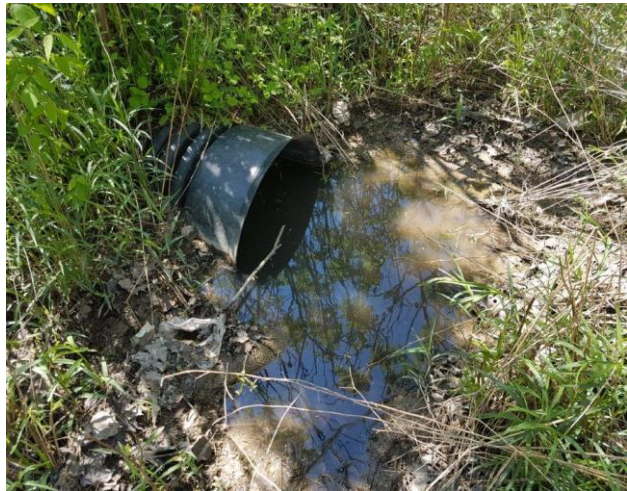
F. 500mm inlet pipe that is 30% submerged

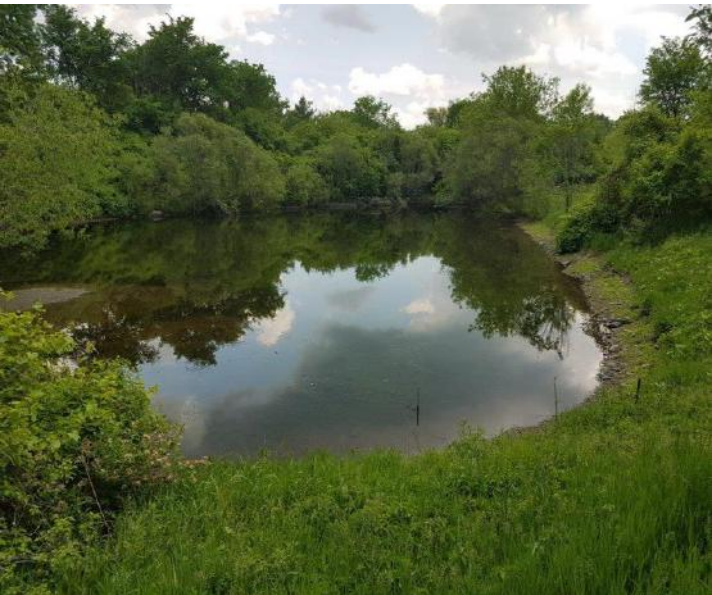
A. Main cell with sediment peninsula to the left of photo.

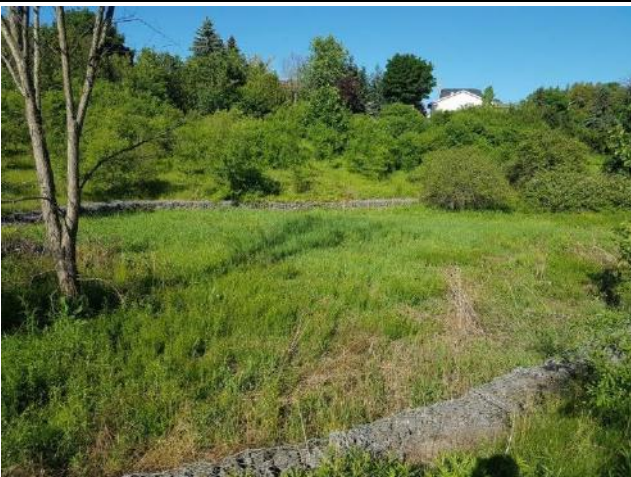
<div>A. Infiltration basin overview</div>

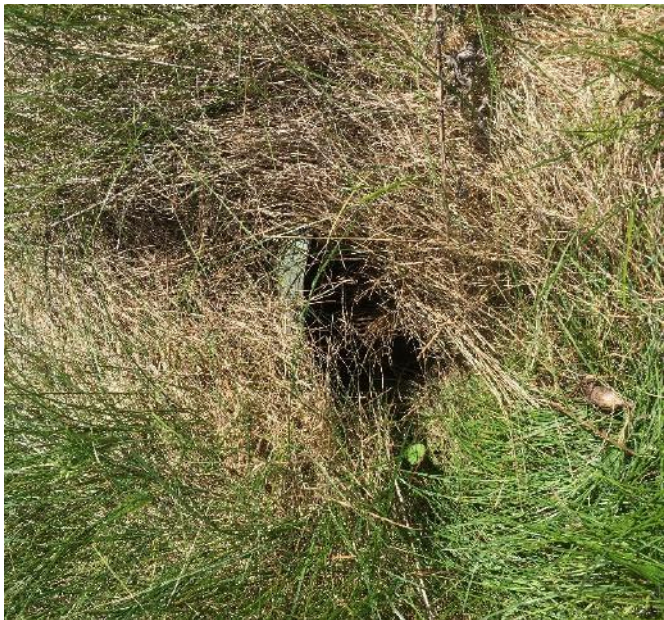
A. Outlet pipe from dry basin perforated riser 30% buried in earth and grass

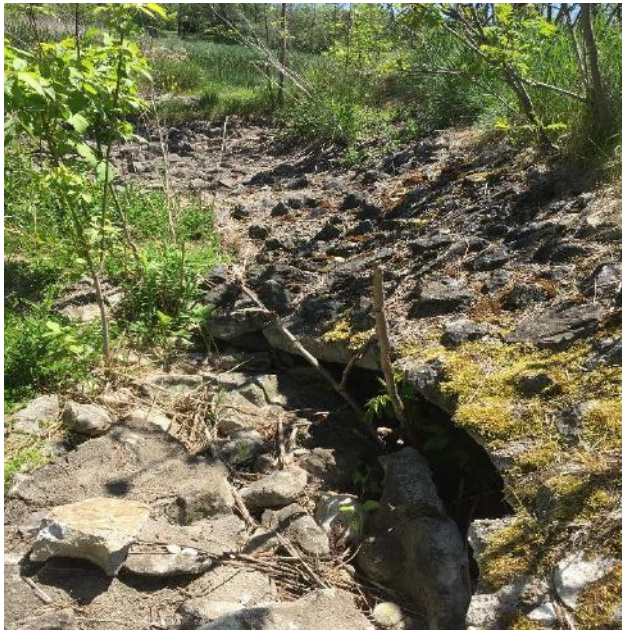
C. Riprap channel between ponds (damaged)

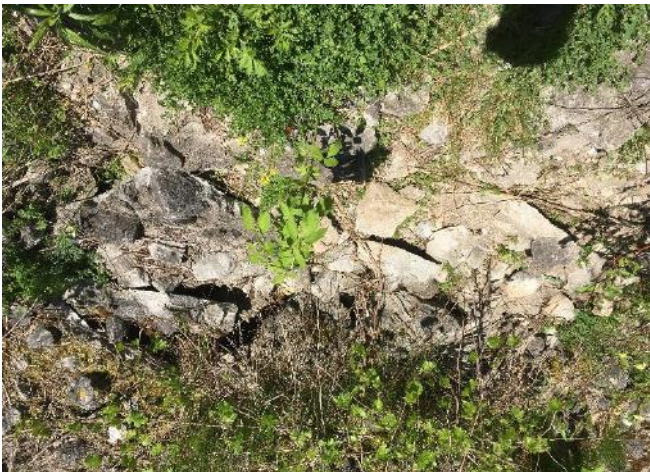
D. Overflow weir from forebay dry pond

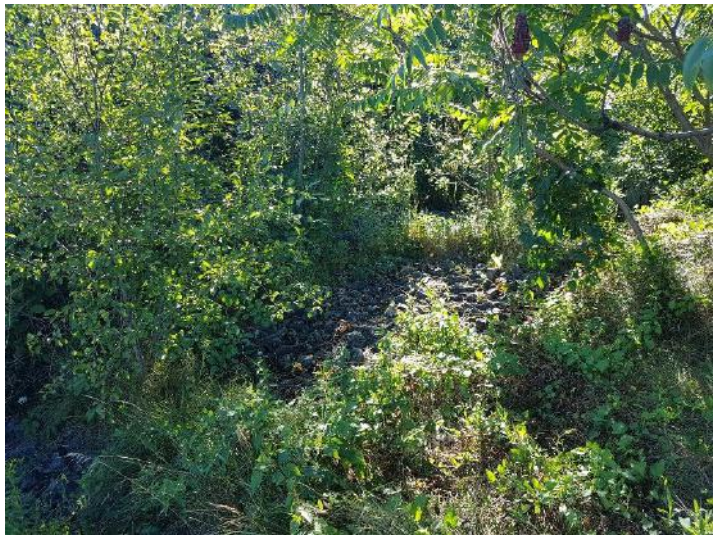
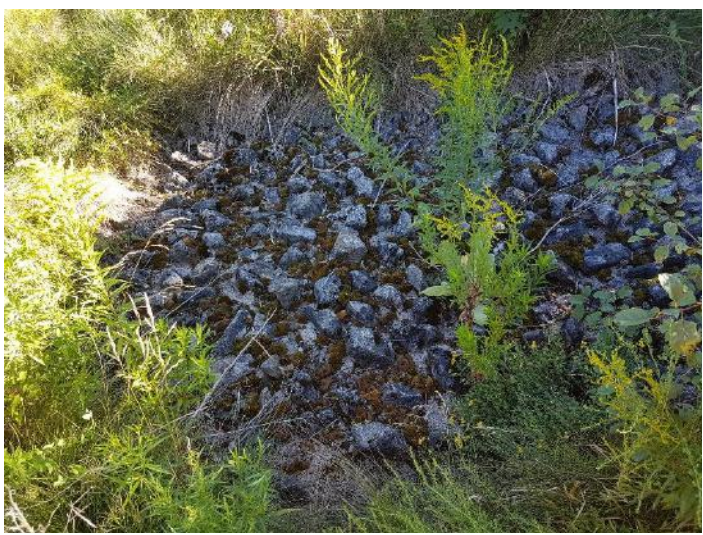
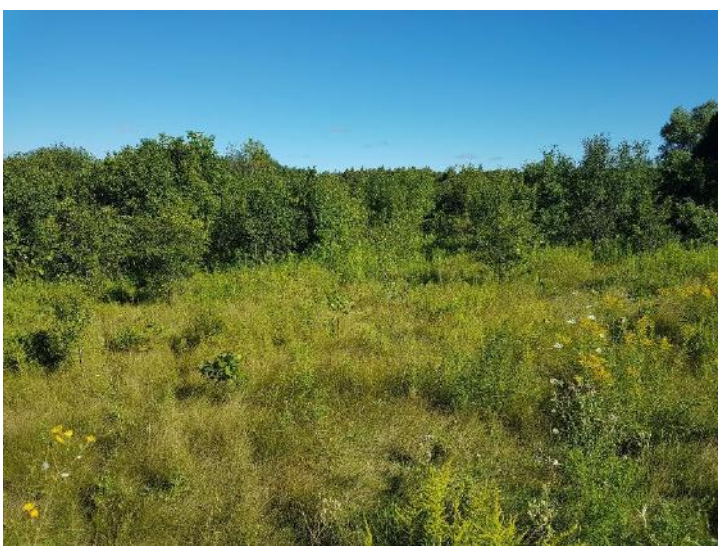
<div>L. Overflow weir from dry pond to infiltration basin with dense vegetation establishment that may cause minor flow restriction</div>	<div>M. Overflow weir material made of concrete base and grouted rip-rap</div>	<div>N. Infiltration basin overview from near dry pond cell overflow weir</div>

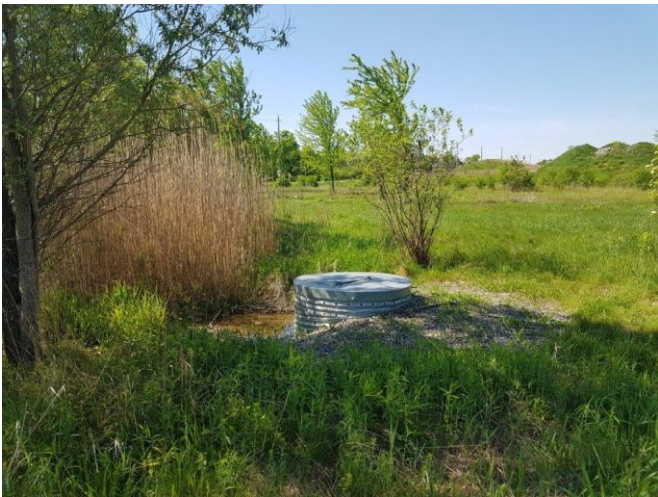
A. Hickenbottom outlet

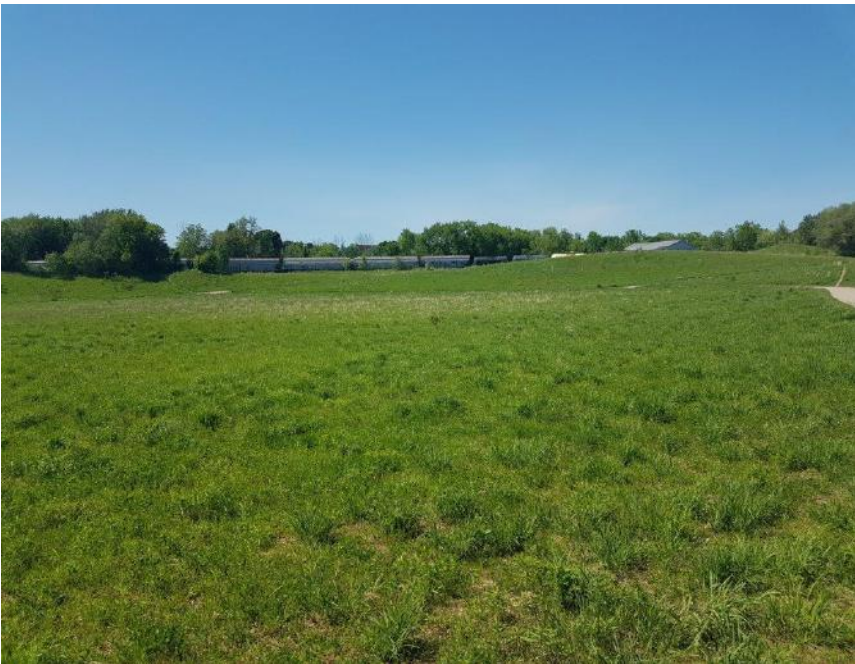
A. Dry basin overview noted as large field area

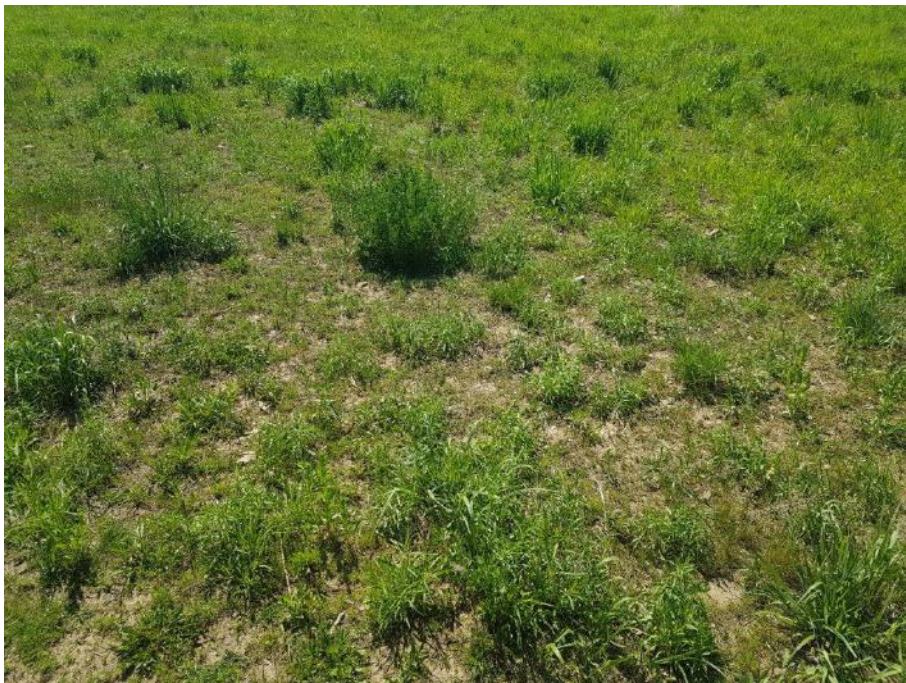
B. Basin materials and vegetation cover
