# Stormwater Management Master Plan

## Appendix M: Erosion Assessment Technical Memorandum – Field Investigations

Prepared by:  
**Aquafor Beech Ltd.**

Reference #: 66636  
August 2021  
Final Report

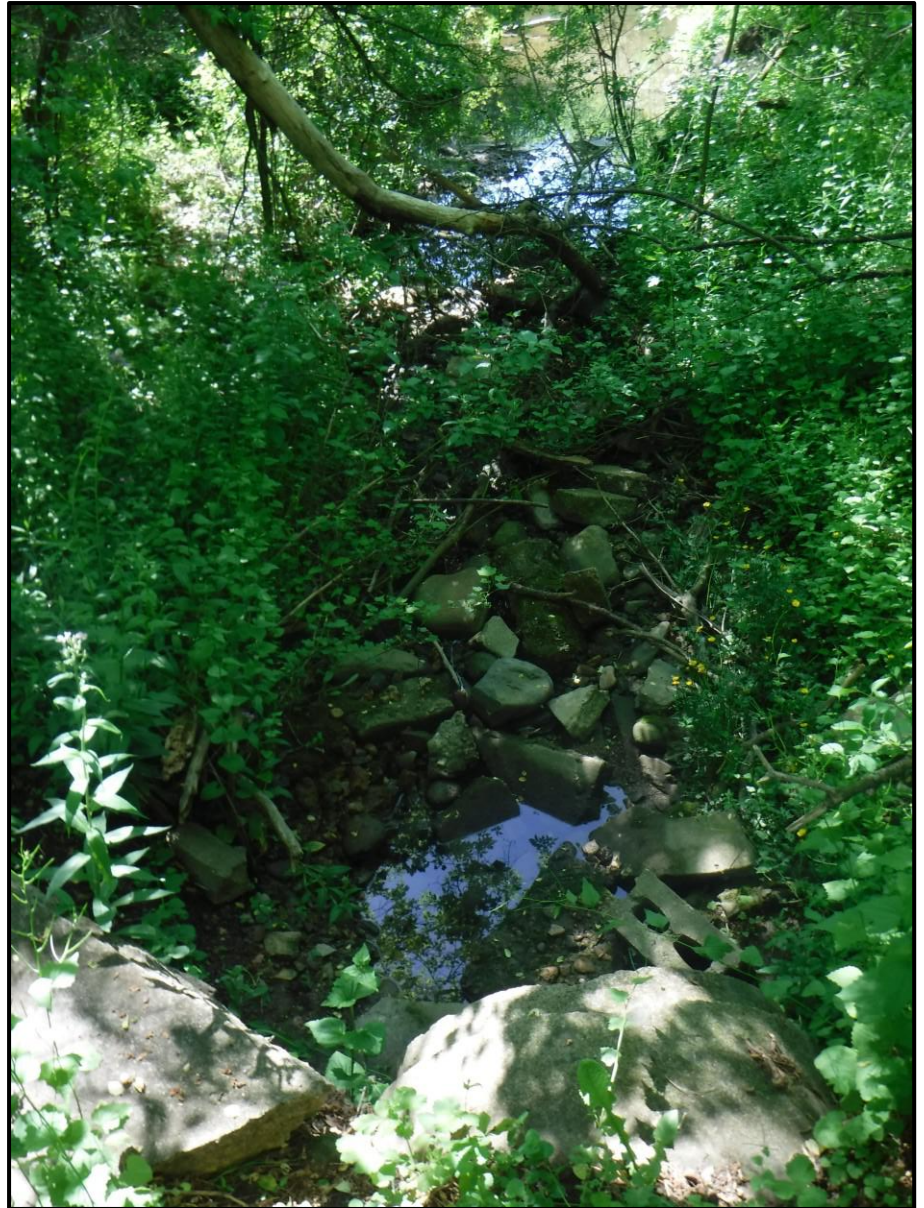
Buildup of organic debris just  
downstream of stormwater outfall

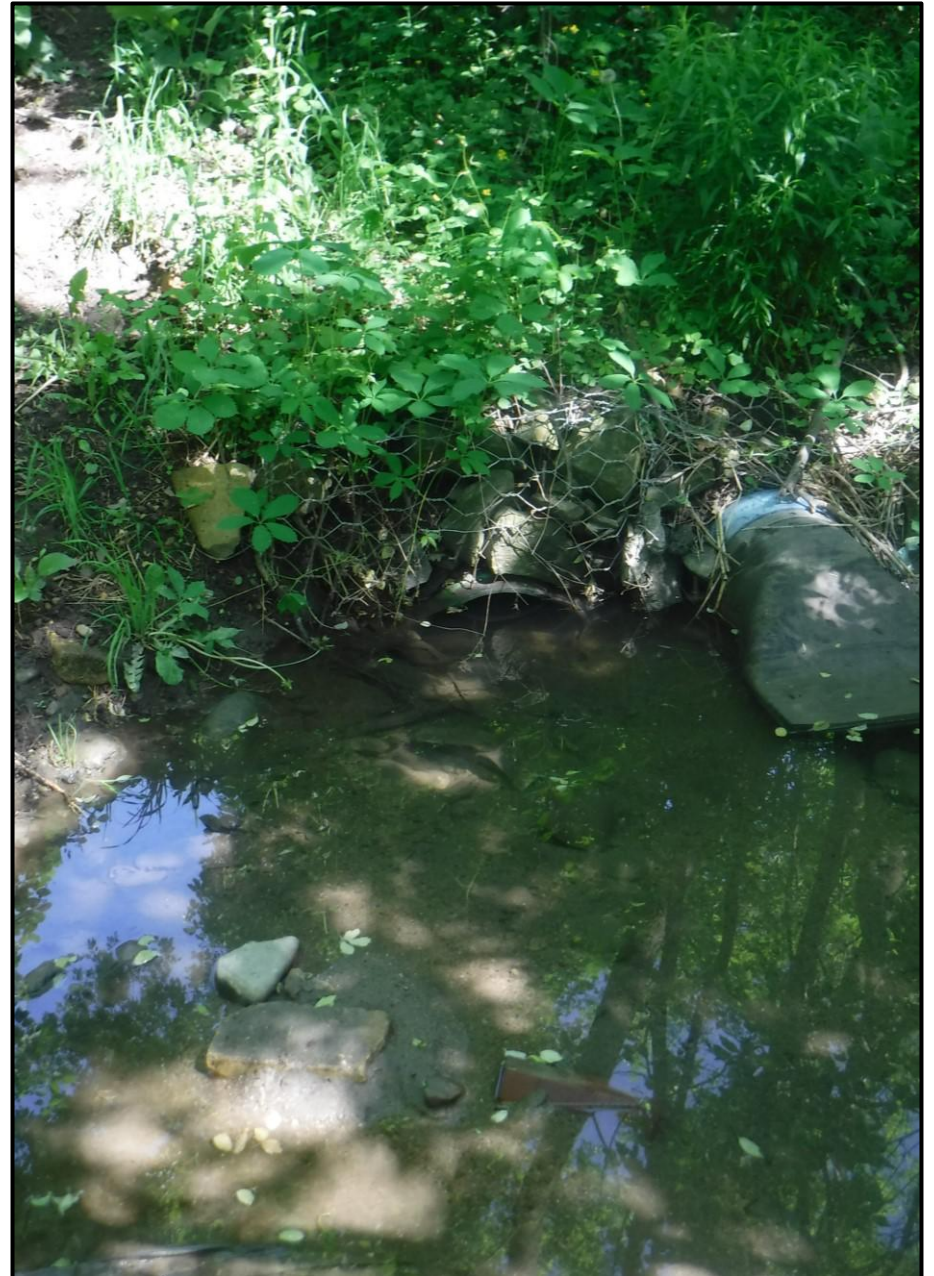
**Site ID: MS#2**

Sediment buildup in and around stormwater outfall restricting flow

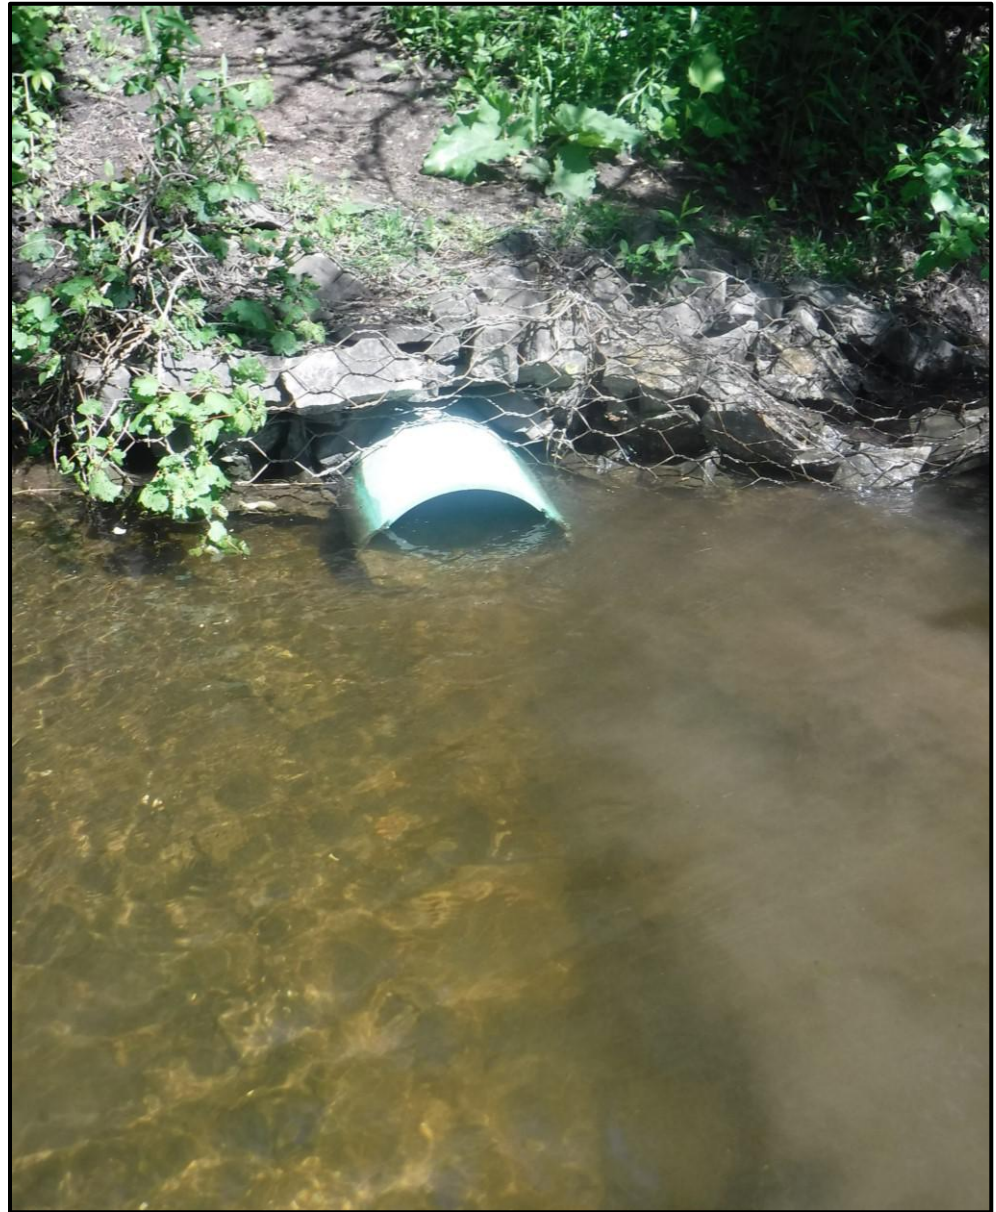
**Site ID: MS#3**

Gabion basket headwall structure  
falling into watercourse

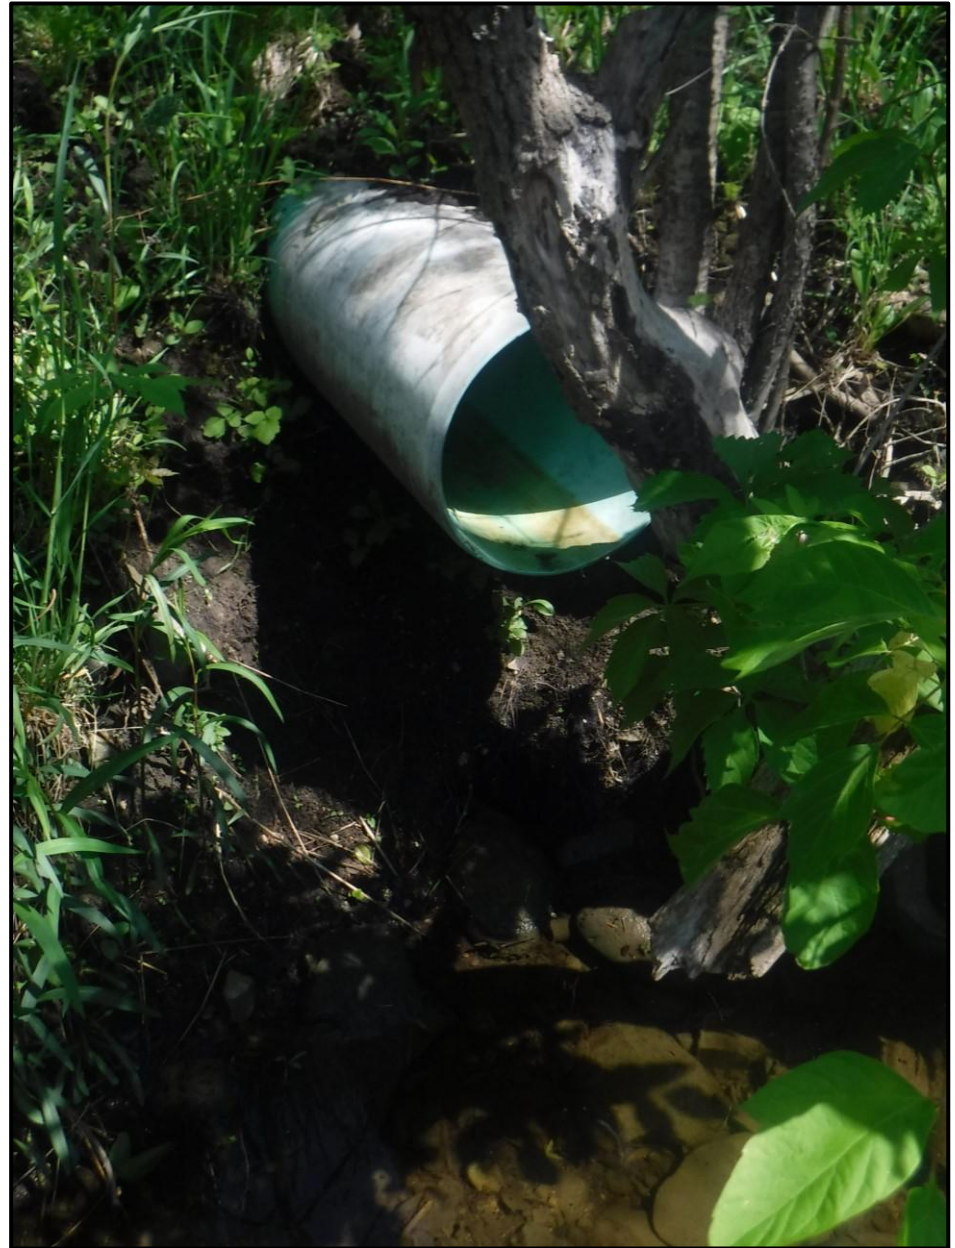
**Site ID: MS#4**

Localized erosion occurring  
around/underneath stormwater  
outfall

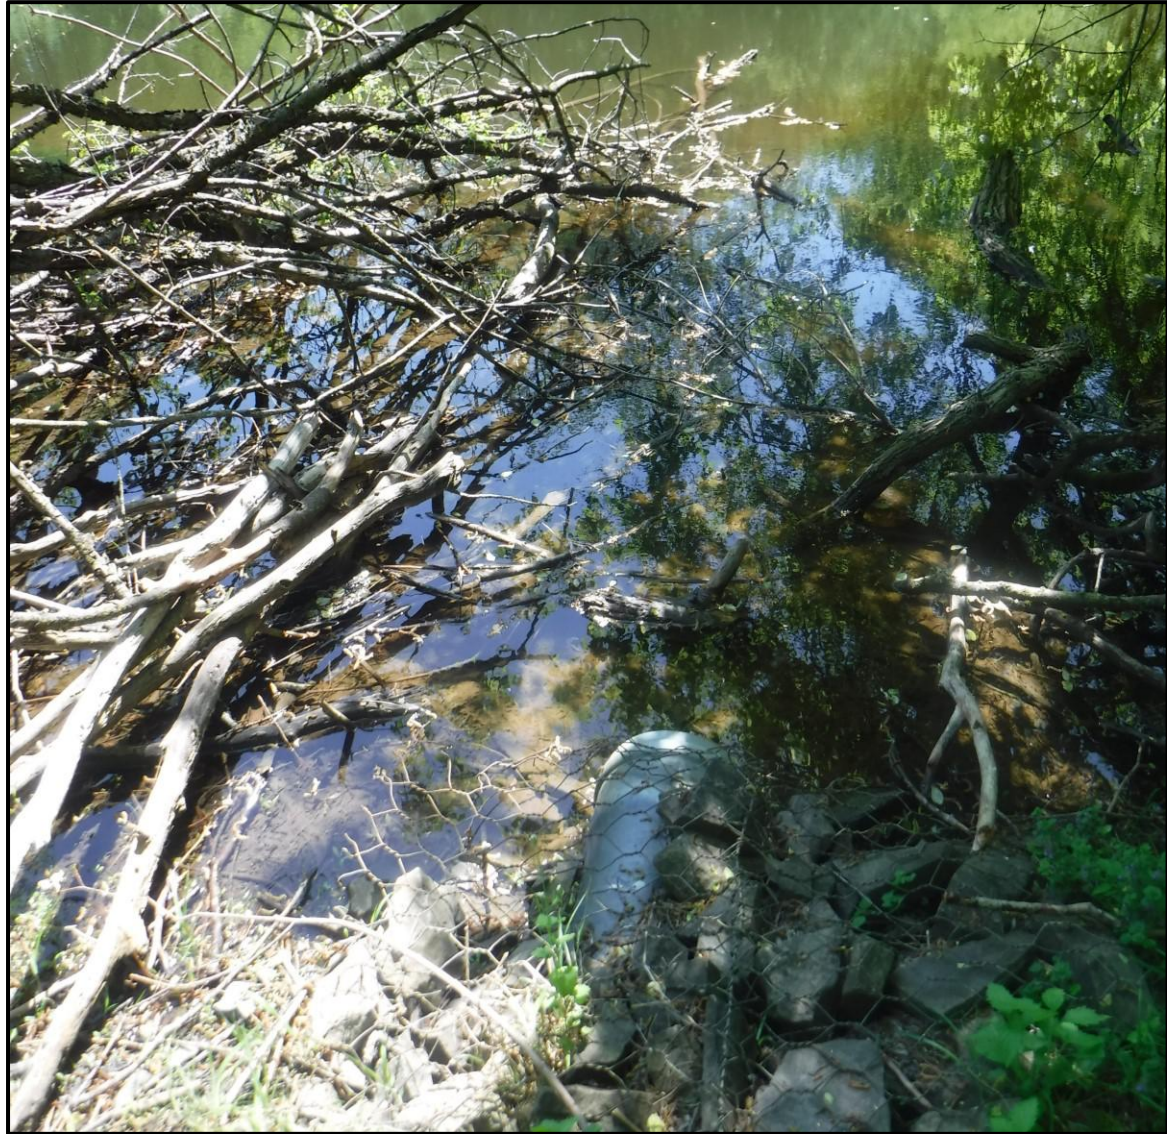
**Site ID: MS#5**

Gabion basket headwall structure around stormwater outfall in poor condition, buildup of organic debris in channel

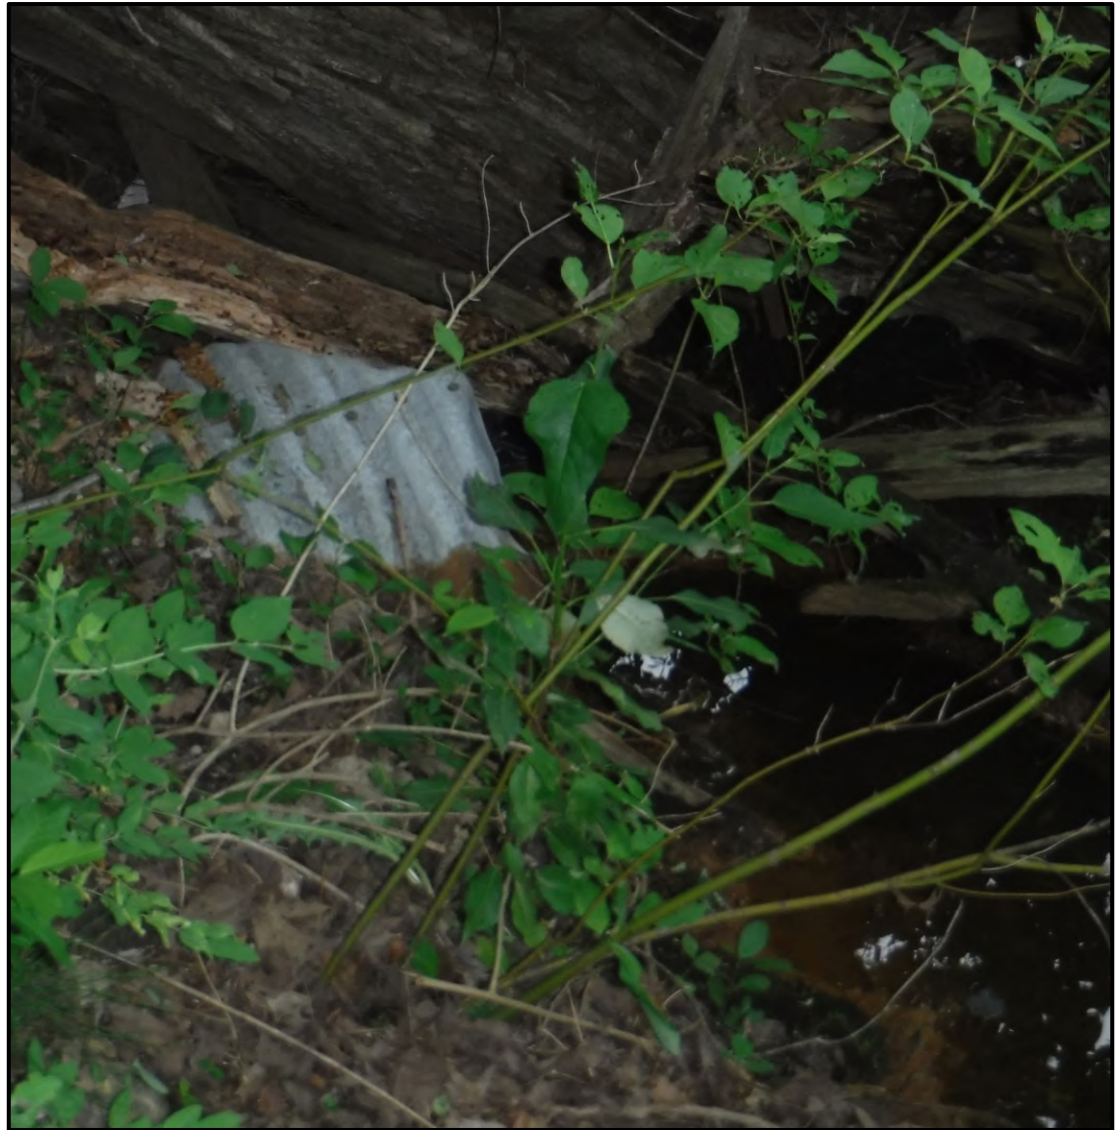
**Site ID: MS#8**

Culvert has been damaged by fallen tree, also flow obstructed by organic debris

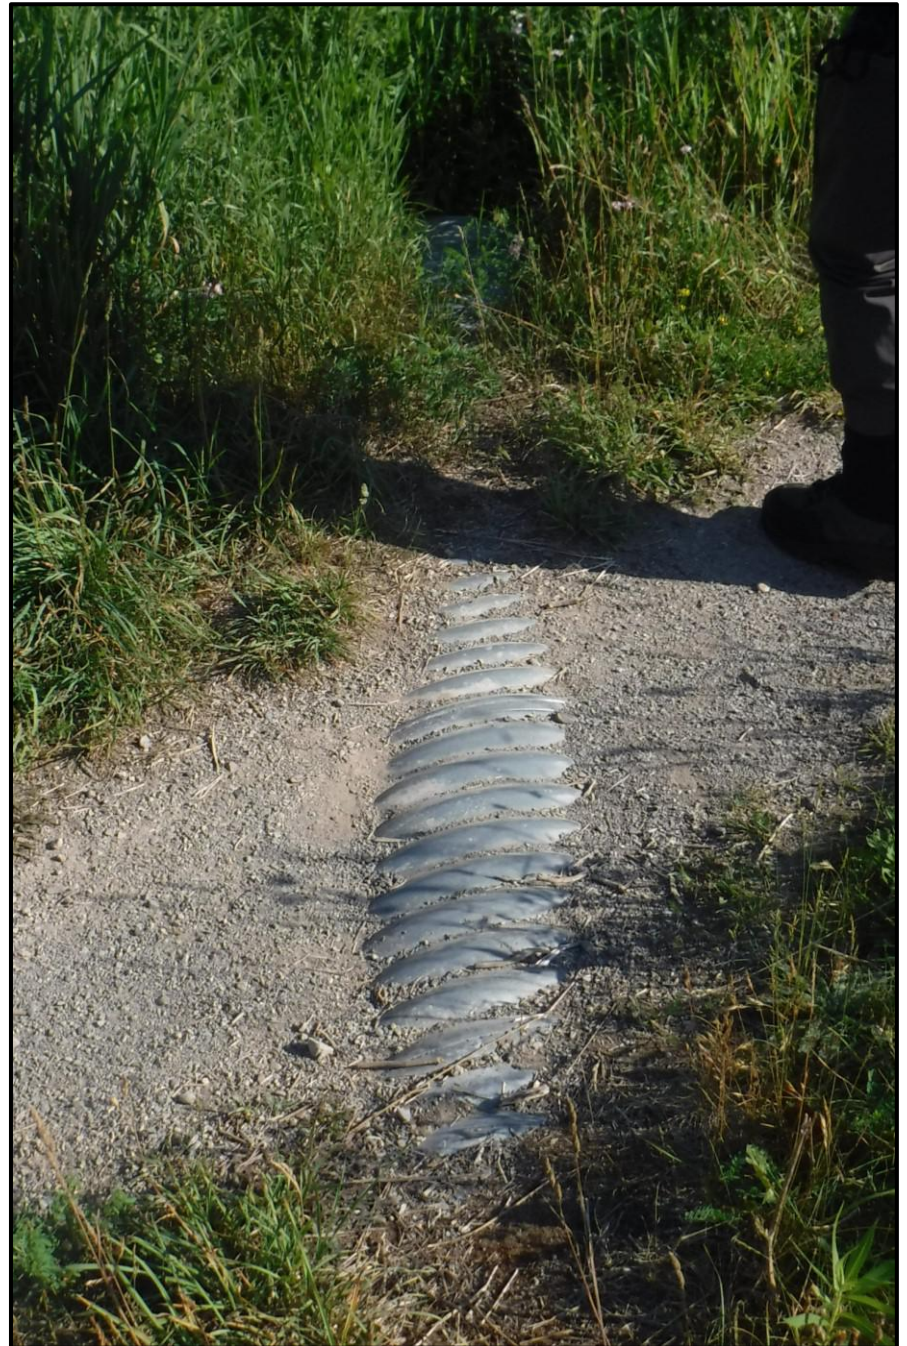
Culvert running under trail becoming exposed

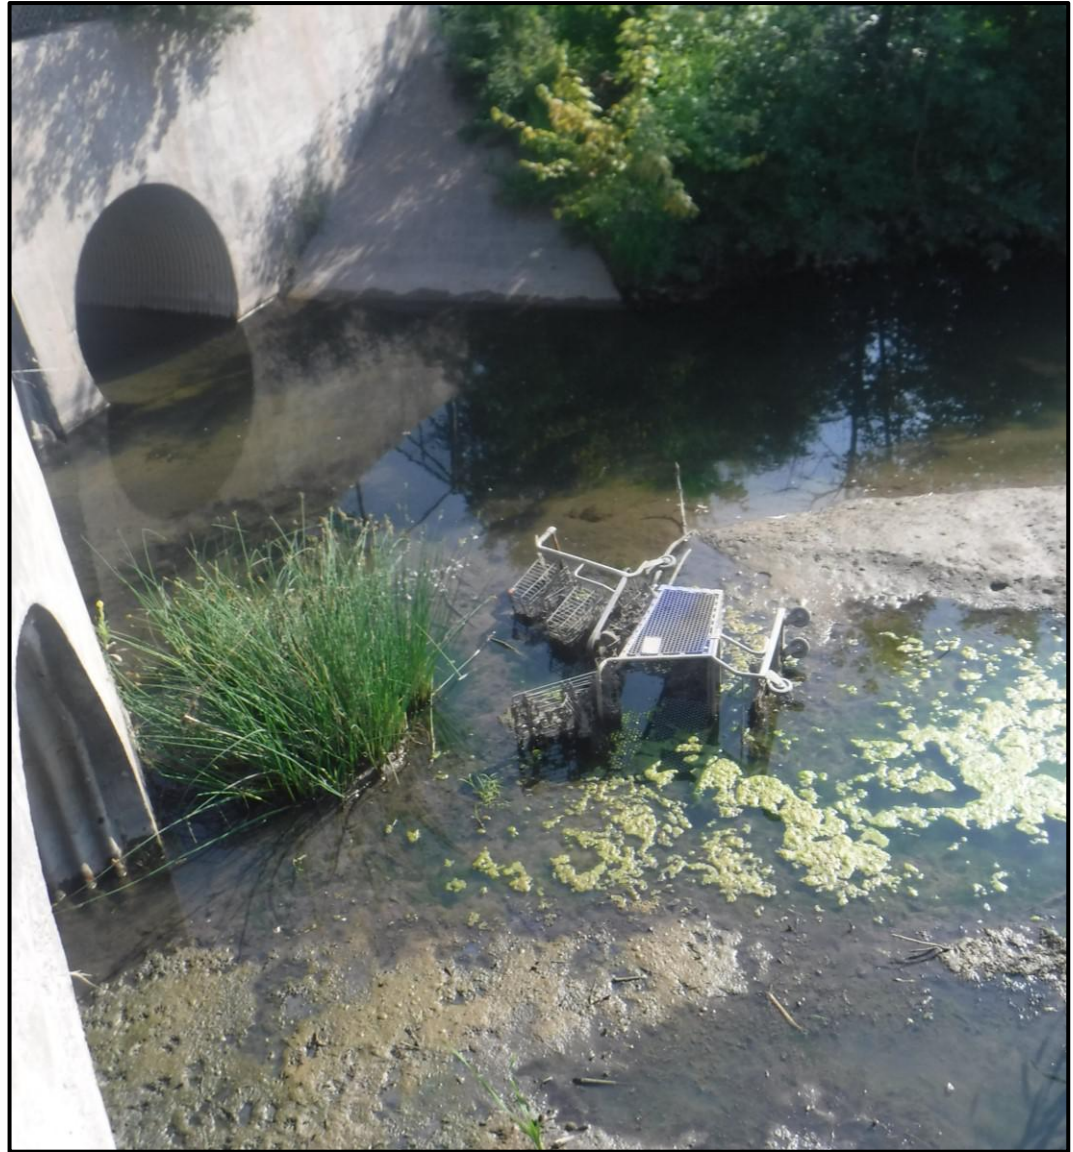
**Site ID: MS#11**

Buildup of sediment just  
downstream of outfalls and  
culverts, buggies and other  
garbage in channel

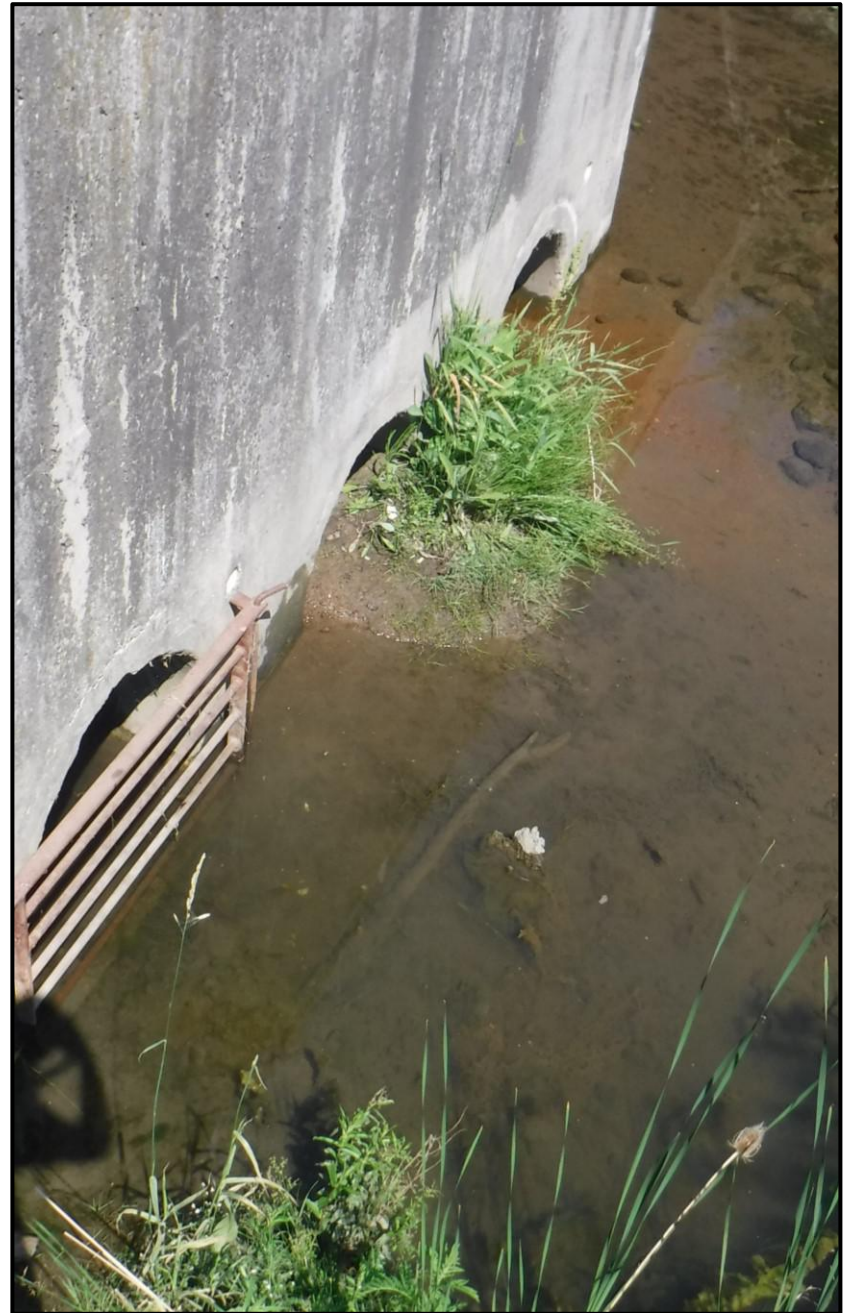
**Site ID: MS#12**

Large amount of sediment buildup obstructing outfall

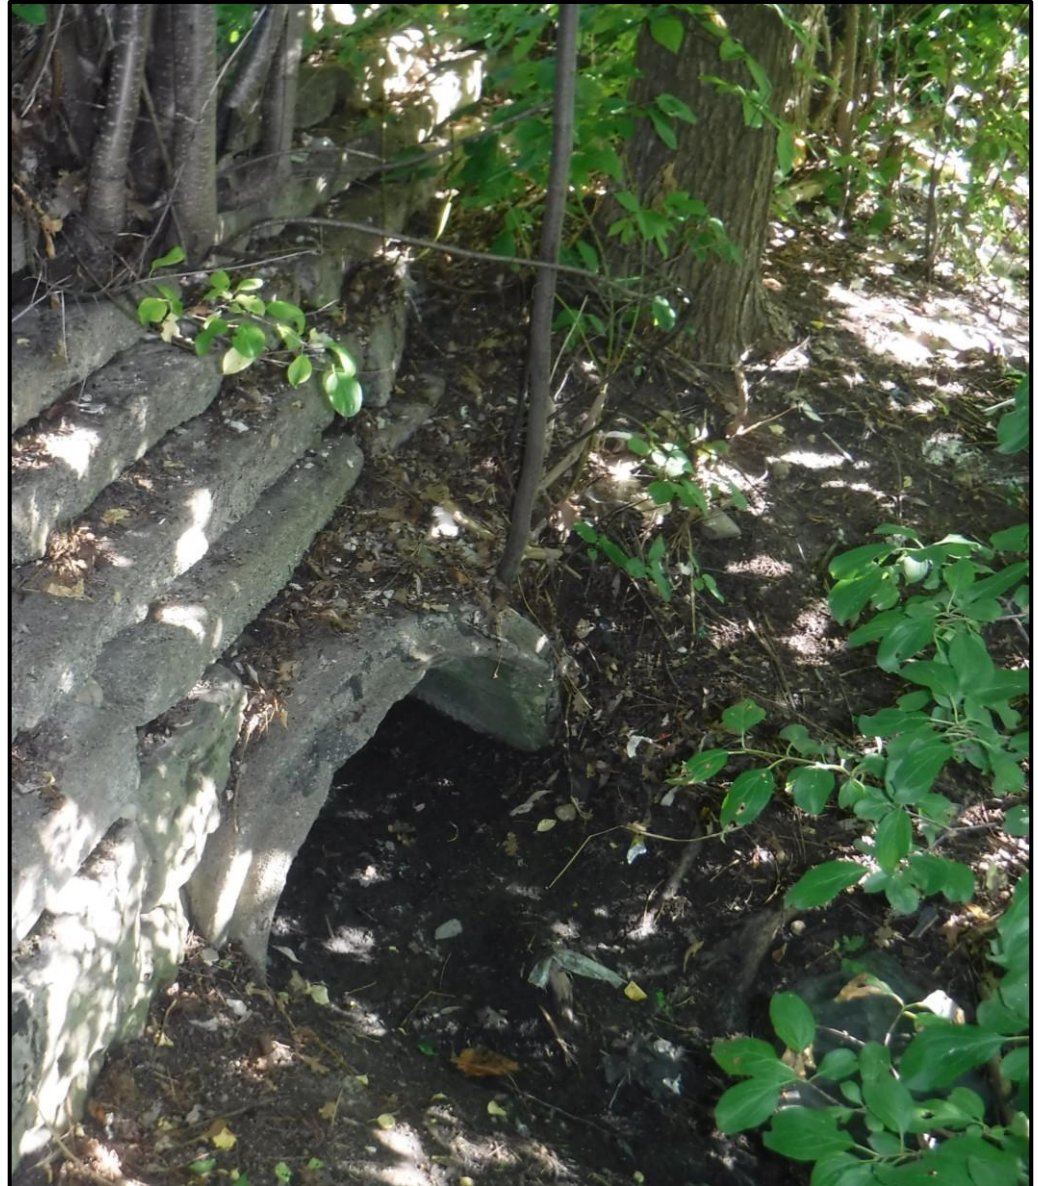
**Site ID: MS#13**

Large amount of sediment  
buildup in stormwater outfall

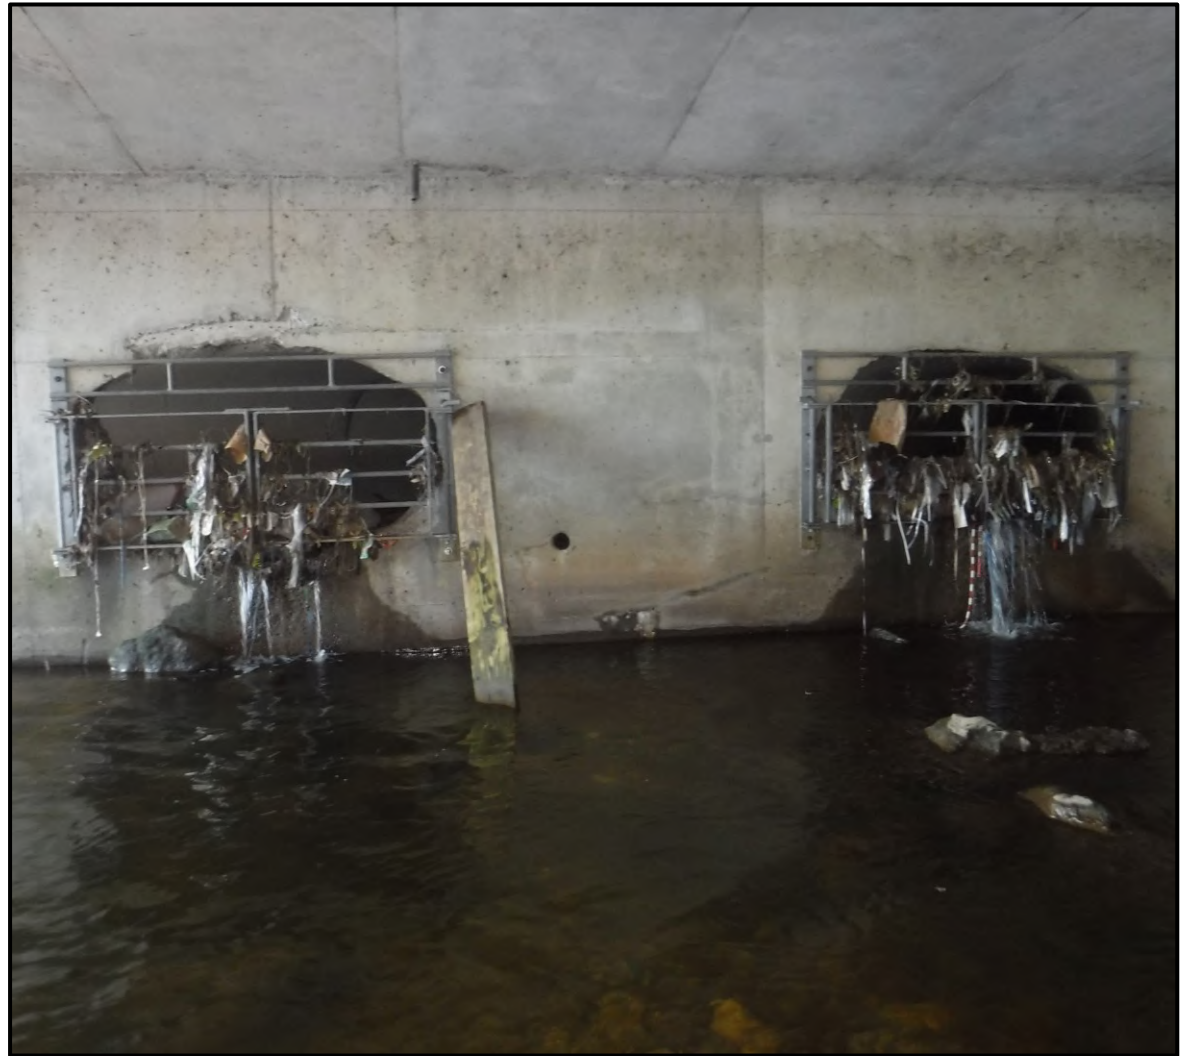
**Site ID: MS#14 &  
MS#15**

Garbage and debris built  
up on stormwater outfall  
grates

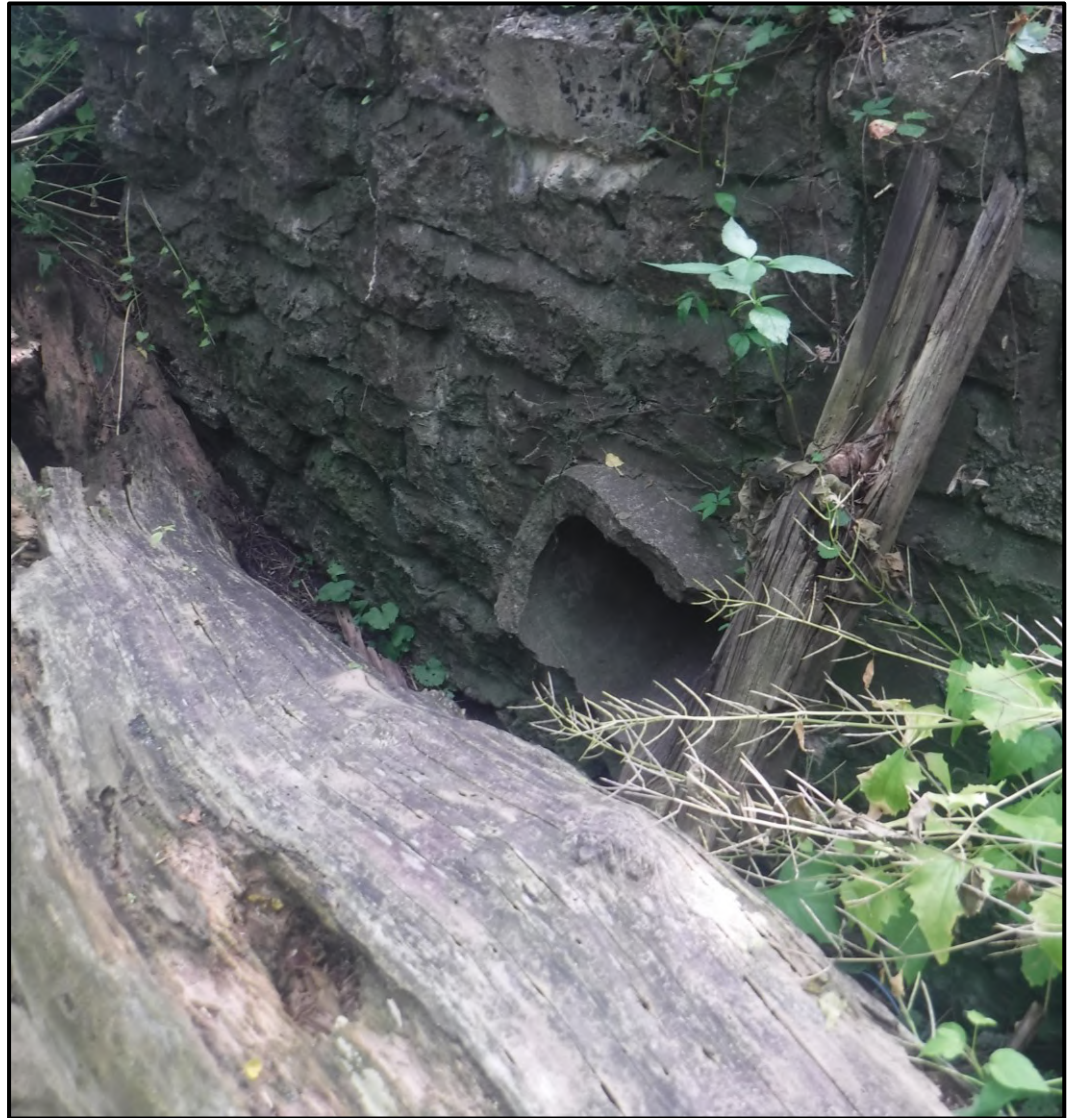
**Site ID: MS#16**

Large pieces of fallen tress and other organic debris blocking outfall

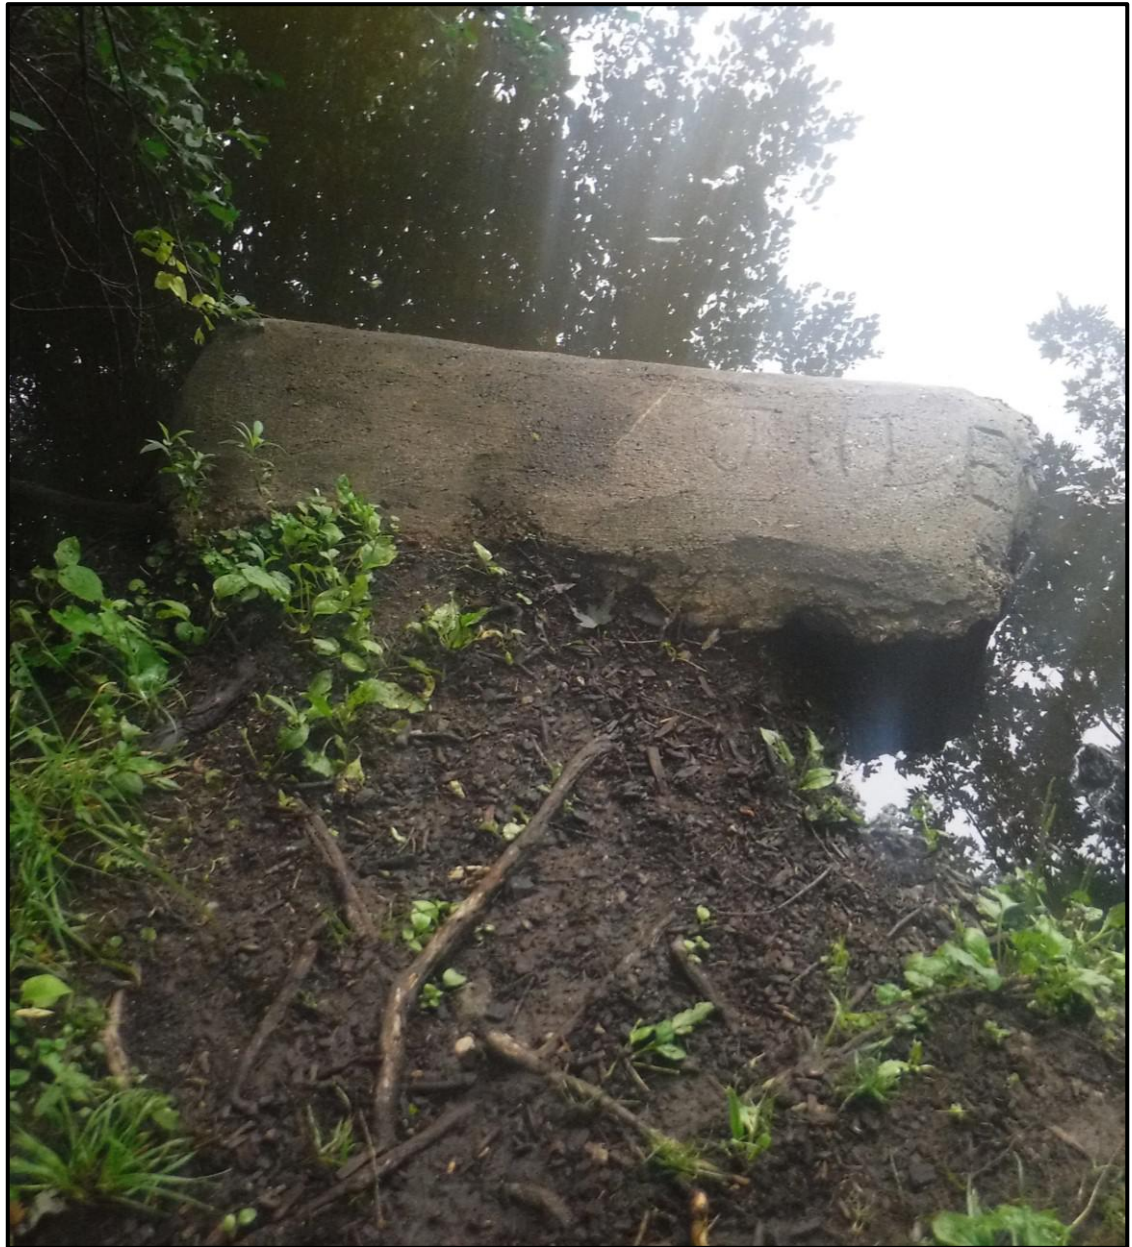
**Site ID: MS#17**

Localized erosion around stormwater outfall, retaining wall is beginning to get outflanked

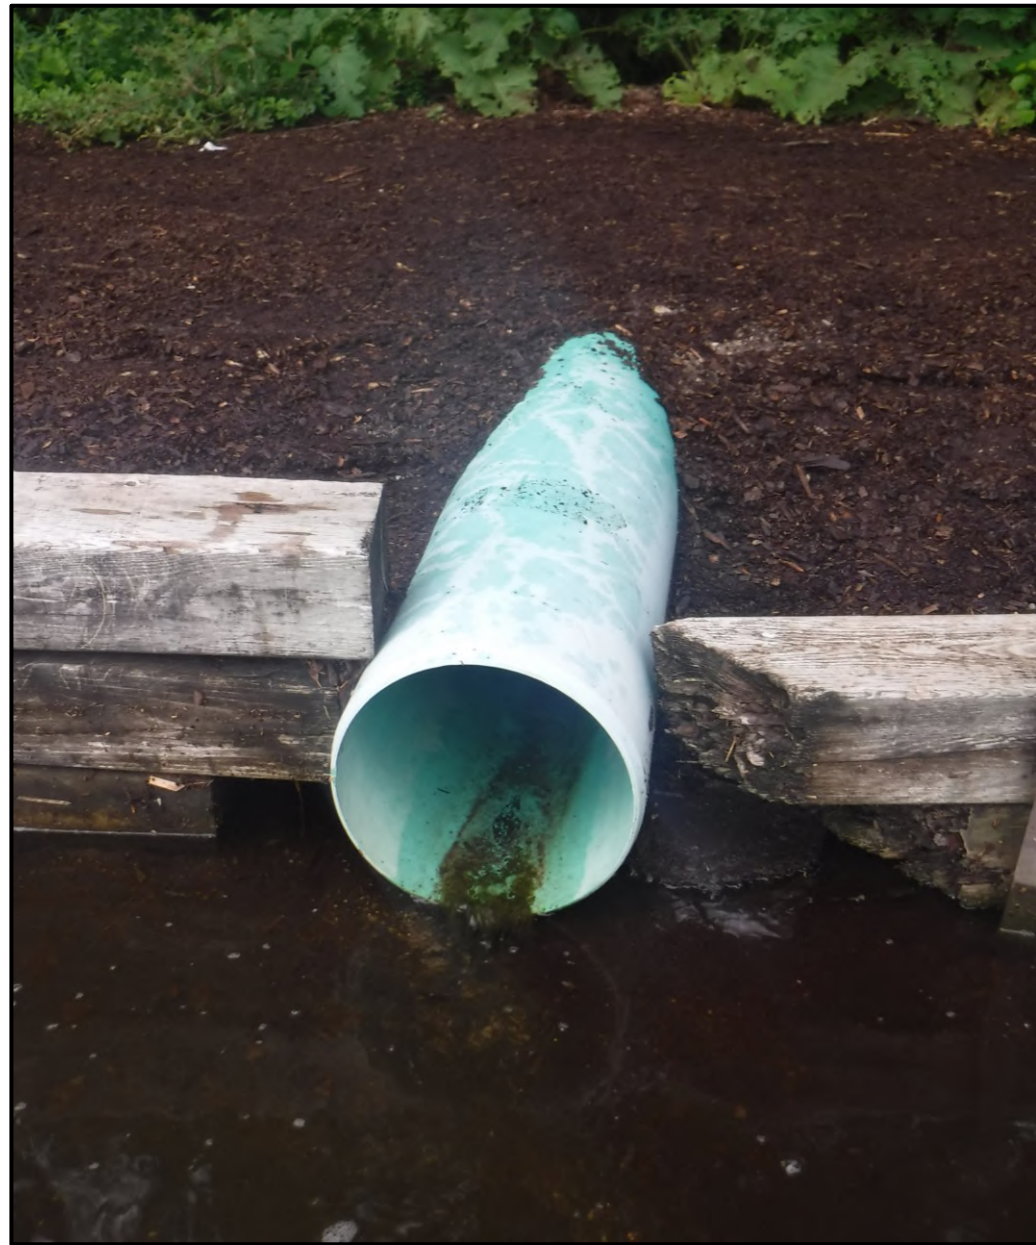
**Site ID: MS#18**

Pipe becoming exposed under trail, localized erosion occurring near outfall

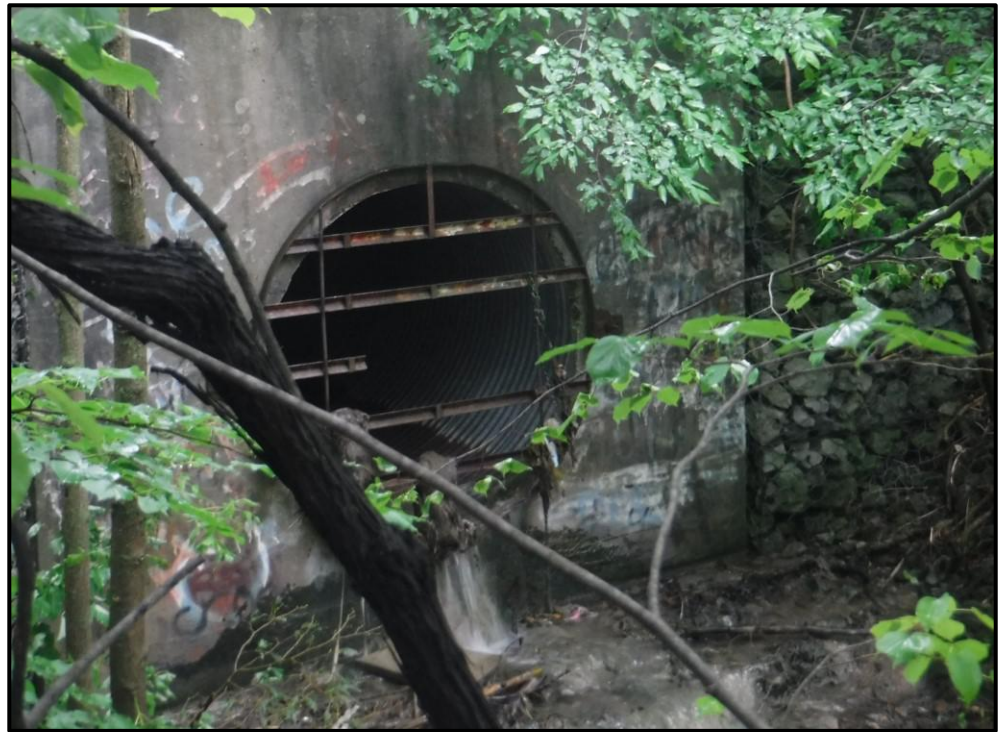
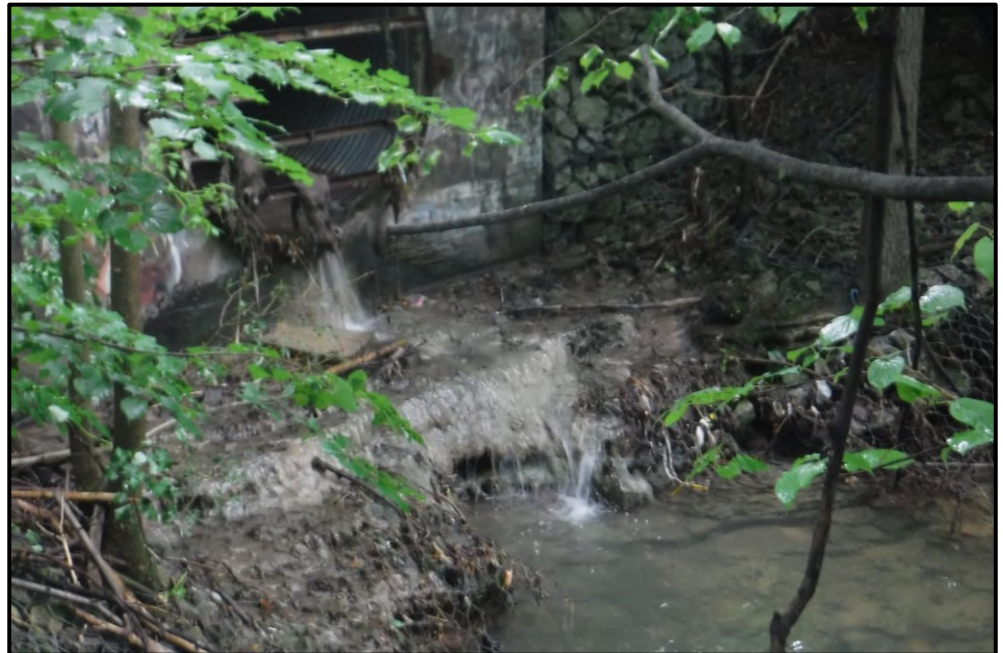
**Site ID: MS#19**

Gabion baskets have burst open under outfall, scour pool has also formed. Grate on outfall is broken.

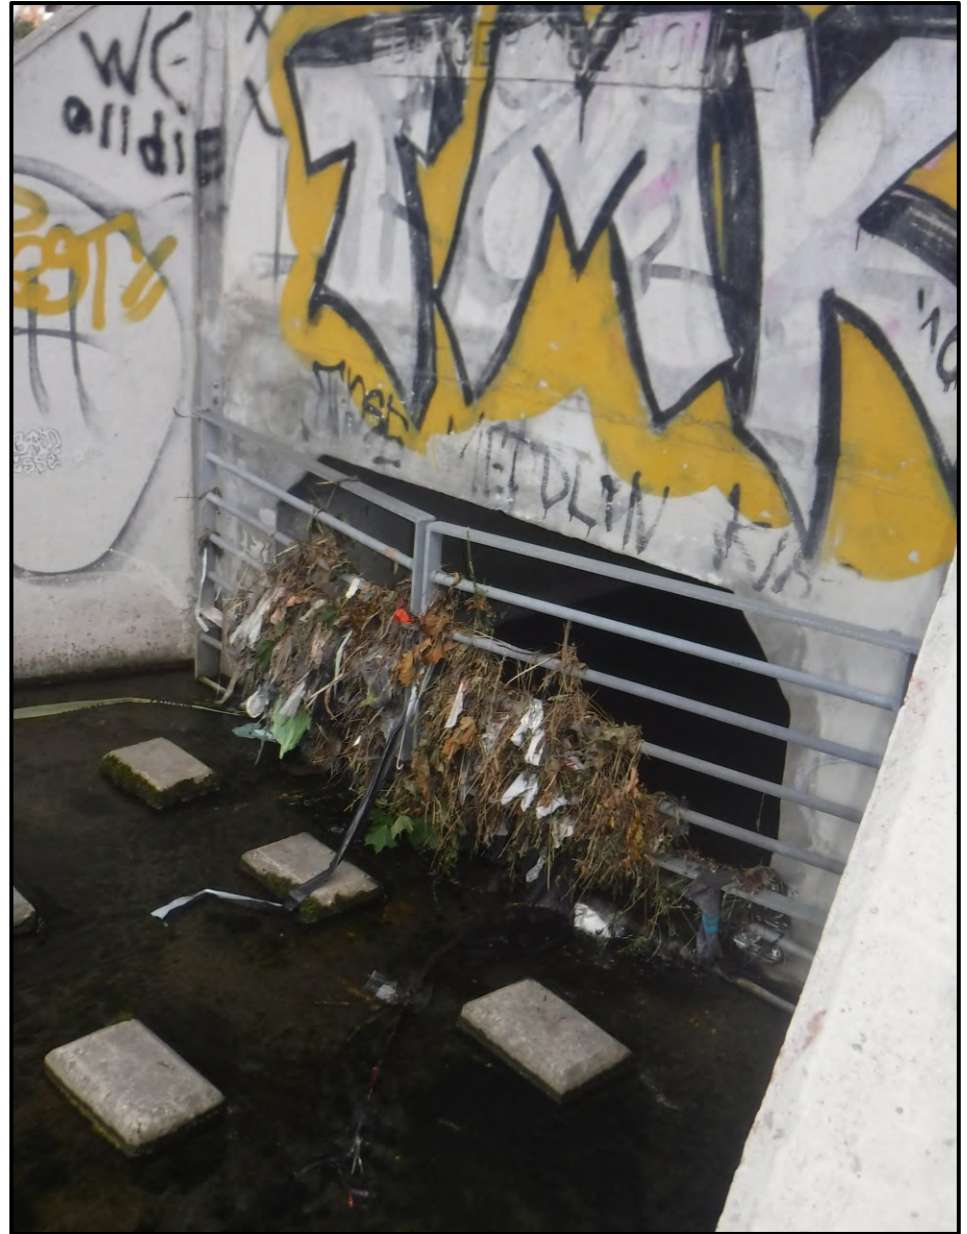
**Site ID: MS#20**

Buildup of garbage and debris on stormwater outfall grate

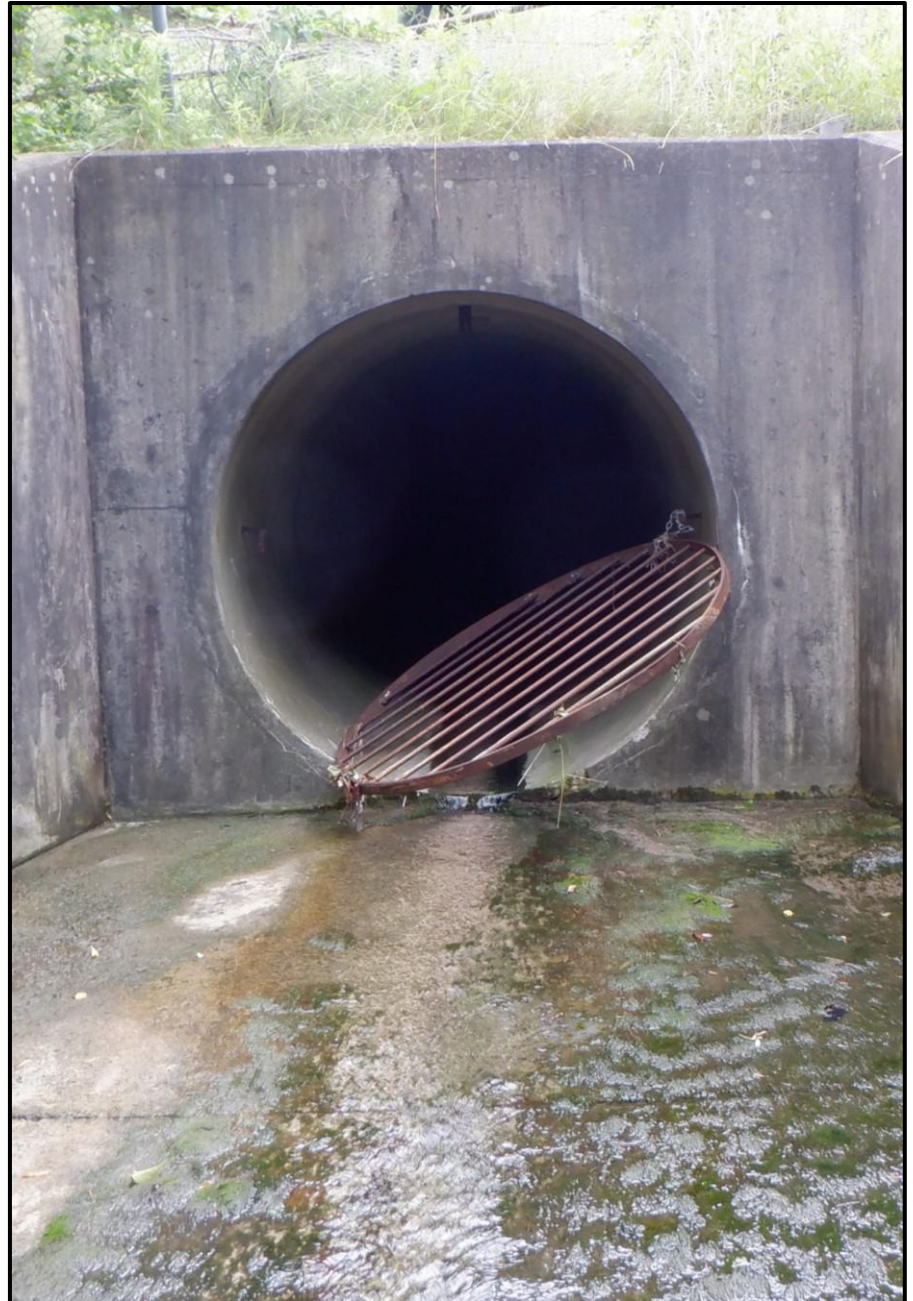
**Site ID: MS#21**

Grate on stormwater outfall has become dislodged

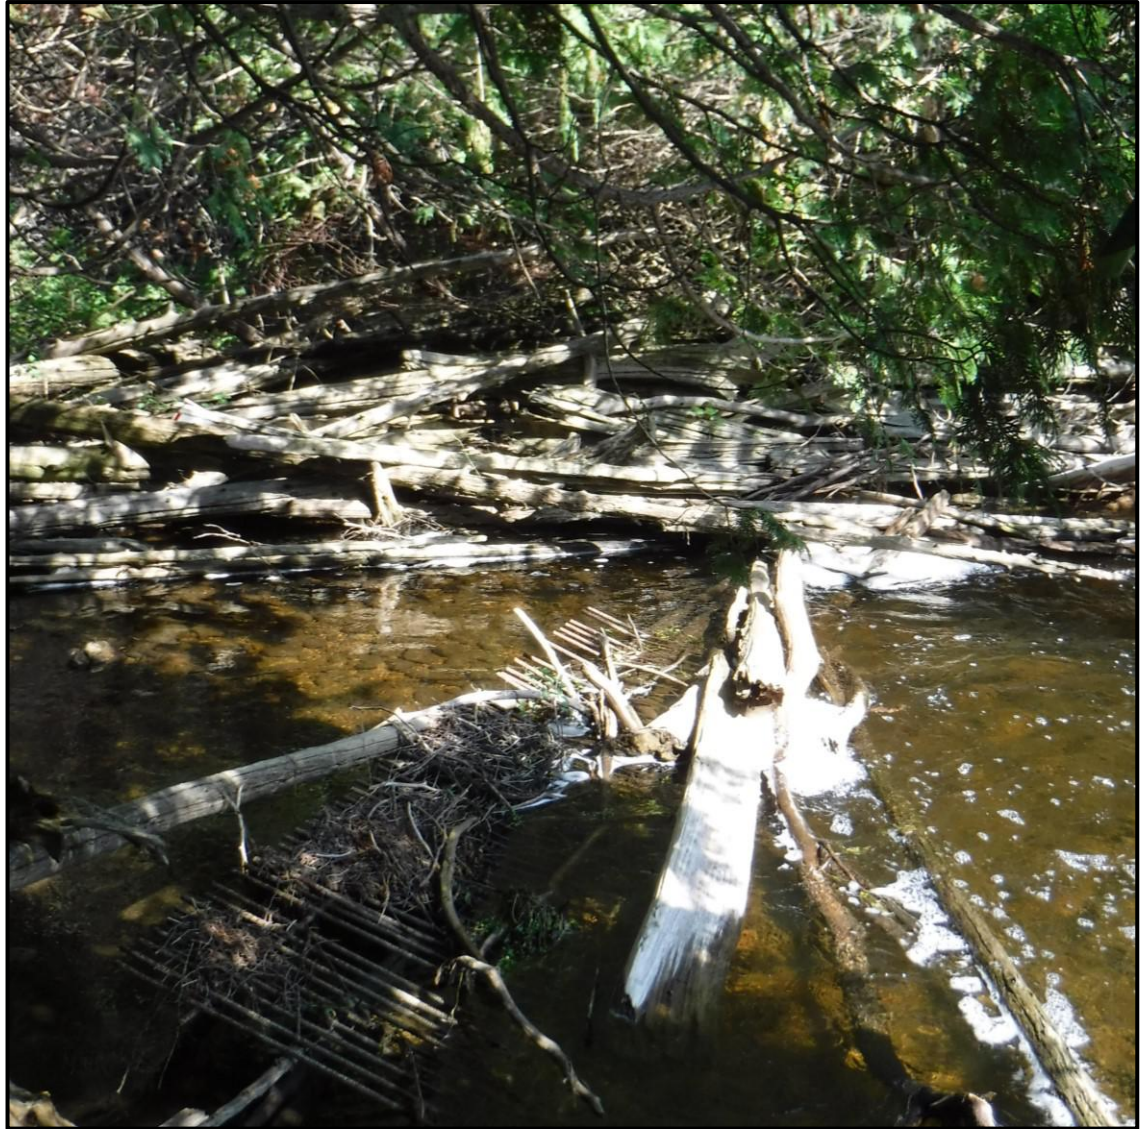
**Site ID: MS#22**

Large debris jam in channel
