# Stormwater Management Master Plan

## Appendix M: Erosion Assessment Technical Memorandum – Field Investigations

Prepared by:  
**Aquafor Beech Ltd.**

Reference #: 66636  
August 2021  
Final Report

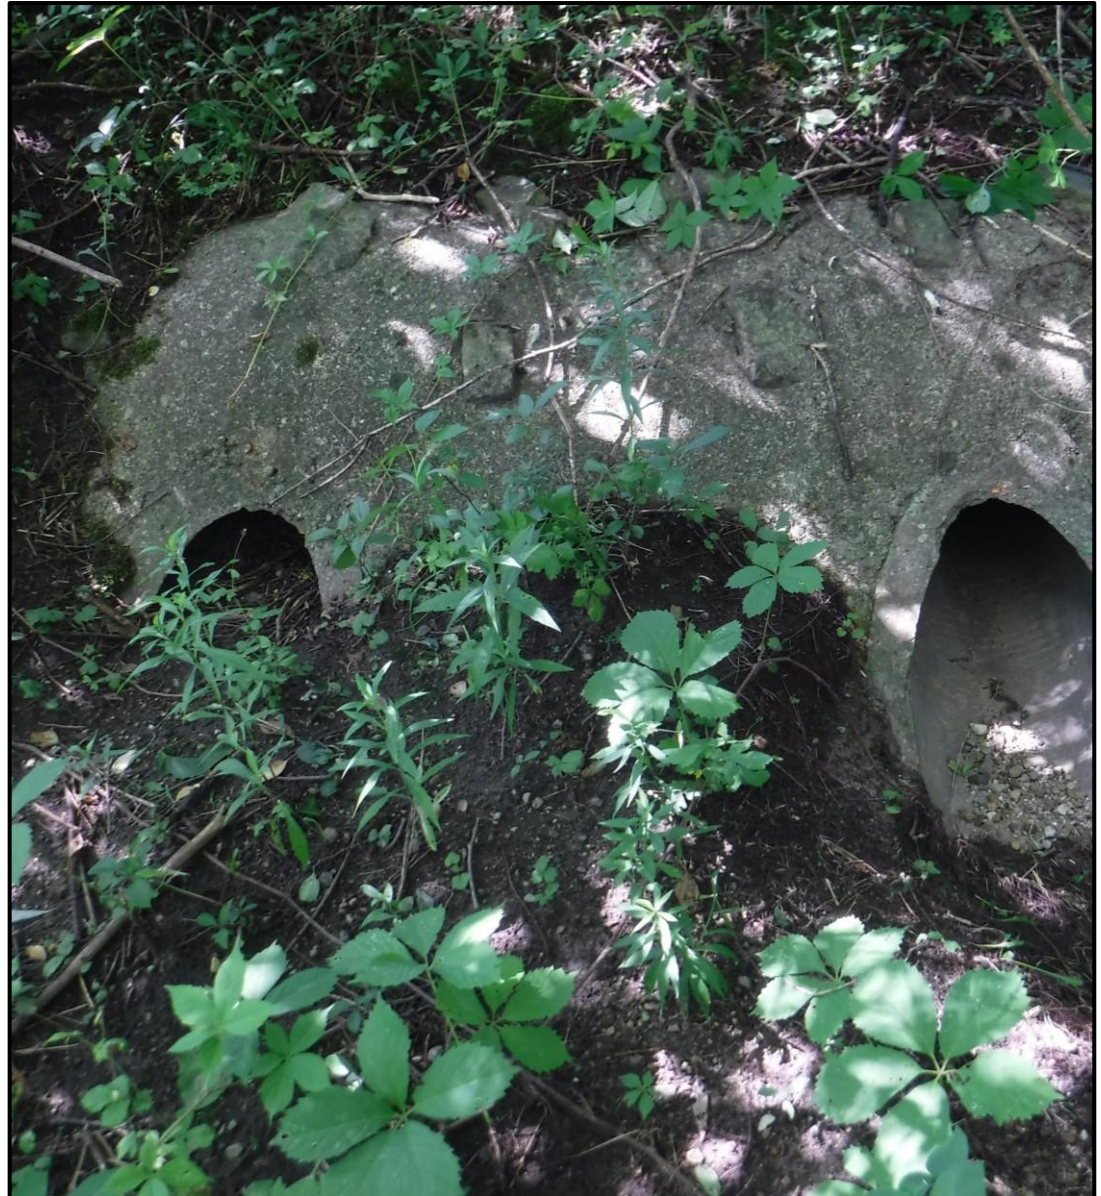
**Site ID: MS#23**

Stormwater outfall almost completely filled with sediment

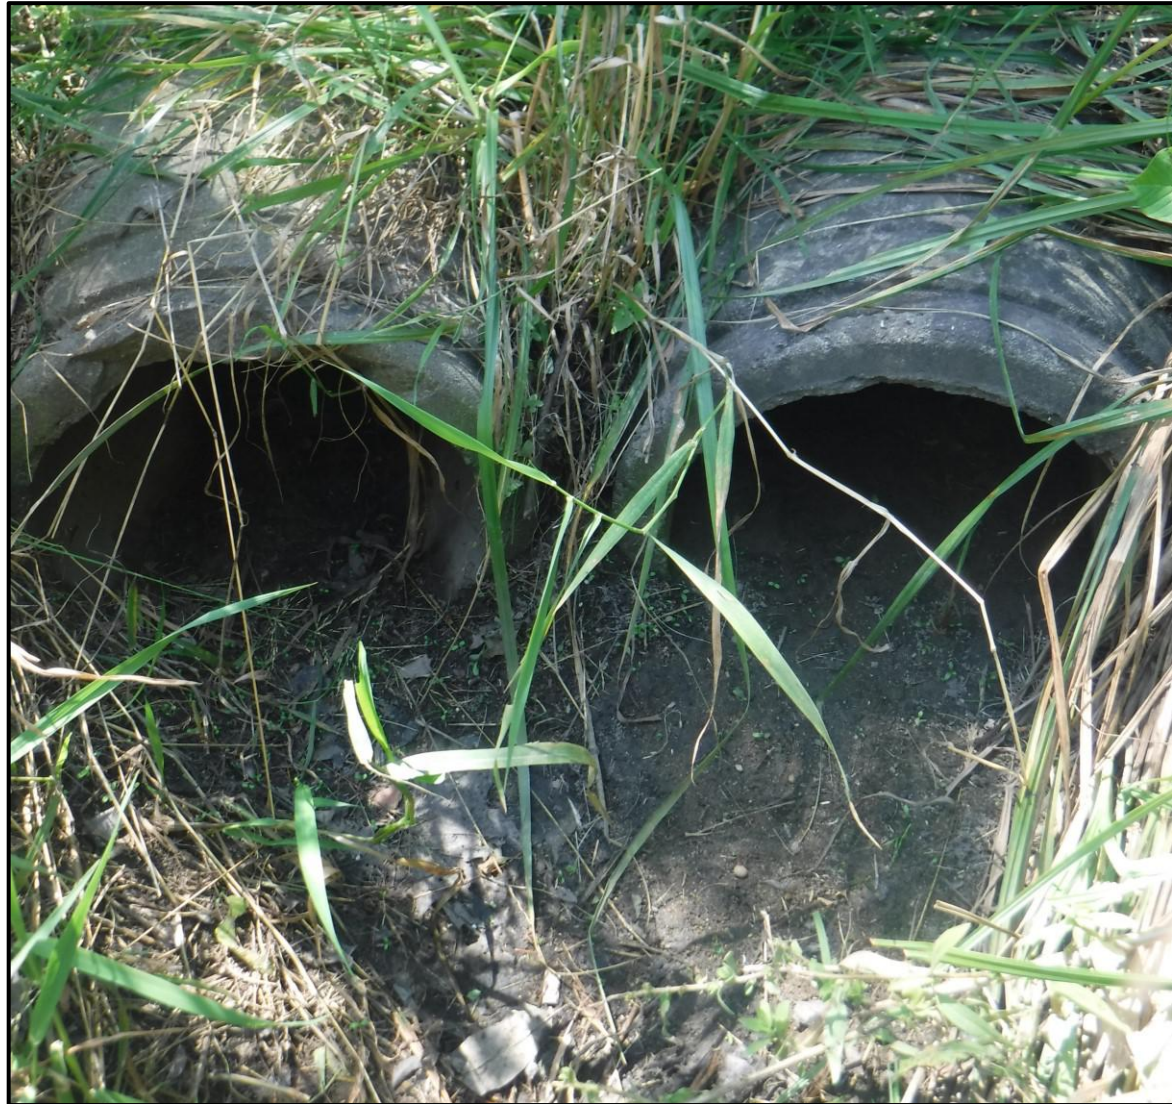
**Site ID:** MS#26 and  
MS#27

Sediment built up in 2  
stormwater outfalls

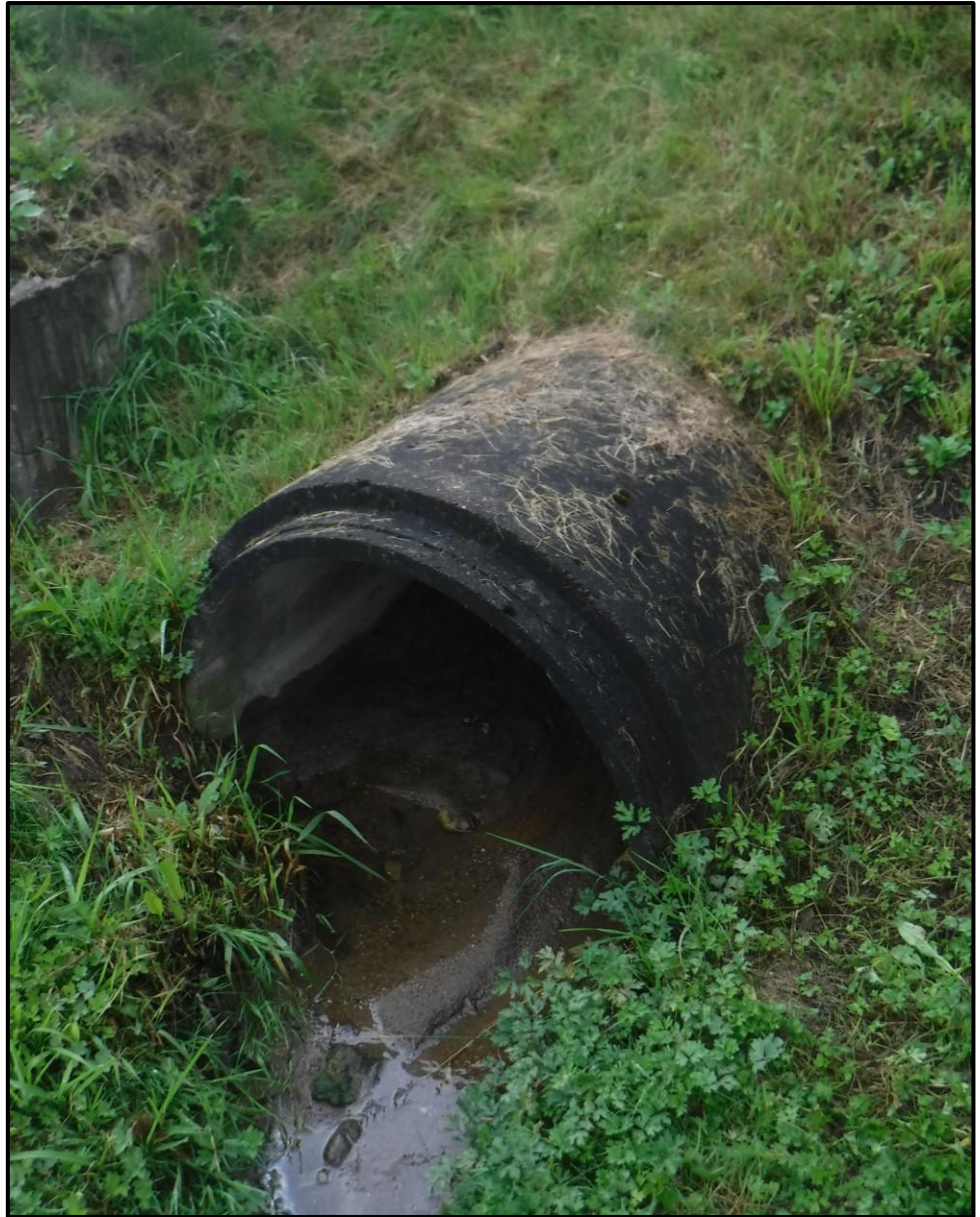
**Site ID: MS#28**

Large amount of sediment built up in outfall

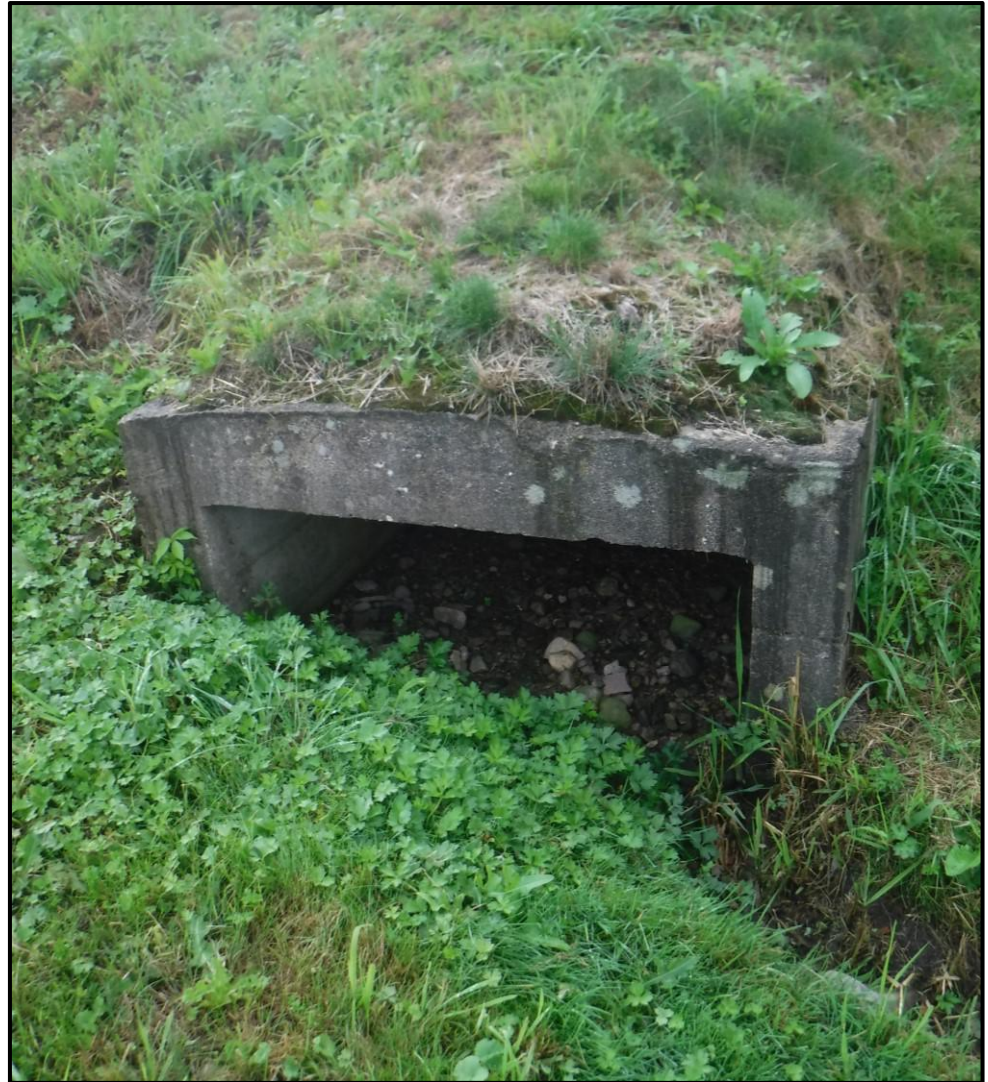
**Site ID: MS#29**

Large amount of sediment built up in outfall

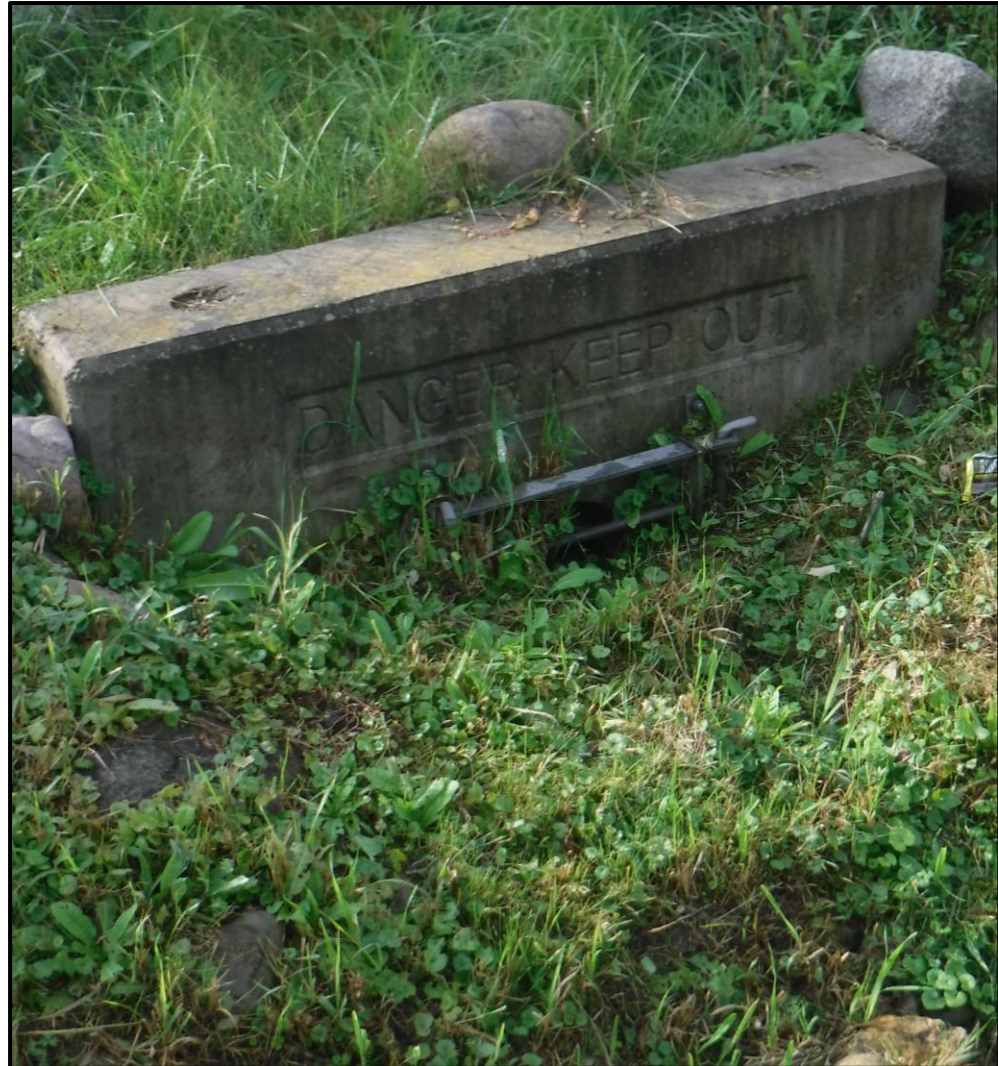
**Site ID: MS#30**

Large amount of sediment built up in outfall, outfall almost completely obstructed

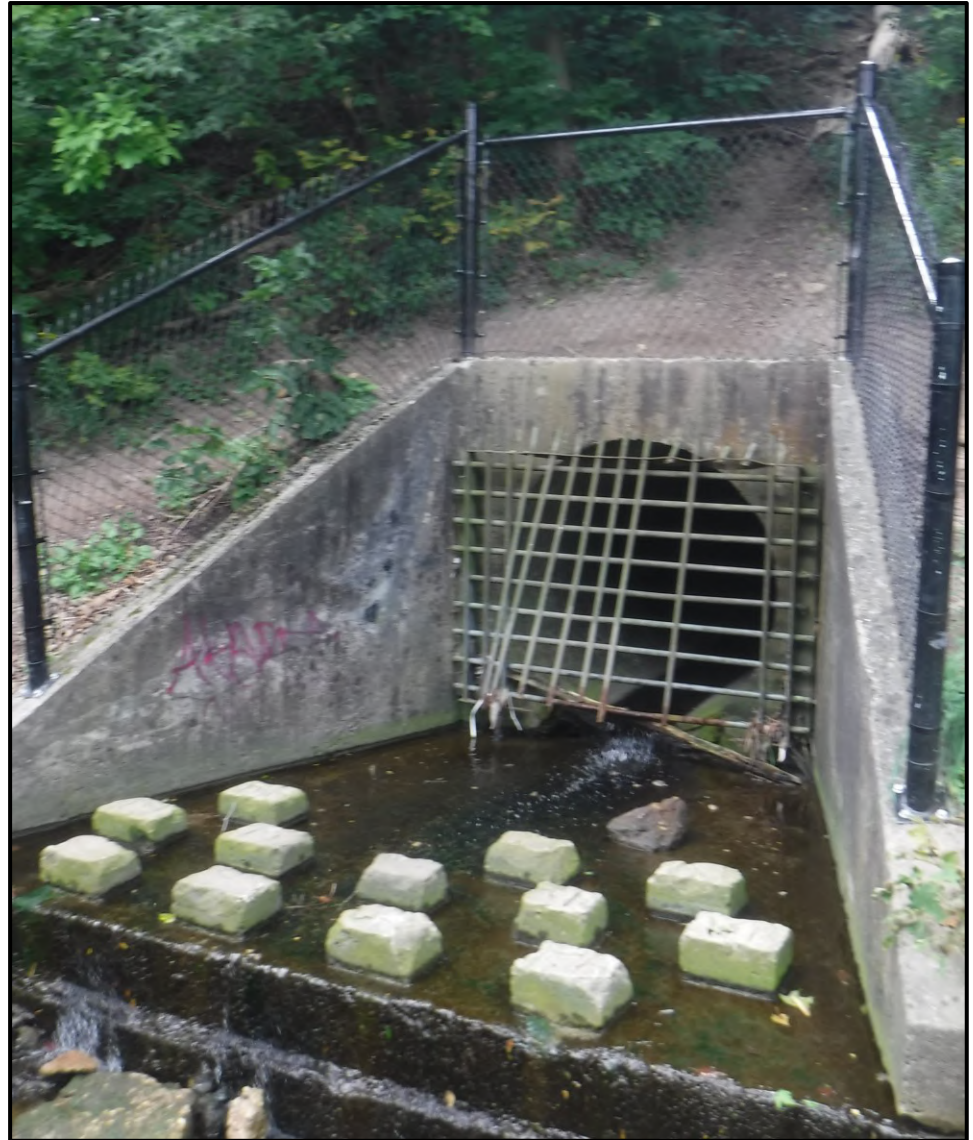
**Site ID: MS#31**

Grate on stormwater outfall is partially dislodged and damaged

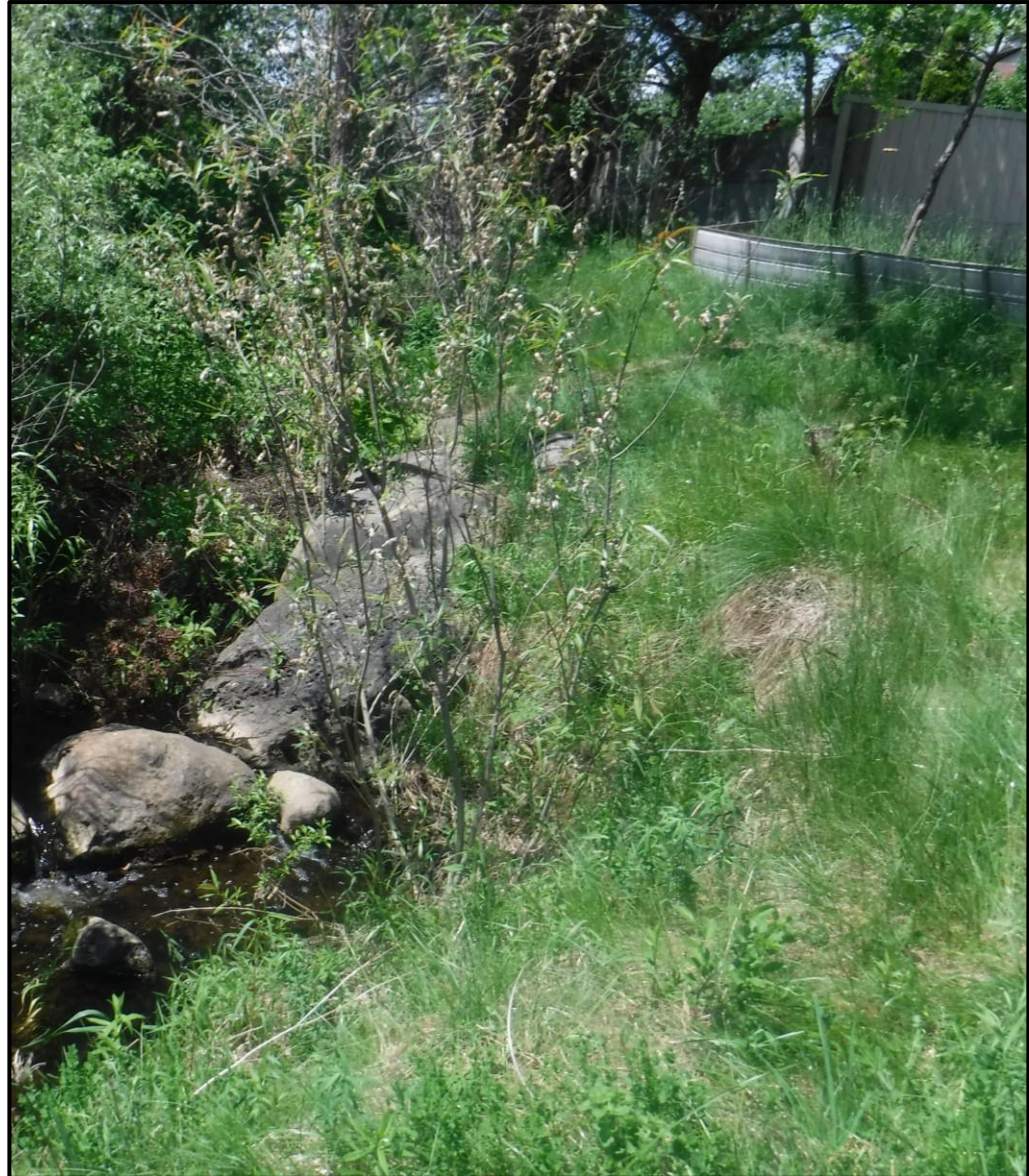
**Site ID: MI#1**

Encroachment from private property

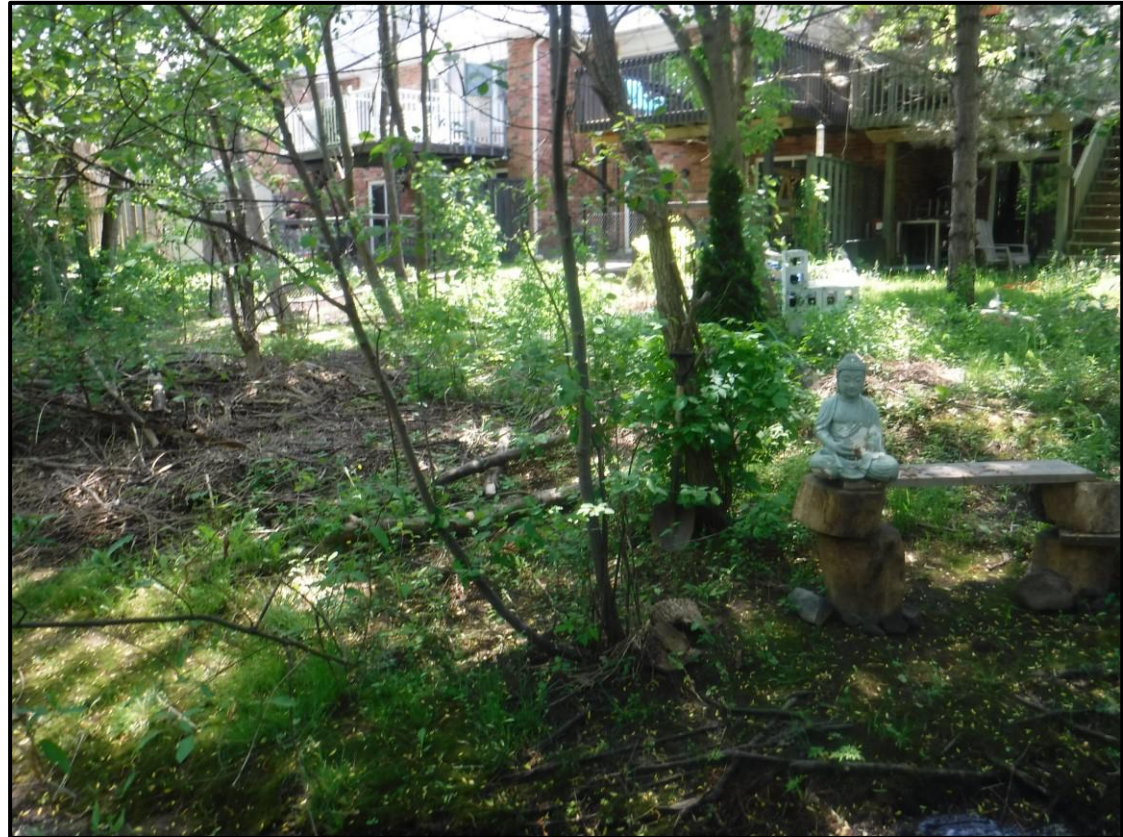
**Site ID: MI#2**

Encroachment from private property

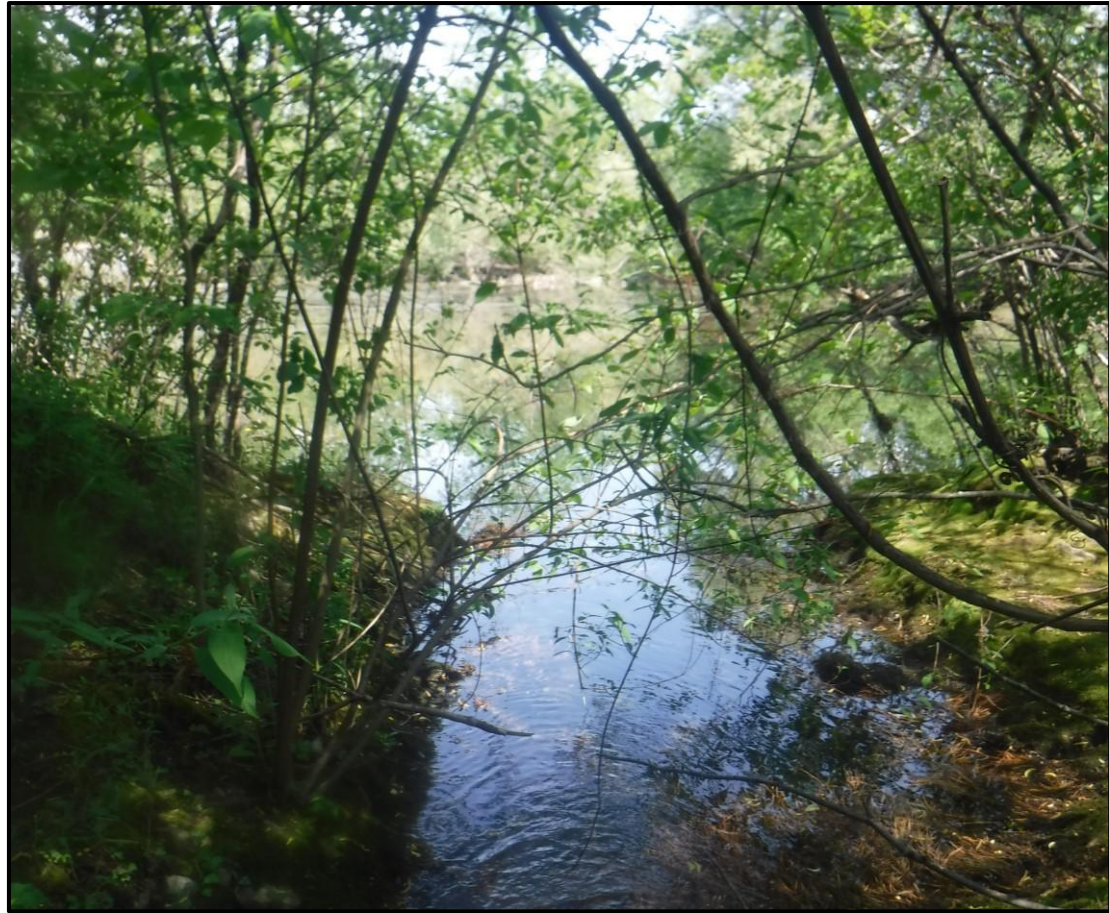
**Site ID: MI#3**

No defined channel anymore, channel enters and exits SWMF. Original watercourse mapping showed reach being separate from SWMF.

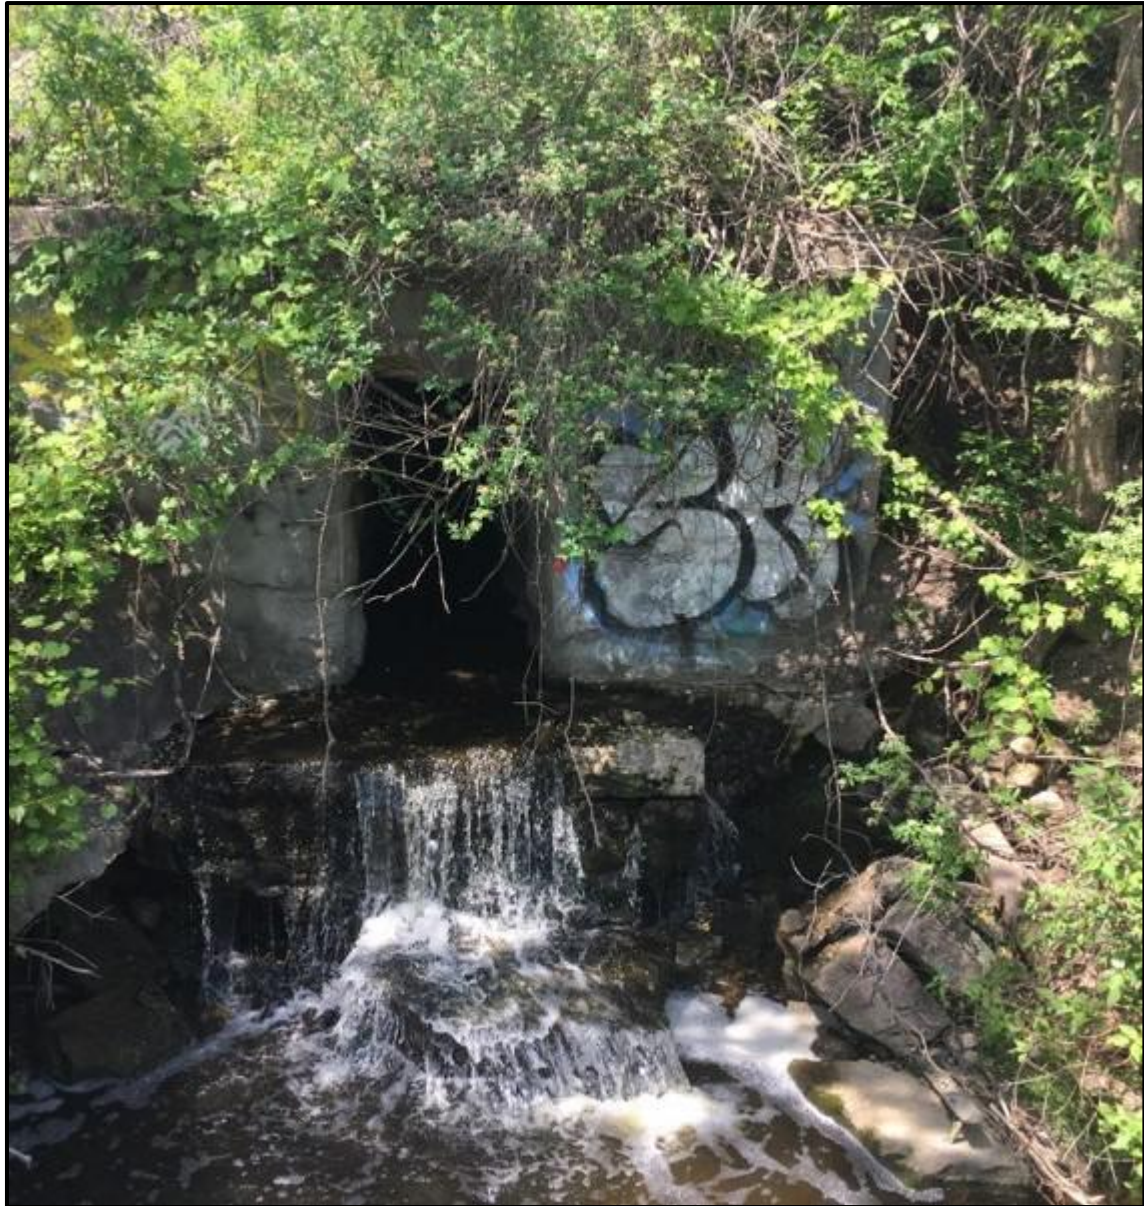
**Site ID: MI#4**

Fish barrier in channel

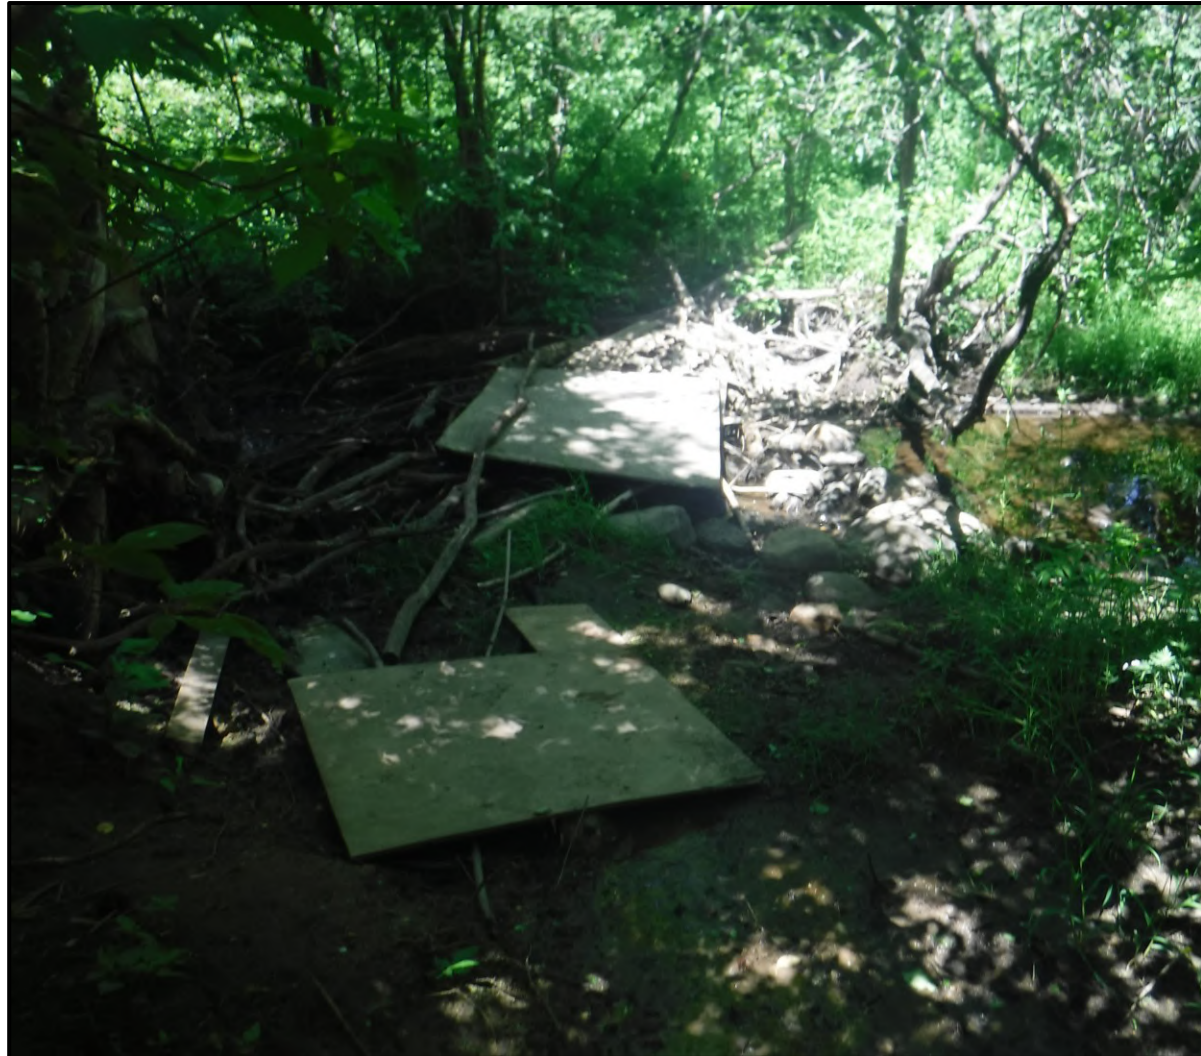
**Site ID: MI#5**

Encroachment from private property

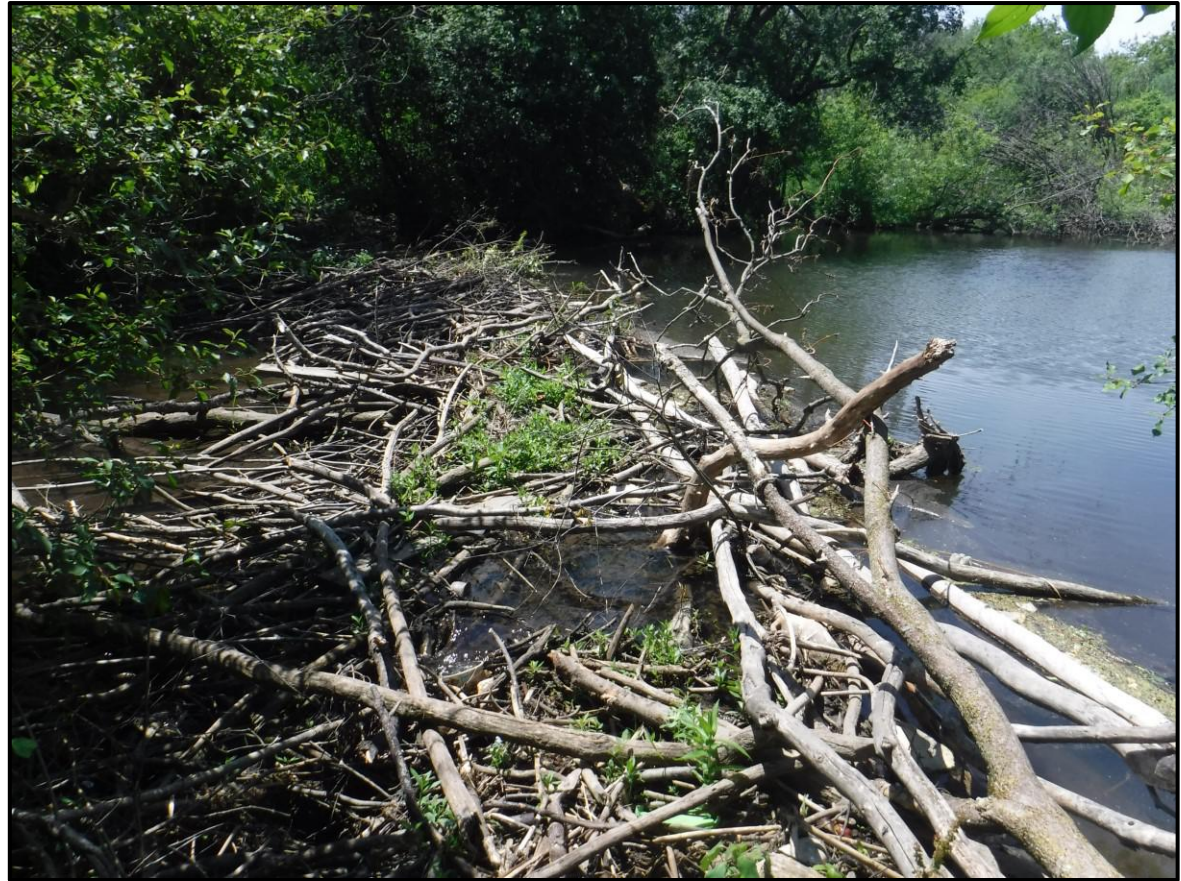
**Site ID: MI#8**

Large beaver dam across  
channel

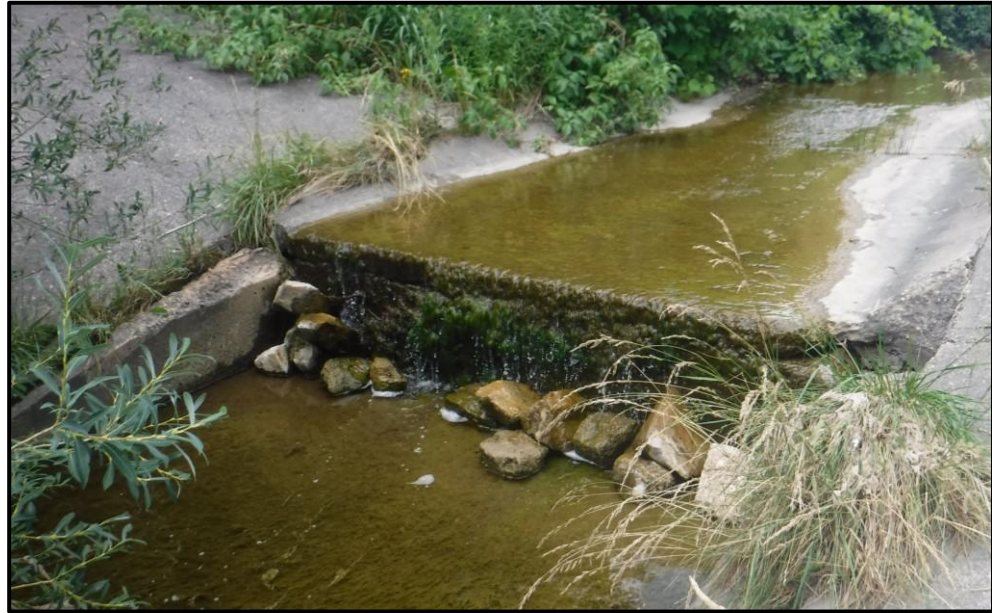
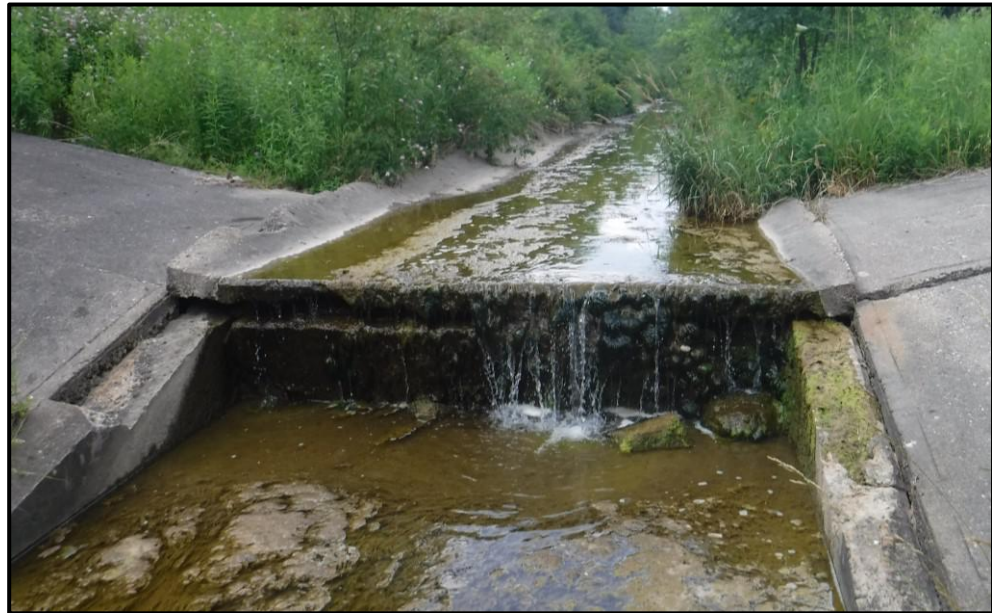
**Site ID: MI#11**

Multiple fish barriers extend  
throughout reach, fish were  
observed at downstream end of  
reach

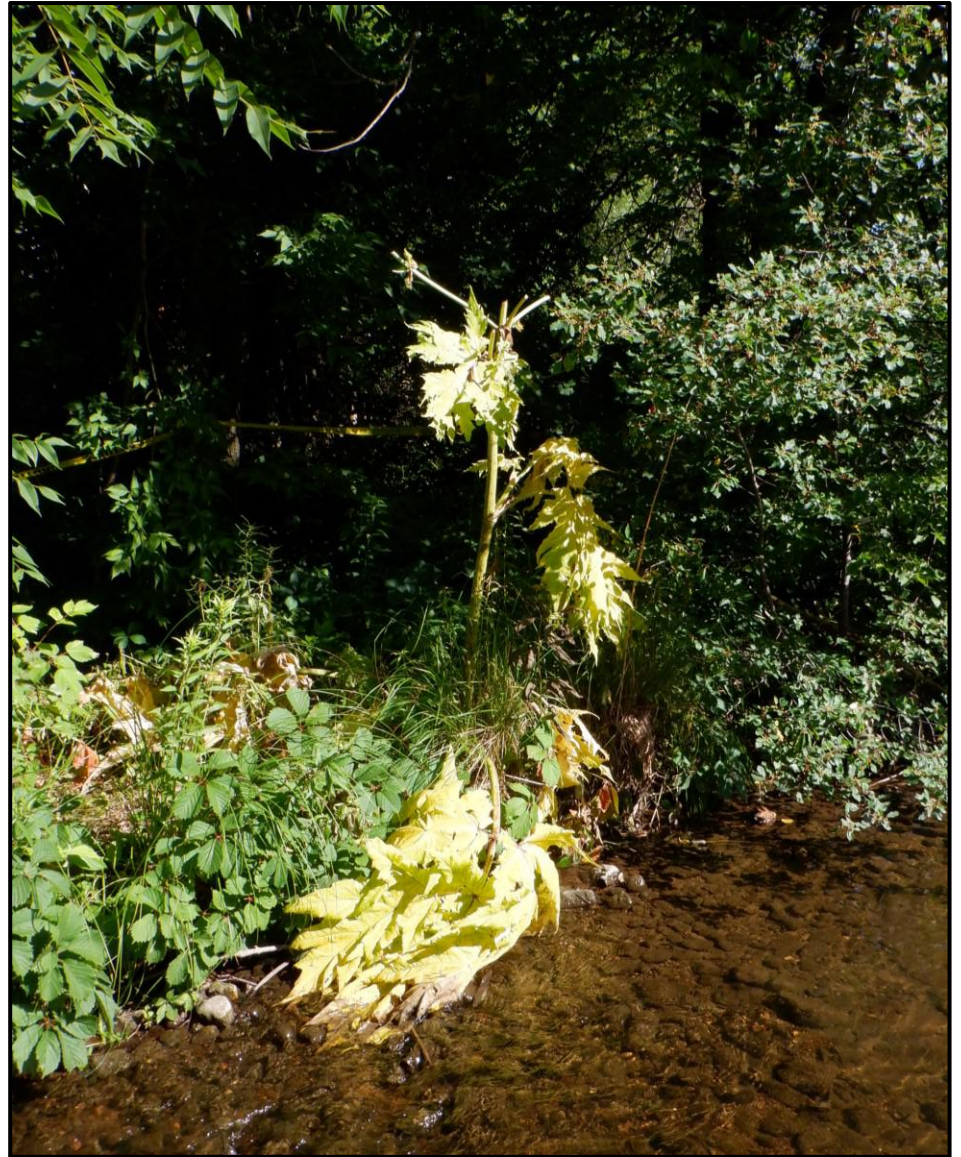
**Site ID: MI#12**

Potential Giant Hogweed spotted  
on bank

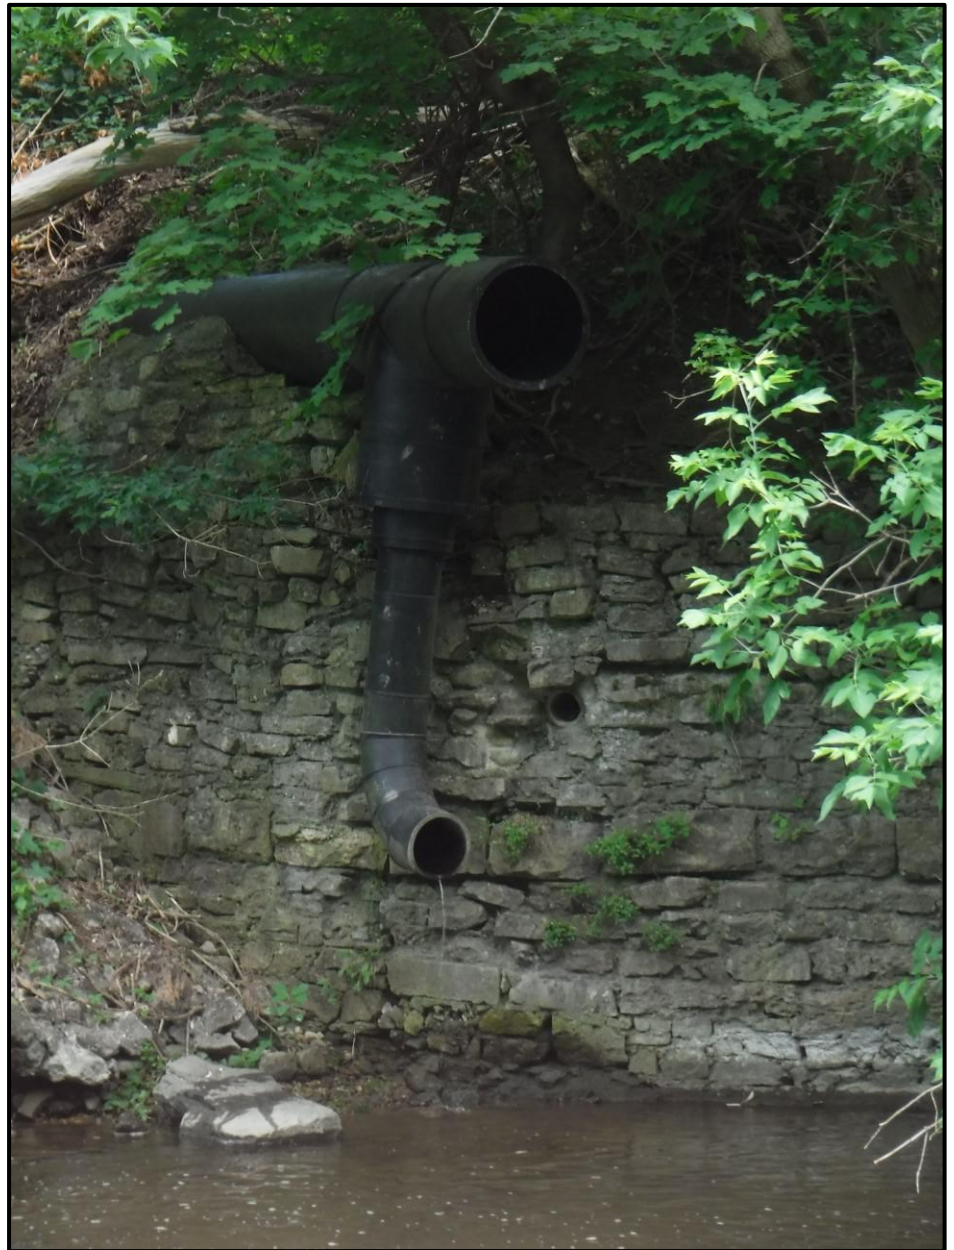
**Site ID: MI#13**

No headwall structures on outlet,  
outfall seems unstable

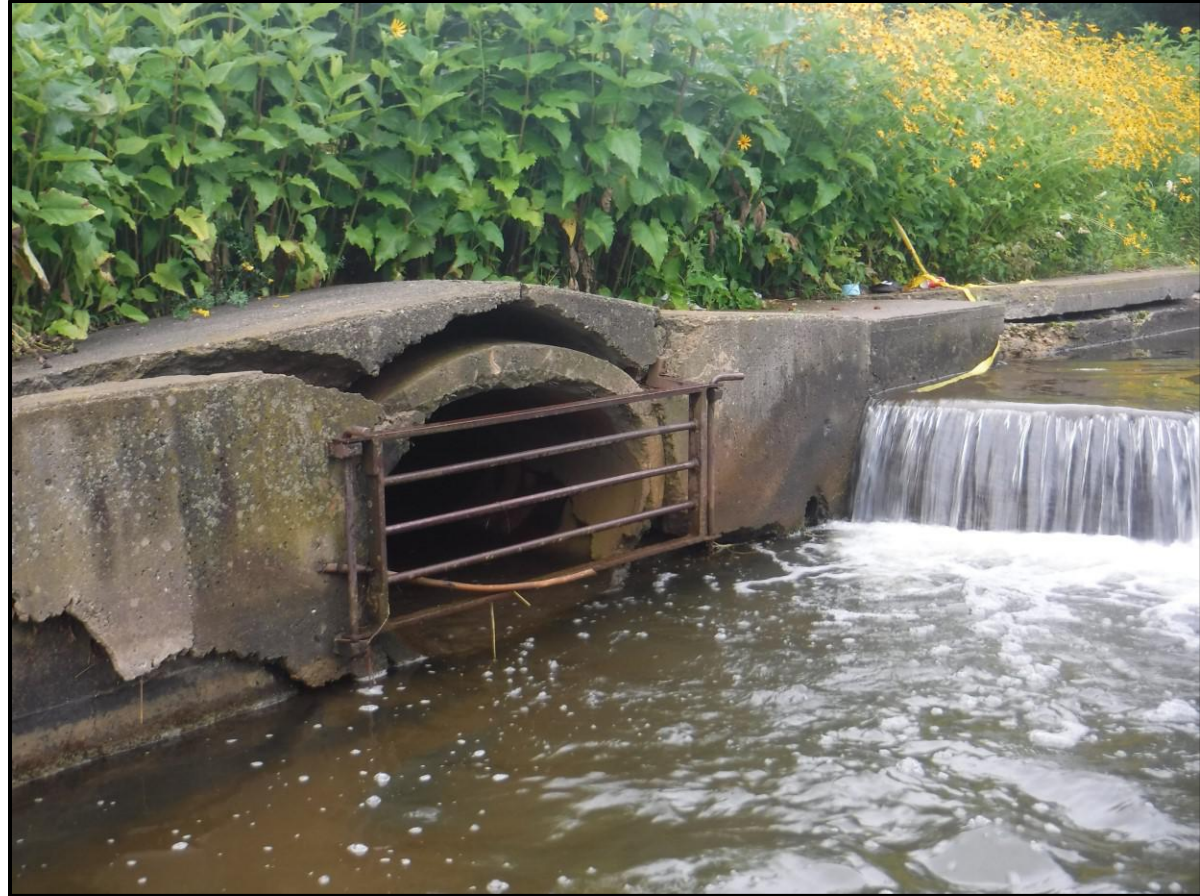
**Site ID: MI#14**

| No. | Watercourse | Reach | Description |
|---|---|---|--|
| MI#14 | Speed River | SR-11 | Headwall/retaining wall has heaved around outfall, cracked and in poor condition |

Headwall  
structure/retaining wall  
around outfall is cracked,  
breaking up, in general  
poor condition
