Biennial Bridge Inspection Report

Niska Road Over Speed River Bridge

No. 00001

August-29-12

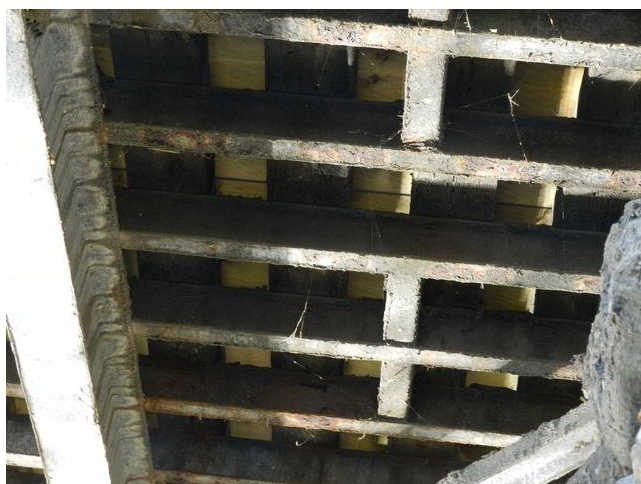
South End. Showing typical fair condition

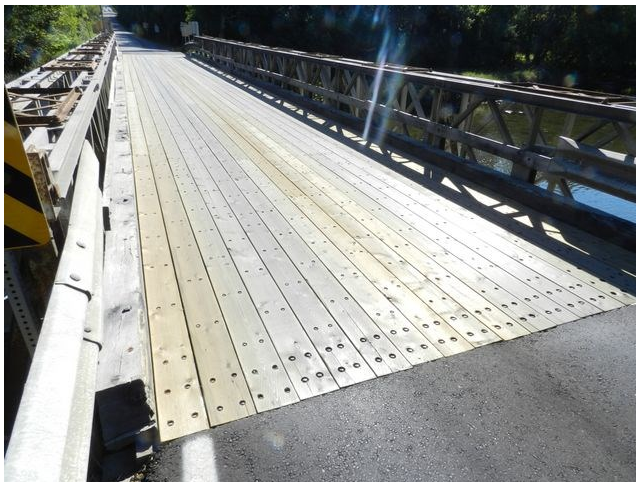
Overall Surface. Showing generally good condition

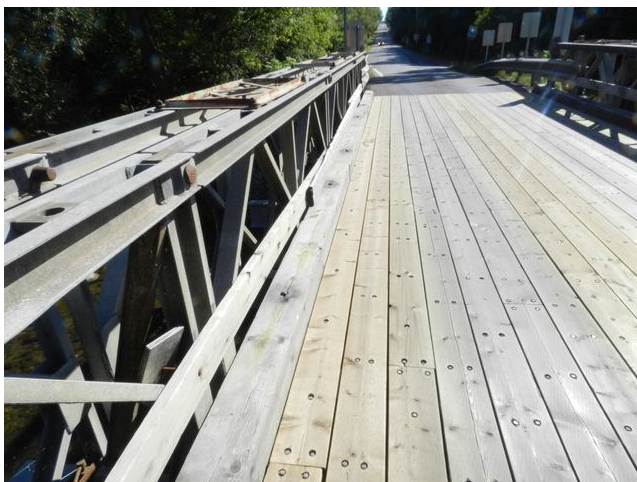
North Surface. Showing generally fair condition

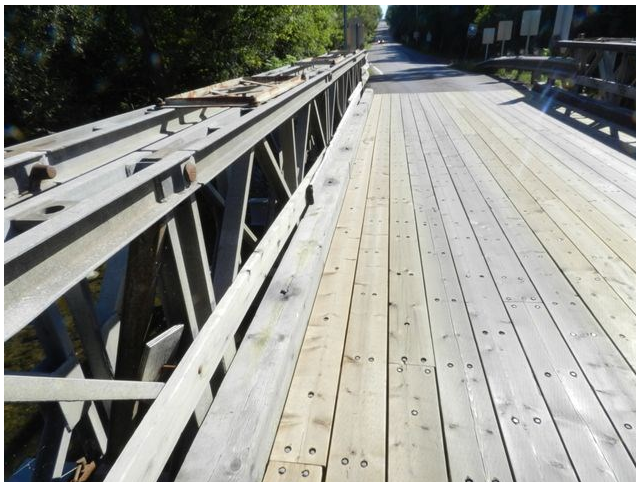
North Surface. Showing generally moderate corrosion

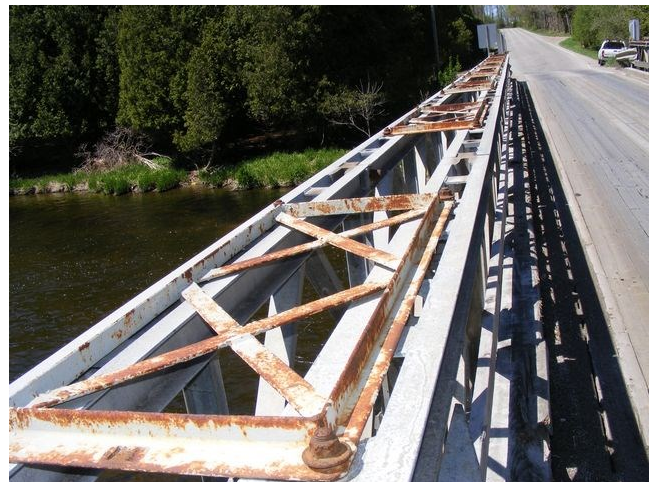
South Surface. Showing widespread medium corrosion

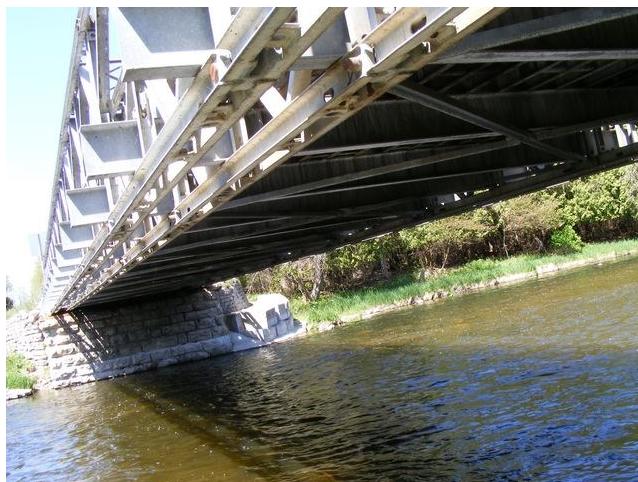
South Surface. Showing generally good condition

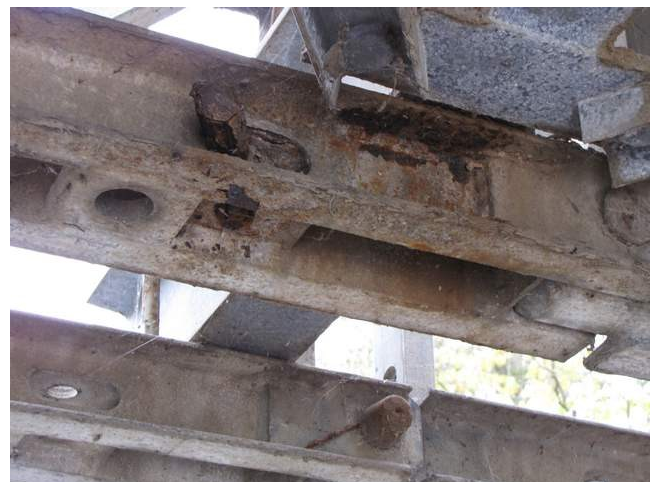
Underside View. Showing isolated severe corrosion.

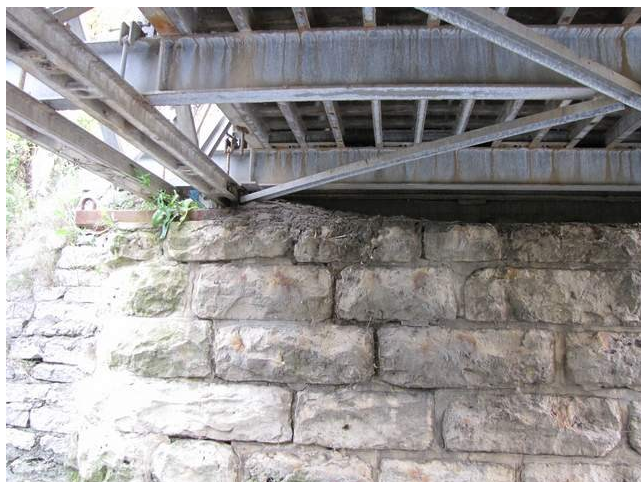
West End. Showing generally good condition

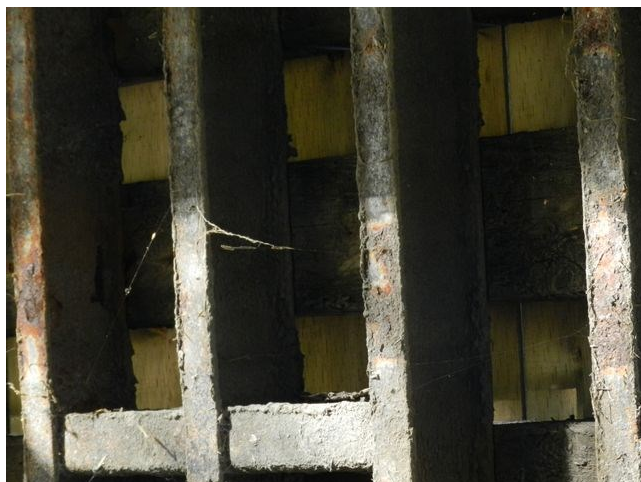
Underside Surface. Showing isolated medium corrosion.

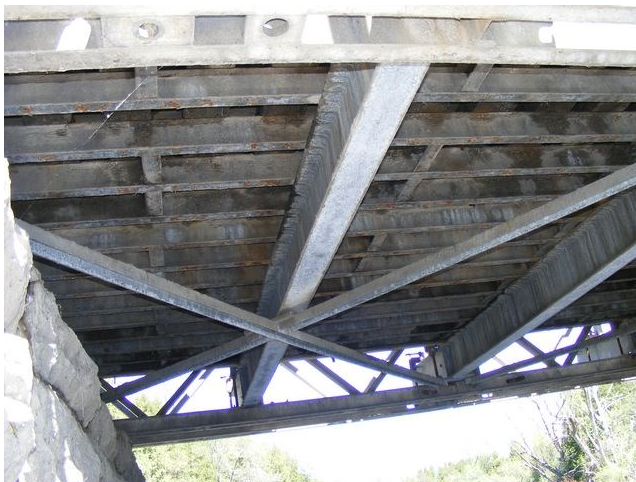
West End. Showing generally good condition

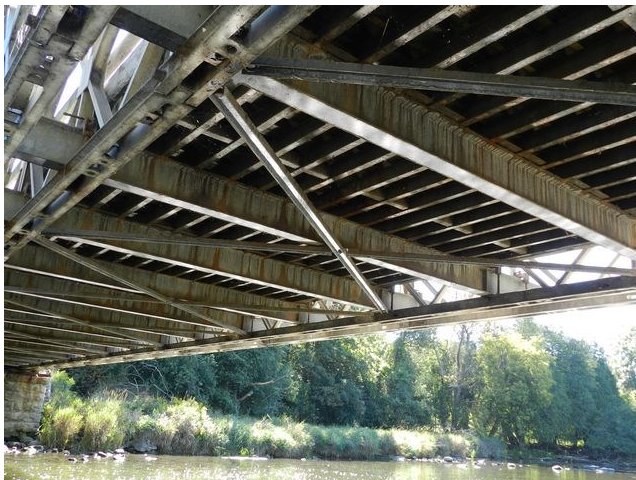
Underside Surface. Showing generally good condition

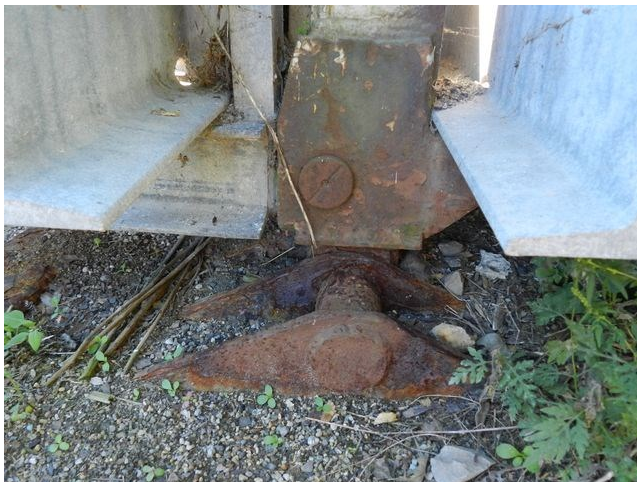
Overall View. Showing severe corrosion.

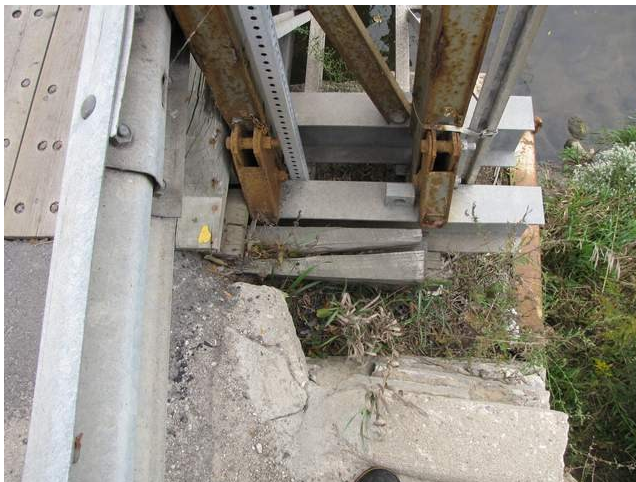
Side. Showing severe deterioration.

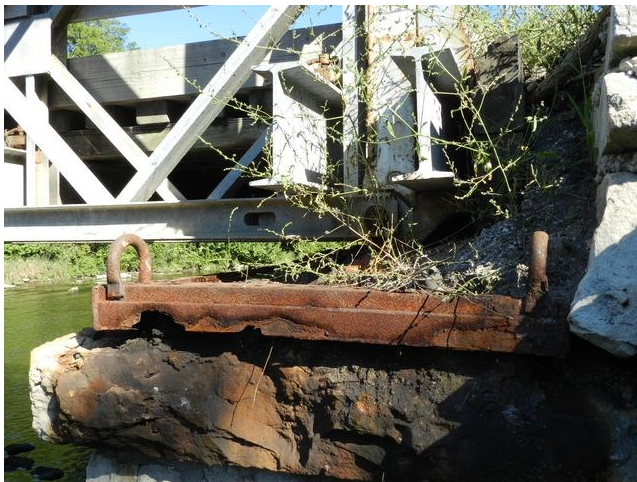
East Side. Showing severe corrosion.

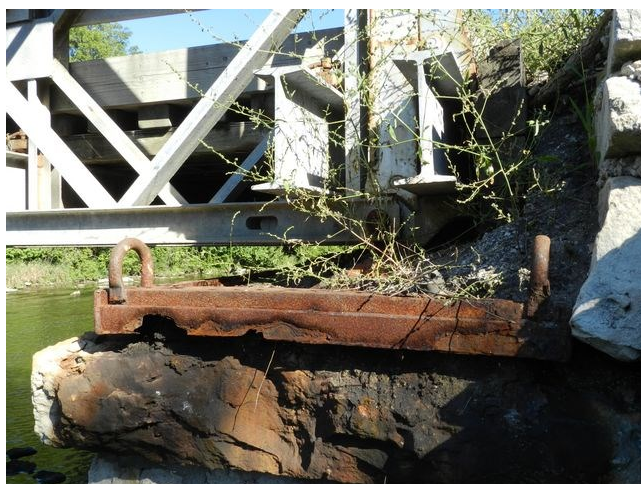
East Side. Showing poor condition.

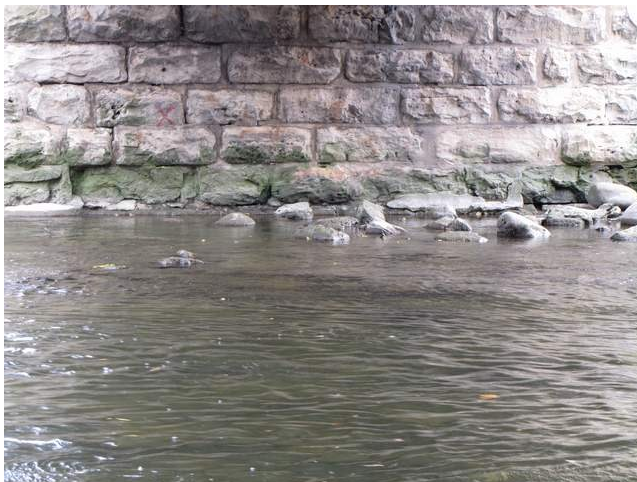
East Side. Showing isolated severe spalling.

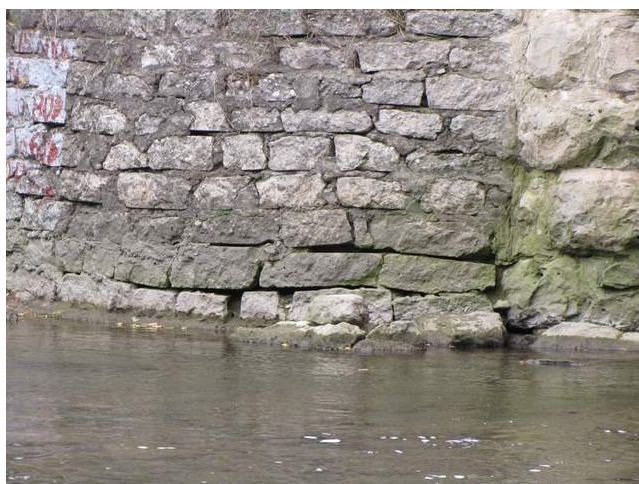
Side. Showing deterioration.
