Biennial Bridge Inspection Report

Niska Road Over Speed River Bridge

No. 00001

April 14, 2014

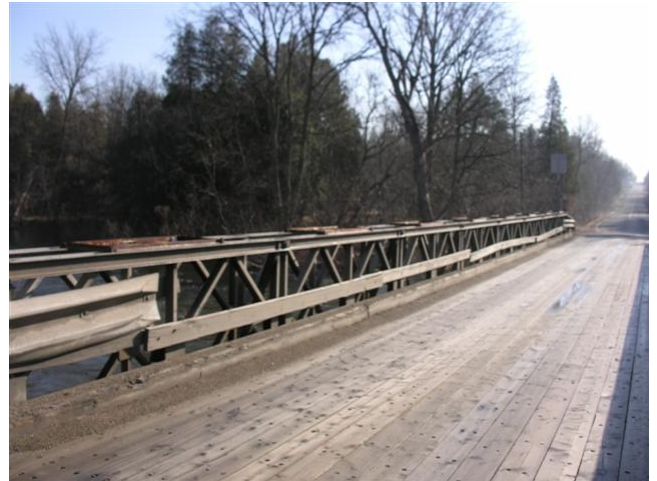
Top Surface. Showing isolated severe deterioration.

Recommended Work : [See Primary Element](#)

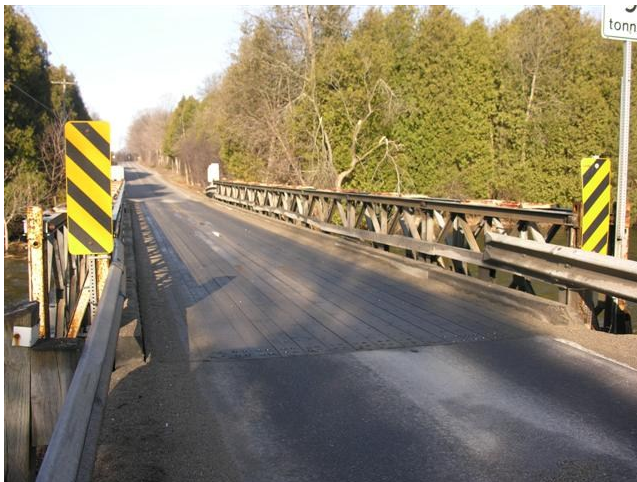
Overall Surface. Showing generally good condition

Recommended Work : Ancillary Replacement

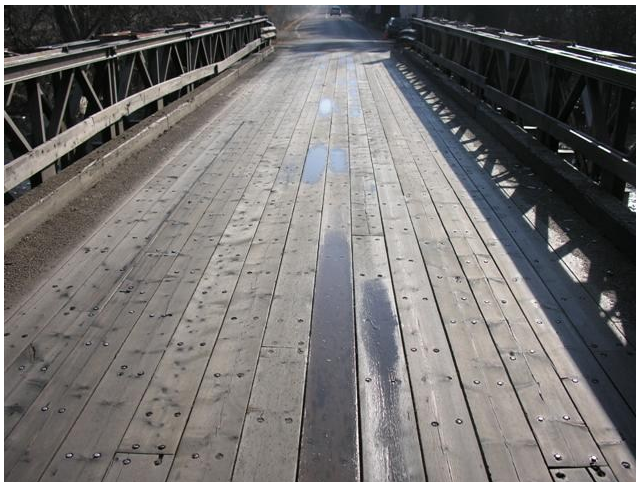
North Surface. Showing generally fair condition

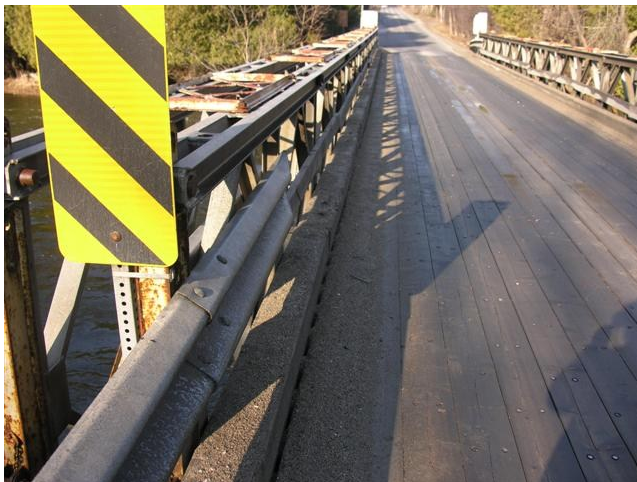
Overall View .

The timber barrier has an estimated mass of 0.2 tonnes. The element is structurally inadequate. Maintenance work is required immediately to extend the service life of the element. There is no estimated service life remaining in its current condition. The entire component will undergo ancillary replacement.

Recommended Work : Ancillary Replacement

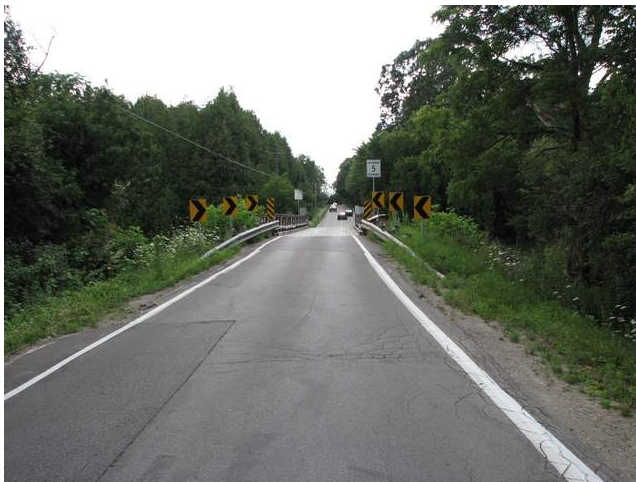
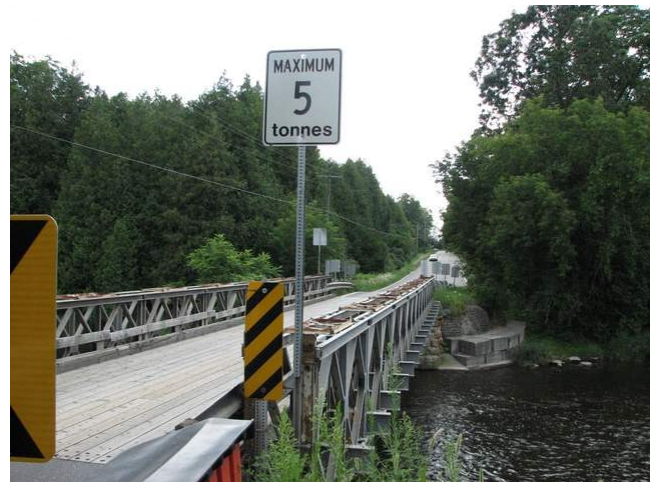
Overall View .

There are 6 aluminum signage. The element is structurally inadequate. Maintenance work is required to extend the service life of the element. The estimated remaining service life in its current condition is 1 year. The entire component will undergo ancillary replacement.

Recommended Work : Ancillary Replacement

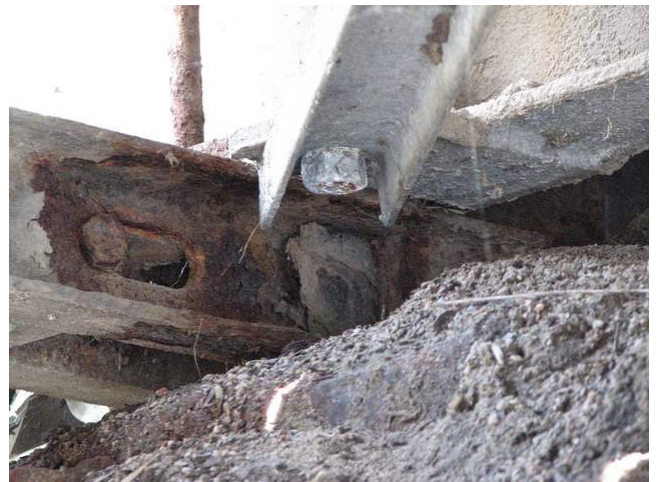
Underside Surface. Showing isolated severe corrosion.

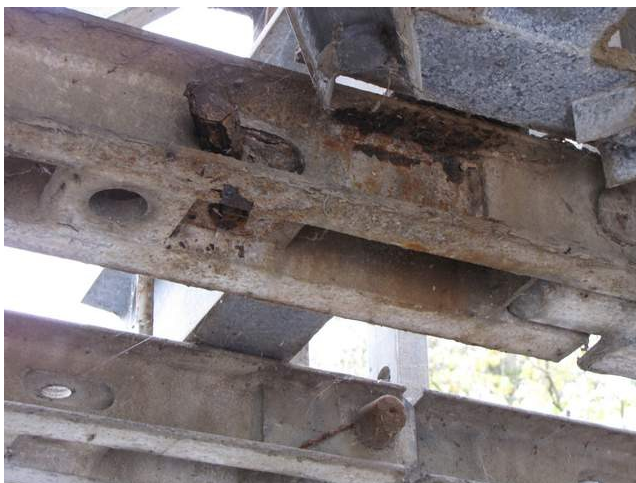
Underside View . Showing isolated severe corrosion.

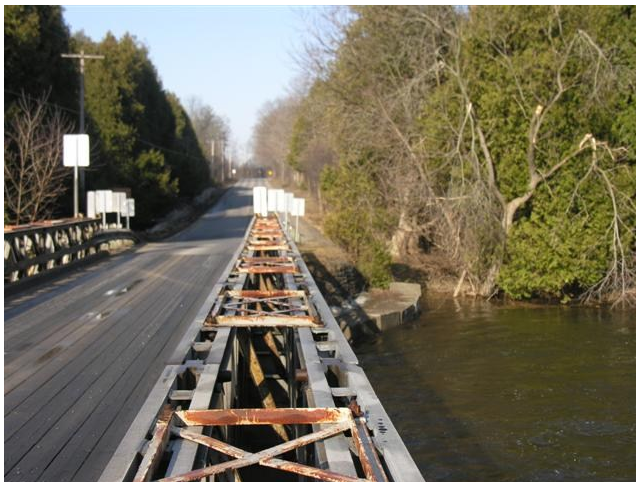
North Surface. Showing generally moderate corrosion

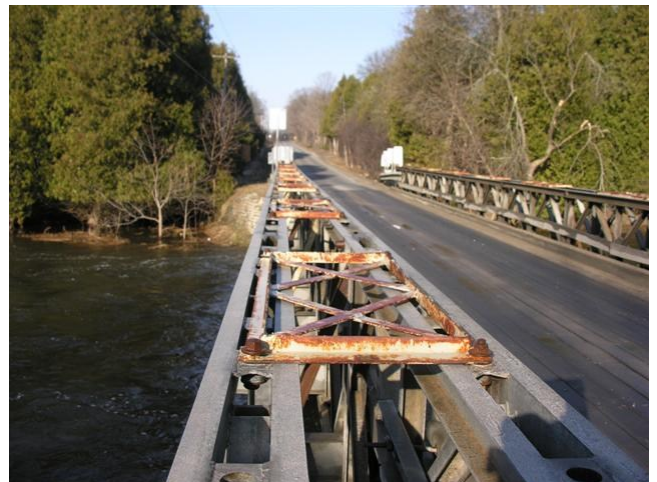
South Surface. Showing widespread medium corrosion

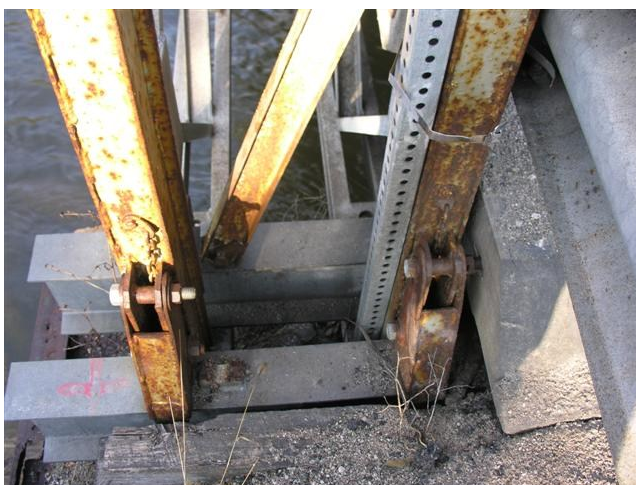
West End. Showing isolated severe corrosion.

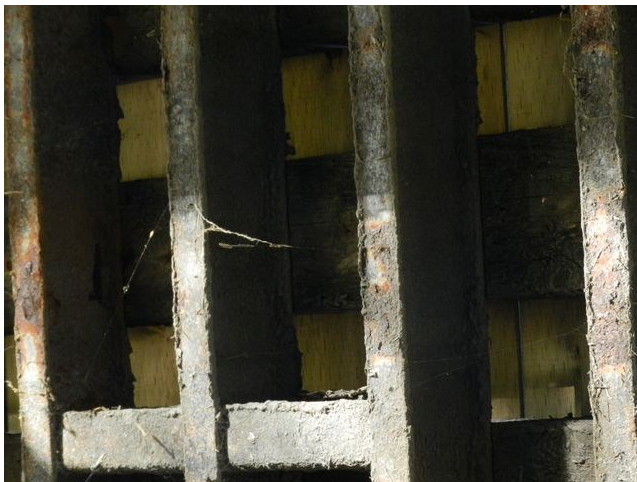
Underside Surface. Showing isolated medium corrosion.

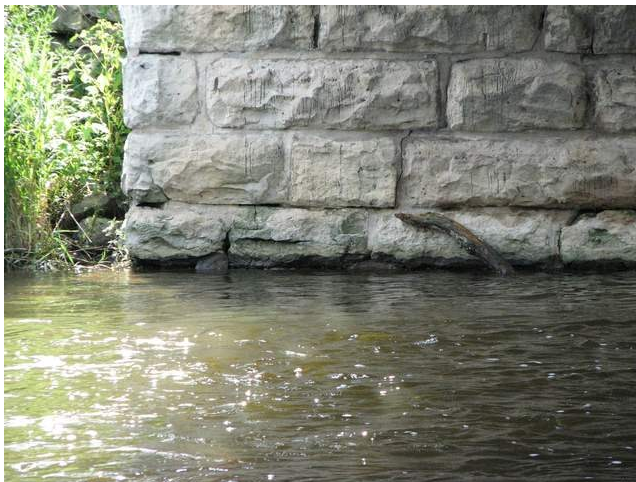
Bottom Surface. Showing isolated severe deterioration.

Recommended Work : Replacement

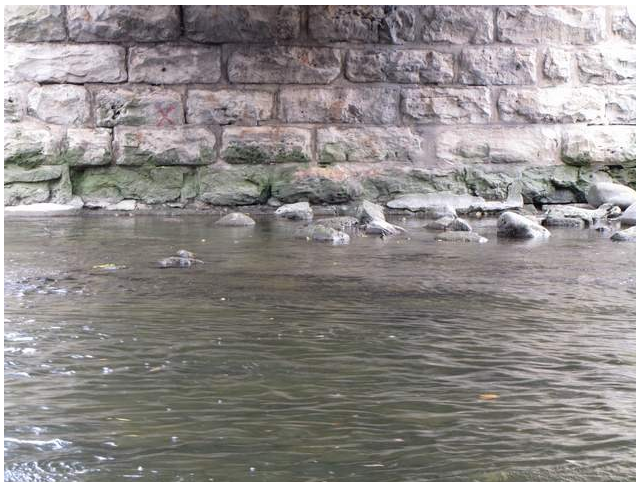
East Surface. Showing isolated severe deterioration.

Recommended Work : Replacement

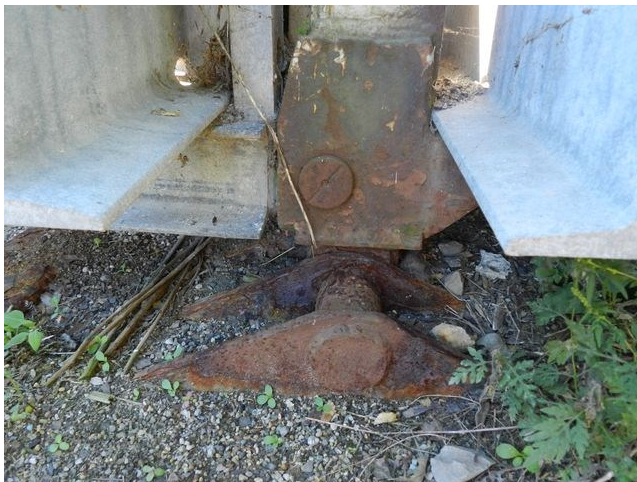
Overall View . Showing severe corrosion.

Recommended Work : Replacement

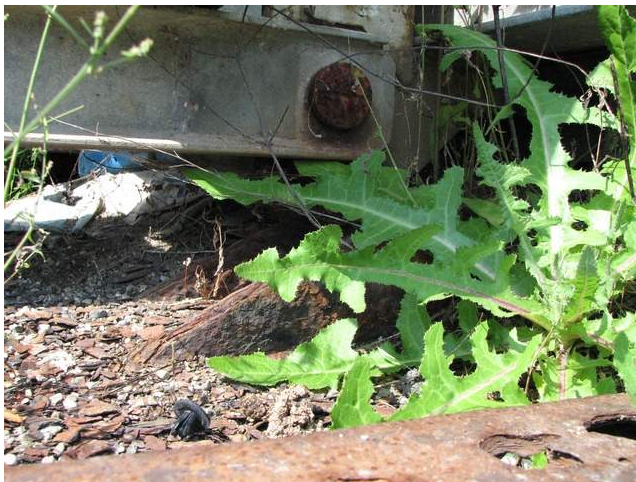
Bottom Surface. Showing extensive severe corrosion.

Recommended Work : Loaded Deep Repair

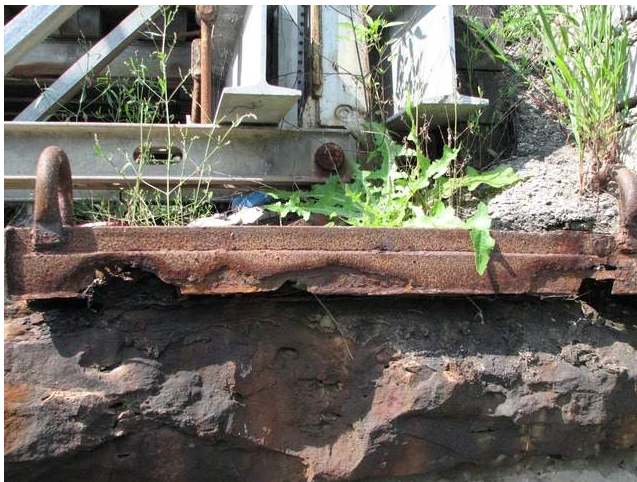
East Side. Showing poor condition.

Recommended Work : Loaded Deep Repair

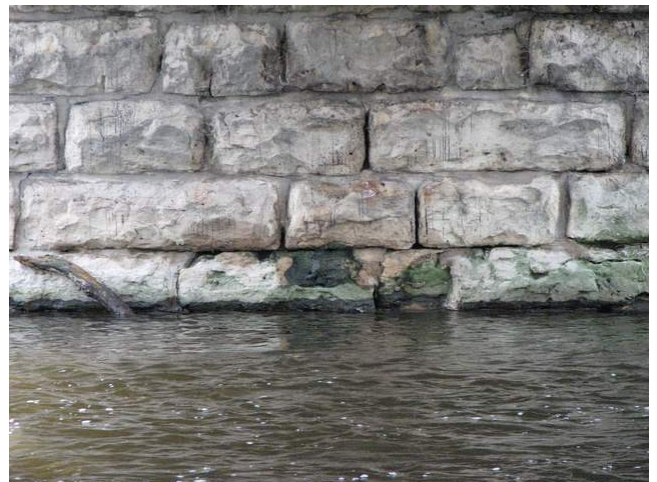
West Surface. Showing isolated severe deterioration.

Recommended Work : Replacement

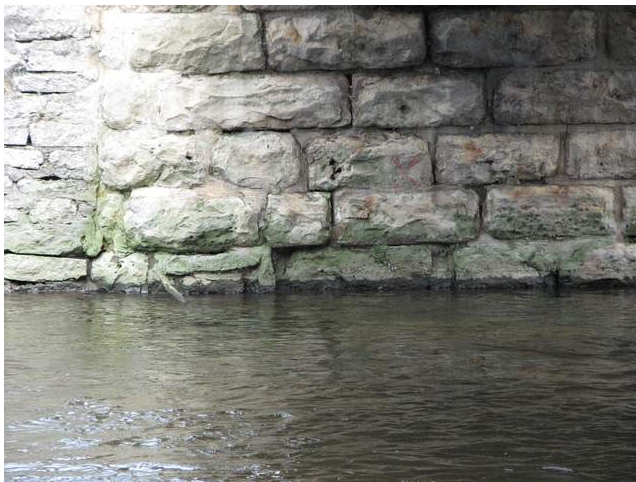
East Side. Showing isolated severe spalling.

Recommended Work : Replacement

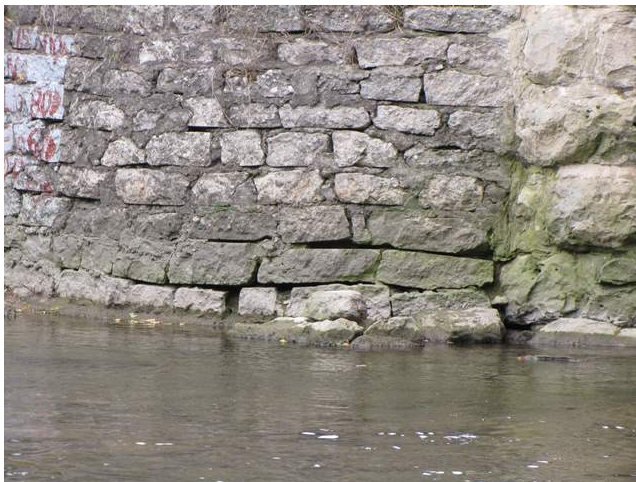
Side. Showing deterioration.

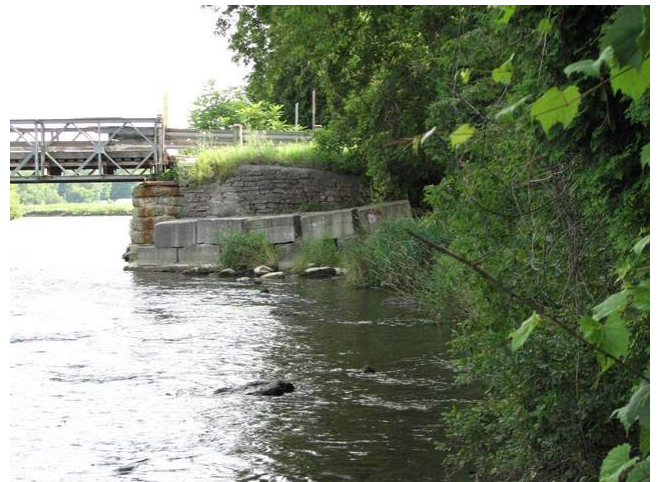
West Surface. Showing extensive severe deterioration.

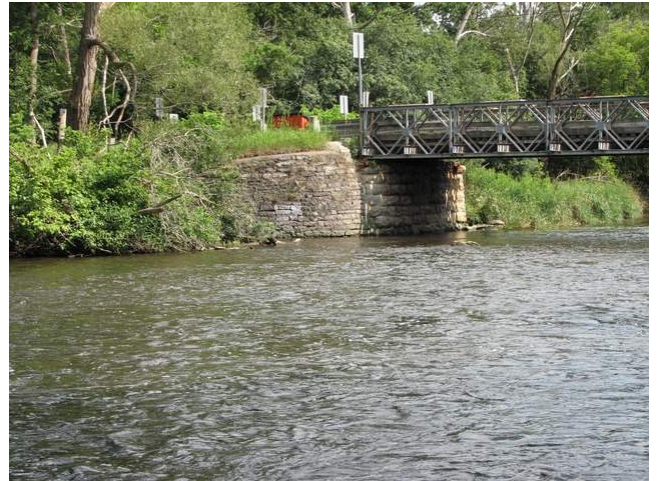
East Surface. Showing isolated severe failure.

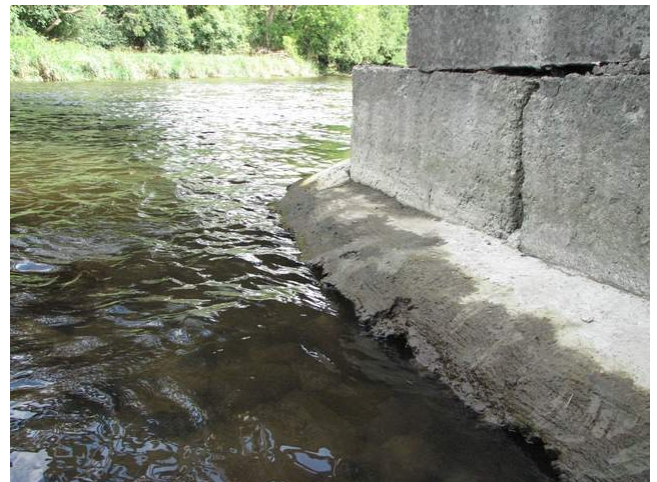
Northw est Side. Show ing deterioration.

Recommended Work :	Reinstallation							
							Urgent <input type="checkbox"/>

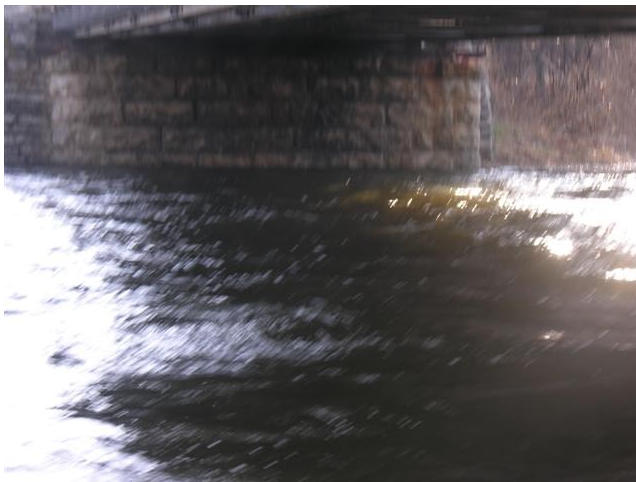
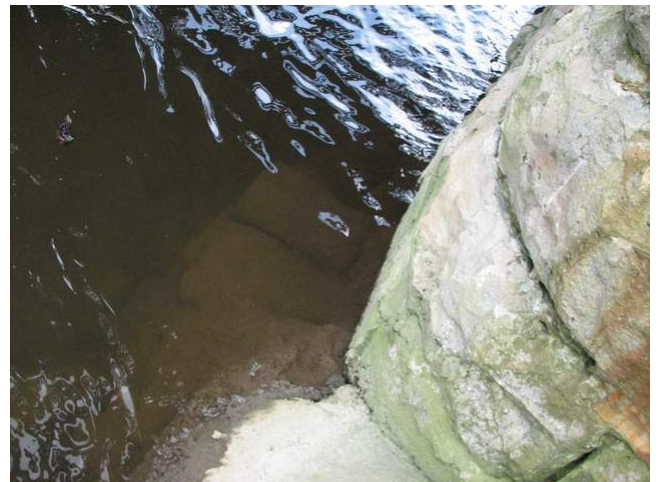
West End. Showing medium deterioration.
