City Of Guelph

Speed River Retaining Walls, North Of Speedvale Avenue Structural Condition Report

GMBP File: 118053

September 2018

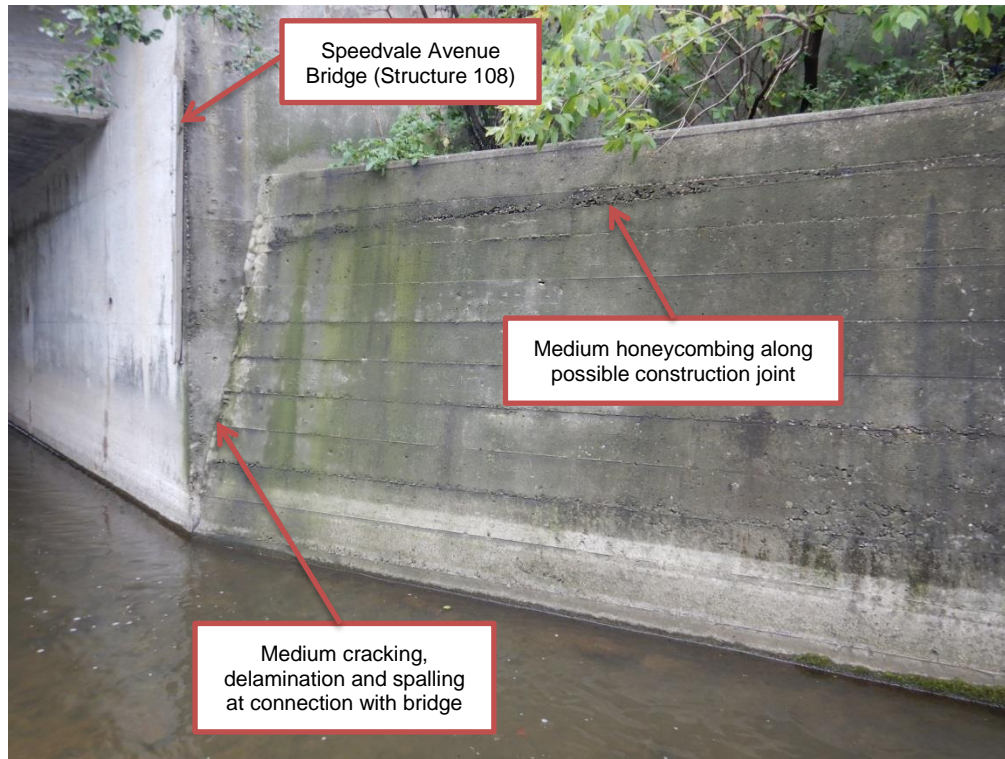
Photograph 3: Approximate Chainage 0+000

Chainage	Observations
0+000 to 0+050	Wall Height at 0+000: 2.95m Wall Height at 0+050: 2.55m
	Comments: Photo
	• Approximately 7 wide vertical cracks extending from river bottom to top of wall. 4
	• Medium cracking, delamination and spalling at connection with bridge. 3
	• Evidence of cold joint with isolated light to medium honeycombing. 3,4
0+050 to 0+100	Wall Height at 0+050: 2.55m Wall Height at 0+100: 2.05m
	Comments: Photo
	• Approximately 3 vertical cracks and 1 medium crack with efflorescence, all extending the full height of wall. 5
	• Isolated medium delamination and spalling. 6

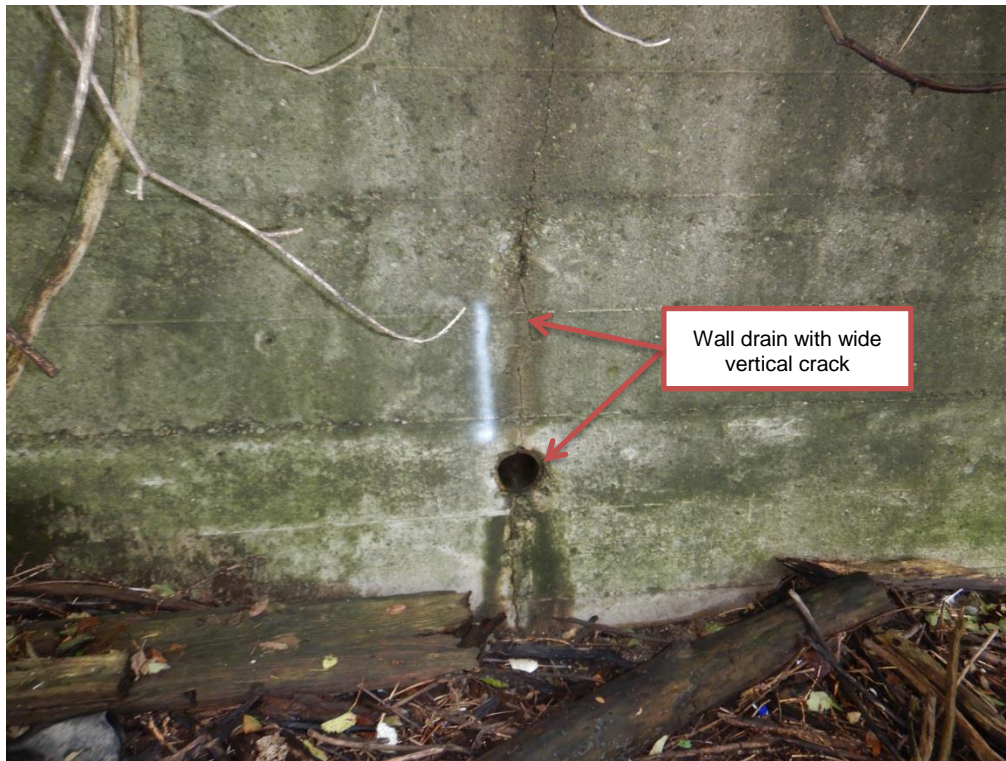
Photograph 7: Approximate Chainage 0+100

Chainage	Observations
0+100 to 0+150	<p>Wall Height at 0+100: 2.05m Wall Height at 0+150: 1.65m</p> <p>Comments: Photo</p> <ul style="list-style-type: none"> Approximately 3 wide vertical cracks and 2 narrow to medium vertical cracks with efflorescence, all extending the full height of wall. 7
0+150 to 0+200	<p>Wall Height at 0+150: 1.65m Wall Height at 0+200: 1.40m</p> <p>Comments: Photo</p> <ul style="list-style-type: none"> Approximately 2 wide vertical cracks and 3 narrow to medium cracks with efflorescence, all extending the full height of wall. 8 Severe delamination and spalling isolated around large stormwater (STM) outlet at chainage 0+160 8
0+200 to 0+250	<p>Wall Height at 0+200: 1.40m Wall Height at 0+250: 1.10m</p> <p>Comments: Photo</p> <ul style="list-style-type: none"> Approximately 3 narrow to medium vertical cracks with efflorescence, all extending the full height of wall. Severe delamination and spalling isolated around small STM outlet with exposed corroded rebar at approximately chainage 0+240. 9

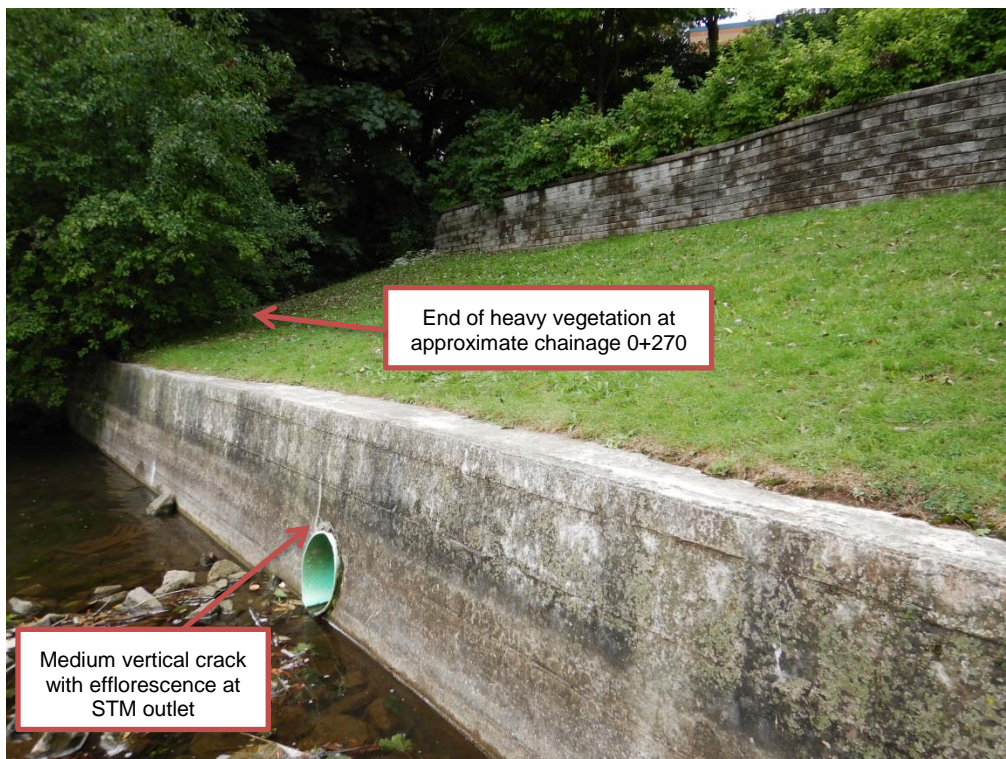
Photograph 10: Approximate Chainage 0+290

0+250 to 0+300	<p>Wall Height at 0+250: 1.10m Wall Height at 0+300: 1.10m</p> <p>Comments: Photo</p> <ul style="list-style-type: none"> Approximately 1 wide vertical crack and 3 narrow to medium vertical cracks with efflorescence, all extending the full height of wall. 10
0+300 to 0+350	<p>Wall Height at 0+300: 1.10m Wall Height at 0+350: 1.05m</p> <p>Comments: Photo</p> <ul style="list-style-type: none"> Approximately 3 wide vertical cracks and 5 narrow to medium vertical cracks with medium spalling and efflorescence. Cracks extend the full height of wall. 11

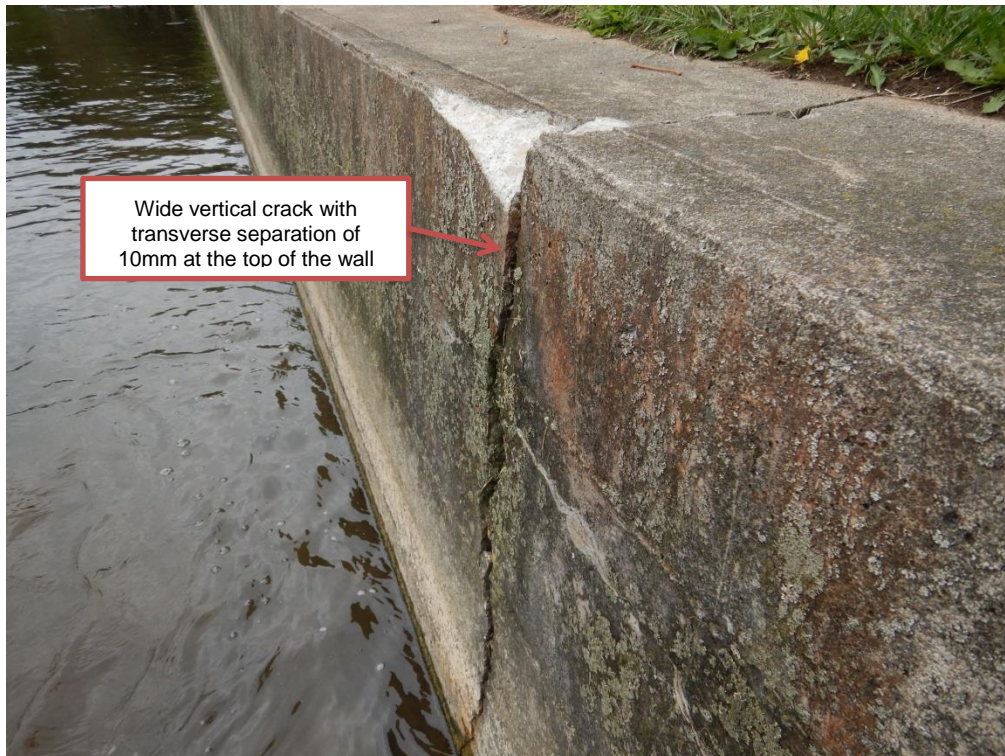
Photograph 12: Approximate Chainage 0+360

Chainage	Observations
0+350 to 0+400	Wall Height at 0+350: 1.05m
	Wall Height at 0+400: 1.05m
	Comments:
	Photo
	<ul style="list-style-type: none"> Approximately 7 wide vertical cracks with spalling and efflorescence, all extending the full height of wall..
	<ul style="list-style-type: none"> 2 wide vertical cracks with forward rotation of the wall on one side causing a 10mm separation measured at the top of the wall.
	<ul style="list-style-type: none"> Wide cracking, severe delamination and spalling around STM outlet.
	<ul style="list-style-type: none"> Anchorage of STM outlet grate to concrete has been compromised due to spalled concrete.
	12,15
	13,14
	13,14
	13
	17,18
	17

- Section 0+350 to 0+400 of the wall exhibits advanced deterioration in relation to the rest of the wall inspected.
- There are some wide vertical cracks resulting in rotation of the wall, indicating differential movement on either side of the crack.
- Oergrown trees and vegetation at the southern extents of the retaining wall from 0+000 to approximately 0+270.

We also recommend that the above noted deficiencies be repaired to preserve the remaining service life of the structure. These repairs should be completed within the next 5 years. Additionally, the vegetation impacting the current and future condition of the wall should be removed immediately and this area should be maintained annually to preserve the remaining service life. Consulting with the Grand River Conservation Authority (GRCA) would be required prior to proceeding with any of this work. **Table 2** includes a high-level cost estimate of repairs.
