MEMORANDUM

Re: Response to June 16, 2015 City Comments for 1511-1517 Gordon and 15 Lowes Road – OPA 1402/ZC1408 Tree Inventory and Management Report

Tree Inventory and Management Report
for
Proposed Commercial Development
1511 Gordon St, 1517 Gordon St, and 15 Lowes Road, Guelph

October 3, 2015
(Revised)

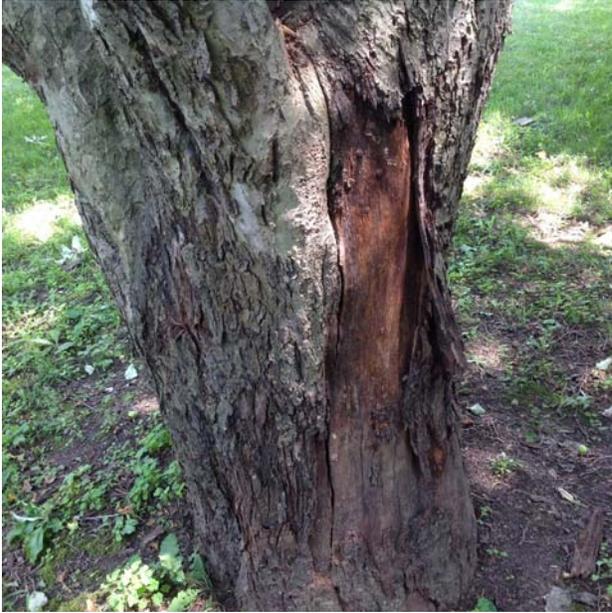
- iv. The two *Acer saccharum* (4,5) are not bylaw exempt, however compensation will not be sought due to their poor condition.
Agreed.
- v. The *Malus* species is not exempt from the Tree Bylaw as the hazard condition is being created as part of the development.
The *Malus* species was determined to be exempt from compensation as it is a fruit tree according to Section 4h of the Tree Bylaw. This detail, coupled with the existence of large, hanging branches which will likely require significant maintenance pruning for general safety in the near future, was the rationale for bylaw exemption. See attached photos (Figures 1 and 2) for reference.

Figure 1. *Malus* spp. bark shedding

The majority of trees to be retained are in good health, but some would nonetheless benefit from corrective pruning. A cedar hedge along the back of 15 Lowes Road, though not of tree caliper size, is in good health and aesthetically useful, and could benefit from pruning of lower dead branches (see LP-1). Likewise, a portion of the cedar hedge on the 1517 Gordon St property along the Lowes Rd. frontage can be retained, and dead branches should be pruned accordingly (see Recommendation & Rationale, Appendix 1). If the owners of 70 and 72 Revell Drive agree, approximately 6 dead or ailing spruce trees on those properties abutting 15 Lowes Rd. should be removed or pruned for safety reasons. As mentioned previously, the *Malus* species should be removed due to hazardous branching.

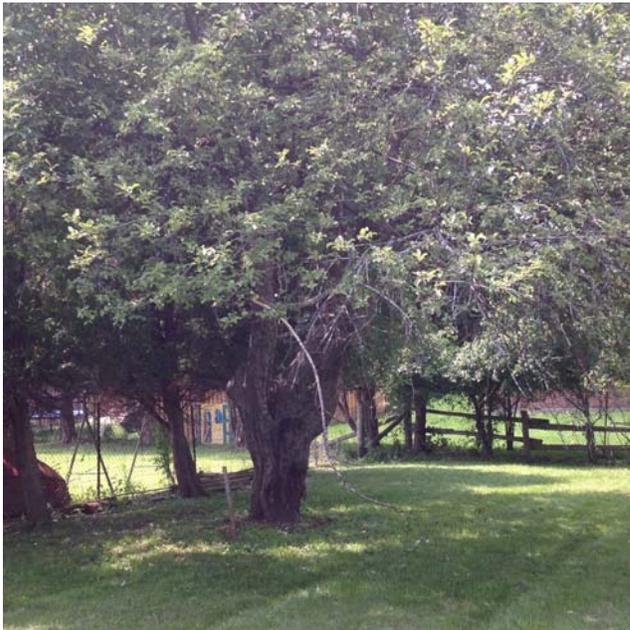
Figure 2. *Malus* spp. Top-heavy branching and co-dominant limbs
