Building Condition Assessment and Preventative Maintenance Plan

Victoria Road Community Complex Guelph, Ontario July 2005

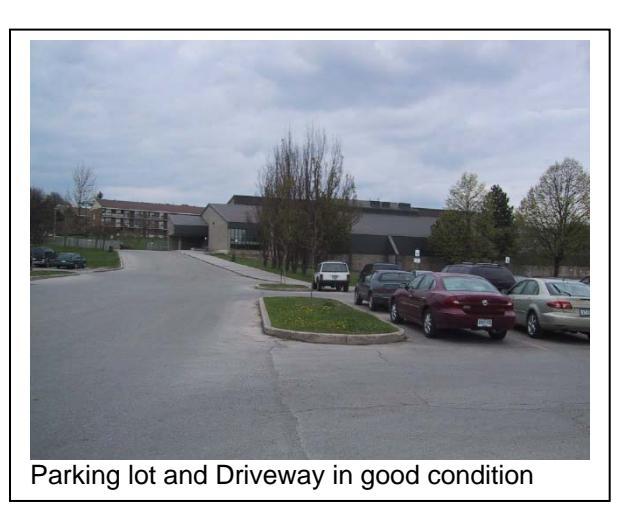
There are asphalt driveways and parking lots. The large lower parking lots between the building and Victoria Road were gravel parking lots at the time of construction in 1975. The sloped road way from the lower parking lot and the entrance out to Hadati Road was paved from the time of original construction. At some time all of the driveways and parking lots were resurfaced with asphalt. Maintenance records that the asphalt was most recently resurfaced in 1998. The asphalt is in good condition, there are a few cracks but no potholes or broken

asphalt. There are concrete curbs at the sloped driveway up from the lower parking lots, the exit out to Hadati Road and at several islands in the lower parking lot. The asphalt should last for a normal life expectancy of 20 years. The concrete curbs appear to be original to the 1975 construction. The concrete does not appear to have settled or broken. The surface scarring on the concrete is likely due to snowploughing. Recommend planning for repairs to 20% of the curbs the next time the asphalt needs to be resurfaced.

Replace asphalt

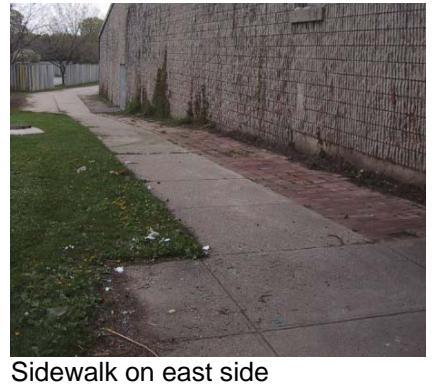
Sidewalk on east sid in good condition

Replace concrete sidewalks

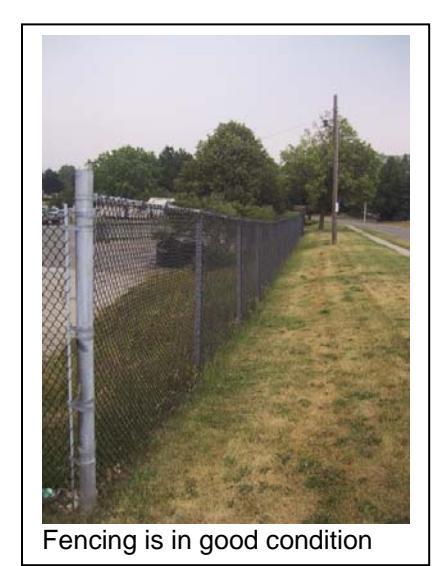
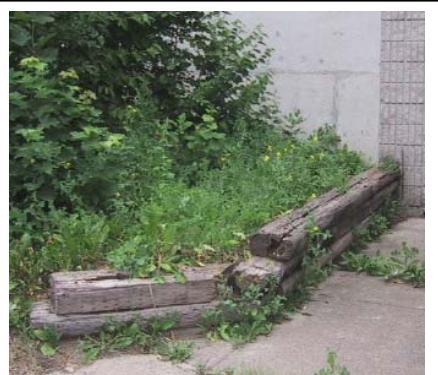
There is a small wood retaining wall at the northwest corner of the arena and at the exit stairs on the east side of the arena. The retaining wall at the northwest corner is constructed of creosote timbers; it needs to be replaced soon. The retaining wall supporting the stairs at the east arena exit is of pressure treated wood and it is in good condition and should last another ten years.

Small retaining wall northwest corner in poor condition

Replace Creosote retain	ning wall northwest corner
Quantity Estimate:	4 m2
Unit Cost Estimate:	\$300 /m2
Cost Estimate:	\$1,200

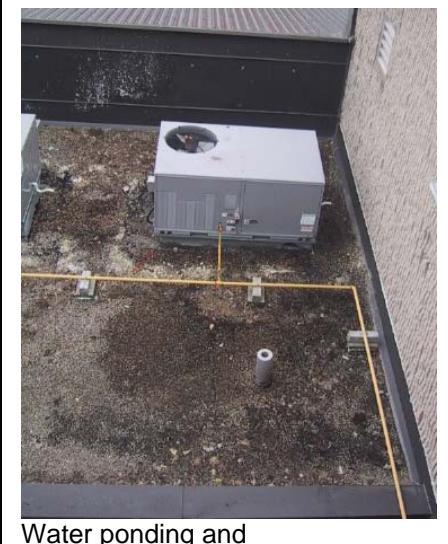
The roof system for this building has had problems from shortly after construction. The original building had a 4 ply built-up roof over the small section east and west of the mechanical rooftop penthouse. The roof over the pool and the ice rink were originally prefinished steel. There were problems with leaks at many of the roof penetrations. There were leaks at the mitered cut edges where the steel panel on the roof met the steel panel on the side wall. There were problems with the bolts securing the panels backing out of the purlins below. There were condensation problems on the underside of the arena roof. In 1987 a second roof was constructed over the original steel roof above the arena. On the arena side rigid insulation was laid on top of the original steel roof, a plywood deck was installed over the insulation and a 2 ply modified bitumen was place on the deck. The modified bitumen

deterioration of 4 ply roof

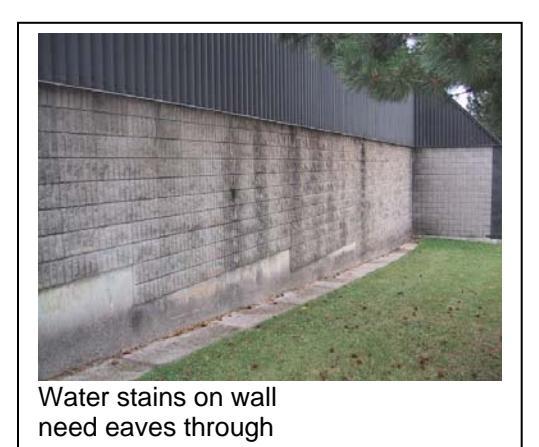
The only spots where eaves troughing currently exist are at the front entrance and at the northwest corner of the arena. Several of the previous reports provided by staff indicate that eaves troughing is required to prevent the deterioration of the concrete block. There are several areas on the building where there is severe damage to the concrete block and it is attributable to water draining from the roof. Eave troughing should be installed but consideration should be given to the attachment of the eaves trough and the gauge of the metal used and the size of the trough. This is a large roof and in a heavy down pour large

volume of water will run off the roof in a short period. The water will likely reach high velocity given the long expanse and steep slope. This over shooting is evident at the inside corners where the adjacent wall is water marked in an arc several feet out from the edge of the roof. Also a snow or ice slide on this metal roof would easily wipe conventional eaves troughing off the edge of the roof. Snow guards should be installed along the lower edge of the steel roof to prevent large snow and ice slides and they should be installed to slow the velocity of the roof water at the edge of the roof. The

down spouts on the two existing eaves troughs should be repaired to direct water away from the building.

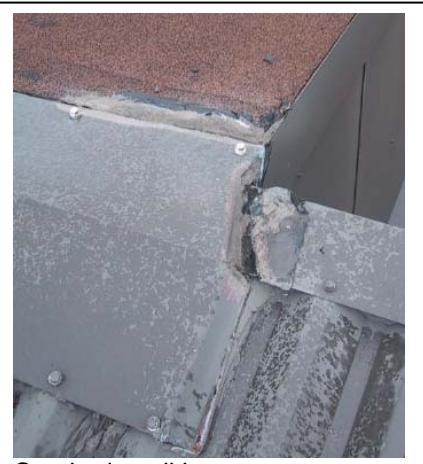
Cracked caulking at roof/flashing joint

<u>Re-caulk building</u> Quantity Estimate: Unit Cost Estimate: Cost Estimate: Life Span Analysis:

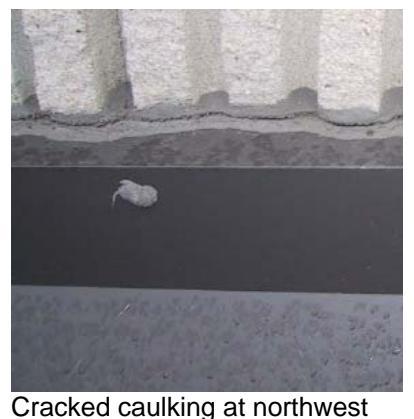
Cracked caulking at northwest Corner over 2 ply roof

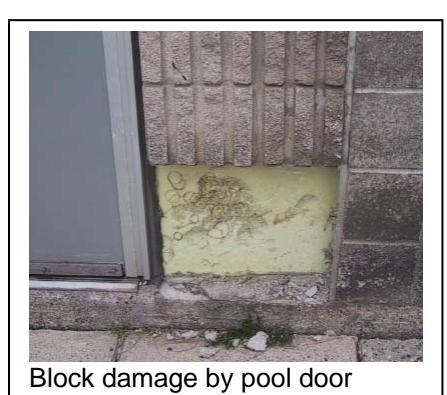
The exterior walls are fluted concrete block. The block is generally in good condition with the exception of places where water damage from the roof has caused the block to be repeatedly wetted. The worst section of the wall is the lowest three courses of block along the south side of the teaching pool and the pool mechanical rooms. There is the largest amount of the water run off at this point and there is no eave trough so the water runs off the roof and hits the paved ground and the back splash thoroughly wets the

lowest courses of block. Other areas of damage include inside corners where water over shooting the roof wets the adjacent sidewall such as the inside corner by the chlorination room and the edged of the roof by the canopy at the east stairwell. There is also damage at selected spots along the south wall. This usually occurs where there is a minor flaw in the flashing at the bottom edge of the steel siding. This flaw tends to concentrate the water draining down the siding at specific points. There are two sections of

Lowest course of block at teaching pool

eaves trough on the building; at the front entrance and at the northwest corner of the building however in both cases the downspouts do not effectively carry the water away from the building and damage has occurred to the block. The block along the edge of the teaching pool and some of the other locations must be replaced; most of the other damage could be halted if eaves troughs and downspouts were installed. As indicated above in the roofing section some care should be given to the design and installation of the eaves trough to ensure it is sized properly and well attached.

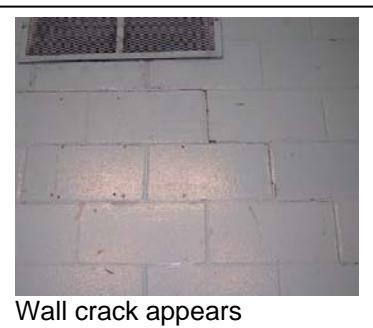
Wall crack appears unchanged from 1998 report Note: The Simon-Carver-Fenco report from 1998 make reference to some wall cracks in the concrete block in dressing room 4. Based on the photos in that report it does not appear that there has been any further movement of these cracks.

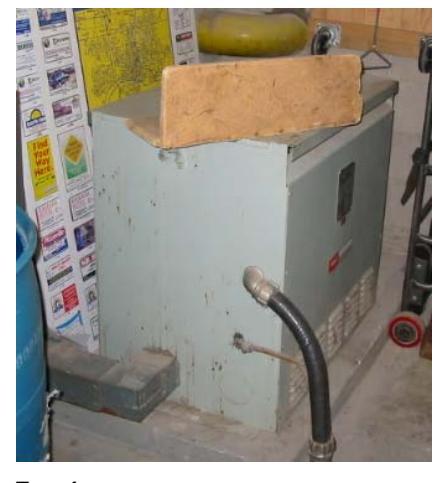
It is important to ensure transformers are properly ventilated. Transformer over heating can dramatically shorten their service lives.
