9 Valley Road, 1242, 1250, 1260, and 1270 Gordon Street, Guelph

Tree Preservation Plan

Project No. 2347A | September 2021

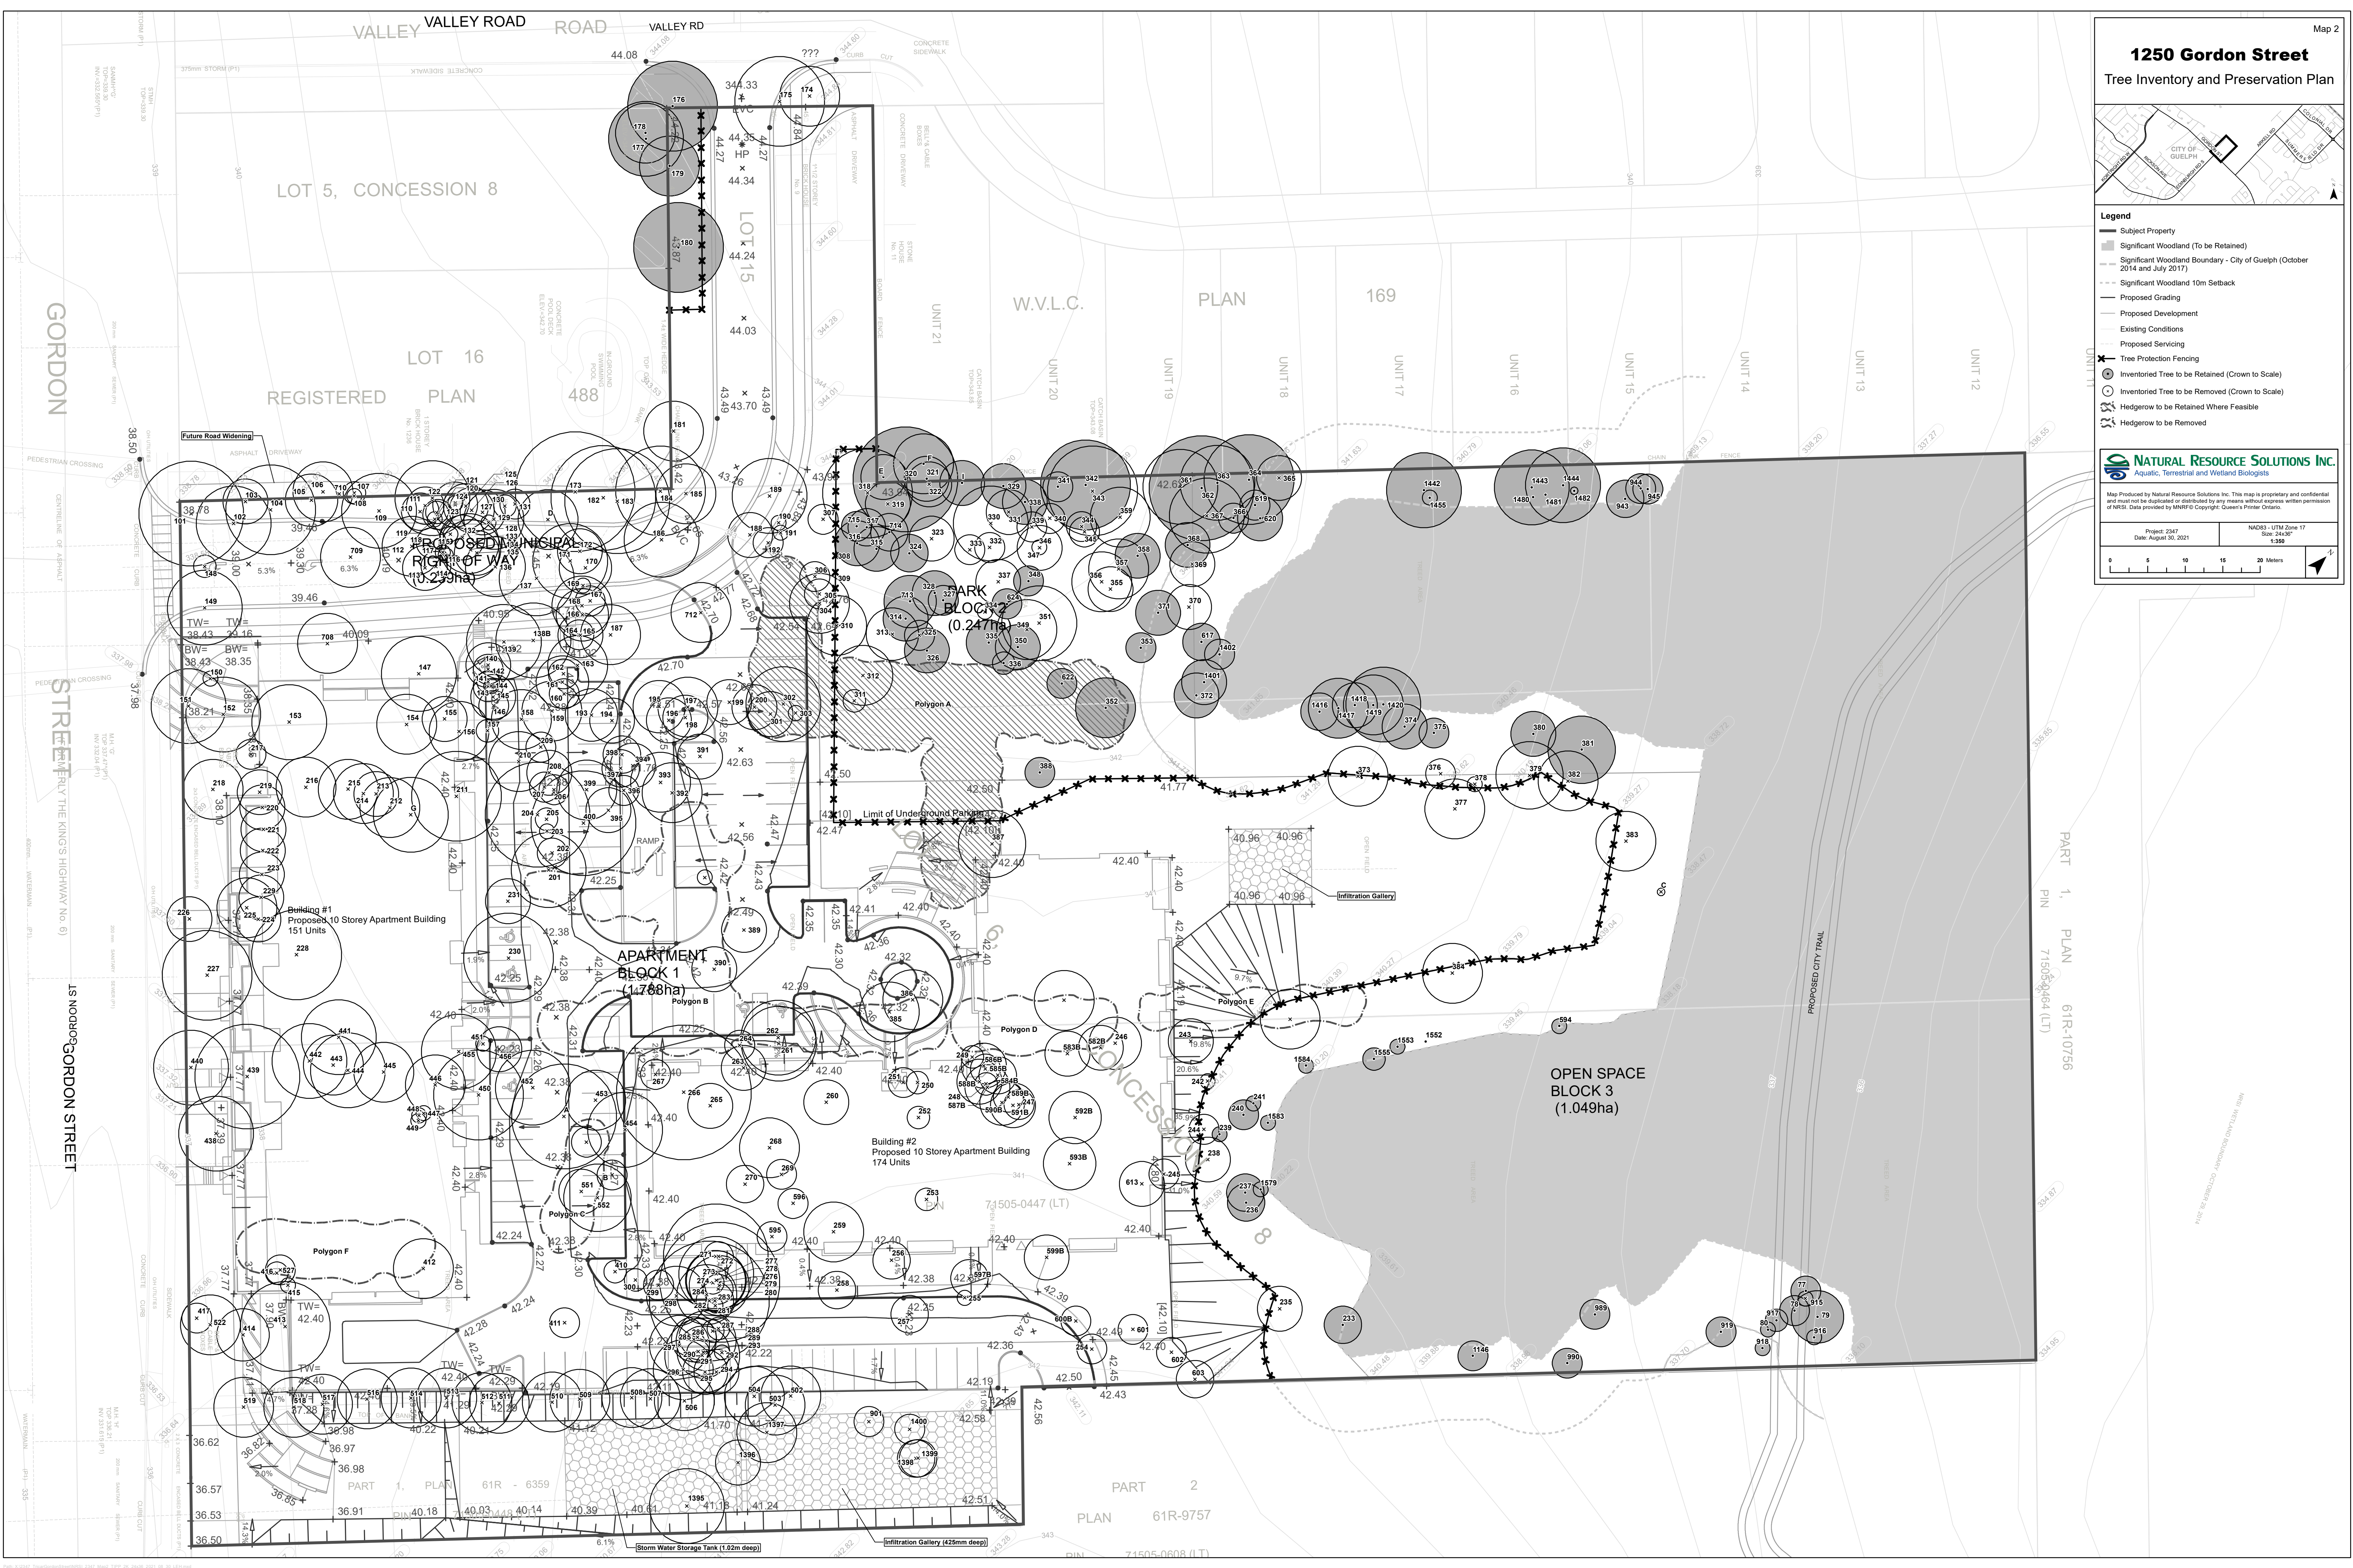
1250 Gordon Street
Tree Inventory and Preservation Plan

In total, 714 trees were inventoried, comprising 39 species. Of the trees inventoried and assessed, 482 (67.5%) are native species and 232 (32.5%) are non-native. Several Eastern White Cedar (*Thuja occidentalis*) hedgerows are present, as well as a hedgerow each of Freeman's Maple (*Acer X freemanii*) and Norway Spruce (*Picea abies*). These trees were inventoried as groups (Polygon A-F) due to the similarity of species, location, age and conditions. A complete list of trees inventoried is provided in Appendix I, with summarizing tables in Appendix IV. Tree locations within and adjacent to the subject property are shown on Map 2.

Of the 714 trees inventoried, 583 are anticipated to be removed (compared to 606 on the previous submission). An additional 41 Eastern White Cedars are present in Polygon A that will be retained where they occur within the protected park block (Map 2). These trees will be inventoried individually and assessed as part of the Detailed Design of this area, through further correspondence with the City of Guelph. This includes trees situated along the grading limit or in close proximity that may incur root damage as a result of grading. Most of these trees are in fair health with an improbable potential for structural failure, and range in size from 10cm DBH to 105cm DBH.

Temporary tree protection fencing (TPF) will be situated where trees are adjacent to the limit of disturbance/grading as shown on Map 2. The temporary TPF will be installed and maintained by the Developer. Prior to any construction activities (rough grading, vegetation and tree removal), the TPF will be installed at the limit of development. Prior to works commencing on-site, fence installation and location is to be inspected by a Certified Arborist and/or the on-site Environmental Inspector. Signage indicating the purpose of protection fencing will be attached to the paige-wire fencing every 100-150m. Recommended fencing locations are along the property edge, as shown on Map 2.
