**VEGETATION INVENTORY REPORT**

GSP File No.: 22139A

14 April 2023

RE: 14 Stevenson Street N, Guelph, Arborist Services

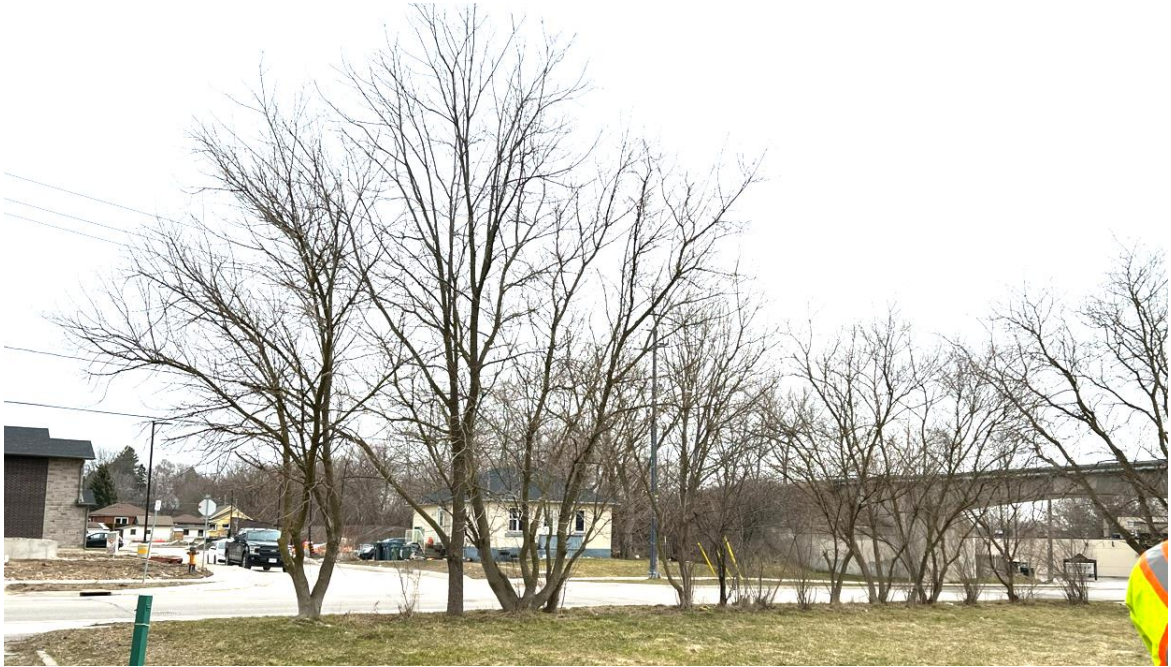
**Trees 2-14**, White Cedars, Black Walnuts and Manitoba Maples, were located along the front yard of the site. These trees will be removed due to construction.

Trees along front yard of site to be removed.

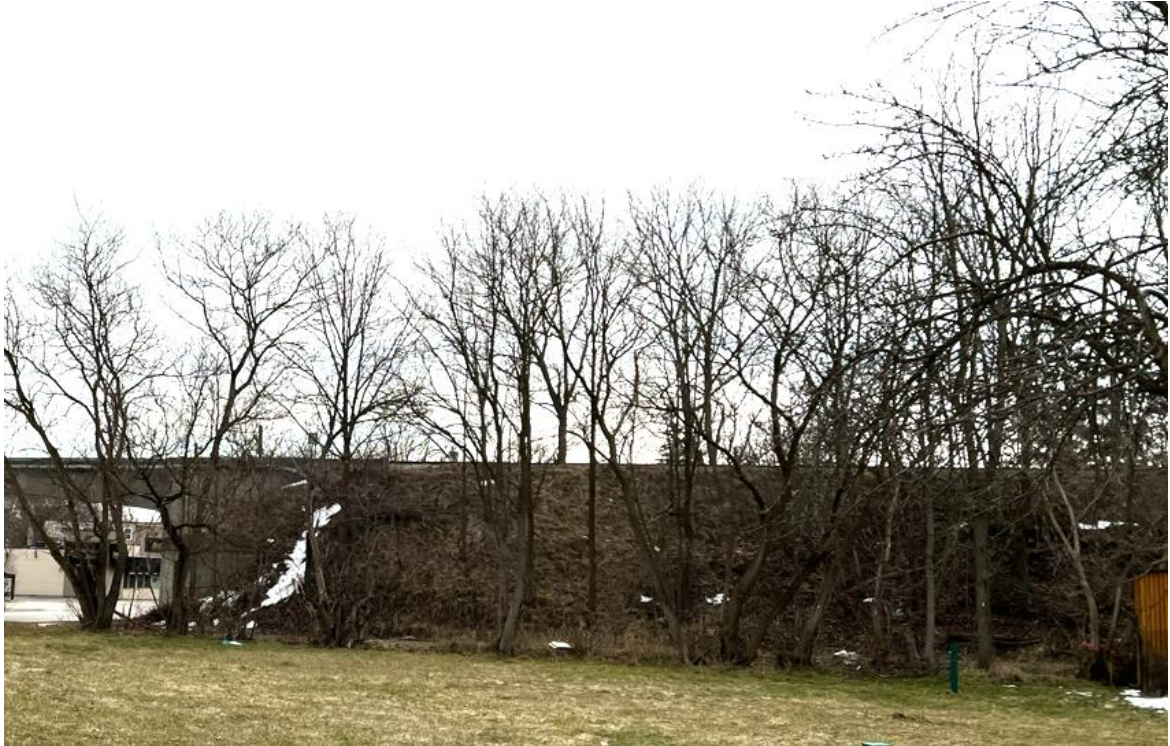
**Trees 15, 16 and 18-21, 23-25** were Manitoba Maples and Black Walnuts located along the east property line, adjacent to the rail corridor. As requested by Metrolinx, trees 15-23 are to be removed to keep 3.5m clear in front of the proposed crash wall. The remaining trees (24 and 25) are to be protected. These trees are in proximity to the proposed ancillary building and their canopies will need to be pruned by a qualified arborist, for safety due to their proximity to the proposed parking lot. Their critical root zones will be impacted moderately by construction and root pruning by a qualified arborist may be needed during earthworks. Specific notations have been provided on drawing TP-1 regarding care to be taken when working within the dripline of these trees.

Trees adjacent to rail corridor to be pruned and protected.
