**Speedvale Apartments  
303-317 Speedvale Avenue,  
Guelph, Ontario**

**ARBORIST REPORT**

Submission: ZBA / Site Plan

January 31<sup>st</sup>, 2024

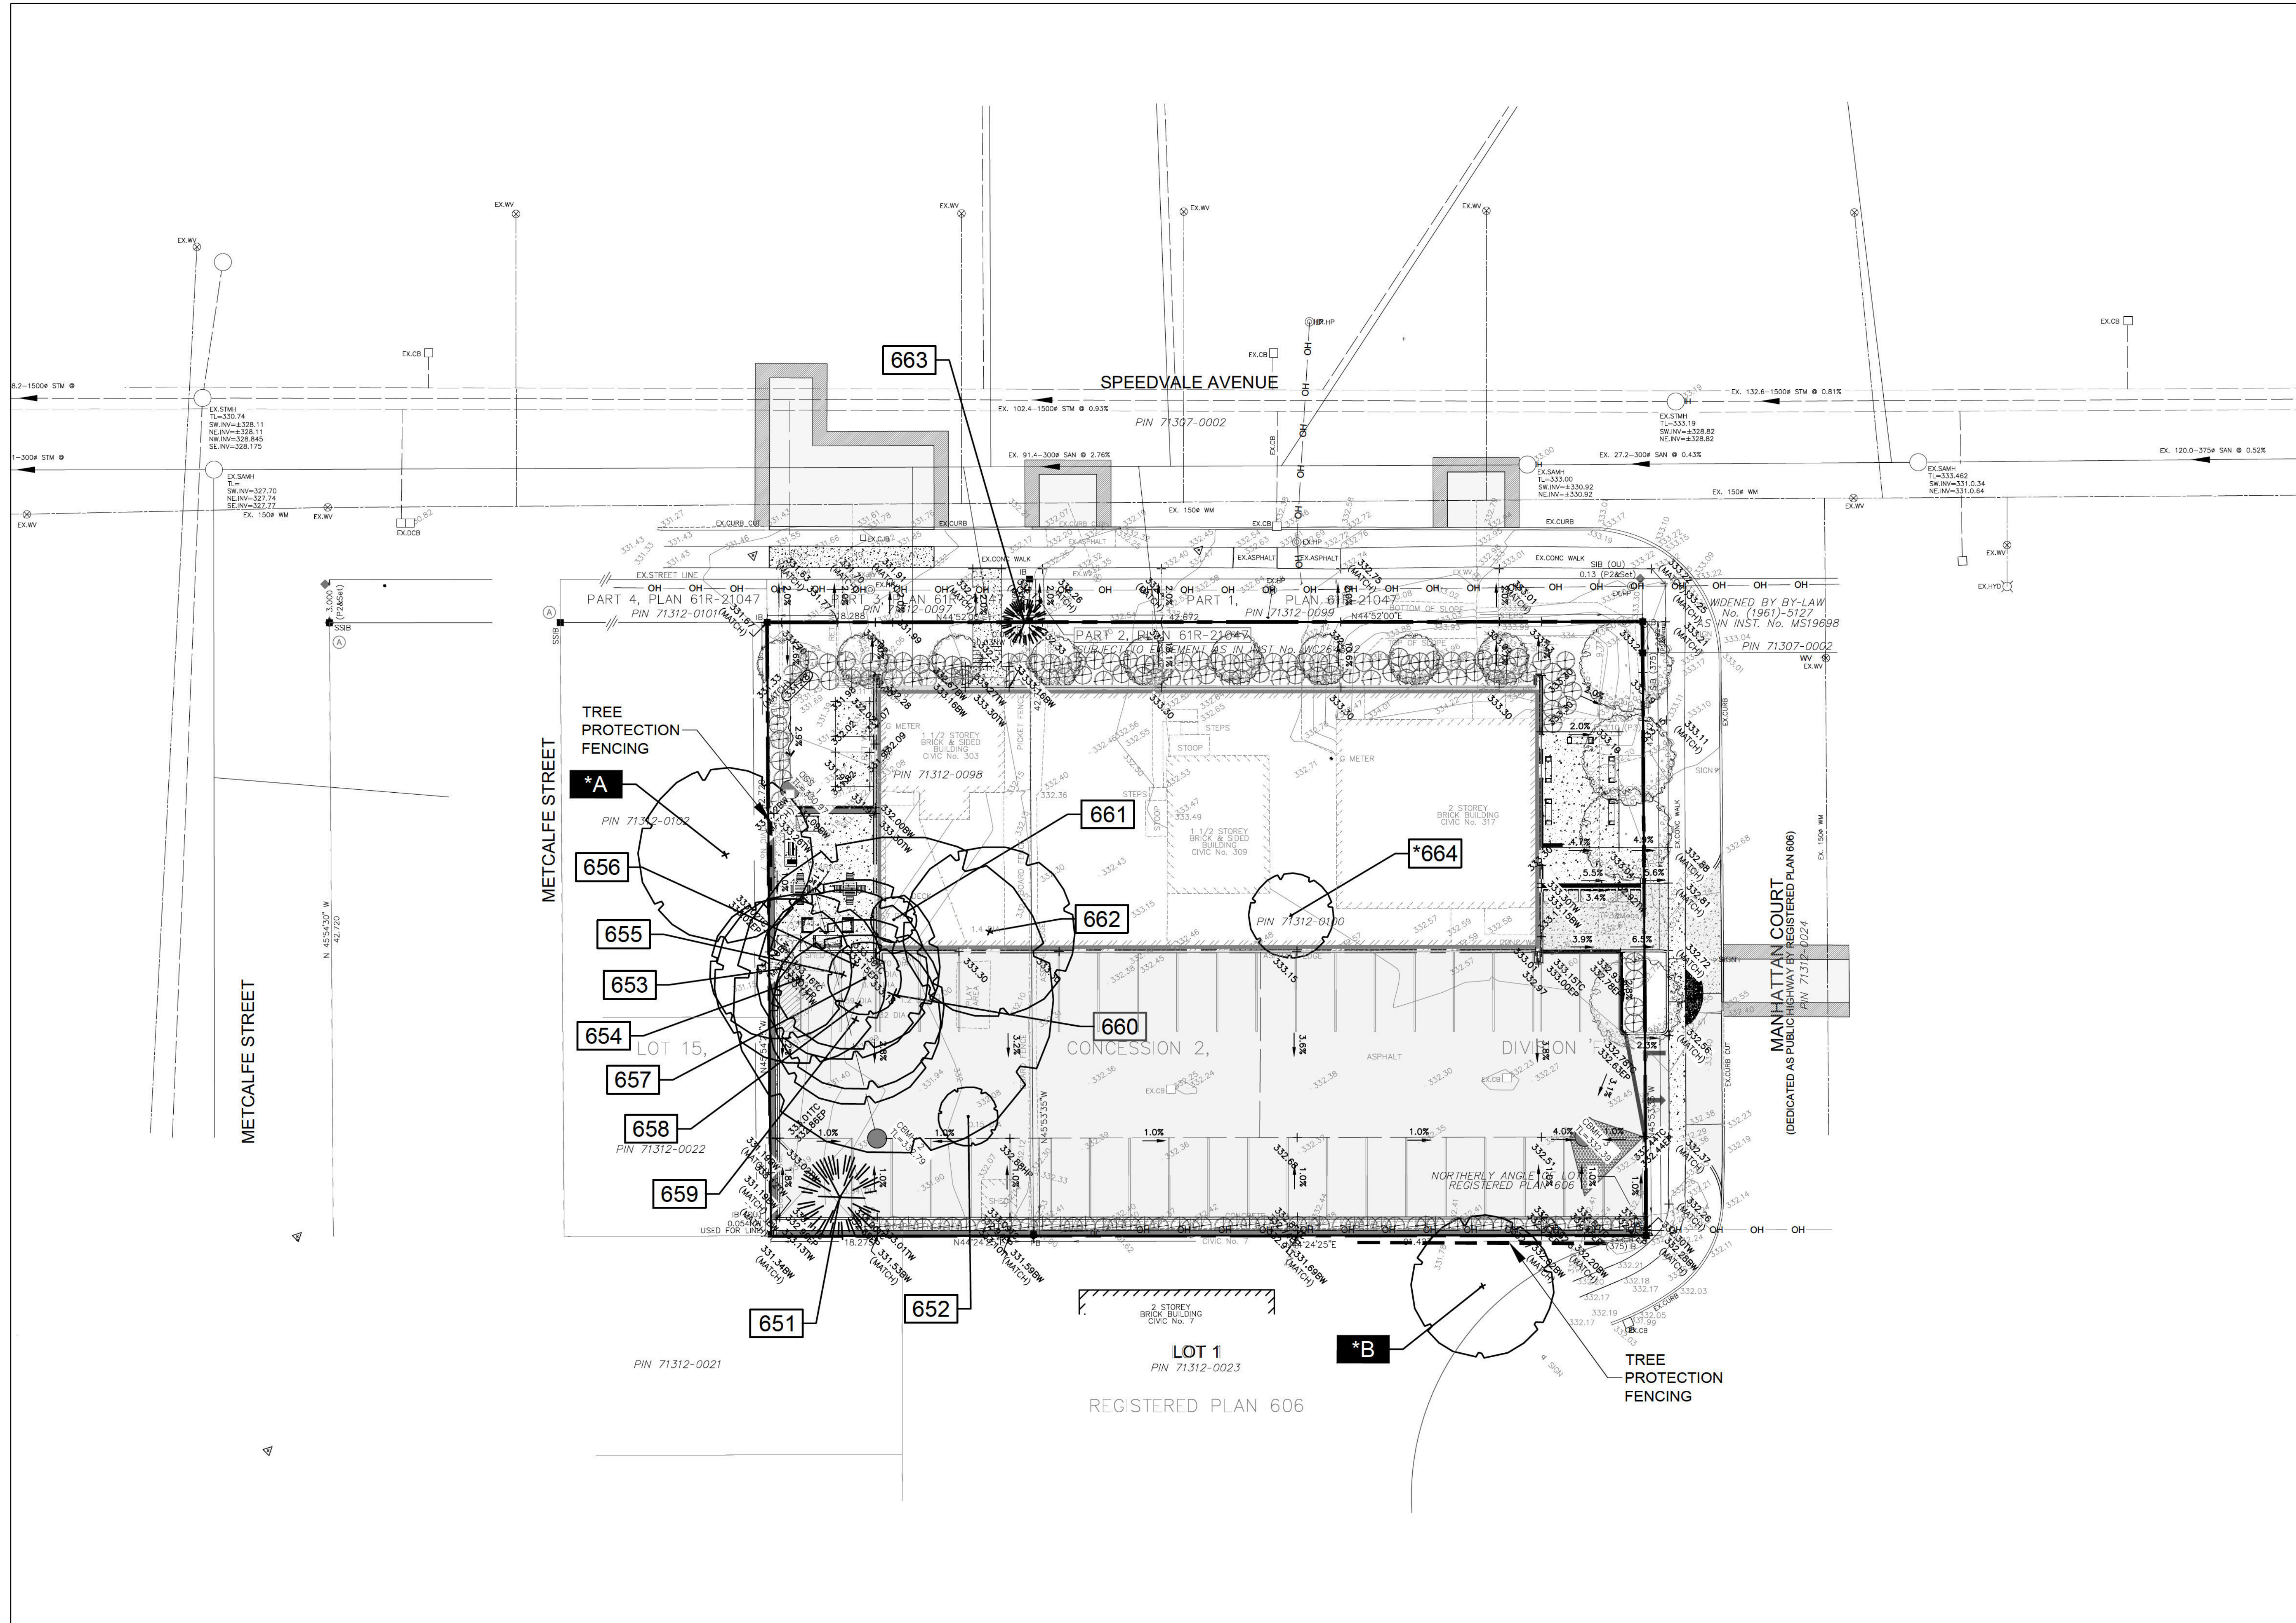
DRAWN BY: GK  
 CHECKED BY: JK  
 DATE: JANUARY 2024  
 SCALE: 1:300  
 PROJECT NO. DWG. NO. **TIPP-1**

Tree 'A' and 'B' were private owned trees located on adjacent neighbouring properties. Trees were located between 3 to 3.5m from the property line and were assessed from the property line to be in good condition.

The trees identified to be removed for the Project were all located on the Project property. A total of fourteen trees, predominantly located in the rear yard of 303 Speedvale Ave., will be removed.

Trees 'A' and 'B' will be retained and protected.

Tree Protection Fence (TPF) locations have been identified on drawing TPP-1, with City details and associated notes provided in on drawing TPP-2 in Appendix 'A'.
