**Tree Inventory and Preservation Plan
76 Wyndham Street South
Guelph, ON**

08 March 2021
Revised: 10 March 2021

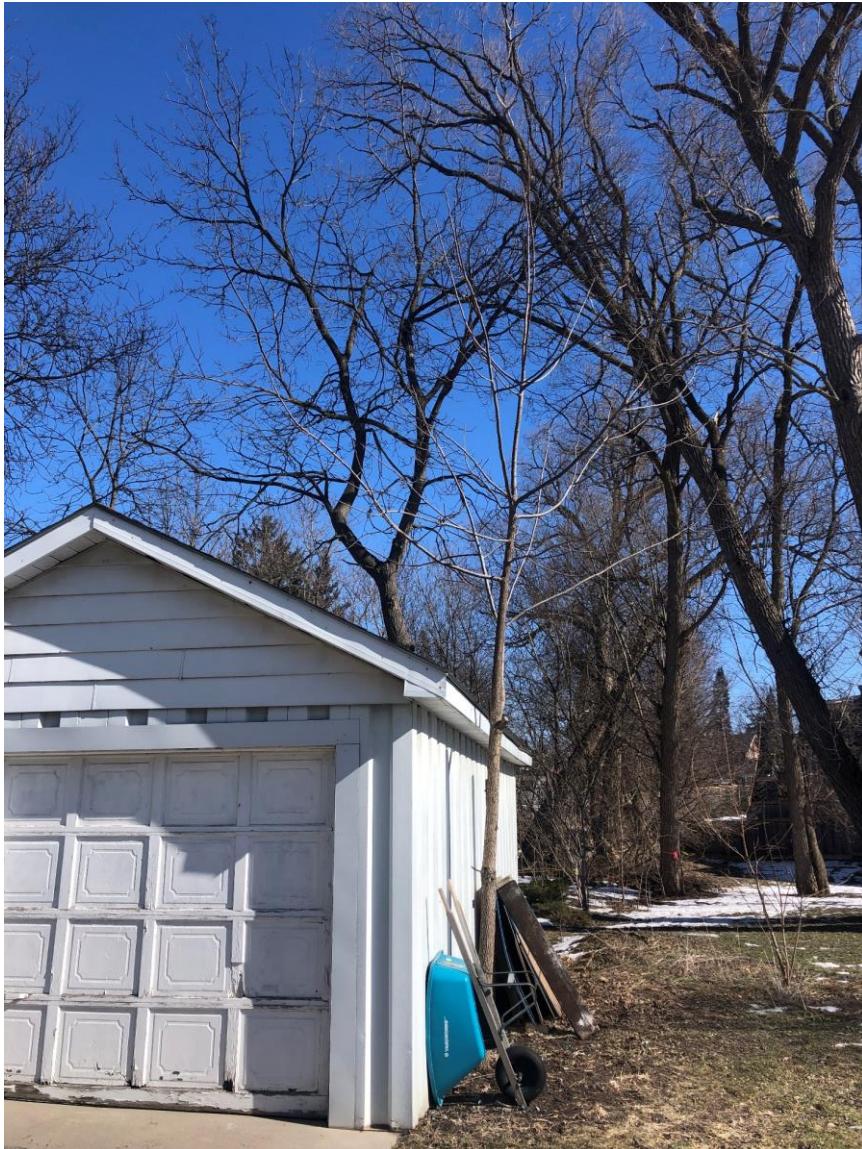
Image 1. Tree 1

The removal of Trees 1 – 6 and N3 will be required to accommodate the proposed development. Trees 3 and 4 have trunks that conflict with the proposed parking lot. Trees 1, 2, and N3 are located close to the proposed parking lot such that their roots would be significantly impacted by construction. Trees 5 and 6 have trunks that conflict with the proposed apartment building. Tree N1 may need to be removed due to the proposed road widening on Wyndham Street South, however, this will be unrelated to the development. It is the Client's intention to plant new trees on the property to compensate for the trees removed due to the development.

The subject property is less than 0.2 hectares in size; therefore, a permit will not be required prior to the removal of Trees 1 – 6 and N3. Tree N3 is located on the shared property boundary and written permission from the neighbouring landowners will be required prior to its removal. Refer to Figure 1 for the locations of the proposed tree removals and Appendix A for the photographs of trees proposed for removal.

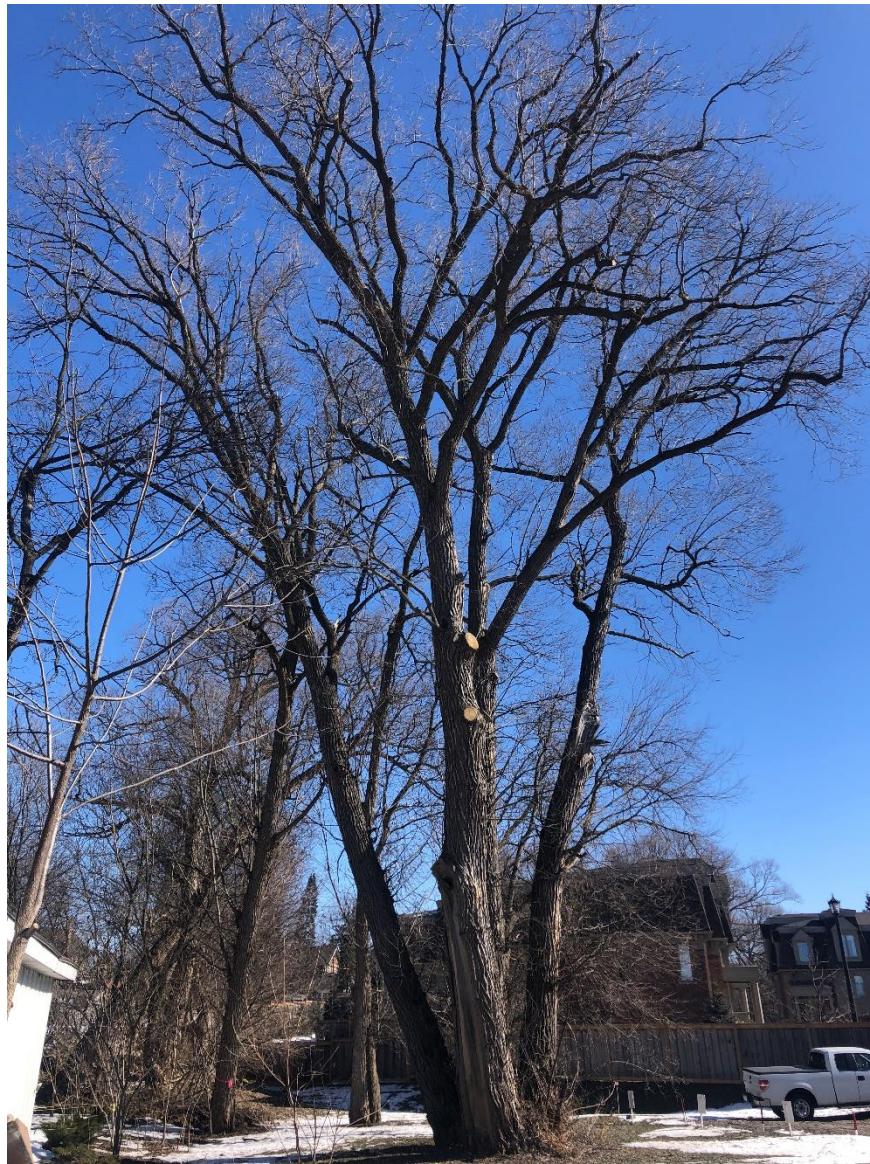
Image 7. Tree N2

Encroachment into the minimum Tree Protection Zone (mTPZ) of Tree N2 will be required to accommodate construction of the proposed parking lot and wooden fence. If the following protection and mitigation measures are employed before, during, and after construction, long-term adverse effects are not anticipated to this tree.

1. The removal of the existing garage within the mTPZ of Tree N2 should be conducted with minimal impact by machinery. The foundation of the existing garage can be carefully lifted with an excavator.

2. Prior to parking lot construction, air-spading technology should be used to excavate a trench at the southeast limit of the proposed parking lot within the mTPZ of Tree N2, as shown in Figure 1.

3. The roots of Tree N2 are to be pruned inside the trench by a Certified Arborist in accordance with Good Arboricultural Standards.
4. The trench is to be backfilled with clean topsoil.

5. Vertical tree protection fencing should be installed adjacent to the backfilled trench within the mTPZ of N2, as shown in Figure 1.
6. Prior to fence installation, air-spading technology should be used to excavate fence post holes within the mTPZ of Tree N2.

7. Any roots of Tree N2 that will be damaged due to fence installation are to be pruned inside the holes by a Certified Arborist in accordance with Good Arboricultural Standards. If structural roots (>5cm diameter) are encountered, the fence post hole should be relocated to an area where no structural roots are encountered.

8. The exploratory holes that will not be used should be backfilled with clean topsoil.
9. Fence posts and fencing are to be installed within the mTPZ of Tree N2 with minimal impact by hand.

10. All works should be supervised by a Certified Arborist in accordance with Good Arboricultural Standards.

As Tree N2 belongs to a neighbouring property, all works prescribed should be discussed with the neighbouring landowner. In addition to the mitigation measures advised for Tree N2, it is recommended that this tree is pruned to remove existing deadwood in the crown. The tree should be periodically monitored due to its age and species.
