**Tree Inventory and Preservation Plan
70 Fountain Street East
Guelph, Ontario**

**Fitzrovia Real Estate
2 St. Clair Avenue West, Suite 2100
Toronto, Ontario M4V 1L5**

11 November 2025

KUNTZ FORESTRY CONSULTING INC. Project P4824

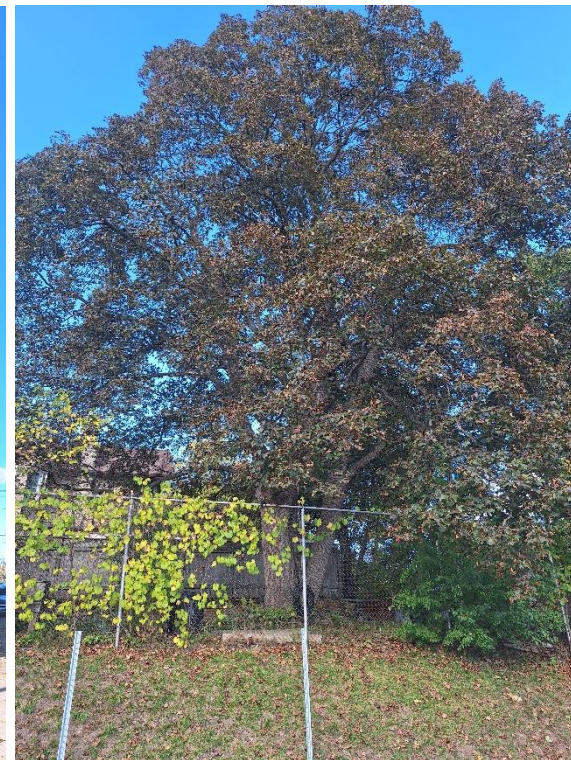
Image 12. Tree E

Encroachment into the mTPZ of Tree E will be required to accommodate excavation associated with the proposed subsurface parking garage. If the following mitigation measures are employed, long-term adverse effects are not anticipated for this tree.

E	Norway Maple	<i>Acer platanoides</i>	~105, 50	~116.5	F	FG	F		9.0	10.0	7.0	V-union at 0.5m and 2m with included bark, lean (L)	Neighbour	Preserve (Injure)
F	Norway Maple	<i>Acer platanoides</i>	~12, 12	~17	PF	F	F		3.5	4.5	1.8	V-union at 0.5m with included bark, included fence (H), lean (L), asymmetrical crown (M)	Subject / Neighbour	Remove

1. Prior to the commencement of the proposed works, tree preservation fencing should be installed as indicated on Figure 1, unless otherwise specified.
2. Where excavation is required within the mTPZ of Tree E, the upper-most portion of the excavation should occur under the supervision of a Certified Arborist, up to a depth of approximately one metre below current grade.
3. Any exposed or damaged roots resulting from the excavation process should be pruned by a Certified Arborist in accordance with Good Arboricultural Standards.
4. Excavation deeper than approximately one metre below current grade may occur in the absence of a Certified Arborist as roots are not expected to occur at these depths.
5. Any branches that require pruning should be pruned by a Certified Arborist or other tree professional in accordance with Good Arboricultural Standards.

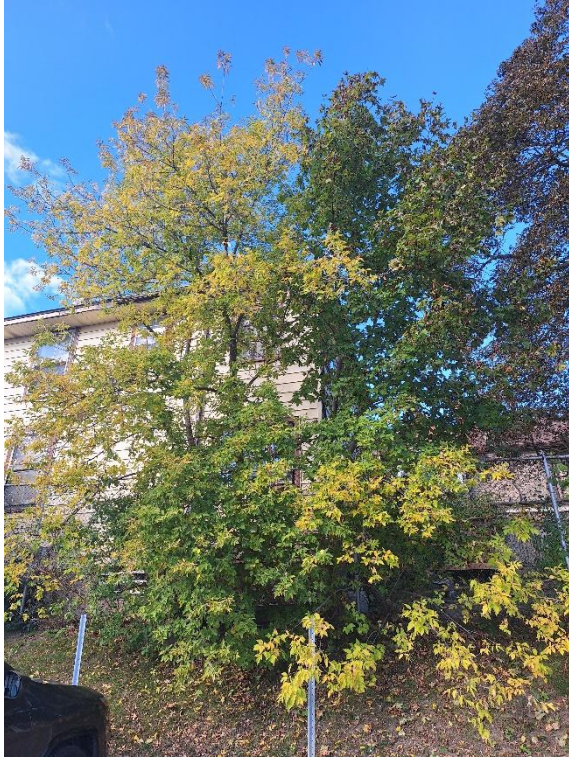
Image 13. Trees F and G

G	Manitoba Maple	<i>Acer negundo</i>	~14, 12	~18.5	F	F	F	10	3.5	4.5	1.8	V-union at 0.5m with included bark, lean (L), fence (L), asymmetrical crown (M), epicormic branching (M)	Subject / Neighbour	Remove
P-1	Norway Maple	<i>Acer platanoides</i>	<10	-	F	F	F				1.2	Ten trees; nine trees acceptable growing stock, one tree unacceptable growing stock	City	Preserve

The removal of five trees will be required to accommodate the proposed development. The trees identified for removal include Trees 964, 965, 967, F, and G. These trees either conflict directly with the proposed development or the level of encroachment into their minimum tree protection zones (mTPZs) resulting from the proposed work would be at an intolerable level such that the trees would not be expected to overcome the injury.

Trees 964, 965, and 967 are located within the City-owned right-of-way and as such, permission from the City of Guelph will be required prior to the removal of these trees. Trees F and G are located along the property boundary between the subject property and a neighbouring property and as such, written permission from the respective neighbouring property owner will be required prior to the removal of these trees. Trees F and G are greater than 10cm DBH and are situated on private property.
