Stormwater Management Master Plan Appendix N: Geomorphic System Assessment Technical Memorandum – Field Investigations

> Reference #: 66636 August 2021 Final Report

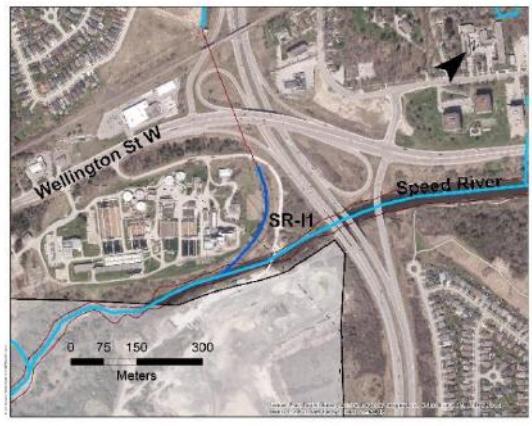
Re-evaluation of the reach divisions (i.e. where one reach ends and another begins) were assessed on similarity of channel type, surficial material, degree of channelization and hydraulic conditions. To that end, Reach SR-I1 (**Figure 3-1**) was piped beneath the Wellington St overpass. The new reach break has been adjusted to reflect only the daylighted segment of that reach.

Figure 3-1: The assessed Reach SR-I1 (dark blue) begins at the Wellington St overpass where it emerges from a culvert (red).

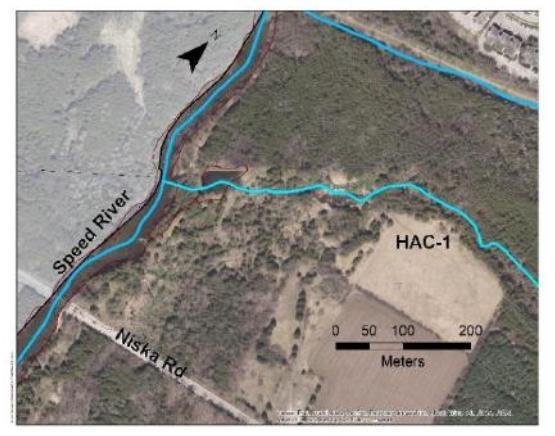
Reach HAC-1 no longer has a standing body of water before its confluence with the Speed River (**Figure 3-3**). The remnants of an earlier weir structure that has since failed is evident. Consequently, the reach now drains directly southwest instead of its previous alignment due south to join the Speed.

Figure 3-3: The wetland and channel that diverts south on Reach HAC-1 (red) has adjusted to join the Speed River to the west (bright blue).

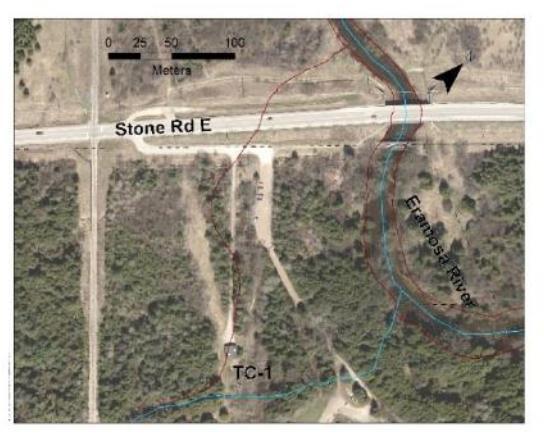
At some point since the digitization of the open-source GIS data and 2012 SWM-MP prepared by AMEC, the Reach TC-1 has been diverted to the south of Stone Rd E. (Figure 3-2). This may actually reflect an earlier watercourse alignment since the replacement of the derelict bridge to the south of the new one. No culverts are obvious at the base of the road bank to allow for the previous planform geomorphology.

Figure 3-2: Reach TC-1 has been diverted from the north side of the Stone Road bridge (red) to the bend south of Stone Road E (light blue).

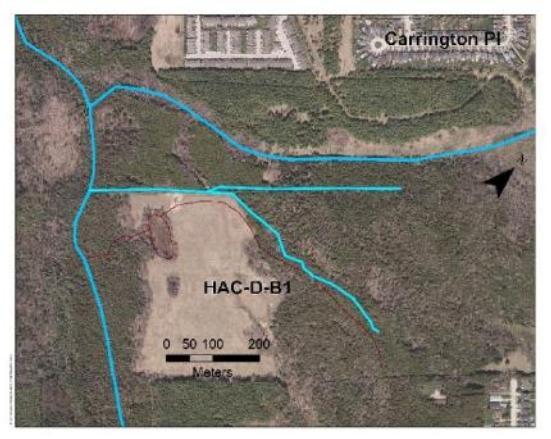
Reach HAC-D-B1 looks to have been realigned to the perimeter of a field that shows evidence of recent agricultural use. The pond that once existed in the field has a failed weir structure and no longer retains a standing body of water through the summer months. The current channel is straight and has foot crossings at 2 locations along a trail at the northern perimeter (**Figure 3-4**).

Figure 3-4: Reach HAC -D-B1 is no longer a meandering ditch and SWM pond (red). Now it is a well-defined channel and drains directly west (bright blue).

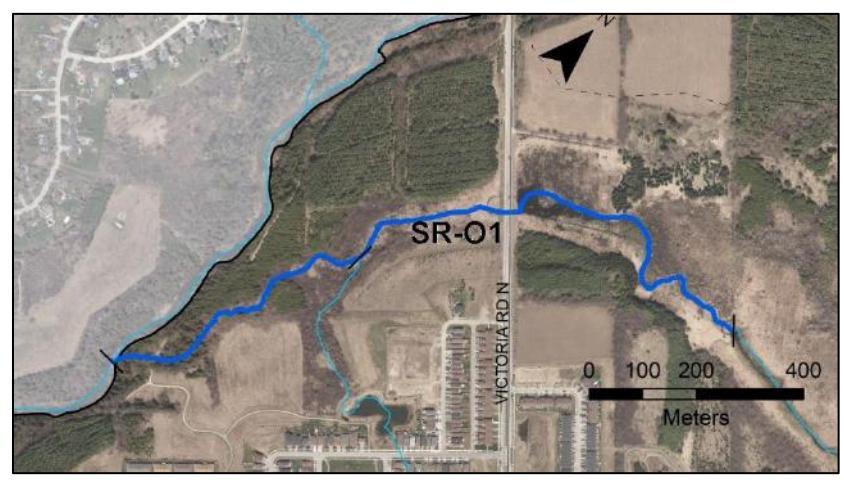
The reach break that separates Reach SR-O1 and Reach SR-O2 was previously located within the lowlying wetland east of Victoria Rd (**Figure 3-5**). Detailed field investigations assessed the flow characteristics, channel morphology and bank and substrate material to show that the section of Reach SR-O1 that was east of Victoria was identical to those conditions in Reach SR-O2. The Reach SR-O1 shows poor channelization, similar to that of Reach SR-O2. The muddy bed material, gradient and ground cover are also identical in these two reaches east of Victoria. West of Victoria Rd however, the channel shows moderate channelization, a slightly steeper gradient and some pebbles and sand in the substrate. The channel banks, while not very large (20 to 40 cm) have sandy segments and grassy vegetation in a loam rich cover. For this reason the reach break has been moved to the Victoria Rd culvert, and separates the more channelized Reach SR-O1 (**Figure 3-6**) from the wetland Reach SR-O2 east of Victoria Rd (**Figure 3-7**).

Figure 3-5: The previous delineation of Reach SR-O1 from the wetland east of Victoria Road to the Speed River.

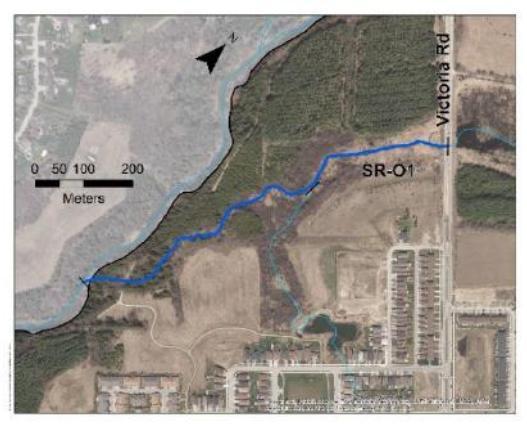
Figure 3-6: The new delineation of Reach SR-O1 at Victoria Rd.

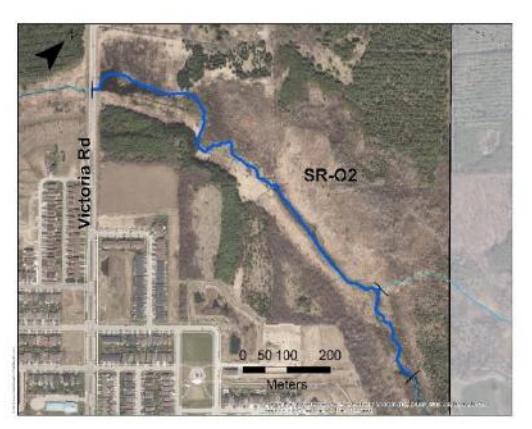
Figure 3-7: Reach SR-O2 now includes all wetland east of Victoria Rd.

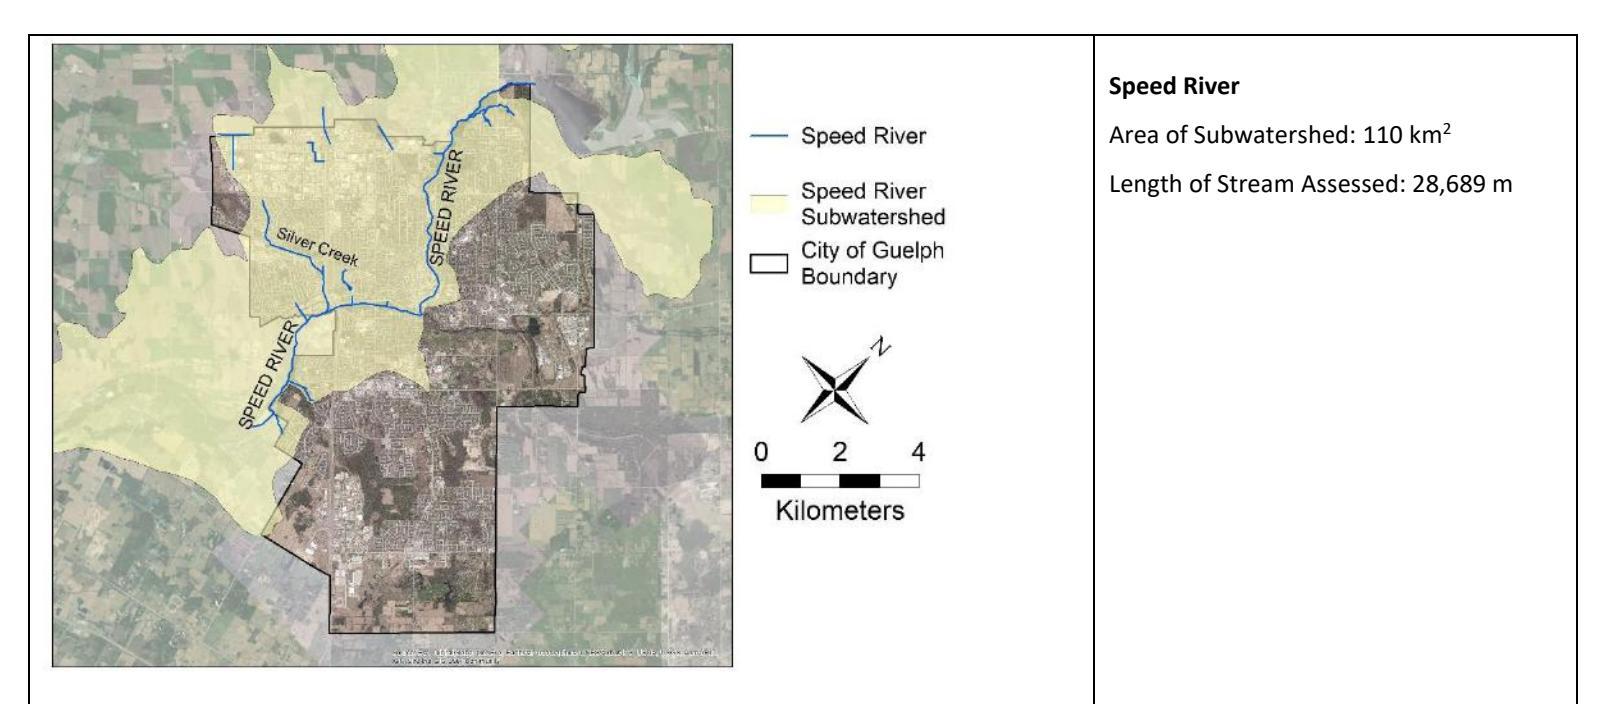
Reach ID	Summary	Representative Photograph	Кеу Мар
SR-2	Natural alluvial meandering channel, with bed material ranging from sand to cobbles and boulders found in riffles. Good riparian cover and high- quality aquatic habitat. <u>RGA Results</u> SI – 0.06 (In Regime)		2 100 220 400 to the tot tot to the tot tot tot tot tot tot tot tot tot to
SR-3	Natural alluvial channel, with bed material ranging from sand to cobbles and boulders found in riffles. Good riparian cover and high-quality aquatic habitat. <u>RGA Results</u> SI – 0.06 (In Regime)		0 50 100 200 Meters 330
SR-4	Natural alluvial channel, with bed material ranging from sand to cobbles and boulders found in riffles. Good riparian cover and high-quality aquatic habitat. At upstream limit there is a quarry on the right bank and the municipal water treatment plant on the left. <u>RGA Results</u> SI – 0.10 (In Regime)		0 200 400 800 Meters

Dominant Process:		
SR-5	Aggradation		
511 5	material ranging from coarse		
	sand to cobbles. Multiple	Contraction of the second second	
	concrete weir structures		
	throughout the reach. Good to		SR-5
	moderate riparian cover and	A REAL PROPERTY OF THE PARTY OF	
	aquatic habitat.		I THE THE
	RGA Results		
	SI – 0.16 (In Regime)		0 108 200 type 400
	Dominant Process:		
	Aggradation		
SR-6	Urbanized channel with bed		
	material ranging from coarse		WELINGTINGEN
	sand to cobbles. Concrete weir	and the second s	
	structures throughout the		
	reach with Wellington Street		SR-6
	Good to moderate riparian		
	cover and aquatic habitat.		
		Prove Charles	0 50 100 200
	RGA Results	the second s	Meters
	SI – 0.05 (In Regime)	the second s	The same state of the same of
	Dominant Process:		
	Degradation		
SR-7	Urbanized channel with		
	concrete retaining walls on left		
	Wellington Street Dam at		A CONTRACT OF THE CONTRACT.
	downstream reach limit. Fair	and the second	SR-7

riparian cover and aquatic		
	habitat.		
			G 50 100 200
	RGA Results		
	SI – 0.06 (In Regime)		
SR-8	Urbanized channel with bed		
	material ranging from silt and		
	sand to boulder and bedrock.		and the A state of the state of
	Part of the reach has concrete		
	retaining walls on right bank.		
	unstream reach limit and		A CALL AND A
	Framosa River confluence at		SR-8
	downstream reach limit.		
	Moderate to good riparian		Charles and the second s
	cover and aquatic habitat.		0-100-200
	$\frac{\text{KGA Results}}{\text{SI} = 0.20 (In Transition)}$	and the second s	
	Dominant Process		
	Degradation

SR-9	Urbanized channel with Macdonell street dam at downstream reach limit. Moderate to good riparian cover and aquatic habitat. <u>RGA Results</u> SI – 0.22 (In Transition) Dominant Process: Degradation	
SR-10	Natural channel with bed material ranging from sand to cobbles. There is a concrete weir structure near downstream end of reach. Good riparian cover and aquatic habitat. <u>RGA Results</u> SI – 0.27 (In Transition) Dominant Process: Aggradation	
SR-11	Urbanized channel with concrete retaining walls and weir structures throughout reach. Dam structure at upstream reach limit. Bed material ranges from sand to boulders. Poor riparian cover, with weir structures acting as fish barriers. <u>RGA Results</u> SI – 0.11 (In Regime) Dominant Process: Degradation	SR-11 SR-11 Personal Folder Personal Folder Pe
SR-12	Partially urbanized channel with concrete retaining walls and dam at downstream reach limit. Moderate riparian cover and aquatic habitat. <u>RGA Results</u> SI – 0.16 (In Regime) Dominant Process: Aggradation and Widening	SR-12 B B B B B B B B B B B B B B B B B B B

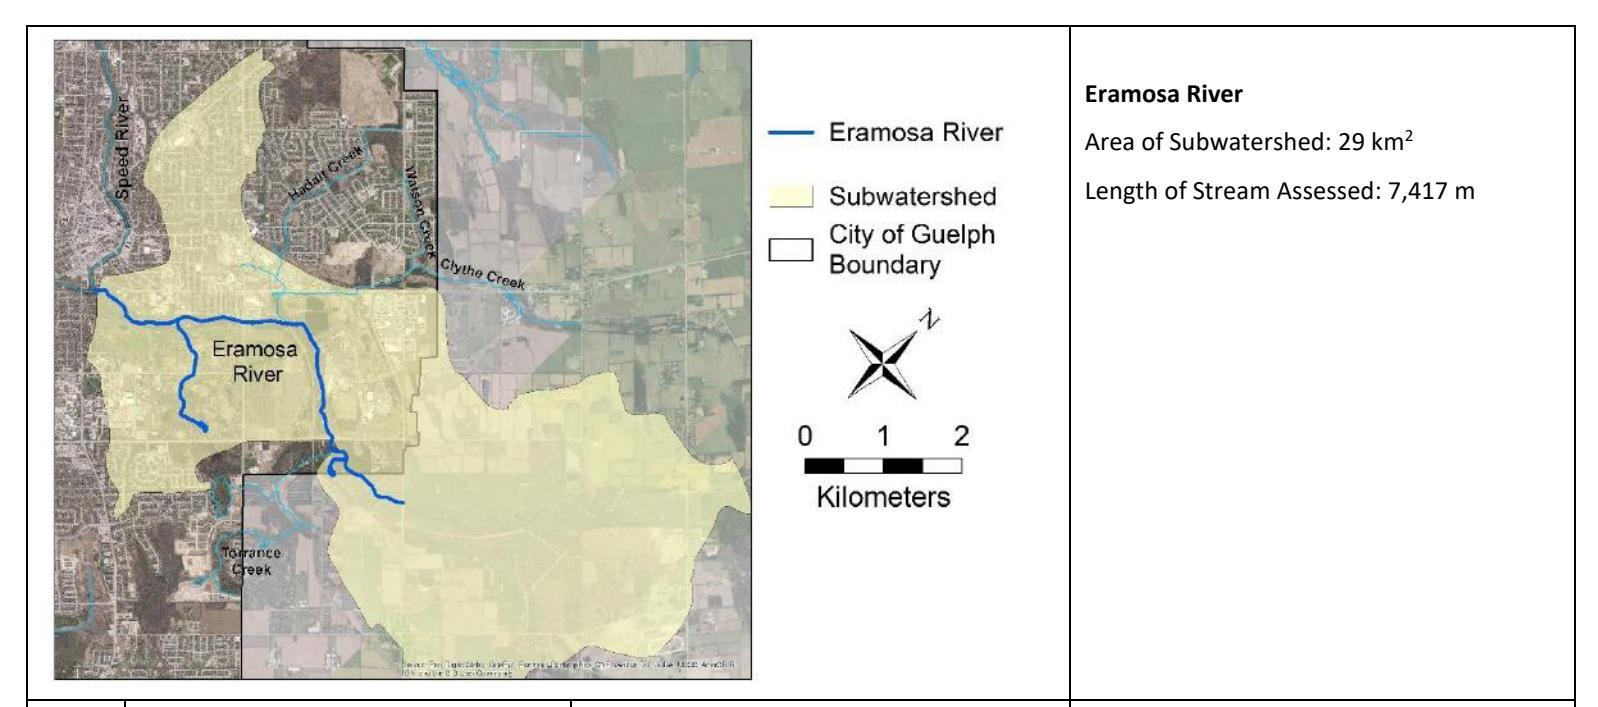
Reach ID	Summary	Representative Photograph	Кеу Мар
ER-1	Natural reach with bed material consisting mostly of silt and sand. Good riparian cover and aquatic habitat. No observable riffle-pool morphology within the reach. Downstream end of reach is the confluence of the Eramosa and the Speed River <u>RGA Results</u> SI – 0.12 (In Regime)		
ER-2	Natural reach with bed material consisting mostly of silt and sand. No observable riffle-pool morphology within the reach. Good riparian cover and aquatic habitat. <u>RGA Results</u> SI – 0.06 (In Regime)		ER-2 0 50.100 200 Meters
ER-3	Natural reach with bed material ranging from silt to cobble. No observable riffle-pool morphology within the reach. Good riparian cover and aquatic habitat. <u>RGA Results</u> SI – 0.09 (In Regime) Dominant Process: Widening		ER-3 0 50 100 200 Vjeteris

ER-4	Natural reach with bed material ranging from silt to cobble. Good riparian cover and aquatic habitat. <u>RGA Results</u> SI – 0.09 (In Regime) Dominant Process: Widening	EEA Barbara Barbara Barbar
ER-5	Natural reach with bed material ranging from silt and sand to predominantly cobbles at upstream end of reach. Good riparian cover and aquatic habitat. <u>RGA Results</u> SI – 0.12 (In Regime) Dominant Process: Widening	D 50 100 200 Meters Rr.5
ER-6	Natural reach with bed material ranging from sand to predominantly cobbles. Good riparian cover and aquatic habitat. <u>RGA Results</u> SI – 0.19 (In Regime) Dominant Process: Aggradation and Widening	EIG-B 0 50 100 200 Meters 5006 6 LL ED 7 CEDEDOS VICTORS
ER-B1	Tributary that flows into the Eramosa River. Channel flows through Guelph Arboretum and Cutten Fields golf course. Channel material mostly consists of silt and sand with grassy banks in Arboretum with the channel becoming more manicured with a grass bed in the golf course. <u>RGA Results</u> SI – 0.07 (In Regime)
