City of Guelph

2018 Annual Report

Closed Eastview Road Landfill Site

Date: April, 2019
Project #: 60598827-1

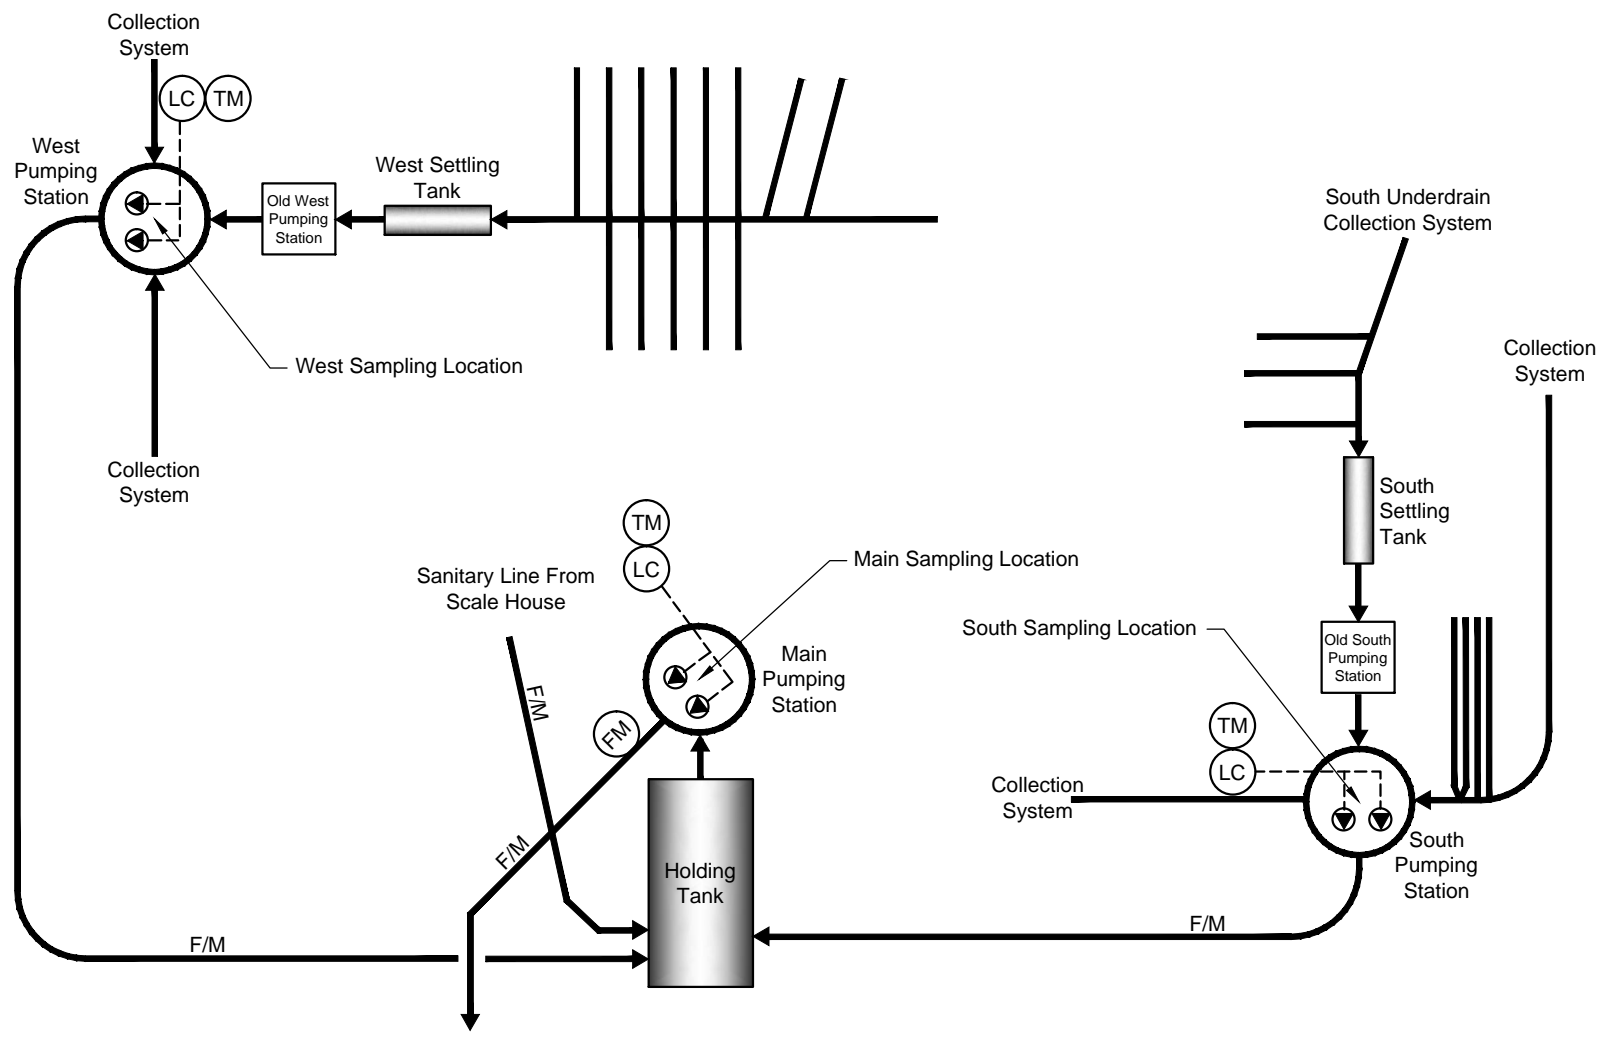
Based on the amended Certificate of Approval # 3-0048-90-006 (C of A) dated February 15, 1996, sample collection of leachate at the Eastview Road Landfill is required from the main pumping station only. Leachate sampling and assessment are required under the C of A, Schedule A, and Condition 8.3. Leachate samples were collected from the main pumping station in 2018. Leachate from the south and west pumping stations is pumped to the main station and then pumped to the municipal sewer for treatment at the Guelph Wastewater Treatment Plant (WWTP). The relative locations of the three-leachate pumping stations at the landfill are shown schematically in **Figure 2**.

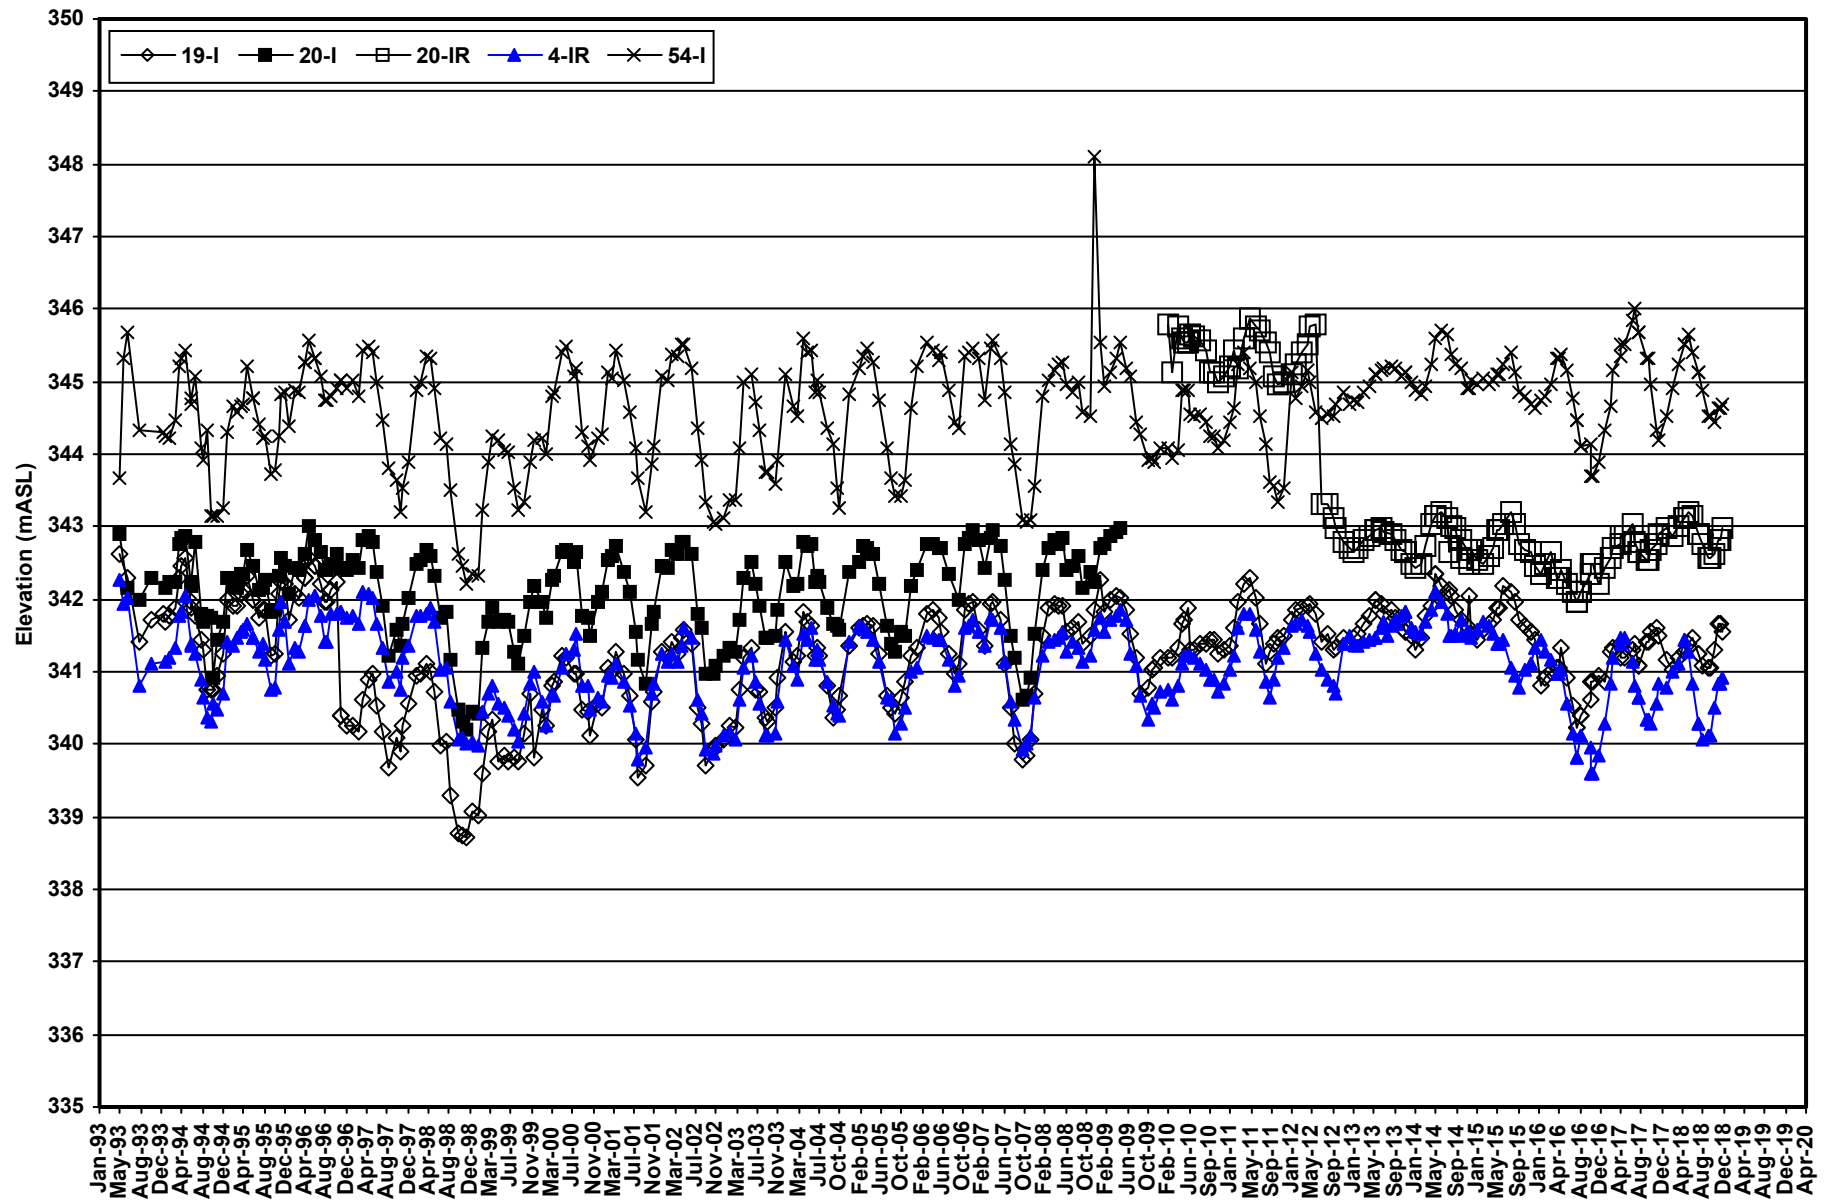
FIGURE
15

Closed Eastview Road Landfill Site
Bedrock Groundwater Elevations
Locations in the Northeast Area of the Landfill Property

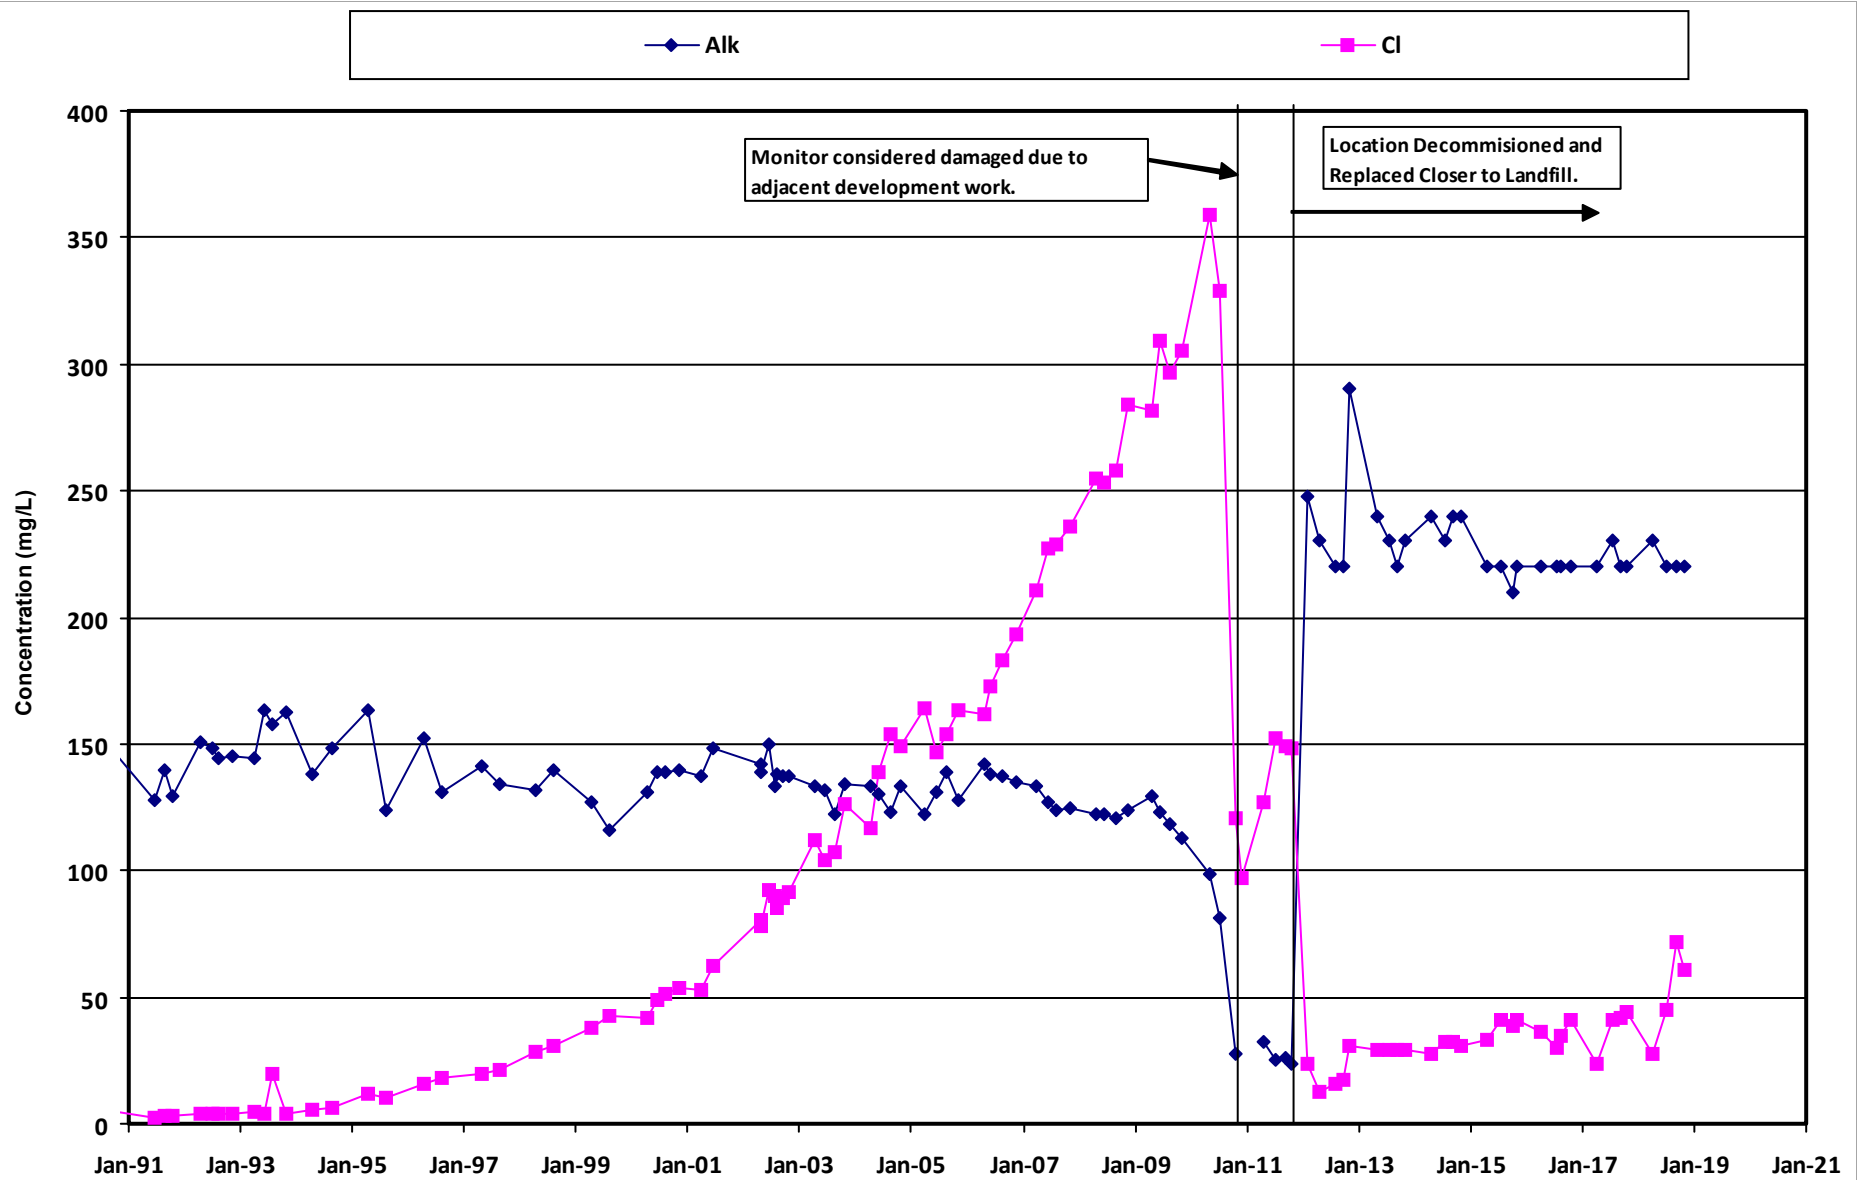
FIGURE
20

Closed Eastview Road Landfill Site
Groundwater Quality Trends
Comparison of Chloride and Alkalinity at Location 37/37R

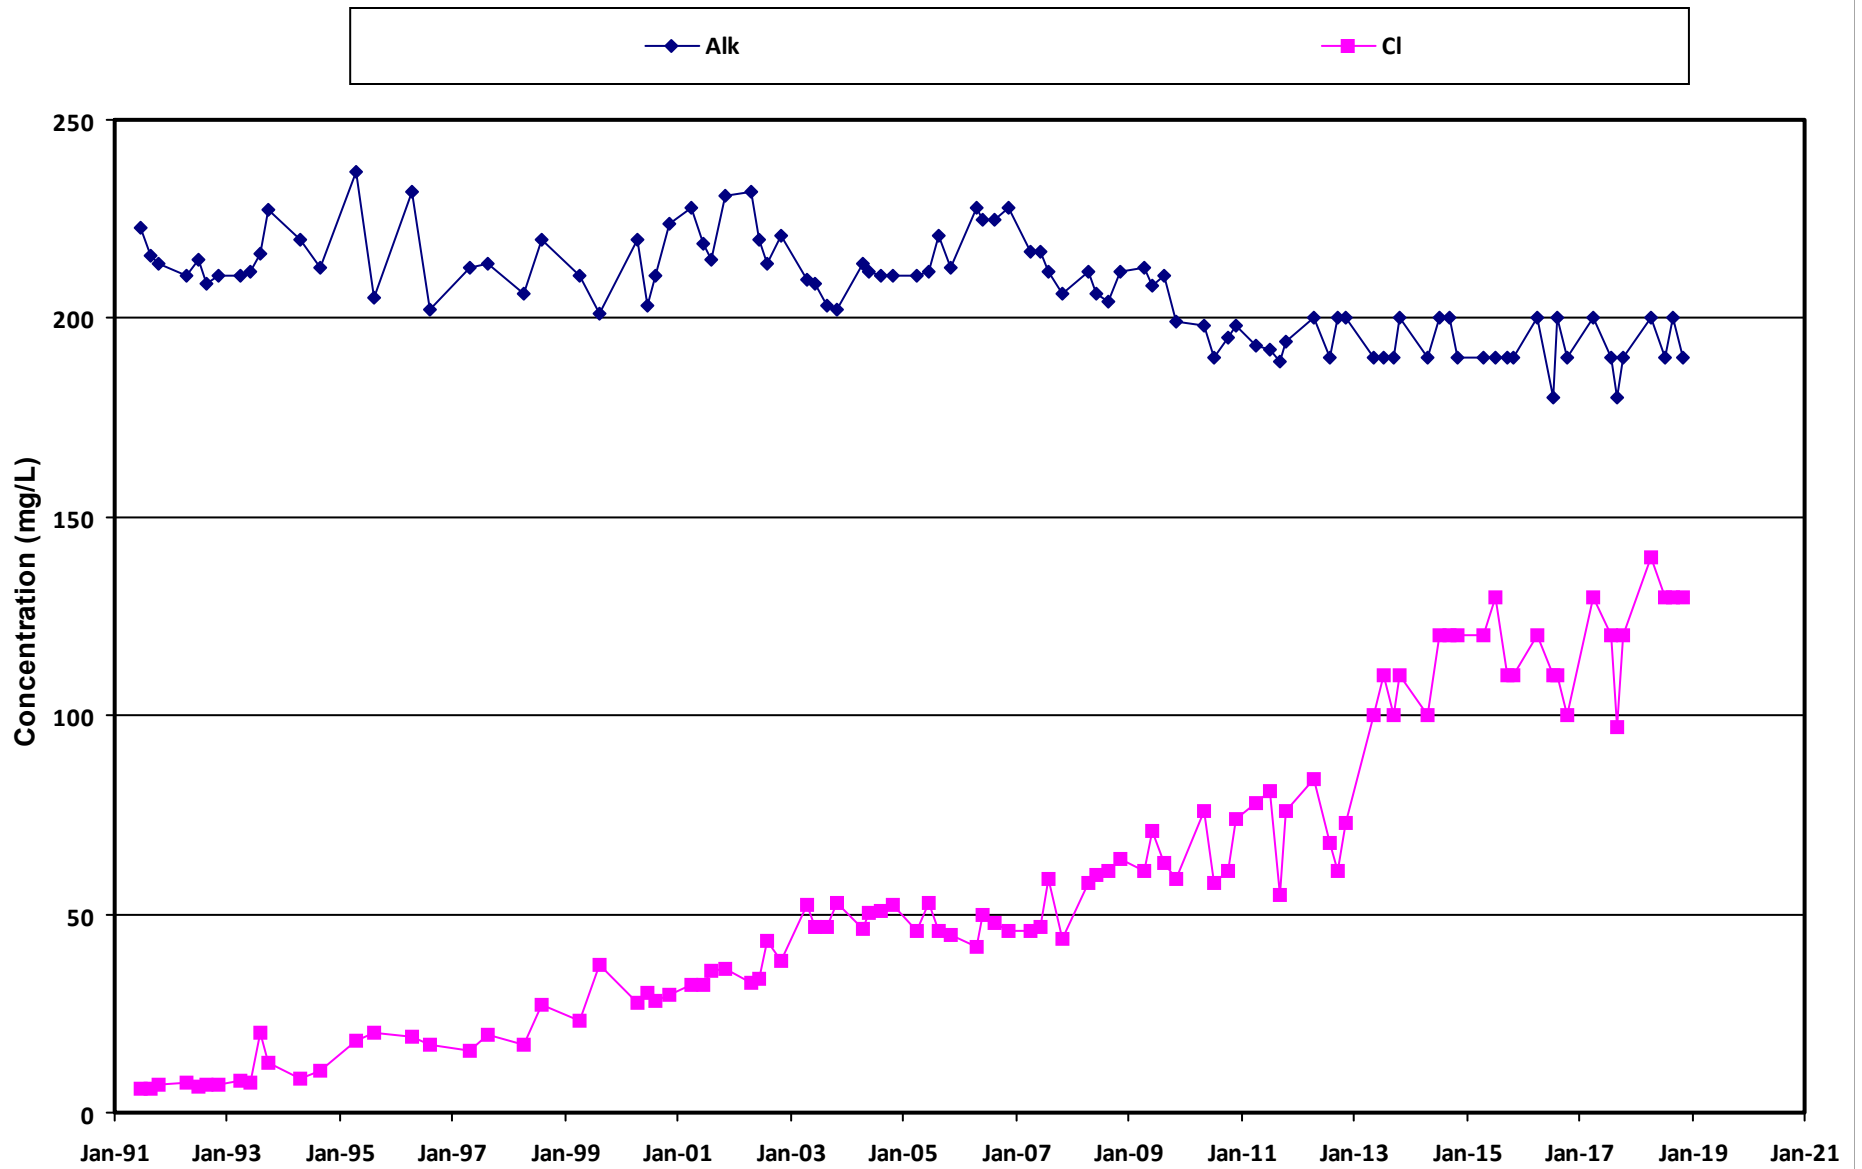
FIGURE
21

Closed Eastview Road Landfill Site
Groundwater Quality Trends
Comparison of Chloride and Alkalinity at Location 50

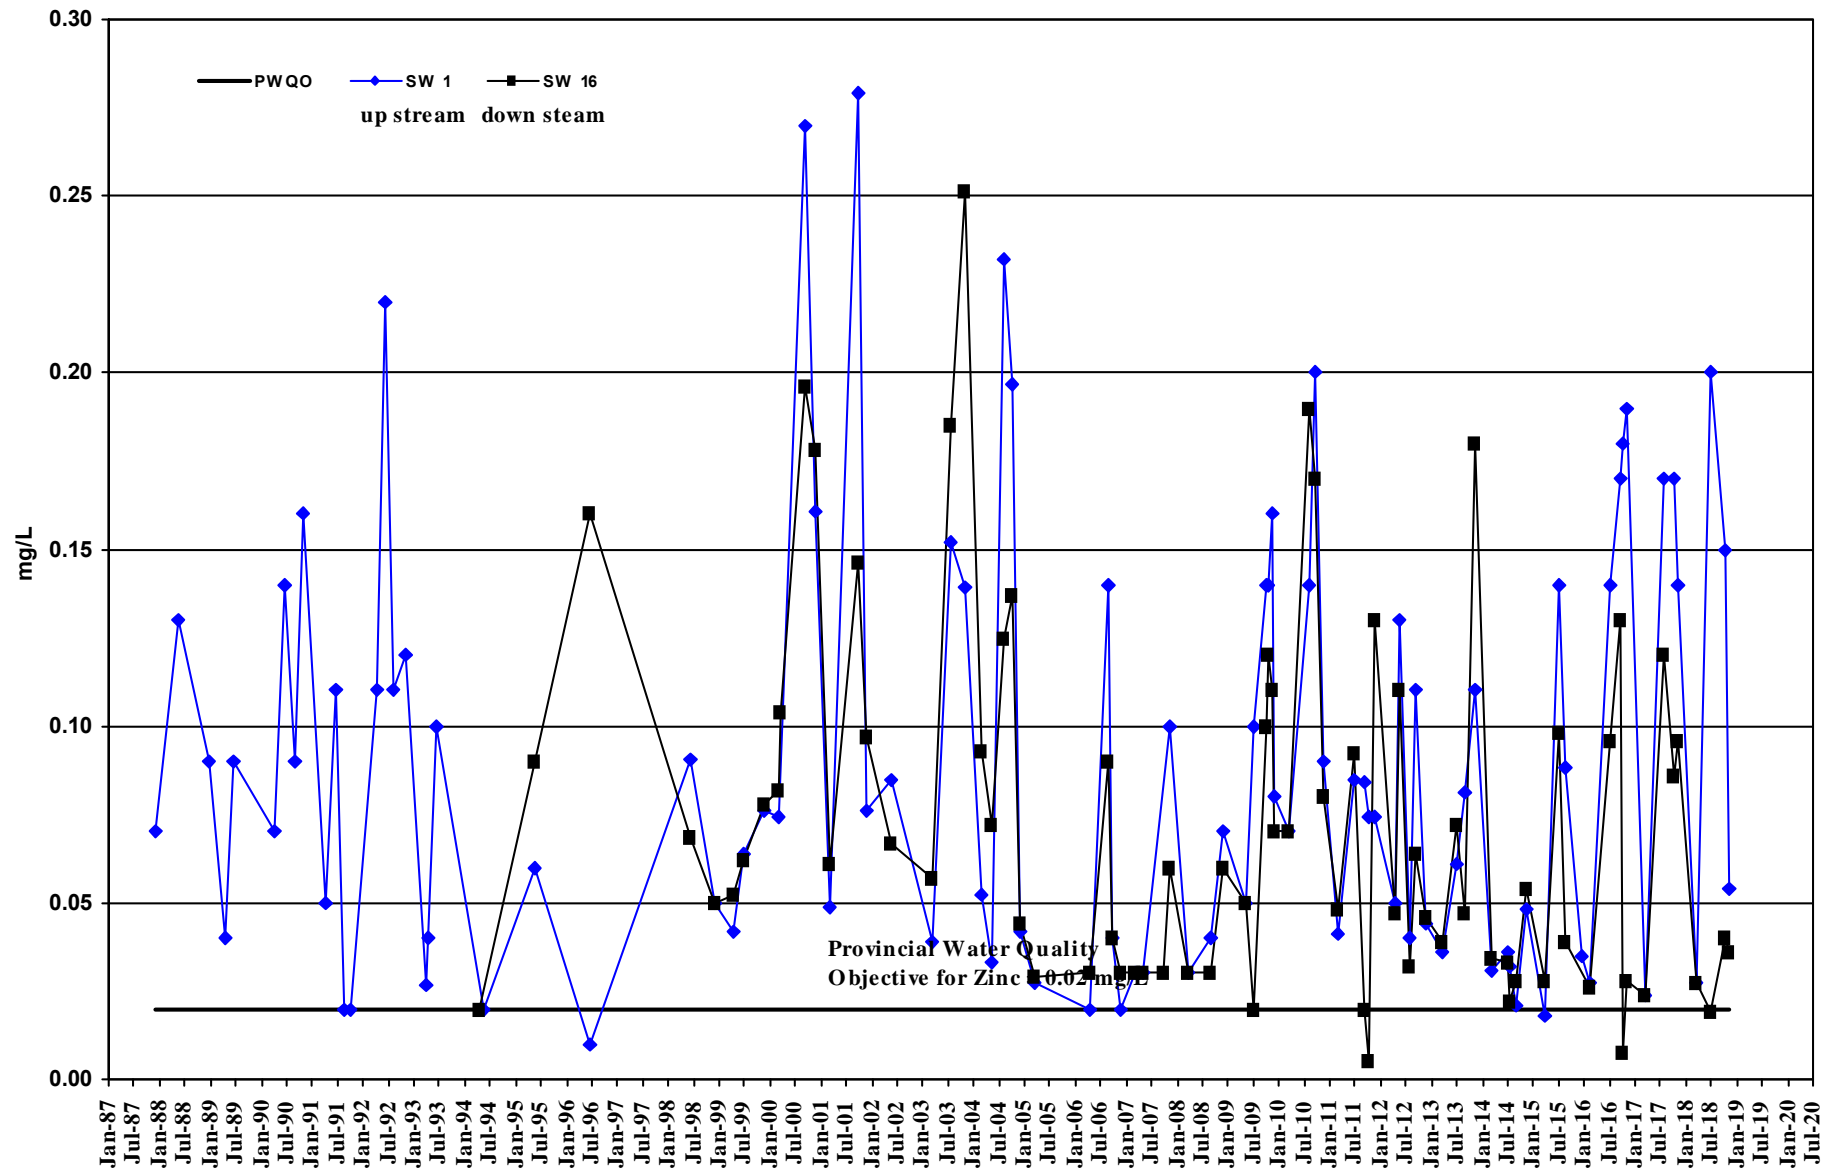
FIGURE
23

Closed Eastview Road Landfill Site
Surface Water Quality Trends
Comparison of Zinc at Locations SW 1 and SW 16

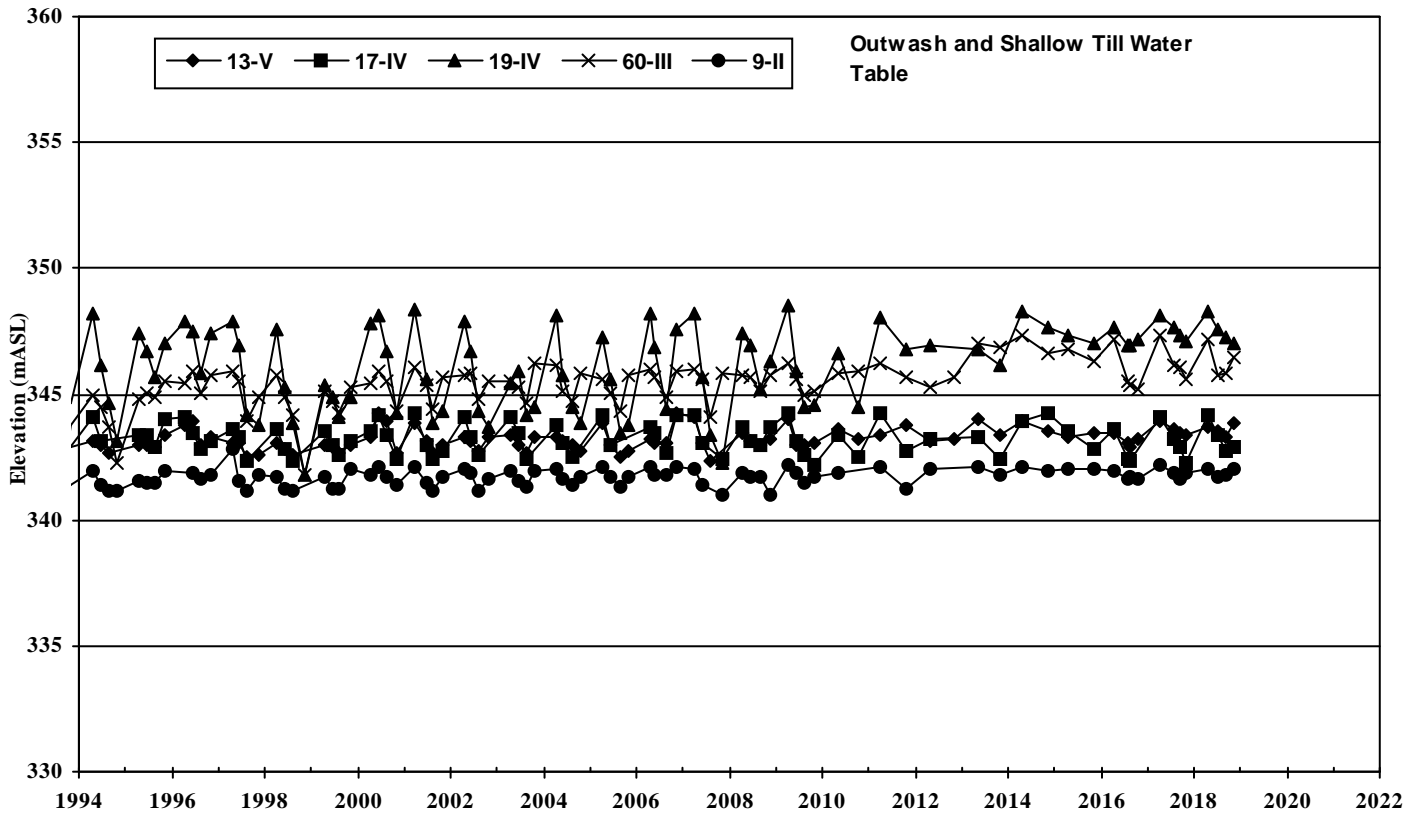
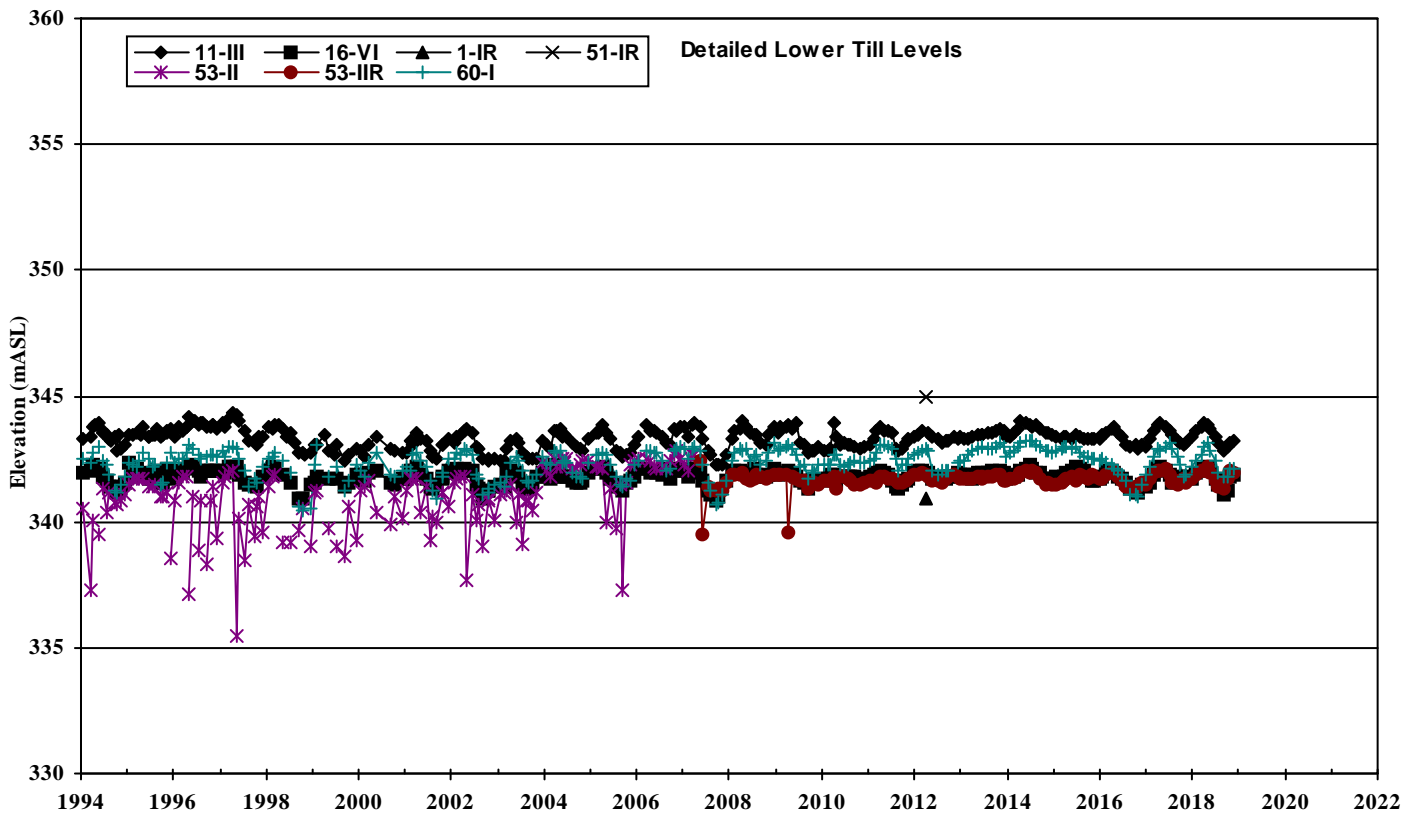
FIGURE
A1
 60598827
 10a Shallow and Detailed Till GW

Closed Eastview Road Landfill Site
Groundwater Elevation Trends
Outwash/Shallow Till and Detailed Lower Till
Levels Around the Landfill

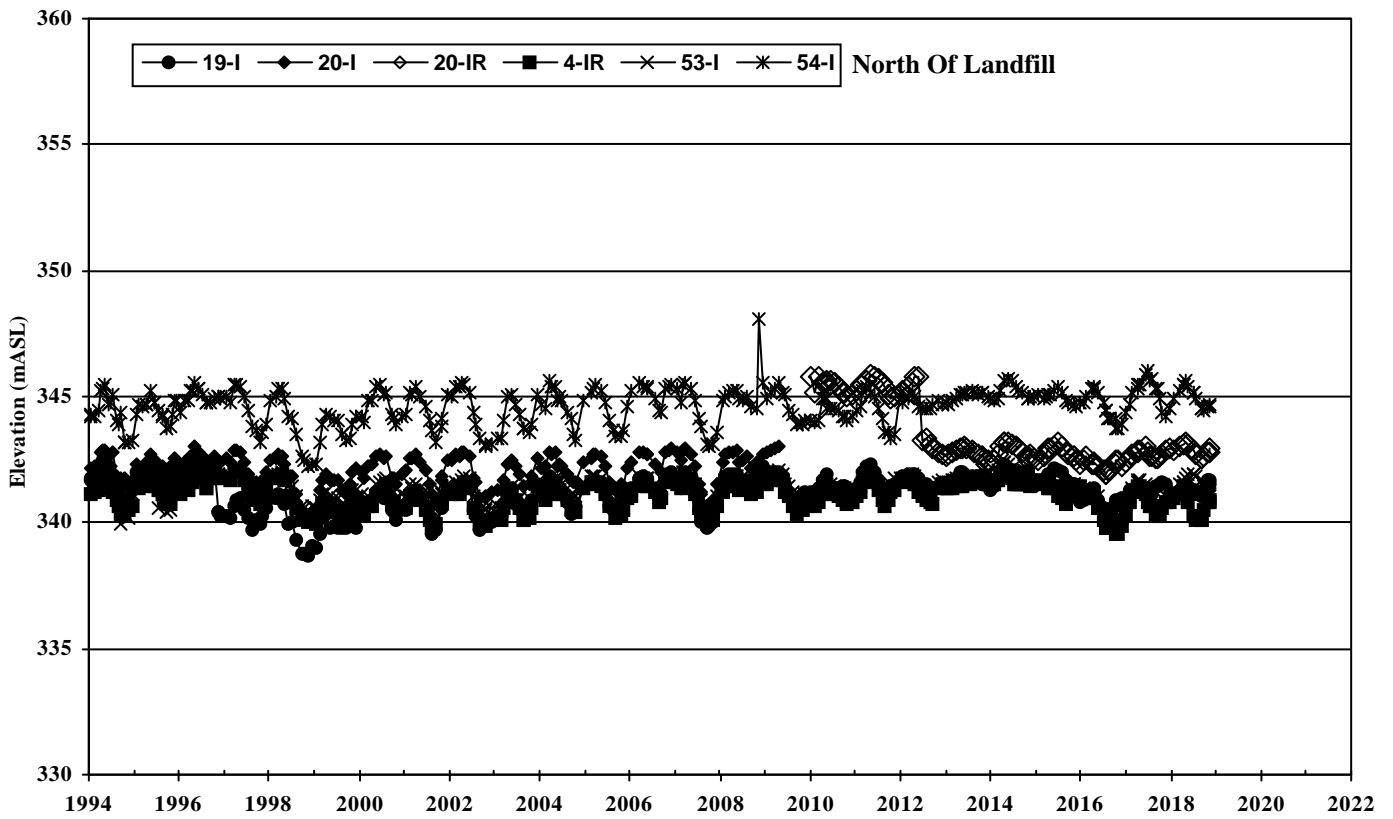
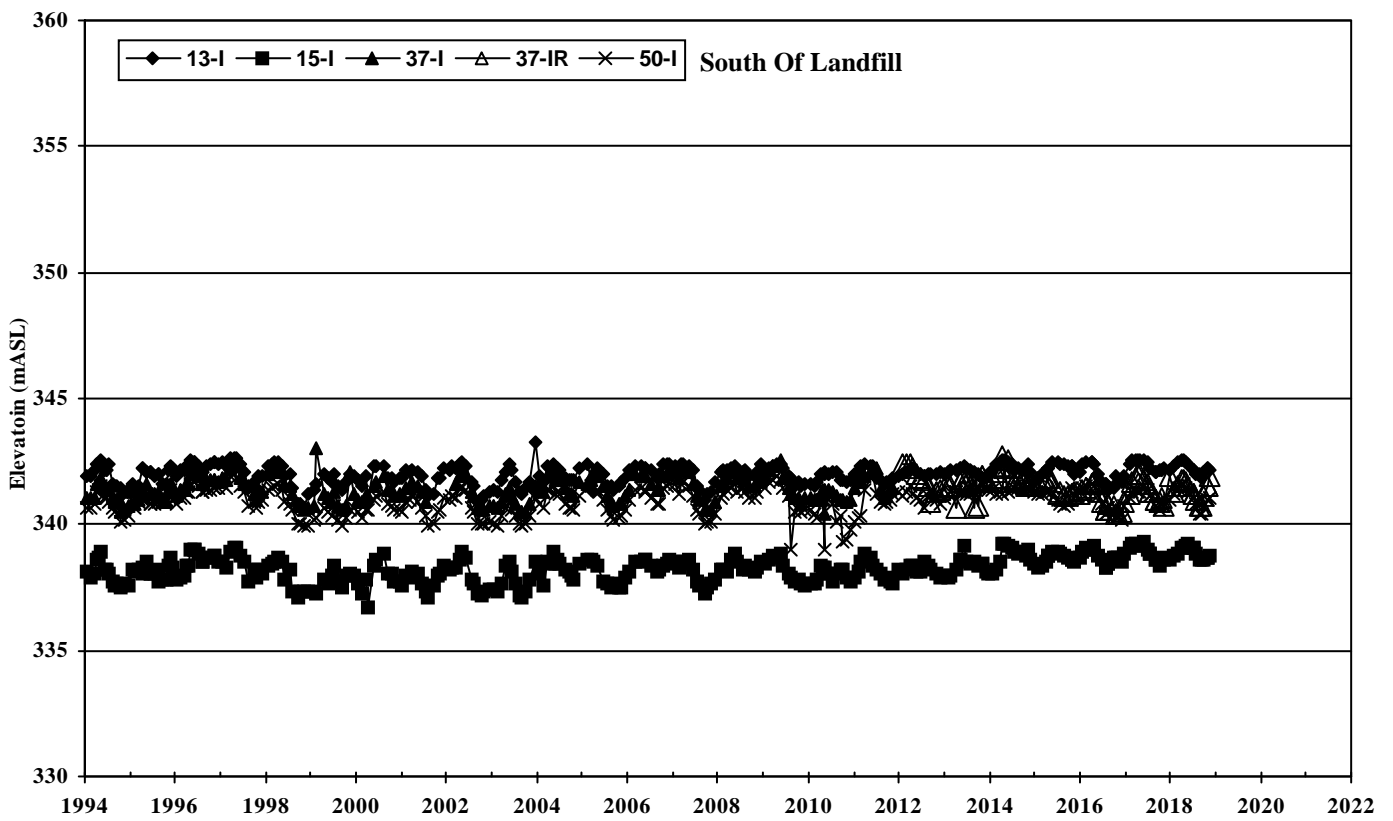
FIGURE
A2

Closed Eastview Road Landfill Site
Groundwater Elevation Trends
Detailed Bedrock Levels North and South of the
Landfill

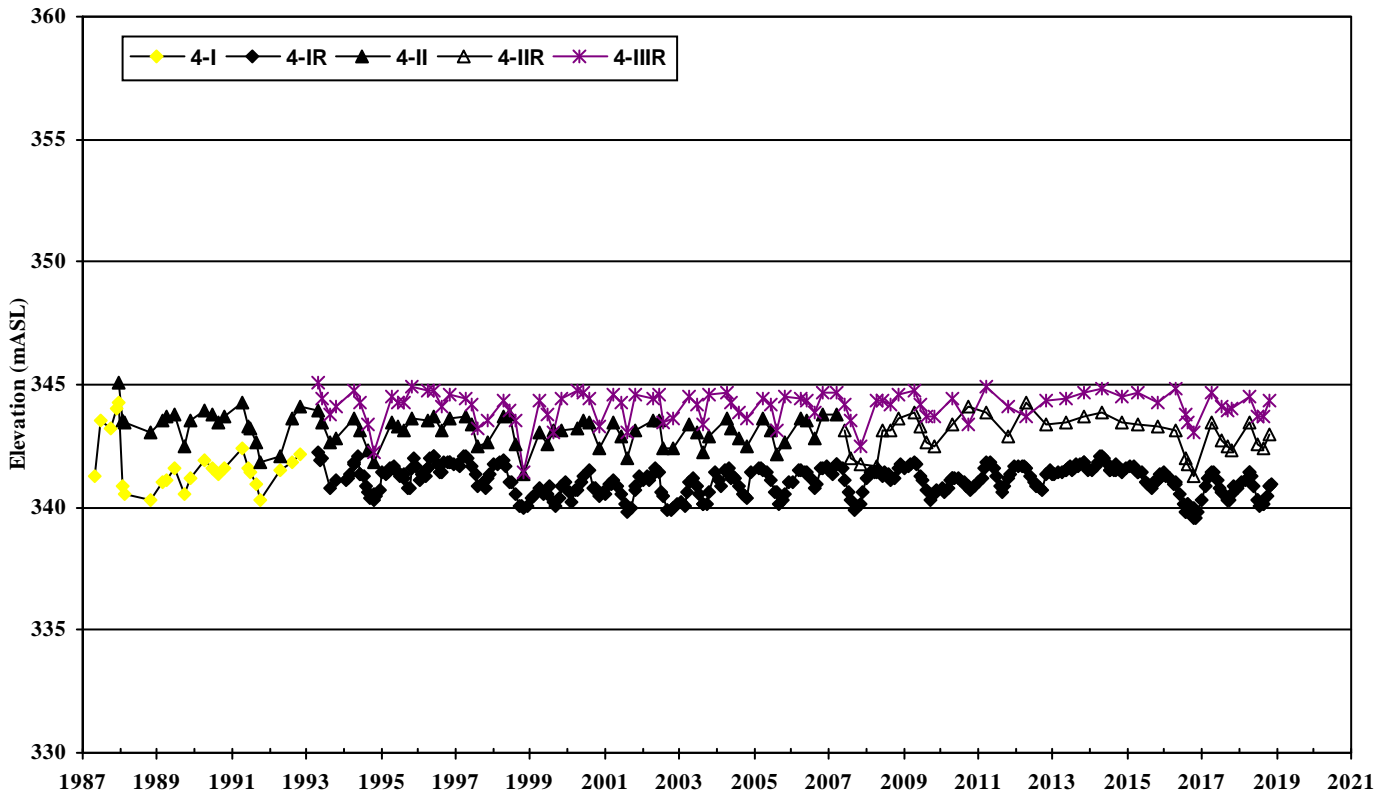
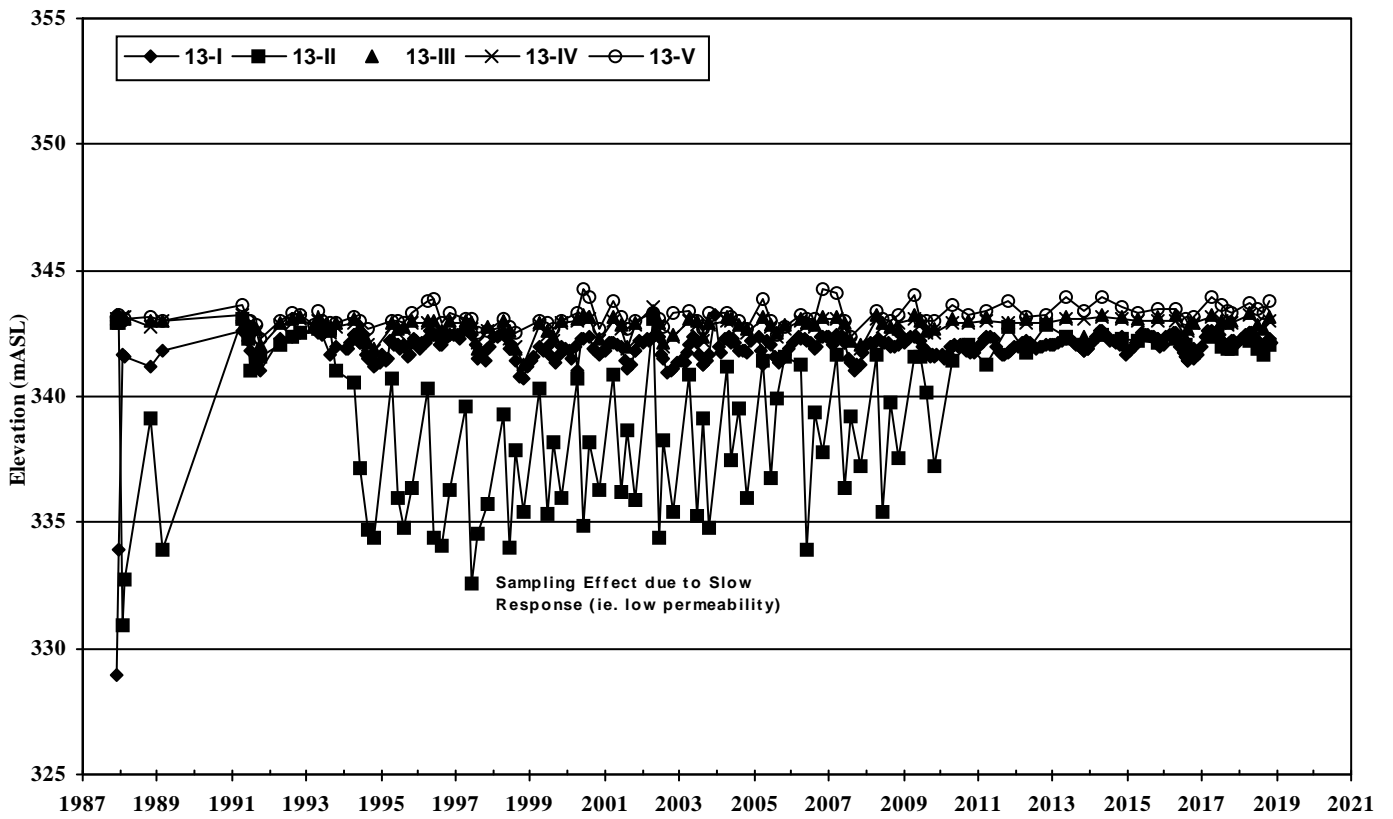
FIGURE
 A3

Closed Eastview Road Landfill Site
 Groundwater Elevation Trends
 Vertical Profiles at Locations 4 and 13

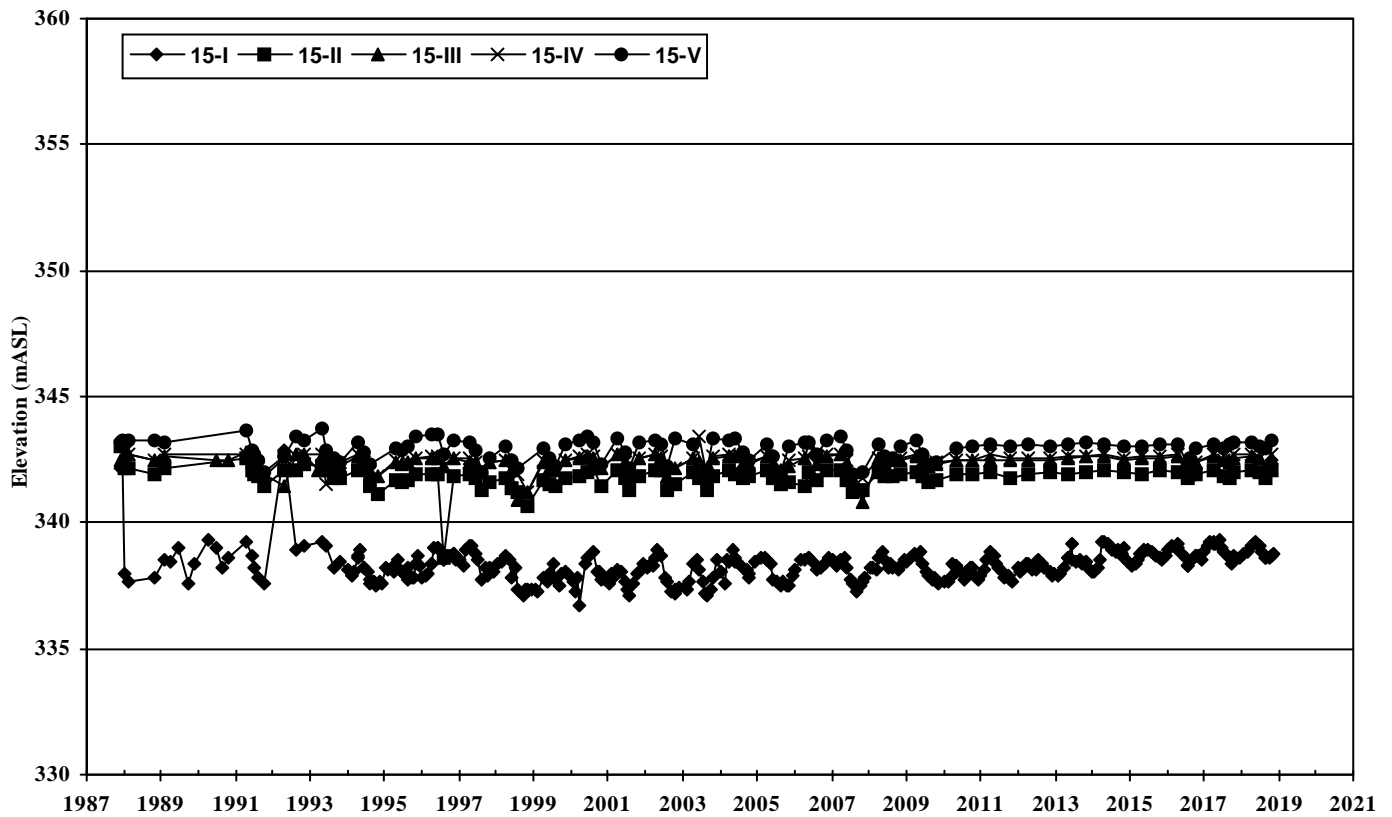
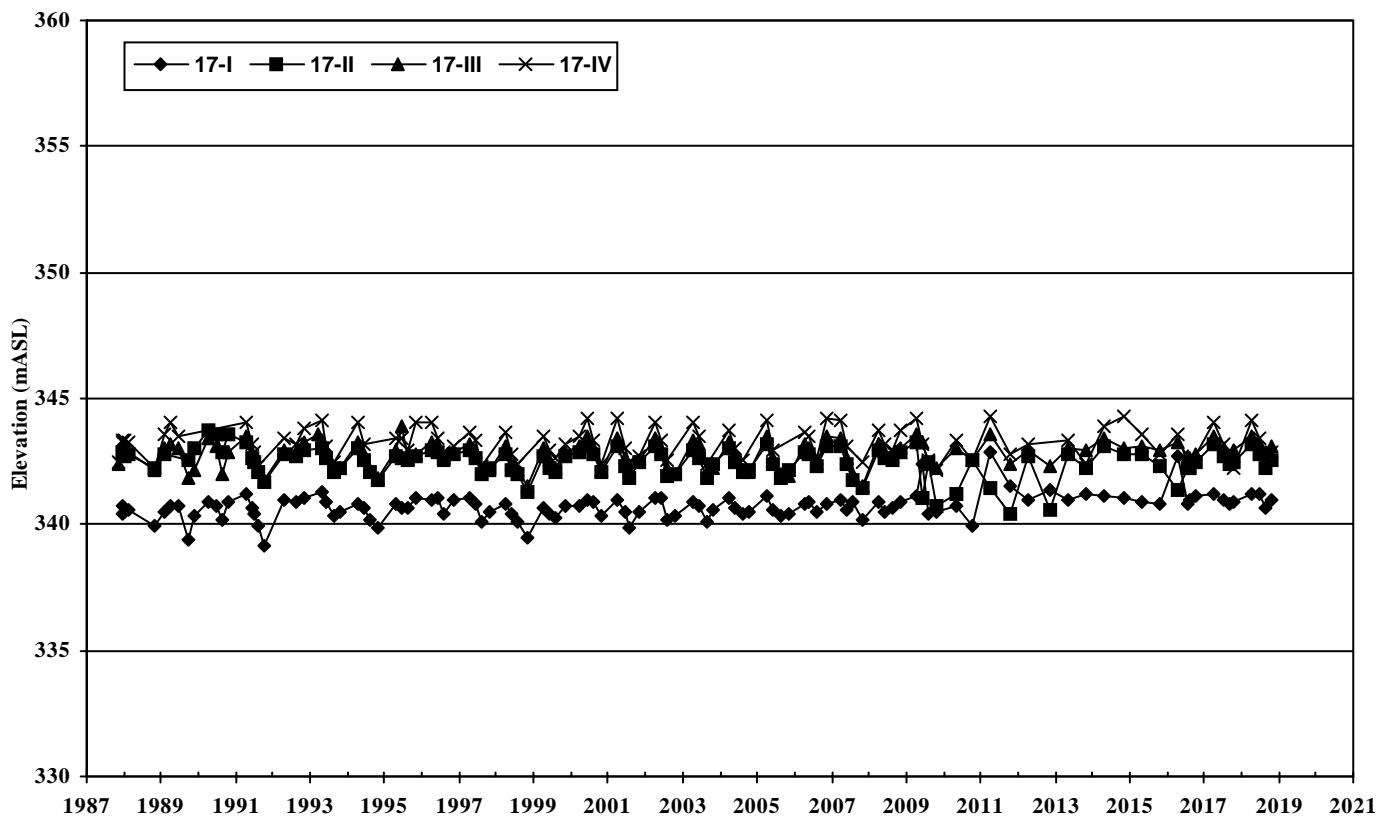
FIGURE
A4
 60598827
 10b Profile 15-17

Closed Eastview Road Landfill Site
Groundwater Elevation Trends
Vertical Profiles at Locations 15 and 17

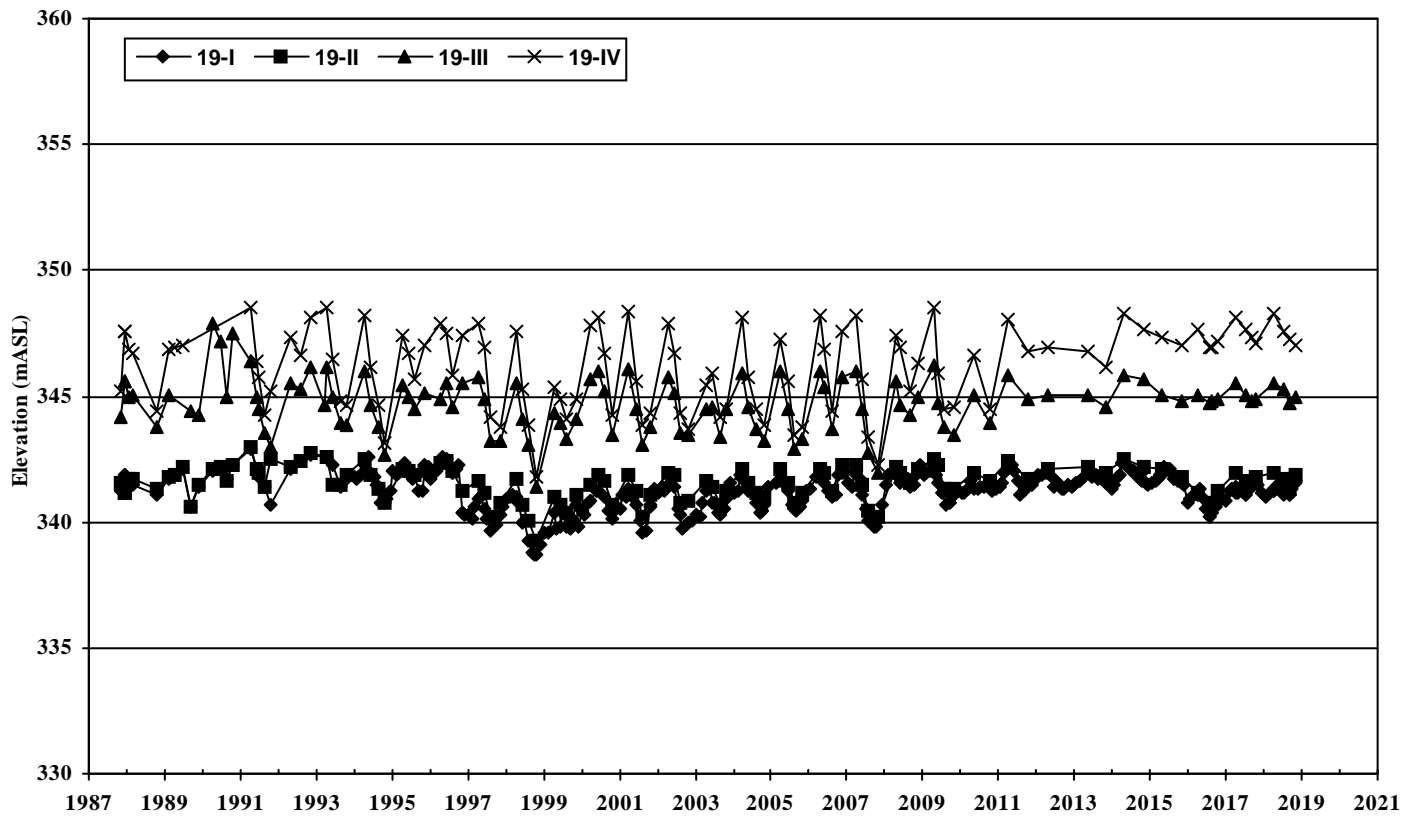
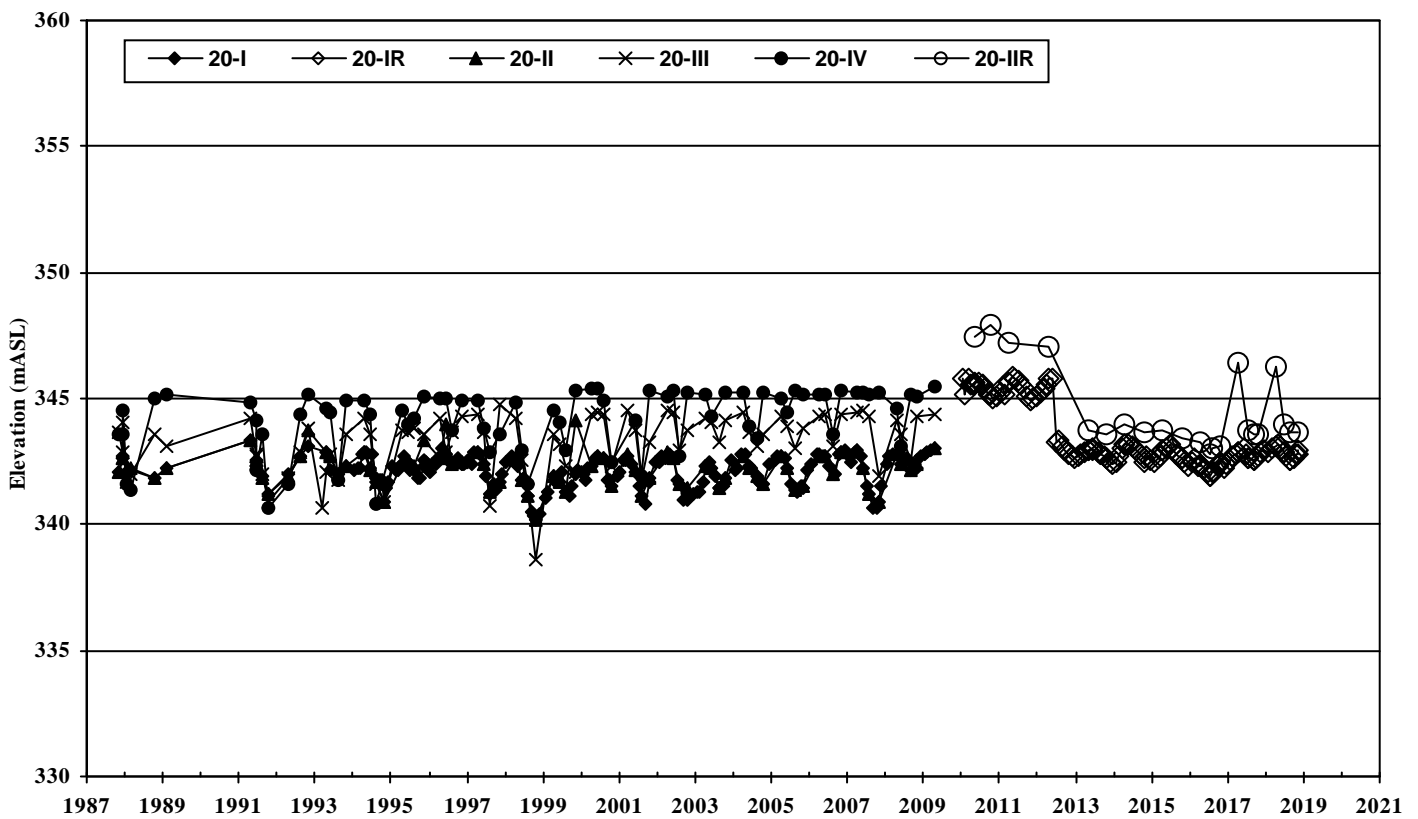
FIGURE
A5

Closed Eastview Road Landfill Site
Groundwater Elevation Trends
Vertical Profiles at Locations 19 and 20
