City of Guelph

2018 Annual Report

Closed Eastview Road Landfill Site

Date: April, 2019
Project #: 60598827-1

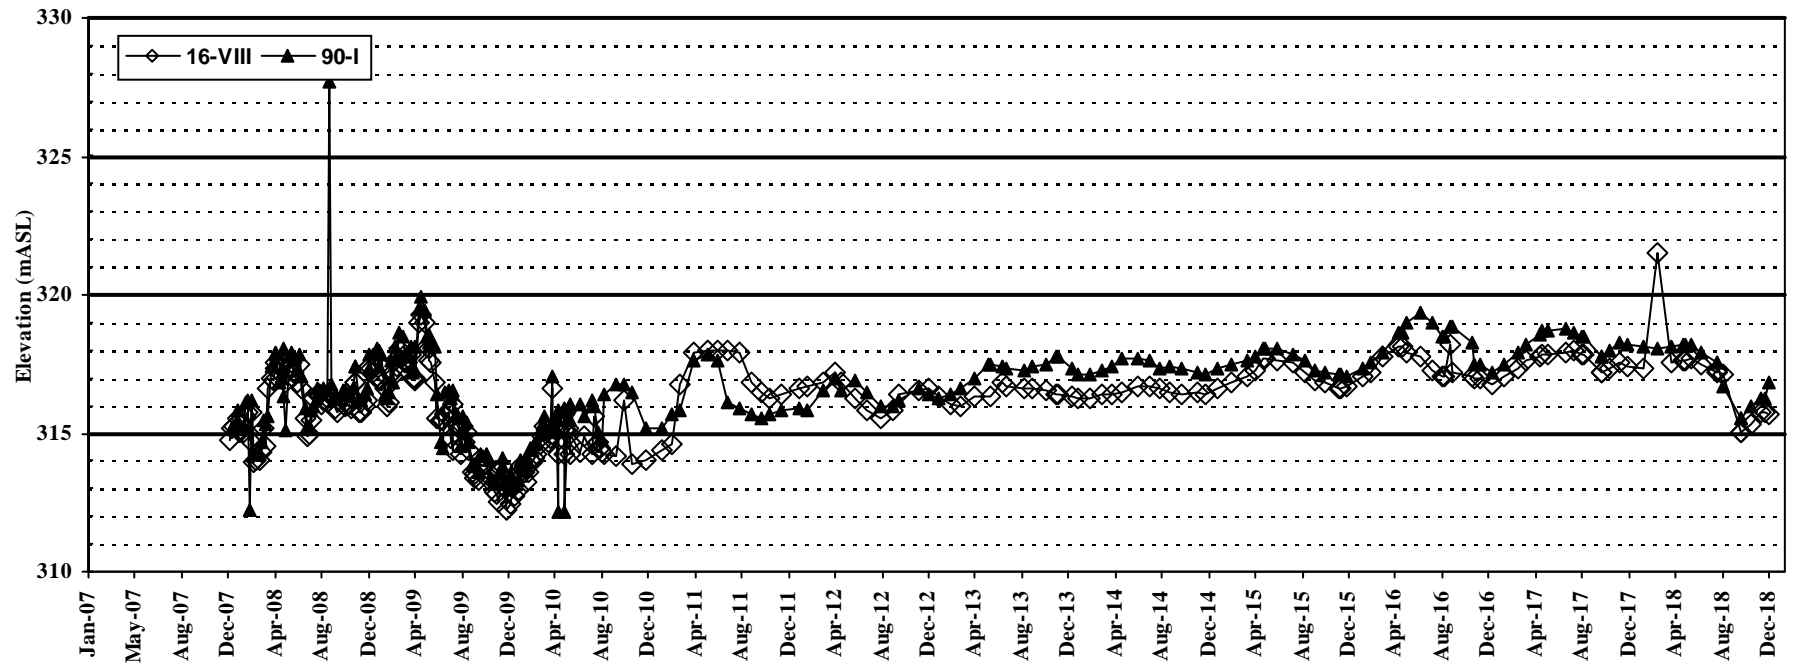
FIGURE
A7

Closed Eastview Road Landfill Site
Bedrock Groundwater Elevations Trends
In Deep Bedrock Aquifer

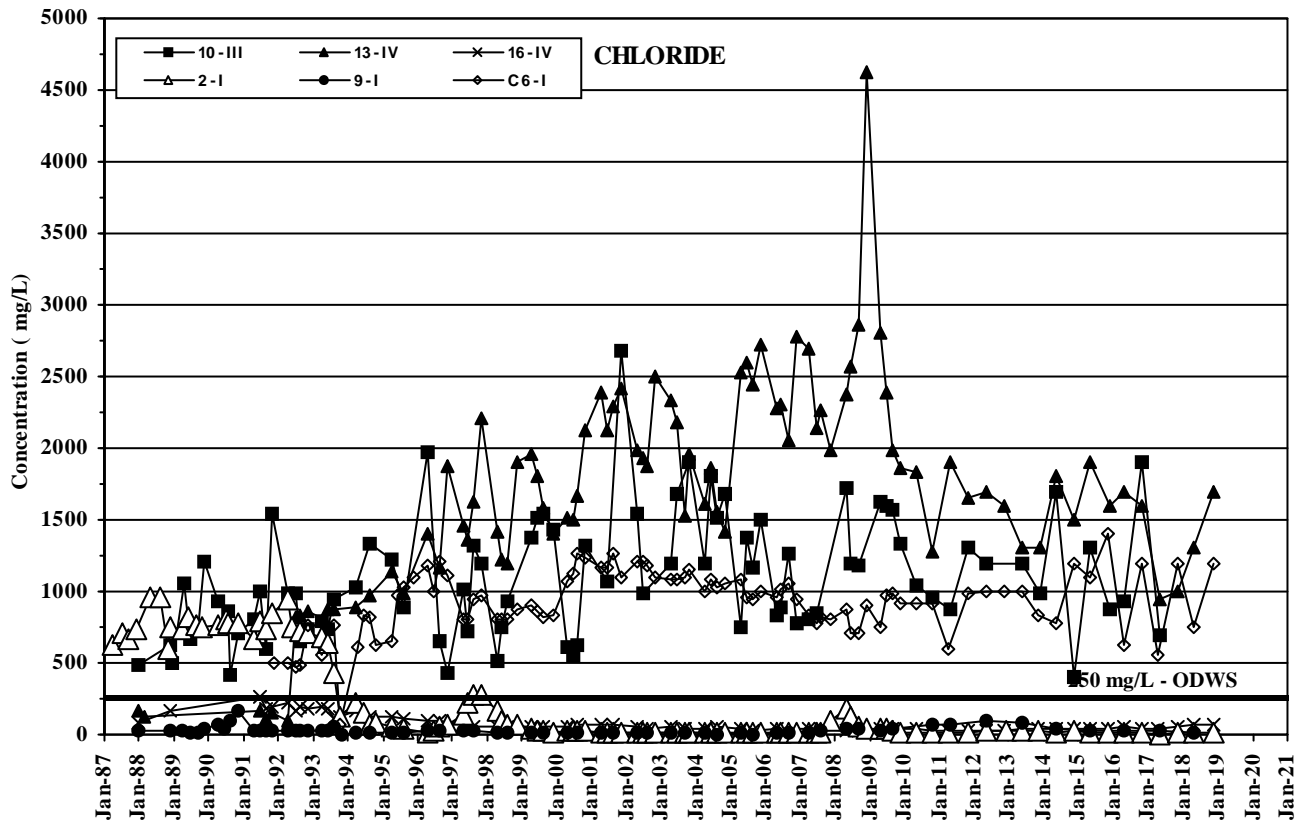
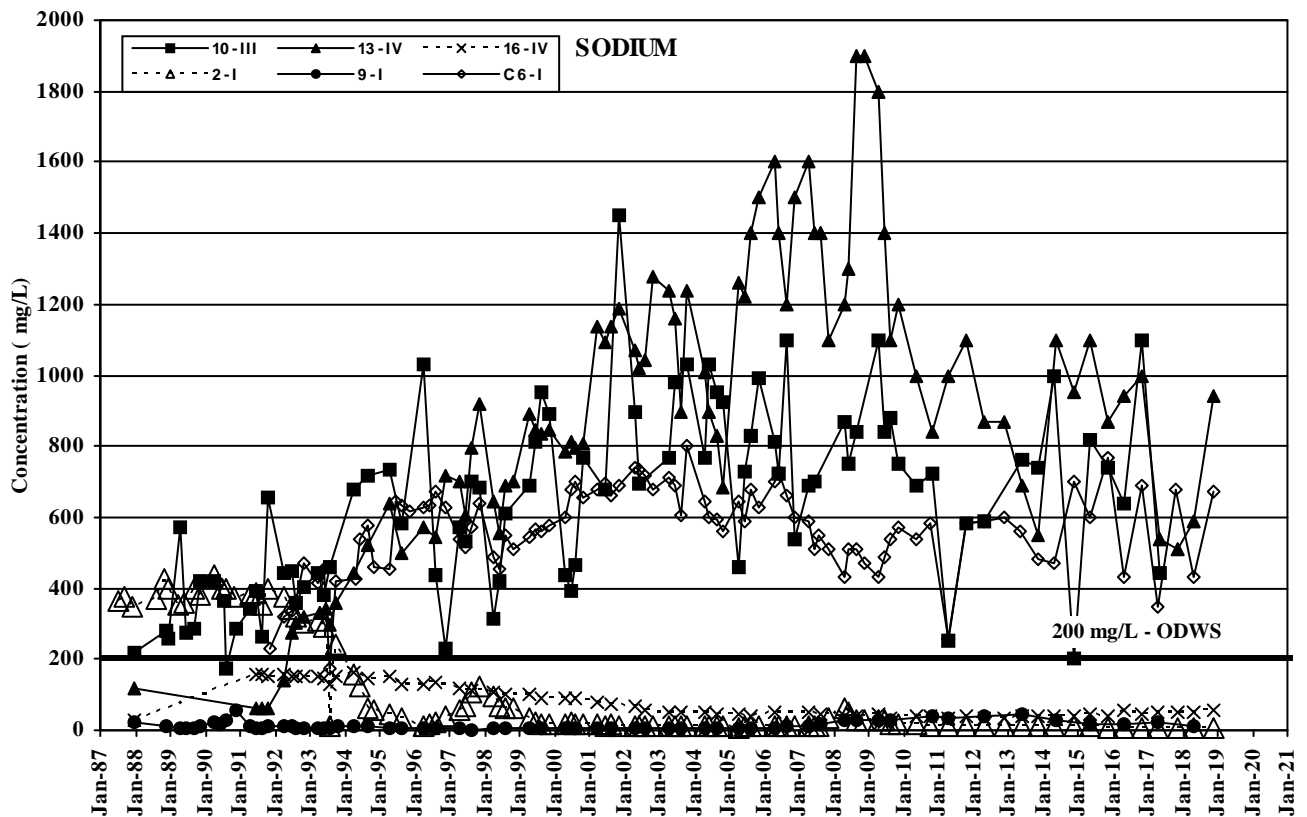
FIGURE
C1

Closed Eastview Road Landfill Site
Ground Water Chemistry Trends
Shallow Overburden South of Landfill

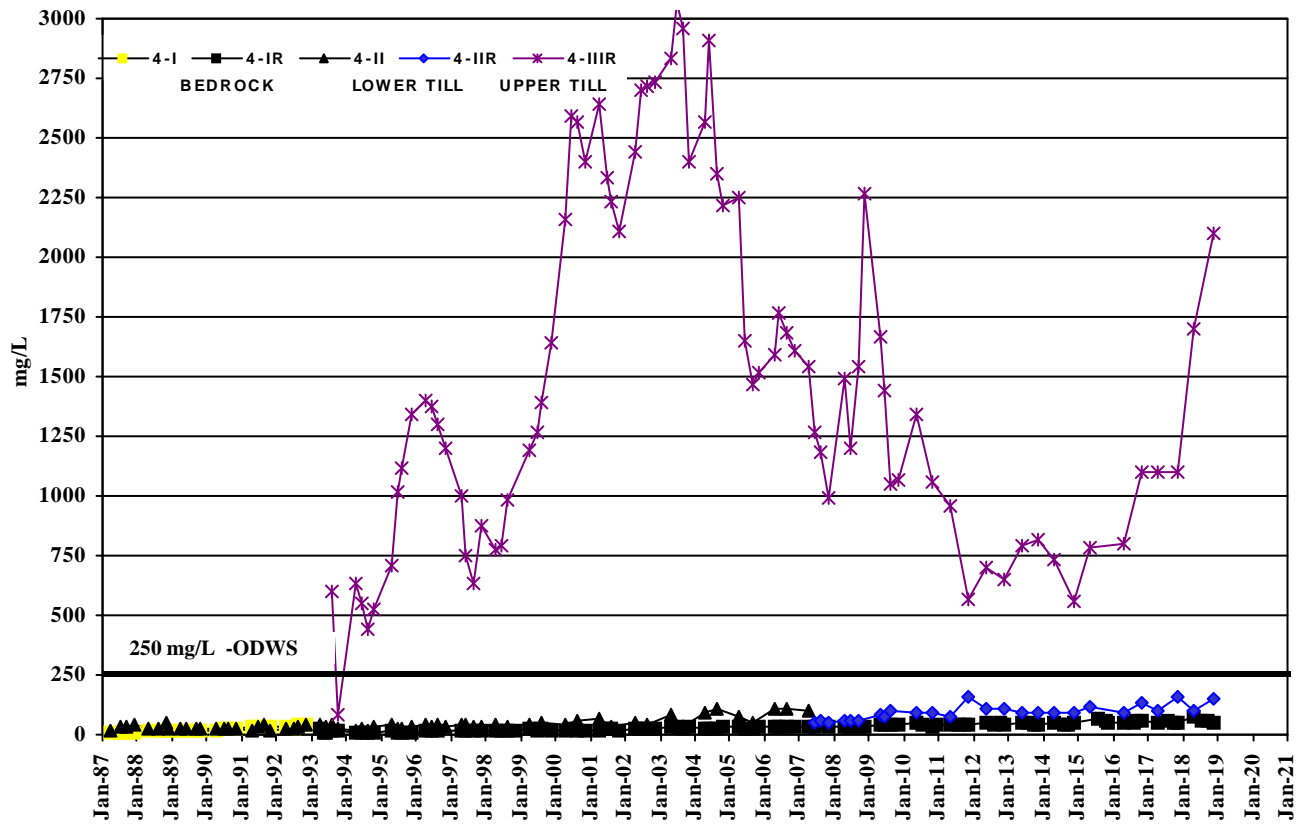
FIGURE
C7

Closed Eastview Road Landfill Site
Ground Water Chemistry Trends
Chloride Concentration Profile

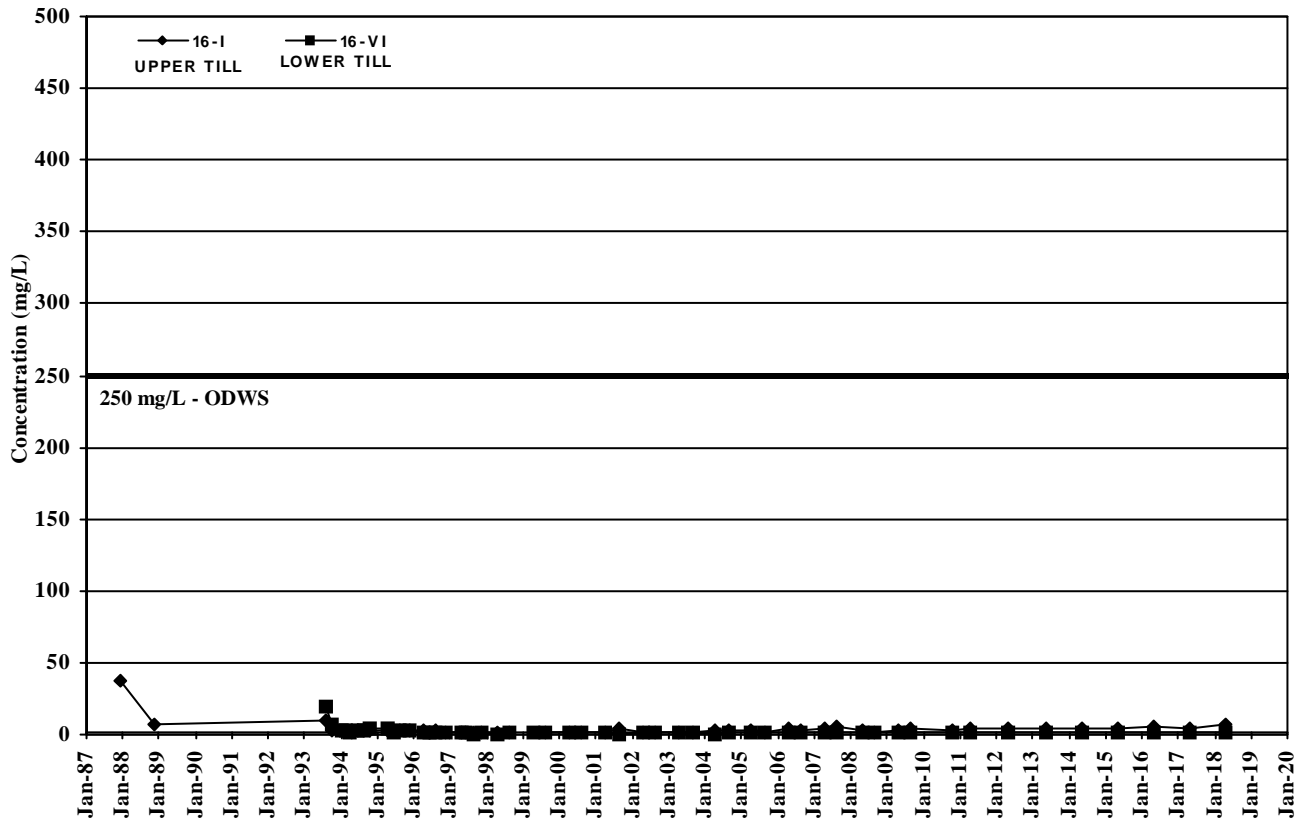
FIGURE
C9

Closed Eastview Road Landfill Site
Ground Water Chemistry Trends
Chloride Concentration Profile

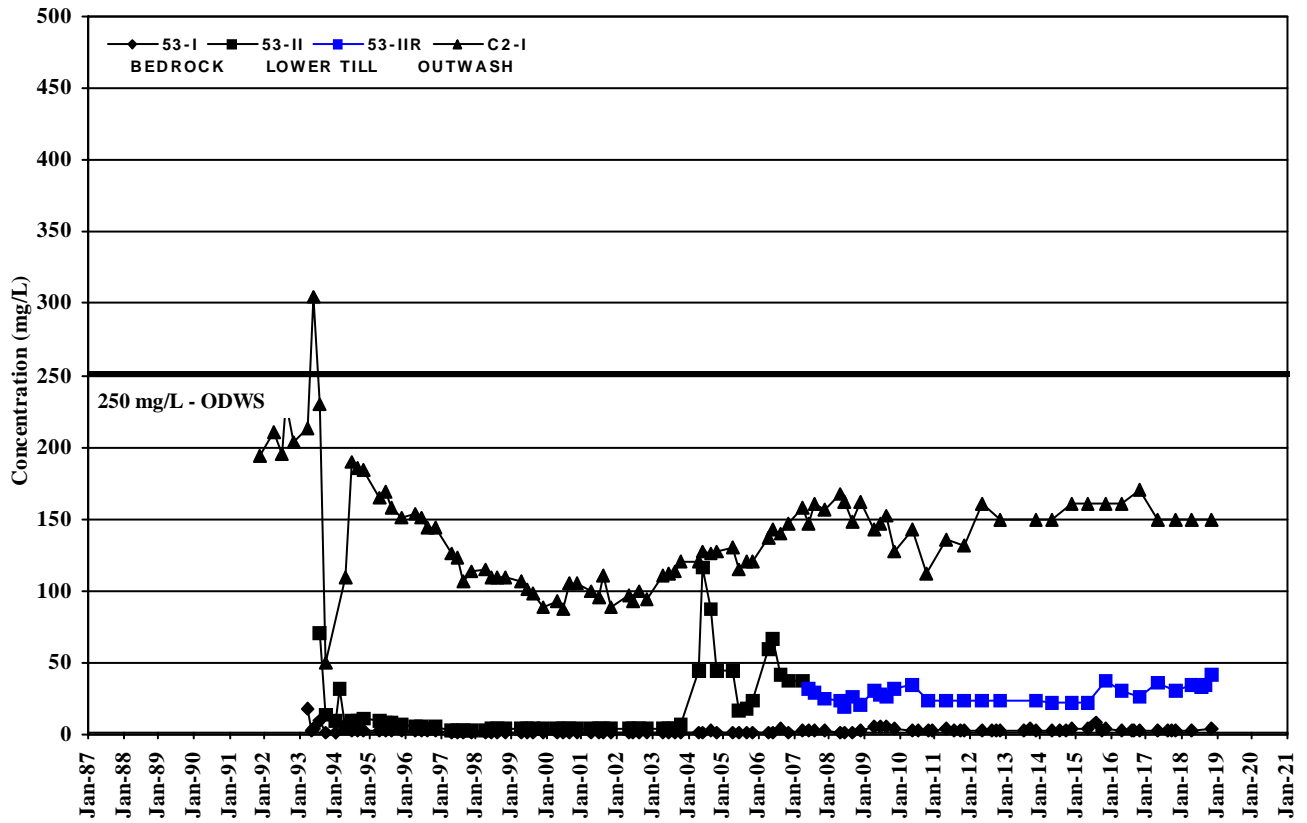
FIGURE
 C10

Closed Eastview Road Landfill Site
 Ground Water Chemistry Trends
 Chloride Concentration Profile

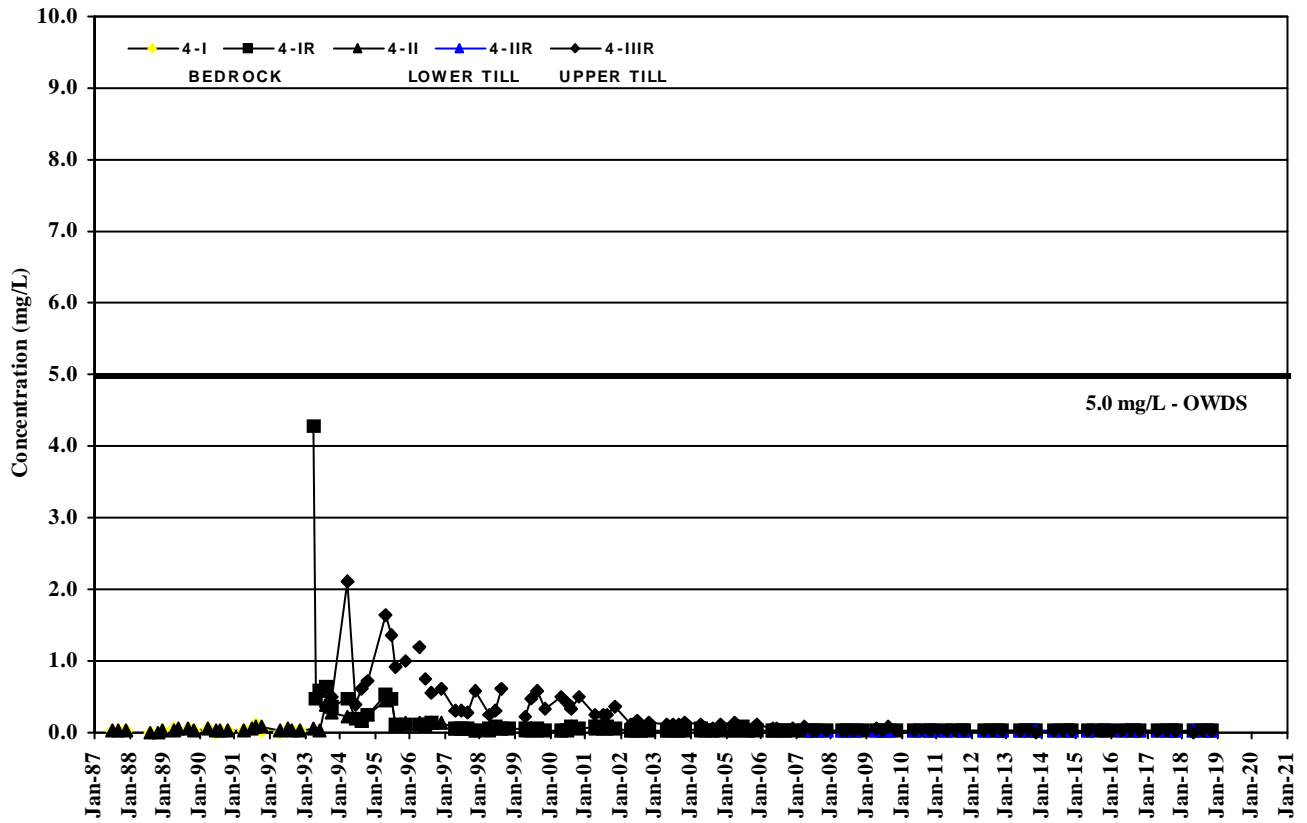
FIGURE
C11

Closed Eastview Road Landfill Site
Ground Water Chemistry Trends
Boron Concentration Profile

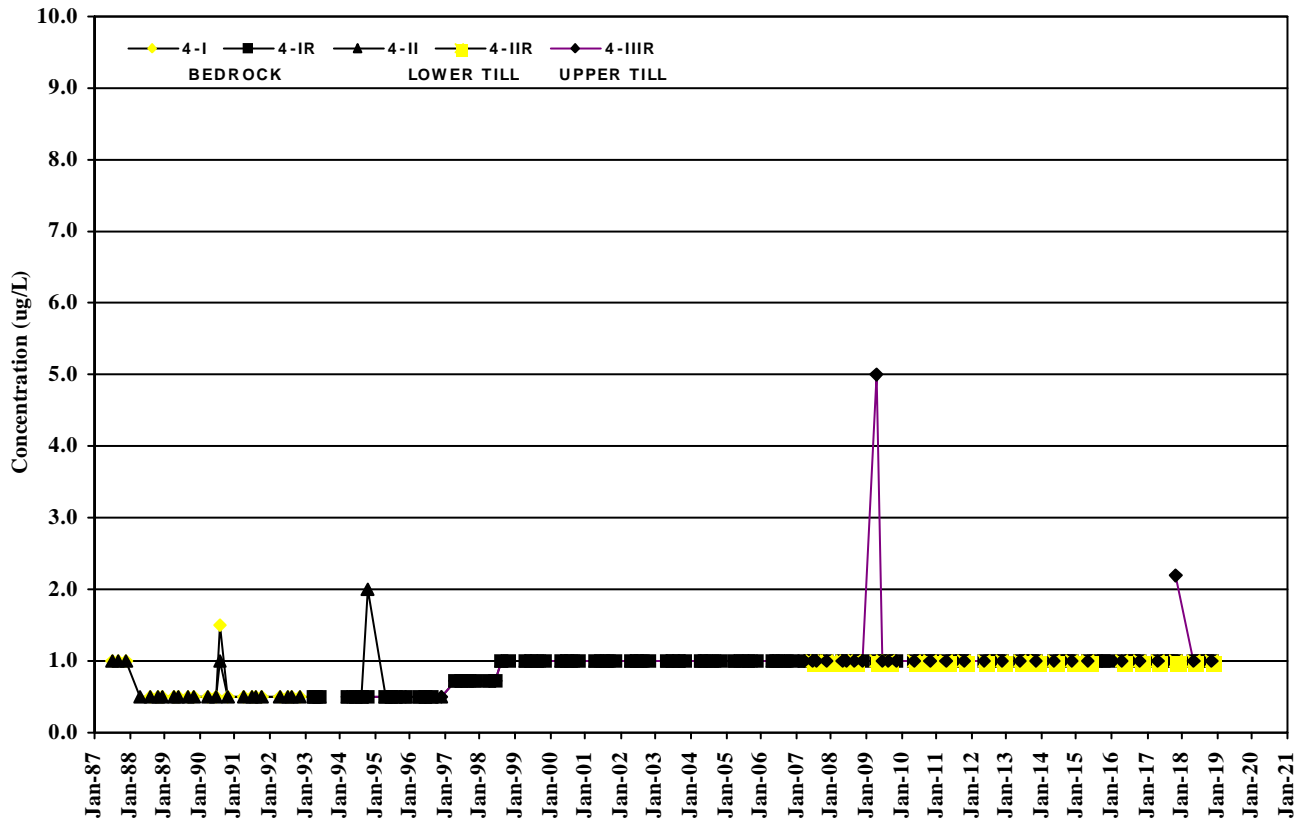
FIGURE
C15

Closed Eastview Road Landfill Site
Ground Water Chemistry Trends
Phenol Concentration Profile

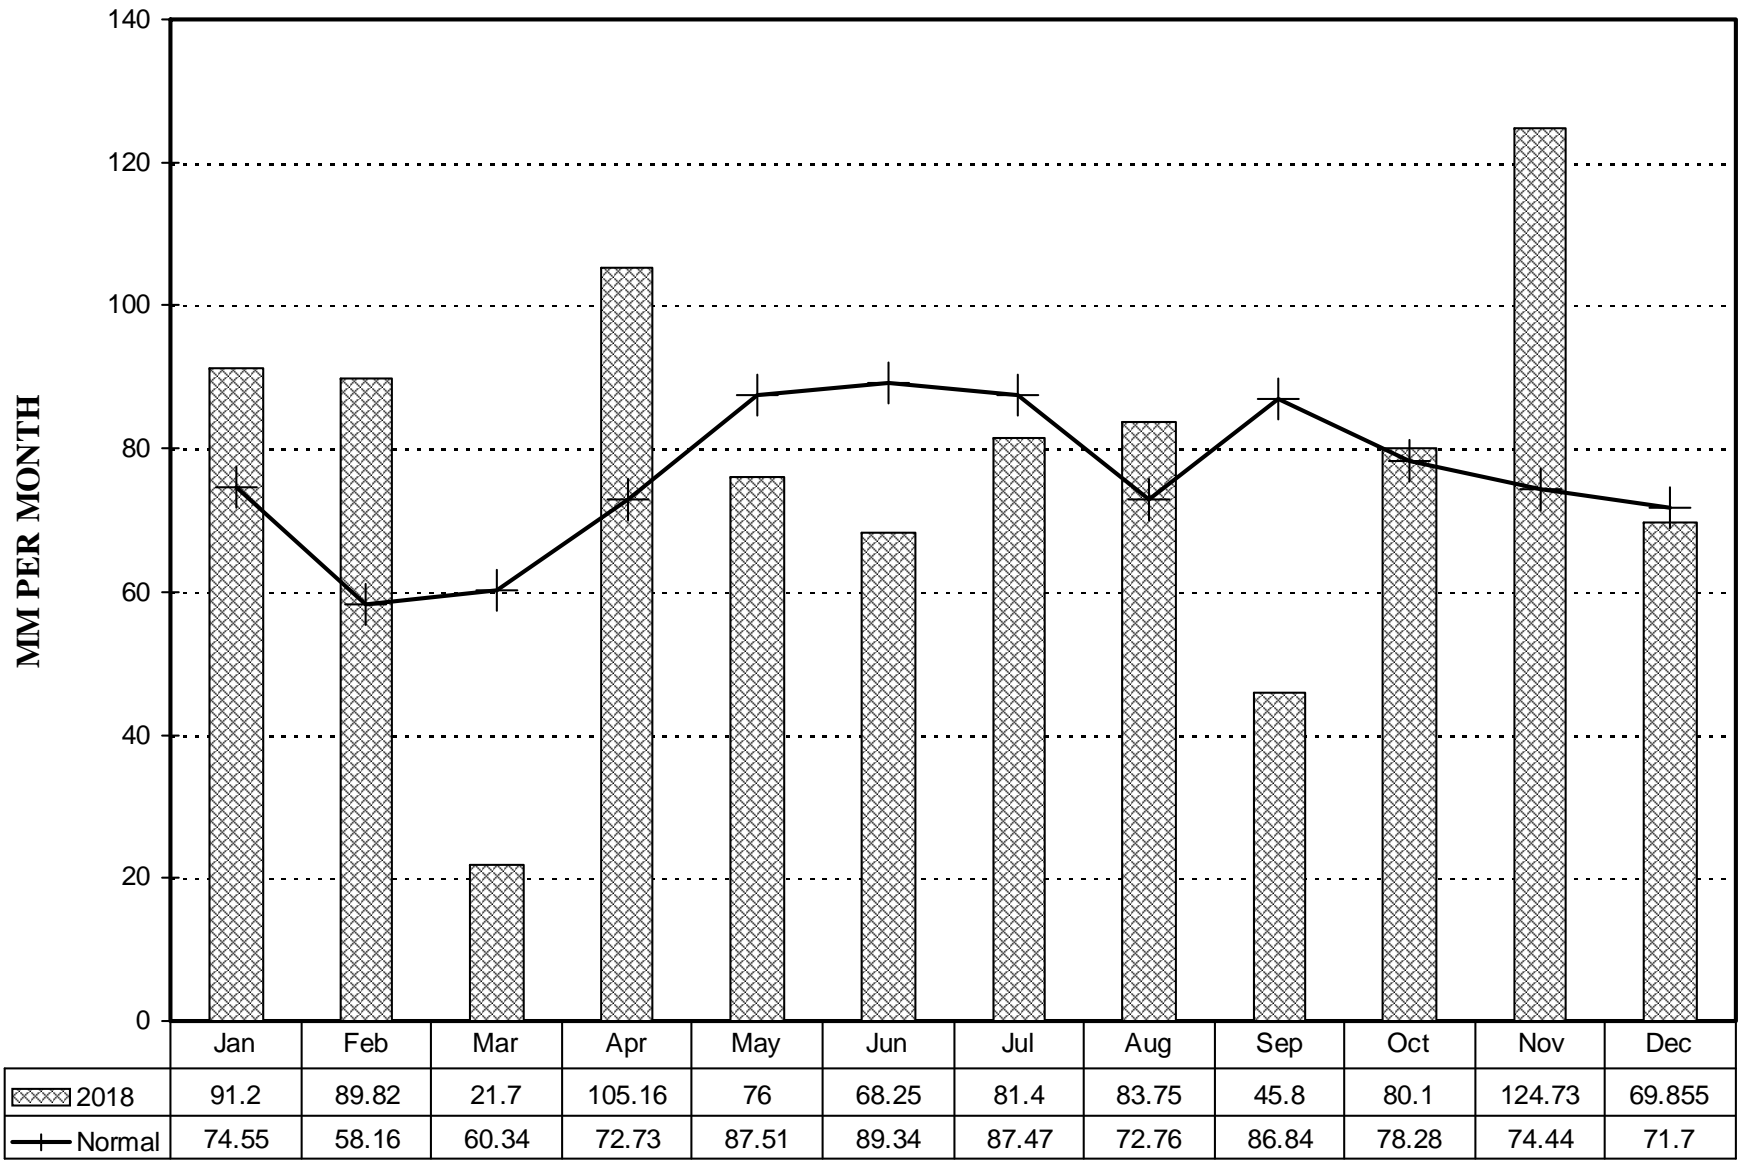
Precipitation Comparison, 2018

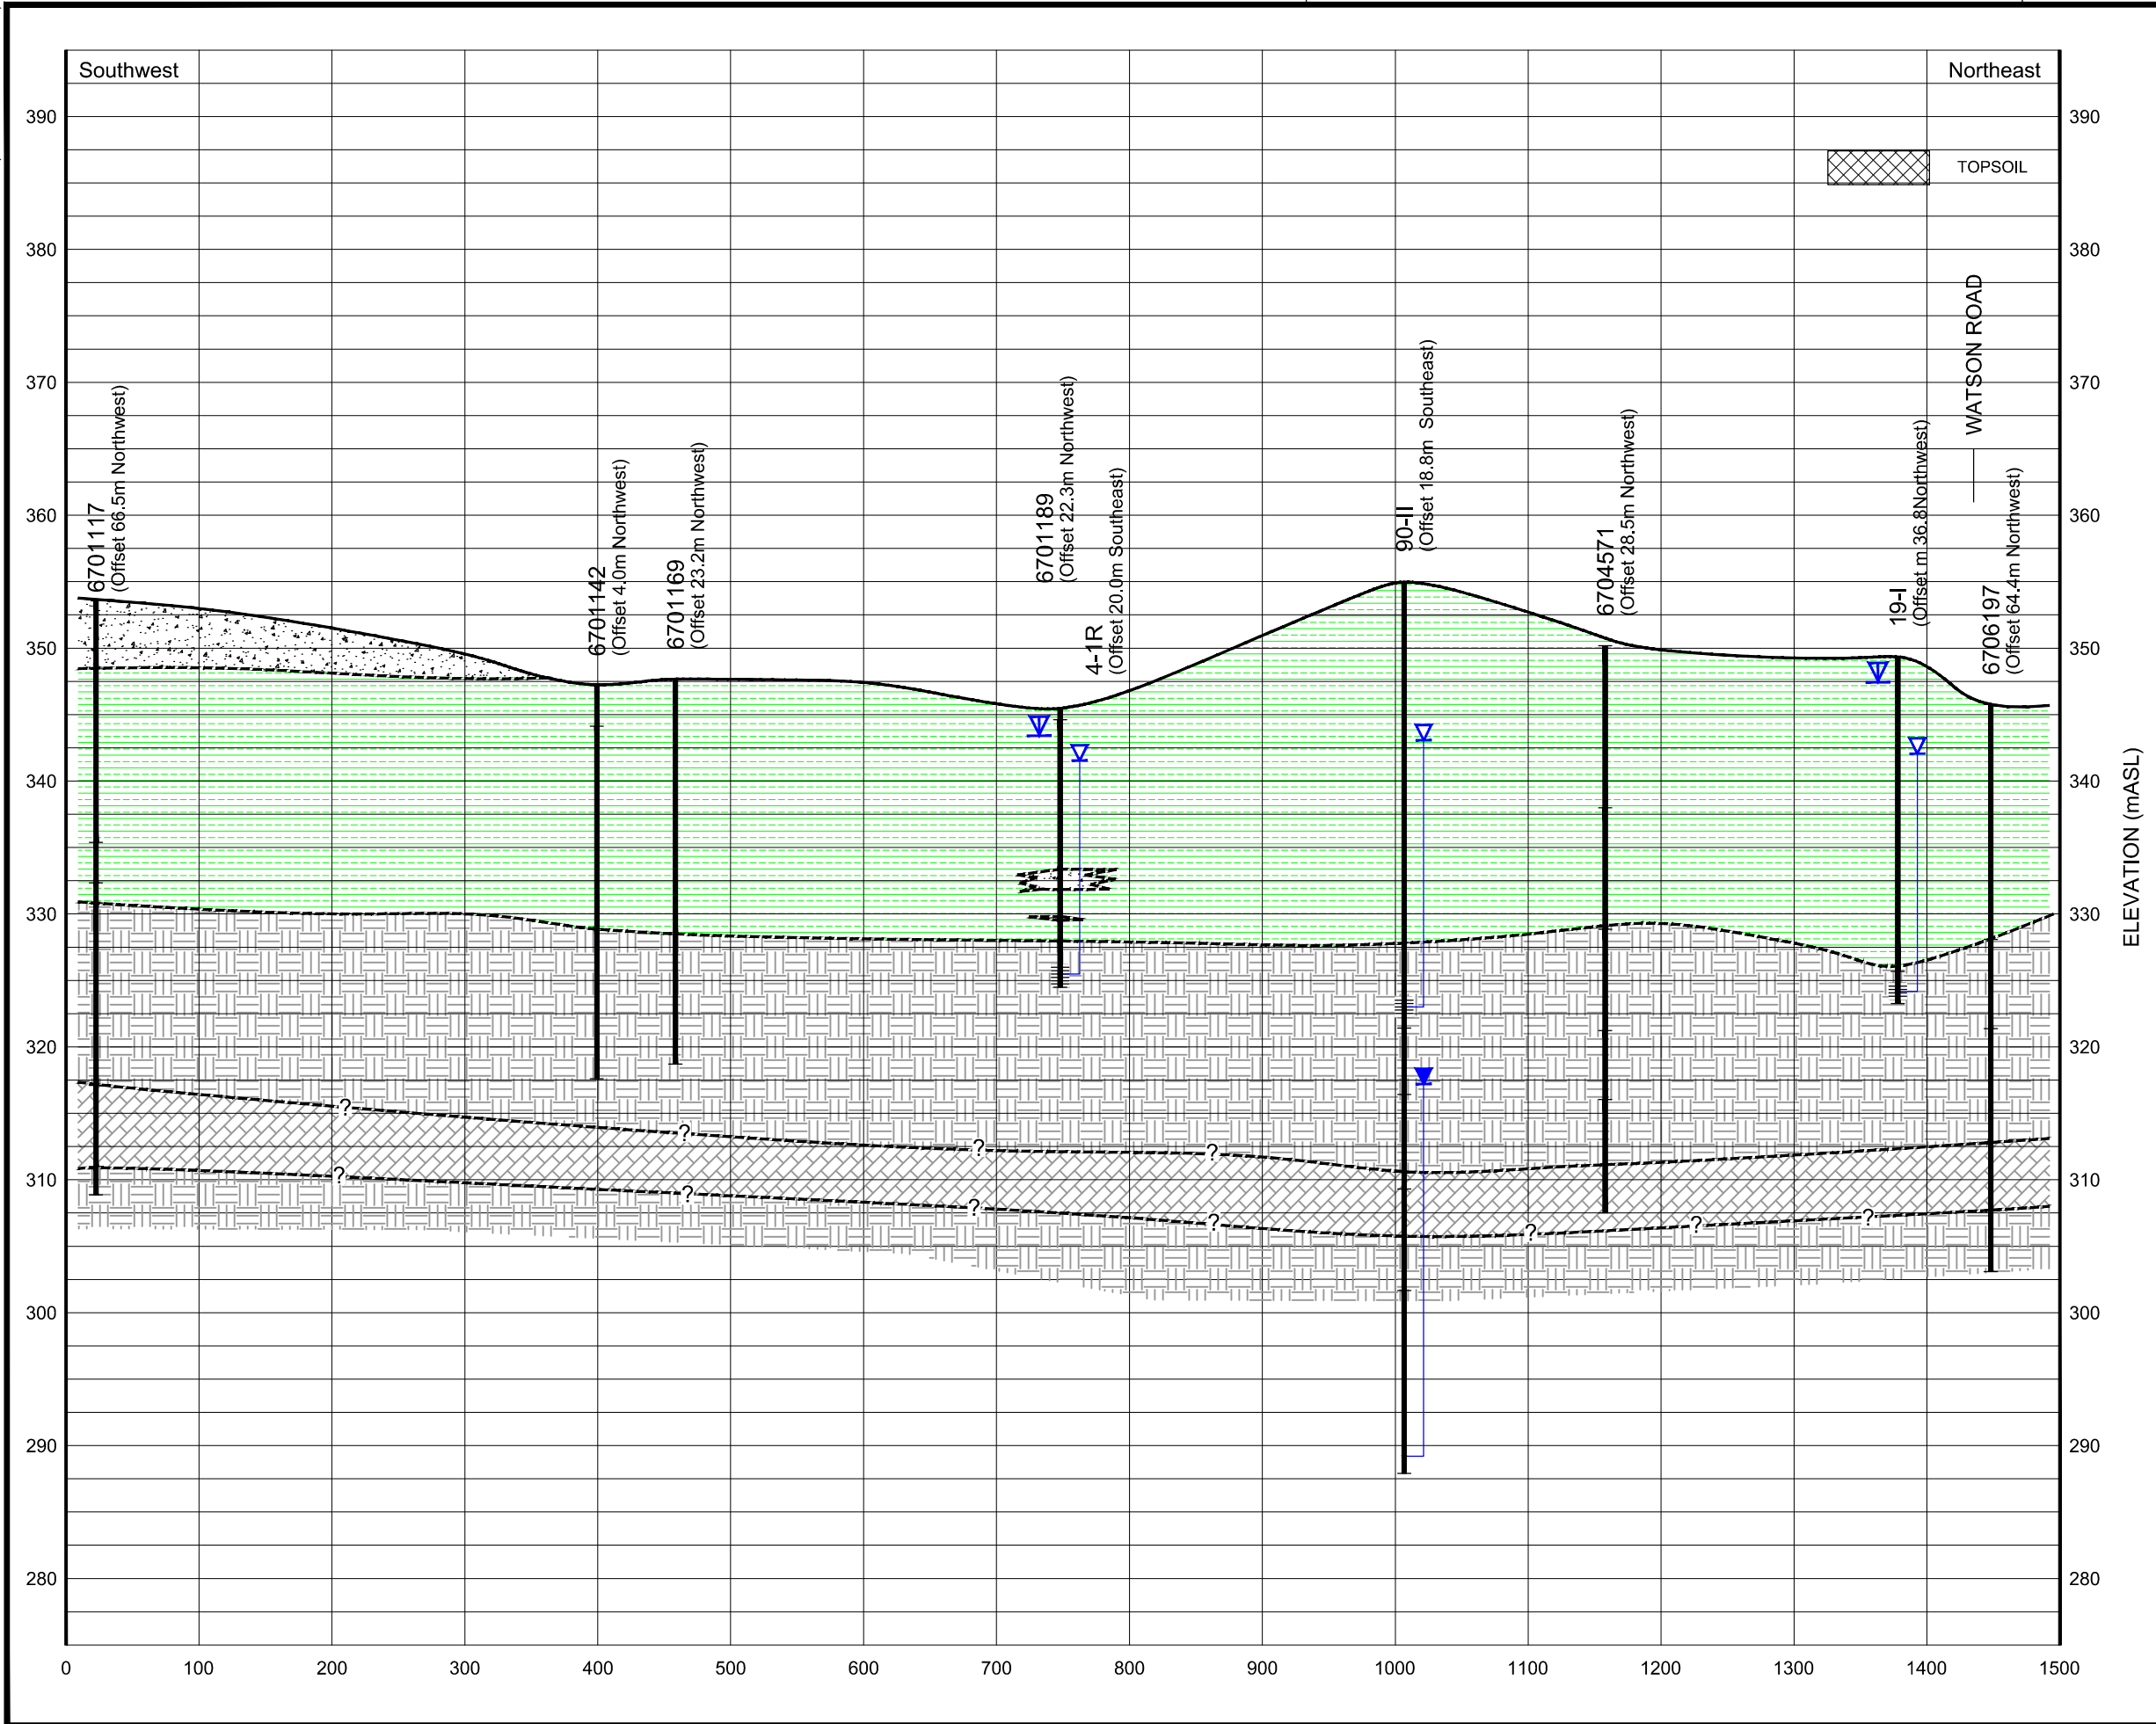
- FILL
- TILL
- OUTWASH (SAND, GRAVELLY SAND, SILTY SAND)
- SANDY GRAVEL
- DOLOSTONE BEDROCK
- SHALEY DOLOSTONE (VINEMOUNT MEMBER)

Eastview Road Landfill City of Guelph		
SECTION A-A'		
PROJECT NUMBER	DATE	FIGURE
60339708	November, 2015	4

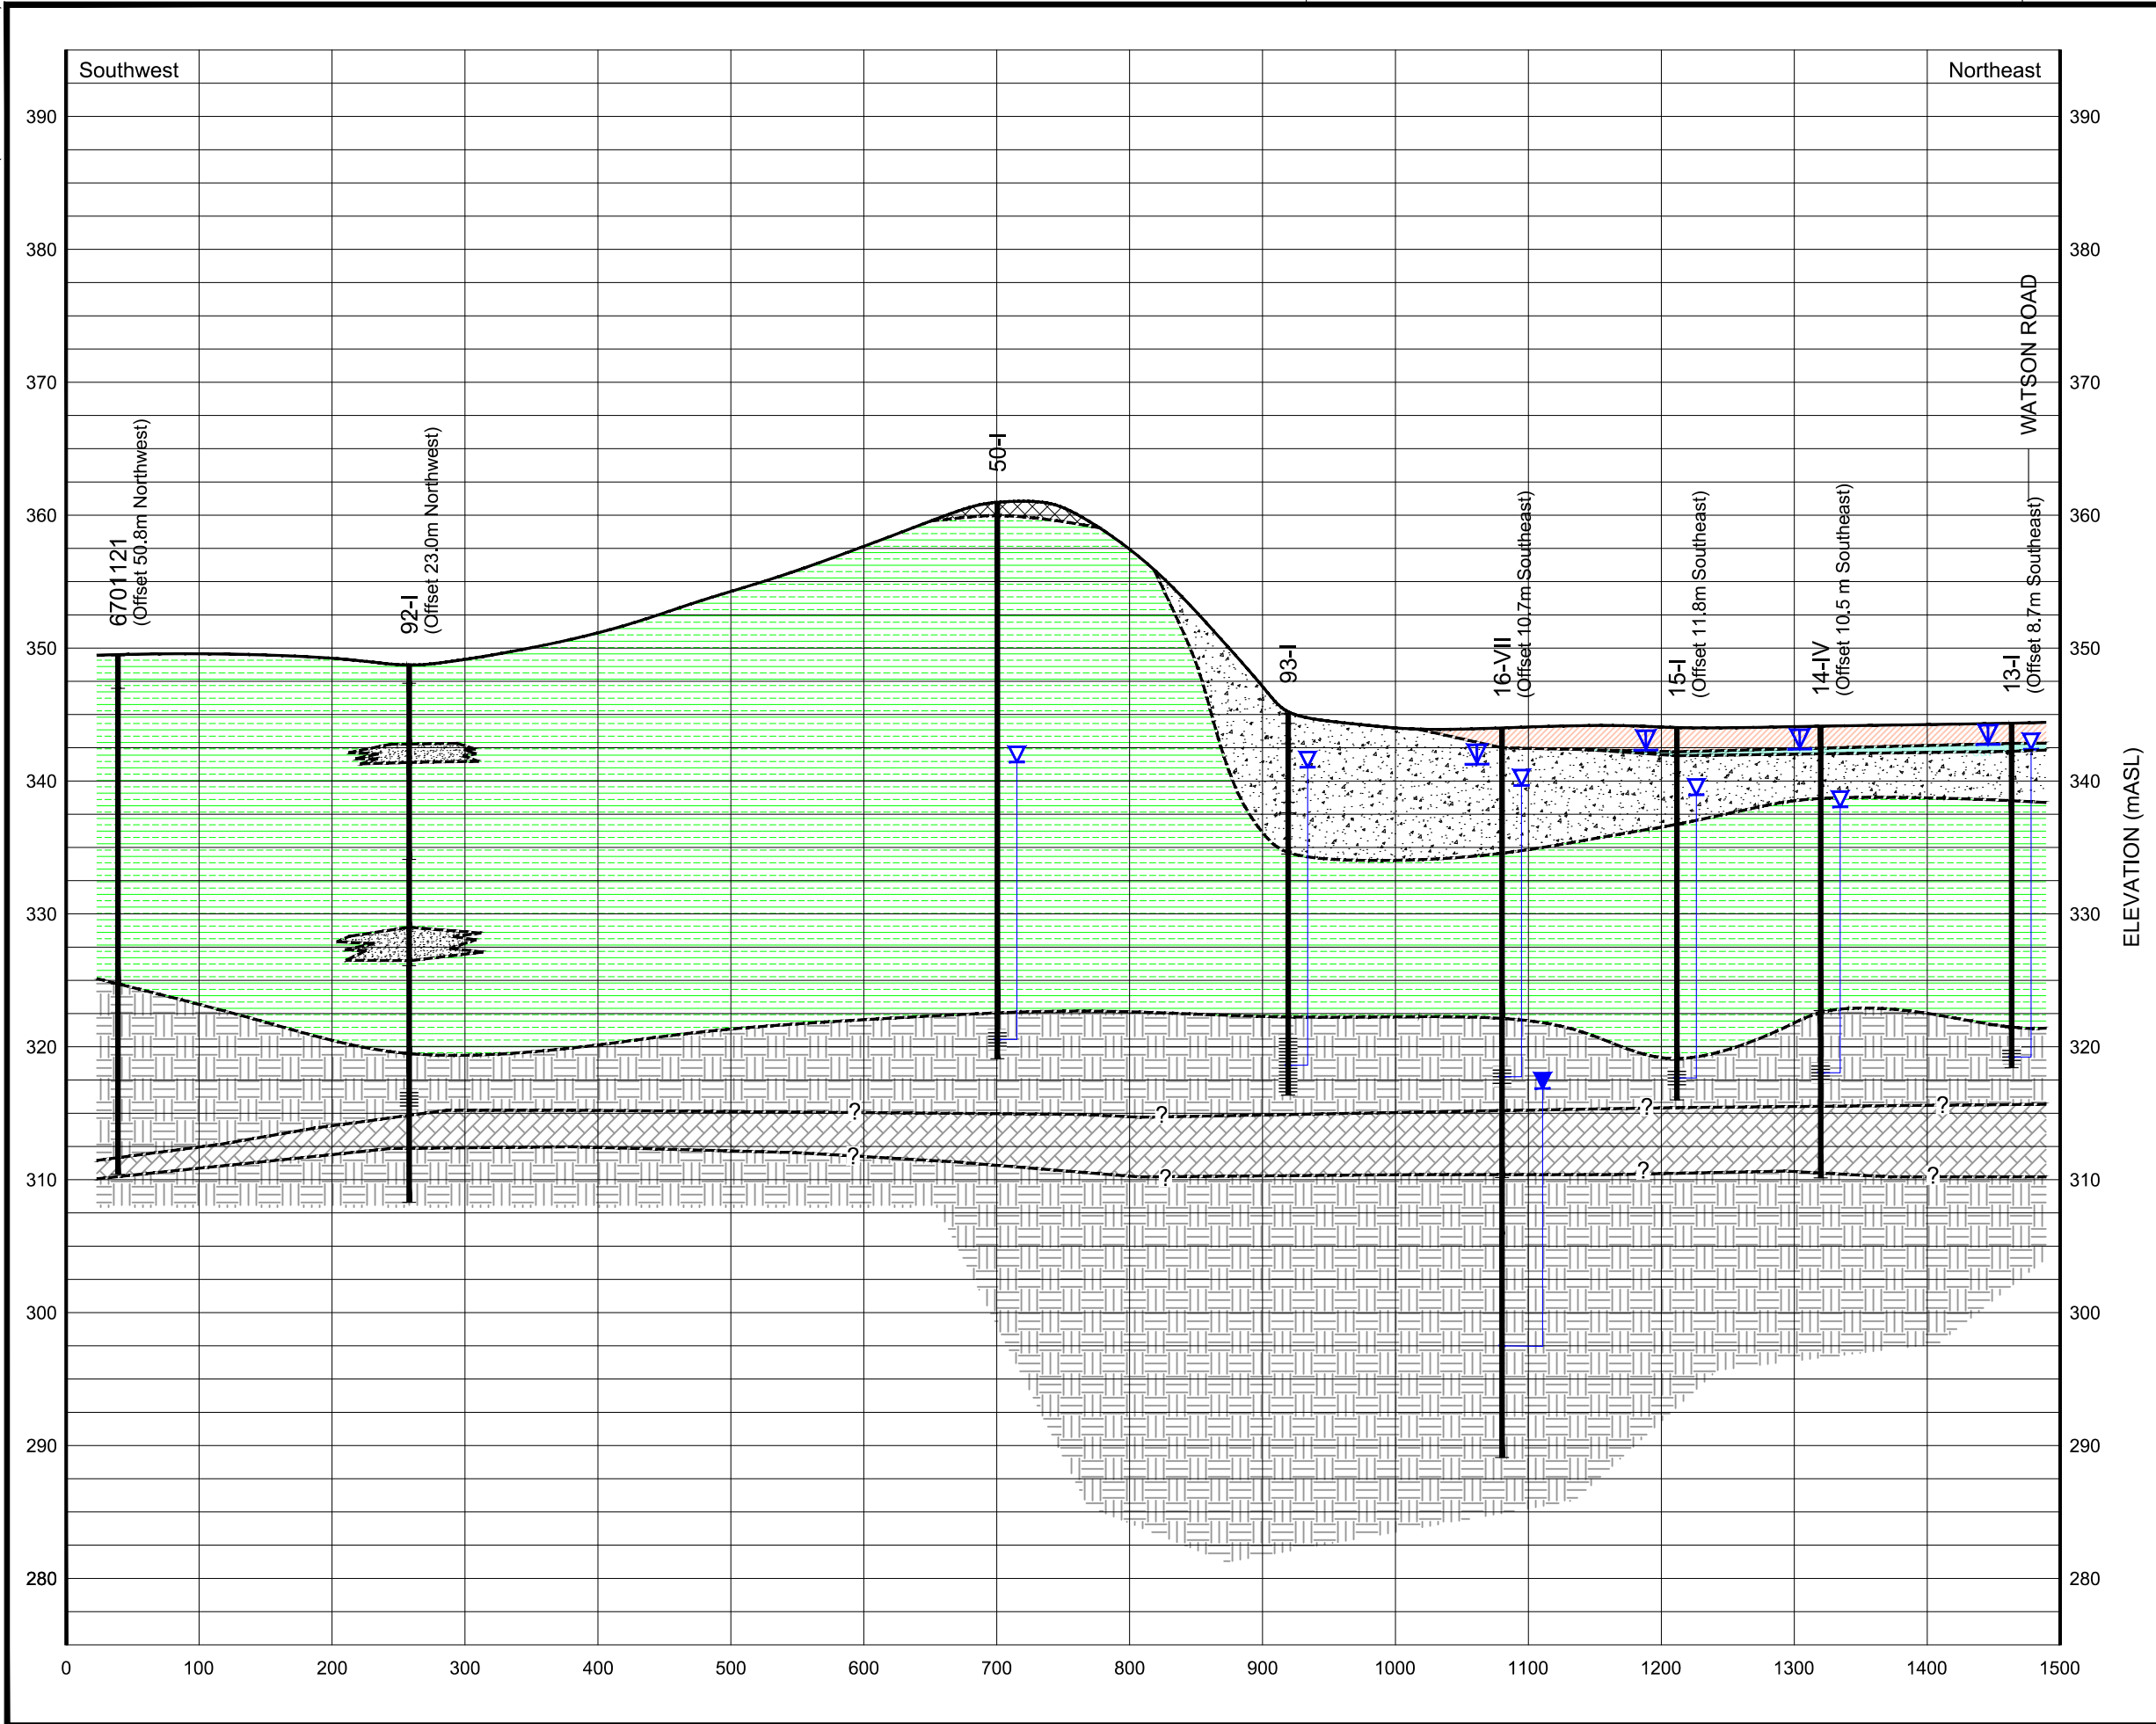
Eastview Road Landfill City of Guelph		
SECTION B-B'		
PROJECT NUMBER	DATE	FIGURE
60339708	November, 2015	5

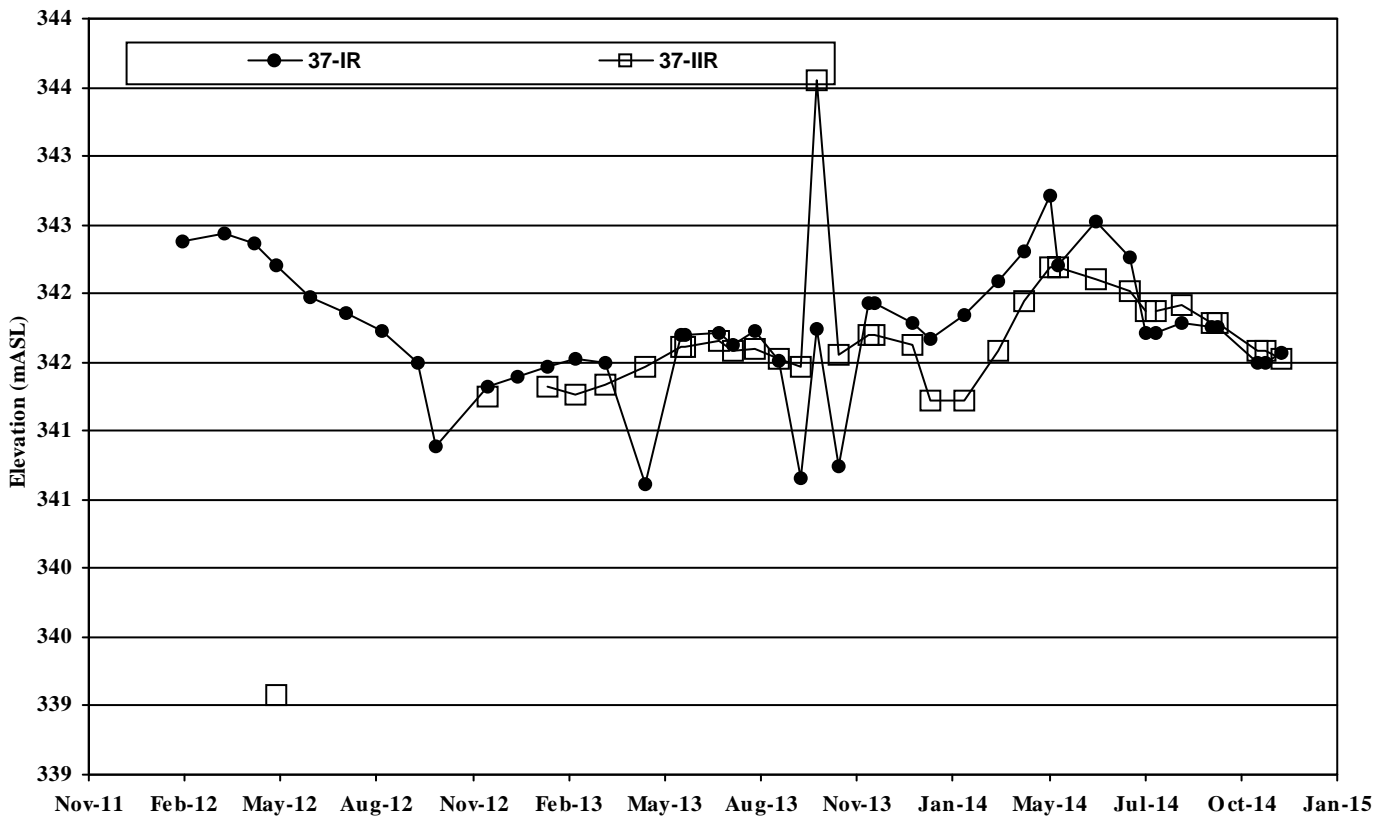
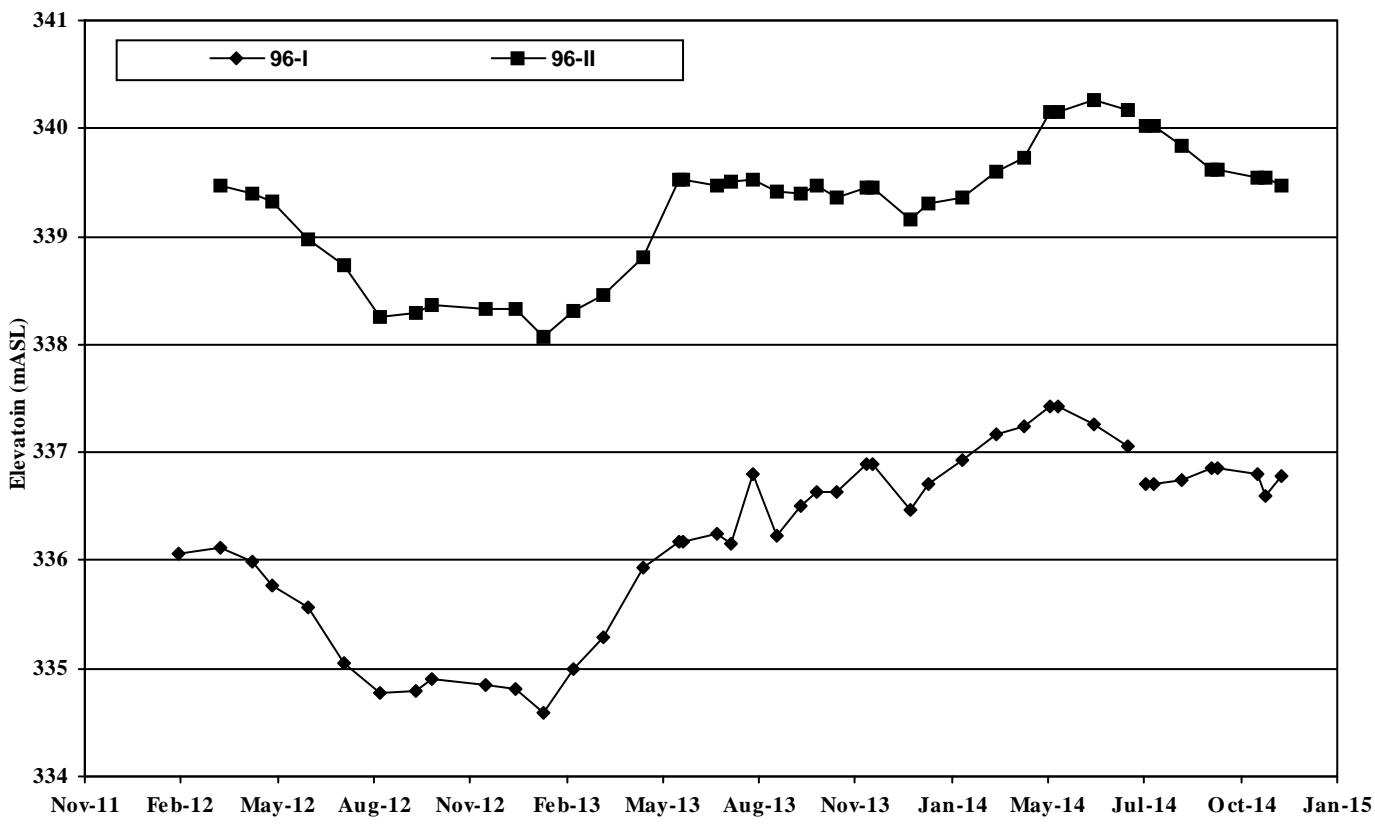
FIGURE
9
 60339708
 TLC-Location 96-37R Bedrock WL

Closed Eastview Road Landfill Site
Groundwater Elevation Trends
Location 37R and 96

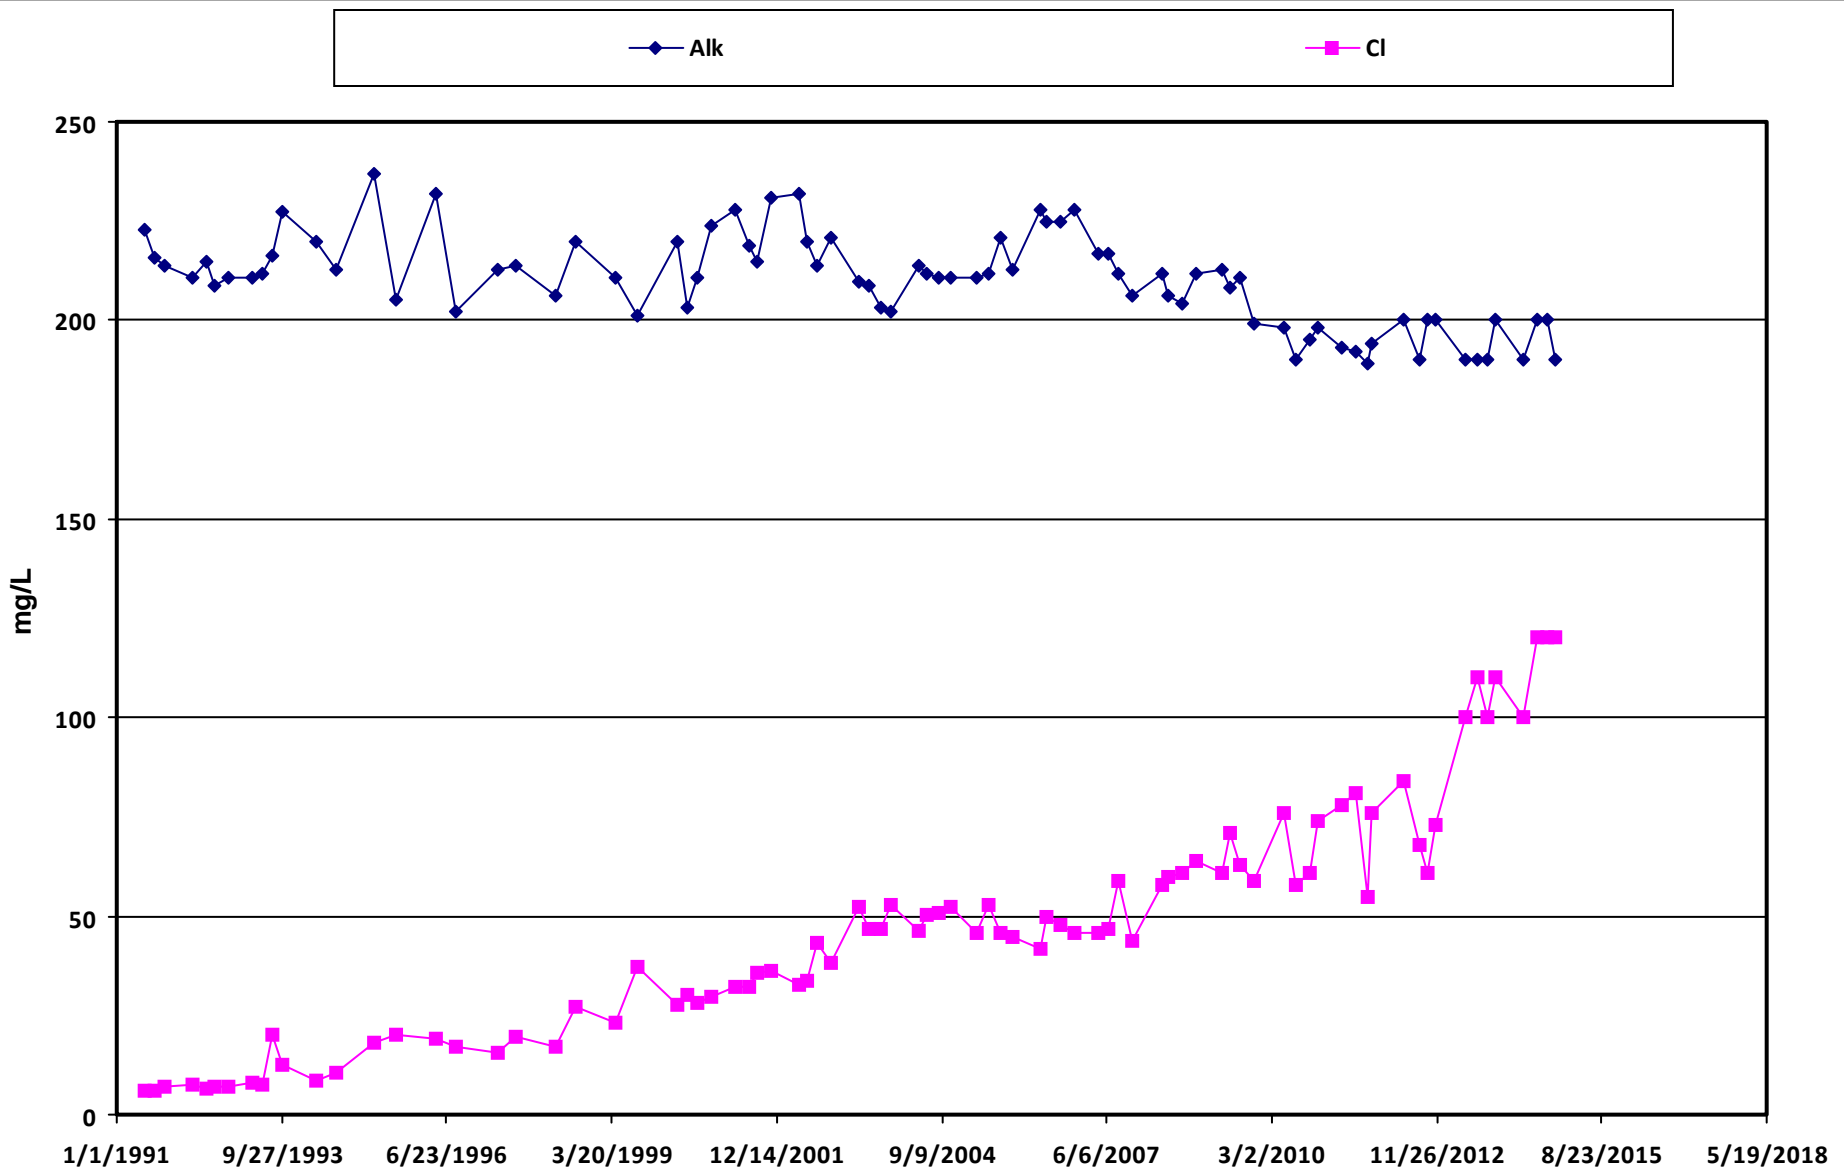
FIGURE
16
 60339708
 TLC-Graph50-L_ALK_CLtrend

Closed Eastview Road Landfill Site
Groundwater Quality Trends
Comparison of Chloride and Alkalinity at Location 50
