City of Guelph

Norwich Street Bridge Class Environmental Assessment Project File (Schedule B)

GMBP File: 116046-1

DRAFT (March 2017)

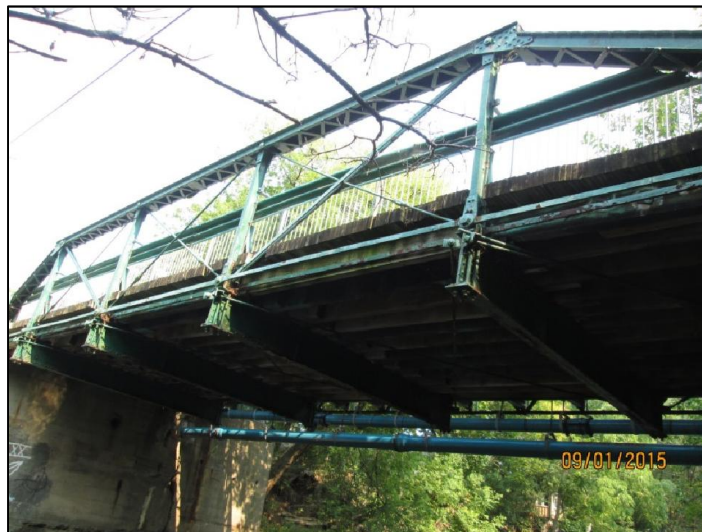
Figure 2: Photograph of Existing Norwich Street Bridge

The existing bridge is a half through Pratt truss (pony truss) bridge located approximately 70 m east of Cardigan Street on the former Norwich Street road allowance, and was built in 1882. It is constructed of a timber deck on riveted steel with a span of 17.0 m and a travelled width of 3.7 m. Refer to **Figure 2** for a photograph of the existing structure.

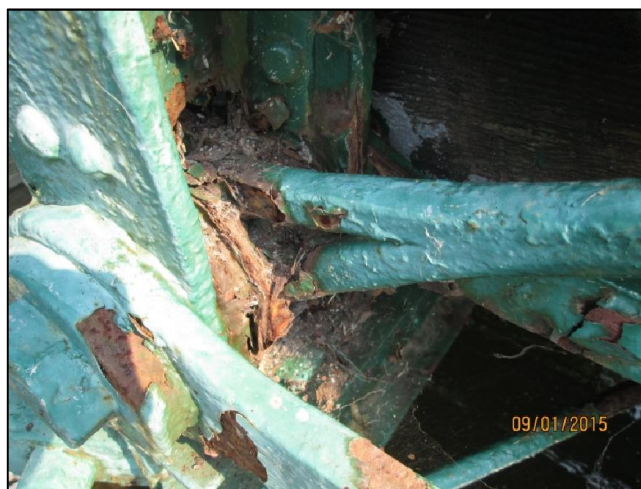
Structural inspections have identified the need for repairs or replacement of the Norwich Bridge due to its poor condition. The bridge was constructed in 1882 by the Hamilton Bridge Company, and is an historical pony truss bridge located approximately 70 m east of Cardigan Street on the former Norwich Street road allowance. It has a span of approximately 17 m and a travelled width of 3.7 m. This structure was used for vehicle traffic until approximately 1998, when it was limited to pedestrian traffic only. The bridge, including its date plates, is designated as a heritage structure under the Ontario Heritage Act, in accordance with By-law Number (1998)-15786. Additionally, a sanitary sewer and water main are suspended from the closed pedestrian bridge adjacent to the Norwich Street bridge.

Problems identified with the Norwich Street bridge include:

- The existing bridge is 134 years-old and is in poor condition;
- There are deficiencies and issues including: severe corrosion, loss of section on the floor beams and pin connections, warping of the top chord of the trusses, severe sections of delamination and disintegration of the abutments and wing walls, and the possible undermining of the northwest abutment footing; and,
- Support of the existing sanitary and water main crossing the Speed River needs to be addressed.

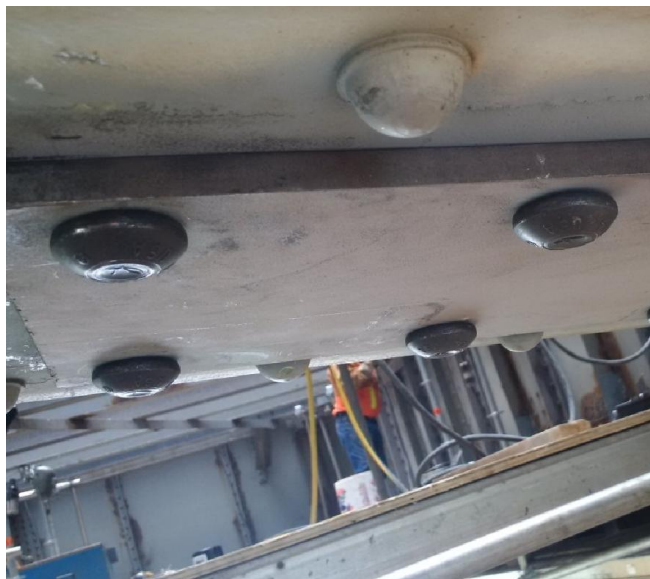
It is estimated that most repairs could be completed by reinforcing existing members with steel plates, or replacing isolated members with identical steel members. Due to the age of the steel used in the trusses, welding may not be possible to strengthen members that are left in place. Bolts would be use, and could mimic the appearance of rivets, as

shown in **Figure 5 and Figure 6** below. This would help to reduce changes in aesthetics to the bridge and soften the appearance of any rehabilitation works.

Figure 5: As viewed from the surface, bolts used adjacent to existing rivets to mimic the appearance of rivets

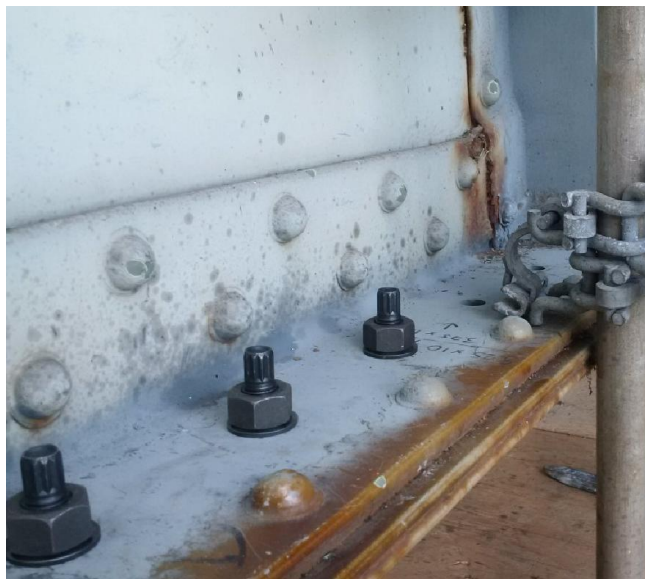
Figure 6: As viewed from the opposite side, these bolts resemble a typical threaded bolt and nut assembly

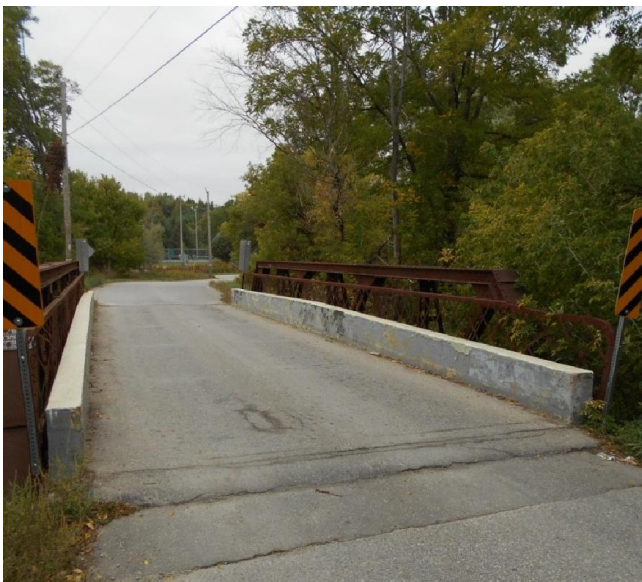
The Norwich Street bridge crossing would be reconfigured to allow for a new bridge structure to convey pedestrian and cyclist traffic while maintaining the historic steel trusses, but not relying on the steel trusses as load carrying members. Refer to **Figure 6 and Figure 7** below, which show a similar historic steel truss bridge that was retrofitted so that traffic is conveyed on a Fibre Reinforced Polymer (FRP) bridge deck that does not rely on the steel trusses for structural support. An alternative design would be a concrete deck on steel girders that can be economically constructed. In comparison to **Figure 6 and Figure 7**, the deck would not require the tall curbs at the sides with pedestrian hand rails either included on the new deck or the existing structure. The exact structural system used to alleviate the existing bridge from the pedestrian and cyclist loads would be determined in the detailed design phase and would be designed to current standards for pedestrian bridges,

Figure 7: Similar truss bridge with FRP deck, where the steel trusses carry only their own weight

In either case, the existing wood deck and wood stringers would be removed to reduce the weight carried by the steel trusses while providing a cavity to place the new deck support system. The trusses could then be repaired and remain in place as an aesthetic feature supporting only their own self-weight. As the Norwich Bridge is a prominent feature of the area, providing scenic views of the Speed River, a bridge structure with an open barrier system would be most appropriate so that views are not obstructed.

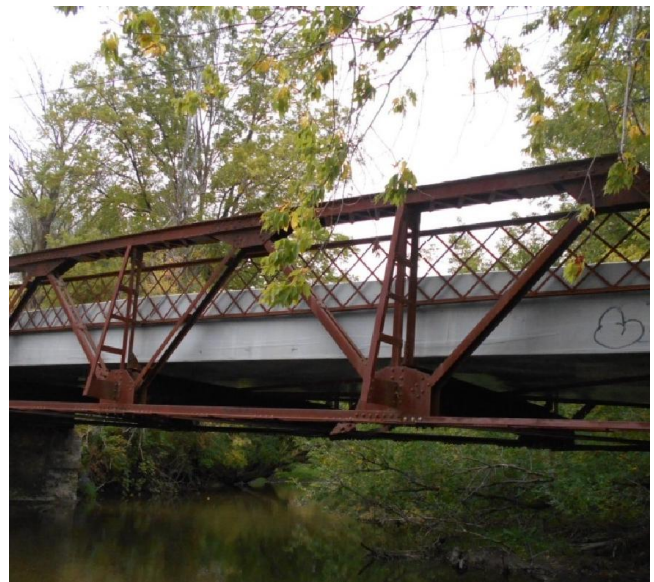
Figure 8: From the sides, the truss structure resembles a normal steel truss bridge

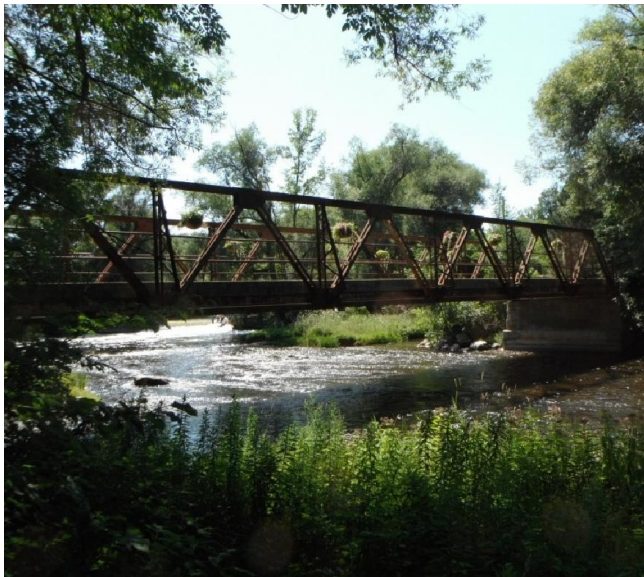
Figure 9: Historic steel truss bridge that was scheduled for replacement with a modern truss structure

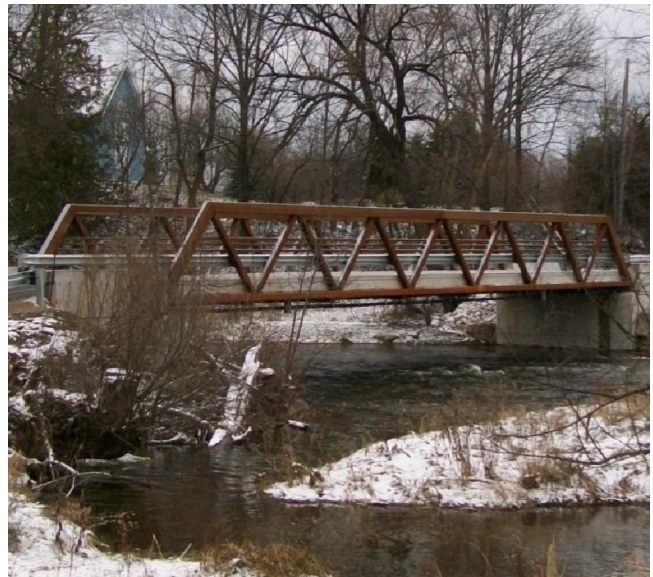
Figure 10: New steel truss bridge constructed with welded connections
