Re: Phase I ESA Update
671 Victoria Road North
Guelph, Ontario
County of Wellington

**PHASE I ESA UPDATE
671 VICTORIA ROAD NORTH
GUELPH, ONTARIO
COUNTY OF WELLINGTON**

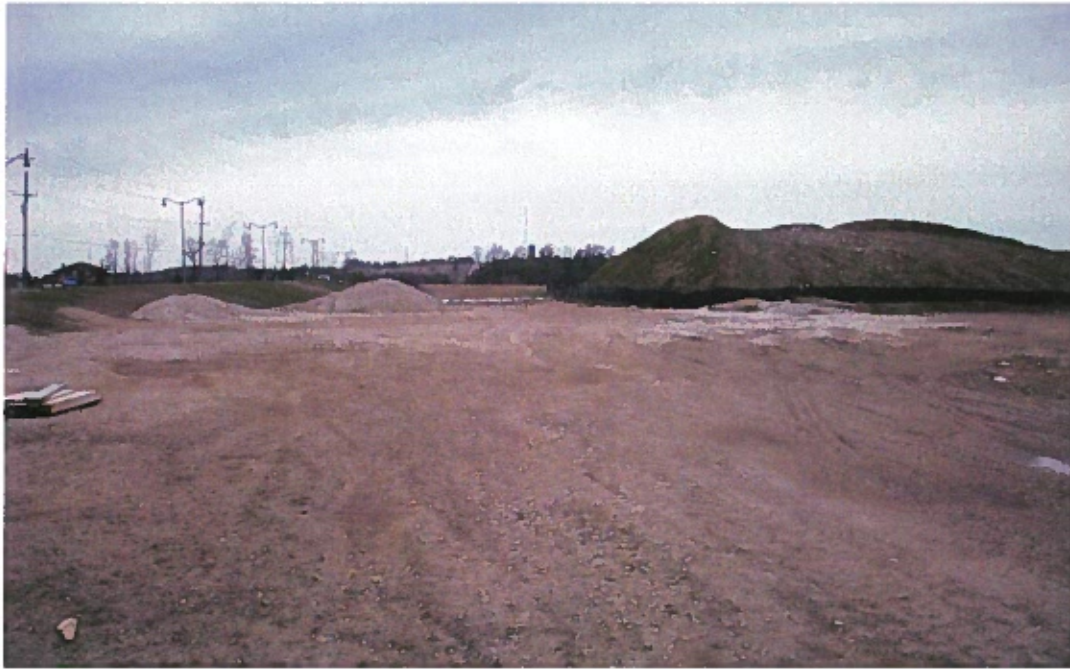
Photo 1: View of subject property and topsoil pile from the corner of Wideman Blvd. and Victoria Road North, looking north.

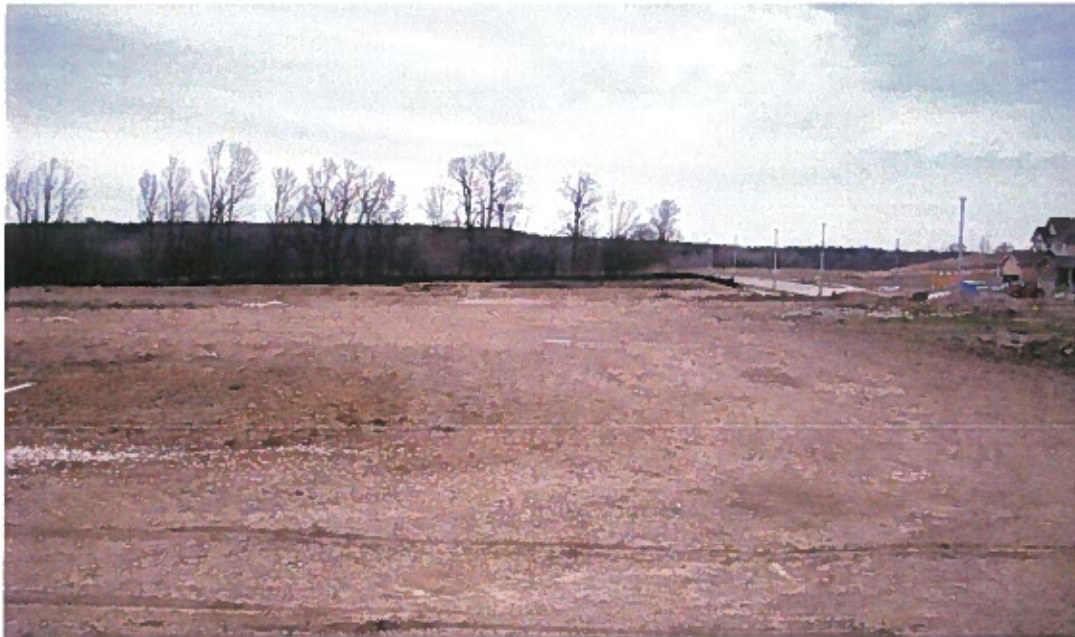
Photo 2: View of the subject property along the south property line from the corner of Wideman Blvd. and Victoria Road North, looking east.

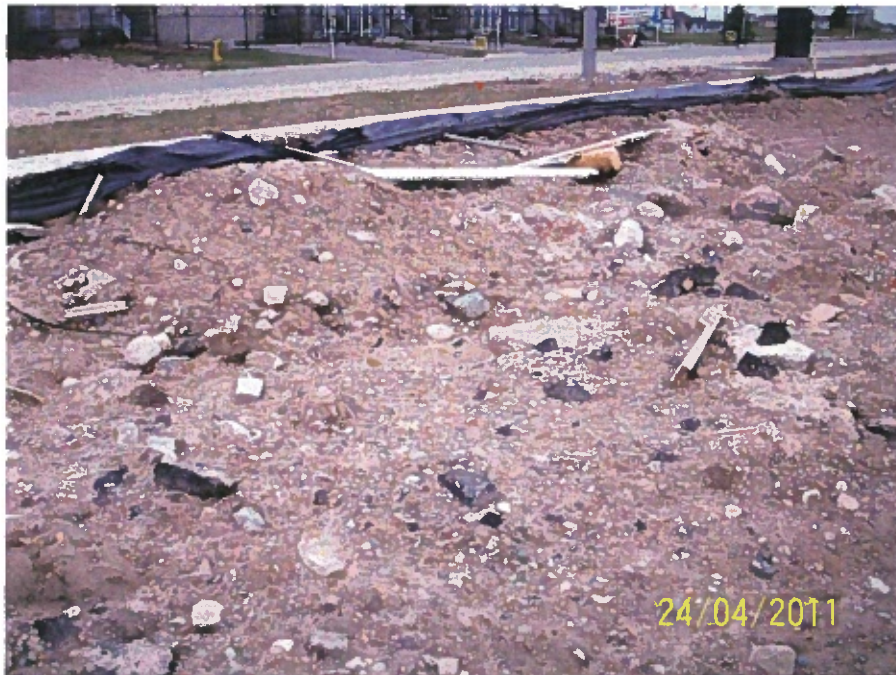
As shown in the attached photographs, a majority of the property has been graded with exposed surficial soils consisting of a mixture of cobbles, sand, gravel, and silt material. A small pile of construction fill was observed near the southern boundary of the subject property, which abuts Wideman Boulevard. The pile contained what appeared to be construction debris consisting of soil, cobbles, concrete, asphalt, wood, plastic and a small quantity of brick.

Photo 3: Small area of fill and construction debris along the southern property boundary, which contains concrete, asphalt, wood, plastics and a small quantity of brick.

Based on the information collected as part of this Phase I ESA update, it is concluded that no additional significant environmental impacts or risks have been identified for the subject property. It is recommended that any waste material and construction debris located on-site be removed and disposed of at an approved waste management facility. No further environmental investigations are recommended at this time.

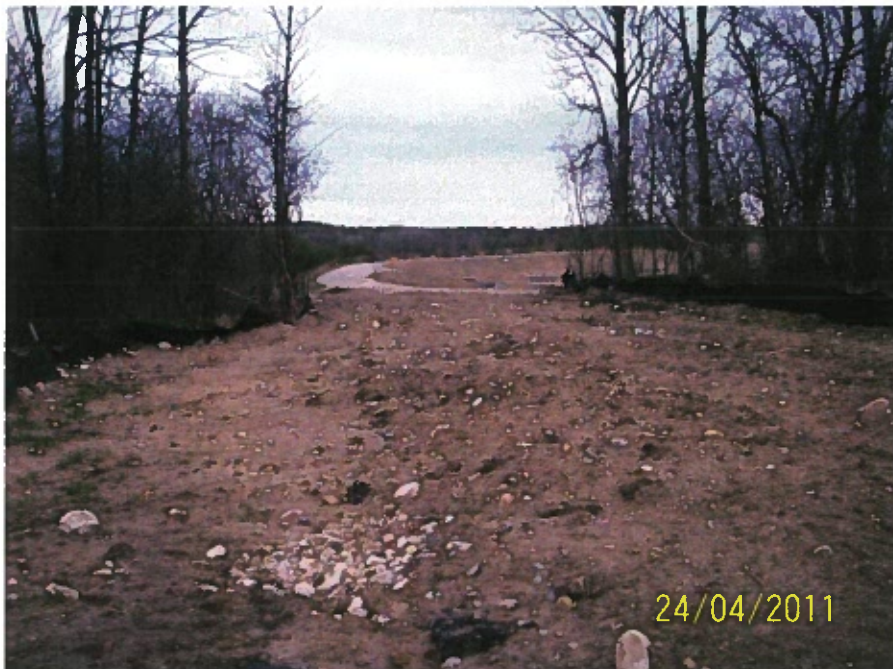
A berm has been constructed along the eastern edge of the subject property. To the east of the subject property is a treed hedgerow beyond which is forested Grand River Conservation lands and a storm water management pond. A section of the hedgerow along the eastern property boundary has been removed to facilitate the installation of a storm sewer to the storm water management pond. The potential for environmental impacts or issues associated with the storm water management pond and properties further east are low.

Photo 4: View of storm sewer easement from the subject property. A section of trees from the hedgerow have been removed and fill imported.

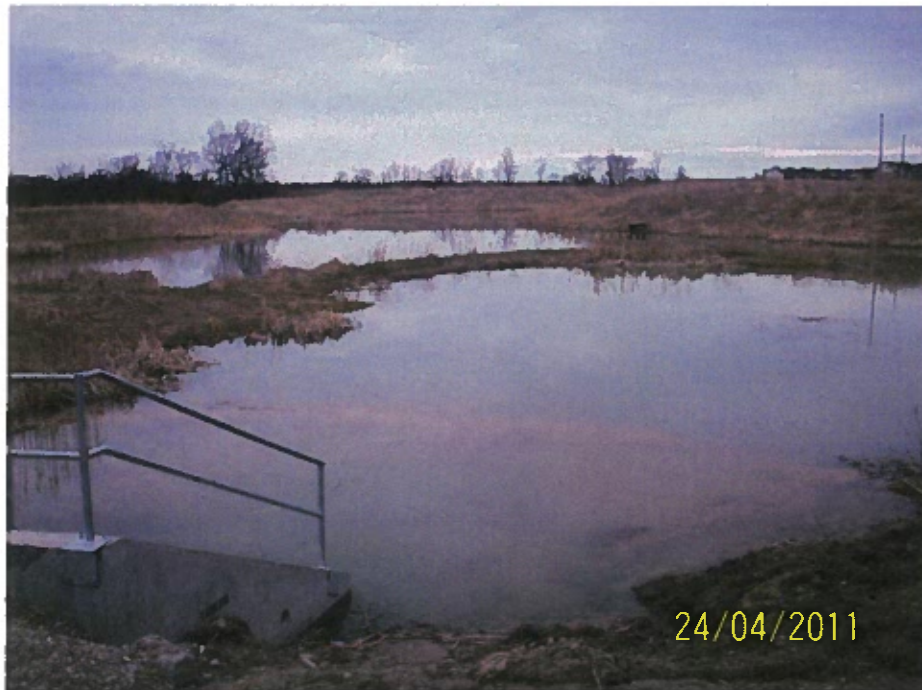
Photo 5: View of the neighbouring storm water management pond to the east of the subject property with recently constructed headwall.

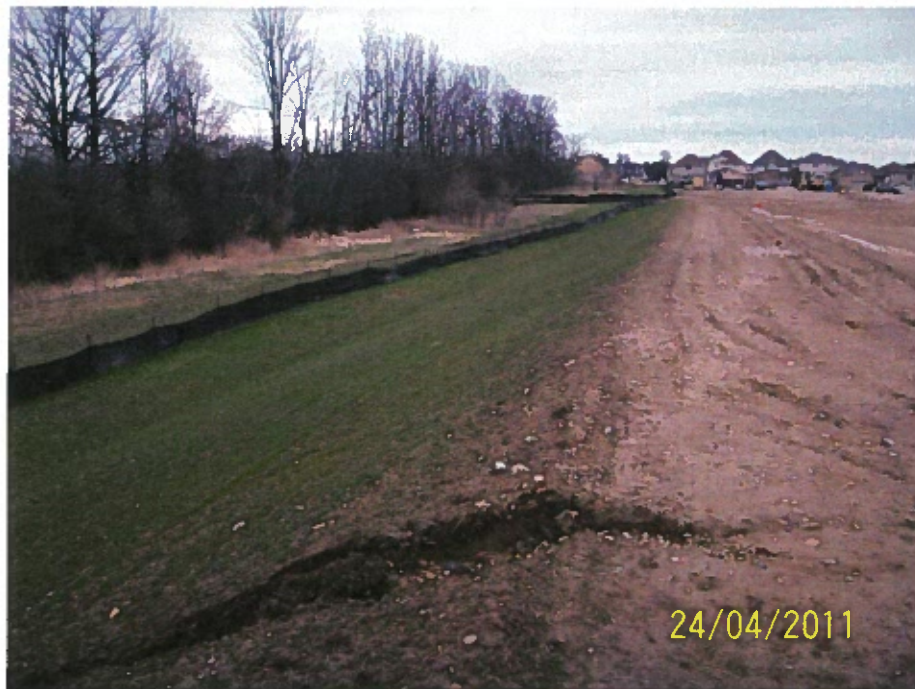
Photo 6: View of the eastern property boundary, looking south.

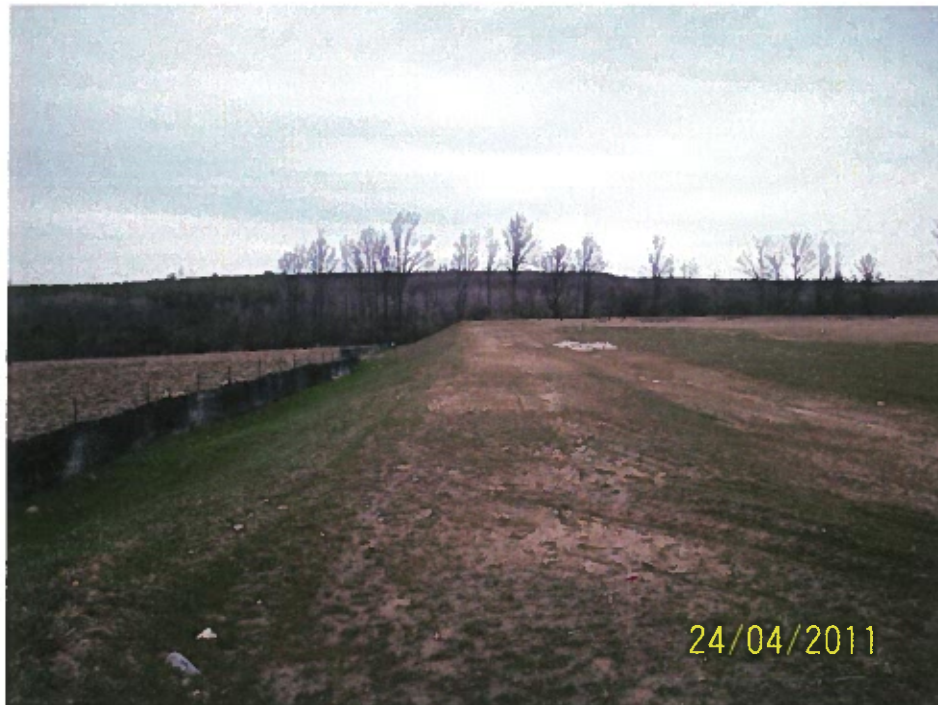
A berm has been constructed along the northern edge of the subject property. The lands to the north of the subject property are bounded by a field beyond which is a treed hedgerow and Grand River Conservation Authority lands. These lands slope towards the Speed River and no apparent change in activities or land use is noted in this area.

Photo 7: View of northern property boundary, looking east.

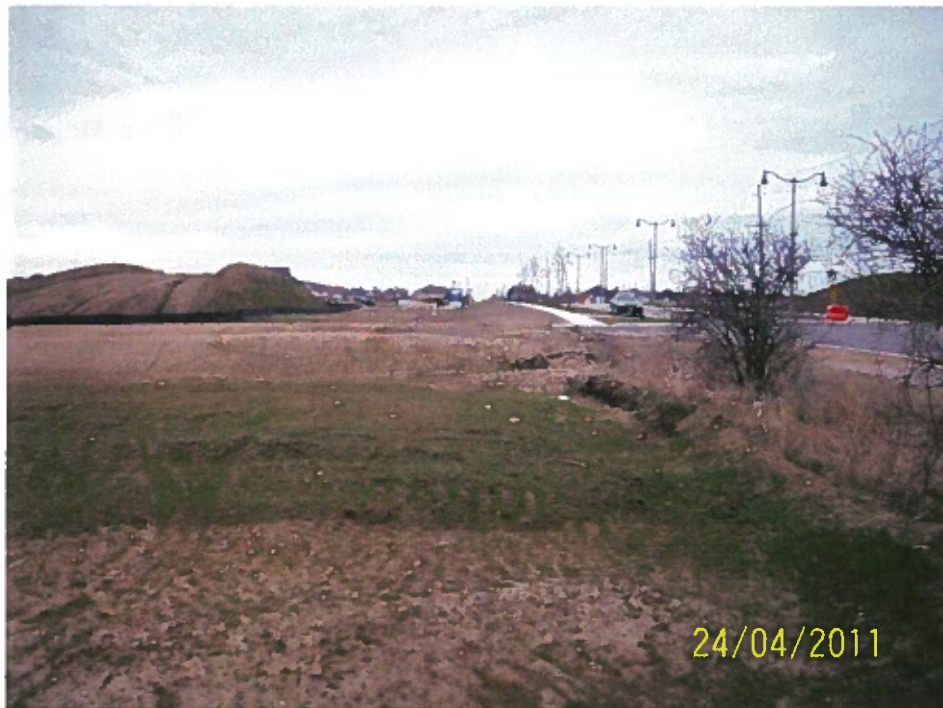
Photo 8: View of the western property boundary, looking south.

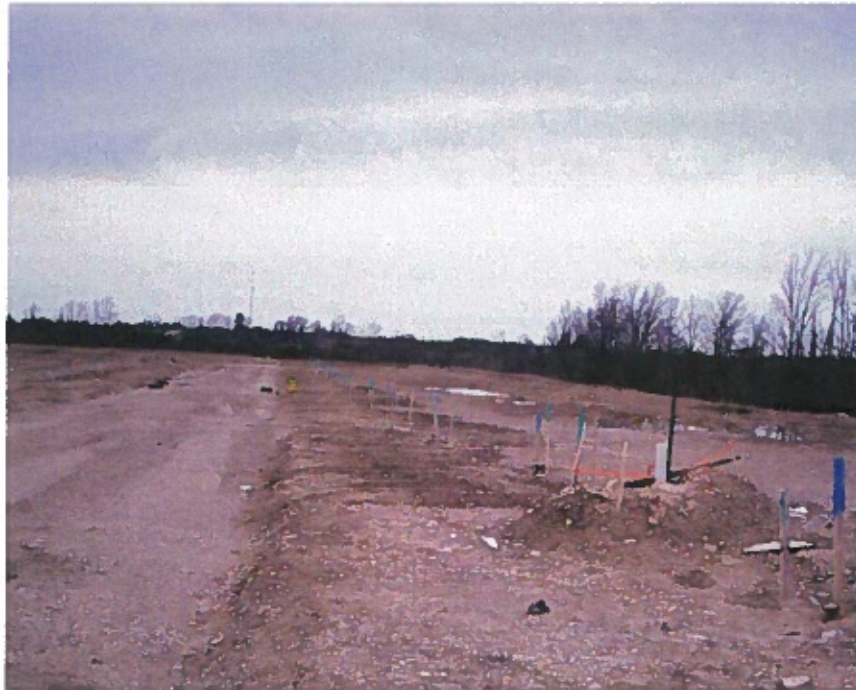
Photo 9: View of Mussen Street under construction looking north. Markers for the watermain, water service lines, sanitary sewer lines and storm sewers within the site can be seen.

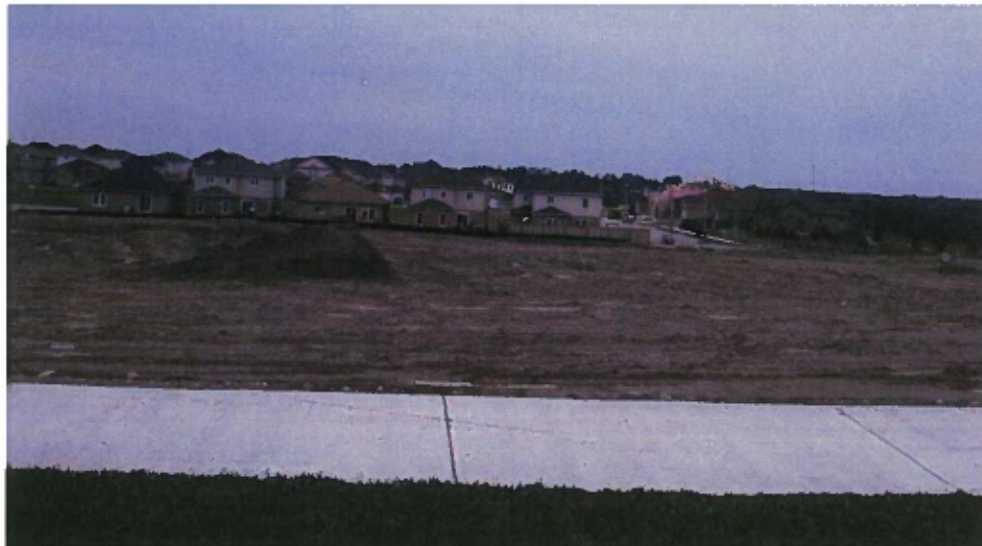
To the west of the subject property is a concrete sidewalk and Victoria Road North. Beyond Victoria Road North is a property in various stages of development. Topsoil had been stripped and piled and grading activities, construction of services and homes were observed on the property at the time of the site visit.

Photo 10: View of the lands to the west of the subject property, currently under various stages of development.
