Dunsire Developments

LANDSDOWN DRIVE

Environmental Impact Study

JULY 2014

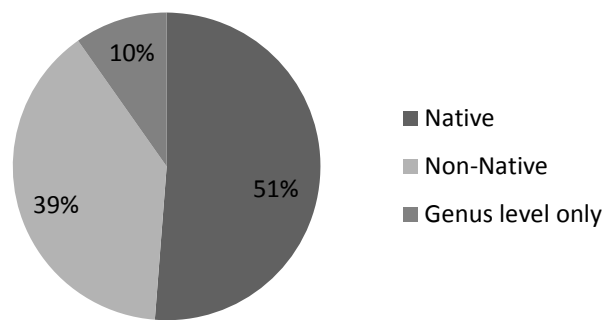
Figure 6. Comparison of native versus non-native plants within CUW1

There were 37 species inventoried of which 21 (51%) are native to Ontario and 16 (39%) are introduced (Figure 6. Comparison of native versus non-native plants within CUW1). Four (4) additional plants were identified to genus level only due to being observed and/or collected at a stage of maturity in which it was not possible to identify them to species level (Appendix F). The mean coefficient of Conservatism for the Cultural Woodland is provided in Table 3. Many Invasive species were noted within the sub canopy, understory, and ground layer, including Buckthorn (*Rhamnus cathartica*).

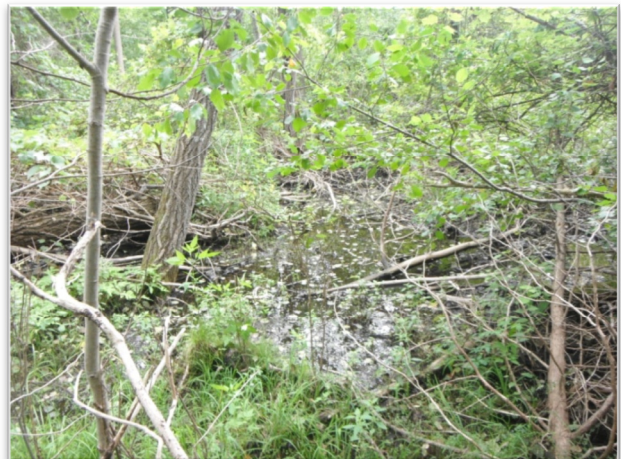
Photo 2. Openings with standing water surrounded by dense ground cover

Habitat: The presence of open water in a wooded setting gives rise to potential for Wood Frog breeding habitat. Woodpecker holes in trees consistent with those made by a Pileated Woodpecker and field siting during a subsequent tree inventory visit conducted by D&A staff on October 22, 2013 confirm the presence of this interior forest indicator species. Deer tracks were observed at the time of the survey.

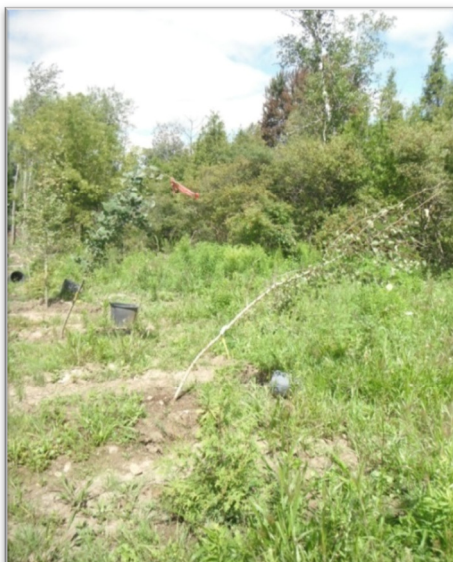
Photo 3. (left) Planted Trembling Aspens are in poor condition at time of survey.

There is a row of planted Trembling Aspen tree whips (*Populus tremuloides*) where the wetland edge was previously cleared (clearing observed on May 13th, 2014 during the wetland boundary delineation. Dunsire subsequently confirmed that clearing was undertaken by the resident.), as described under Anthropogenic Communities in this Report (see *Photos 3 & 4*). The trees are planted at approximately 2 m spacing. Some are falling over and have dead branches at top of their canopy (see *Photo 3*). A few small (approximately 50 cm tall) Eastern White Cedars were also planted in this area.

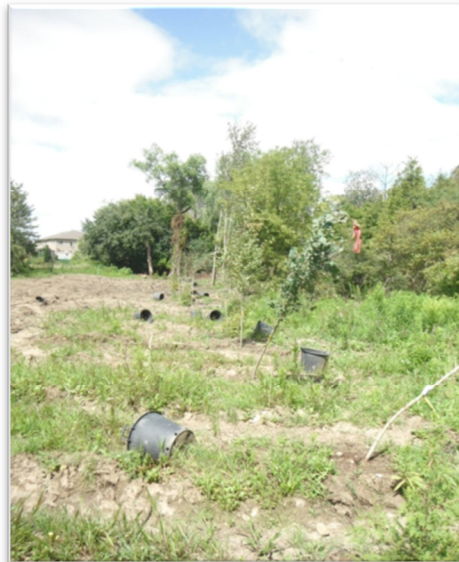
Photo 4. (right) Planted Trembling Aspen trees planted in a row in area of disturbance.

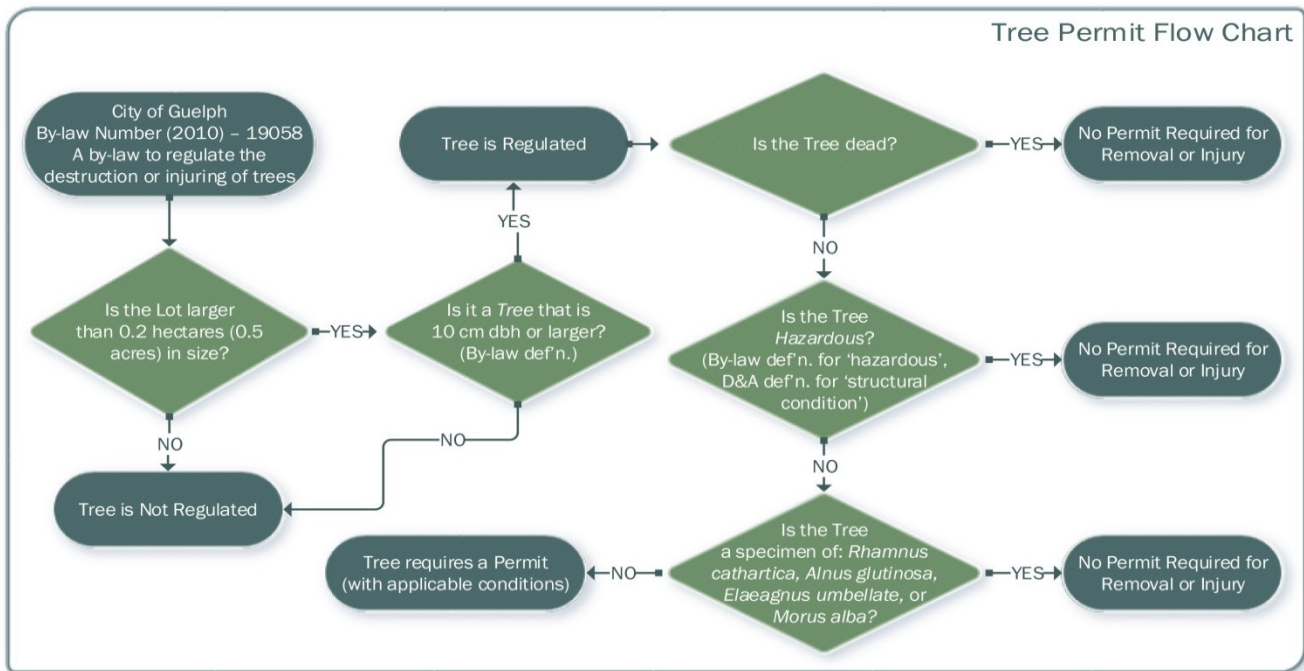
Figure 13. Tree permit flow chart.

A two-step process was used to determine tree compensation numbers. Step one, based on the City of Guelph Tree By-law involves filtering the tree data (Appendix D) to determine if the tree requires a Permit for removal (see Figure 13). When trees require a Permit, they are subject to conditions under the By-law (Section 7). Step two applies the criteria of the Guelph Natural Heritage Strategy OPA 42 to Permitted trees to determine when compensation is required (see Figure 14).

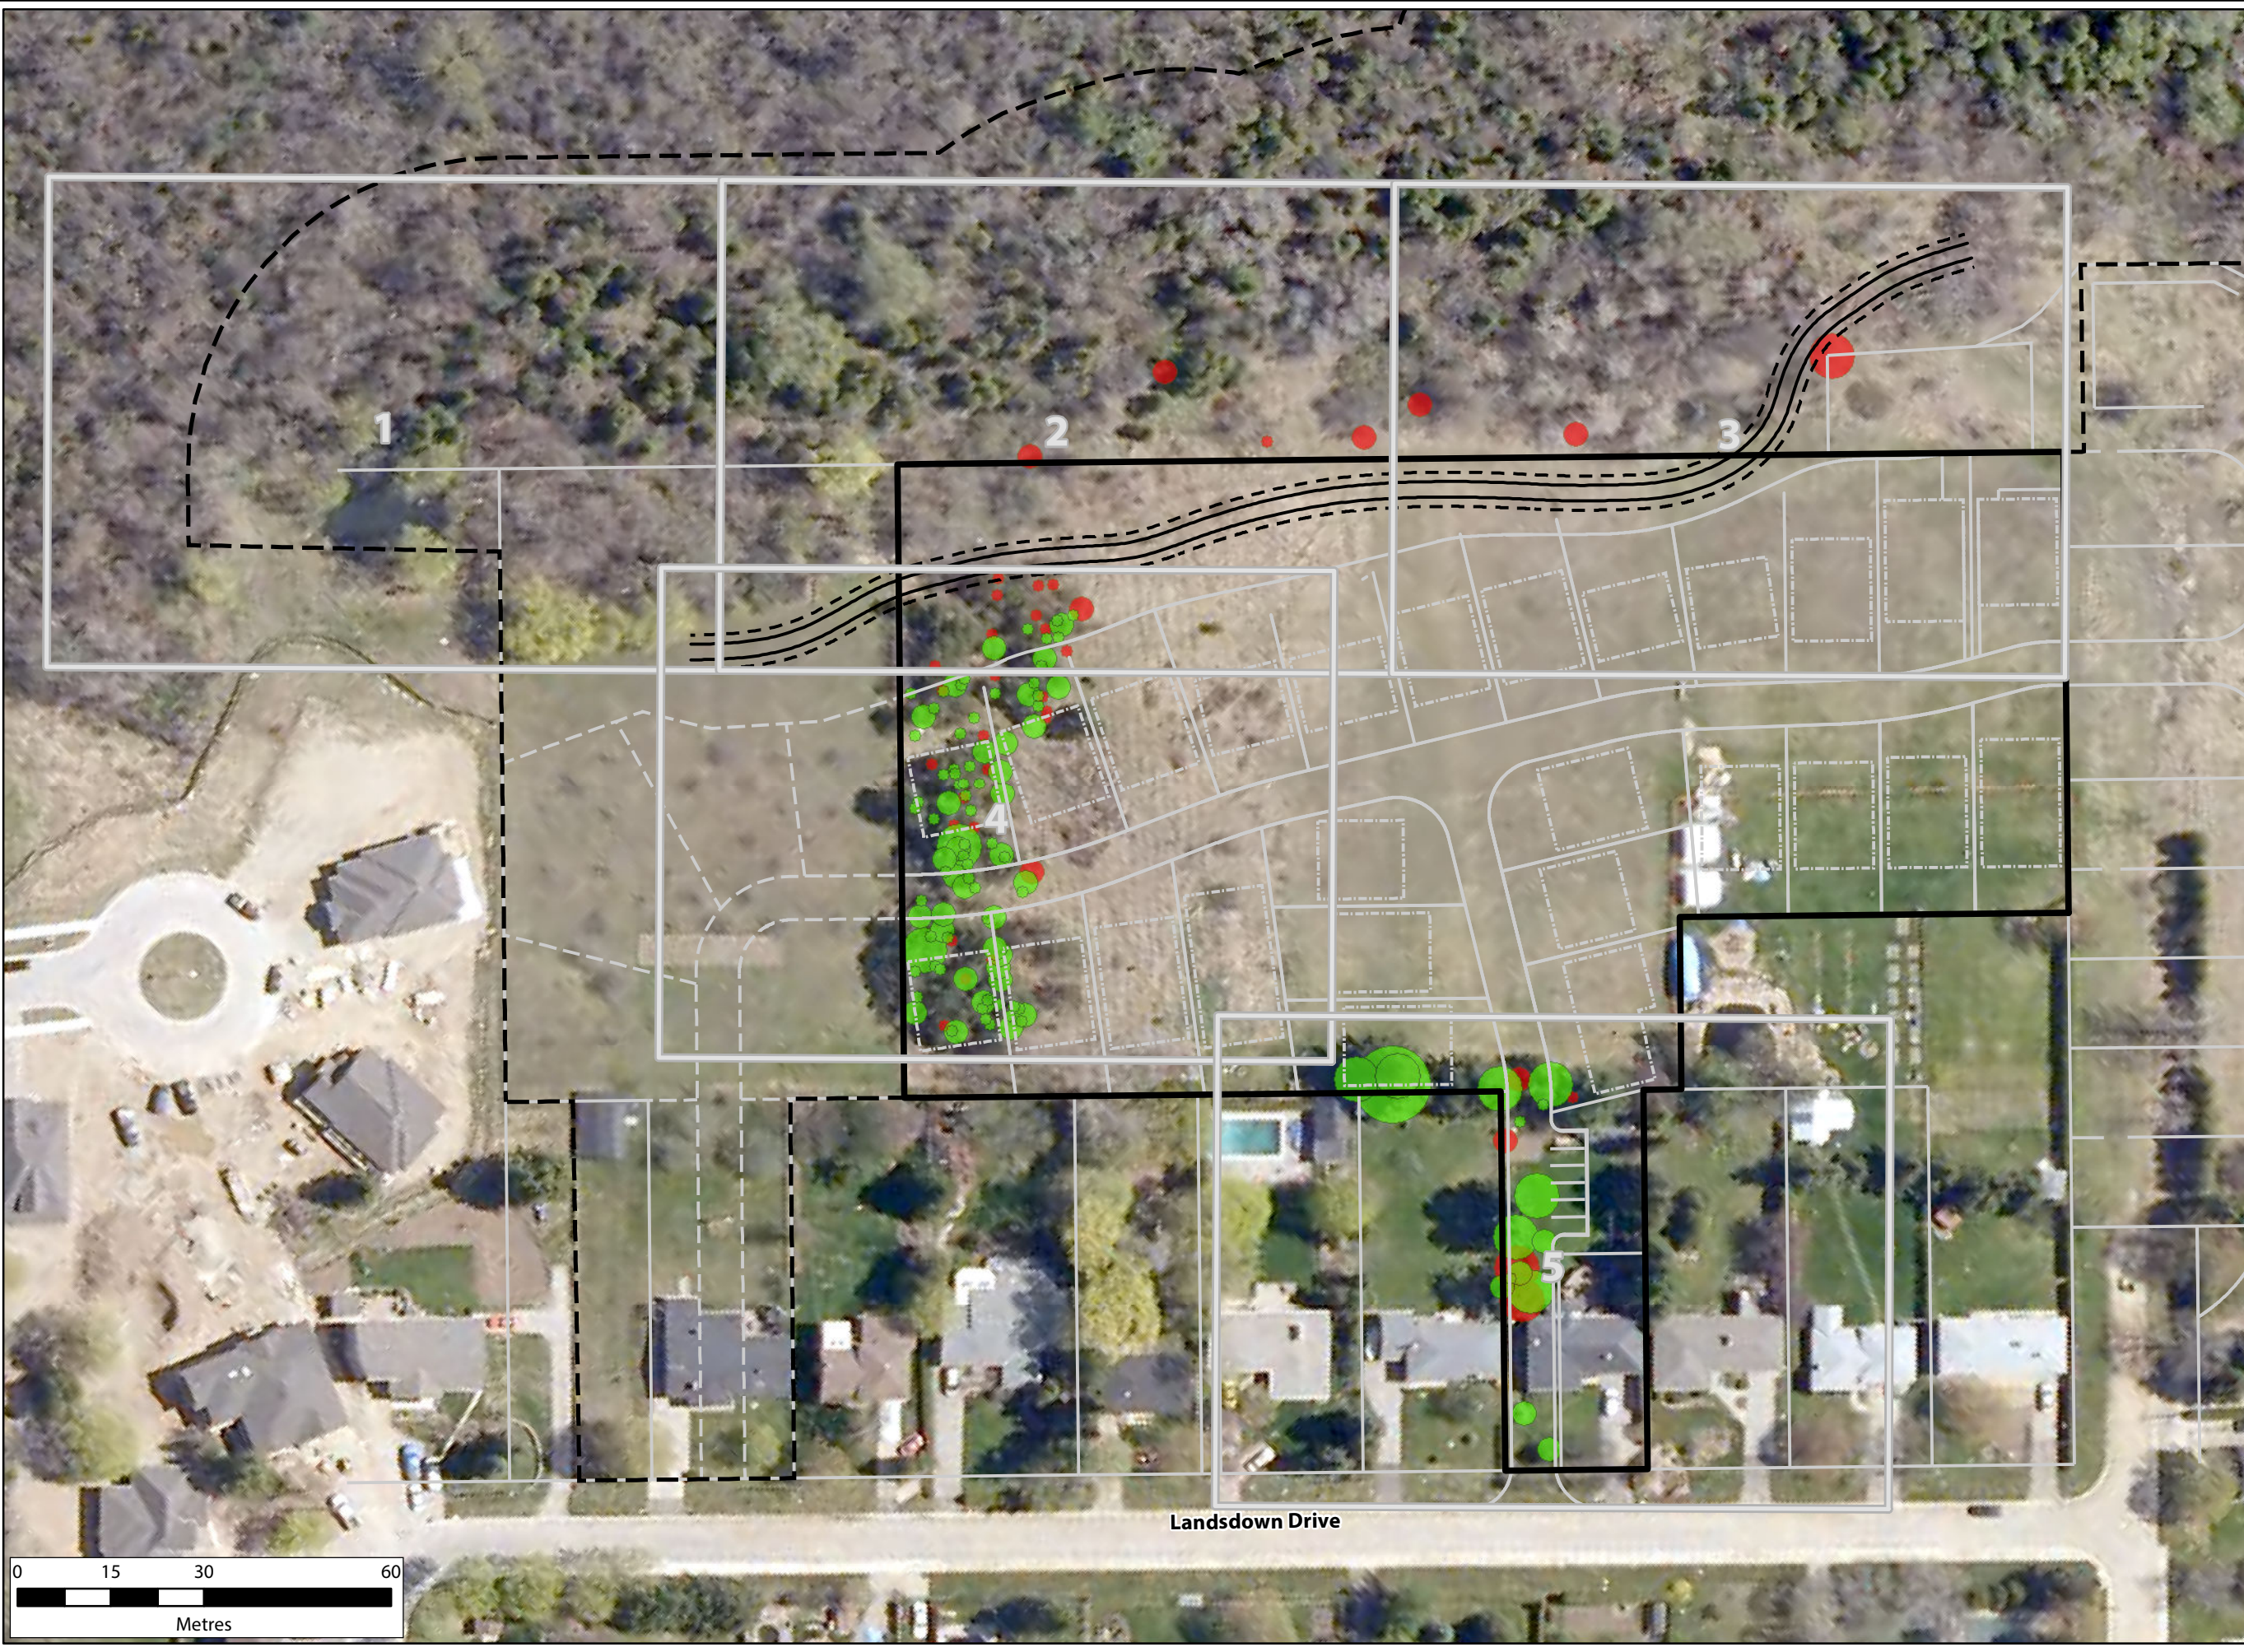
Figure 19. Tree Compensation Plan

The locations of the trees surveyed and their respective crown reserve (diameter of the canopy), preservation priority, and hazard potential are shown on *Figure 19. Tree Compensation Plan. Appendix D Tree Inventory Data* provides a summary of all tagged tree data. Detailed descriptions of the parameters used in the arborist assessment are available at the end of *Appendix D*.
