Draft Terms of Reference

Environmental Impact Study (EIS)

York Road Environmental Design Study

City of Guelph

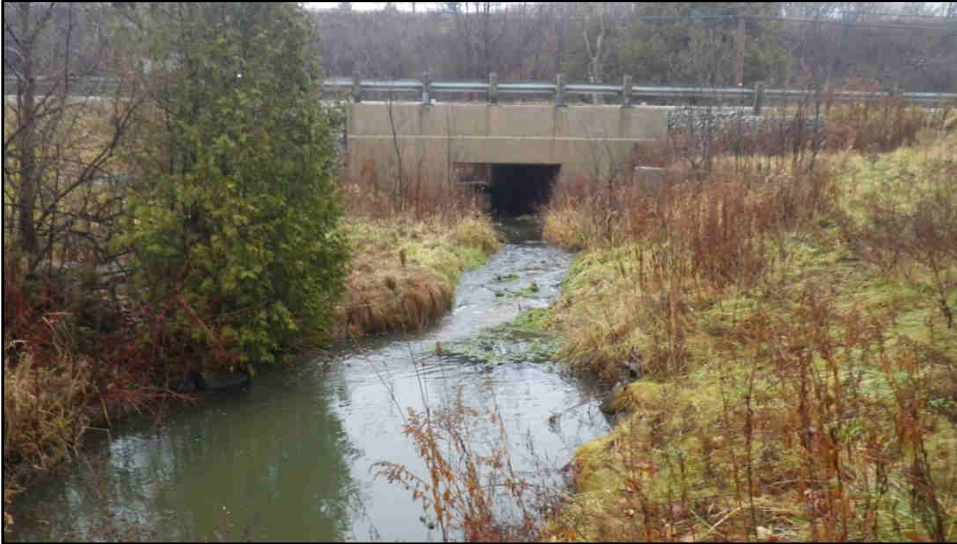
1. York Road crossing of Clythe Creek. Structure is a concrete box culvert , a pool has formed downstream from a transition riffle .

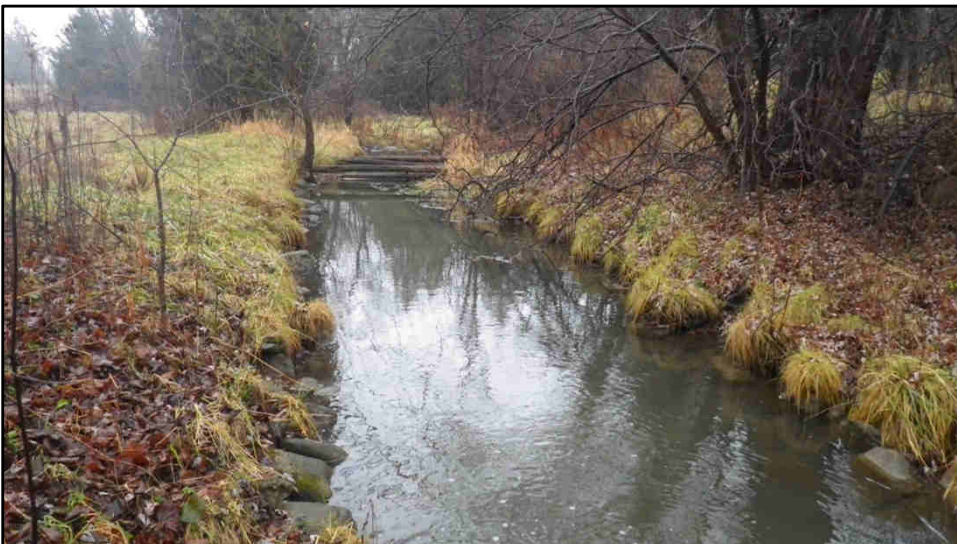
2. Looking downstream along Clythe Creek; channel is straight with rock protection located along banks.

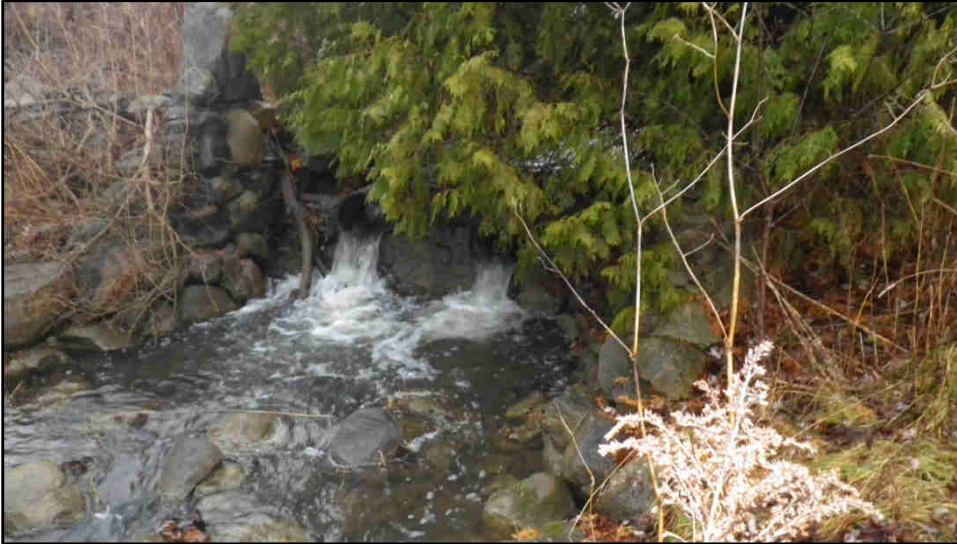
3. Two clay pipes convey flow downstream from a grade control weir. Channel banks are protected by stone.

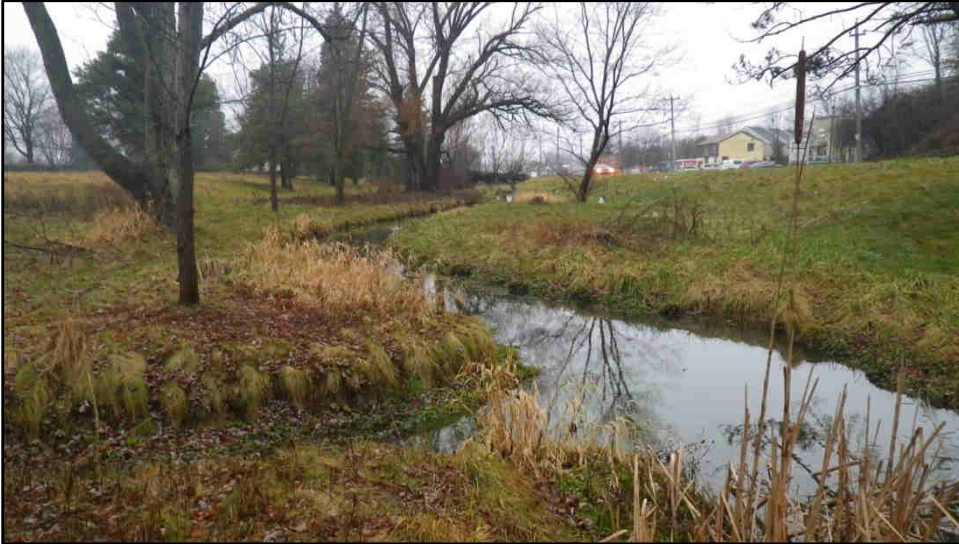
5. Looking downstream along Clythe Creek channel; minor tributary enters the creek in the foreground.

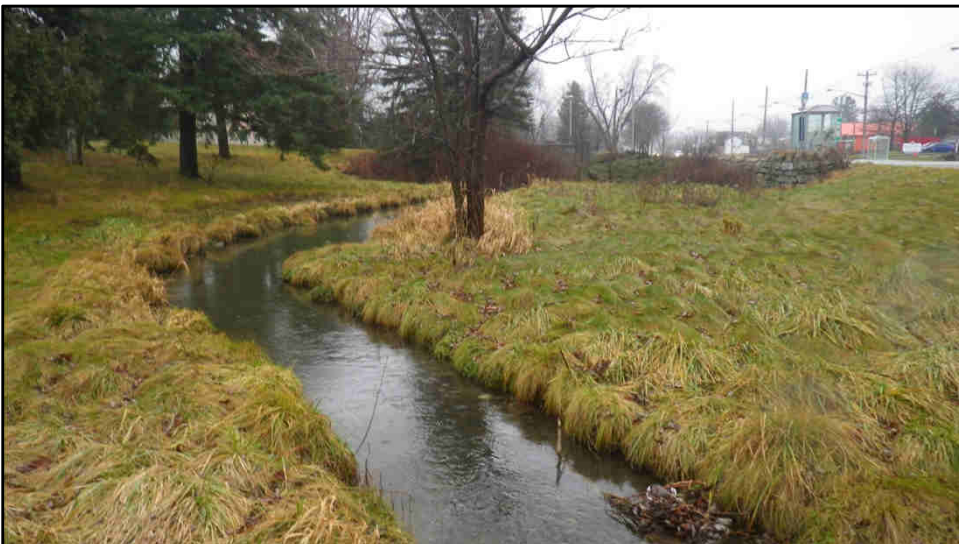
6. Looking downstream along Clythe Creek. Slow moving water appears to be just below bankfull height.

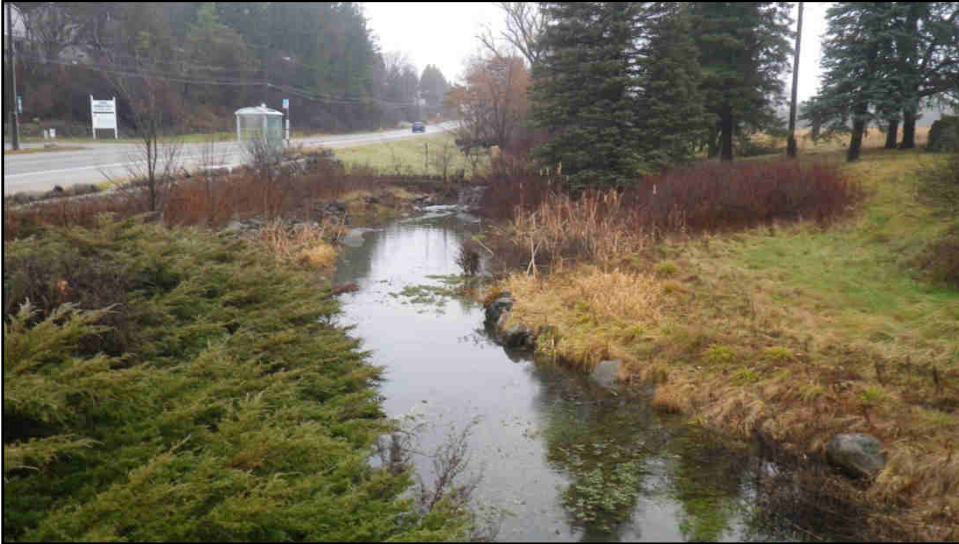
7. Looking upstream along Clythe Creek from the historic stone bridge (access to institution lands); a grade control weir is present in the background.

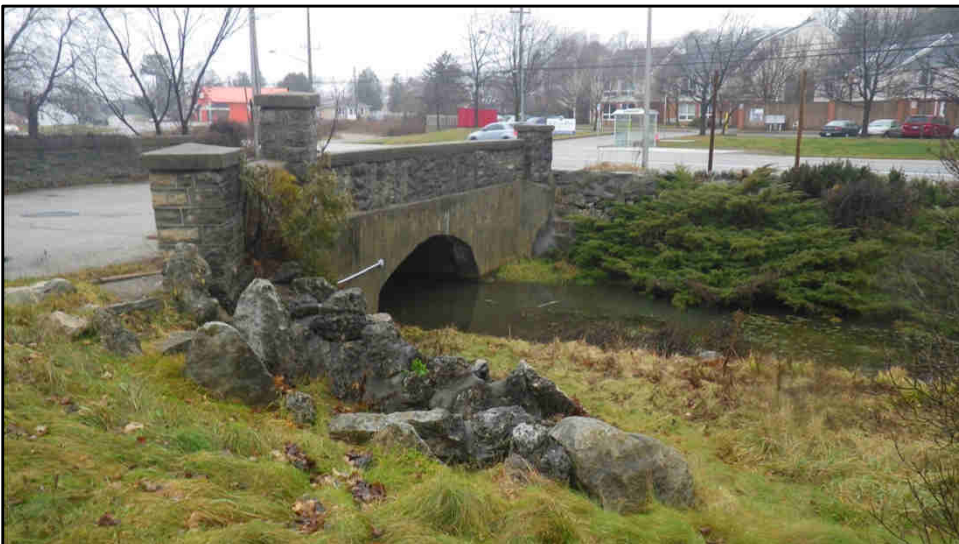
8. Historic stone bridge is main access to institution lands.

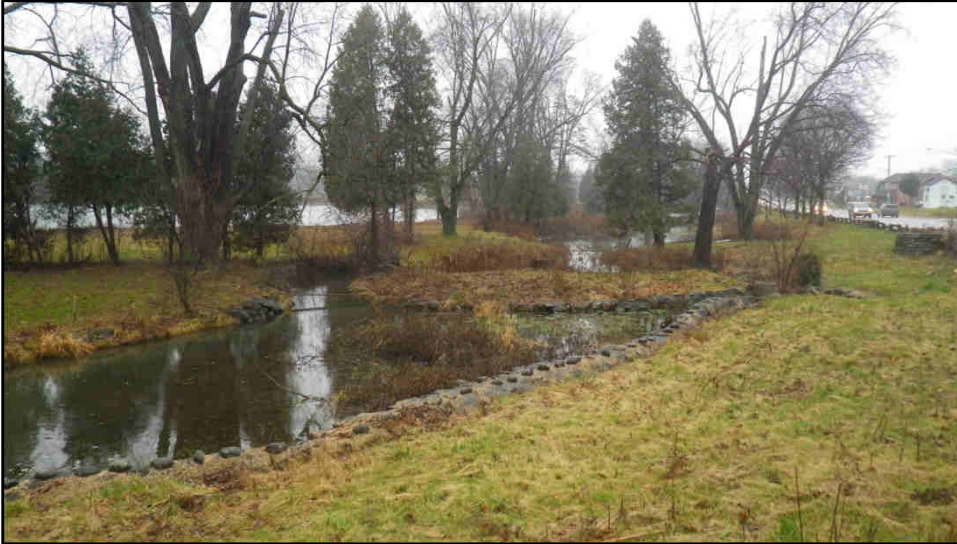
9. Looking downstream along Clythe Creek from the historic stone bridge; aesthetic islands present in the background.

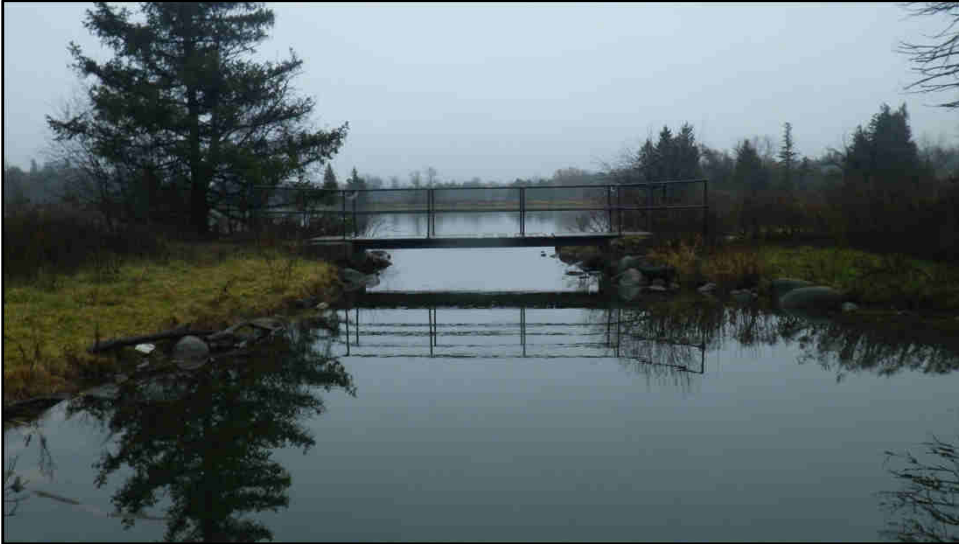
11. Looking upstream along the North Pond connection channel and pedestrian bridge.

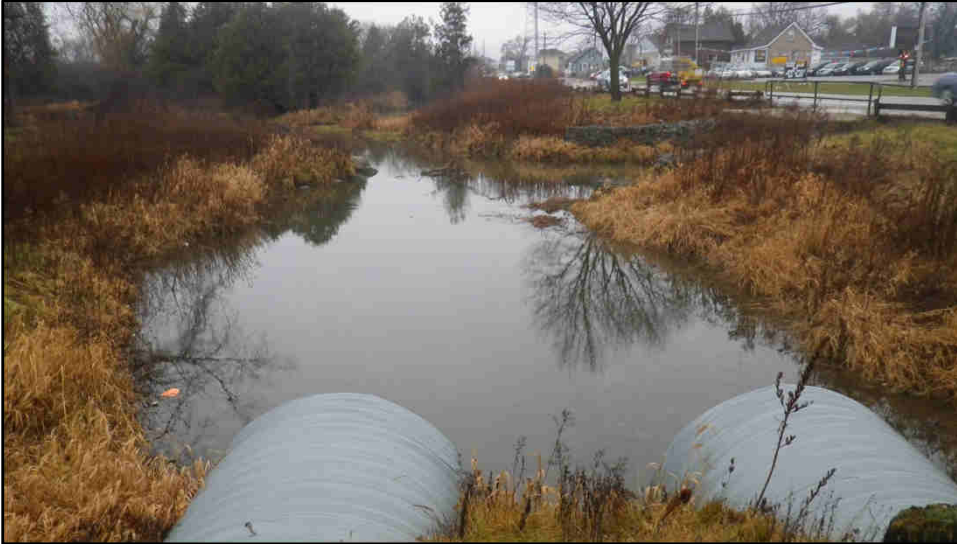
13. Two CSP culverts convey flows downstream from a parklands access road; channel immediately regains width downstream before Hadati Creek Confluence (background, right bank).

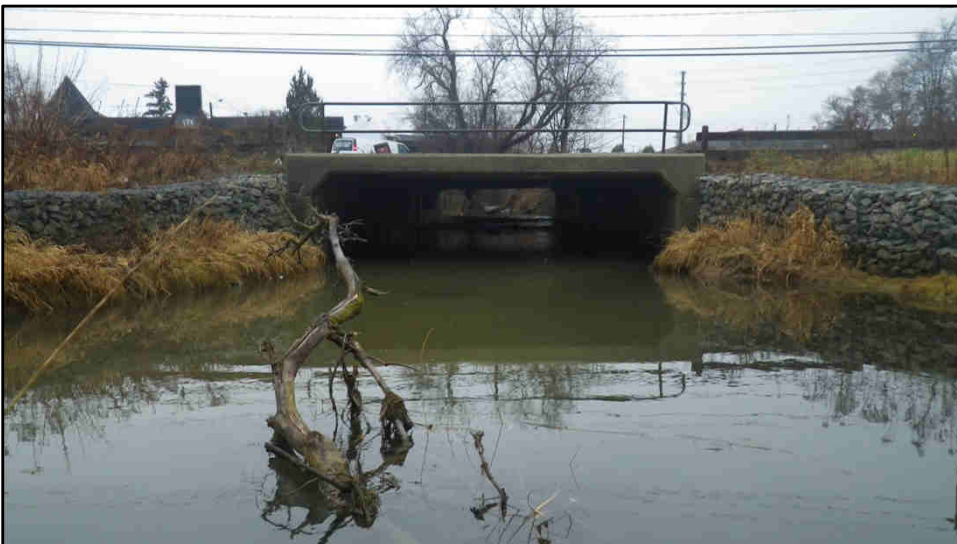
14. York Road crossing of Hadati Creek; structure is a concrete box culvert , gabion wing-walls protect the banks.

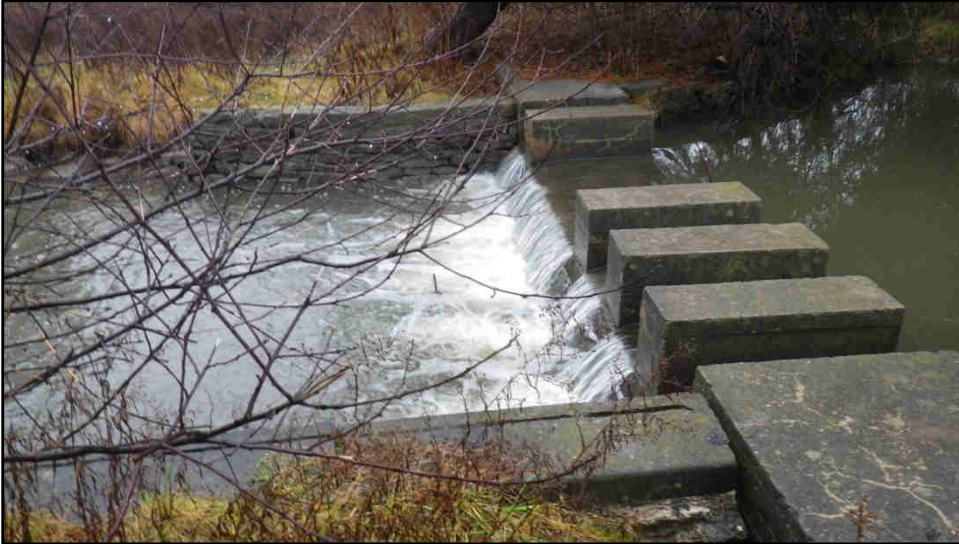
15. Flow control structure downstream from Hadati Creek confluence.

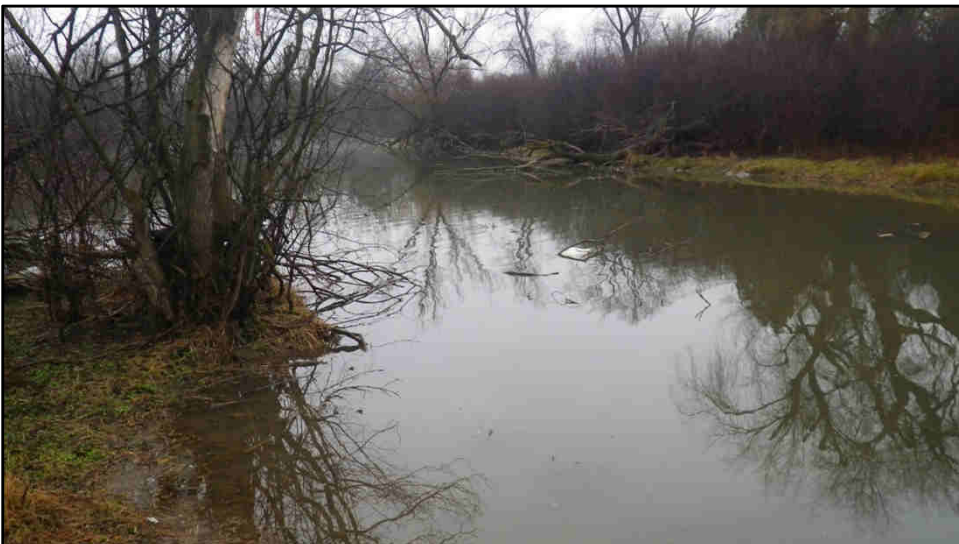
16. Channel remains wide and stagnant downstream from Hadati Creek. Water is turbid and woody debris is frequent.

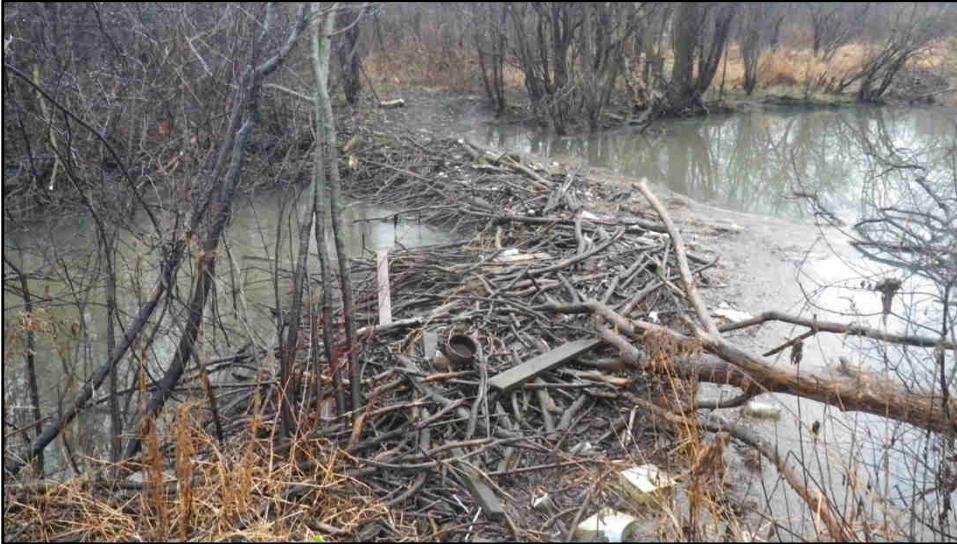
17. Beaver dam located approximately 250m upstream from the Eramosa River confluence.

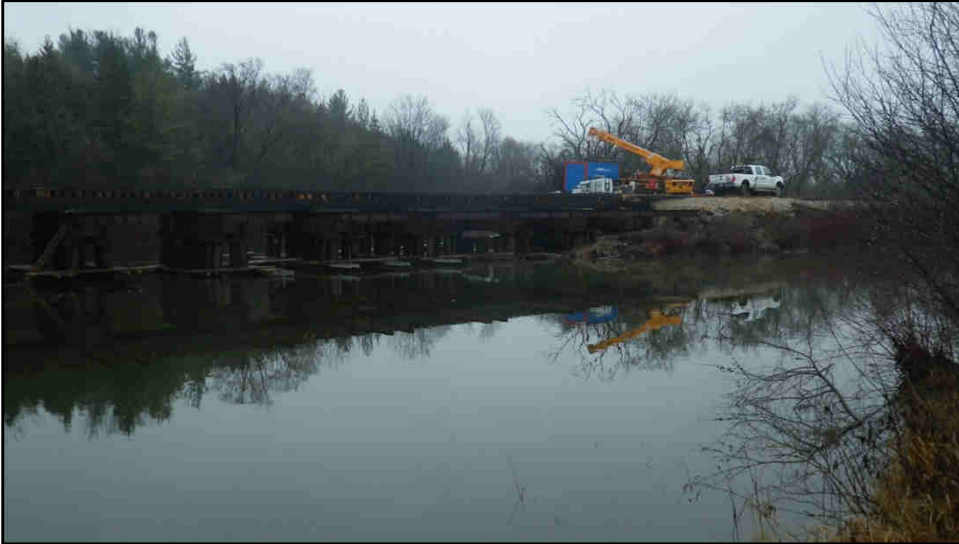
19. Looking downstream along the Eramosa River towards the Clythe Creek confluence located to the right. Railway embankment and bridge structure crossing the Eramosa River also present in background.

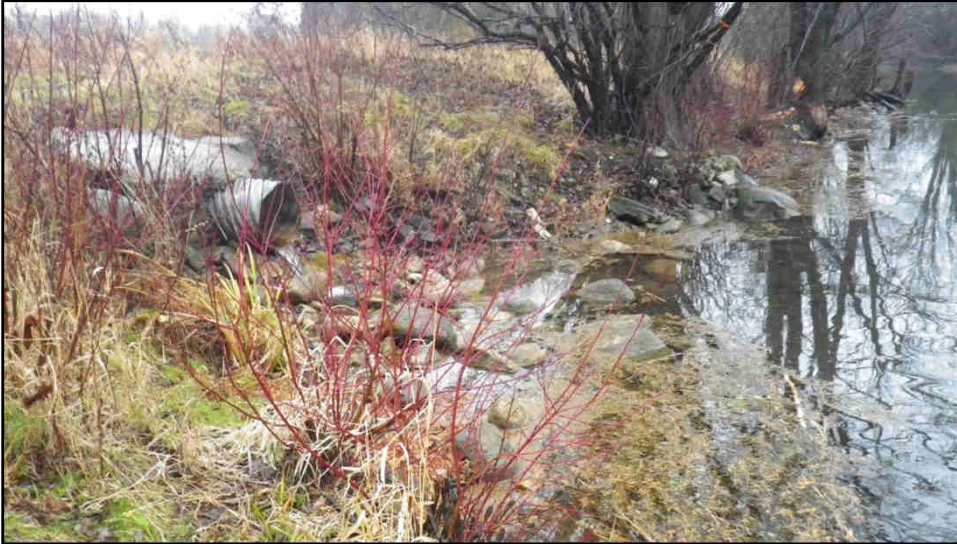
21. South Pond connection to the Eramosa River through an CSP pipe elevated approximately 30cm; the pipe appears to be blocked and discharge is minimal.

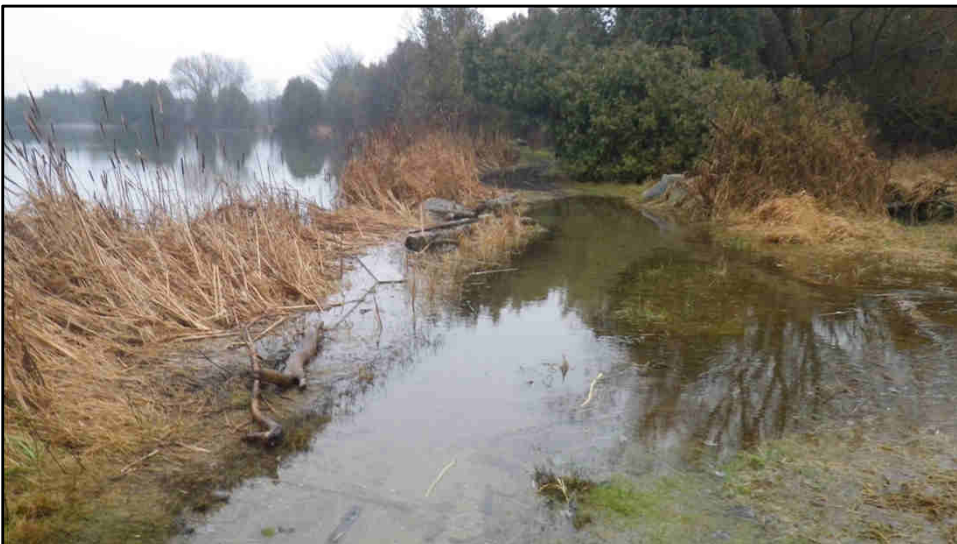
22. South pond breaches its banks at the ponds north-east corner; flow is contributed to a surface drainage tributary that flows adjacent to the pond and into the Eramosa River.

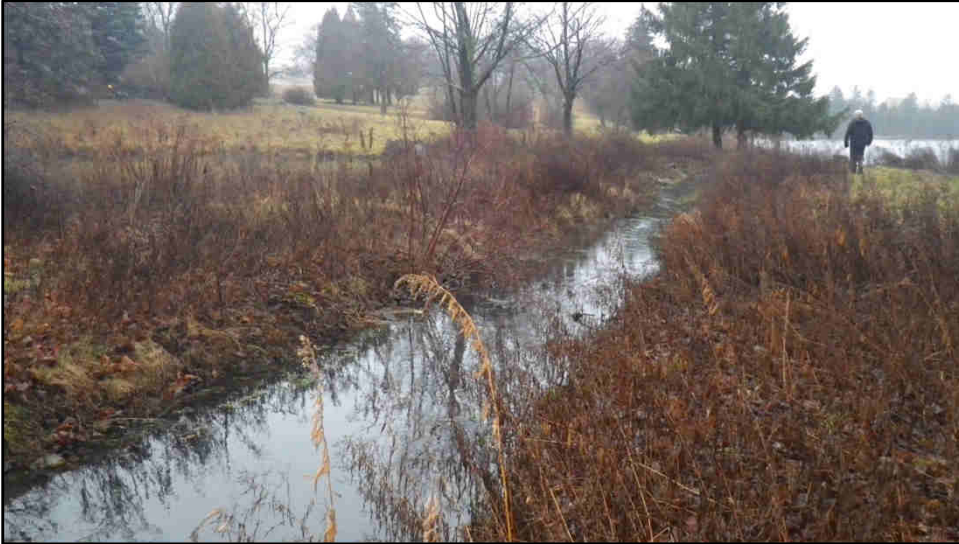
23. Drainage channel from decorative ponds discharges into the South Pond.

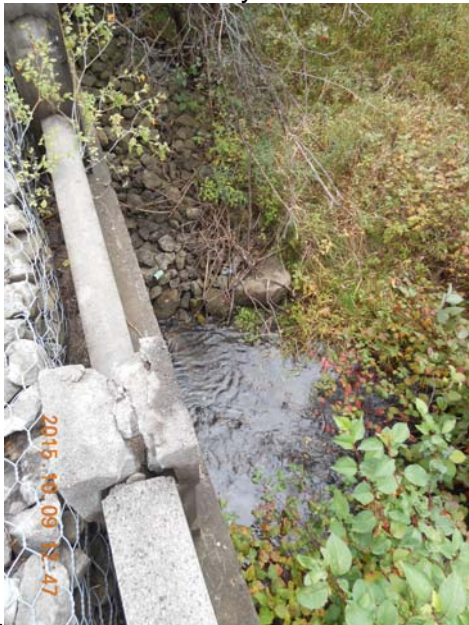
Upstream face of Clythe Creek crossing

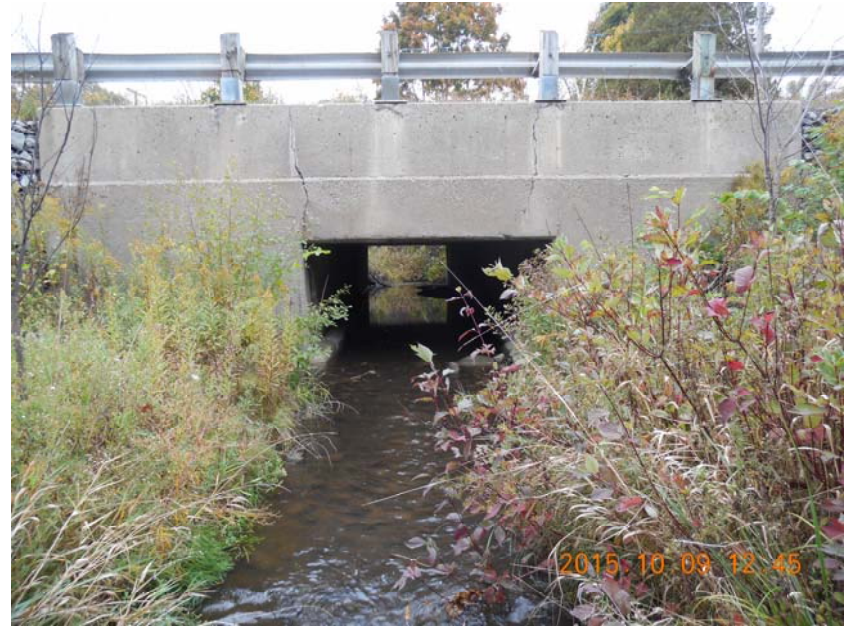
Downstream face of Clythe Creek

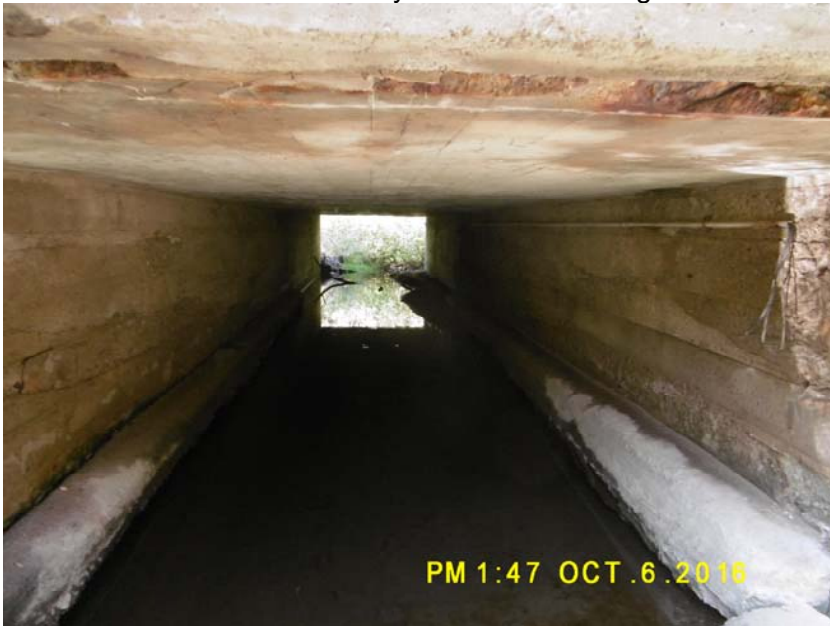
Clythe Creek culvert

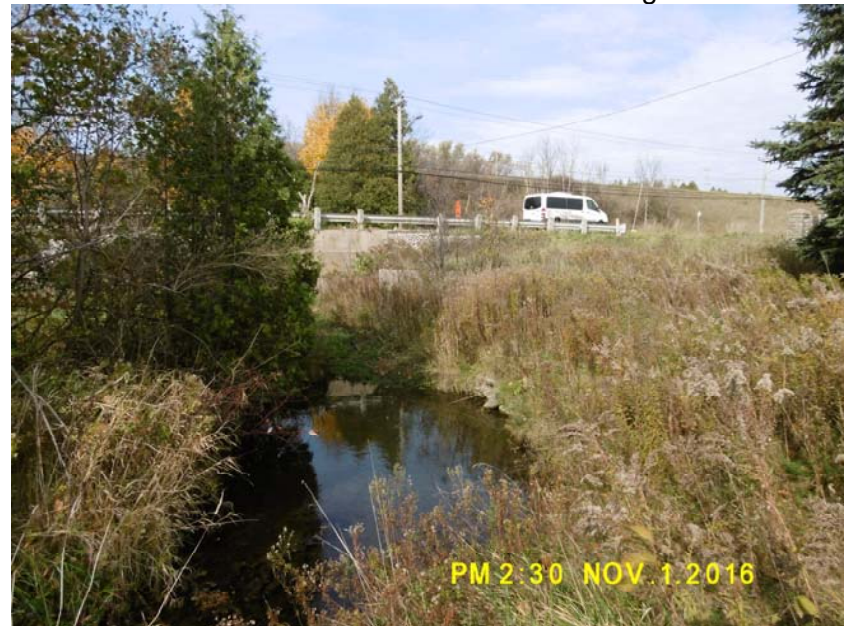
Pool feature immediately downstream of culvert

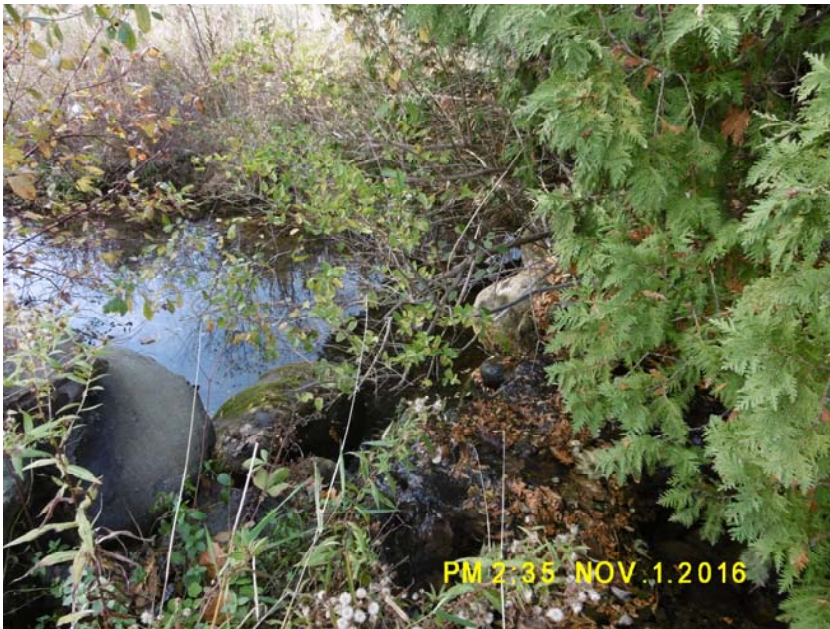
Cultural heritage weird structure

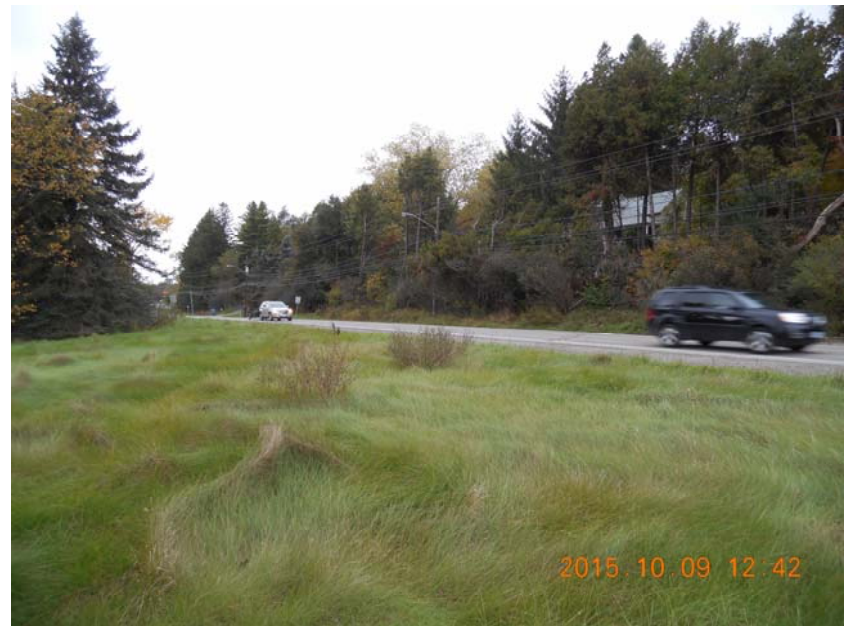
Steep grading along north side of road

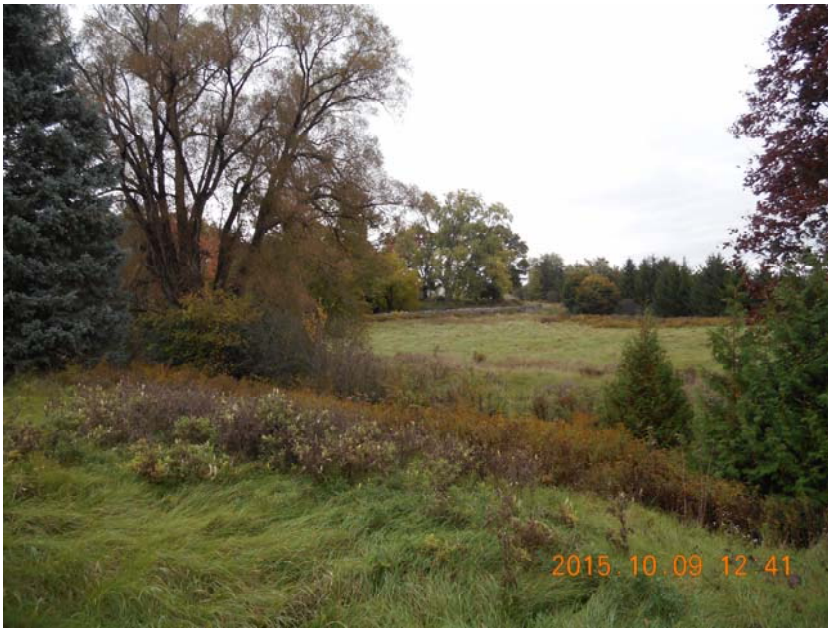
Cultural heritage wall south of creek

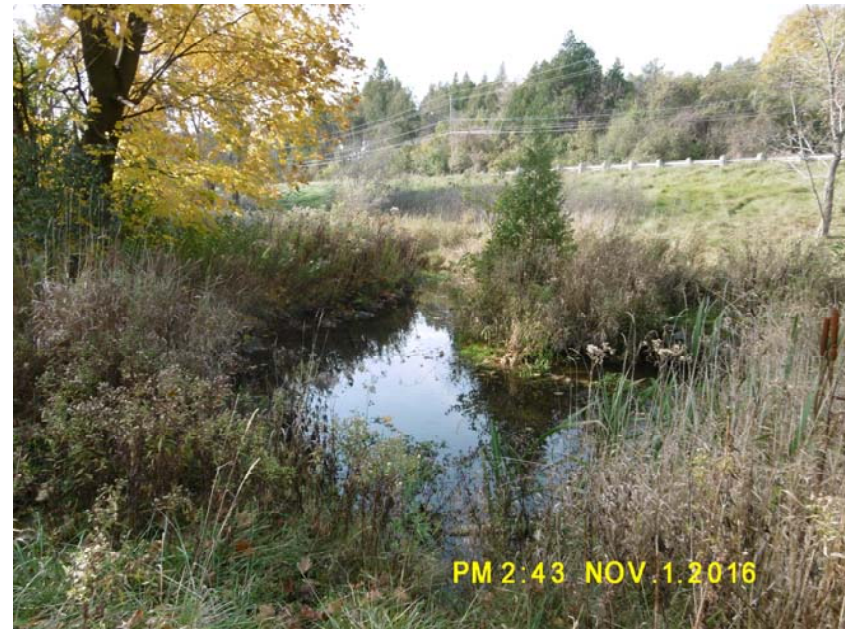
Pool downstream of culvert

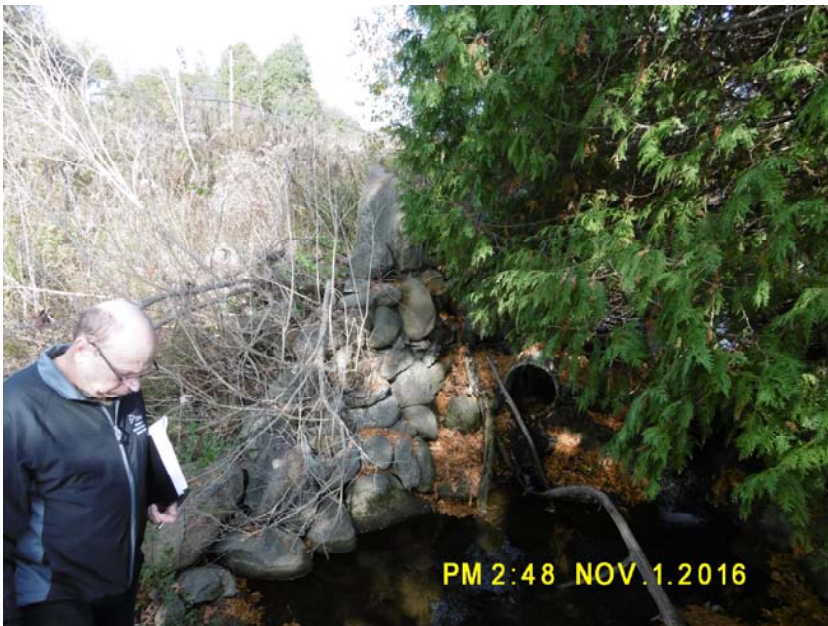
Cultural heritage drop structure with side walls and pipes

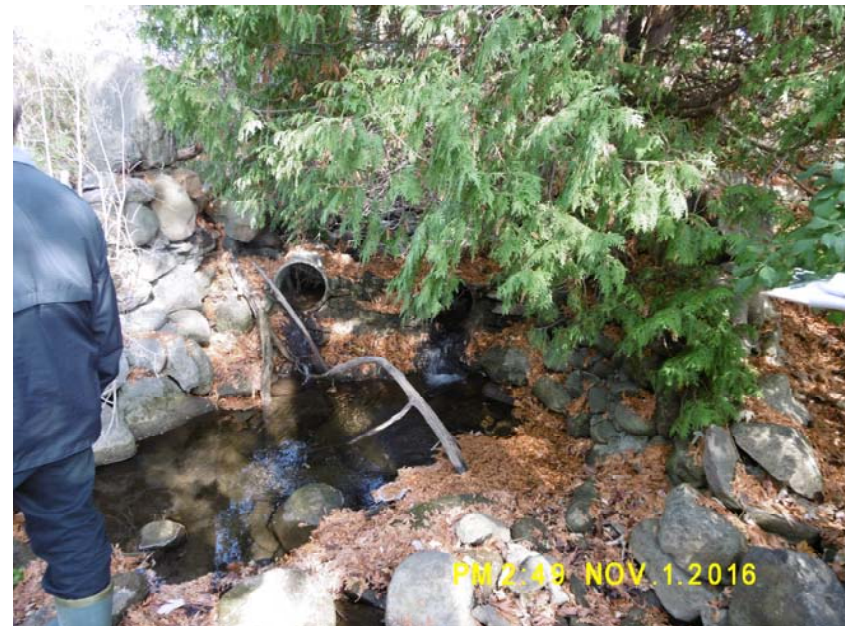
Cultural heritage drop structure with side walls and pipes

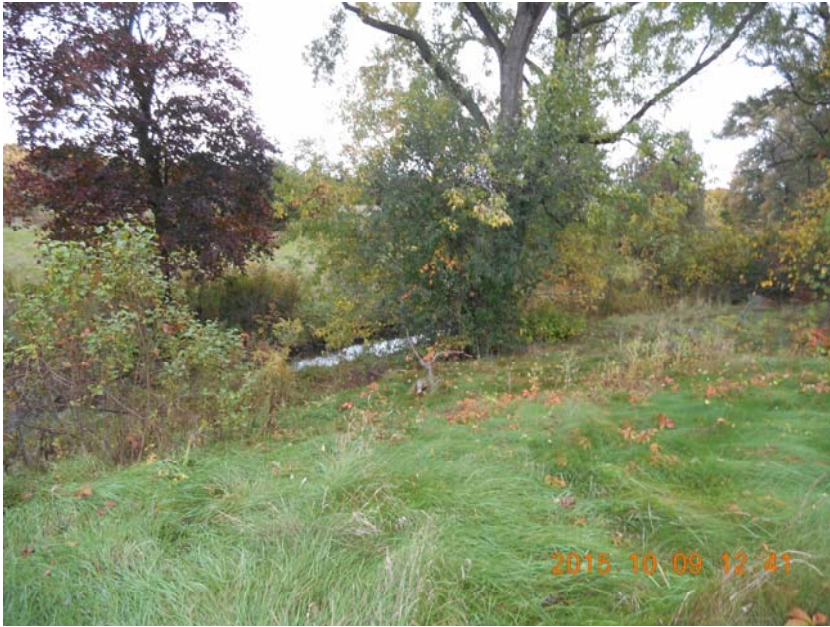
Creek parallel to road

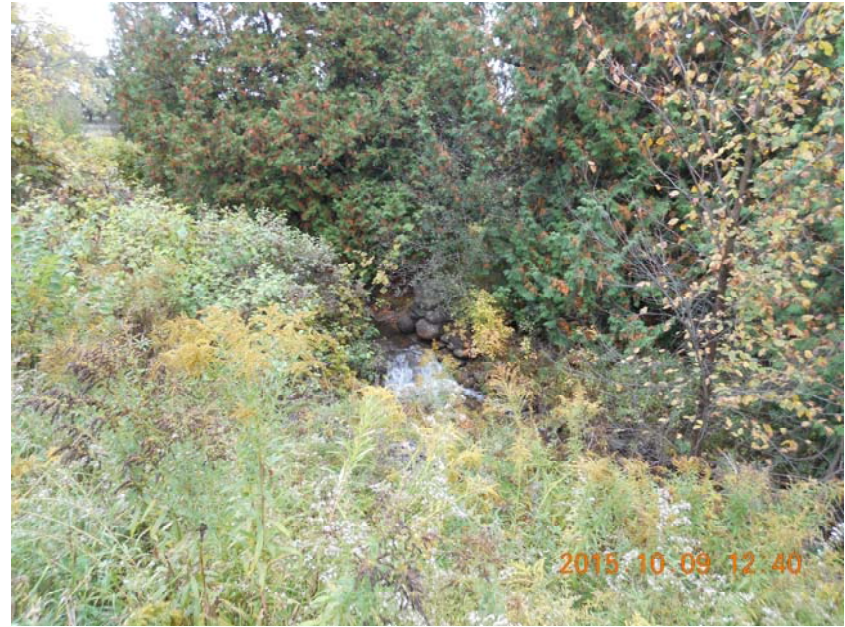
Cultural heritage drop structure

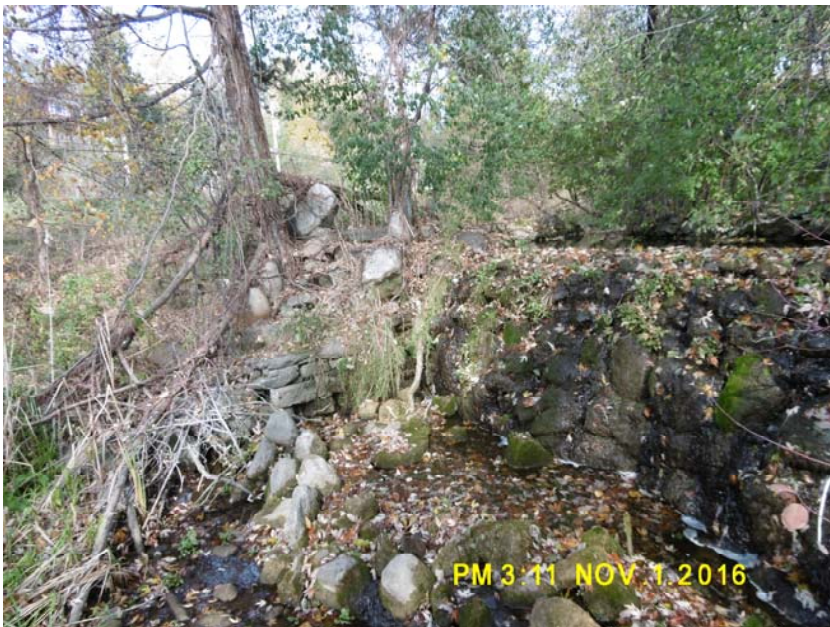
Cultural heritage drop structure

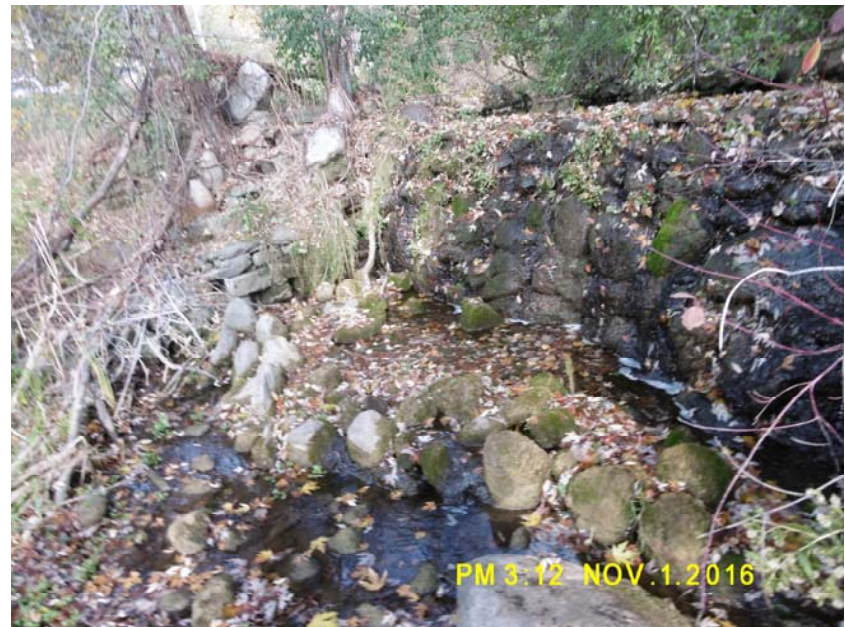
Cultural heritage drop structure

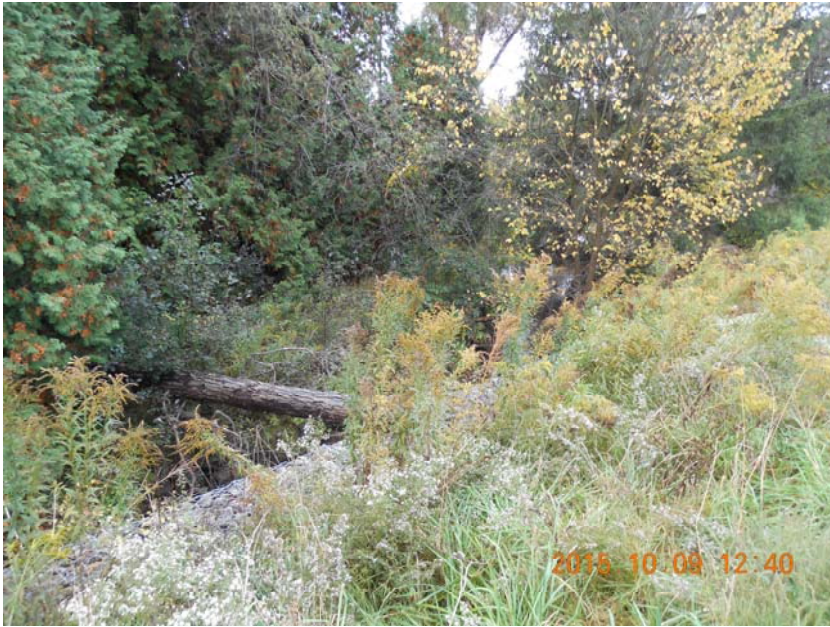
Gabion baskets next to roadway

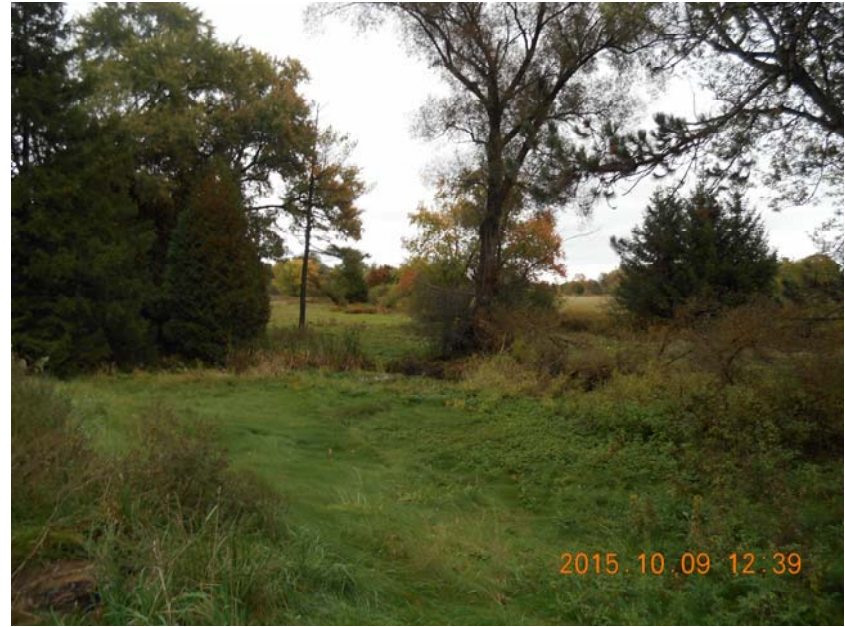
Creek moves away from the road

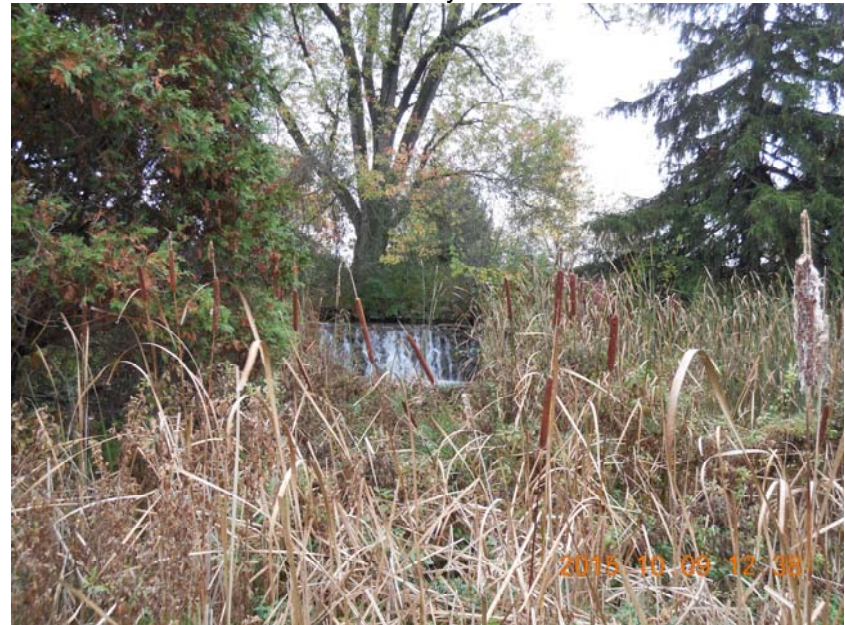
Cultural heritage drop structure

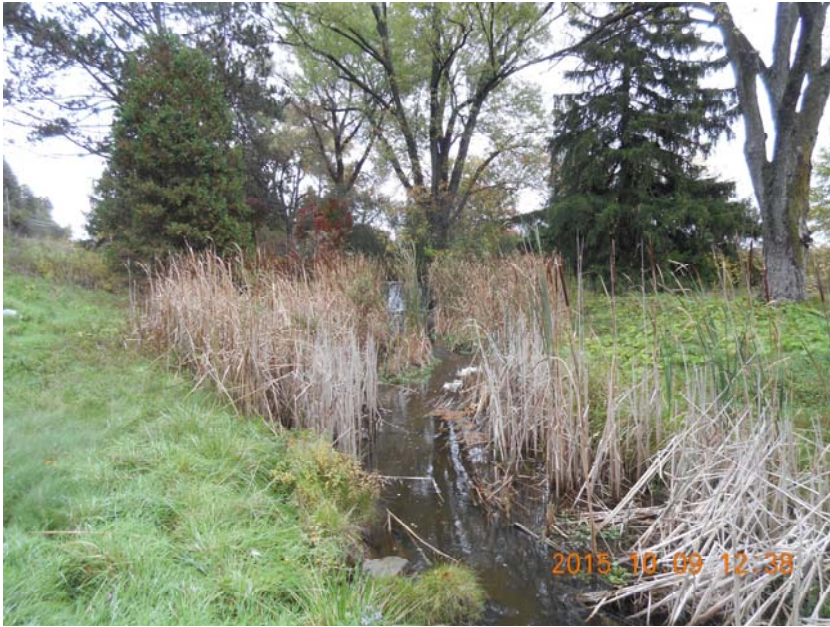
Creek in close proximity to road

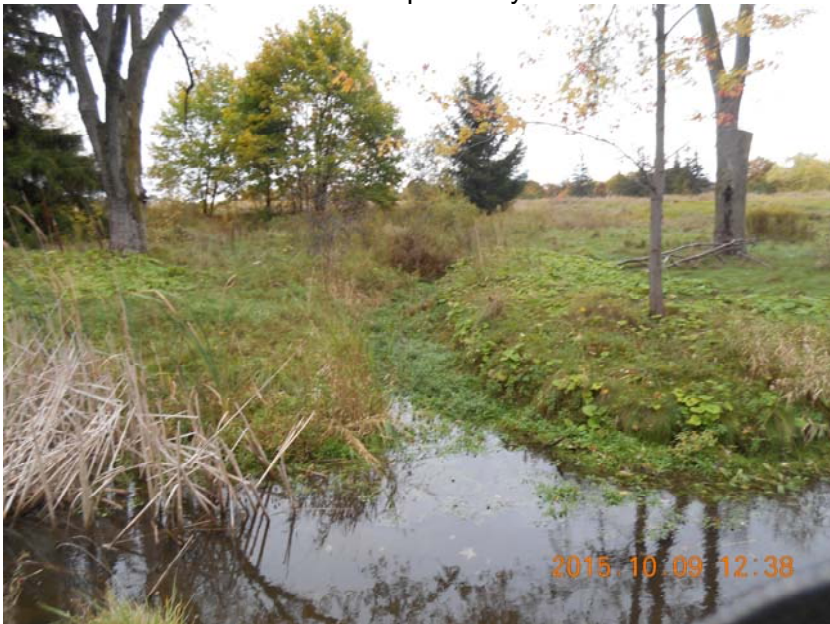
Drainage feature confluence with the creek

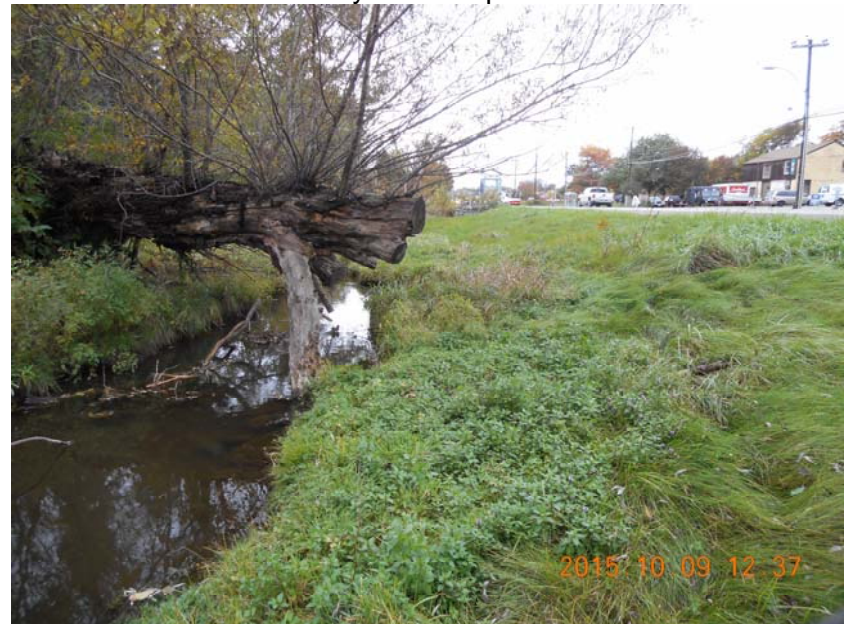
Creek in close proximity to the roadway

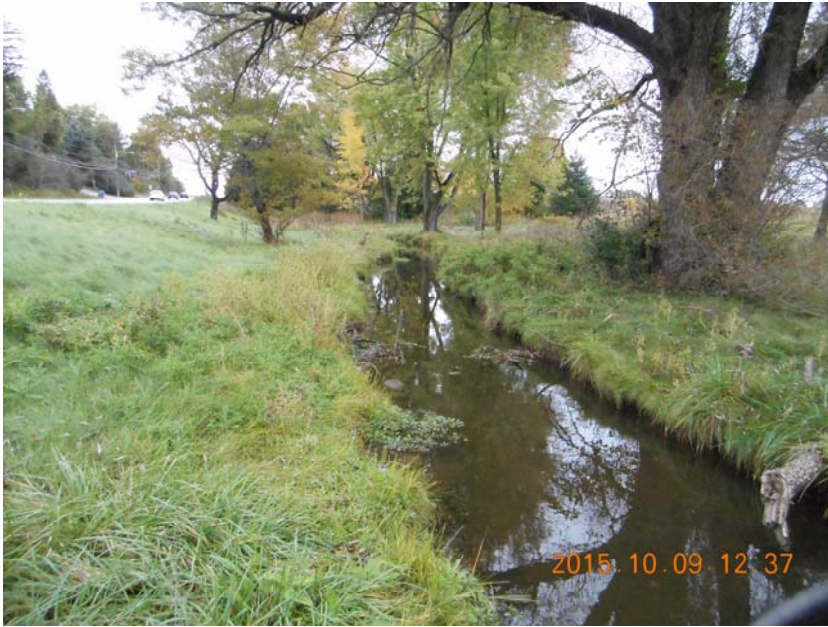
Creek in close proximity to roadway

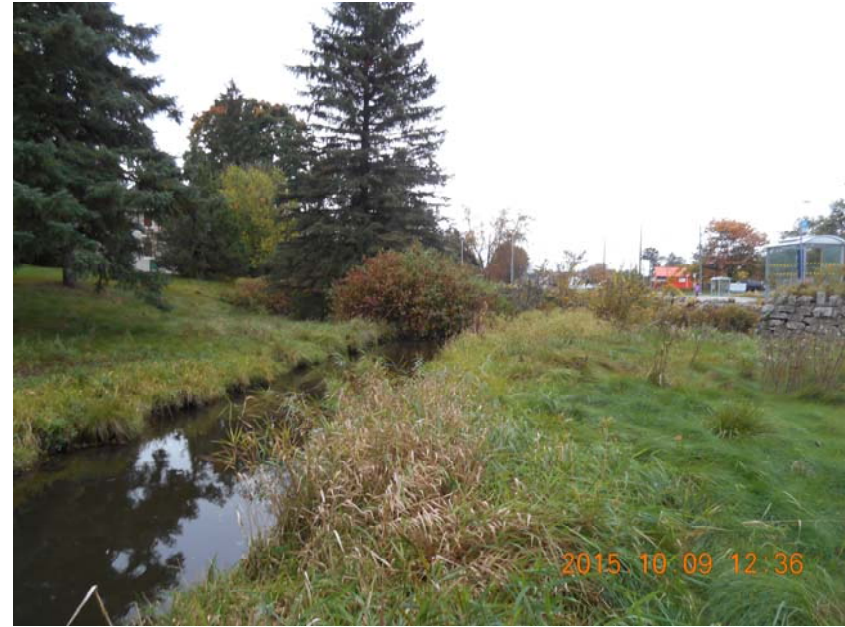
Cultural heritage wall feature

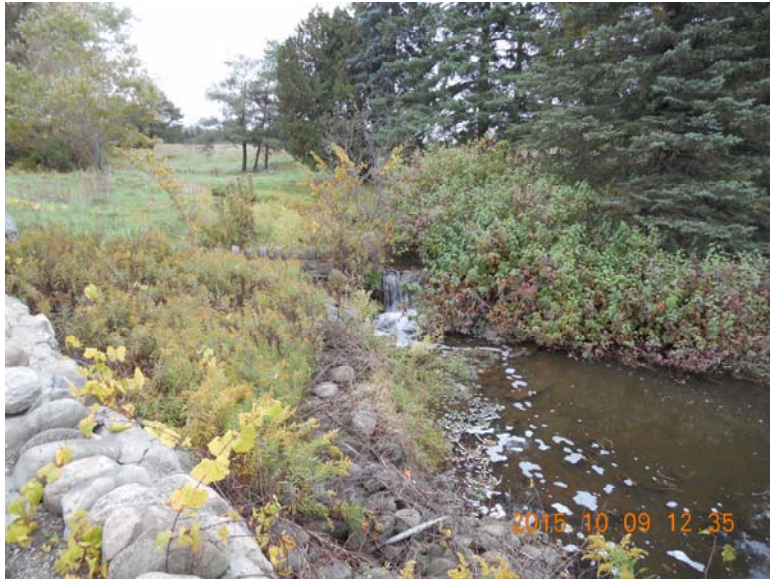
Cultural heritage wall and drop structure just west of former Reformatory driveway

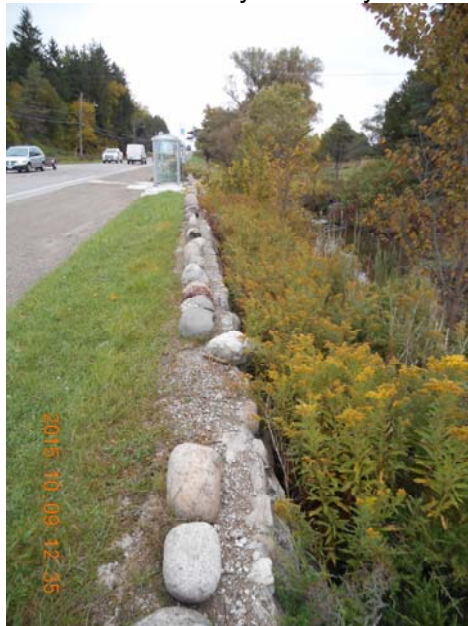
Cultural heritage wall along York Road

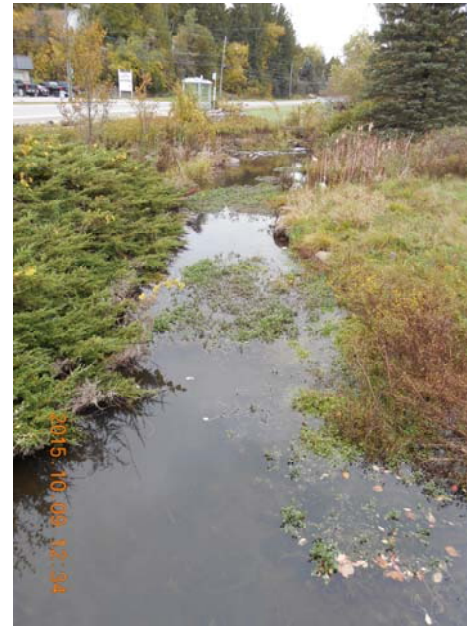
Creek immediately upstream of former Reformatory driveway
Note creek is in a backwater condition

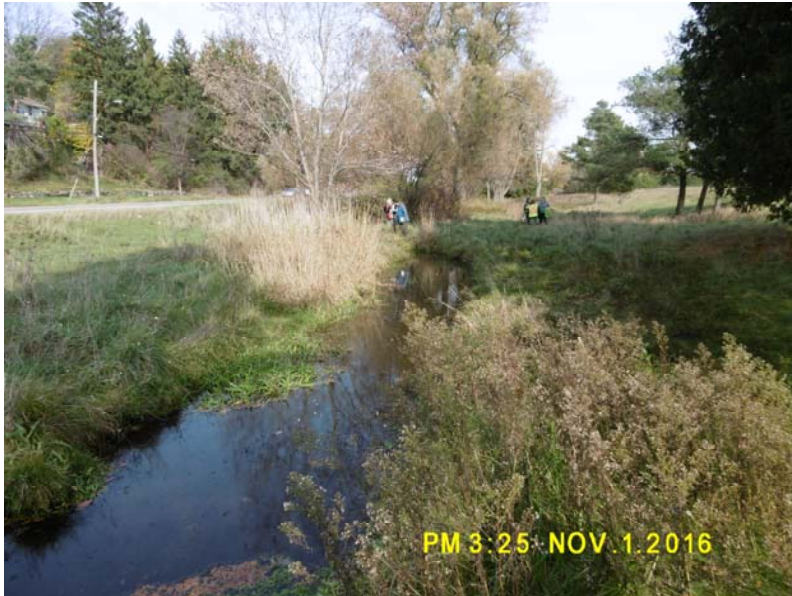
Creek immediately upstream of former Reformatory driveway
Note creek is in a backwater condition
