Draft Terms of Reference

Environmental Impact Study (EIS)

York Road Environmental Design Study

City of Guelph

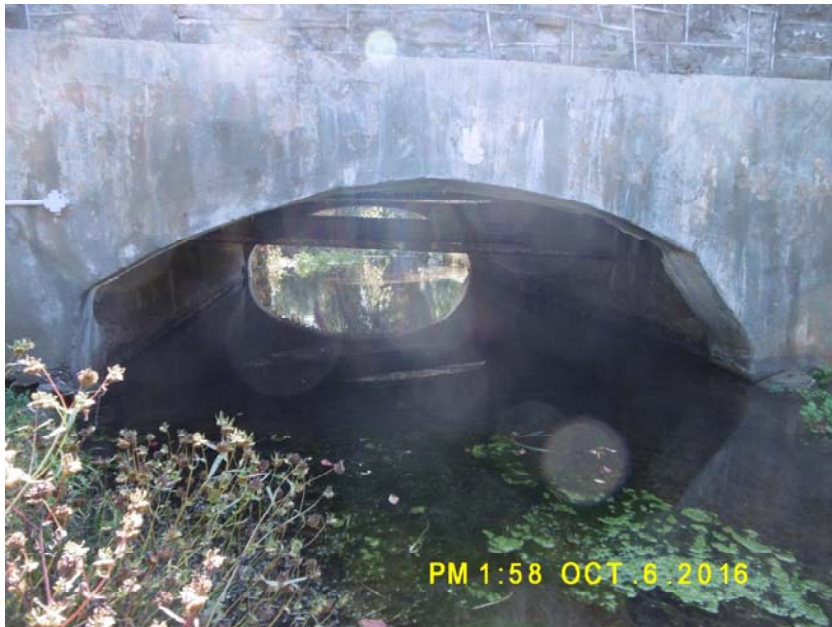
Former Reformatory driveway crossing

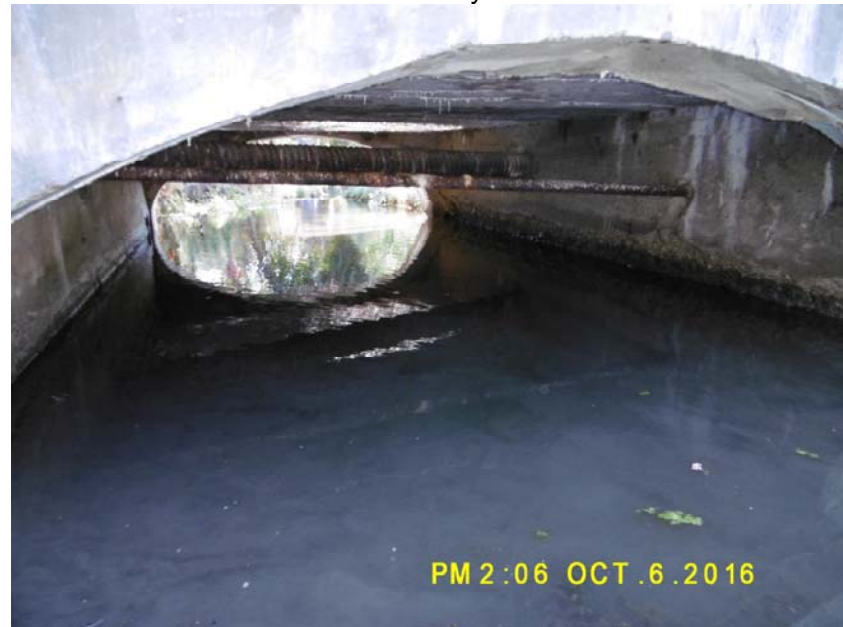
Former Reformatory driveway crossing

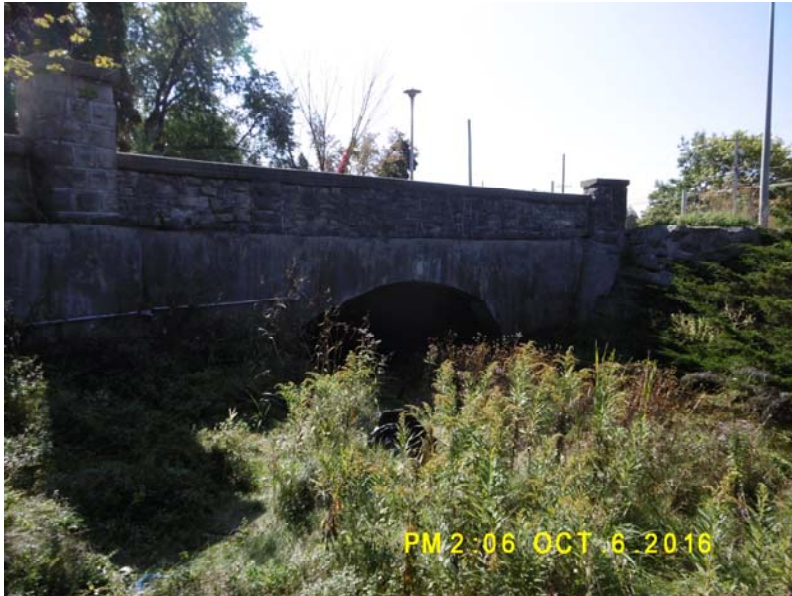
Former Reformatory driveway crossing

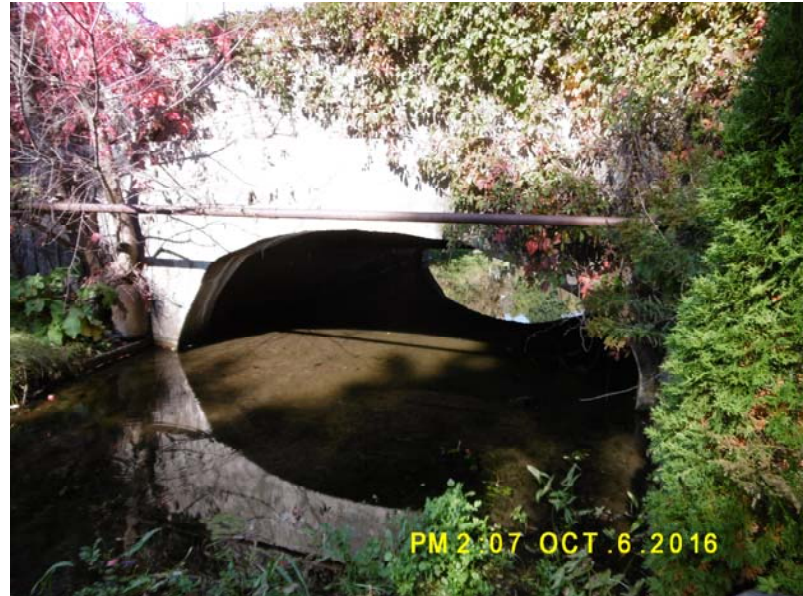
Former Reformatory driveway crossing

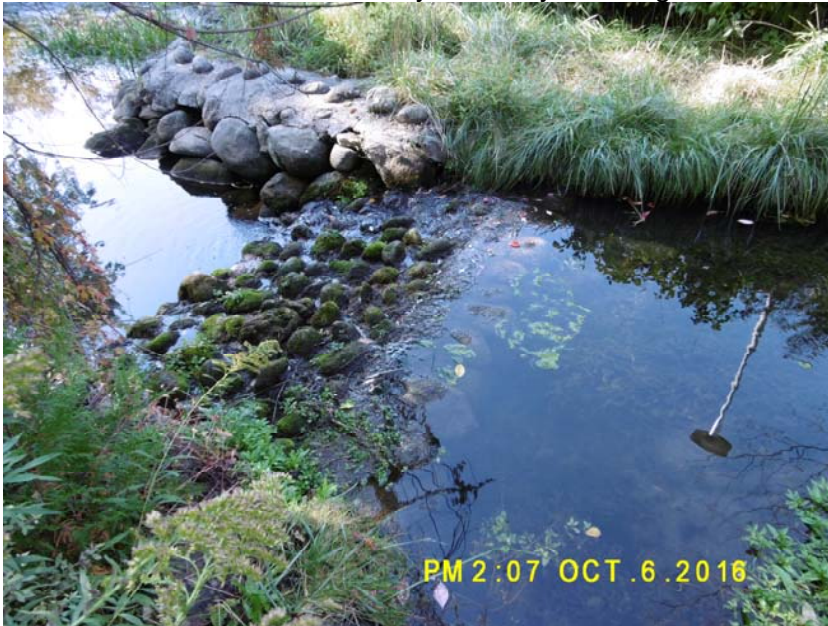
Downstream of former Reformatory driveway crossing
Note drop structure

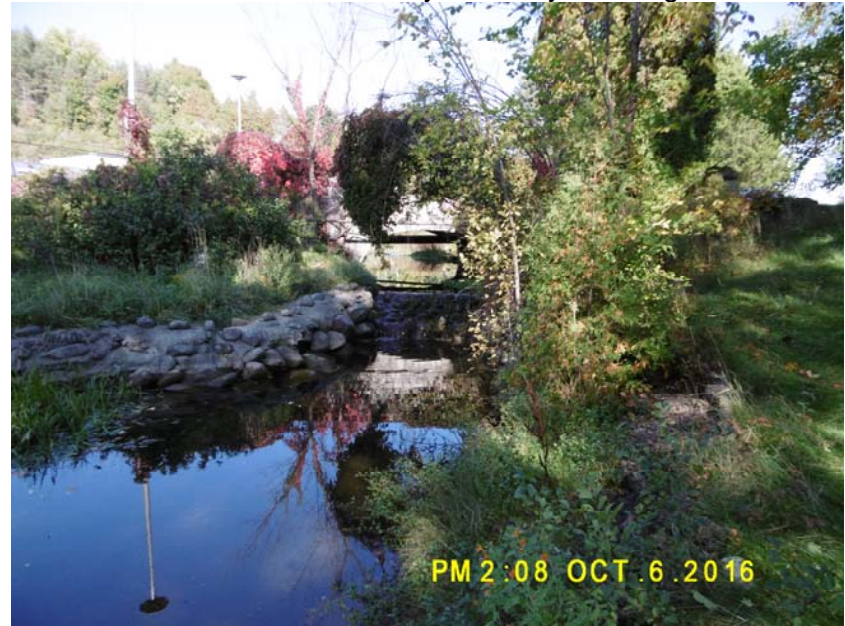
Lined channel downstream of former Reformatory driveway

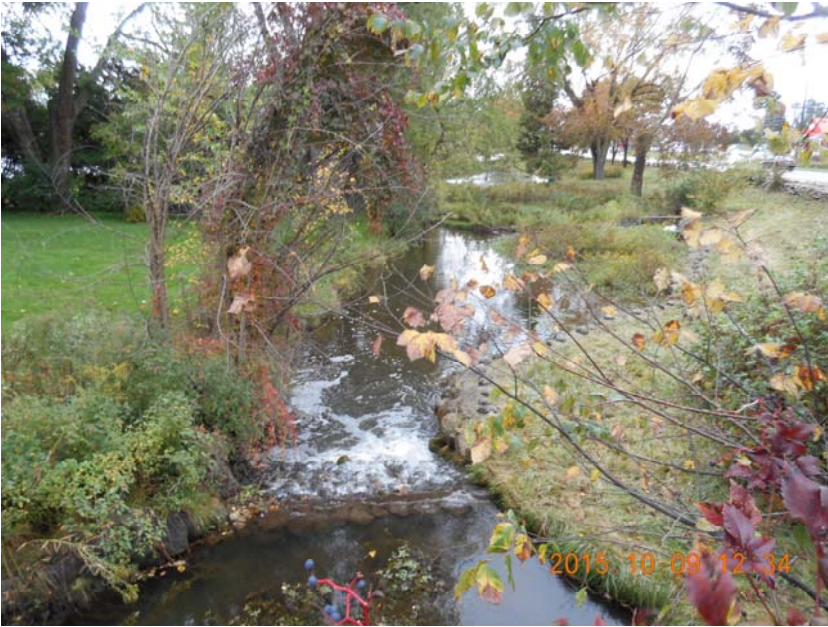
Drop structure downstream of former Reformatory driveway crossing

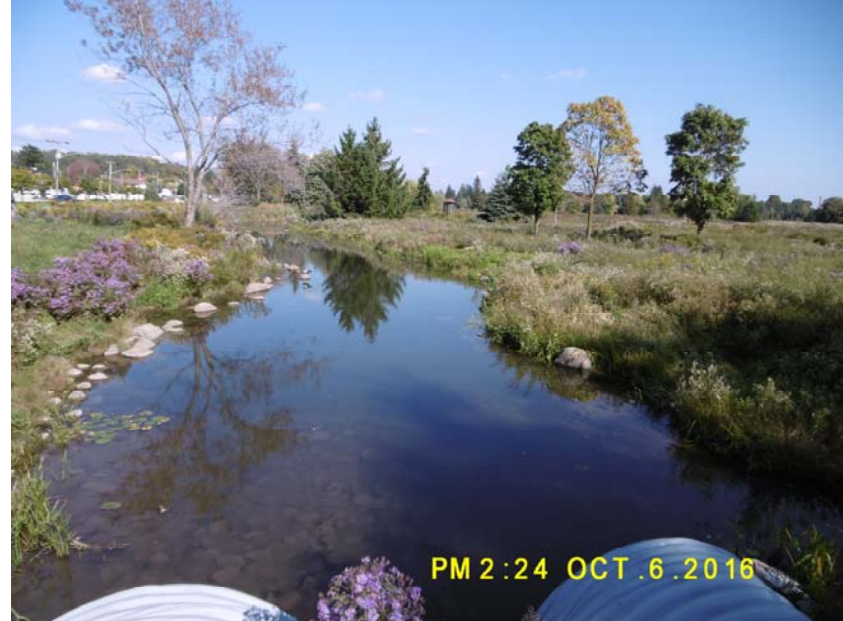
Upstream of twin CSP crossing into park parking lot

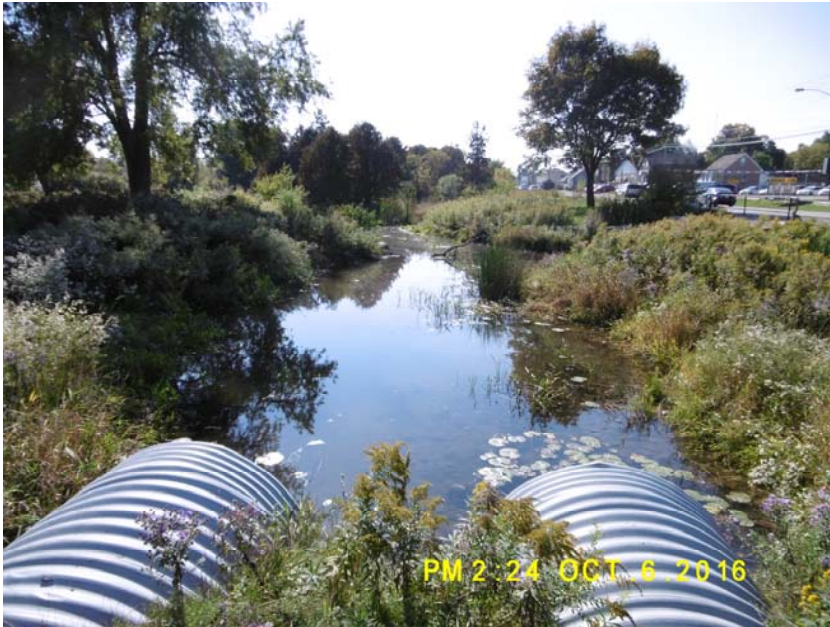
Downstream of twin CSP culverts

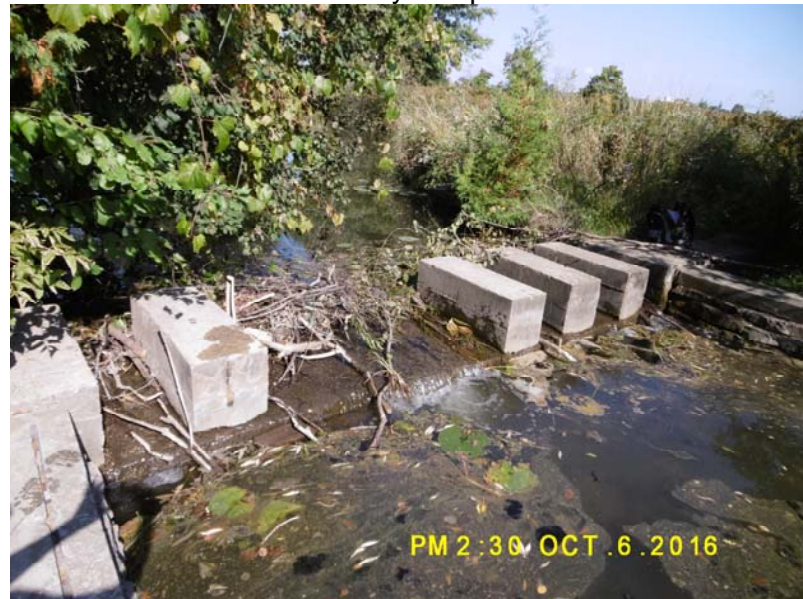
Damaged energy dissipation structure upstream of confluence with the Eramosa River

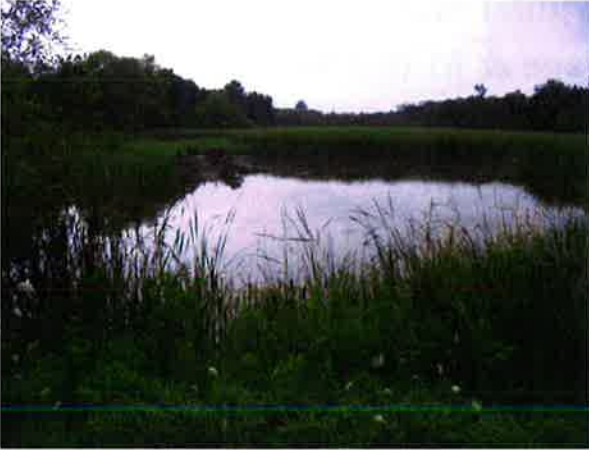
Photo 1: Large online pond created by a weir at Jones Baseline. The pond is located downstream of Site 1 and immediately upstream of Site 2. The pond is likely the primary cause of the observed increase in water temperature.

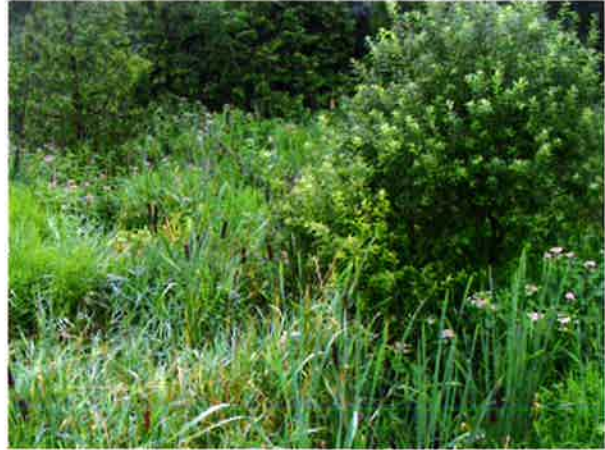
Photo 2: Dense vegetation downstream of Jones Baseline (Site 2) presents a challenge to exploring the Creek. A pump used for taking water for the irrigation of a garden was observed in the Creek just downstream of Site 2.

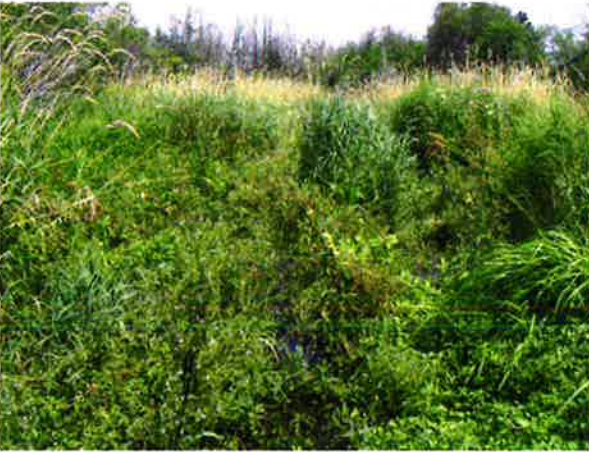
Photo 3: Dense riparian vegetation typical of the Creek between Highway 7 (Site 3) and Watson Road North (Site 4). Groundwater seeps were observed in this section of Creek and watercress was observed in the channel.

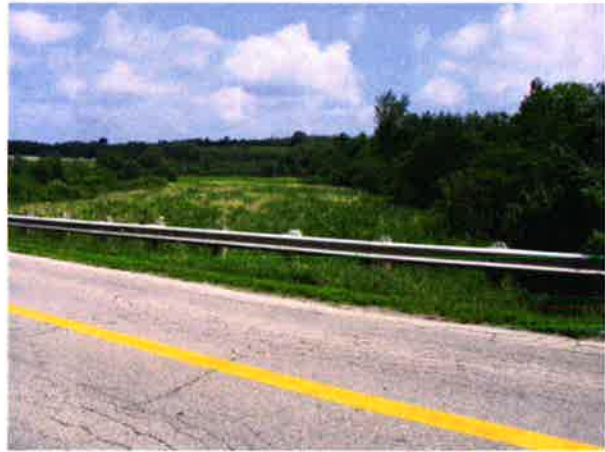
Photo 4: The Creek meanders through a wetland immediately upstream of Watson Road North (Site 4). Hills to the north of the Creek have been cleared for development (construction in progress) and storm water ponds have been constructed.

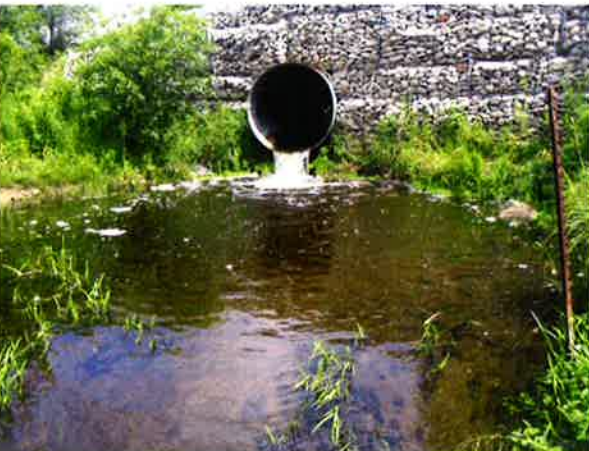
Photo 5: Perched culvert at Watson Road North (Site 4) presents a significant barrier to fish migration. Large schools of minnows (and minnow traps) can usually be observed in the pool below the culvert.

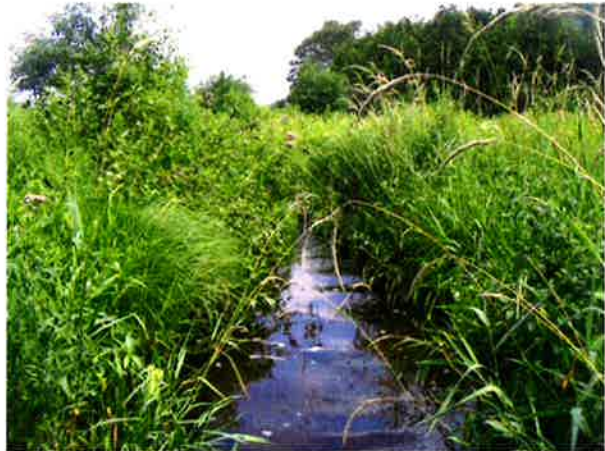
Photo 6: Sections of the Creek between Watson Road North (Site 4) and Watson Parkway (Site 5) have been channelized; however, the Creek is relatively narrow with areas of gravel streambed and some riparian cedar trees.

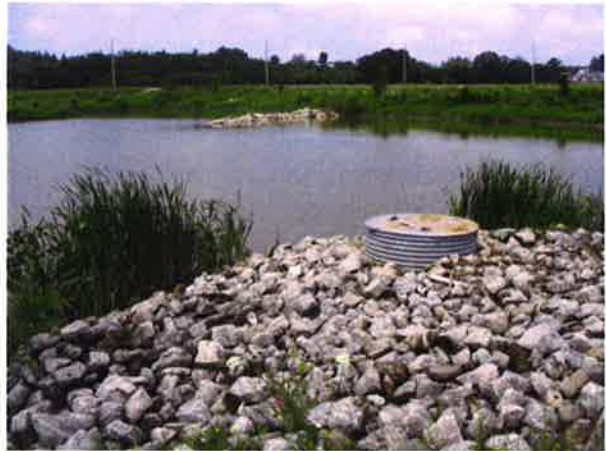
Photo 8: Storm water management pond collects runoff from the developing portion of the watershed near Starwood Drive and Grange Road. The pond discharges to the Creek just upstream of Watson Parkway (Site 5).

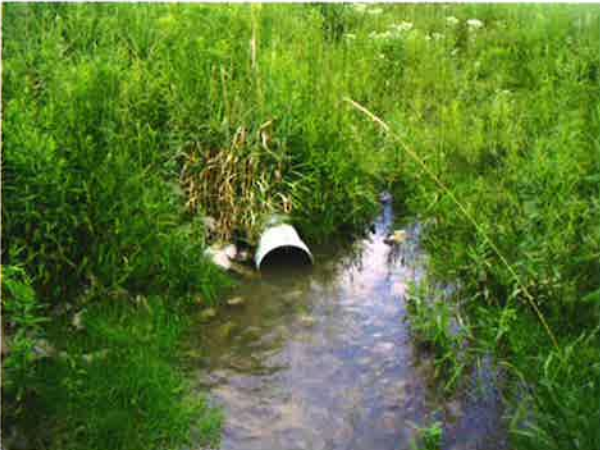
Photo 9: Discharge from the storm water pond was consistently turbid throughout the summer. Water quality in Clyde Creek was noticeably impacted and sedimentation of the Creek channel downstream of the pond outlet was observed.

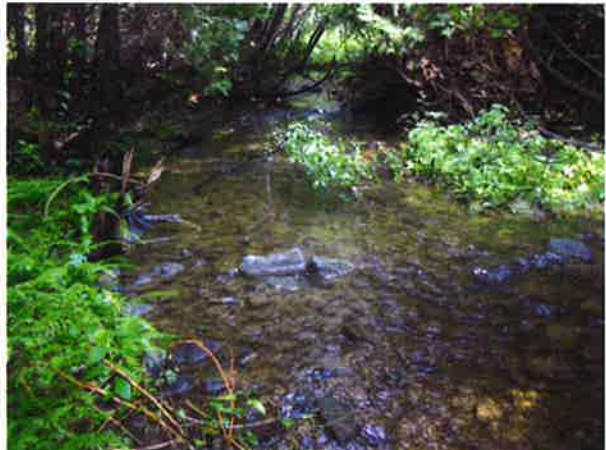
Photo 10: The Creek flows through a small patch of dense cedar forest between Watson Parkway (Site 5) and Highway 7 (Site 6). Numerous groundwater seeps can be found in this area. Sedimentation of the Creek channel is evident.

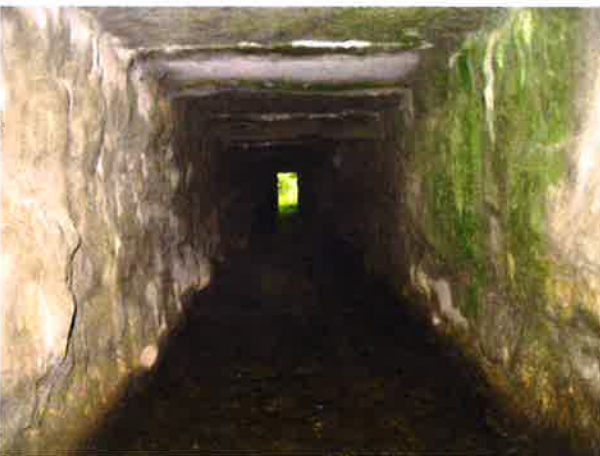
Photo 11: A long, dual-channelled, concrete culvert diverts the Creek from the north to the south side of the railway line.

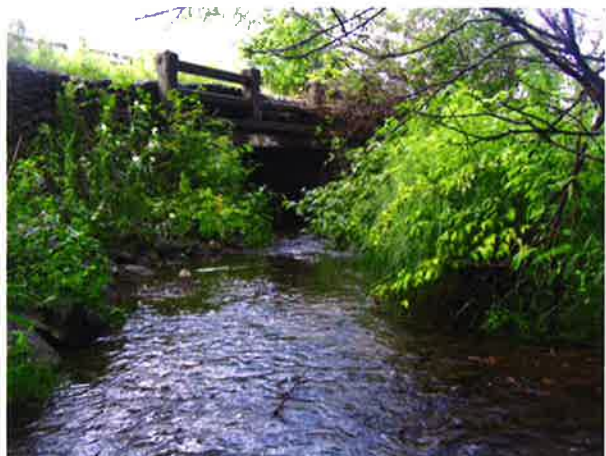
Photo 12: The Creek passes under Highway 7 (Site 6) and flows along the north side of the highway toward its confluence with the Eramosa River. This section of the Creek is highly altered with numerous dams, weirs and ponds.

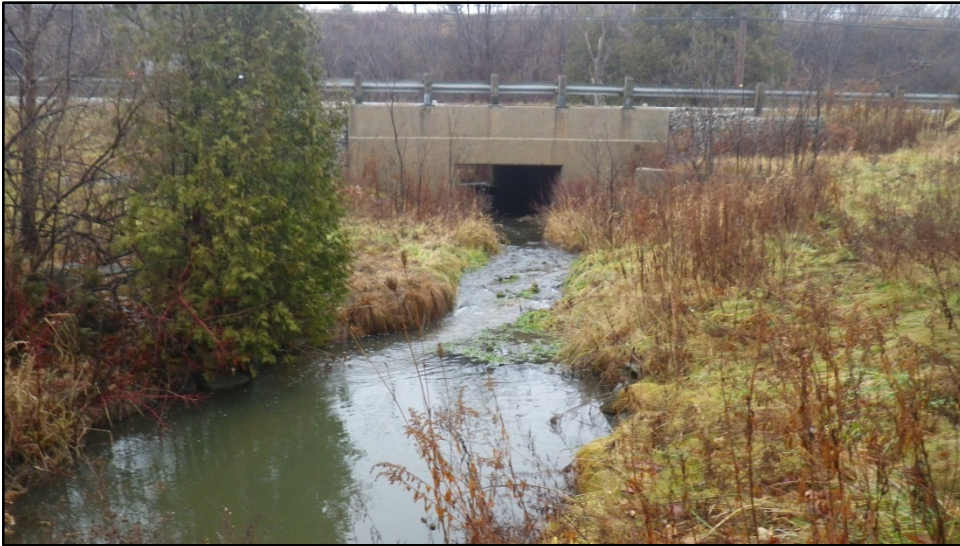
1. York Road crossing of Clythe Creek. Structure is a concrete box culvert. A pool has formed downstream from a transition riffle.

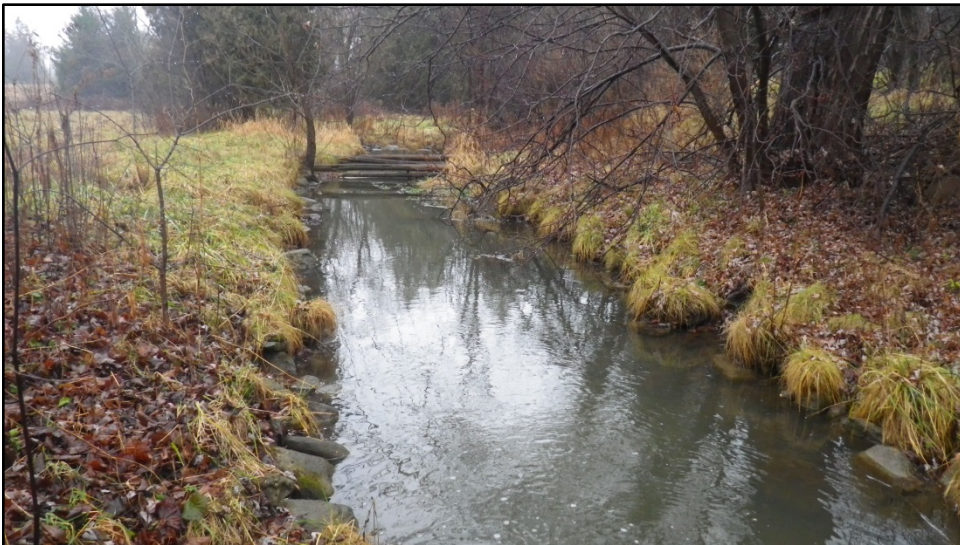
2. Looking downstream along Clythe Creek; channel is straight with rock protection located along banks.

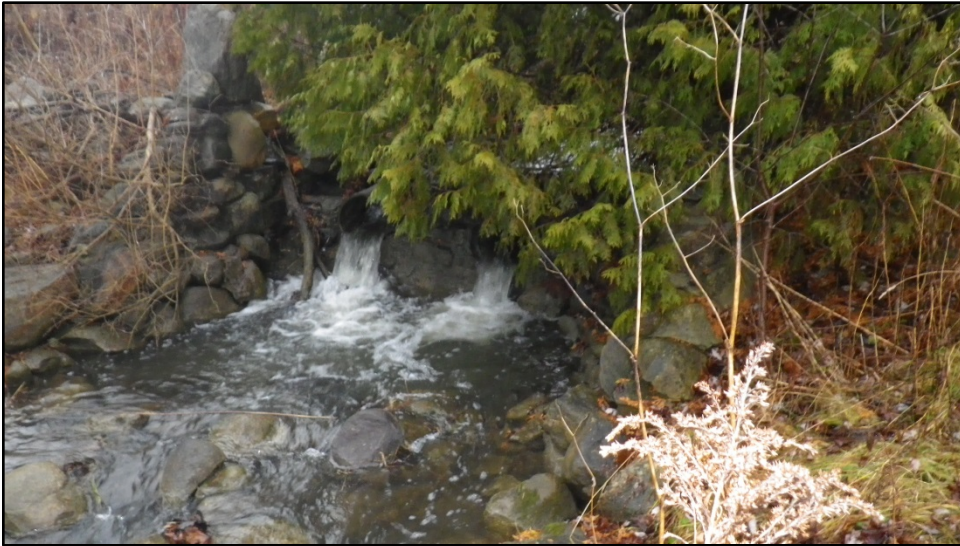
3. Two clay pipes convey flow downstream from a grade control weir. Channel banks are protected by stone.

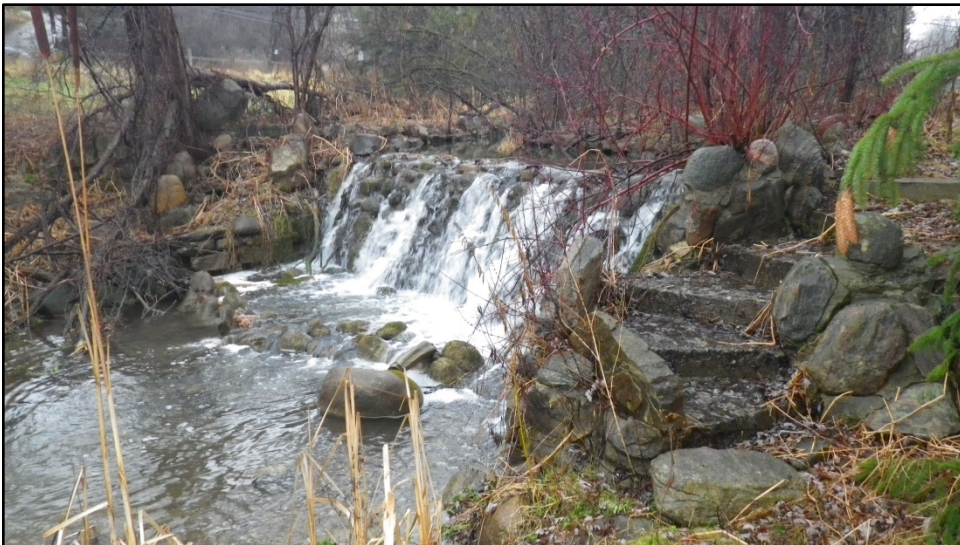
4. Approximately 250 m downstream from York Road, an approximate 1.2 m stone weir grade control structure is present.

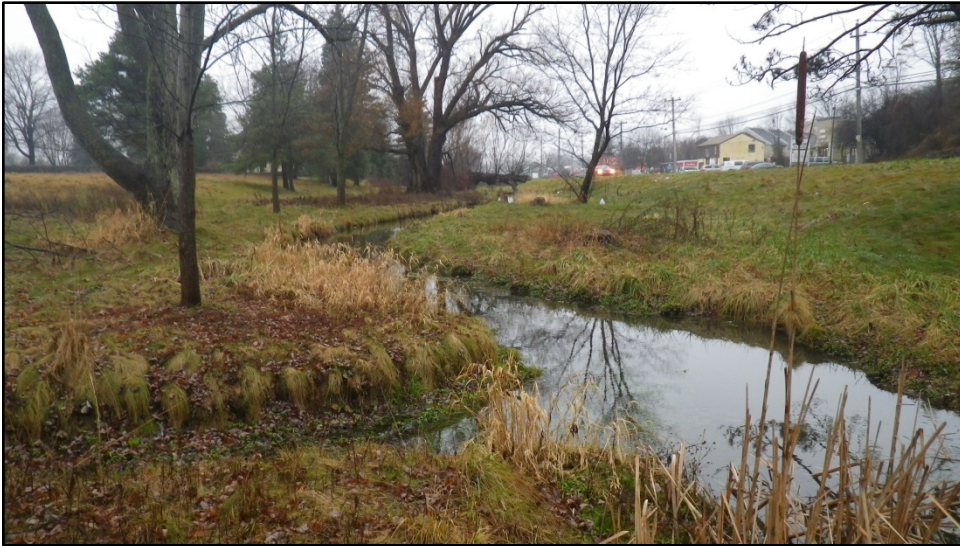
5. Looking downstream along Clythe Creek channel; minor tributary enters the creek in the foreground.

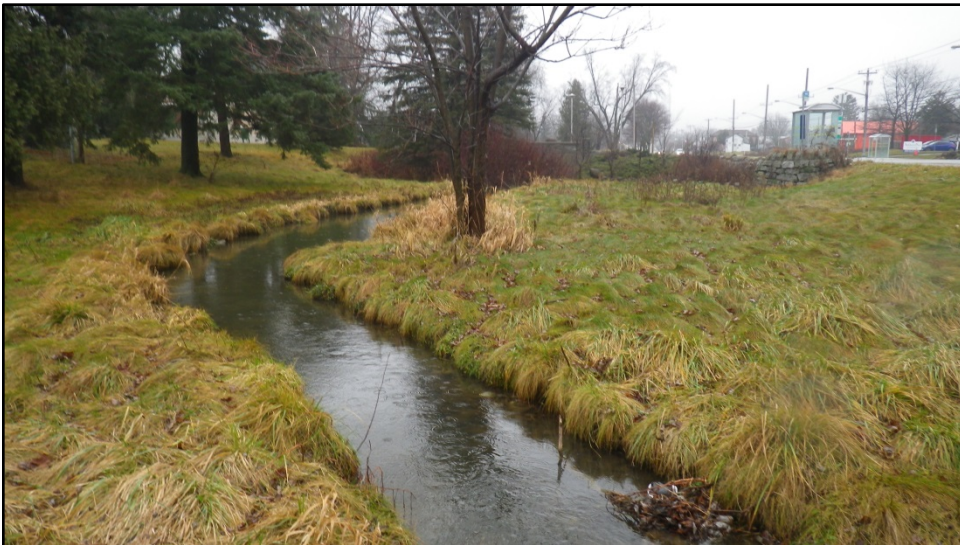
6. Looking downstream along Clythe Creek. Slow-moving water appears to be just below bankfull height.

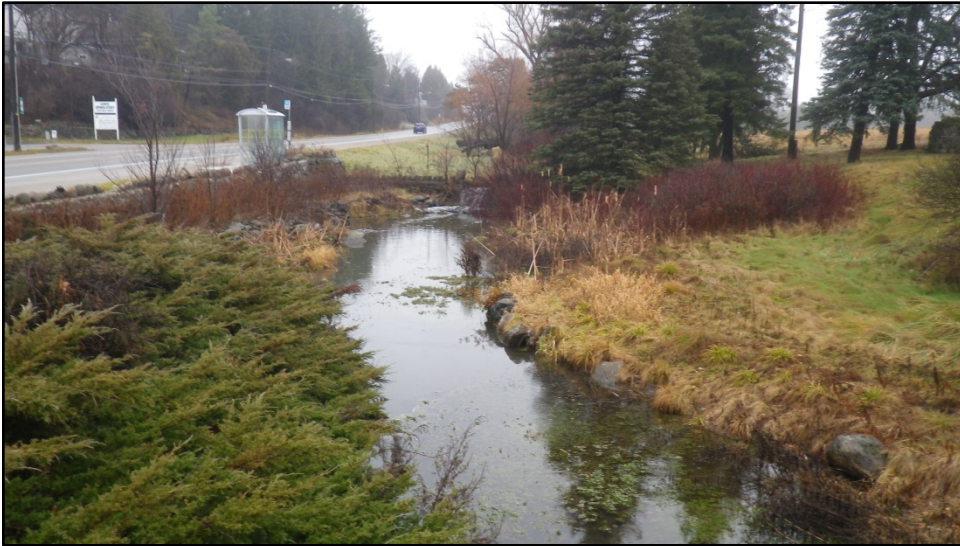
7. Looking upstream along Clythe Creek from the historical stone bridge (access to institution lands); a grade control weir is present in the background.

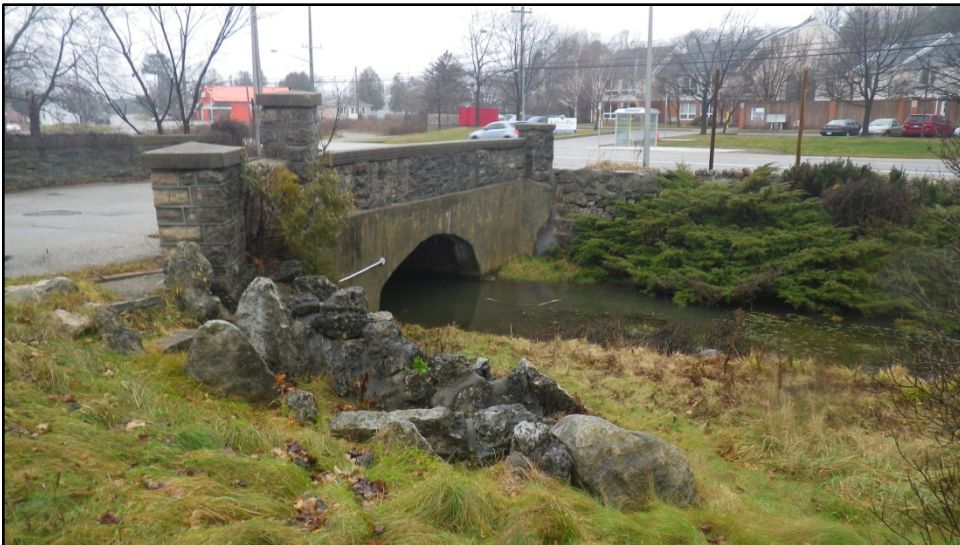
8. Historical stone bridge is main access to institution lands.

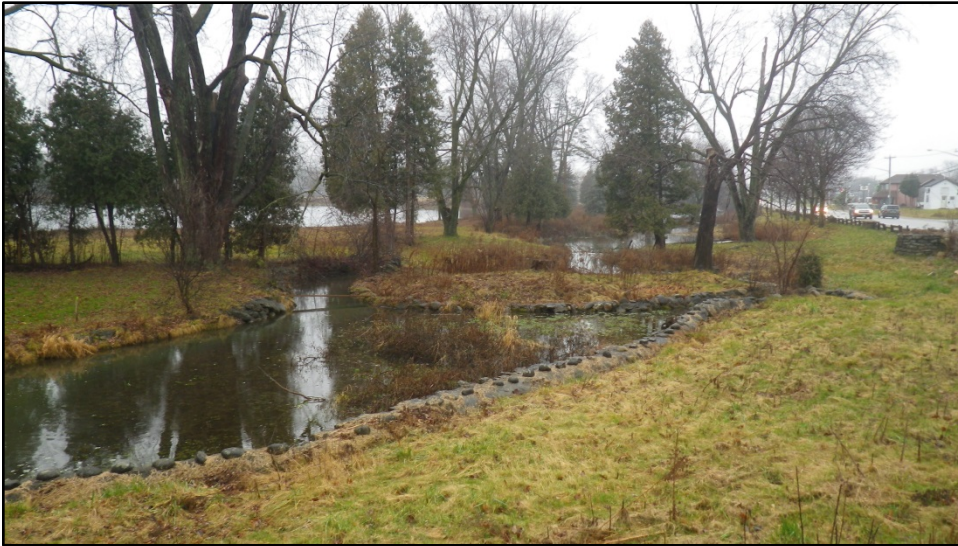
9. Looking downstream along Clythe Creek from the historical stone bridge; aesthetic islands are present in the background.

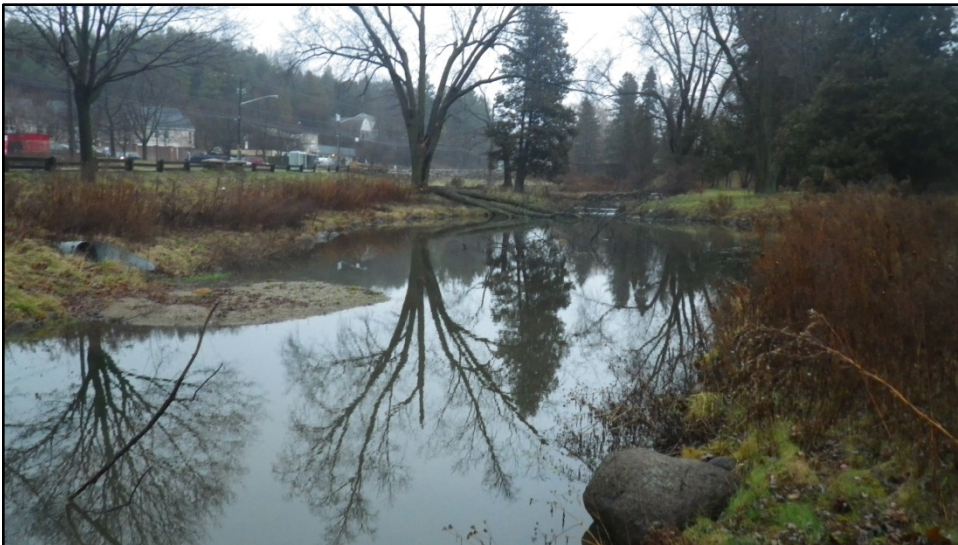
10. Looking upstream along Clythe Creek; channel is over-widened and stagnant; a CSP culvert contributes surface discharge from the north side of York Road; a sediment bar has formed downstream from the CSP.

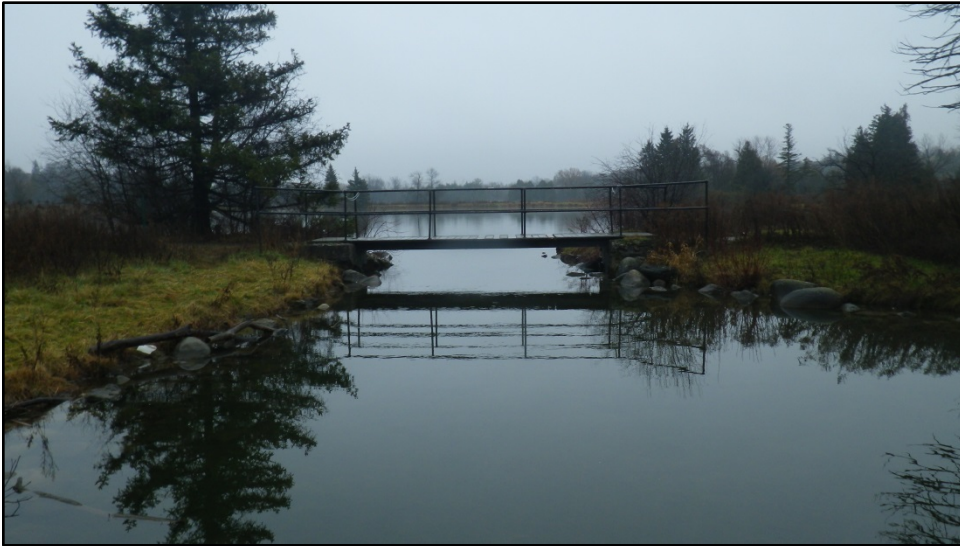
11. Looking upstream along the north pond connection channel and pedestrian bridge.

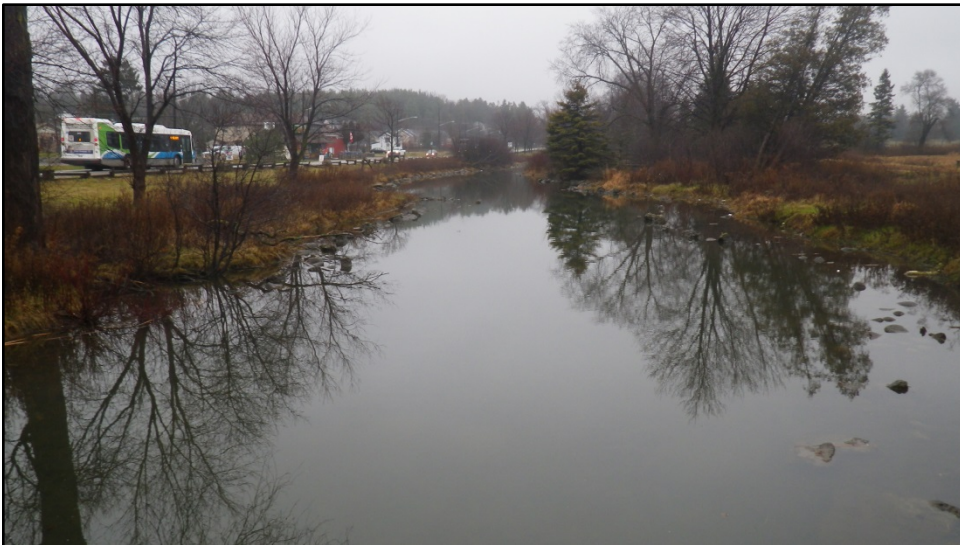
12. Looking upstream along Clythe Creek; channel is over-widened and slow moving.

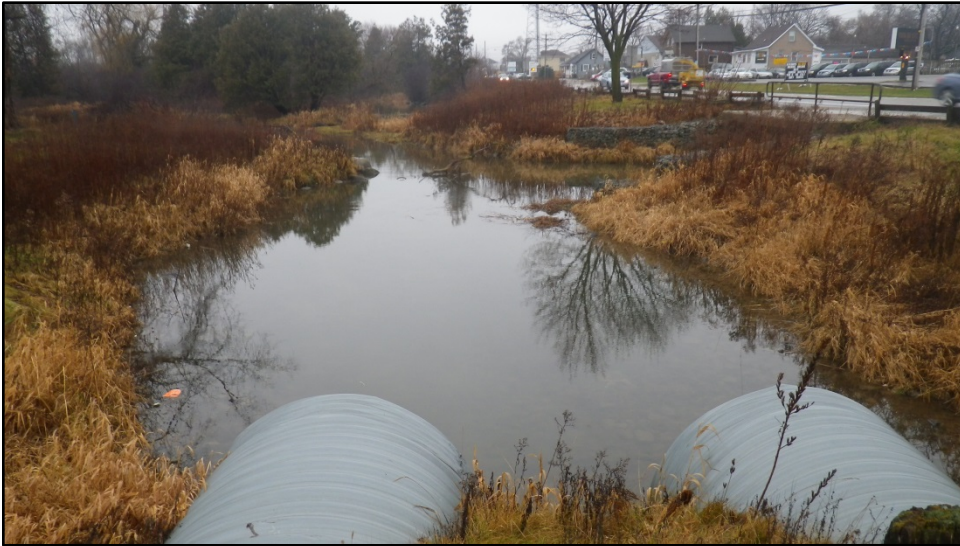
13. Two CSP culverts convey flows downstream from a parklands access road; channel immediately regains width downstream before Hadati Creek Confluence (background, right bank).

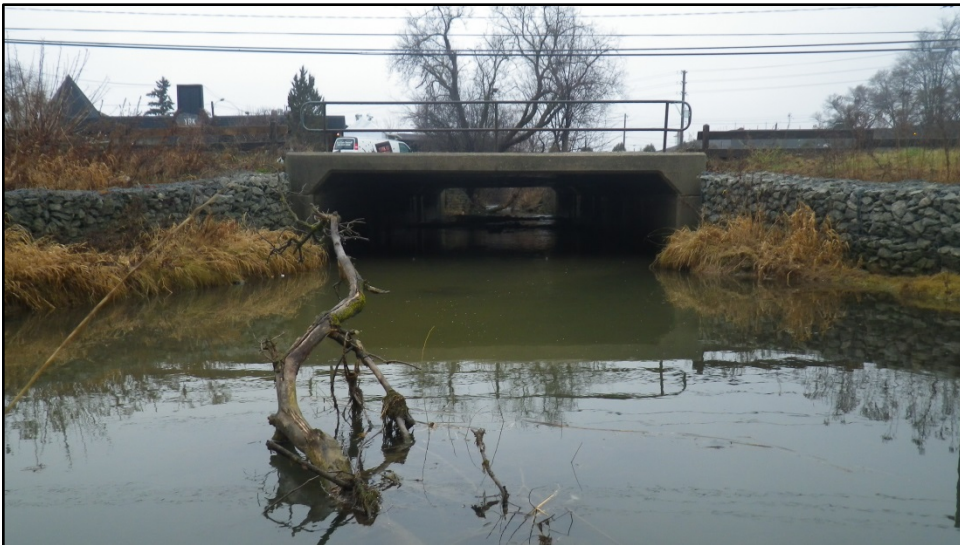
14. York Road crossing of Hadati Creek; structure is a concrete box culvert; gabion wing-walls protect the banks.

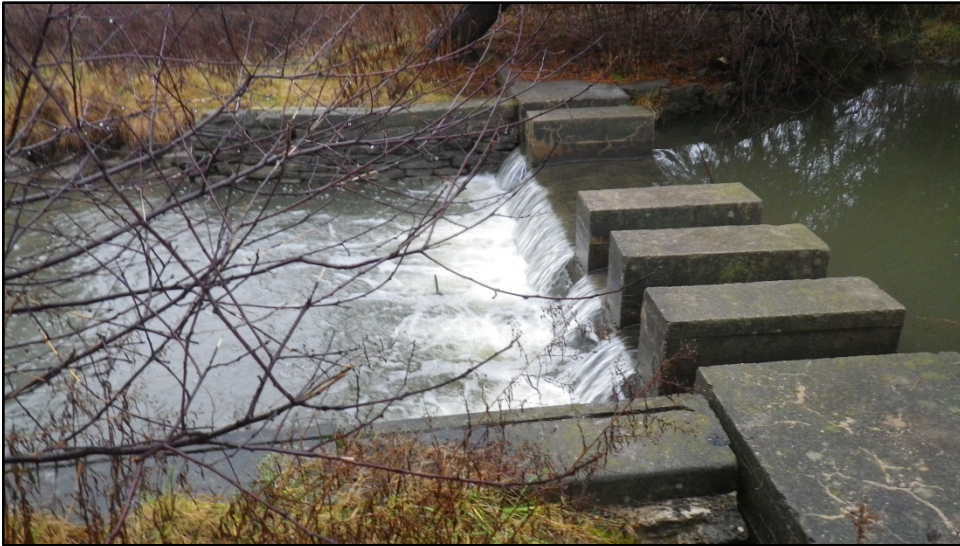
15. Flow control structure downstream from Hadati Creek confluence.

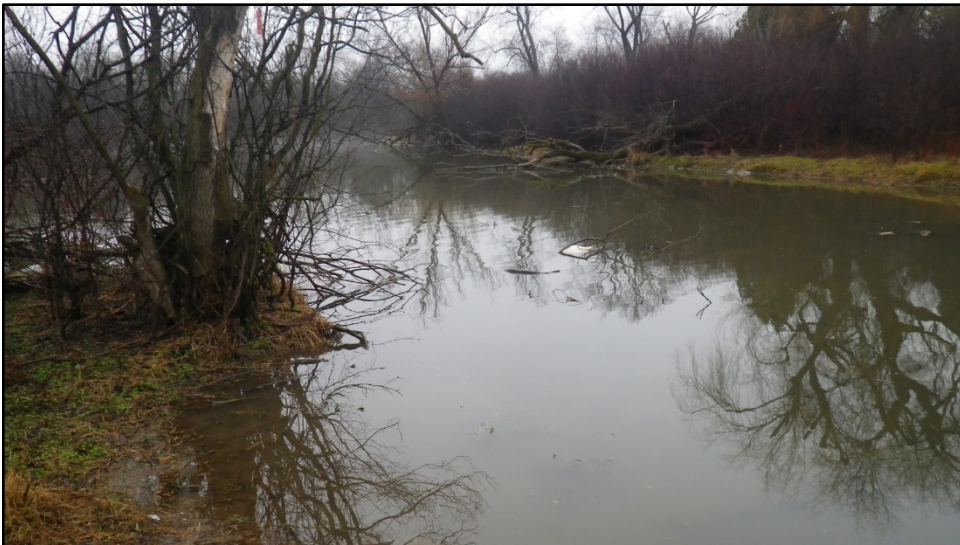
16. Channel remains wide and stagnant downstream from Hadati Creek. Water is turbid, and woody debris is frequent.

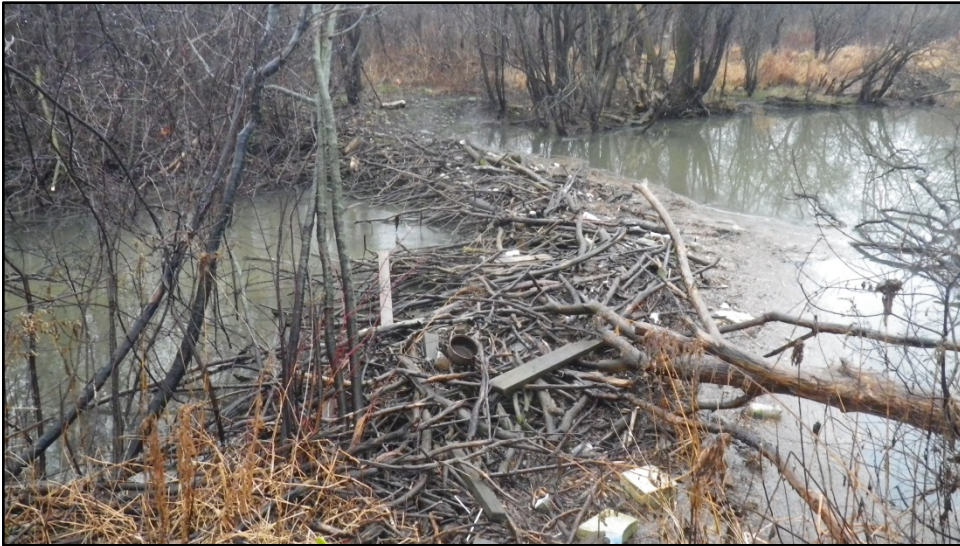
17. Beaver dam located approximately 250 m upstream from the Eramosa River confluence.

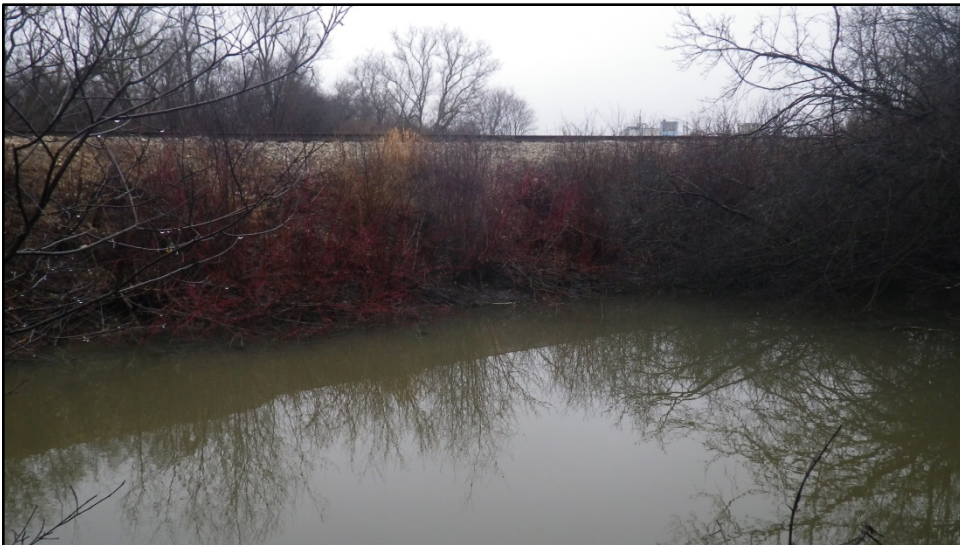
18. Clythe Creek flows immediately adjacent to railway embankment; embankment protection appears to be limited to vegetation. Water turbidity changes colour to appear more beige.

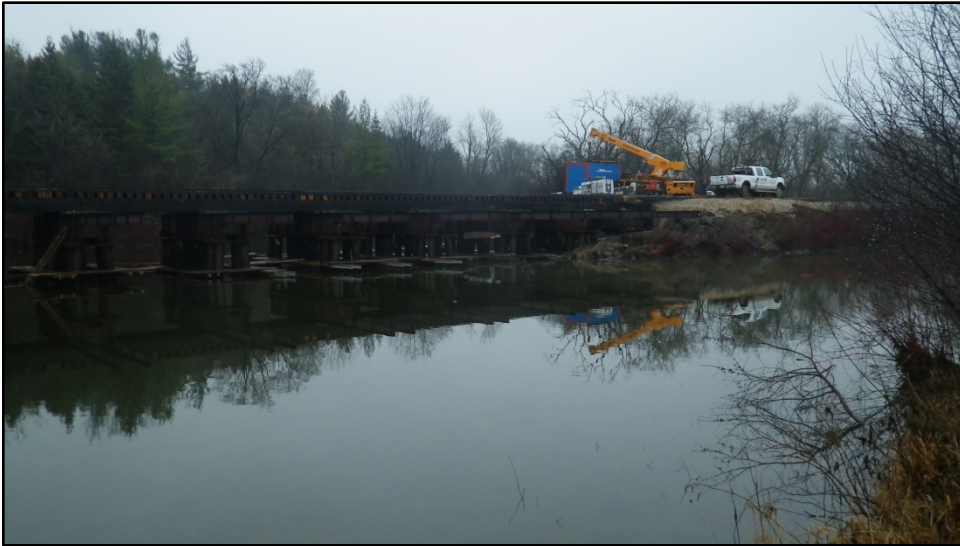
19. Looking downstream along the Eramosa River towards the Clythe Creek confluence located to the right. Railway embankment and bridge structure crossing the Eramosa River also present in background.

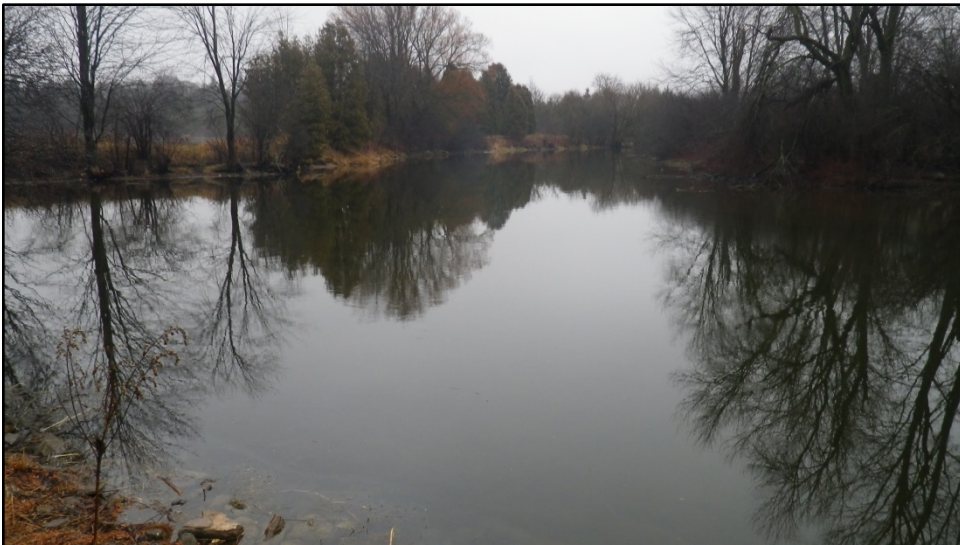
20. Looking upstream along the Eramosa River; embankment separating the south pond and Eramosa River visible in the background left.

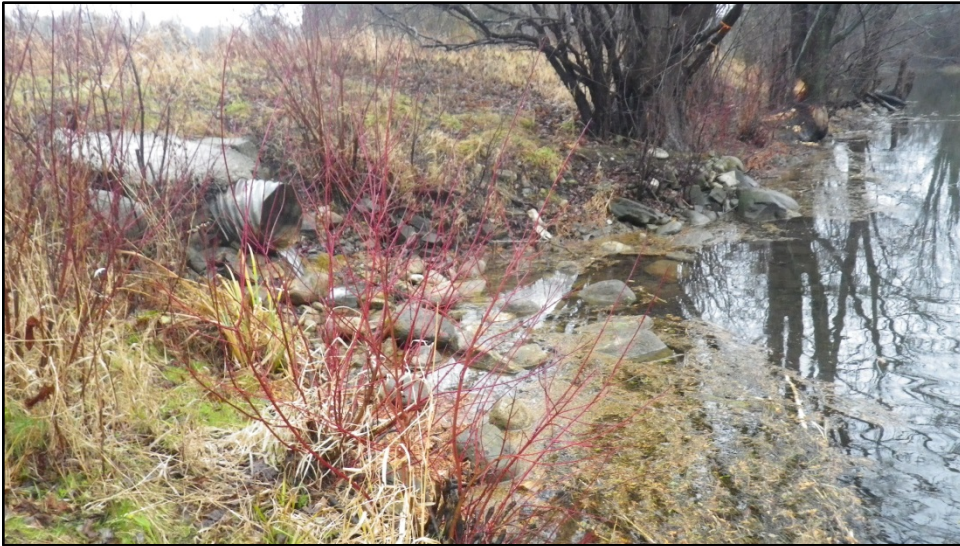
21. South pond connection to the Eramosa River through a CSP pipe elevated approximately 30 cm; the pipe appears to be blocked, and discharge is minimal.

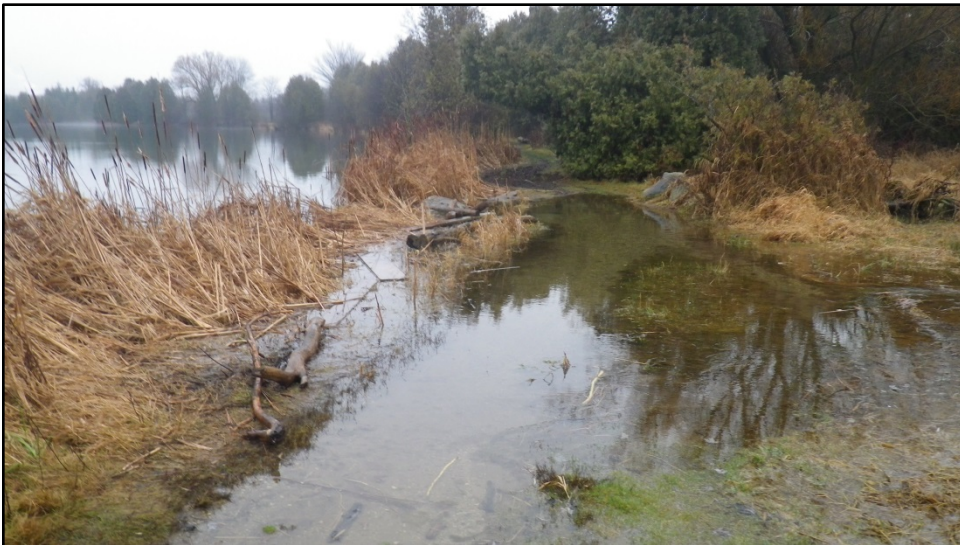
22. South pond breaches its banks at the pond's northeast corner; flow is contributed to a surface drainage tributary that flows adjacent to the pond and into the Eramosa River.

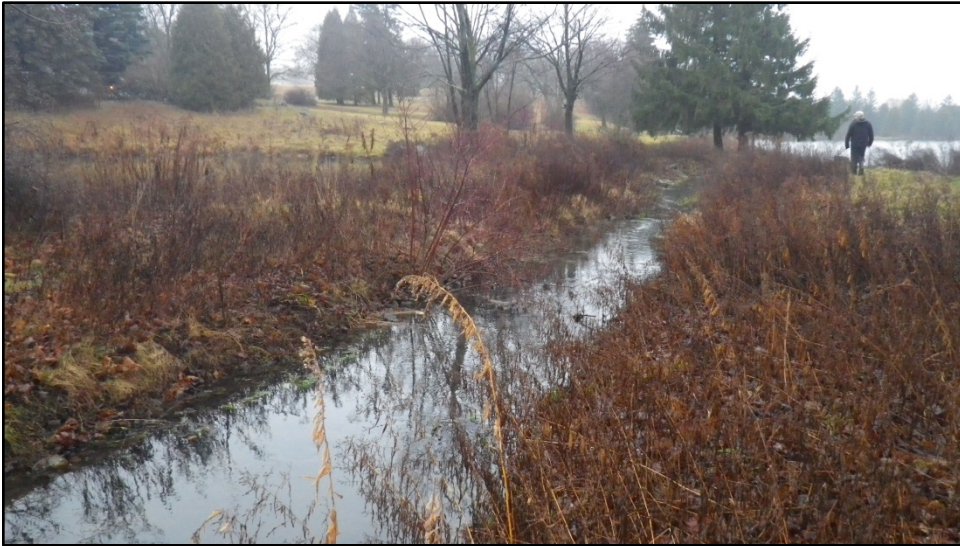
23. Drainage channel from decorative ponds discharges into the south pond.

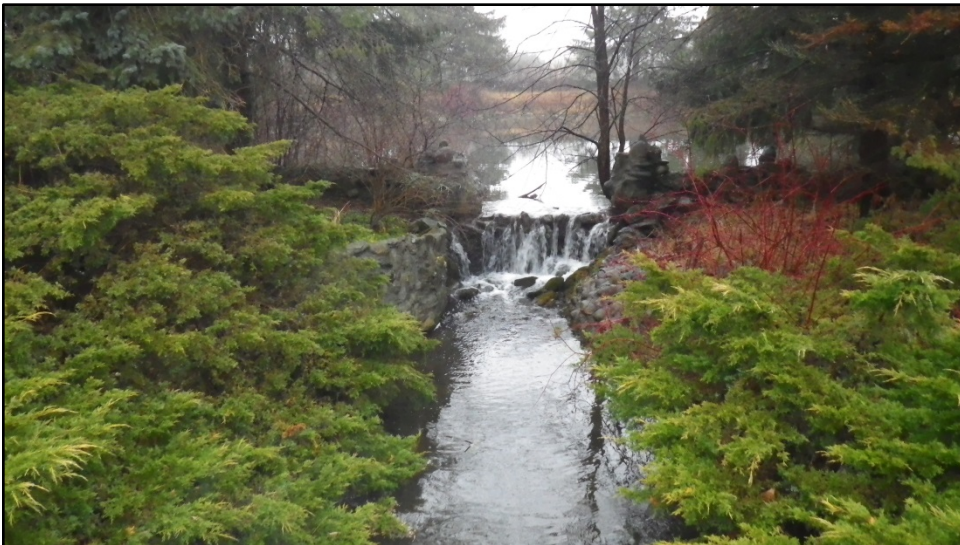
24. Decorative pond, grade control feature.

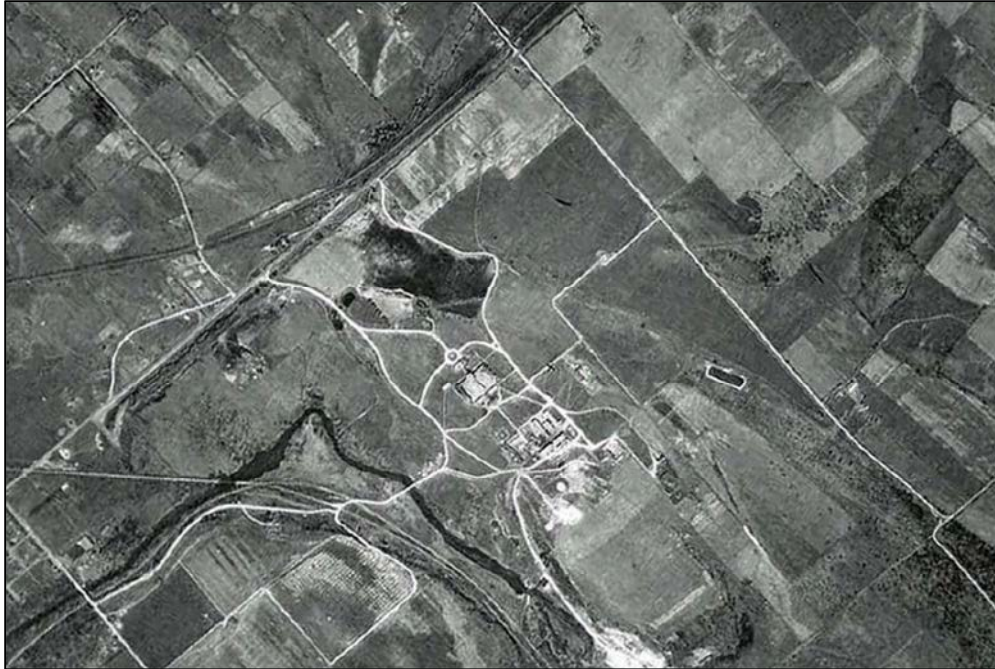
FIGURE 2.2 1930 Historical Aerial Image for the Study Area

A historical aerial image from 1930 (**Figure 2.2**) was obtained for the study area and was used to infer past and present land uses within the area. Within the image, several features that are consistent with current land use are present, including the GCC (buildings and access roads), York Road, railway alignments, and the Eramosa River. Two aesthetic ponds are located on opposite sides of the correctional facility main driveway, and several small drainage features, originating to the west of the correctional facility, are present and discharge directly into the Eramosa River. Clythe Creek flows adjacent to York Road, becoming wider with multiple flow pathways in the downstream direction. Both the north and south ponds are absent from the image.
