Draft Terms of Reference

Environmental Impact Study (EIS)

York Road Environmental Design Study

City of Guelph

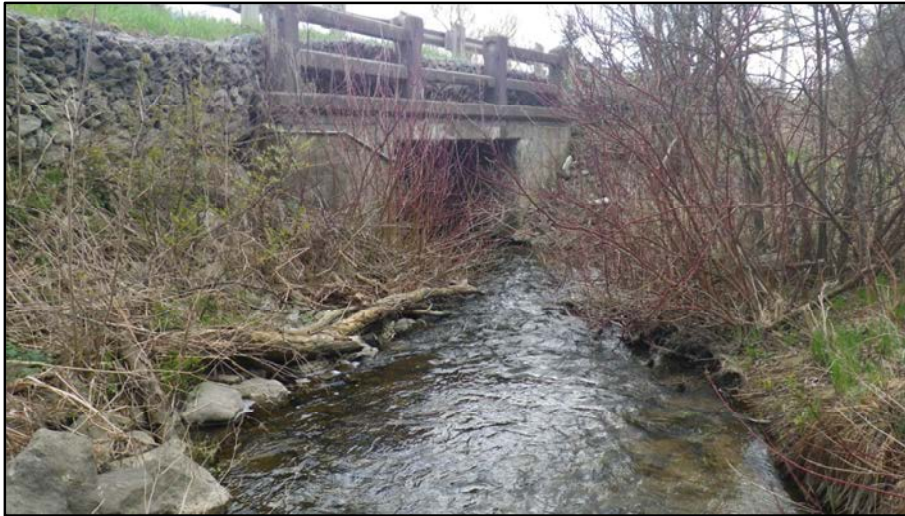
1. Reach C-9A: Clythe Creek culvert inlet at York Road. Gabion protection along road embankment and rip rap placement along the channel banks. Channel approaches culvert at a 45 degree angle; rip rap protection limits bank scour at inlet.

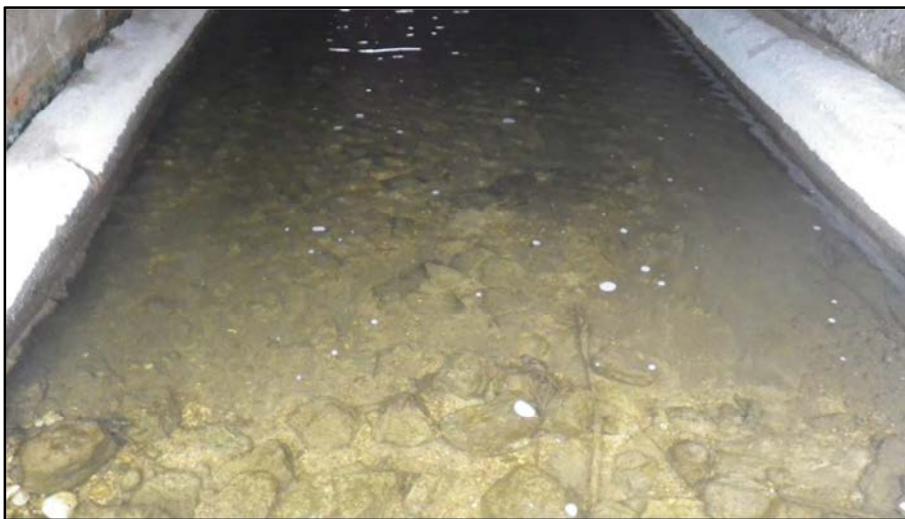
2. Reach C-9A: Substrate inside York Road culvert. Wetted channel width occupies the entire culvert width.

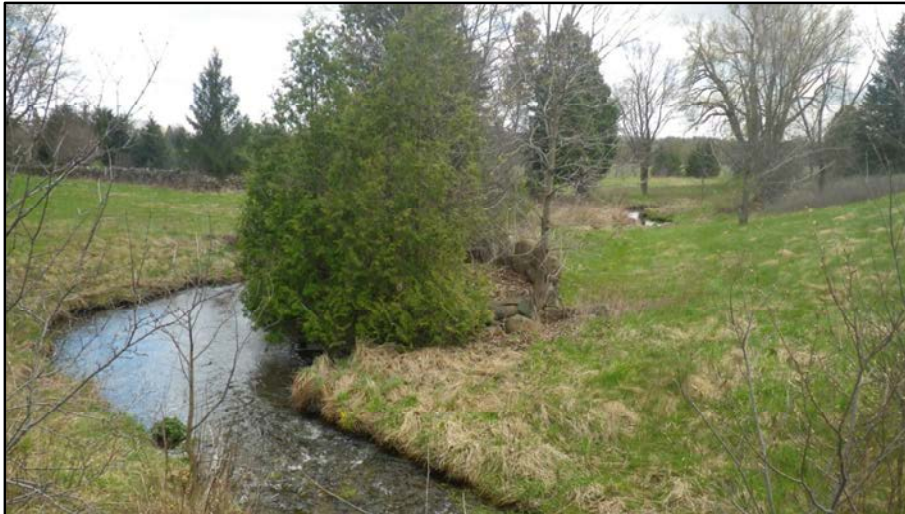
3. Reach C-9A: Looking downstream from York Road culvert outlet.

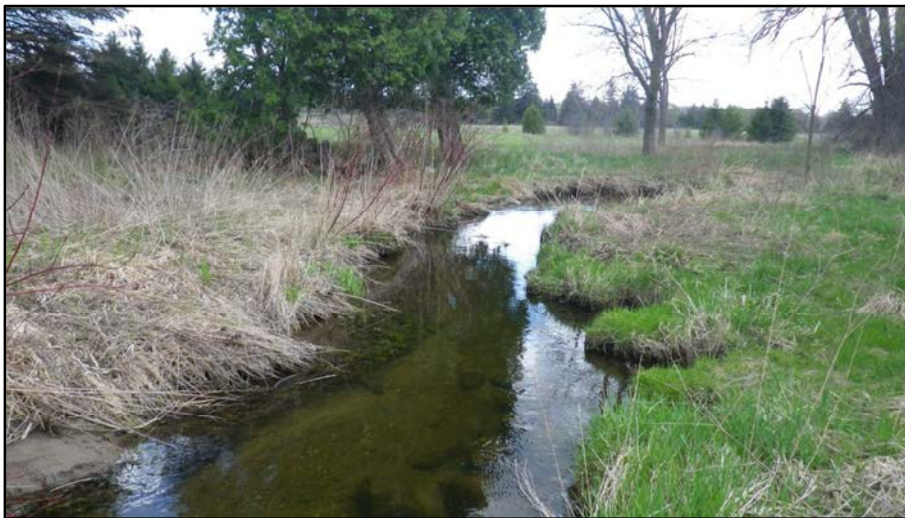
4. Reach C-9A: Typical cross section within the reach. Water level site near bankfull, banks are oversaturated and slumping causing hummocky terrain.

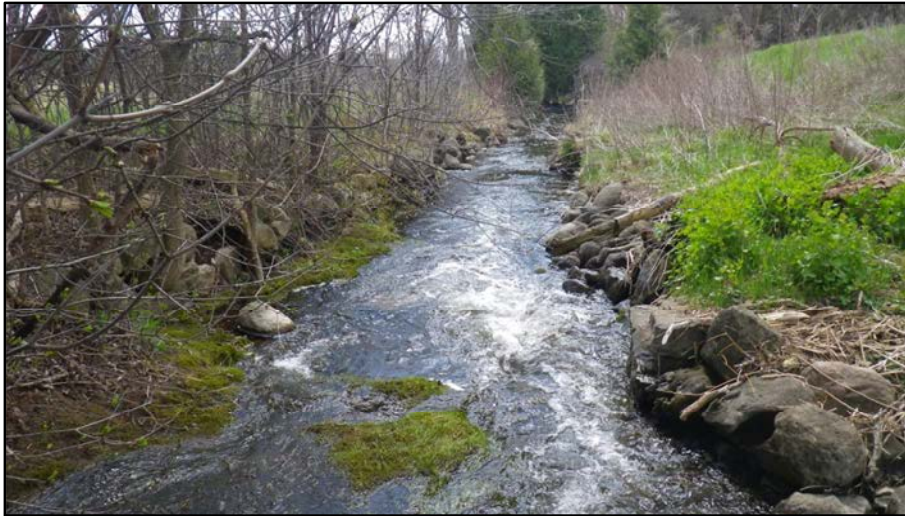
5. Reach C-9A: Banks are typically lined with small boulders.

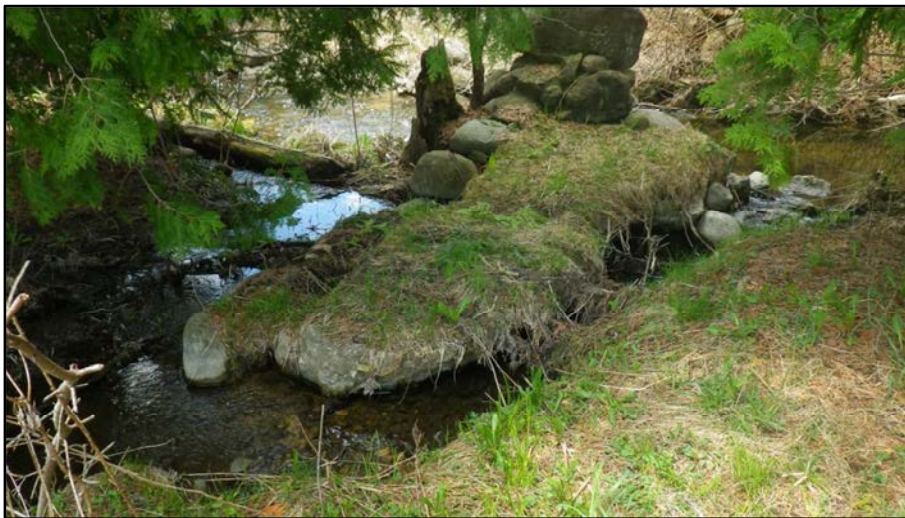
6. Reach C-9A: Channel outflanks in-stream weir structure.

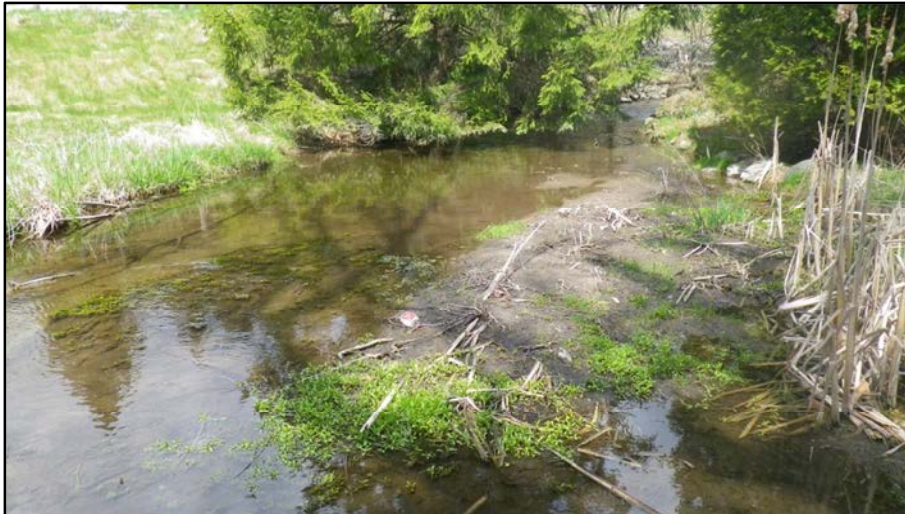
7. Reach C-9A: Section of over widened channel upstream from weir where water is ponded. Sediment deposition occurs and cat tail growth observed.

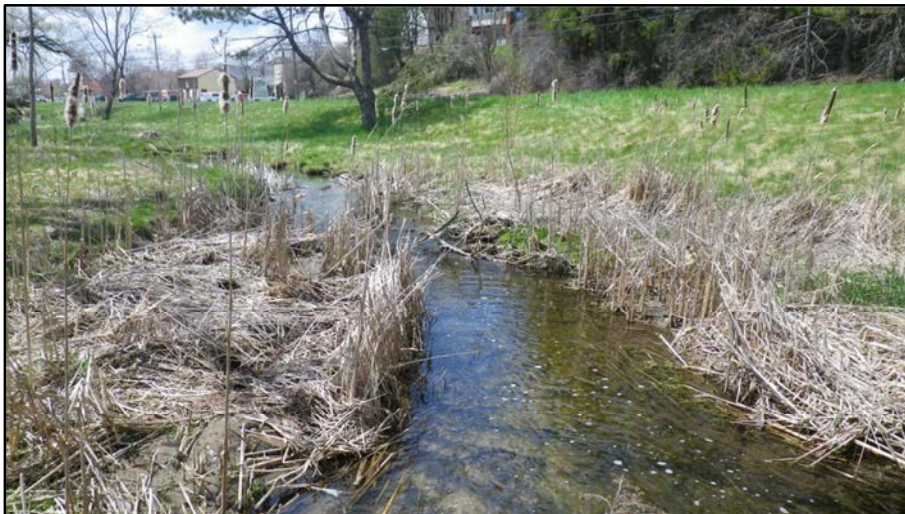
8. Reach C-9A: Channel is locally widened downstream from weir structure that spans approximately 2x bankfull width. Deposition and infill occurs to compensate.

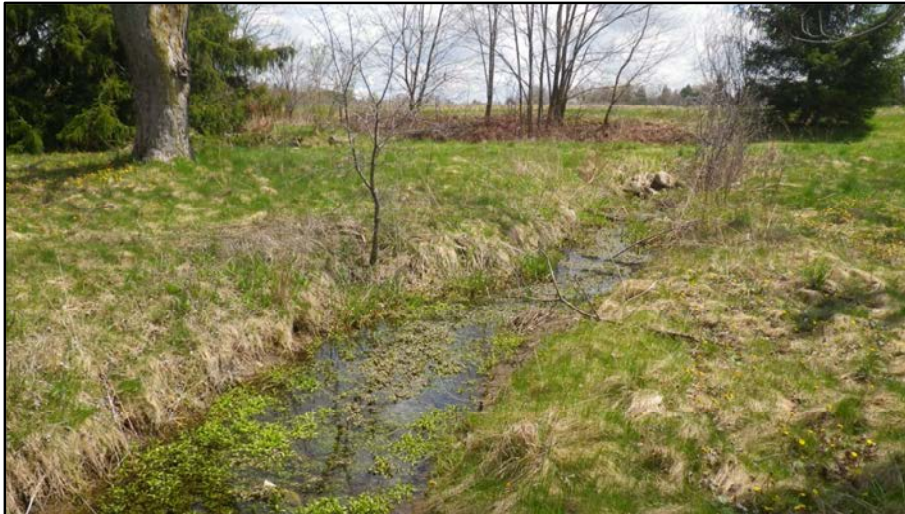
9. Reach C-9A: Tributary channel through ornamental grounds that confluences' with Clythe Creek.

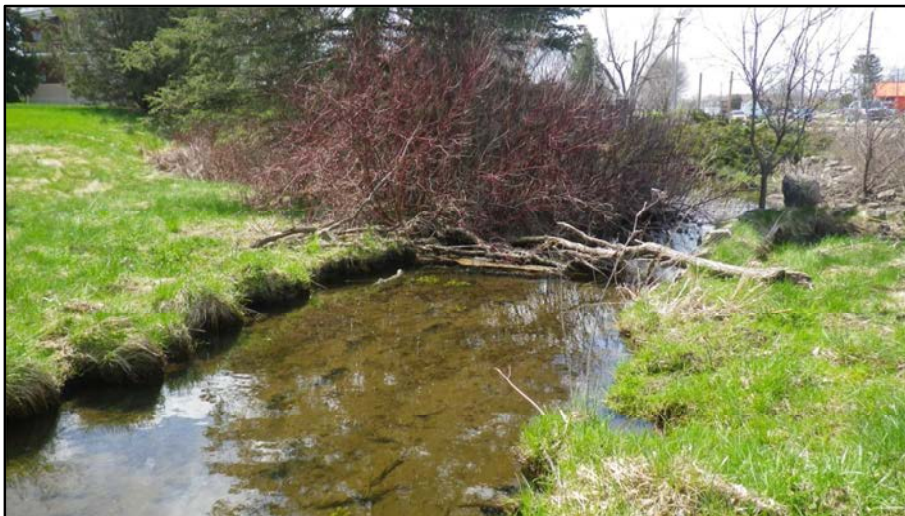
10. Reach C-9A: Minor debris upstream from wier.

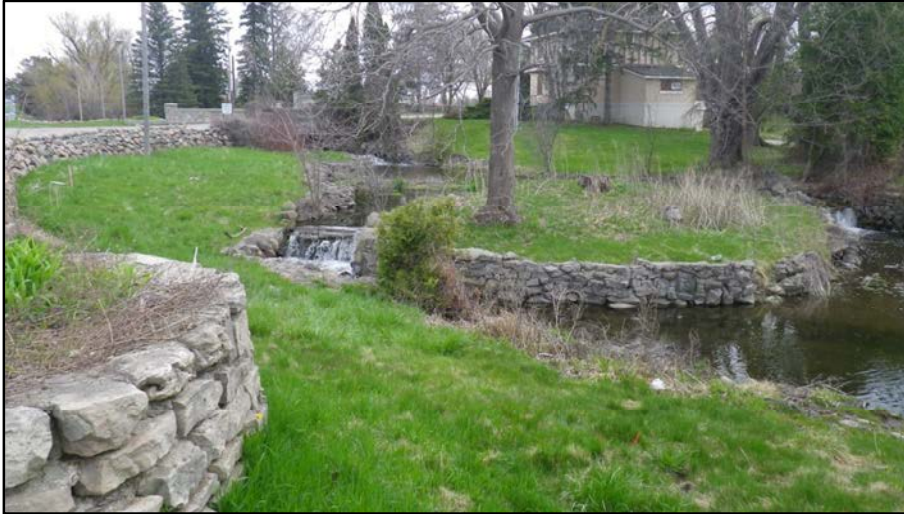
11. Reach C-9B: Looking upstream towards man-made island and main correctional facility entrance.

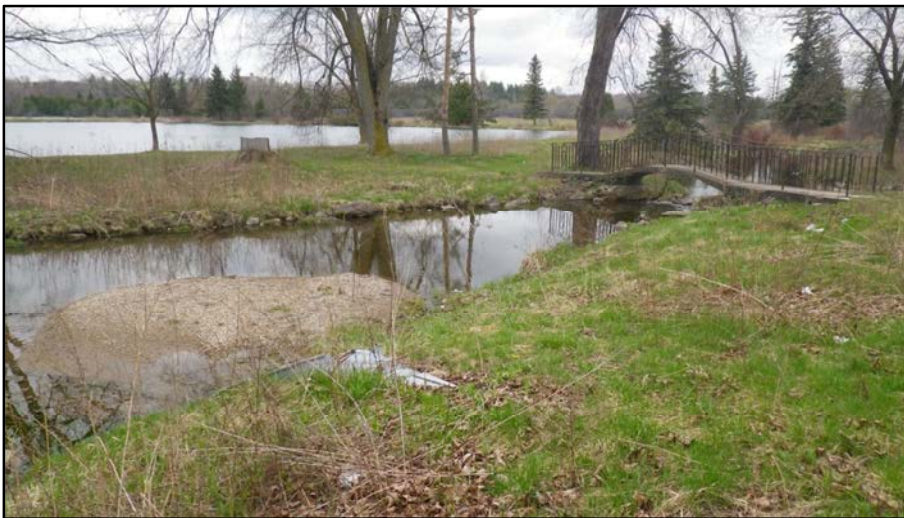
12. Reach C-9B: CSP outlet and sediment deposition plume upstream from pedestrian bridge.

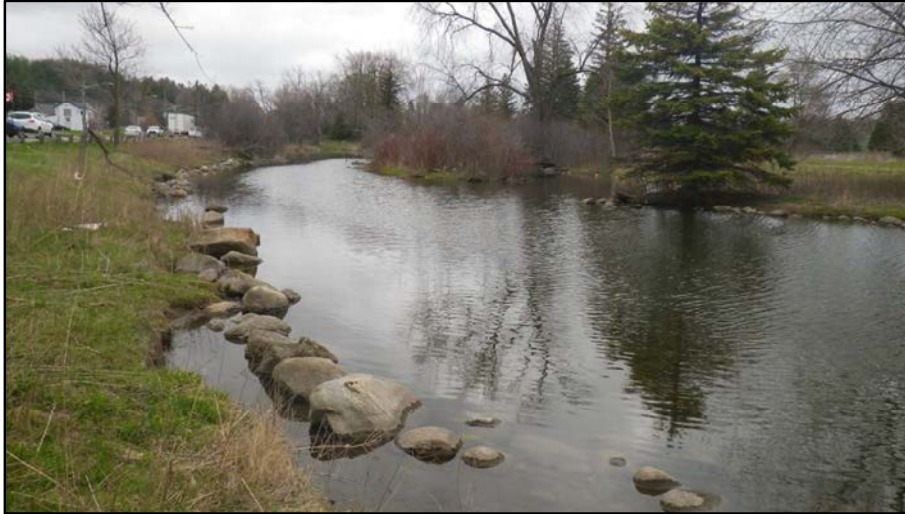
13. Reach C-9B: Looking upstream along Clythe Creek adjacent to Jaycee Park.

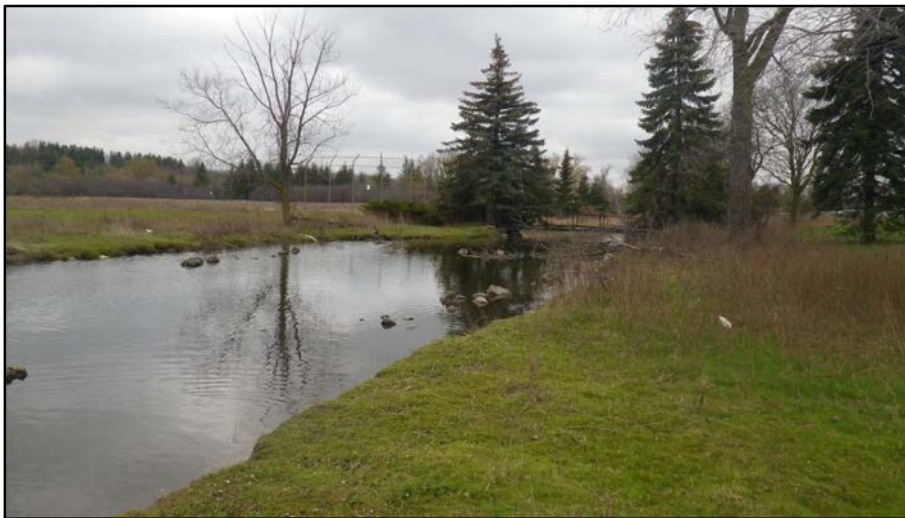
14. Reach C-9B: Looking downstream along Clythe Creek adjacent to Jaycee Park.

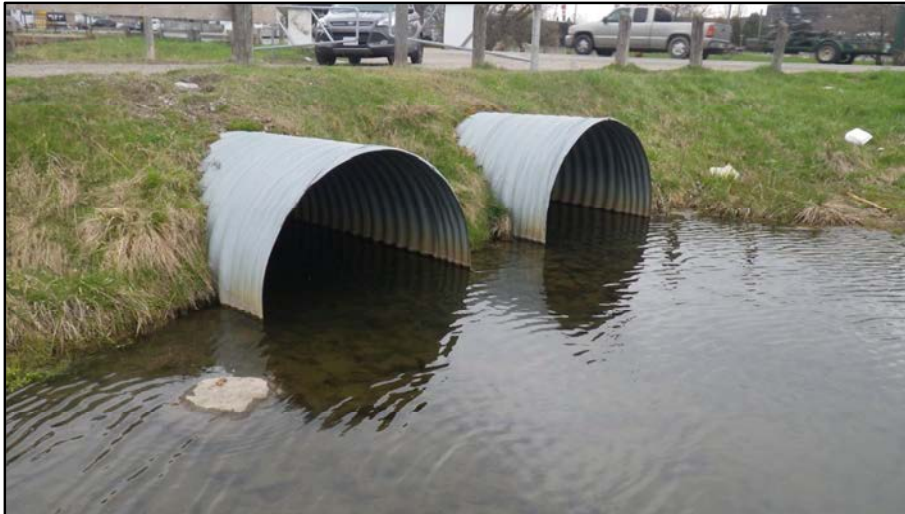
15. Reach C-9B: Double CSP culvert at entrance to Jaycee Park.

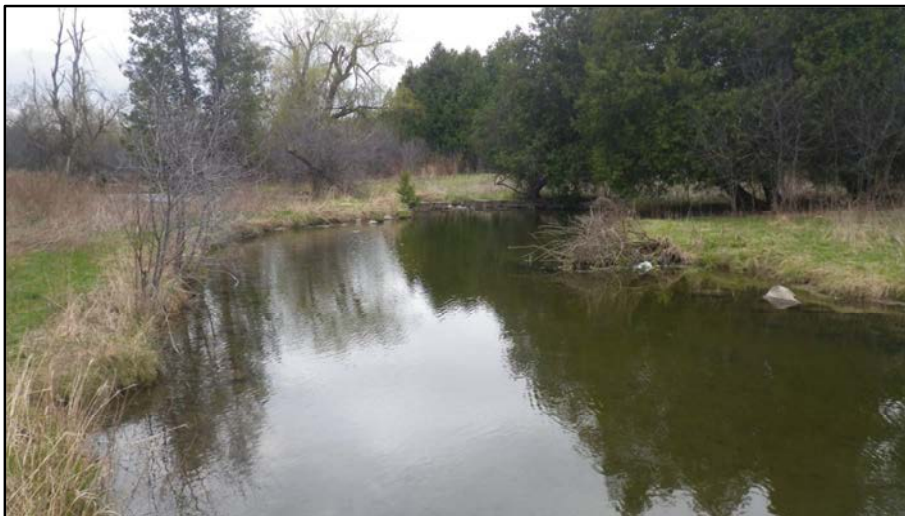
16. Reach C-10: Clythe Creek downstream from Hadati Creek confluence; flow is ponded upstream from flow splitter.

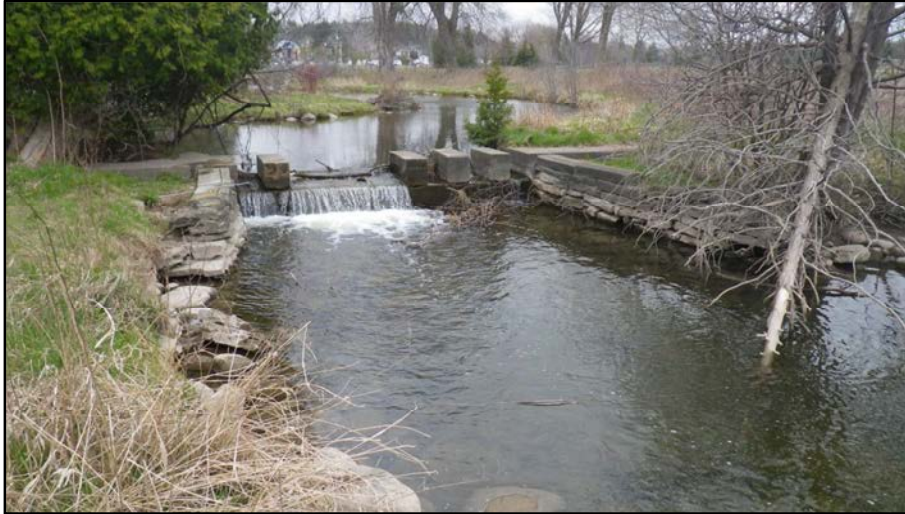
17. Reach C-10: Flow splitter structure installed along Clythe Creek.

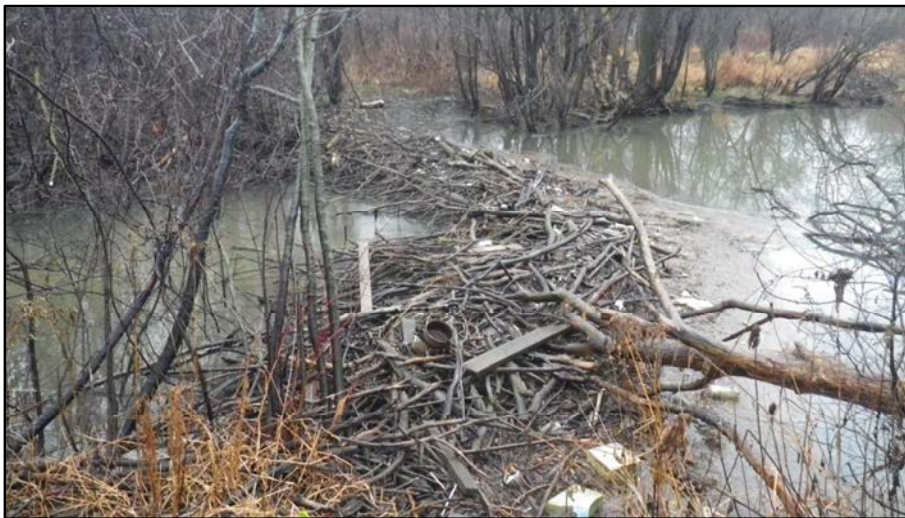
18. Reach C-10: Beaver dam towards the downstream extent of the reach contributing to ponding water.

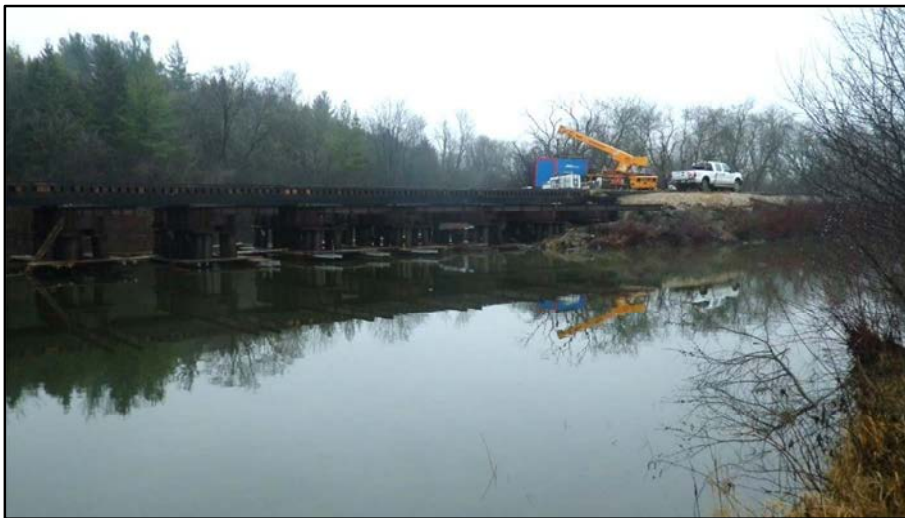
19. Reach C-10: Channel flows adjacent to CNRL embankment at the Eramosa River confluence.

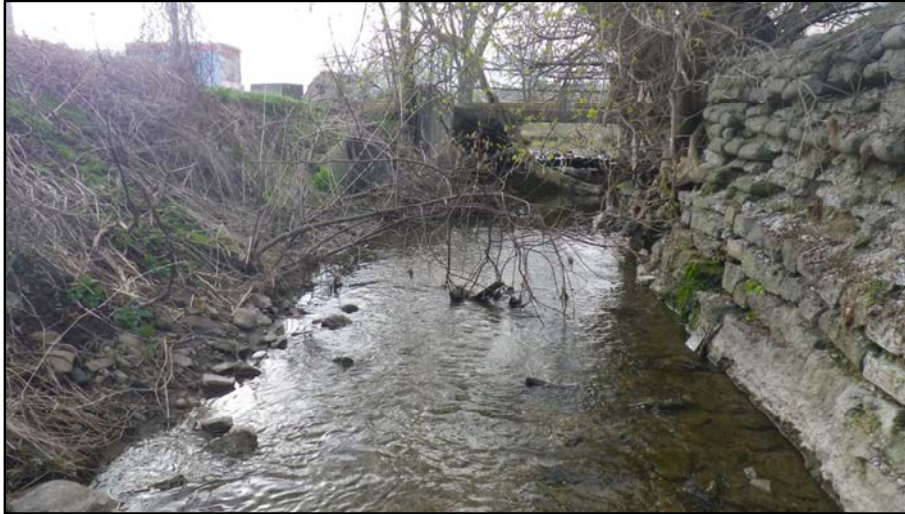
20. Reach C-10: Confluence with the Eramosa.

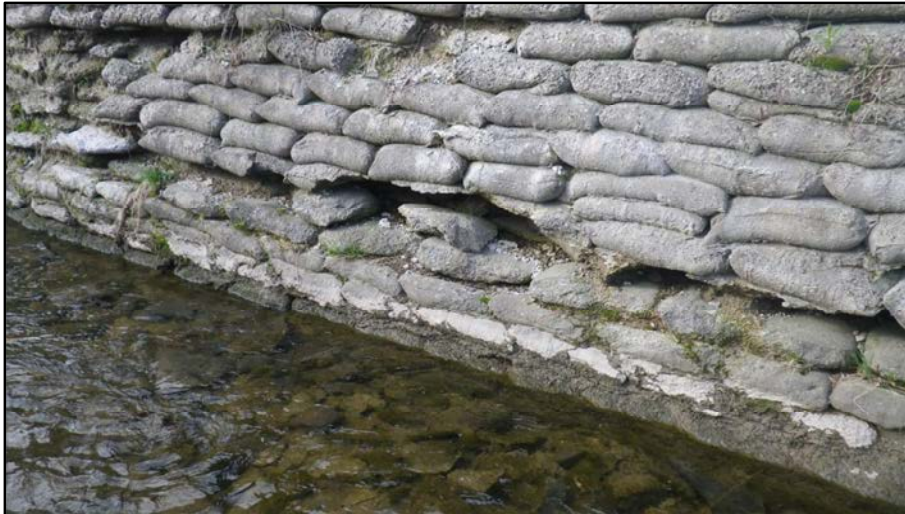
23. Reach HC-1: Concrete cushion bank protection installed along the west bank is failing.

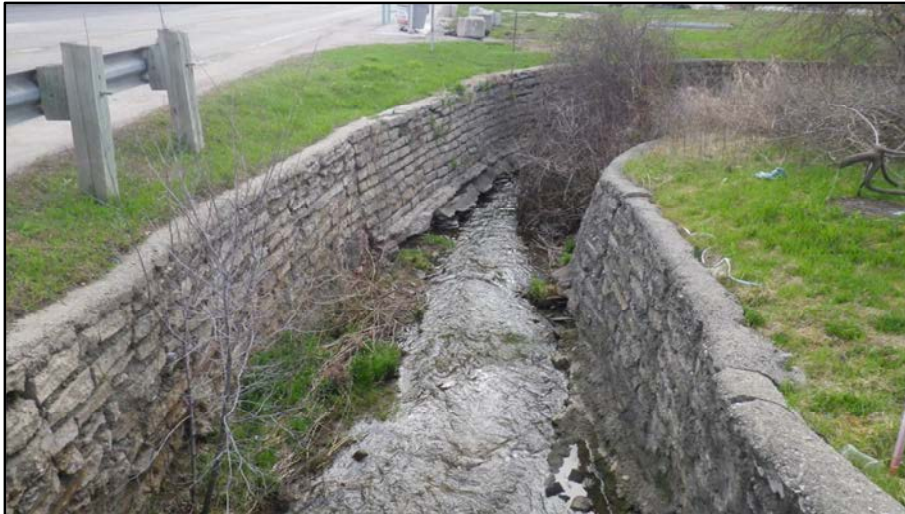
24. Reach HC-1: Concrete block wall at channel bend is undermined.

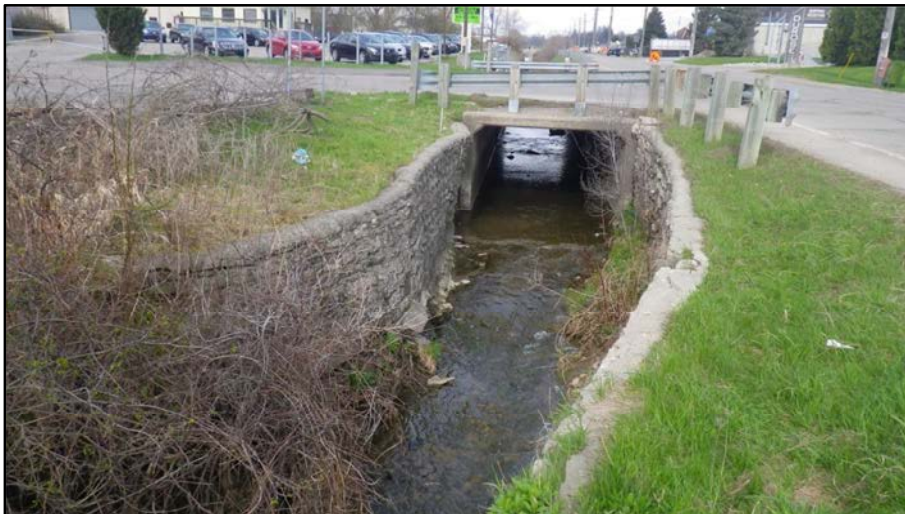
25. Reach HC-1: Channel immediately downstream from Beaumont Cres. Both banks are lined with concrete and shale bricks. Bank protection is undermined along meander bend.

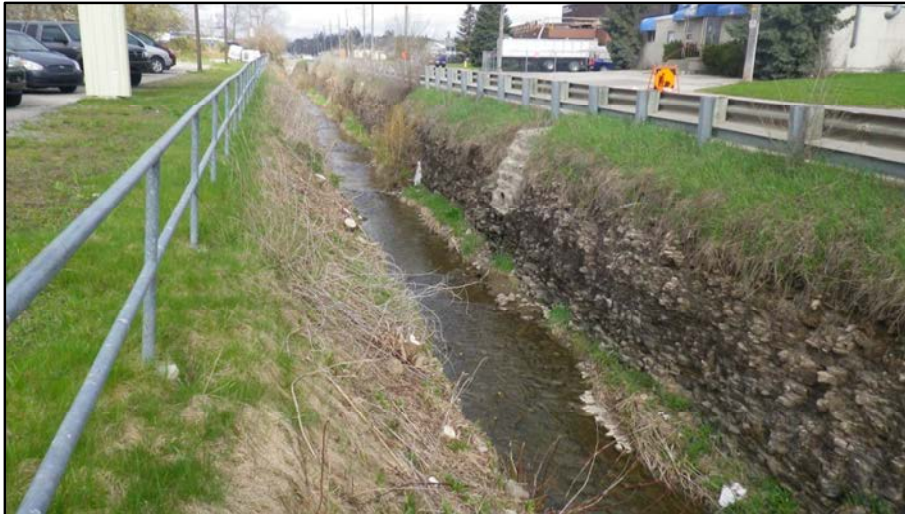
28. Reach HC-1: Looking upstream from Beaumont Cres crossing. Channel is lined with concrete for approximately 18 m.

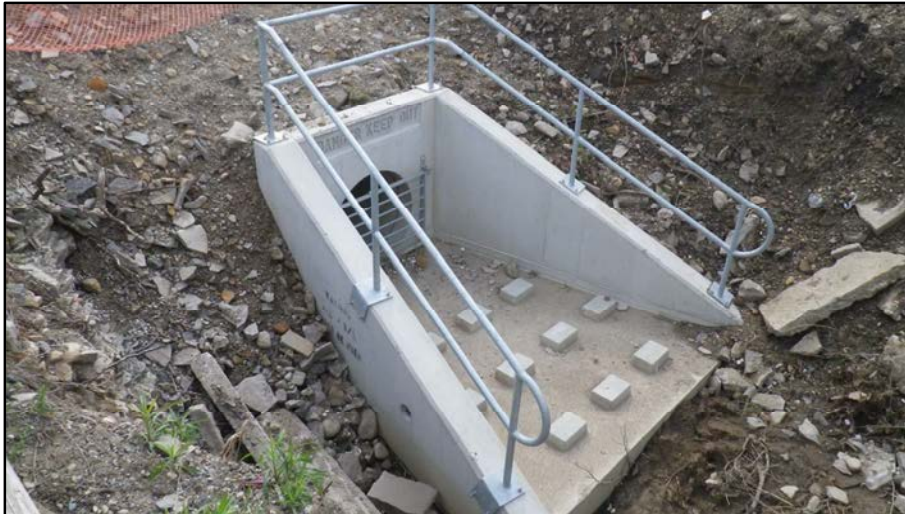
30. Reach HC-1: Culvert crossing at Industrial Ave. Channel has been buried for approximately 60 m upstream from Industrial Ave.

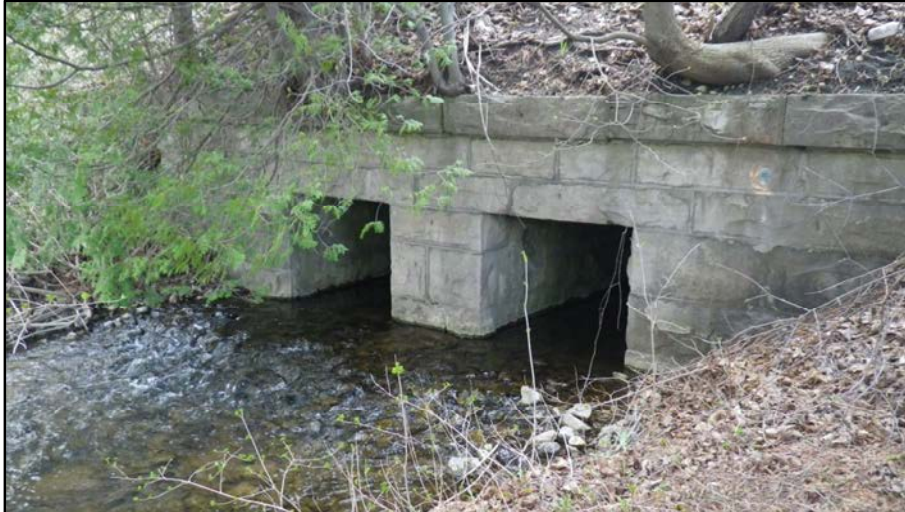
1. Feature #1: Ashlar stone culvert (potential significance) north of York Road. Culvert is 25 m upstream from York Road and conveys Clyde Creek flow underneath the CNR line. The double box culvert has approximate dimensions of 1.2 m wide by 1.4 m high. Substrate is present along the bed of the culvert however, natural light does not penetrate and the upstream inlet is not visible.

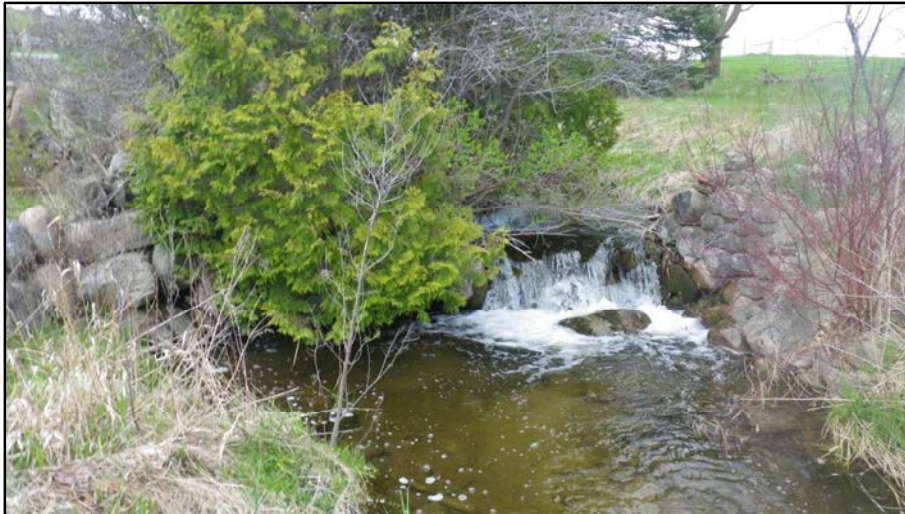
3. Feature #3: Fieldstone weir with steps and sentinel stones (listed, non-designated significant feature). Structure height is 0.5 m above water level with an additional 0.45 m scour pool (total height above bed 0.95 m). At the time of survey, flow depth over the structure was 0.08 m and 1.6 m wide. Backwatering upstream from the structure had a depth of 0.45 m. Channel has scoured out downstream from the weir, over-widening the channel to 4m

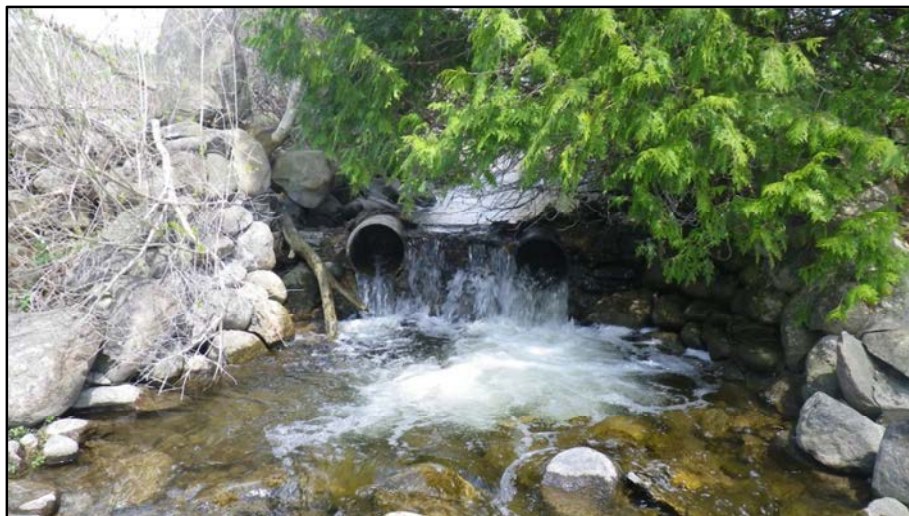
5. Feature #5: Fieldstone weir with clay pipes (listed, non-designated significant feature). Two clay pipes are imbedded into concrete and fieldstone weir structure. The feature is 2m wide and has a total height of 1.1 m; 0.5 m above existing water level plus 0.6 m scour depth. Feature imposes a significant barrier to downstream flow movement and has trapped woody debris at its crest.

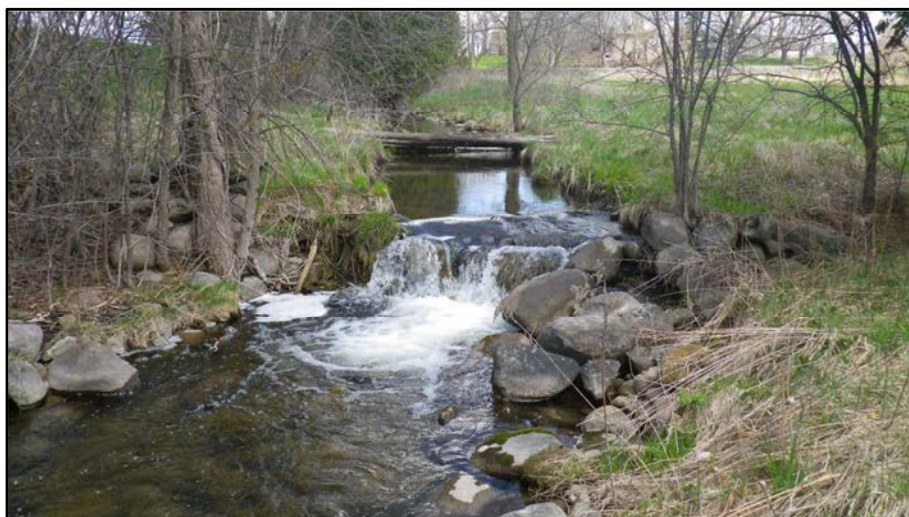
8. Feature #8: Fieldstone weir (listed, non-designated significant feature). This feature is made from fieldstone and concrete with decorated stones placed along the banks. The feature is 1m high; 0.55 m above existing water level plus 0.45 m scour pool. The upstream pool created by backwater is 0.4 m deep with a flow depth of 0.04 m over the crest of the feature. Width of the feature is 2m conforming to the bankfull channel.

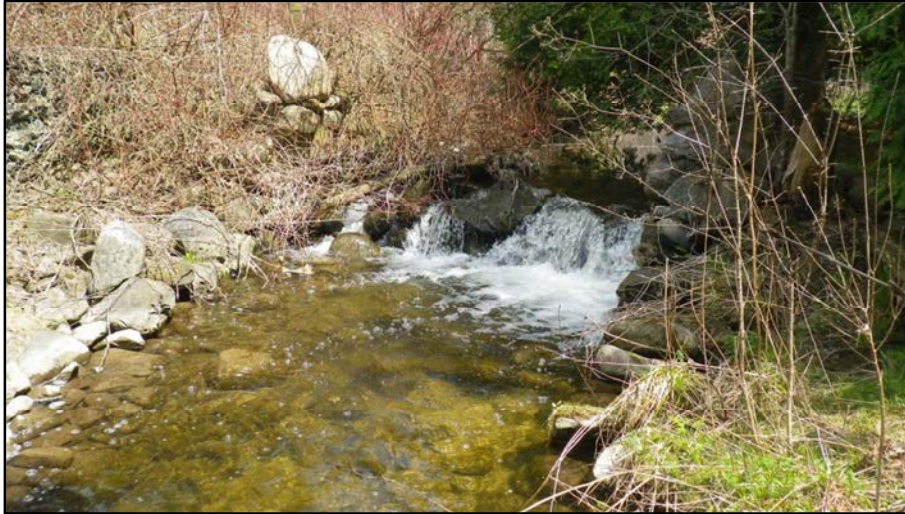
9. Feature #9: Fieldstone weir (listed, non-designated significant feature). This feature is located within a group of cedar trees and the feature and been outflanked to the south. Channel banks are lined with decorative stone and gabion baskets are in place along the road embankment to the north. The feature is 0.9 m high with a downstream scour pool

Within Reach C-9A, local works will be required to restore the channel following a culvert extension or replacement at York Road. There will be no impact to cultural heritage features located within the channel. In order to maintain the features, a retaining wall will be constructed adjacent to features 9 and 10 in order to accommodate grading requirements of the road widening.

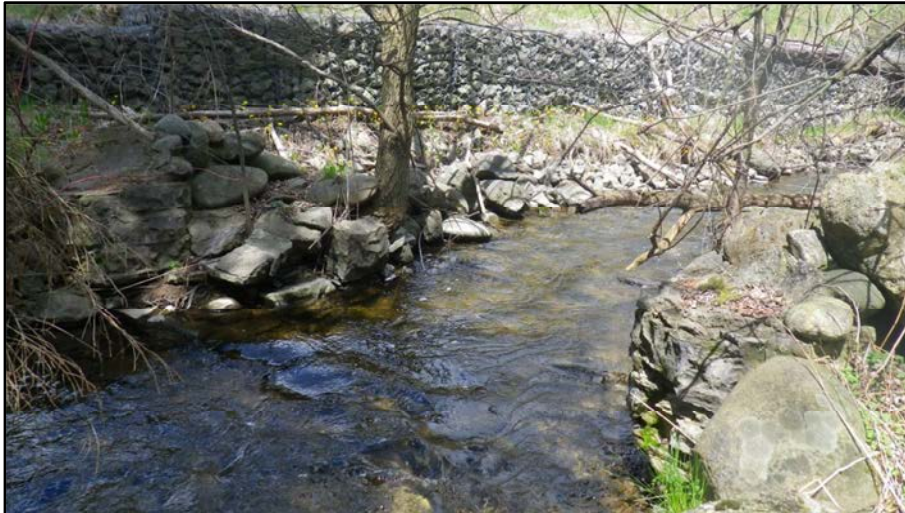
10. Feature #10: Fieldstone weir (listed, non-designated significant feature). No in-stream structure is visible, however banks are lined with decorative stone. Bankfull width is 2m and wetted depth is 0.15 m.

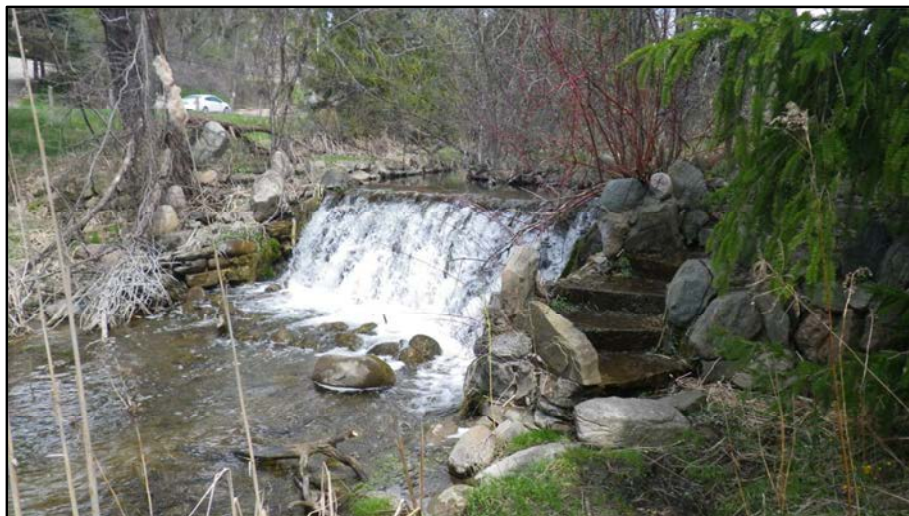
11. Feature #11: Fieldstone weir with steps and ashlar stone terrace wall (listed, non-designated significant feature). This feature is 4m wide and 1.4 m high from the channel bed to crest. Stone placement along the channel bed downstream from the feature limits scour. Decorative stone placement line the banks of the channel.

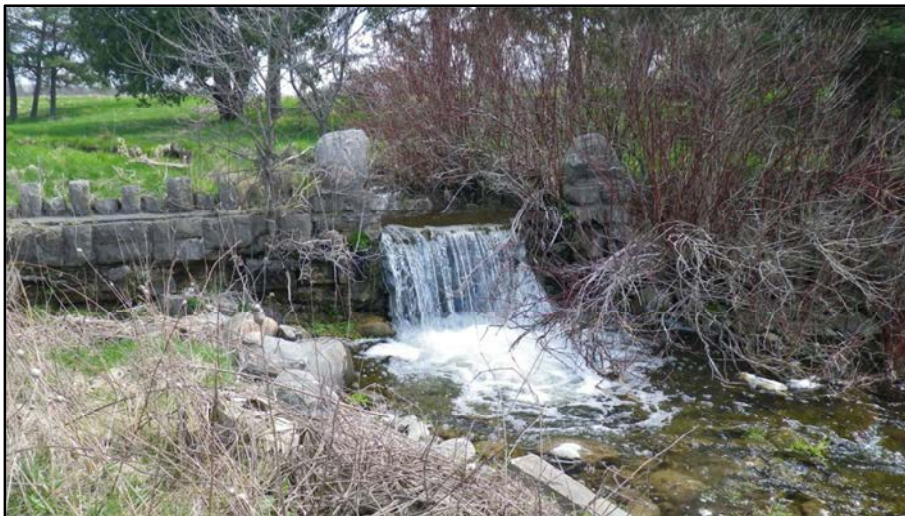
14. Feature #14: Fieldstone weir with cut stone terrace wall (listed, non-designated significant feature). The crest of this feature is 1.5 m wide between the two main sentinel stones and is 1.45 m high from the base of the downstream scour pool. The backwater pool upstream from the feature is 0.55 m deep. Noticeable sedimentation is occurring behind the structure, with unconsolidated material measuring 10-15 cm.

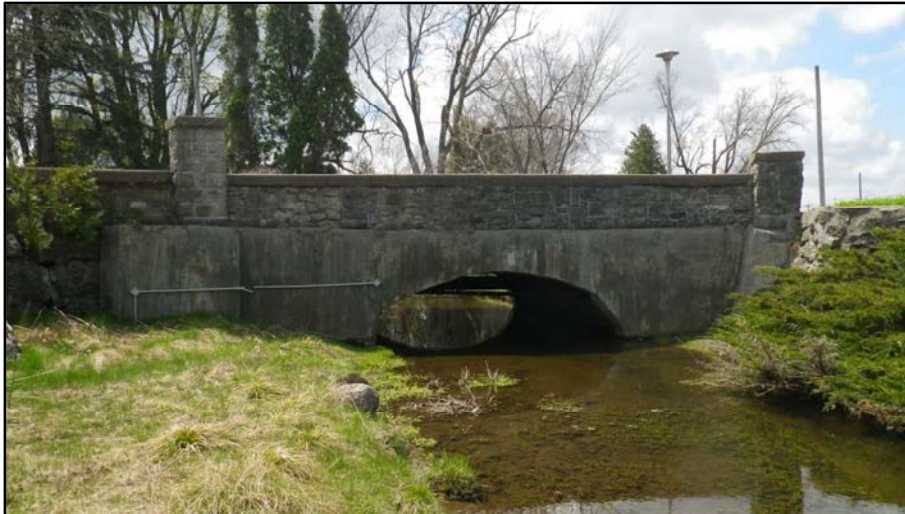
17. Feature #17: Stone and concrete road bridge (listed, non-designated significant feature). The bridge and wing-wall structure is approximately 14 m wide. The inlet to convey Clythe Creek is 4m wide and is considered to be undersized from a geomorphic perspective as the channel has widened and pooled on either side of the inlet.

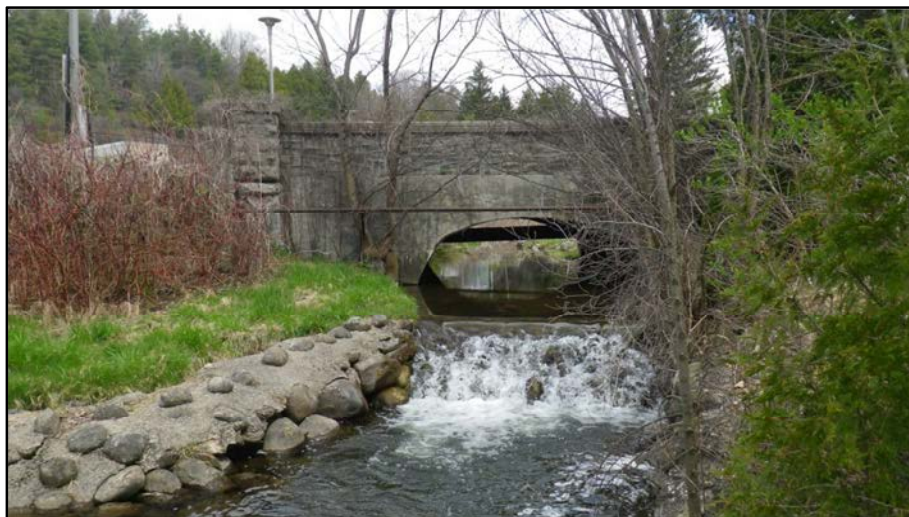
22. Feature #22: Fieldstone weir (listed, non-designated significant feature). The feature is located 6m downstream from Feature #17, and is made from concrete with small boulders protruding which emphasizes the “rushing” waterfall effect. Structure width is 2.5 m along the crest and is 1.5 m height from the downstream bed elevation. The downstream water depth within the associated scour pool is 0.8 m.

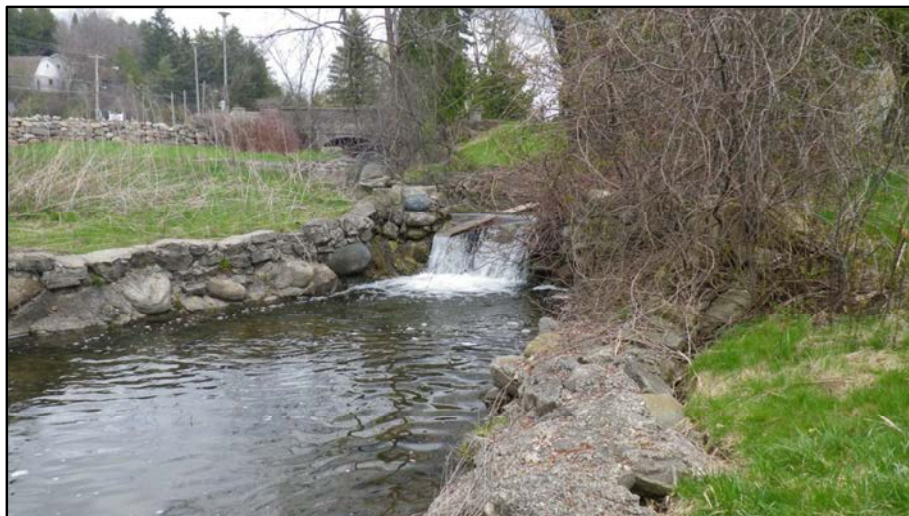
23. Feature #23: Fieldstone weir (listed, non-designated significant feature). This feature is located to the south of a man-made island downstream from the main entrance. The feature is 2m wide and is made out of concrete with small boulders protruding which emphasizes the “rushing” waterfall effect. Channel banks are lined with decorative stone and there is visual evidence of the structure detaching from the bank.

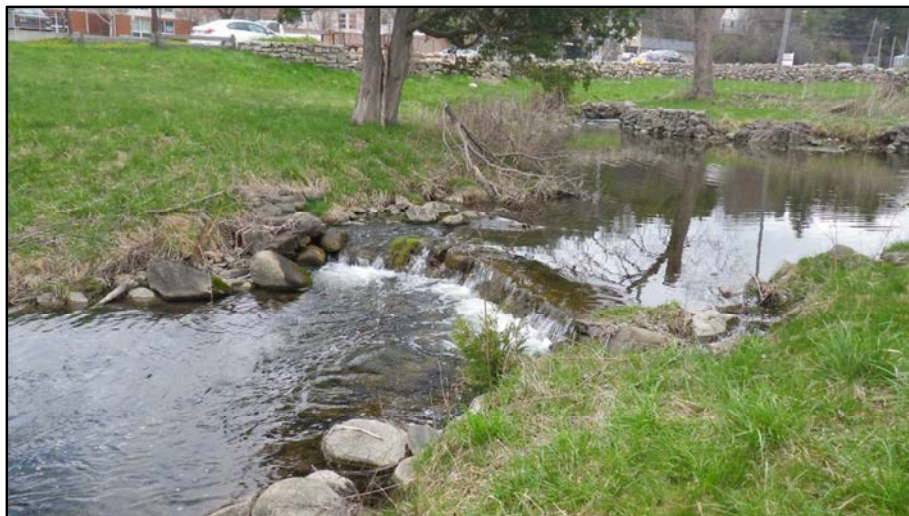
24. Feature #24: Fieldstone weir (listed, non-designated significant feature). This feature is located to the north of a man-made island downstream from the main entrance. The feature is 2.1 m wide and is made out of concrete with small boulders protruding which emphasizes the “rushing” waterfall effect. Channel banks are lined with decorative stone. There are fracture lines present along the northern bank adjacent to the downstream stone wall. The structure is 0.7 m high, with the downstream bank heights/stone wall 1m high. Stone placement along the channel bed limits scour.

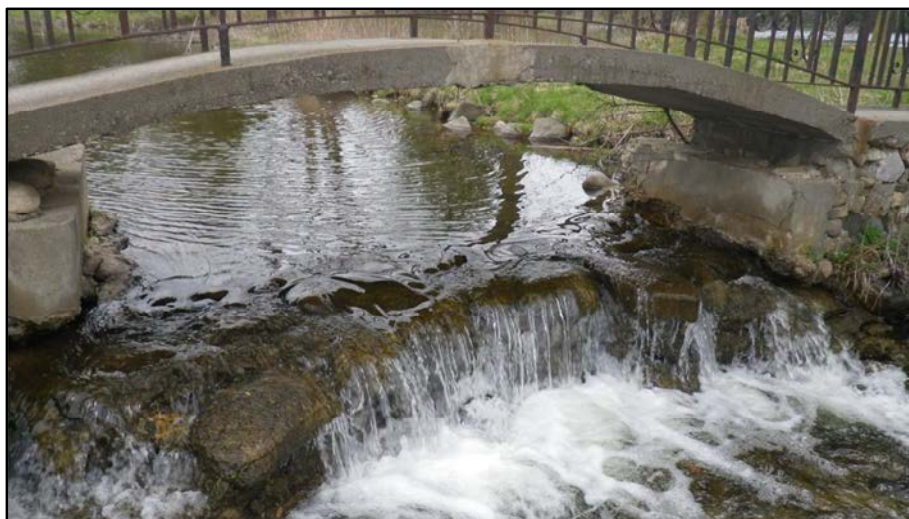
26. Feature #26: Fieldstone weir (listed, non-designated significant feature). The feature height is 1m from the crest to the downstream channel bed, scour depth is 0.4 m. The feature is spanned by Feature #27 and decorative stone is placed along the banks.

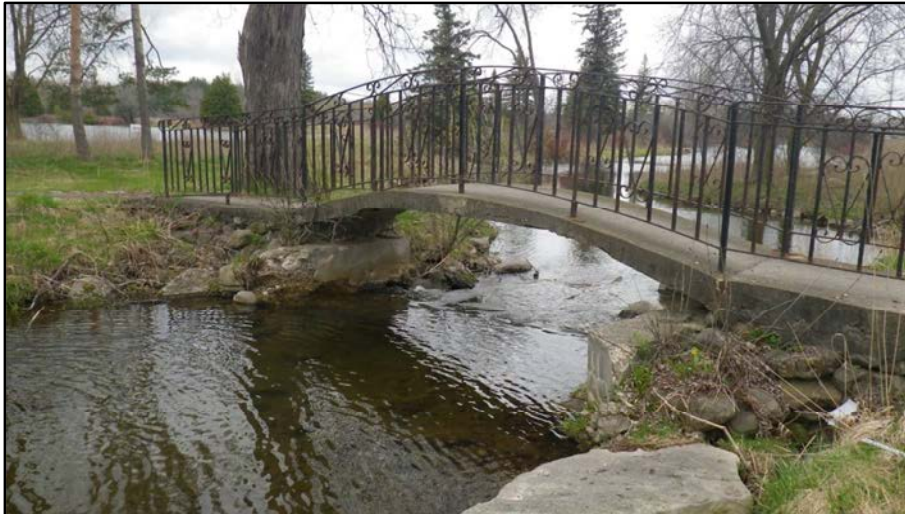
27. Feature #27: Arched concrete and metal pedestrian bridge with stone abutments (potential significance). The bridge is 6.5 m long, and 2.5 m wide, the opening between footings allowing for channel flow is 3.5 m wide.

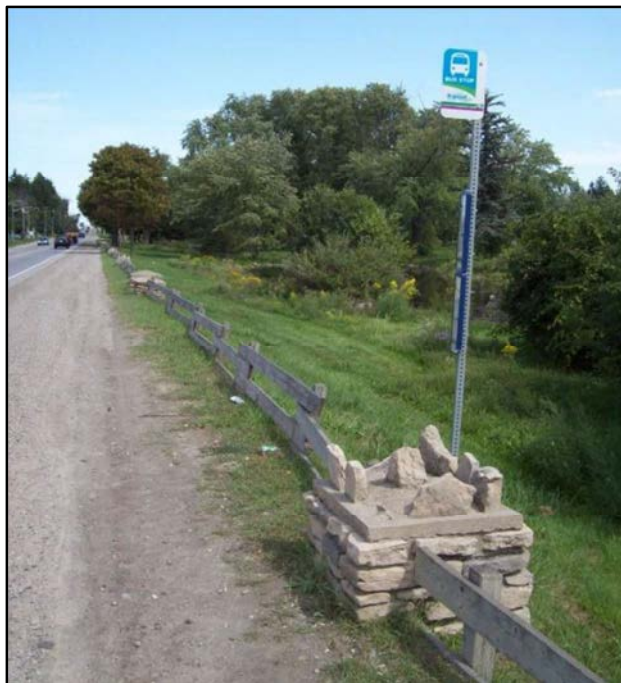
28. Feature #28 and #29: Limestone pillars with wood board fencing leading to main entrance (potential significance). This feature runs parallel to York Road north of Clythe Creek, and extends for 630 m along the edge of the property.

28, 29 Feature #28 and #29: Limestone pillars with wood board fencing leading to main entrance (potential significance). Potential for feature to be modified as a result of roadway grading requirements.

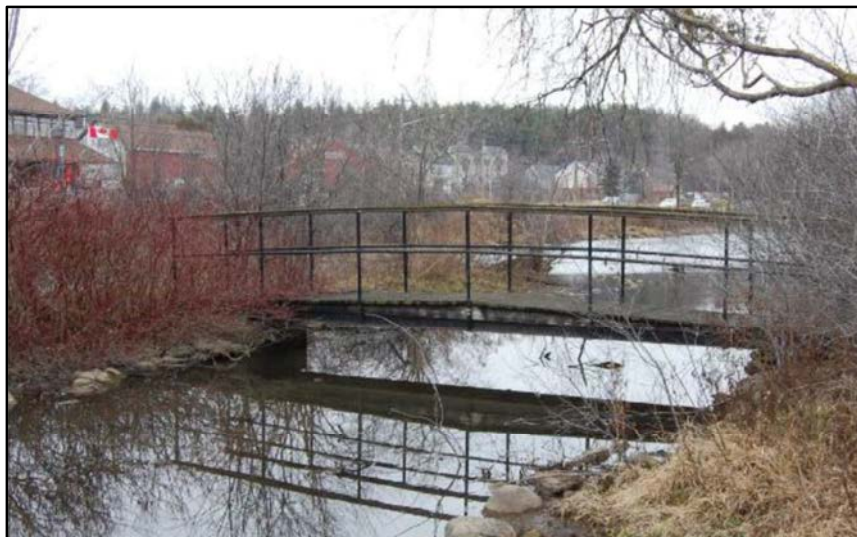
30. Feature #31: metal and wooden pedestrian bridge (potential significance). The bridge is 7m long and 1.8 m wide, with a metal railing and concrete block footings. Water depth under the bridge is 0.65 m with 0.8 m freeboard between the water surface and the bridge deck. Minimum width of the outlet channel is 6.5 m indicating that the bridge is likely undersized.

31 Feature #31: metal and wooden pedestrian bridge (potential significance). Potential for feature to be modified to accommodate pedestrian traffic and multi-use pathway.

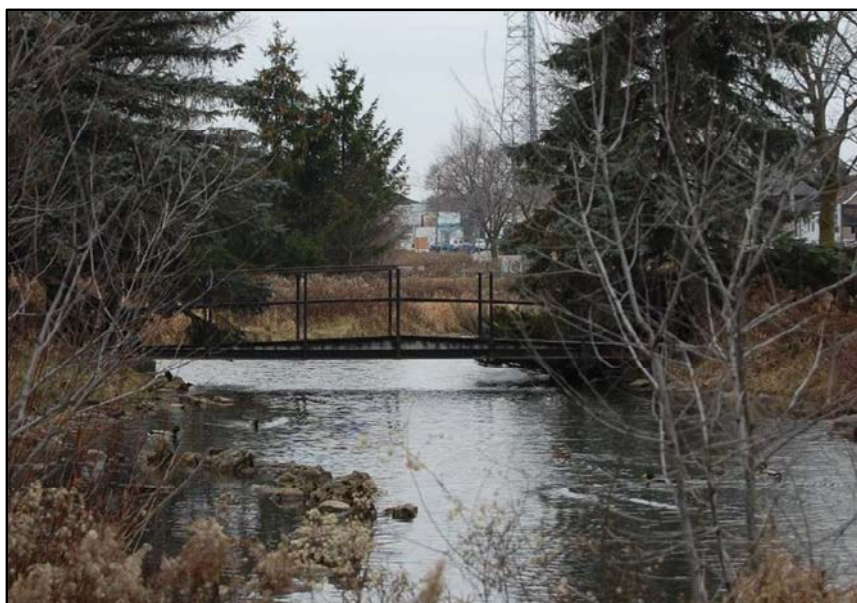
31. Feature #32: Metal and wood pedestrian bridge (potential significance). This pedestrian bridge leads from the south floodplain downstream from Feature #31 to a small island feature within Clythe Creek. The bridge is 9m long and 1.1 m wide sitting on concrete block footings. Wetted depth under the bridge is 0.28 m. Significant sedimentation has occurred within the vicinity of the bridge, with a depth of approximately 0.55 m of soft unconsolidated material present.

32 Feature #32: Metal and wood pedestrian bridge (potential significance). No impact to feature anticipated.

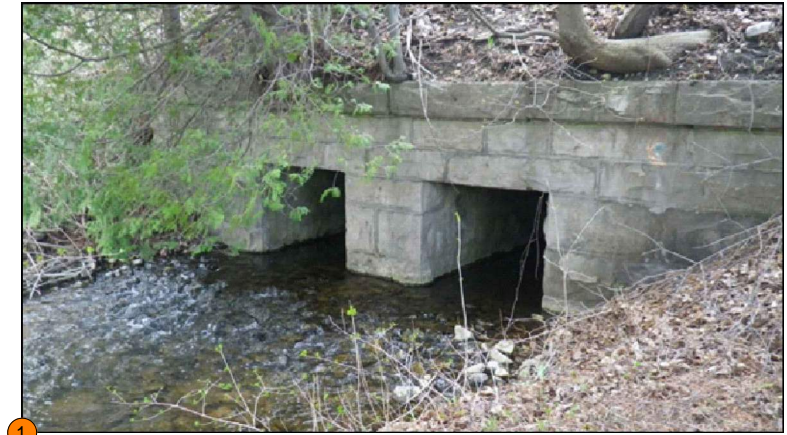
Feature #1: Ashlar stone culvert (potential significance). No impact to feature anticipated.

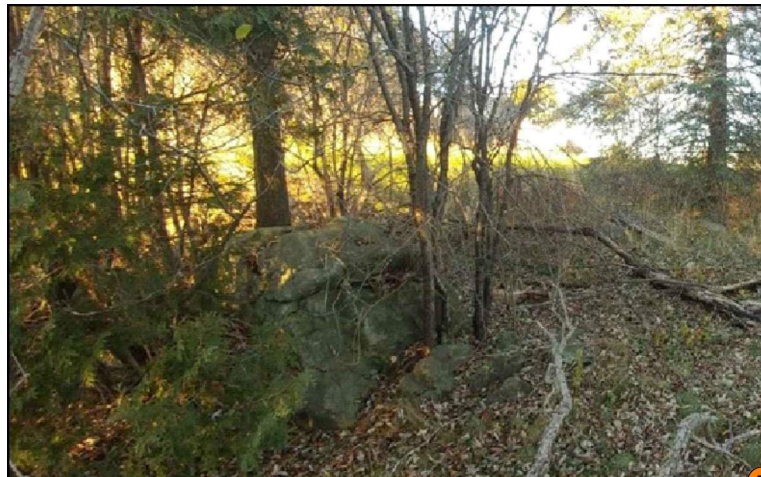
Feature #7: Large boulder or bedrock outcrop (potential significance). No impact to feature anticipated.
