Draft Terms of Reference

Environmental Impact Study (EIS)

York Road Environmental Design Study

City of Guelph

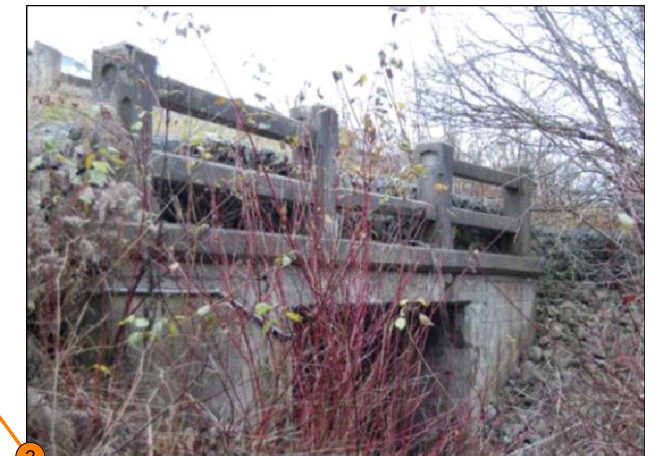
Feature #2: Reinforced concrete road bridge railing (potential significance). Feature to be modified to accommodate road widening works.

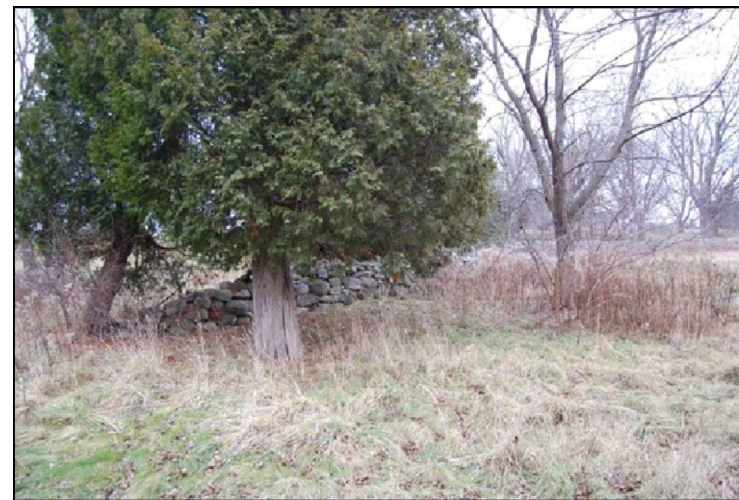
Feature #4: Fieldstone garden wall with sentinels (listed, non-designated significant feature). No impact to feature anticipated.

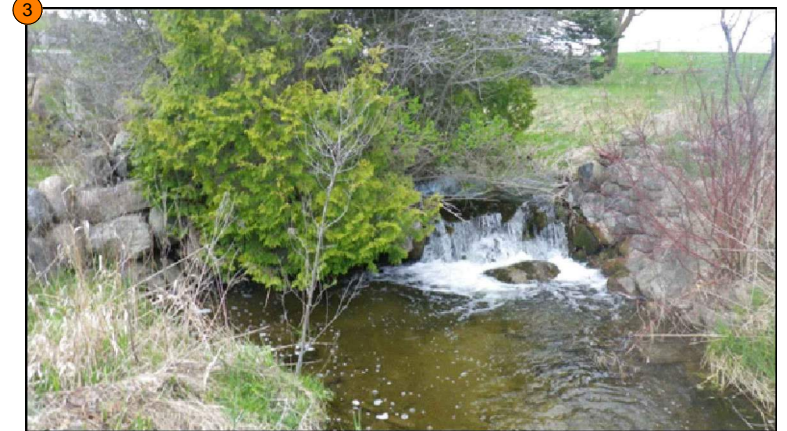
Feature #3: Fieldstone weir with steps and sentinel stones (listed, non-designated significant feature). No impact to feature anticipated.

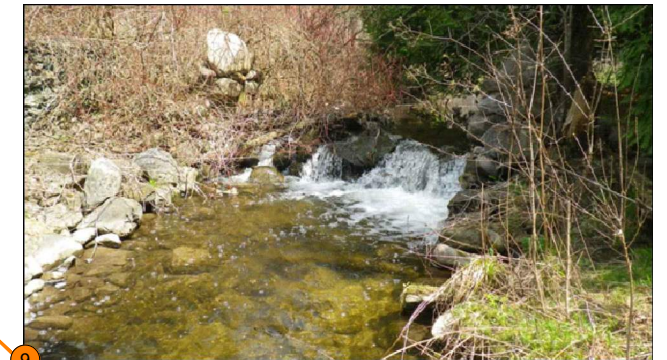
Feature #9: Fieldstone weir (listed, non-designated significant feature). No impact to feature anticipated. Retaining wall required to be built to protect/maintain feature from anticipated roadway grading limits.

Within Reach C-9A, local works will be required to restore the channel following a culvert extension or replacement at York Road. There will be no impact to cultural heritage features located within the channel. In order to maintain the features, a retaining wall will be constructed adjacent to features 9 and 10 in order to accommodate grading requirements of the road widening.

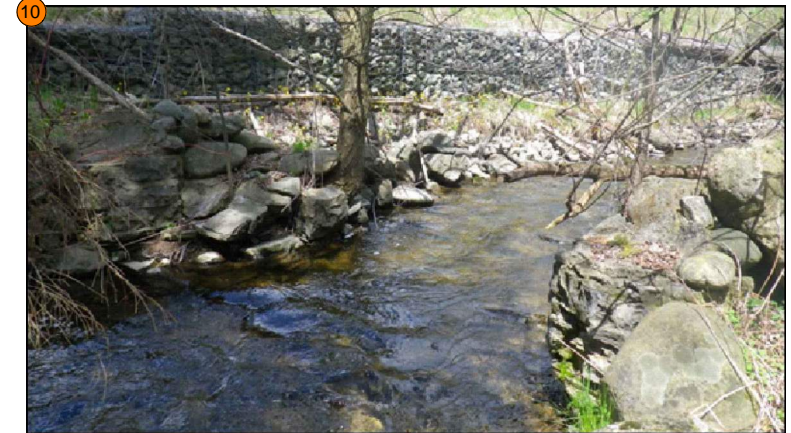
Feature #10: Fieldstone weir (listed, non-designated significant feature). Retaining wall required to be built to protect/maintain feature from anticipated roadway grading limits. Part of flagstone to be removed to accommodate retaining wall.

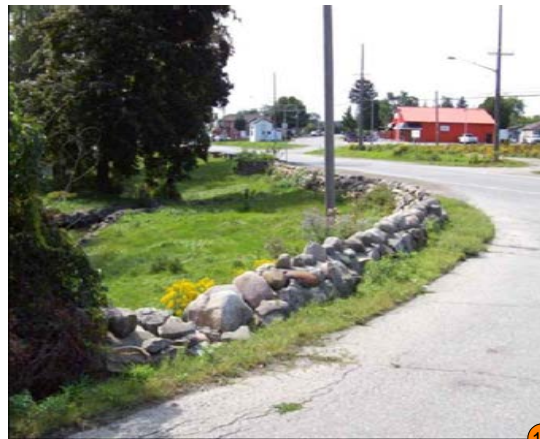
Feature #16: Fieldstone west entrance wall with sentinel stones (listed, non-designated significant feature). Potential for feature to be modified as a result of roadway grading requirements.

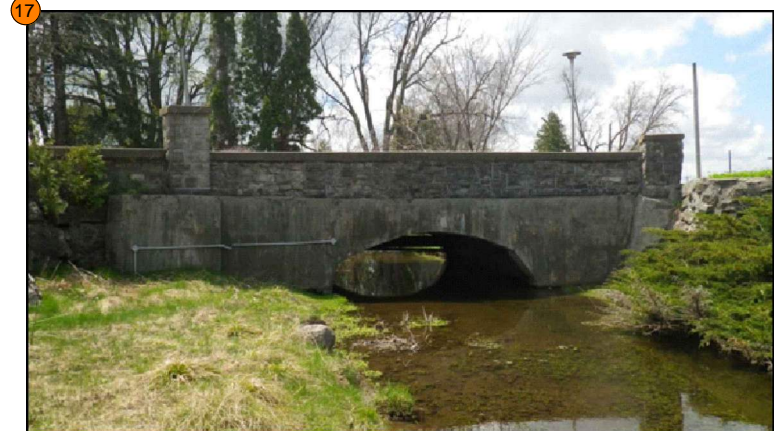
Feature #17: Stone and concrete road bridge (listed, non-designated significant feature). No impact to feature anticipated. No impact to feature anticipated.

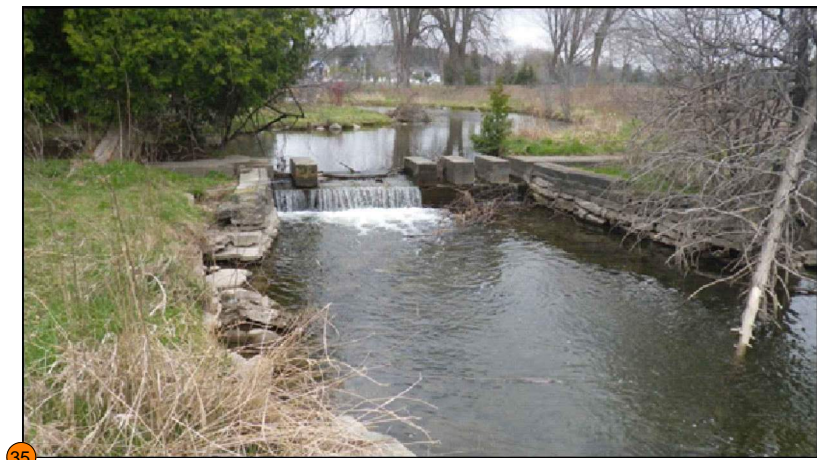
35 Feature #35: Concrete and stone weir (potential significance). No impact to feature anticipated.

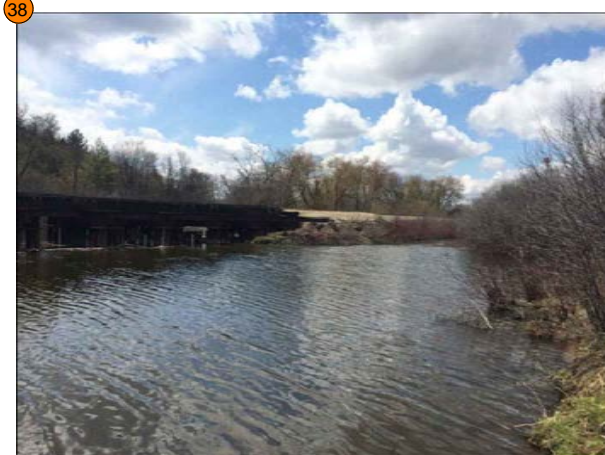
38 Feature #38: GJR railway bridge (potential significance). No impact to feature anticipated.

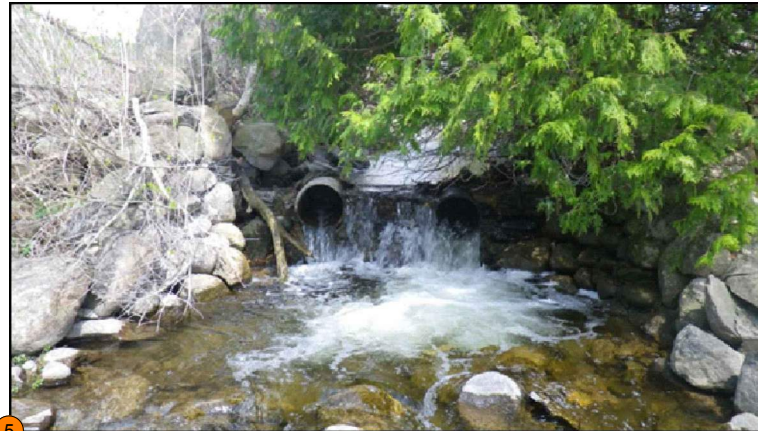
Feature #5: Fieldstone weir with clay pipes (listed, non-designated significant feature). No impact to feature anticipated. Feature is a substantial barrier to fish passage and limiting factor in overall channel function and health. Feature to be taken off-line/disconnected from active flow as a result of channel realignment. Feature will be maintained in landscape but impacted by loss of flow.

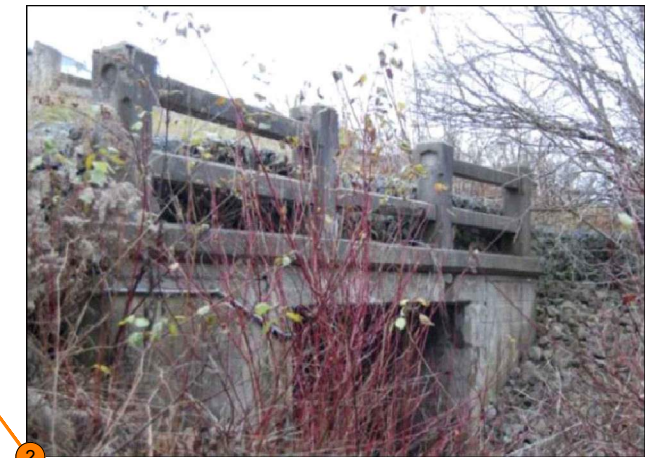
Feature #2: Reinforced concrete road bridge railing (potential significance). Feature to be modified to accommodate road widening works.

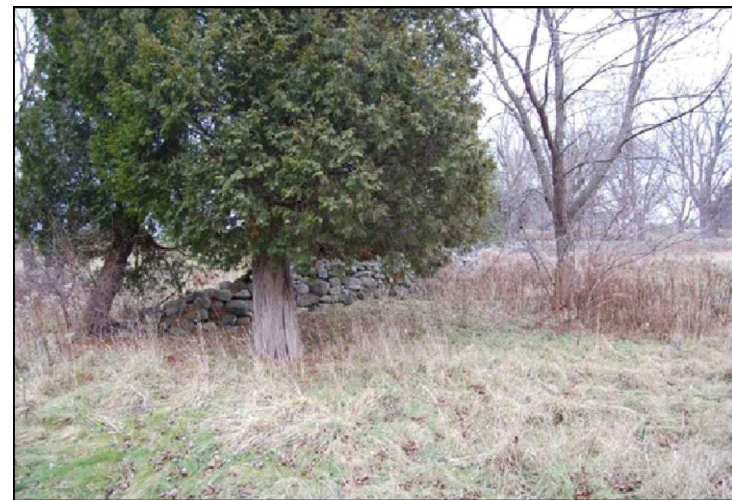
Feature #4: Fieldstone garden wall with sentinels (listed, non-designated significant feature). No impact to feature anticipated.

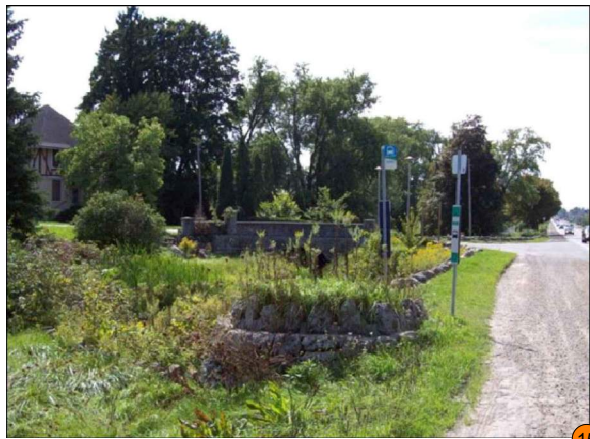
Feature #15: Fieldstone east entrance wall with sentinel stones (listed, non-designated significant feature). No impact to feature anticipated.

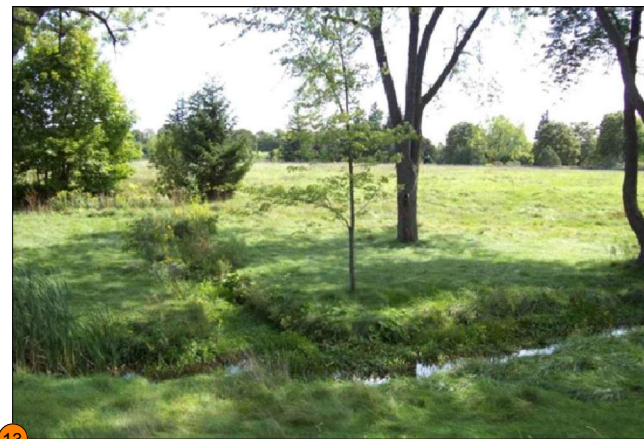
Feature #13: Confluence of Clythe Creek and intermittent stream (potential significance). Feature to be taken off-line/disconnected from active flow as a result of channel realignment. Tributary connection to Existing Clythe Creek will be filled. Existing groundwater draw to be incorporated and maintained within proposed re-alignment.

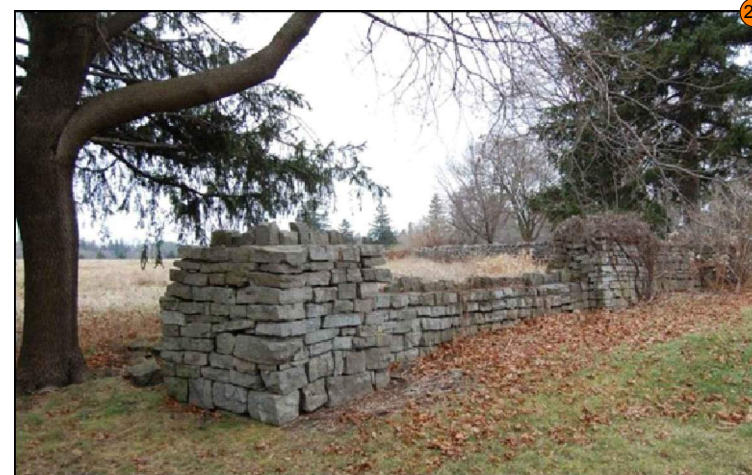
Feature #20: Ashlar dry stone wall (listed, non-designated significant feature). No impact to feature anticipated.

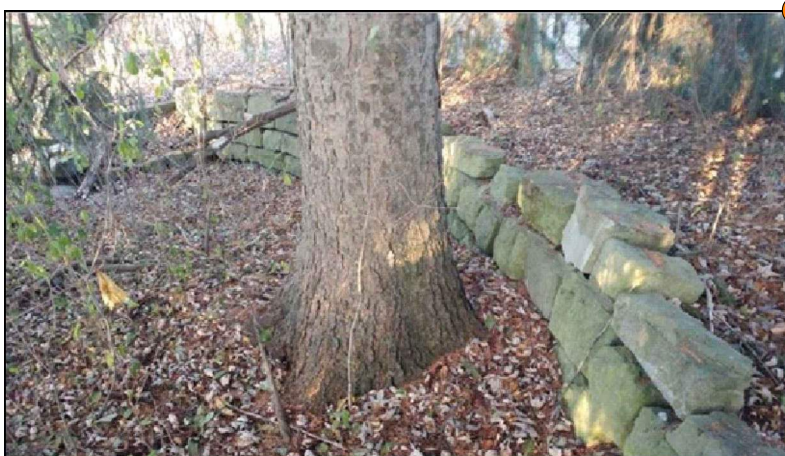
Feature #12: Ashlar limestone wall (listed, non-designated significant feature). Part of feature impacted by proposed creek realignment.

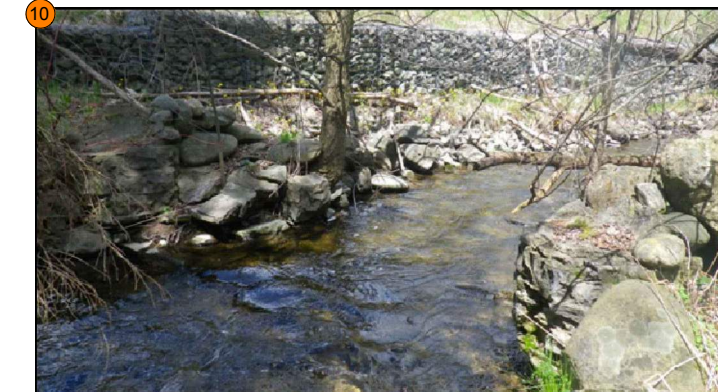
Feature #10: Fieldstone weir (listed, non-designated significant feature). No impact to feature anticipated. Feature is a substantial barrier to fish passage and limiting factor in overall channel function and health. Feature to be taken off-line/disconnected from active flow as a result of channel realignment. Feature will be maintained in landscape but will be impacted by loss of flow.

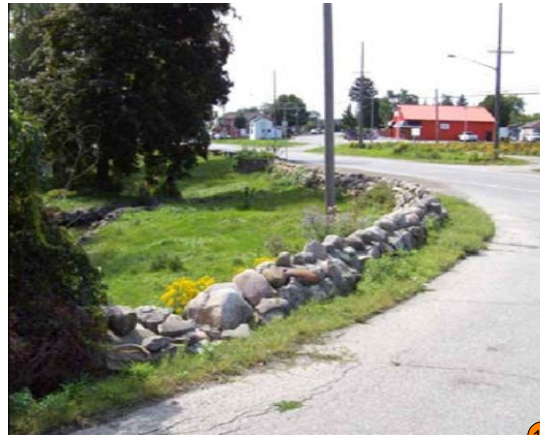
Feature #16: Fieldstone west entrance wall with sentinel stones (listed, non-designated significant feature). Potential for feature to be modified as a result of roadway grading requirements.

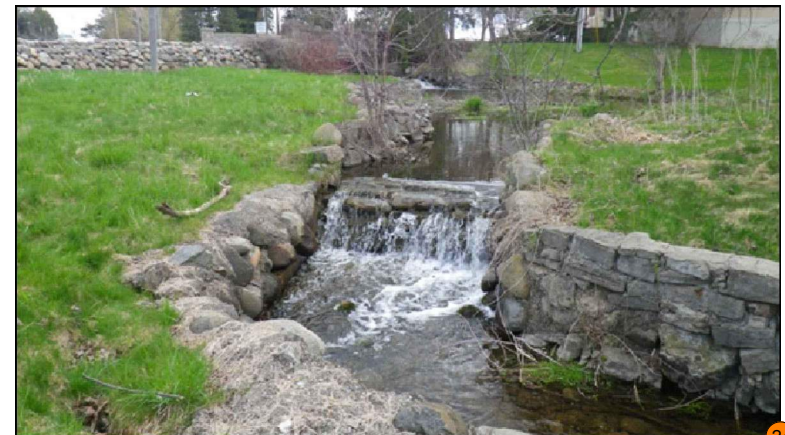
Feature #24: Fieldstone weir (listed, non-designated significant feature). Feature is a substantial barrier to fish passage and limiting factor in overall channel function and health. Feature to be taken off-line/disconnected from active flow as a result of proposed channel works. Potential for feature to be impacted as a result of required grading/fill as a result of proposed channel works.

24. Feature #24: Fieldstone weir (listed, non-designated significant feature). This feature is located to the north of a man-made island downstream from the main entrance. The feature is 2.1 m wide and is made out of concrete with small boulders protruding which emphasizes the “rushing” waterfall effect. Channel banks are lined with decorative stone. There are fracture lines present along the northern bank adjacent to the downstream stone wall. The structure is 0.7 m high, with the downstream bank heights/stone wall 1m high. Stone placement along the channel bed limits scour.

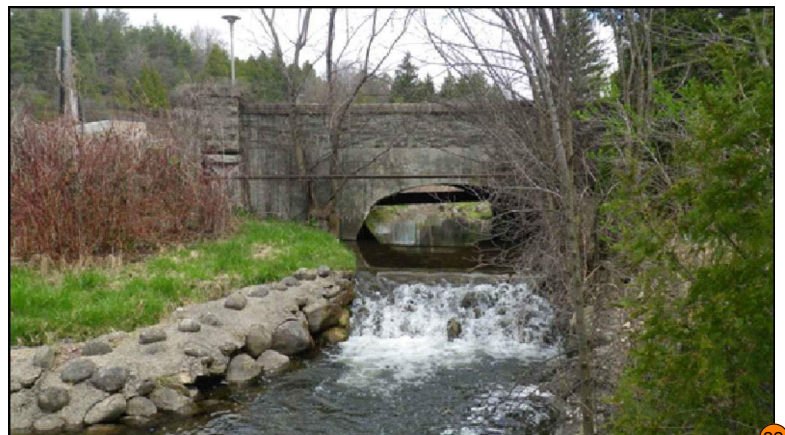
Feature #22: Fieldstone weir (listed, non-designated significant feature). No impact to feature anticipated.

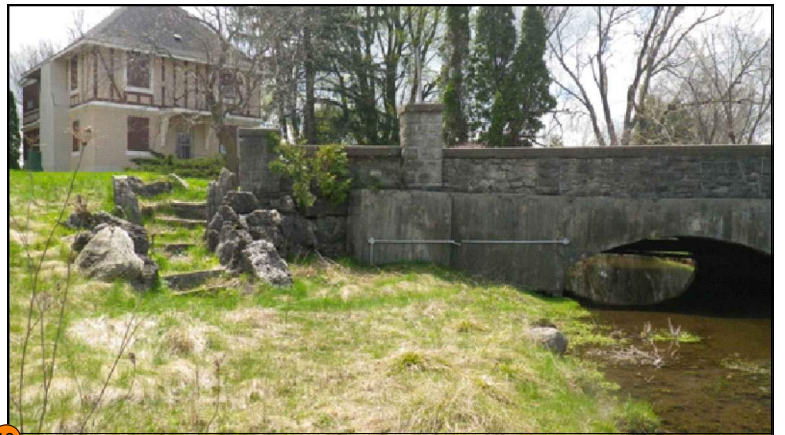
Feature #18: Fieldstone steps to the south of road bridge (listed, non-designated significant feature). No impact to feature anticipated. No impact to feature anticipated.

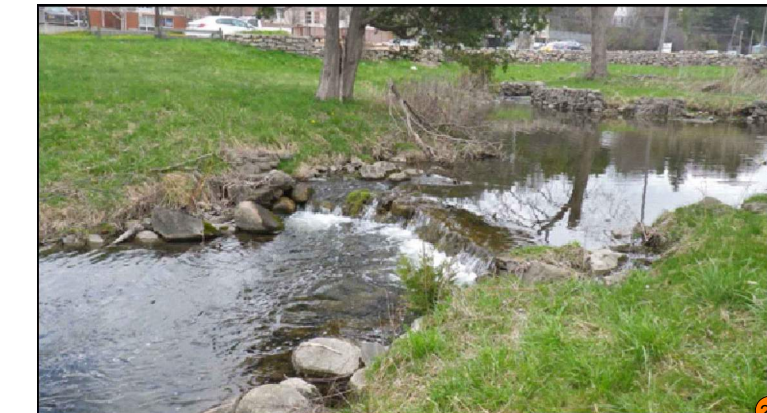
Feature #25: Fieldstone weir (listed, non-designated significant feature). Feature is a substantial barrier to fish passage and limiting factor in overall channel function and health. Feature will require modification or removal (confirmed during detailed design) as a result of channel works.

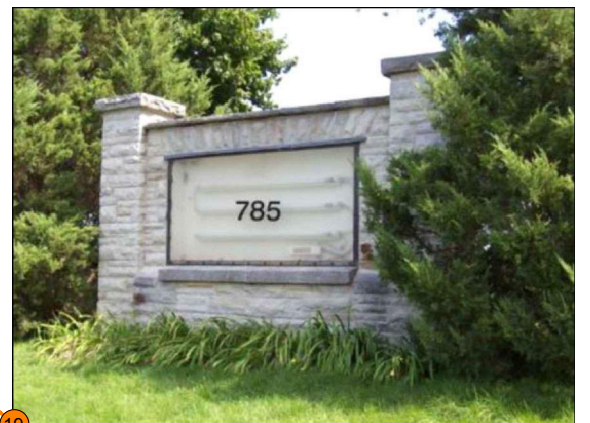
Feature #19: Entrance sign, ashlar stone with jack arch (potential significance). No impact to feature anticipated.

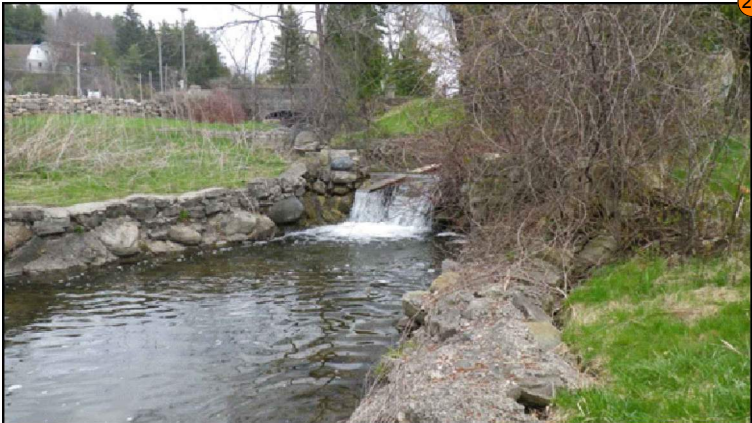
Feature #23: Fieldstone weir (listed, non-designated significant feature). Feature is a substantial barrier to fish passage and limiting factor in overall channel function and health. Feature will require modification or removal (confirmed during detailed design) as a result of channel works.

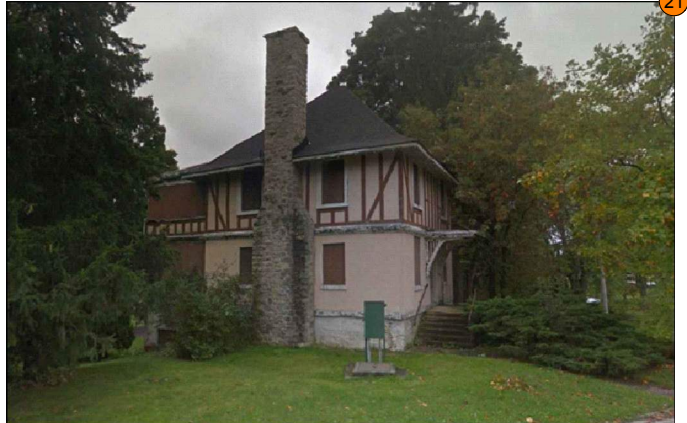
Feature #21: Willowbank Hall (listed, non-designated significant feature). No impact to feature anticipated.

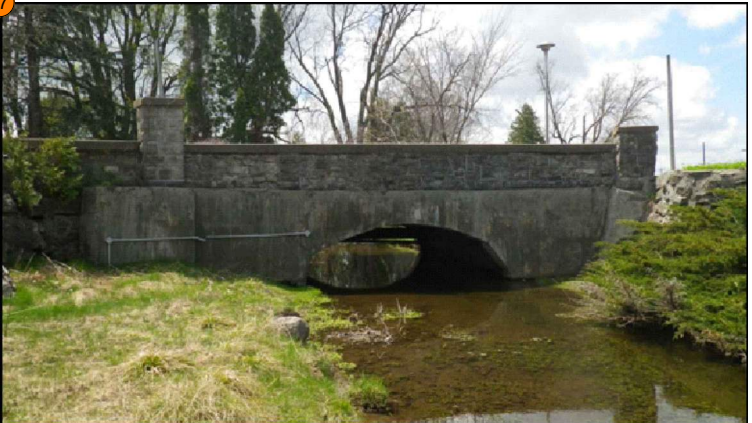
Feature #17: Stone and concrete road bridge (listed, non-designated significant feature). No impact to feature anticipated, existing capacity dimensions to be maintained.

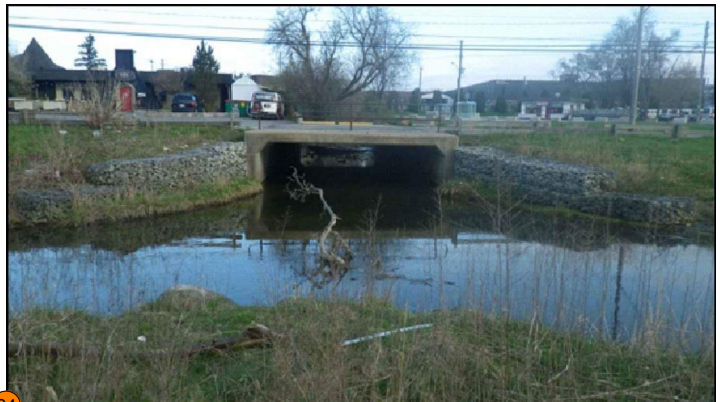
34 Feature #34 (not considered cultural heritage feature): Box culvert at confluence of Clythe Creek and Hadati Creek. Potential culvert extension to accommodate roadway grading requirement and CSP replacement.

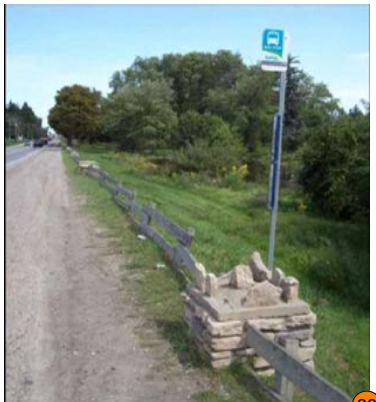
30 Feature #30: Limestone pillars (potential significance). Potential for feature to be modified as a result of roadway grading requirements.

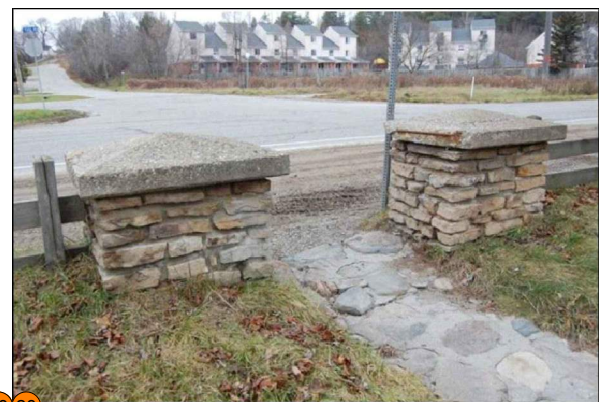
28, 29 Feature #28 and #29: Limestone pillars with wood board fencing leading to main entrance (potential significance). Potential for feature to be modified as a result of roadway grading requirements.

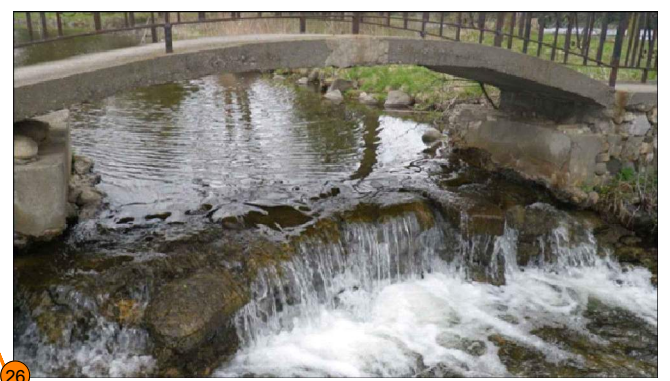
26 Feature #26: Fieldstone weir (listed, non-designated significant feature). Feature is a substantial barrier to fish passage and limiting factor in overall channel function and health. Feature will require modification or removal (confirmed during detailed design) as a result of channel works.

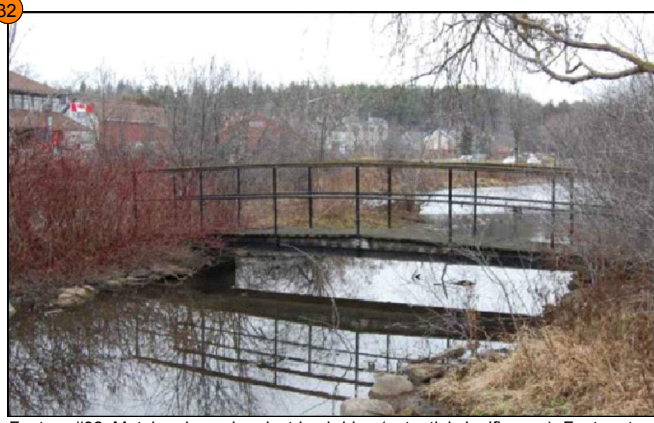
32 Feature #32: Metal and wood pedestrian bridge (potential significance). Feature to be removed as a result of proposed channel works.

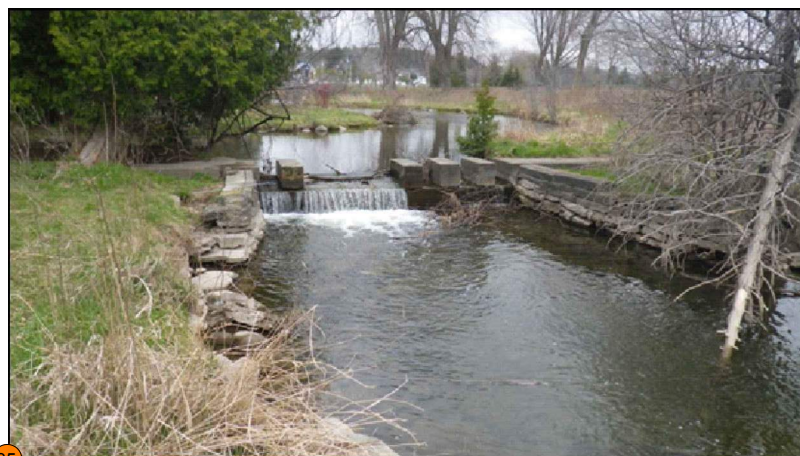
35 Feature #35: Concrete and stone weir (potential significance). Feature to be removed as a result of proposed channel works.

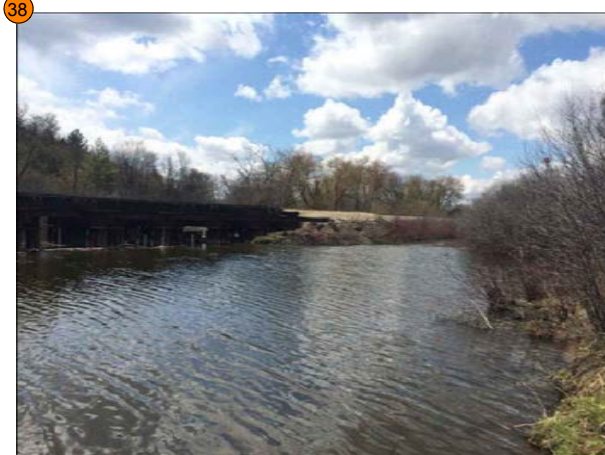
38 Feature #38: GJR railway bridge (potential significance). No impact to feature anticipated.

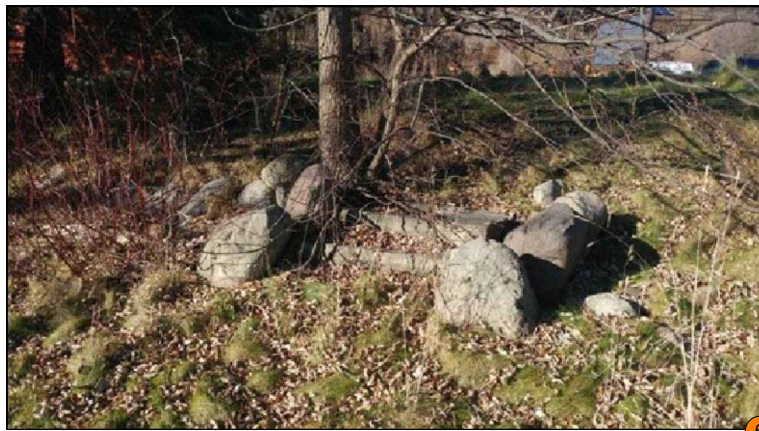
Feature #6: Fieldstone steps (listed, non-designated significant feature). Feature is located within the floodplain and will not be impacted by proposed channel works.

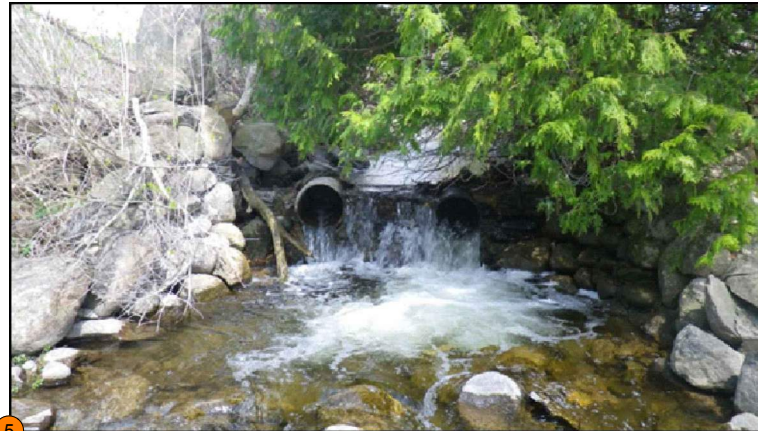
Feature #5: Fieldstone weir with clay pipes (listed, non-designated significant feature). Feature is a substantial barrier to fish passage and limiting factor in overall channel function and health. Feature to be taken off-line and disconnected from active flow as a result of channel realignment. Feature will be maintained in the landscape.

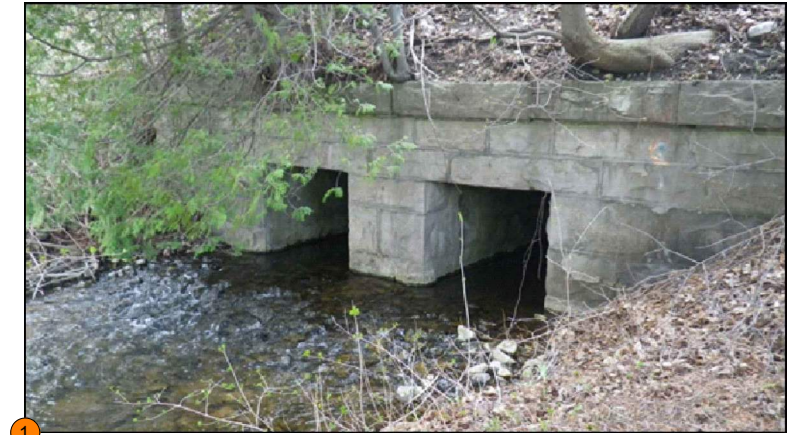
Feature #1: Ashlar stone culvert (potential significance). Channel works are not proposed upstream from York Road therefore the feature will not be impacted by proposed channel works.

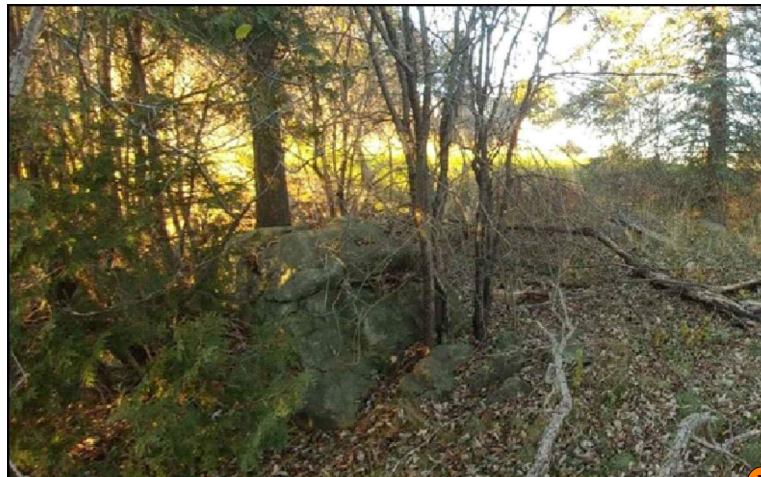
Feature #7: Large boulder or bedrock outcrop (potential significance). Feature is located within the floodplain and will not be impacted by proposed channel works.

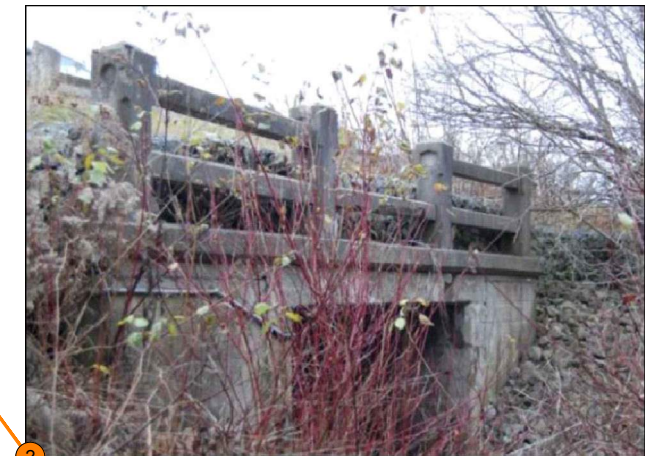
Feature #2: Reinforced concrete road bridge railing (potential significance). No impact to feature anticipated as a result of proposed channel works.

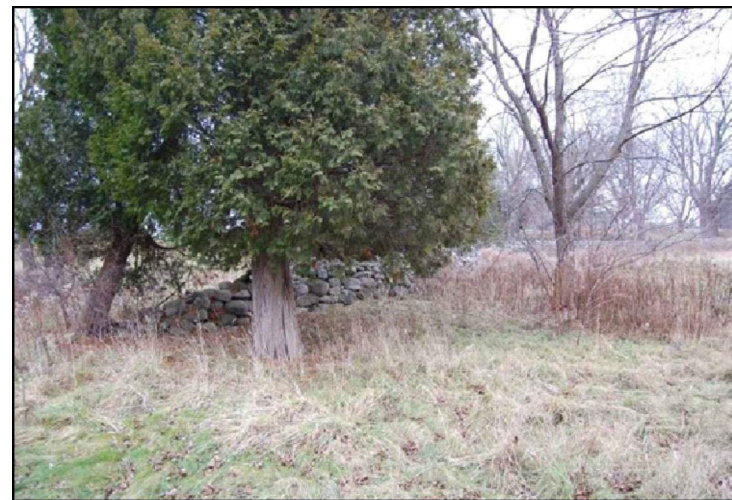
Feature #4: Fieldstone garden wall with sentinels (listed, non-designated significant feature). In order to maintain the feature, the existing channel planform will be utilized. As the feature is within the floodplain and will not be impacted by proposed channel works.

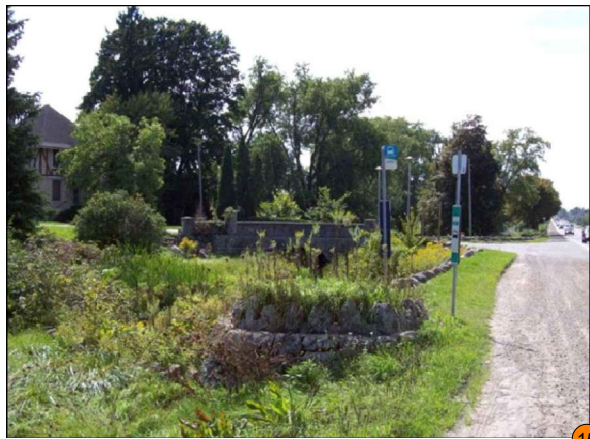
Feature #15: Fieldstone east entrance wall with sentinel stones (listed, non-designated significant feature). No impact to feature anticipated as a result of proposed channel works.

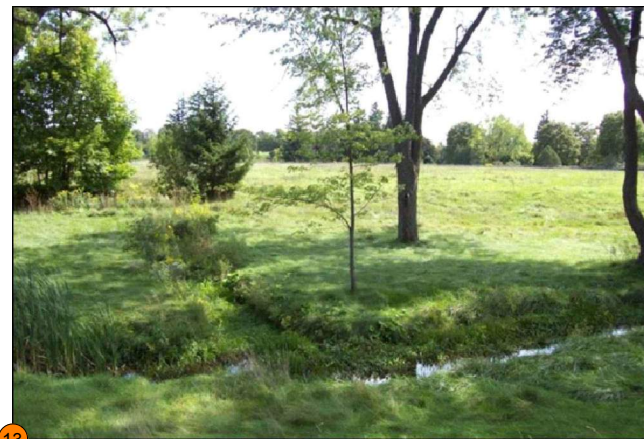
Feature #13: Confluence of Clythe Creek and intermittent stream (potential significance). Feature will be 'filled' and the floodplain restored to uniform elevation. The proposed channel alignment utilizes a local section of the intermittent streams platform, as a result existing groundwater draw will be maintained within proposed re-alignment.

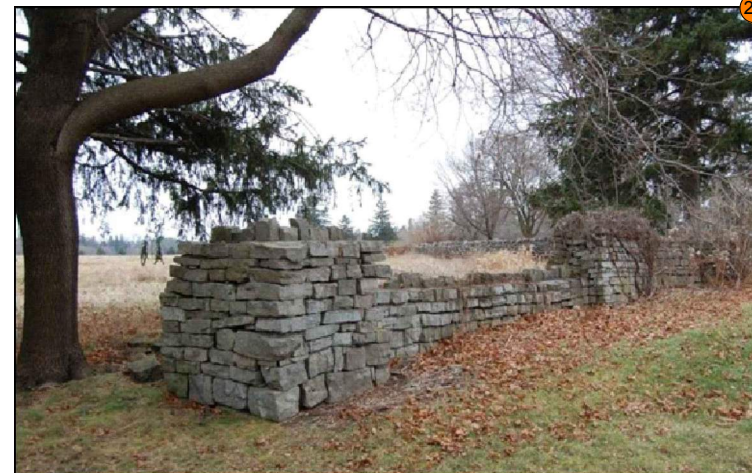
Feature #20: Ashlar dry stone wall (listed, non-designated significant feature). Feature is located within the floodplain and will not be impacted by proposed channel works.

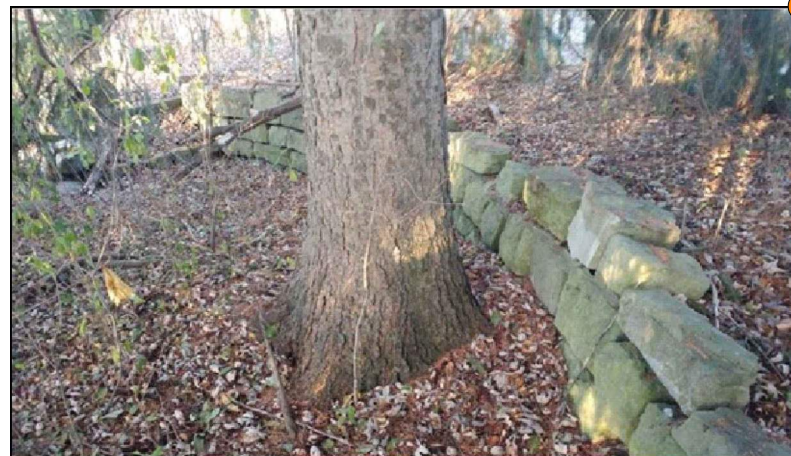
Feature #12: Ashlar limestone wall (listed, non-designated significant feature). Feature is located within the floodplain and will not be impacted by proposed channel works.

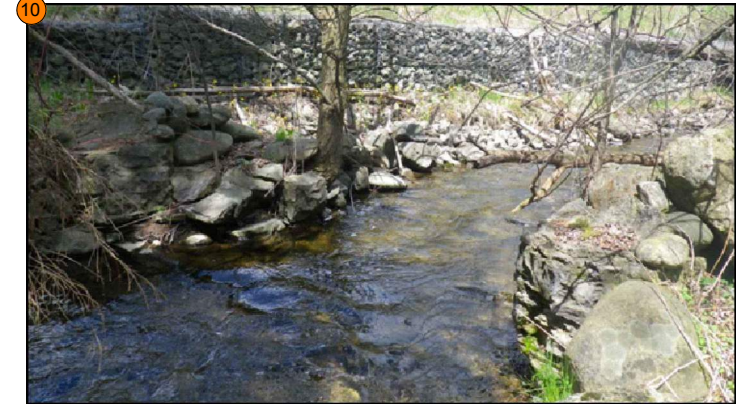
Feature #10: Fieldstone weir (listed, non-designated significant feature). Feature is a substantial barrier to fish passage and limiting factor in overall channel function and health. Feature to be taken off-line and disconnected from active flow as a result of channel realignment. A retaining wall will be installed in order for the feature to be maintained in the landscape.

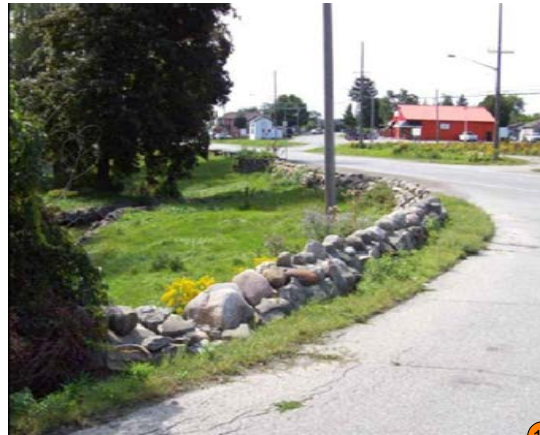
Feature #16: Fieldstone west entrance wall with sentinel stones (listed, non-designated significant feature). No impact to feature anticipated as a result of proposed channel works.

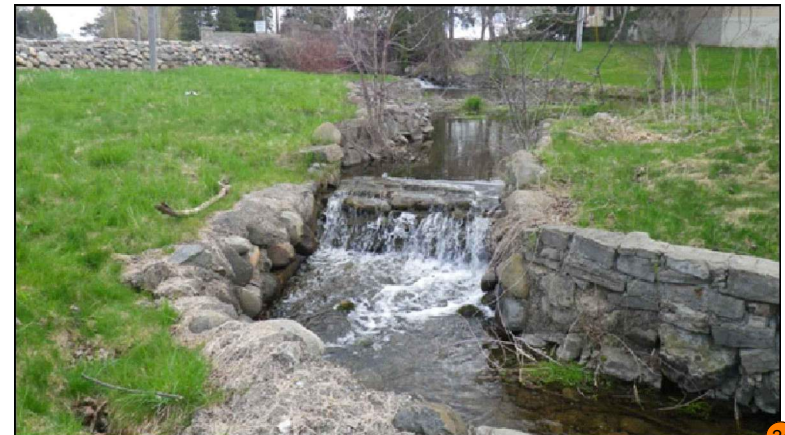
Feature #24: Fieldstone weir (listed, non-designated significant feature). Feature is a substantial barrier to fish passage and limiting factor in overall channel function and health. Feature to be taken off-line and disconnected during low-flow stages as a result of proposed channel realignment. An overflow channel will be incorporated so that the feature will be reconnected during high-flow stages (i.e., flows greater than the 2yr discharge).

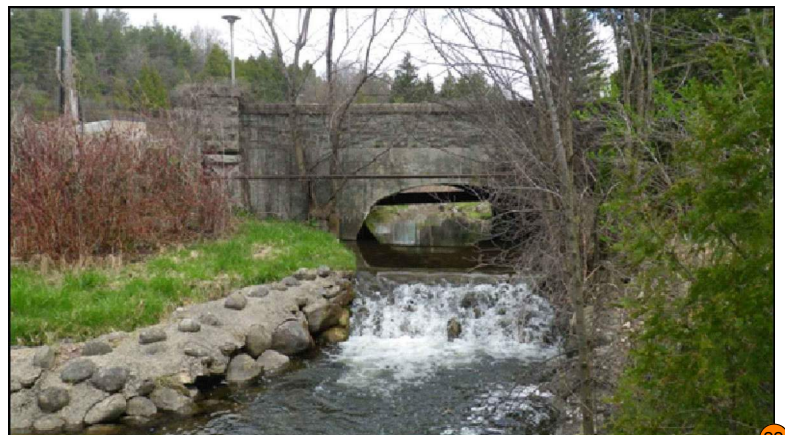
Feature #22: Fieldstone weir (listed, non-designated significant feature). Feature will require modification as a result of proposed channel realignment. Proposed channel realignment will require a "tie-in" location immediately downstream from Feature 17. Full extent of proposed modification to be confirmed during detailed design.

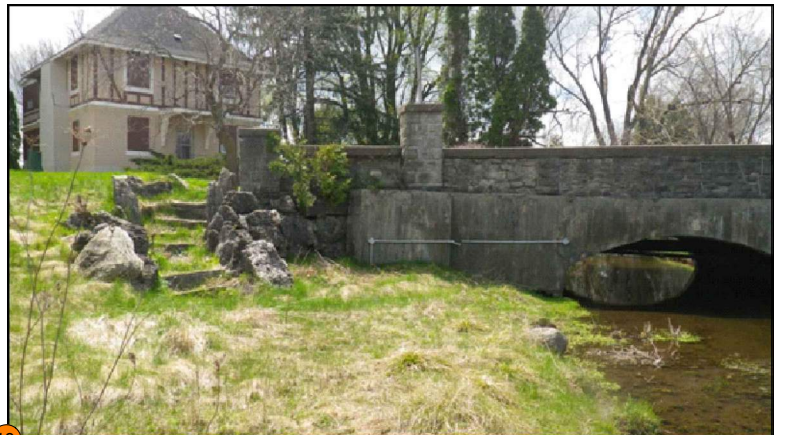
Feature #18: Fieldstone steps to the south of road bridge (listed, non-designated significant feature). Feature is located within the floodplain and will not be impacted by proposed channel works.

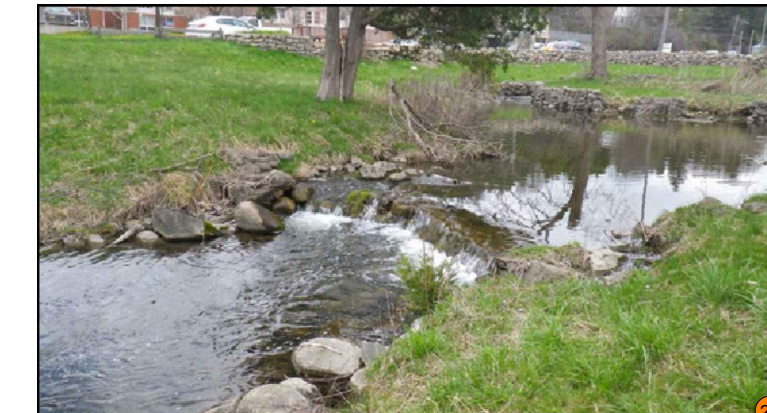
Feature #25: Fieldstone weir (listed, non-designated significant feature). Feature is a substantial barrier to fish passage and limiting factor in overall channel function and health. Feature to be taken off-line and disconnected during low-flow stages as a result of proposed channel realignment. An overflow channel will be incorporated so that the feature will be reconnected during high-flow stages (i.e., flows greater than the 2yr discharge).

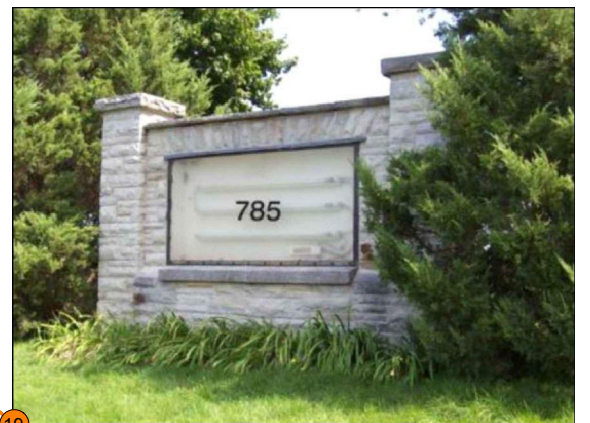
Feature #19: Entrance sign, ashlar stone with jack arch (potential significance). Feature is located within the floodplain and will not be impacted by proposed channel works.

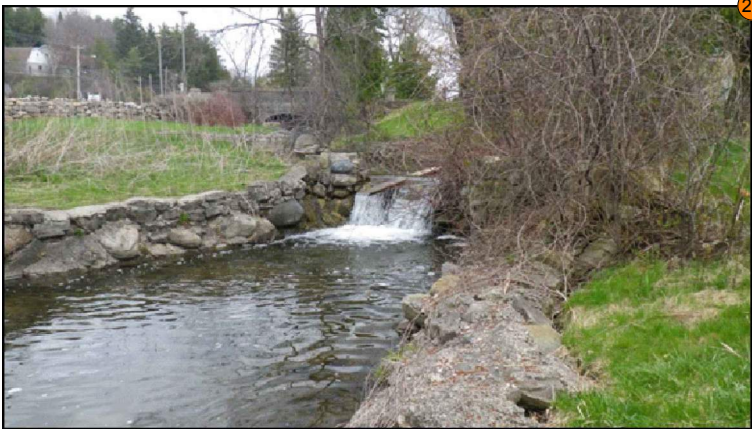
Feature #23: Fieldstone weir (listed, non-designated significant feature). Feature is a substantial barrier to fish passage and limiting factor in overall channel function and health. Feature to be taken off-line and disconnected during low-flow stages as a result of proposed channel realignment. An overflow channel will be incorporated so that the feature will be reconnected during high-flow stages (i.e., flows greater than the 2yr discharge).

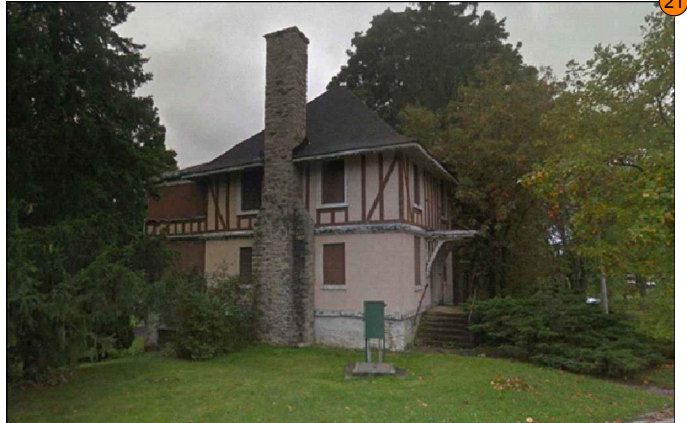
Feature #21: Willowbank Hall (listed, non-designated significant feature). Feature is located within the floodplain and will not be impacted by proposed channel works.

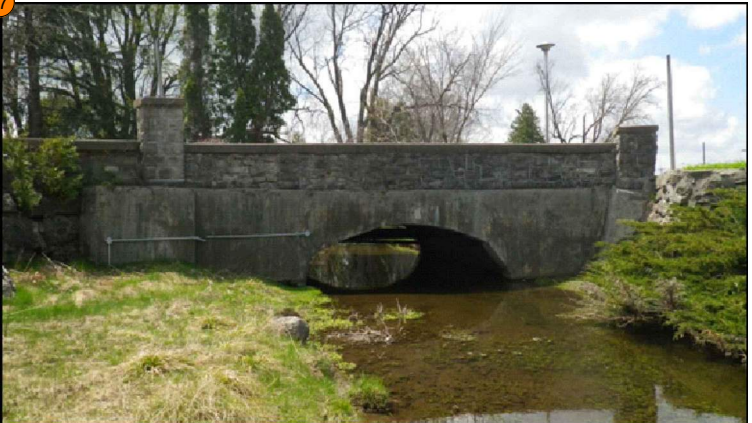
Feature #17: Stone and concrete road bridge (listed, non-designated significant feature). No impact to feature anticipated as a result of proposed channel works, existing capacity dimensions to be maintained.

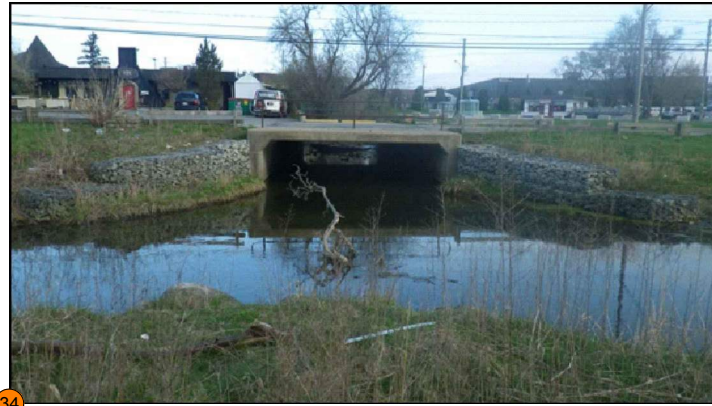
34 Feature #34: Confluence of Clythe Creek and Hadati Creek (potential significance). Potential impact to culvert outlet to accommodate roadway grading requirement and CSP replacement.

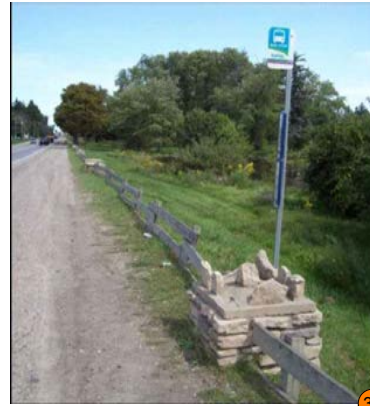
30 Feature #30: Limestone pillars (potential significance). No impact to feature anticipated as a result of proposed channel works.

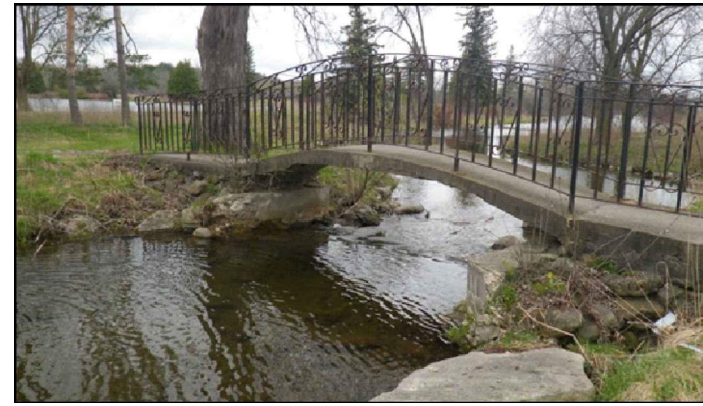
27 Feature #27: Arched concrete and metal pedestrian bridge with stone abutments (potential significance). Potential for feature abutments to be modified as a result of proposed channel works. The proposed channel will require a "tie-in" location in the vicinity of the abutments both upstream and downstream. Full extent of proposed modification to be confirmed during detailed design.

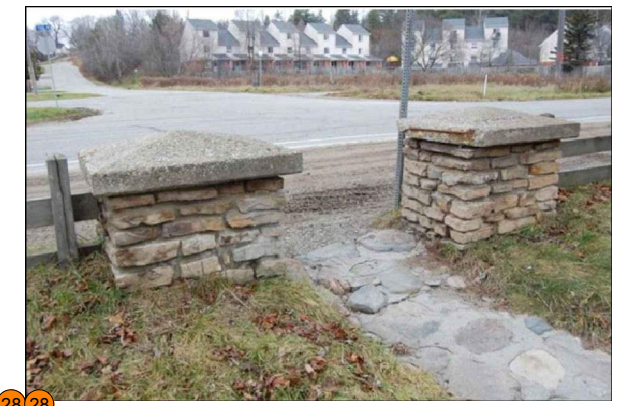
28, 29 Feature #28 and #29: Limestone pillars with wood board fencing leading to main entrance (potential significance). No impact to feature anticipated as a result of proposed channel works.

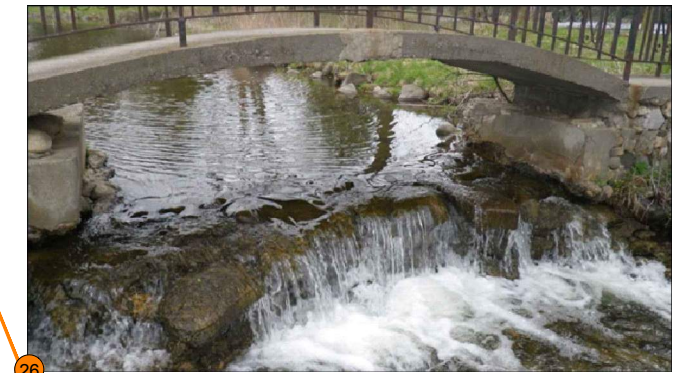
26 Feature #26: Fieldstone weir (listed, non-designated significant feature). Feature is a substantial barrier to fish passage and limiting factor in overall channel function and health. As a result of proposed channel works it is anticipated that the feature will be backwatered, decreasing or eliminating the existing fish passage barrier.

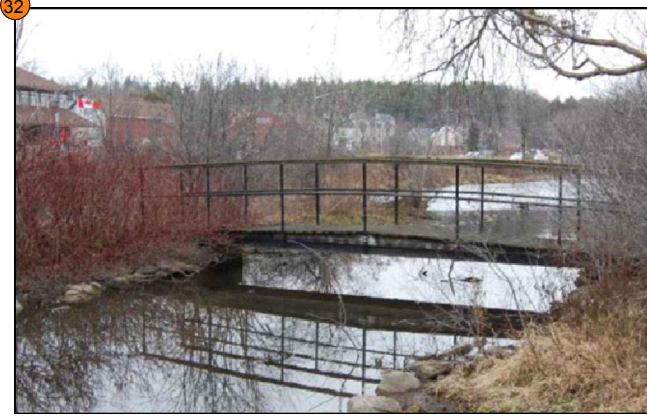
32 Feature #32: Metal and wood pedestrian bridge (potential significance). Feature is likely to be modified or removed as a result of proposed channel works.

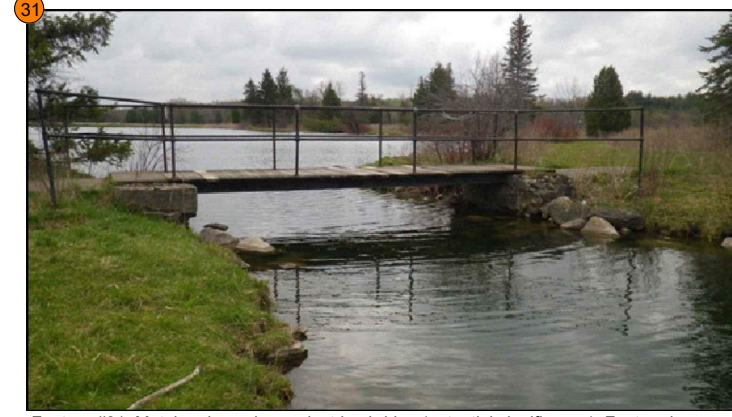
31 Feature #31: Metal and wooden pedestrian bridge (potential significance). Feature is likely to be modified or removed as a result of proposed channel works.

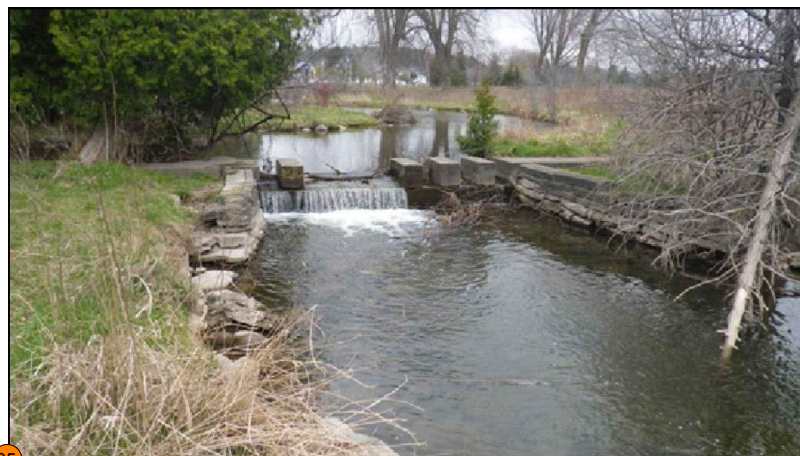
35 Feature #35: Concrete and stone weir (potential significance). Feature to be taken off-line and disconnected during low-flow stages. An allowance for overflow capabilities will be incorporated so that the feature will be reconnected during high-flow stages (i.e., flows greater than the 2yr discharge).

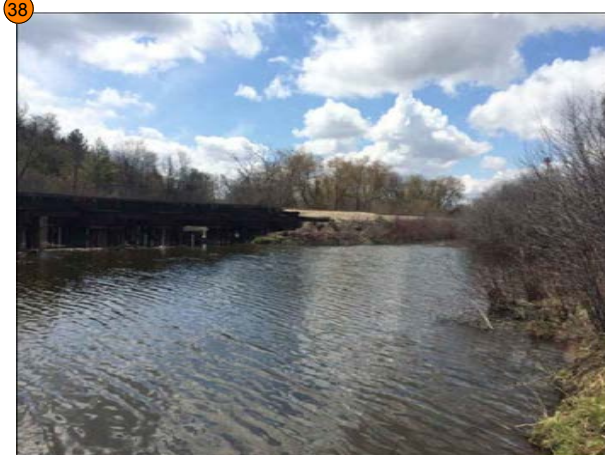
38 Feature #38: GJR railway bridge (potential significance). No impact to feature anticipated.
