Draft Terms of Reference

Environmental Impact Study (EIS)

York Road Environmental Design Study

City of Guelph

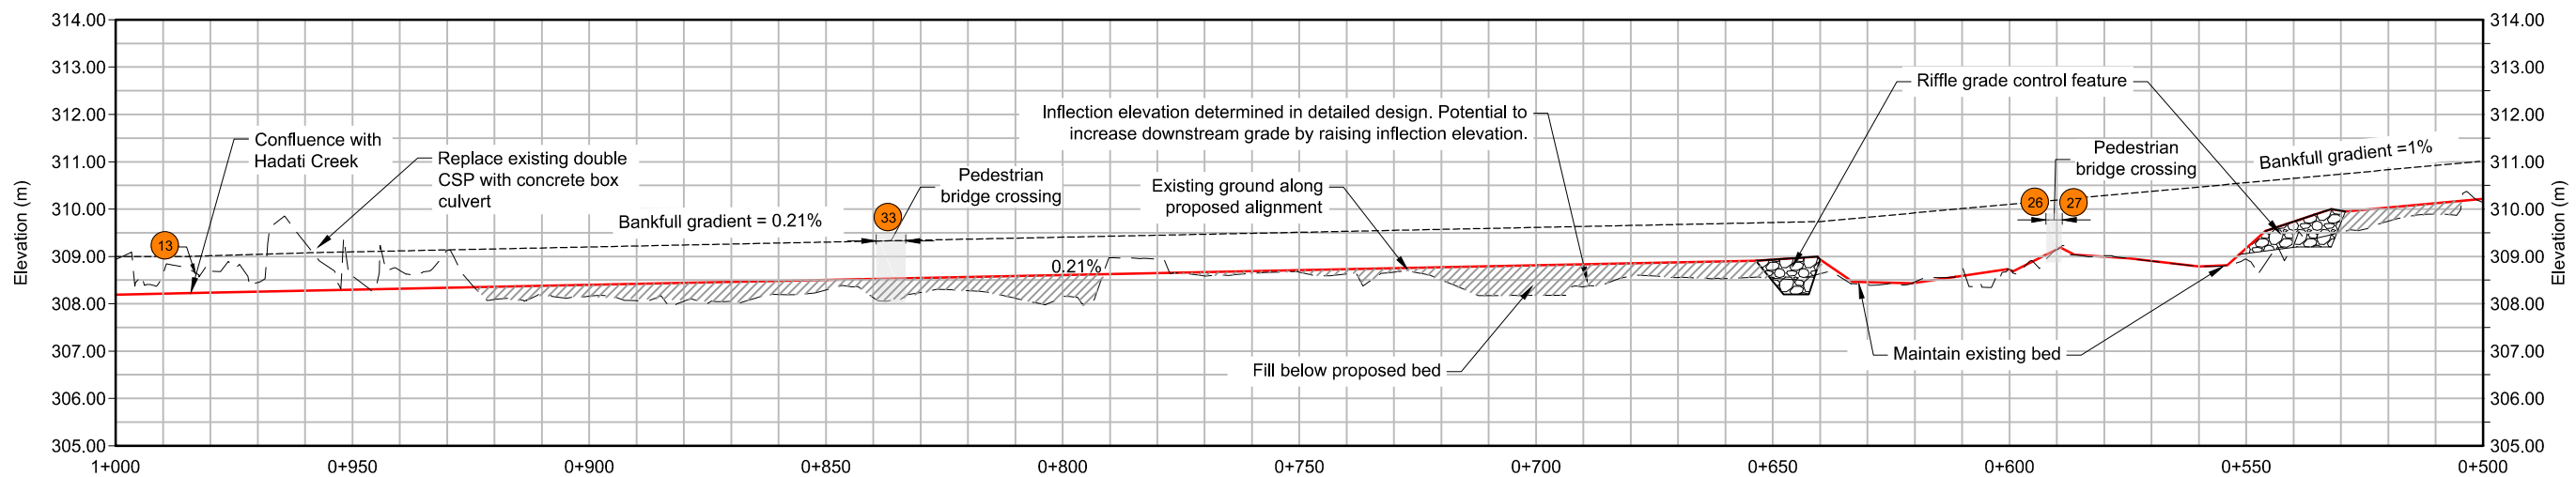
Channel Profile
 Horizontal Scale 1:1500
 Vertical Scale 1:150

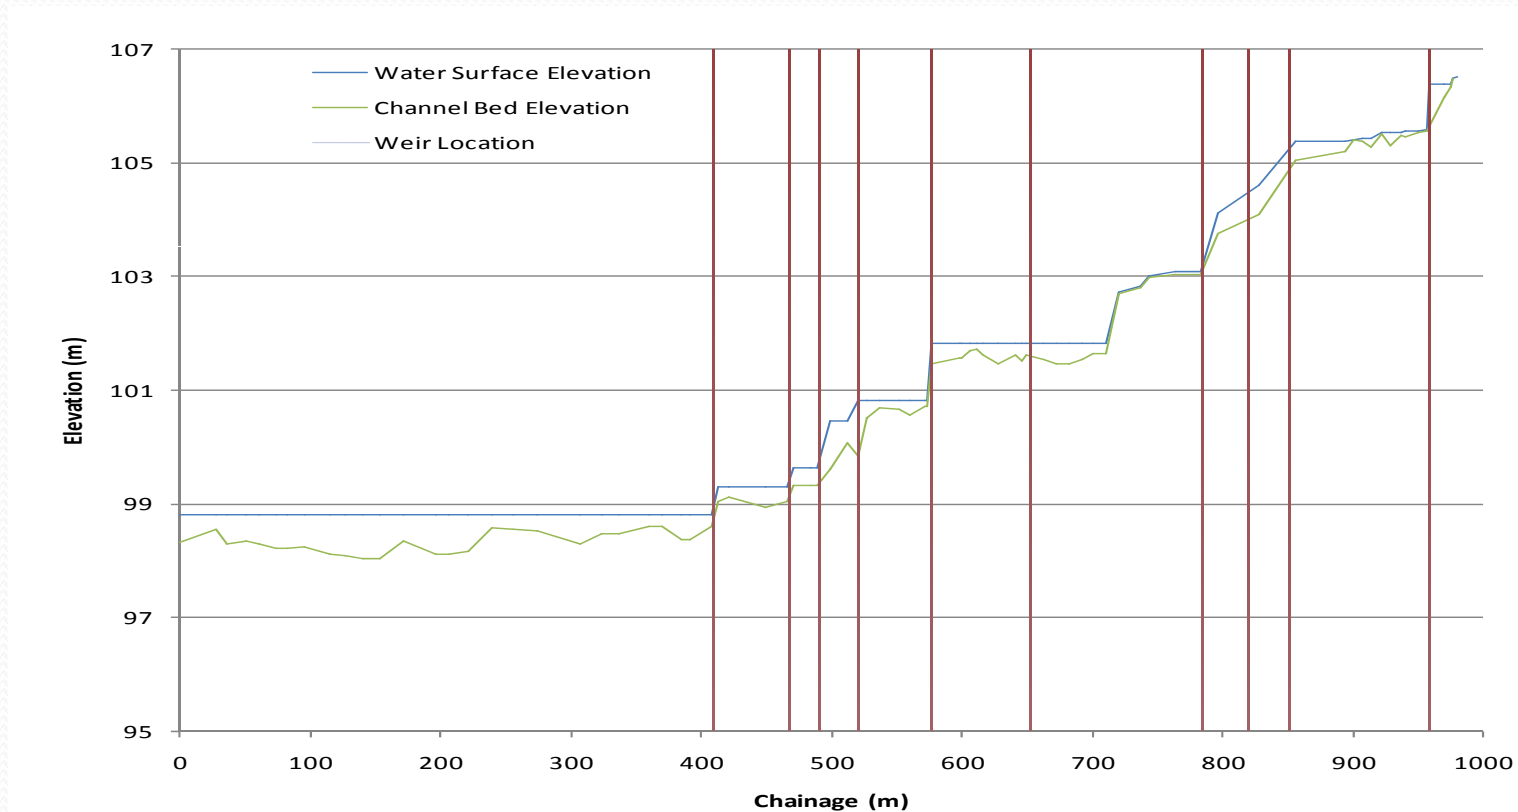
- Water velocities during base flow approximately 0.005m/s

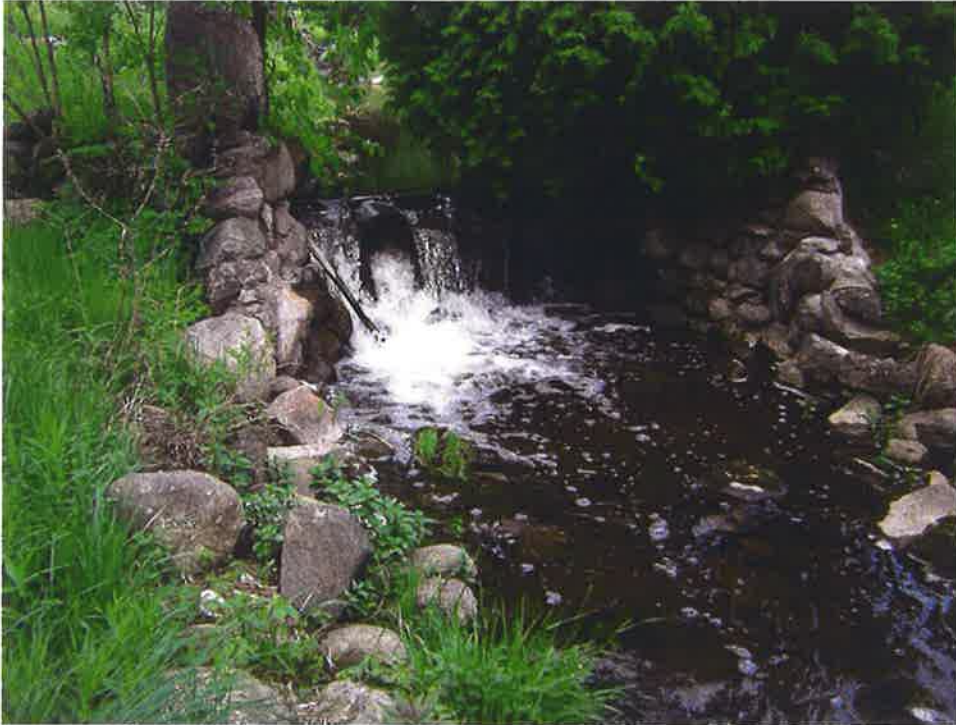
Photo 1 – Clythe Creek, example of the many weirs in the study area

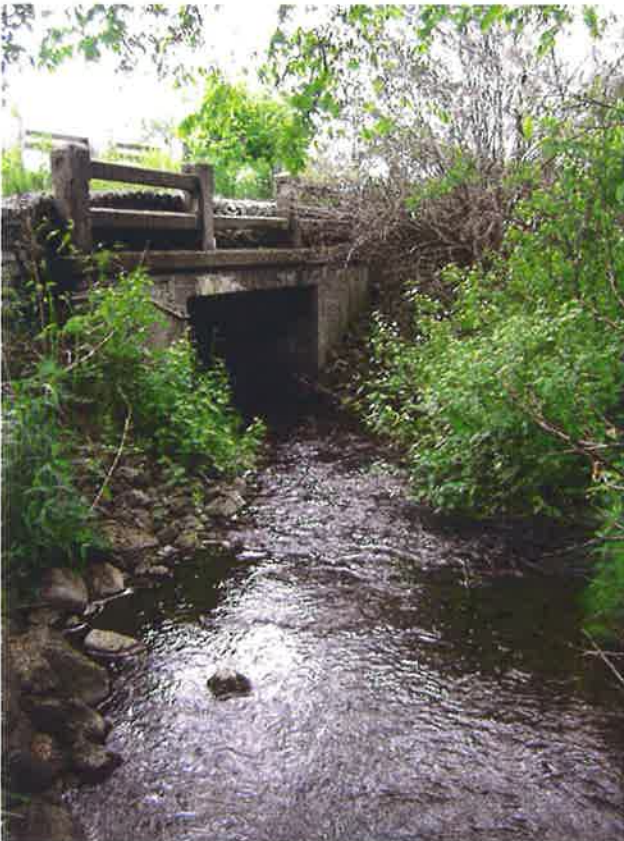
Photo 2 – Clythe Creek, Reach 1, looking downstream

The channel in Reach 1 is approximately 3m wide, and is very entrenched. The bank height ranges from approximately 1.9 to 2.2m, and bank slopes are nearly vertical. Most of the banks are hardened with a concrete bag wall (see Photo 10, Appendix I).

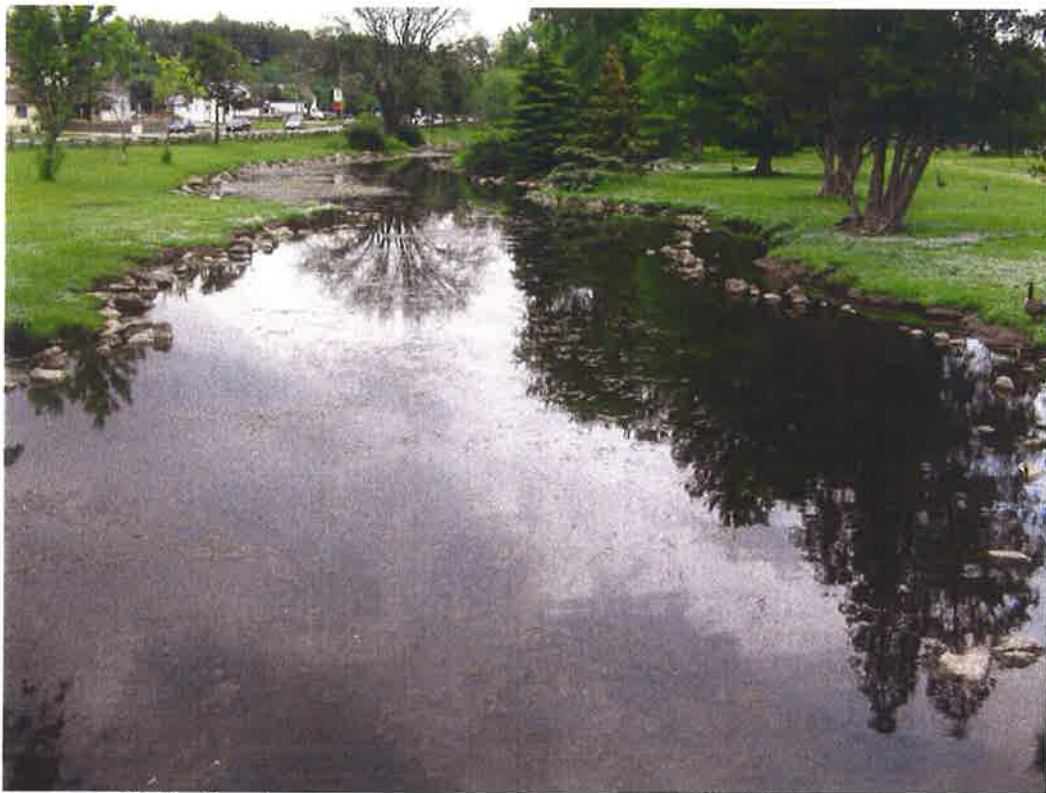
Photo 4 – Clythe Creek, Reach 3, looking upstream

The bank height ranges from approximately 0.1 to 0.3m, and the bank-full channel width varies between 7 and 12m. This widened section of Clythe Creek has some meandering form, but intensive modifications have left it with a low gradient. As a result, the water becomes ponded during low flow (see Photo 4, Appendix I). The substrate reflects the depositional nature of the slow, diffused flows. It is approximately 50% silt, 30% boulder, and 20% muck.

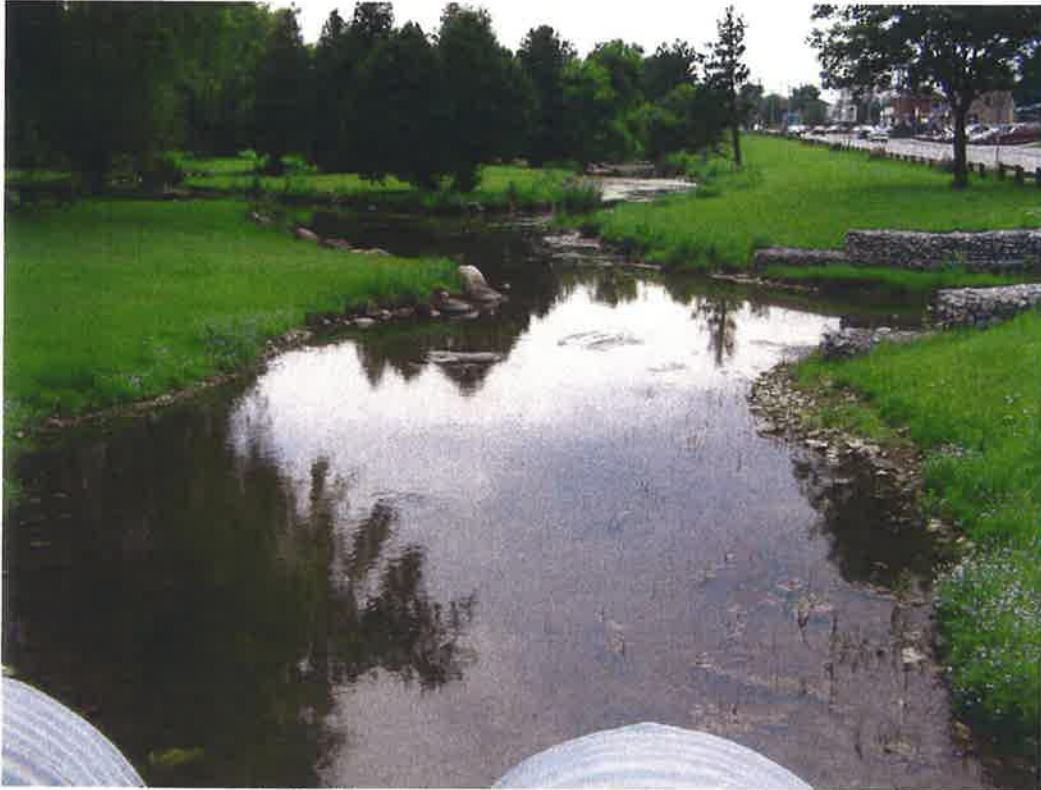
Photo 5 – Clythe Creek, Reach 4, looking downstream toward Hadati Cr. outlet and ponds

This reach lies between the outlet of Hadati Creek and the downstream limit of two online ponds (Figure 2). The flow diverges downstream of the Hadati Creek outlet to flow into the two ponds, which are located side-by-side (see Photo 5, Appendix I). The east online pond is at a lower elevation and is the larger of the two. The land on the east side of this pond is wooded. The land in between the two ponds and west of the ponds is manicured grass with occasional trees. Boulders were used as a landscaping feature along the banks, and there is abundant aquatic vegetation throughout both ponds.

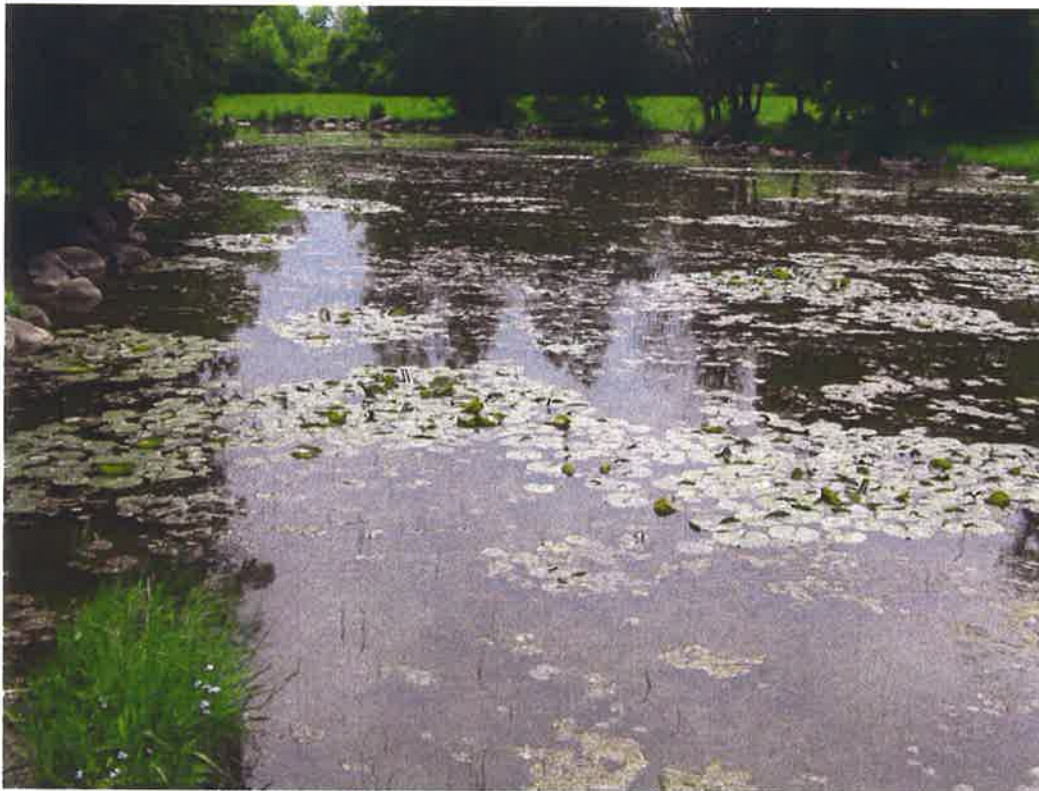
Photo 6 – Clythe Creek, Reach 4, abundant aquatic plants in the online ponds

On June 8, 2006, the water was relatively shallow (approximately 0.3m deep) throughout most of the area of the ponds. Water temperature was measured where the flow from the upper (west) pond joins the lower (east) pond. At 2:45pm, the water temperature was 23.5°C and the air temperature was 24°C. The pH at this location was 7.80 and the conductivity was 812µs/cm. The dissolved oxygen level was 9.3ppm, indicating supersaturated conditions (approximately 110% at 23.5°C). This was likely a result of the prolific growth of aquatic plants (see Photo 6, Appendix I). Fish from the families Centrarchidae (*Lepomis* sp.) and Cyprinidae were observed in the ponds.

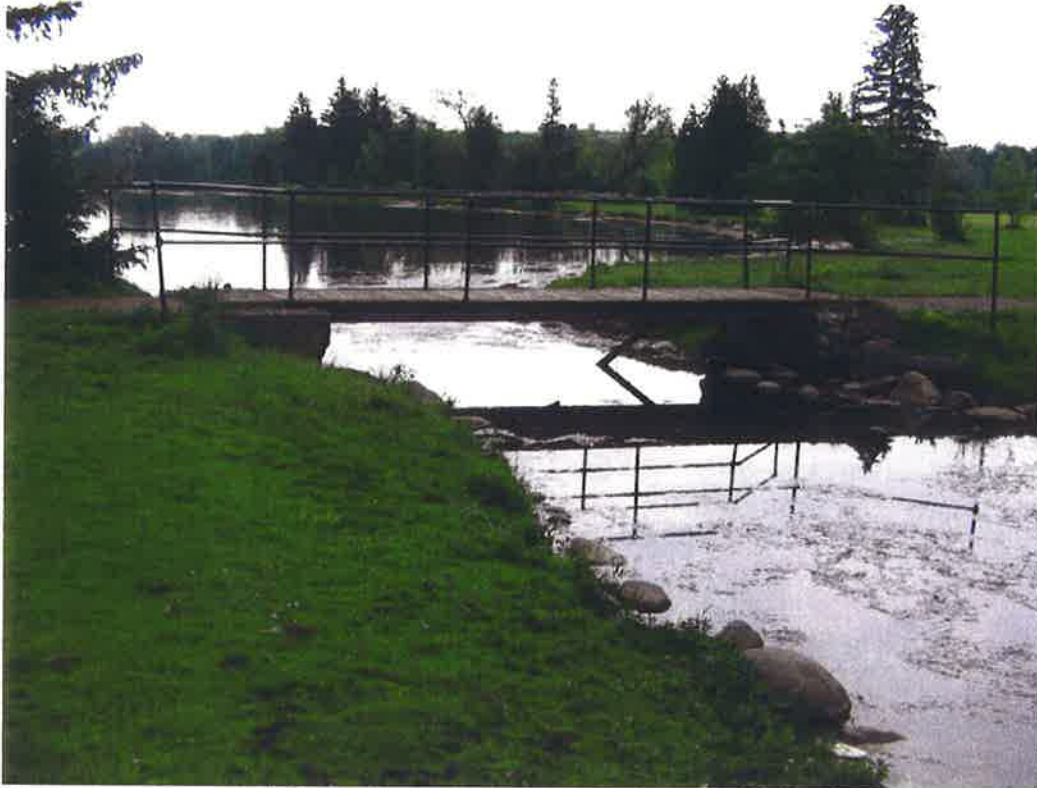
Photo 7 – Connection between the north pond and Reach 3 of Clythe Creek

The ponds at the Guelph Correctional Centre consist of two large ponds to the south of York Road and Clythe Creek (Figure 2). The north pond is closer to Clythe Creek, and is connected via a short channel approximately 10m long and 3 to 4m wide (see Photo 7, Appendix I). The flow of water moves slowly out of the pond as it joins the slow-moving water of this widened section of Clythe Creek. The south pond is not directly connected to Clythe Creek.

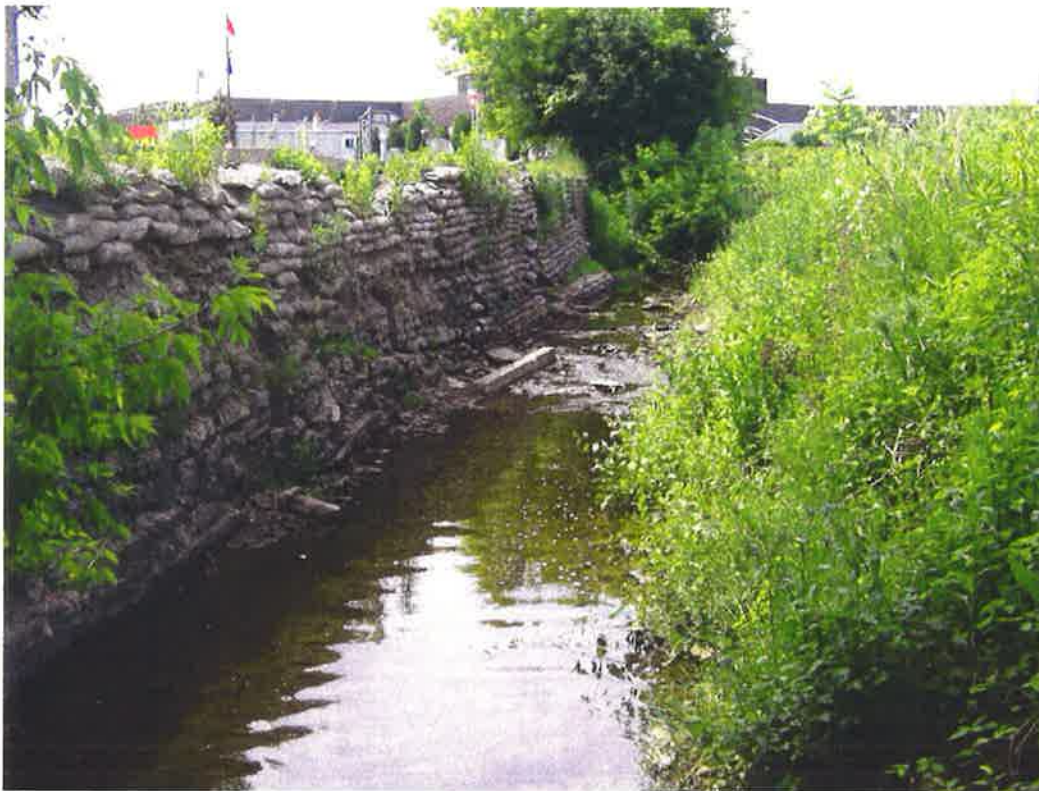
Photo 10 – Hadati Creek, Reach 1, looking upstream
