REPORT Phase One Environmental Site Assessment

63, 79, 85, and 99 Clair Road East, Guelph, ON

WSP Canada Inc.

December 14, 2023

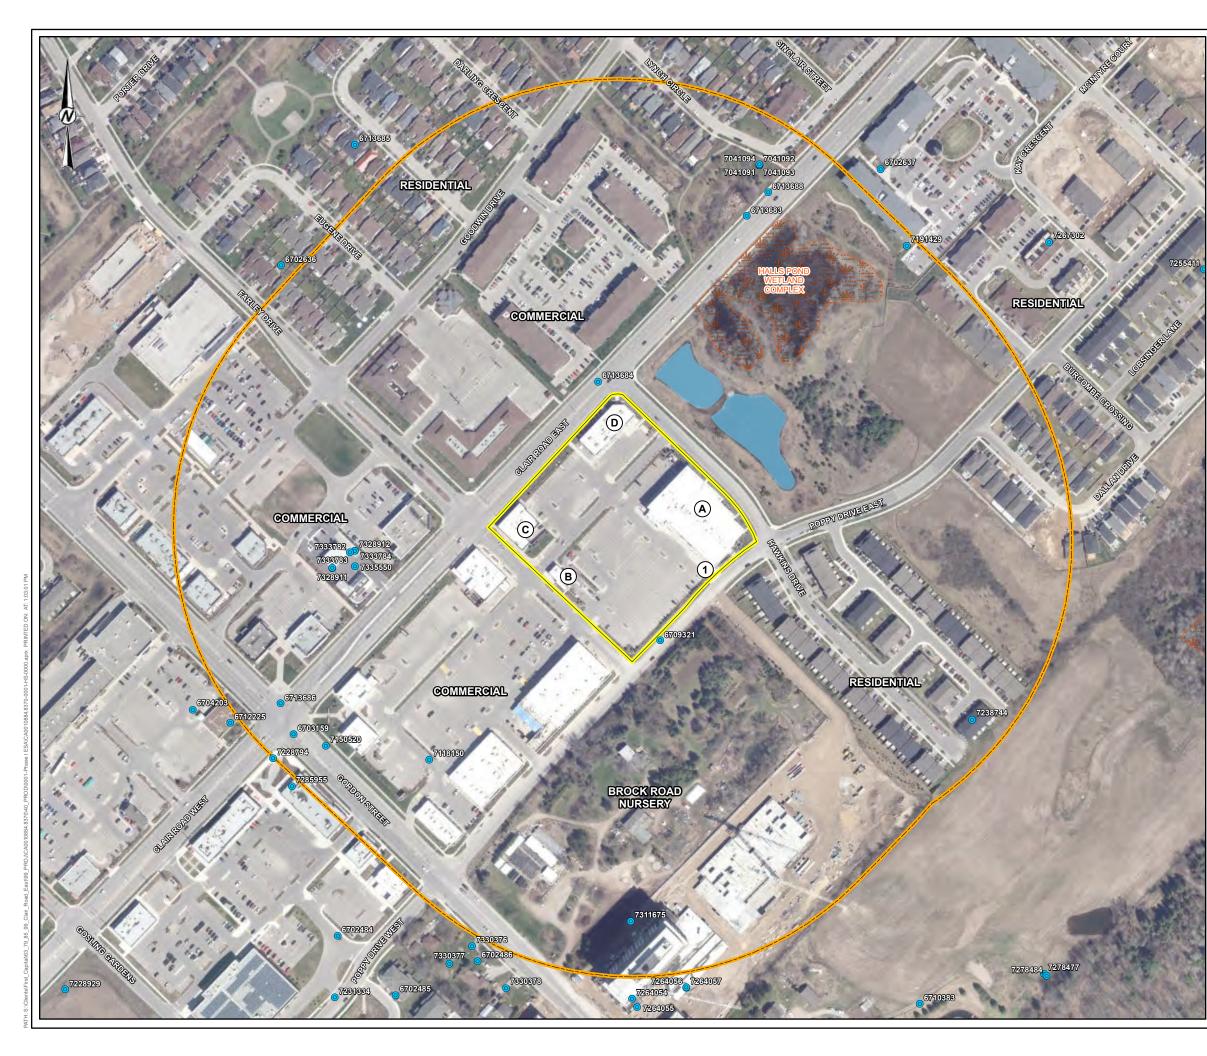
PHASE ONE PROPERTY AND PHASE ONE STUDY AREA

A Phase One ESA is a preliminary qualitative assessment of the environmental condition of a property, based on a review of current activities and historical information for the Phase One Property and a review of relevant and readily available environmental information for the surrounding properties located within a 250 m radius of the boundary of the Phase One Property (collectively referred to as the "Phase One Study Area"). The boundary of the Phase One Study Area is presented in Figure 2.

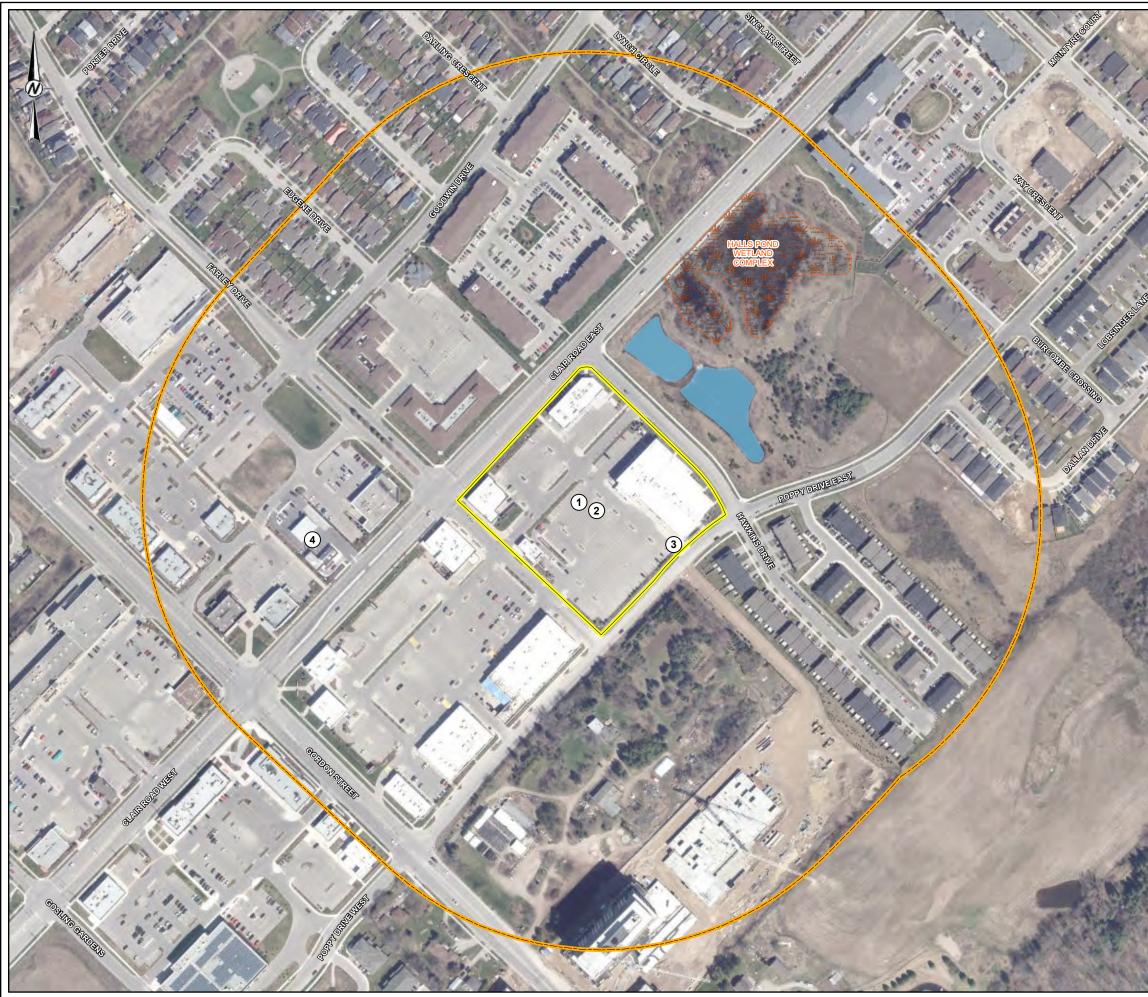
TITLE POTENTIALLY CONTAMINATING ACTIVITIES

LABEL	PCA	DESCRIPTION
1	30 - IMPORTATION OF FILL MATERIAL OF UNKNOWN QUALITY	DEVELOPMENT OF THE PHASE ONE PROPERTY WAS FIRST OBSERVED IN THE 2012 AERIAL IMAGERY AND MAY HAVE INCLUDED USE OF FILL MATERIALS FOR ENGINEERING PURPOSES. NO FILL MATERIALS WERE PRESENT AT THE TIME OF THE SITE VISIT
2	OTHER	SALT IS APPLIED TO WALKWAYS AND PARKING LOTS DURING WINTER MONTHS FOR VEHICLE AND PEDESTRIAN SAFETY.
3	55 - TRANSFORMER MANUFACTURING, PROCESSING AND USE	PAD-MOUNTED TRANSFORMER
4	28 - GASOLINE AND ASSOCIATED PRODUCTS STORAGE IN FIXED TANKS	A MOBIL RETAIL FUEL OUTLET (RFO) WAS OBSERVED APPROXIMATELY 112 M WEST OF THE PHASE ONE PROPERTY.

Location	Potentially Contaminating Activity	Information Source	Rationale for Potential Contribution of the PCA to an APEC
Phase One Property	#30. Importation of Fill Material of Unknown Quality – Development of the Phase One Property began around 1970 and may have included use of fill materials for engineering purposes. No fill materials were observed at the time of the Phase One ESA Site visit.	Site visit, aerial imagery.	The PCA is located on the Phase One Property and must be identified as an APEC. The fill materials are anticipated to be present in the shallow soil at the Phase One Property.
Phase One Property	N/A. Application of De-Icing Materials during Winter Months – Salt is applied to walkways and parking lots during winter months for vehicle and pedestrian safety.	Site visit	The PCA is located on the Phase One Property however is not considered to be contributing to an APEC based on the activity and salt-related impacts.

Phase One Property	#55. Transformer Manufacturing, Processing and Use	Site visit	An electrical transformer was observed at the southern corner of the Galaxy Cinemas.
Phase One Study Area	#28A. Gasoline and Associated Product Storage in Fixed Tanks – A Mobil gas station was observed approximately 112 m west of the Phase One Property.	Site visit	Based on the separation distance (~100 m) and downgradient location to the Phase One Property, this PCA is not considered to result in an APEC at the Phase One Property.

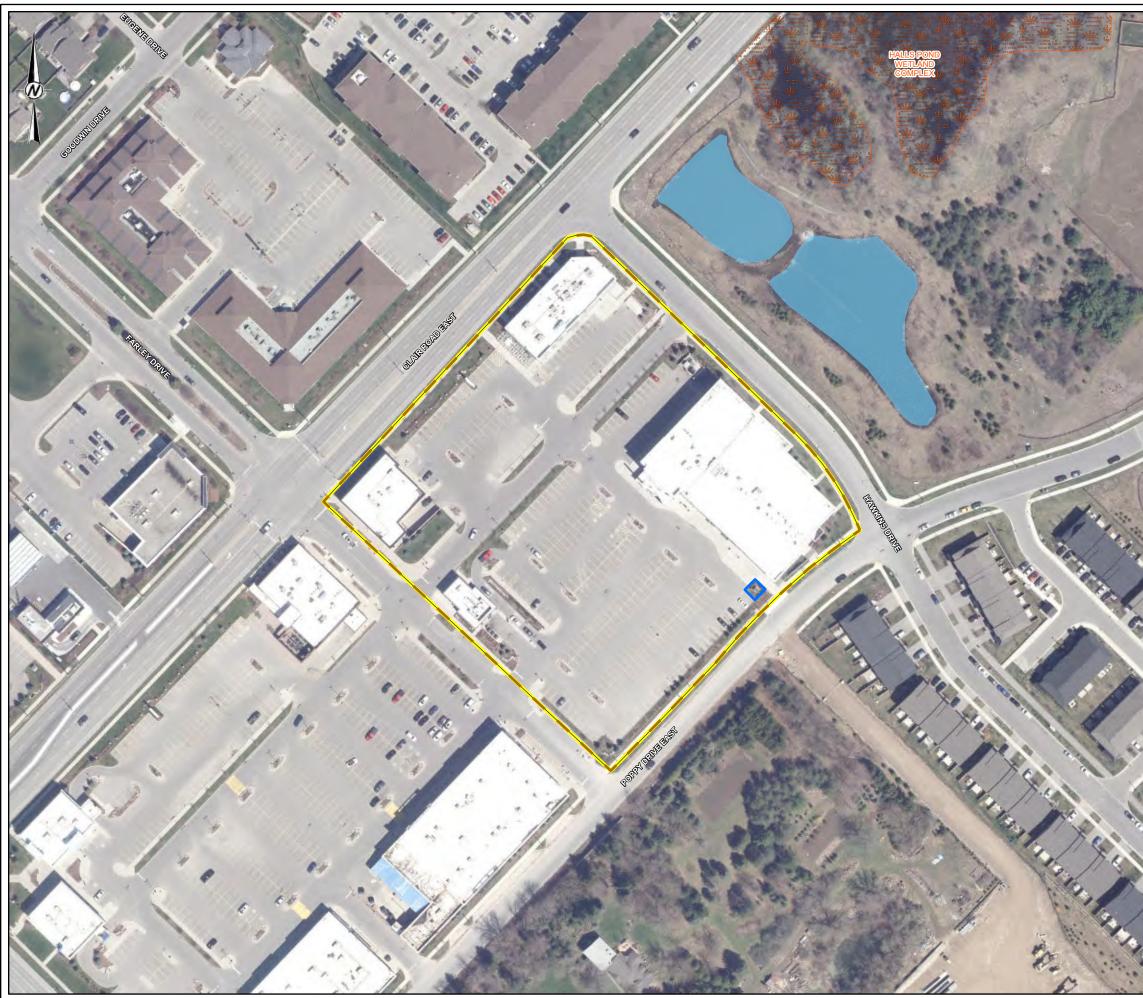
APEC	DESCRIPTION
1	DEVELOPMENT OF THE PHASE ONE PROPERTY WAS FIRST OBSERVED IN THE 2012 AERIAL IMAGERY AND MAY HAVE INCLUDED USE OF FILL MATERIALS FOR ENGINEERING PURPOSES.
2	PAD-MOUNTED ELECTRICAL TRANSFORMER

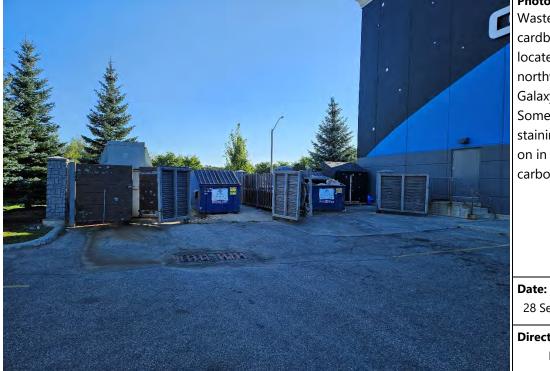
Photo 3: Waste bins and cardboard baler located on the northwest side of Galaxy Cinemas Some oxidation staining observed on in front of the carboard baler.
