City of Guelph

Norwich Street Bridge Class Environmental Assessment Project File (Schedule B)

GMBP File: 116046-1

September 2017

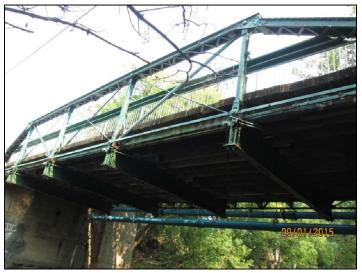
Figure 2: Photograph of Existing Norwich Street Bridge

The existing bridge is a half through Pratt truss (pony truss) bridge located approximately 70 m east of Cardigan Street on the former Norwich Street road allowance, and was built in 1882. It is constructed of a timber deck on riveted steel with a span of 17.0 m and a travelled width of 3.7 m. Refer to **Figure 2** for a photograph of the existing structure.

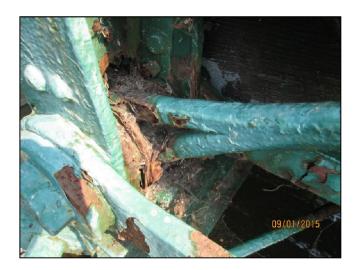
Structural inspections have identified the need for repairs or replacement of the Norwich Bridge due to its poor condition. The bridge was constructed in 1882 by the Hamilton Bridge Company, and is an historical pony truss bridge located approximately 70 m east of Cardigan Street on the former Norwich Street road allowance. It has a span of approximately 17 m and a travelled width of 3.7 m. This structure was used for vehicle traffic until approximately 1998, when it was limited to pedestrian traffic only. The bridge, including its date plates, is designated as a heritage structure under the Ontario Heritage Act, in accordance with By-law Number (1998)-15786. Additionally, a sanitary sewer and water main are suspended from the closed pedestrian bridge adjacent to the Norwich Street bridge.

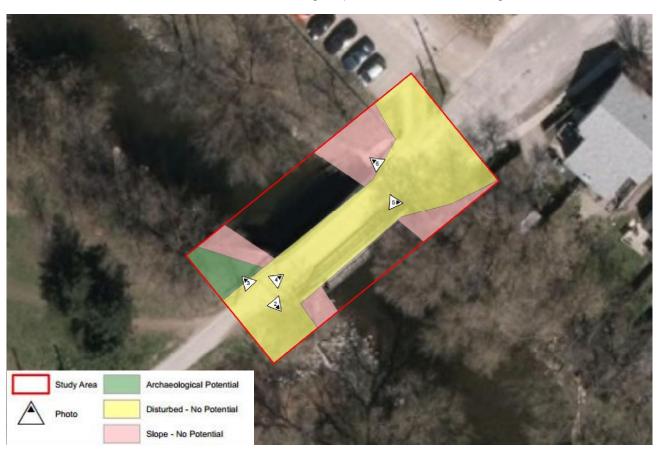
Figure 5: Results of Property Inspection
(Source: ASI Stage 1 Archaeological Assessment Report – Figure 8)

Recommendations from the Stage 1 Archaeological Assessment report included that if the area outside the slope at the northwest corner of the existing bridge be impacted by the selected preferred alternative, a Stage 2 assessment would be required.

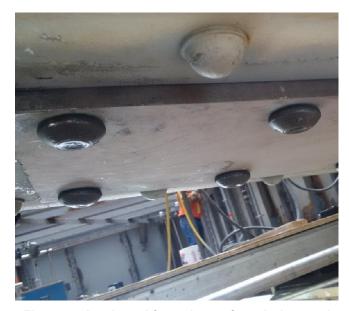
It is estimated that most repairs could be completed by reinforcing existing members with steel plates, or replacing isolated members with identical steel members. Due to the age of the steel used in the trusses, welding may not be possible to strengthen members that are left in place. Bolts could be use, and could mimic the appearance of rivets, as shown in **Figure 7 and Figure 8** below. This would help to reduce changes in aesthetics to the bridge and soften the appearance of any rehabilitation works; however, this would not address the brittle nature of the existing steel, which is an undesirable property to have in structural design.

Figure 7: As viewed from the surface, bolts used adjacent to existing rivets to mimic the appearance of rivets

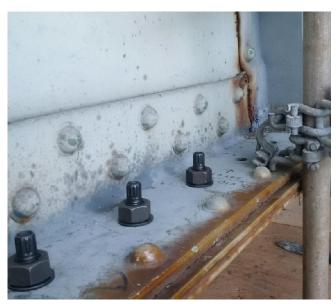
Figure 8: As viewed from the opposite side, these bolts resemble a typical threaded bolt and nut assembly

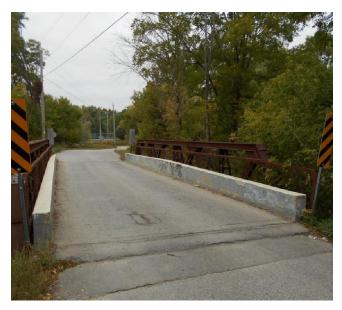
The Norwich Street bridge crossing would be reconfigured to allow for a new bridge structure to convey pedestrian and cyclist traffic while maintaining the historic steel trusses, but not relying on the steel trusses as load carrying members. Refer to **Figure 9 and Figure 10** below, which show a similar historic steel truss bridge that was retrofitted so that traffic is conveyed on a Fibre Reinforced Polymer (FRP) bridge deck that does not rely on the steel trusses for structural support. An alternative design would be a concrete deck on steel girders that can be economically constructed. In comparison to **Figure 9 and Figure 10**, the deck would not require the tall curbs at the sides with pedestrian hand rails either included on the new deck or the existing structure. The exact structural system used to alleviate the existing bridge from the pedestrian and cyclist loads would be determined in the detailed design phase and would be designed to current standards for pedestrian bridges,

Figure 9: Similar truss bridge with FRP deck, where the steel trusses carry only their own weight

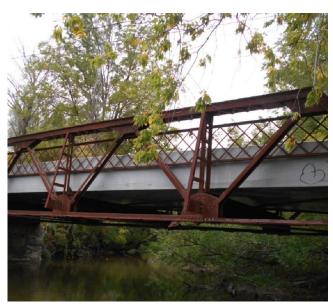
Figure 10: From the sides, the truss structure resembles a normal steel truss bridge

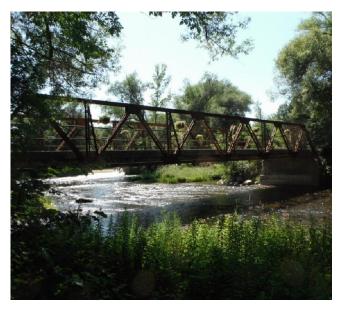
Figure 11: Historic steel truss bridge at the end of its useful life requiring replacement

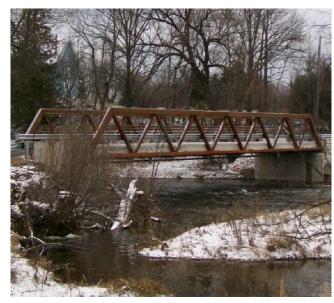
Figure 12: New steel truss bridge constructed with welded connections to mimic previous structure
