1242, 1250, 1260, 1270 Gordon Street and 9 Valley Road, Guelph, ON – Environmental Impact Study Addendum Version 2

Final Report

June 17, 2022 File: 161413684

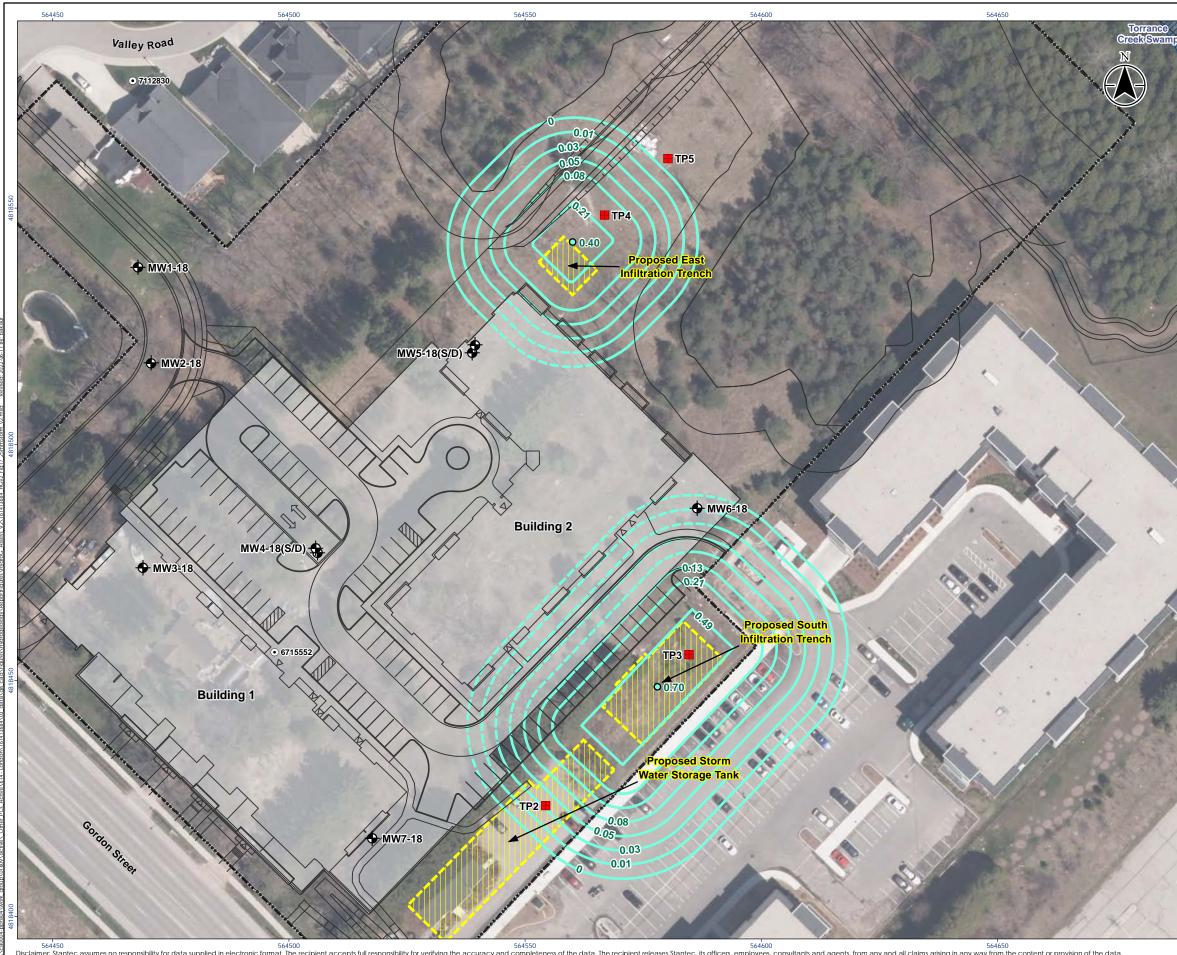
Notes 1. Coordinate System: NAD 1983 UTM Zone 17N 2. Base features produced under license with the Ontario Ministry of Natural Resources and Forestry & Queen's Printer for Ontario, 2020. 3. Orthoimagery 6 First Base Solutions, 2021. Imagery flown in 2020. 4. MECP water wells have been positioned based on published UTM coordinates should be considered approximate. Project Location 161413 City of Guelph Prepared by PRM on 2022-0 Client/Project TRICAR DEVELOPMENTS INC. 1242, 1250, 1260 GORDON ST AND 9 VALLEY RD HYDROGEOLOGICAL ASSESSMENT			0	25		50 Metre
Coordinate System: NAD 1983 UTM Zone 17N Coordinate System: NAD 1983 UTM Zone 17N Subset features produced under license with the Ontario Ministry of Natural Resources and Forestry © Queen's Printer for Ontario, 2020. Orthoimagery © First Base Solutions, 2021. Imagery flown in 2020. MECP water wells have been positioned based on published UTM coordinates should be considered approximate. Project Location 161413 City of Guelph Prepared by PRM on 2022-C Client/Project TRICAR DEVELOPMENTS INC. 1242, 1250, 1260 GORDON ST AND 9 VALLEY RD HYDROGEOLOGICAL ASSESSMENT		1:1,2	50 (At origina	l document s	ize of 11x17)

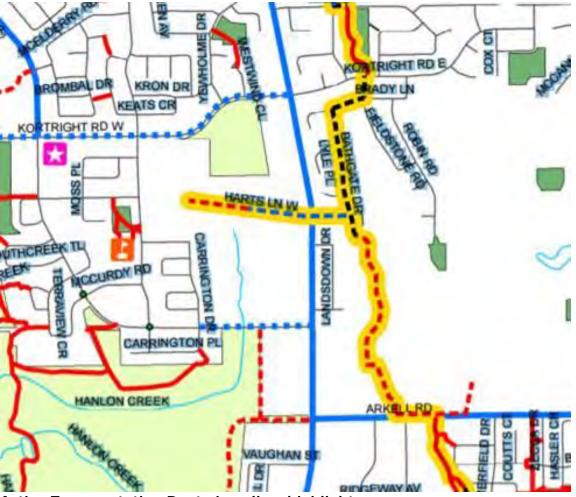
Active Transportation Route in yellow highlight

The trail system from Arkell Road to Brady Lane aligns with the active transportation route and serves both recreational and transportation purposes. This route is being detailed designed in segments through review of the past and current development applications. The trail route immediately north of the subject property was identified through site plan approval process of the existing Valley Road extension condominium and the trail property immediately south of the subject property has been secured through development approval process on 1280 and 1284 Gordon Street. Multi-Use Trail/AT Route (east-west) from Gordon Street to the proposed Trail west of Torrance Creek PSW: Provide a direct, accessible, multi-use active transportation route from the Gordon Street to the proposed Multi Use Trail system.

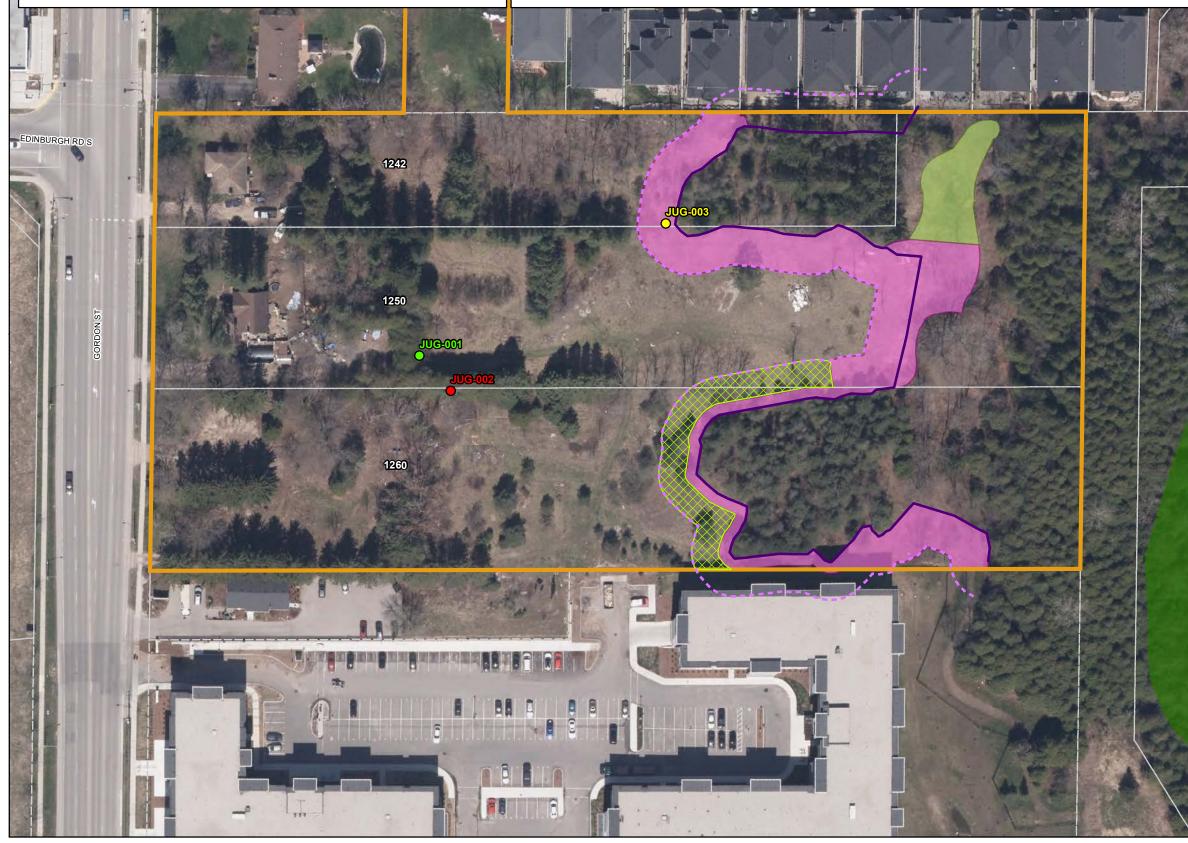
Map 1

- Subject Property
- Parcel Boundary
- Category 1 Butternut Hybrid Proposed to be Removed
- Category 2 Butternut Tree Proposed to be Removed
- O Category 2 Butternut Tree Proposed to be Harmed
- Proposed Tree Violation Compensation and Butternut Companion Planting Area (0.248ha)*
- Proposed Butternut Planting Area (0.041ha)†
- Additional Planting Area, as Required
- -- Significant Woodland 10m Setback
- Significant Woodland Boundary City of Guelph (October 2014 and July 2017)
- Provincially Significant Wetland (PSW)

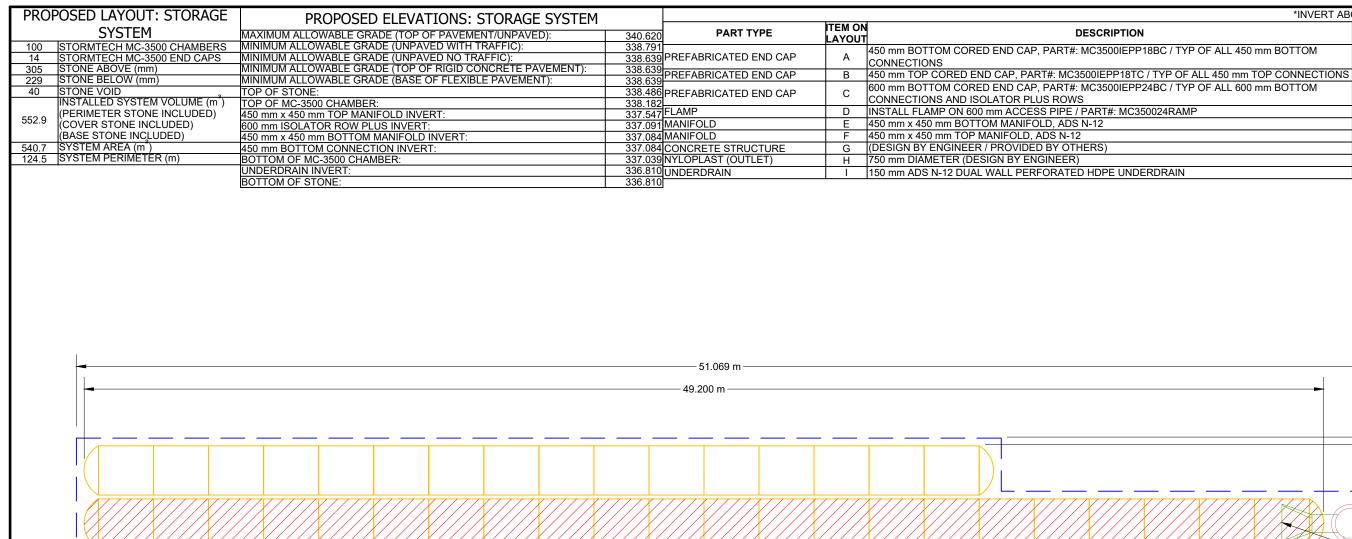
PLACE MINIMUM 5.334 m OF ADSPLUS175 WOVEN GEOTEXTILE OVER BEDDING STONE AND UNDERNEATH CHAMBER FEET FOR SCOUR PROTECTION AT ALL CHAMBER INLET ROWS

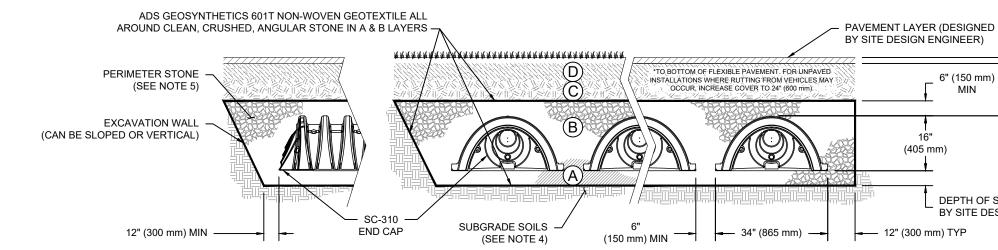
- 1. CHAMBERS SHALL MEET THE REQUIREMENTS OF ASTM F2922 (POLETHYLENE) OR ASTM F2418 (POLYPROPYLENE), "STANDARD SPECIFICATION FOR CORRUGATED WALL STORMWATER COLLECTION CHAMBERS".

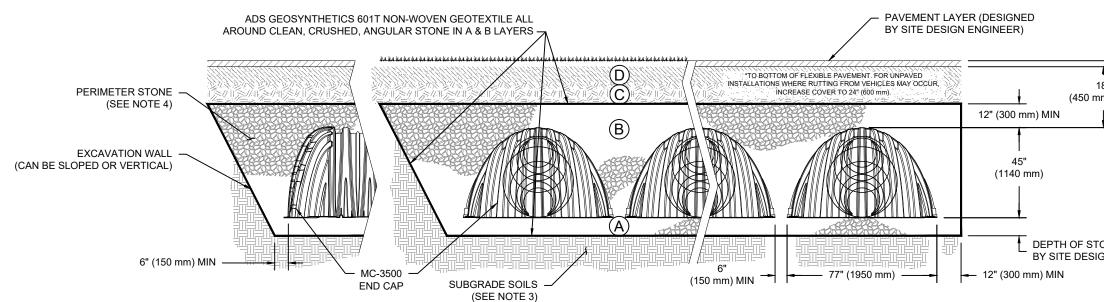
- 1. CHAMBERS SHALL MEET THE REQUIREMENTS OF ASTM F2418, "STANDARD SPECIFICATION FOR POLYPROPYLENE (PP) CORRUGATED WALL STORMWATER COLLECTION CHAMBERS" CHAMBER CLASSIFICATION 45x76 DESIGNATION SS.

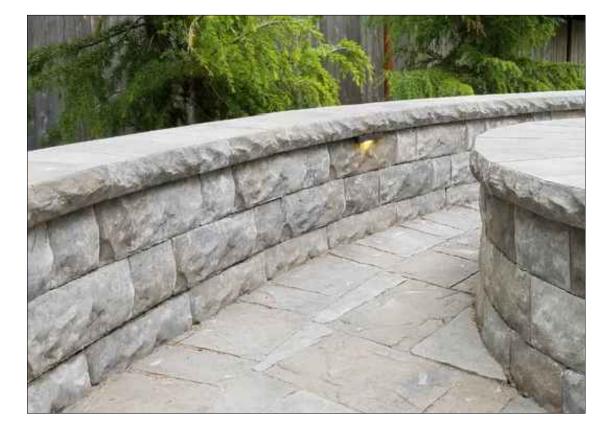
CONCEPTUAL SEAT WALL DETAIL N.T.S.
