190-216 ARKELL ROAD GUELPH, ON

Phase I Environmental Site Assessment

190-216 Arkell Road
Guelph, ON

MTE Consultants Inc.
520 Bingemans Centre Drive
Kitchener, ON N2B 3X9

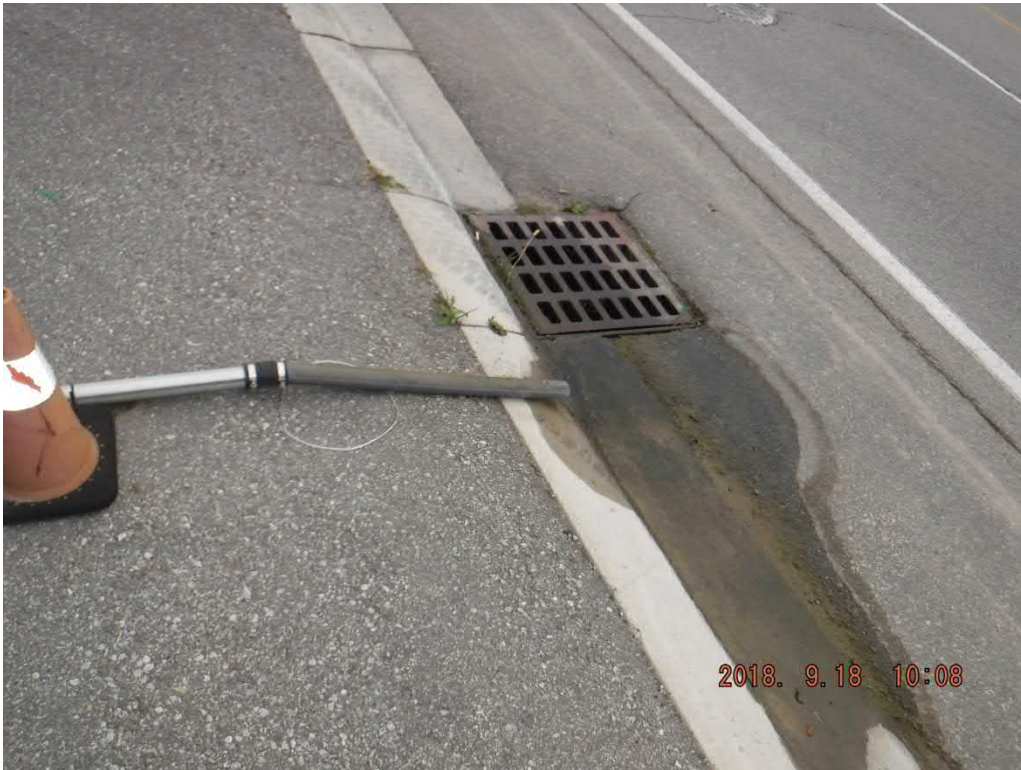
Photograph No. 1 – View of sump drainage from 216 Arkell Road in to storm sewer catch basin on Arkell Road.

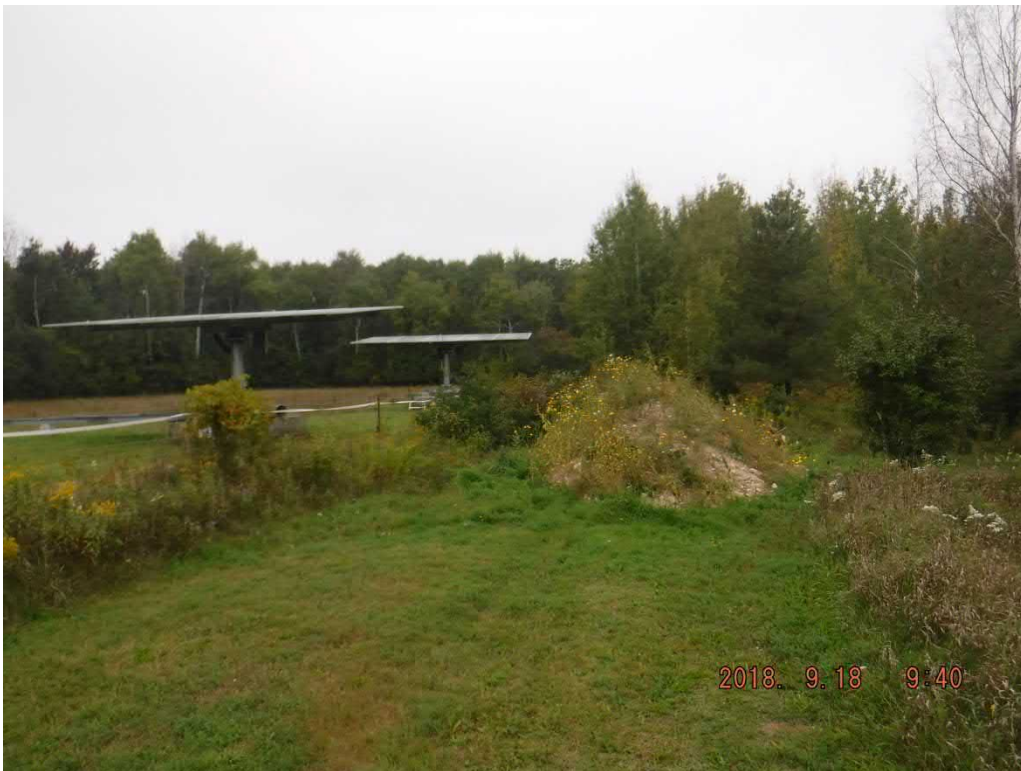
Photograph No. 2 – View of one stock pile, facing west toward the western property line.

intrusive investigation to address the aforementioned issues is recommended. In particular, a Phase II ESA is recommended to investigate the quality of fill material at 190 Arkell Road associated with the current stockpiles and the demolition of the former residential dwelling, as well as to investigate the presence of releases from potential historic use of fuel oil for heating purposes at all residential dwellings.

Stockpiled fill materials were observed to the north of the residence at 190 Arkell Road, around the pond area in three piles (see **Figure 3**). The Site Representative indicated that approximately 100 tonnes of fill was imported from 1 Castlebury Drive, Guelph, and would potentially be utilized to re-grade the Site for redevelopment. No analytical information regarding the imported fill material was provided.

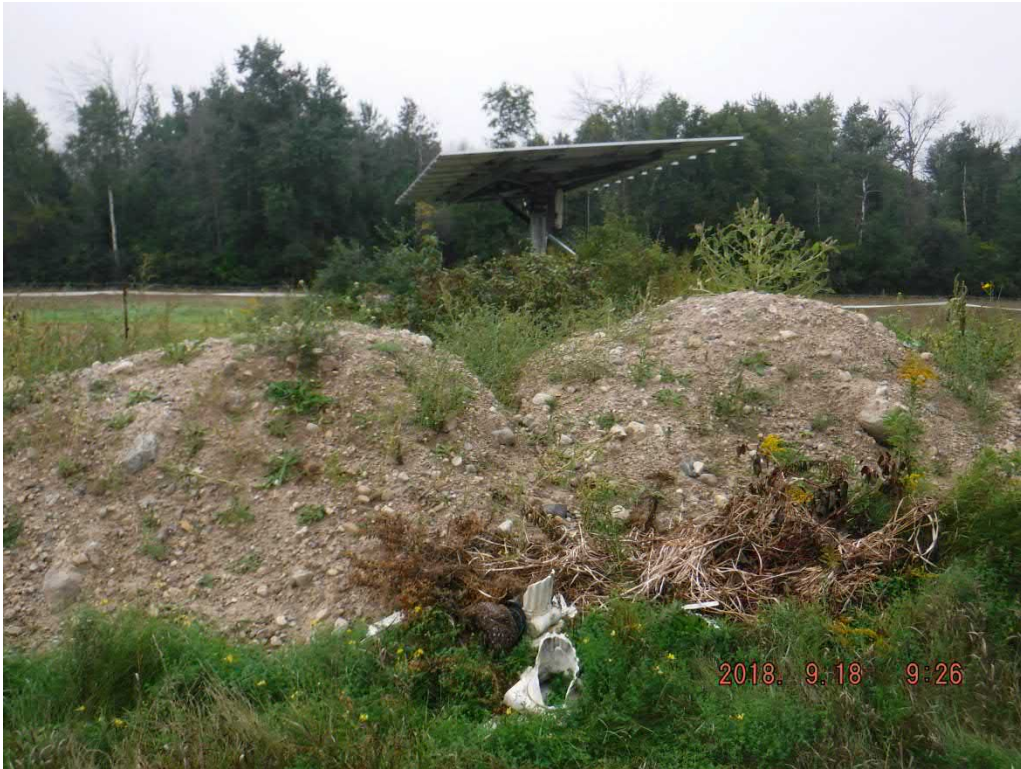
Photograph No. 3 – Additional view of one stock pile, facing south toward the southern property line.

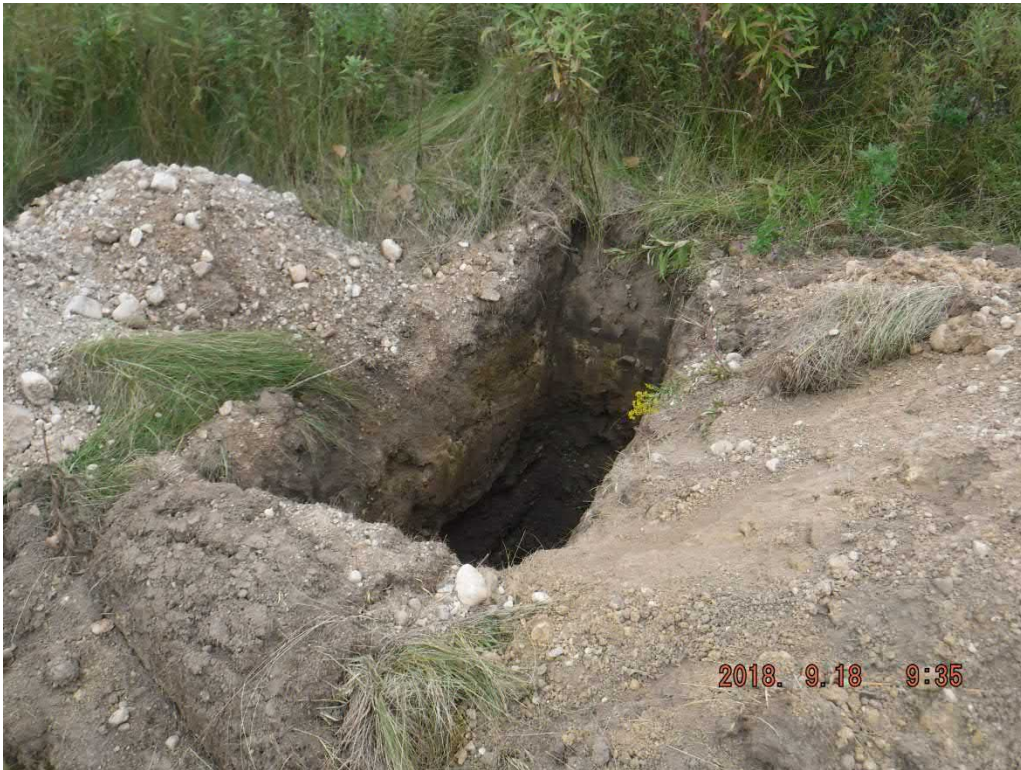
Photograph No. 4 – View of open excavation located to the west of the shed at 210 Arkell Road.

At the time of the initial Site visit, a small, open excavation was observed in the central area of the Site to the west of the shed at 210 Arkell Road. The tenant of the residence indicated that the excavation was the result of testing the function of a mini-excavator and soil was not excavated for any other reason. The tenants indicated to the Site Representative that the excavation would be backfilled. See **Figure 3** for the location of the excavation.

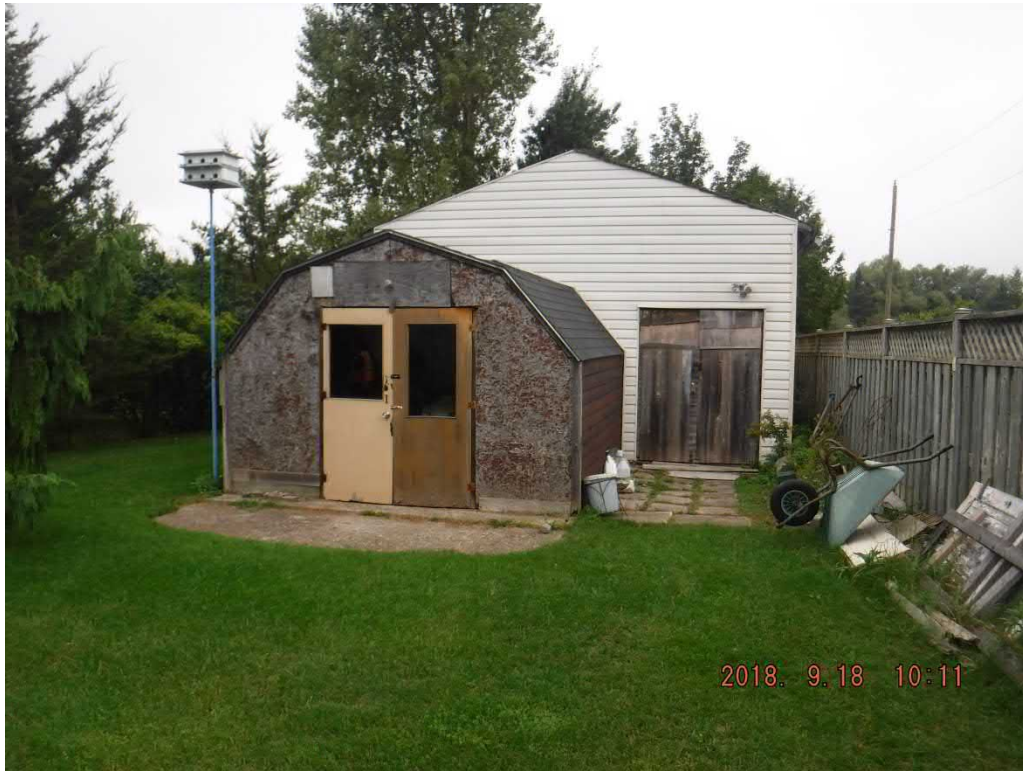
Photograph No. 5 – Front view of the shed in the backyard of 216 Arkell Road. The shed housed equipment for handcrafted furniture.

According to the tenant at 216 Arkell Road, minor amounts of varsol, wood stains and glue were historically used for recreational woodshop purposes. Reportedly, no wastes were generated from the use of these chemicals.

During the Site visit, MTE observed multiple small pails of waste oil at the east exterior of the woodshop shed at 216 Arkell Road. According to the tenant, the waste oil was from lawn mower maintenance and the tenant reportedly disposes the oil regularly at an off-Site facility.

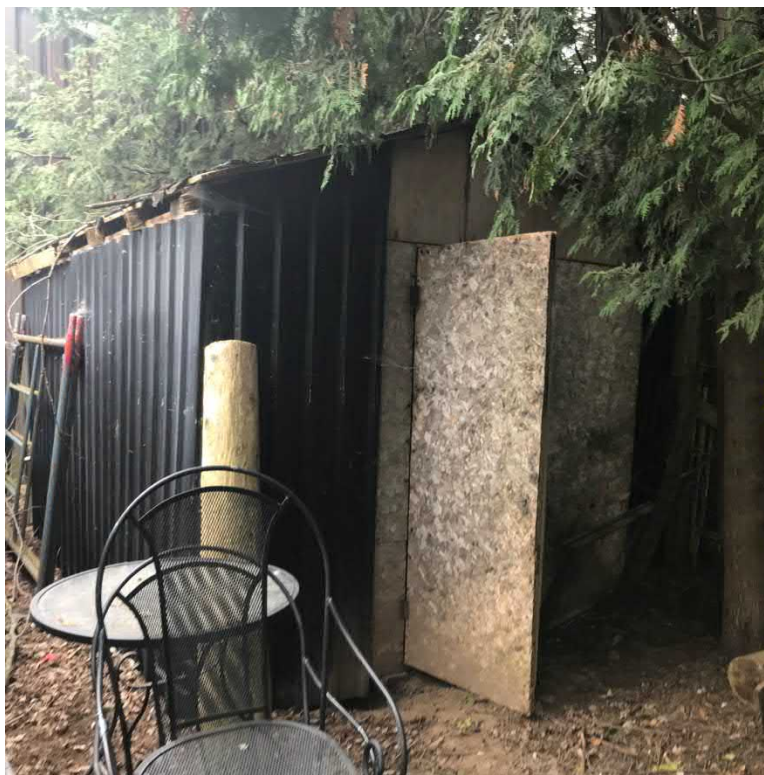
Photograph No. 6 – View of the front of the shed in the backyard at 202 Arkell Road. The shed housed garden and lawn supplies.

Small quantities of consumer-sized cleaning supplies and paint were observed to be stored on shelves or the concrete floor of the basement at 190 Arkell Road. Small quantities of consumer-sized kerosene and hypochlorite solution were observed within the shed of 216 Arkell Road. Consumer-sized containers of oils were observed on a shelf within the shed at 210 Arkell Road and small quantities of gasoline in jerry cans were observed within the sheds at 202 and 216 Arkell Road.

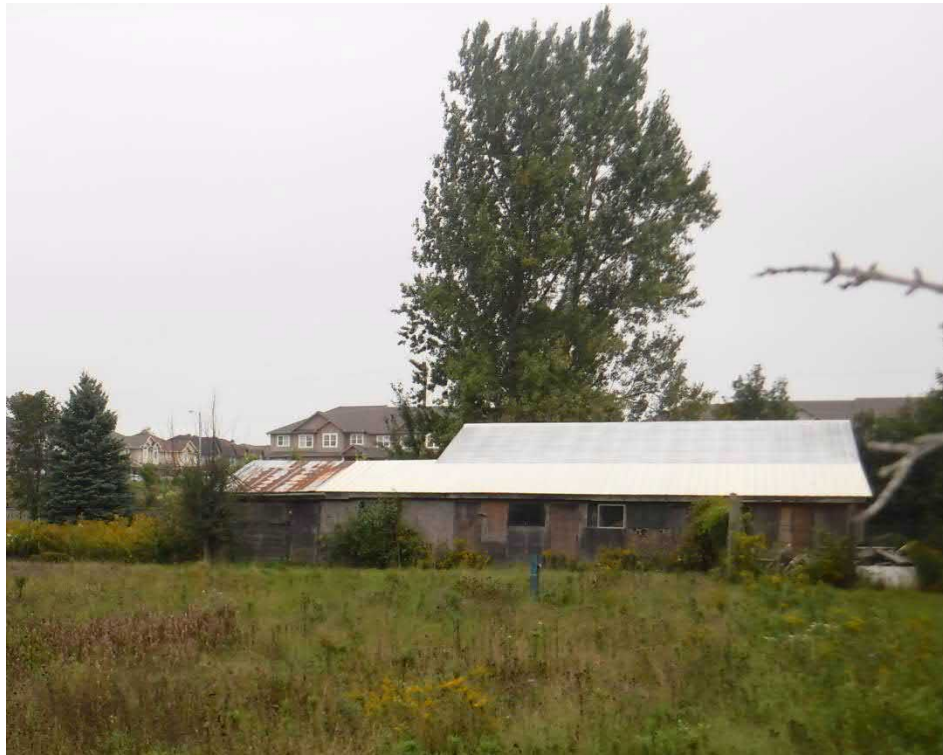
Photograph No. 7 – View of southern wall of the shed located at 210 Arkell Road. The shed was used as a personal vehicle shop and former chicken coop. A monitoring well installed by PML in 2017 is visible in the foreground.

Waste oils generated from personal vehicle maintenance at 210 Arkell Road was reportedly collected and disposed of off-Site at a recycling facility. No active oil storage was observed at 210 Arkell Road by MTE during the Site visit.

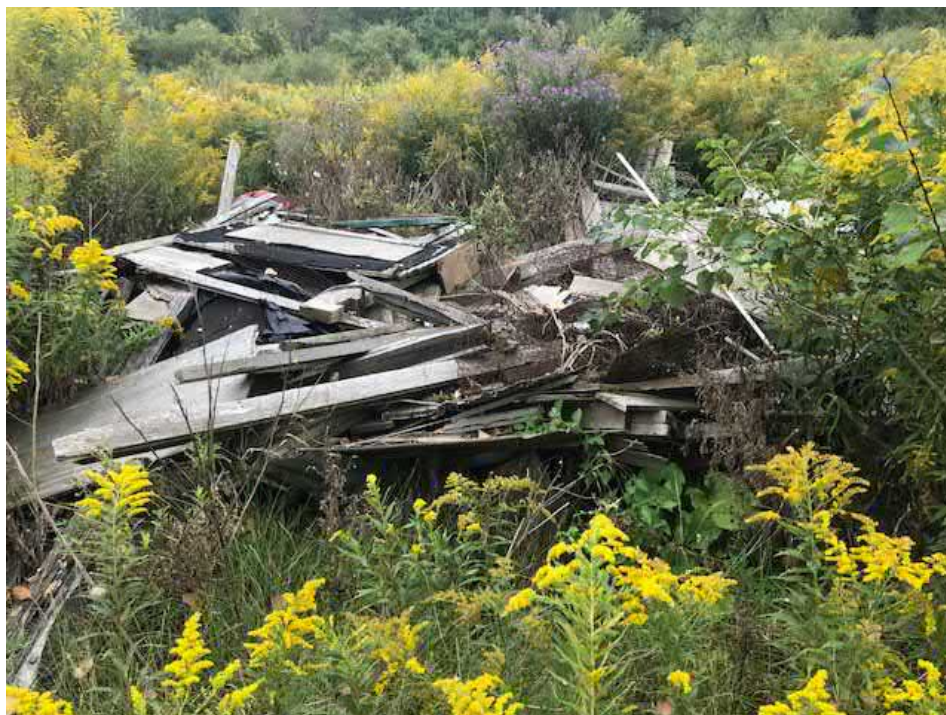
Photograph No. 8 – View of the metal and wood waste storage located east of the shed at 210 Arkell Road.

Scrap metal/waste wood was observed on the bare ground to the west of the shed at 210 Arkell Road. According to the Site Representative, this scrap metal and waste wood was reportedly associated with the demolition of former structures located north and west of the current shed at 210 Arkell Road. Several empty pails and eight empty metal drums were observed within the shed at 210 Arkell Road. According to the former tenant, the empty pails were used for wine-making or storing grains and the empty drums were used to store grains for the poultry formerly raised on the property.

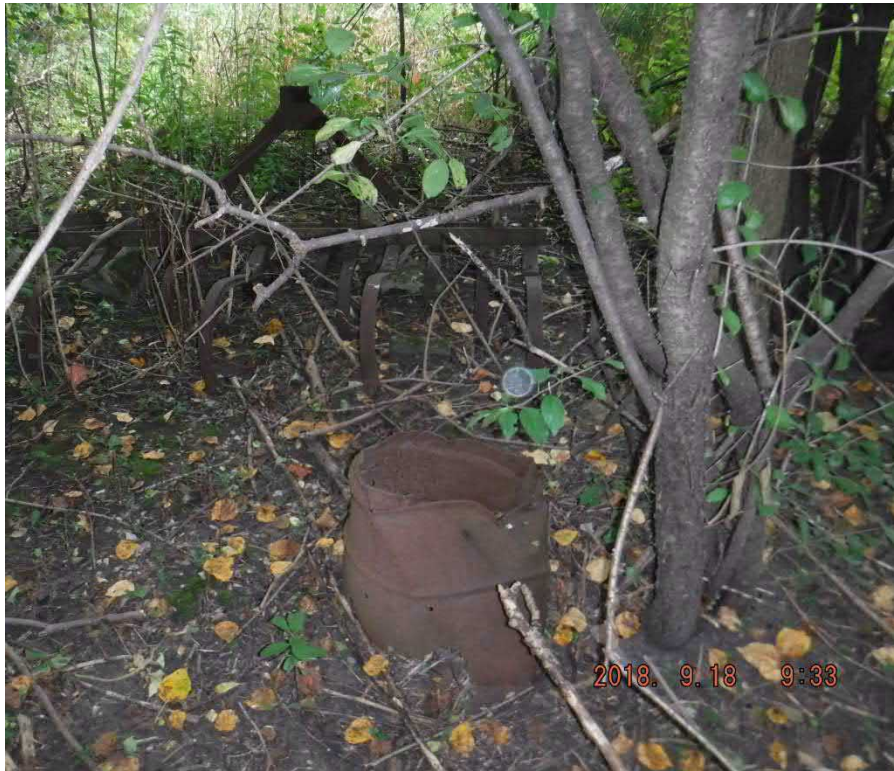
Photograph No. 9 – View of potential former storage area/waste area, located in the forested portion of 210 Arkell Road (west end of the property).
