**GUELPH GAS WORKS STUDY**

**PREPARED FOR  
THE CITY OF GUELPH**

**PREPARED BY  
ENVIRONMENTAL STRATEGIES LIMITED**

**ESL 87-907  
JULY, 1988**

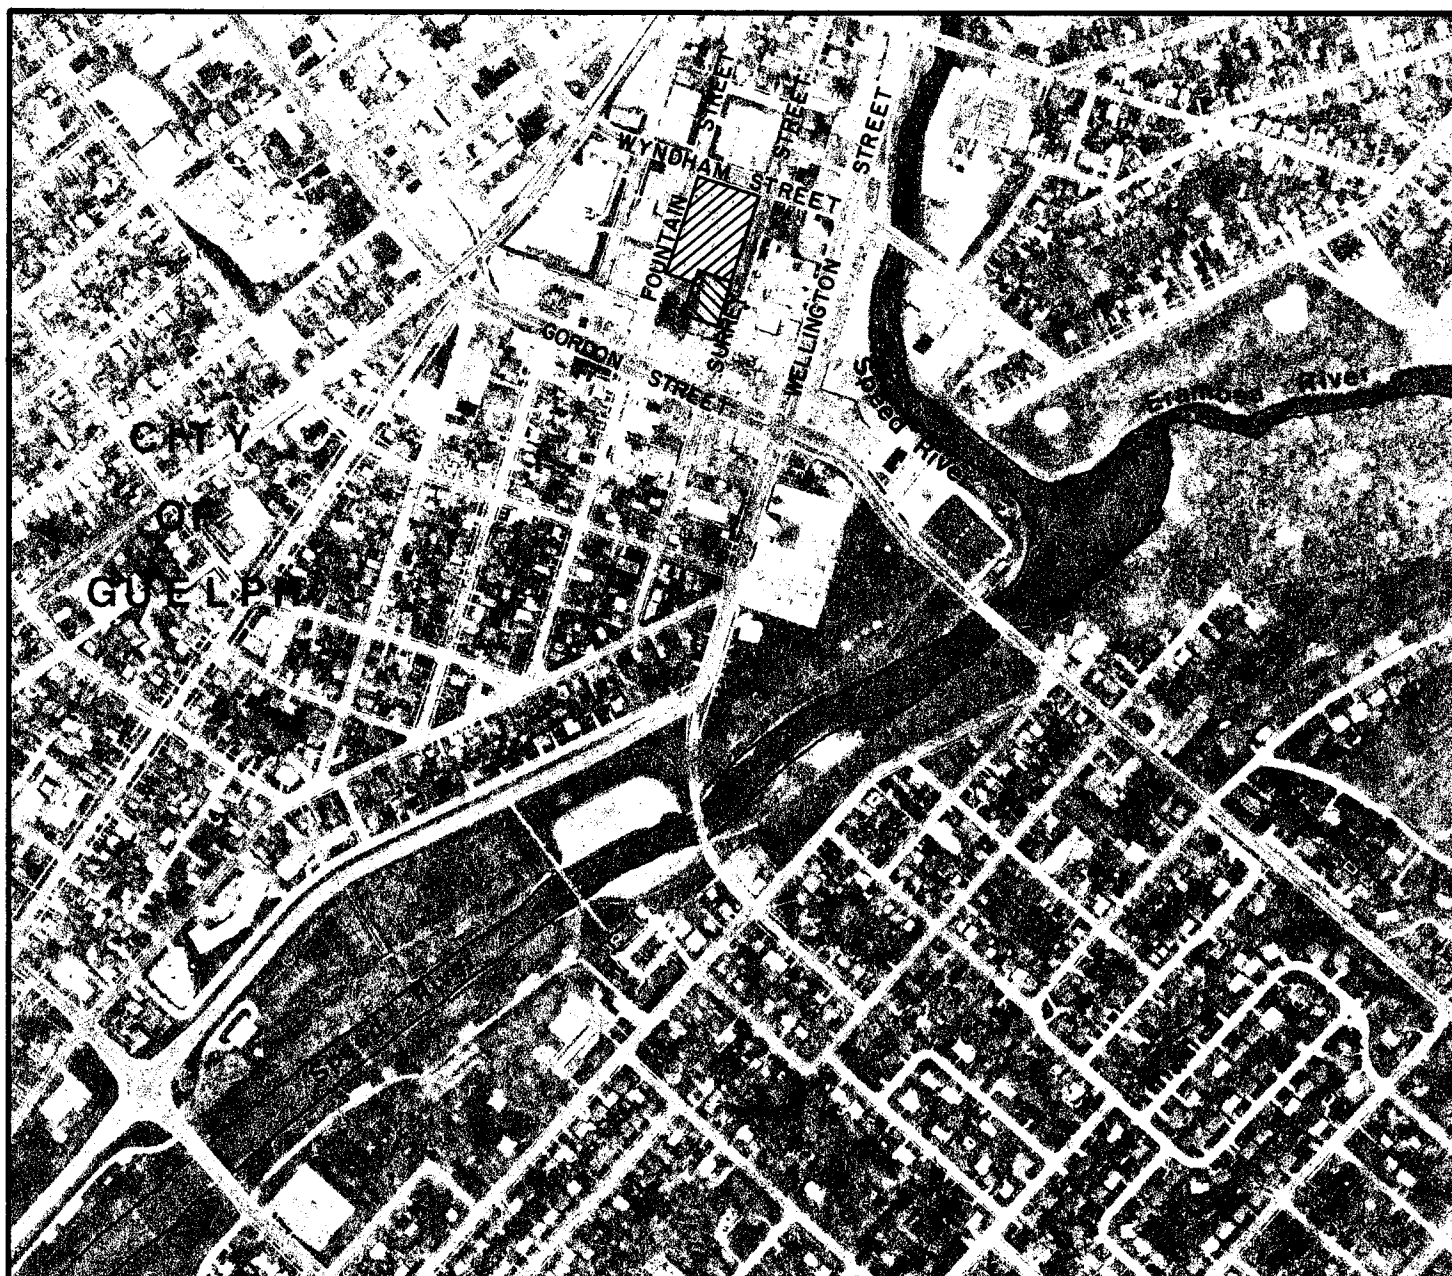
## Location of Guelph Gas Works

The City of Guelph is currently one of the owners of the site of the former Guelph Gas Works (Figure 1). The plant operated on Fountain Street from 1871 to 1957. The plant was then dismantled. The City's portion of the site was largely unused for several years. Lately, it was redeveloped for a municipal parking lot. The remainder of the site has been used as the offices and service yard of the Union Gas Company.

Area Of Plant Site Currently  
Owned By City Of Guelph

Area Of Plant Site Currently  
Owned By Union Gas

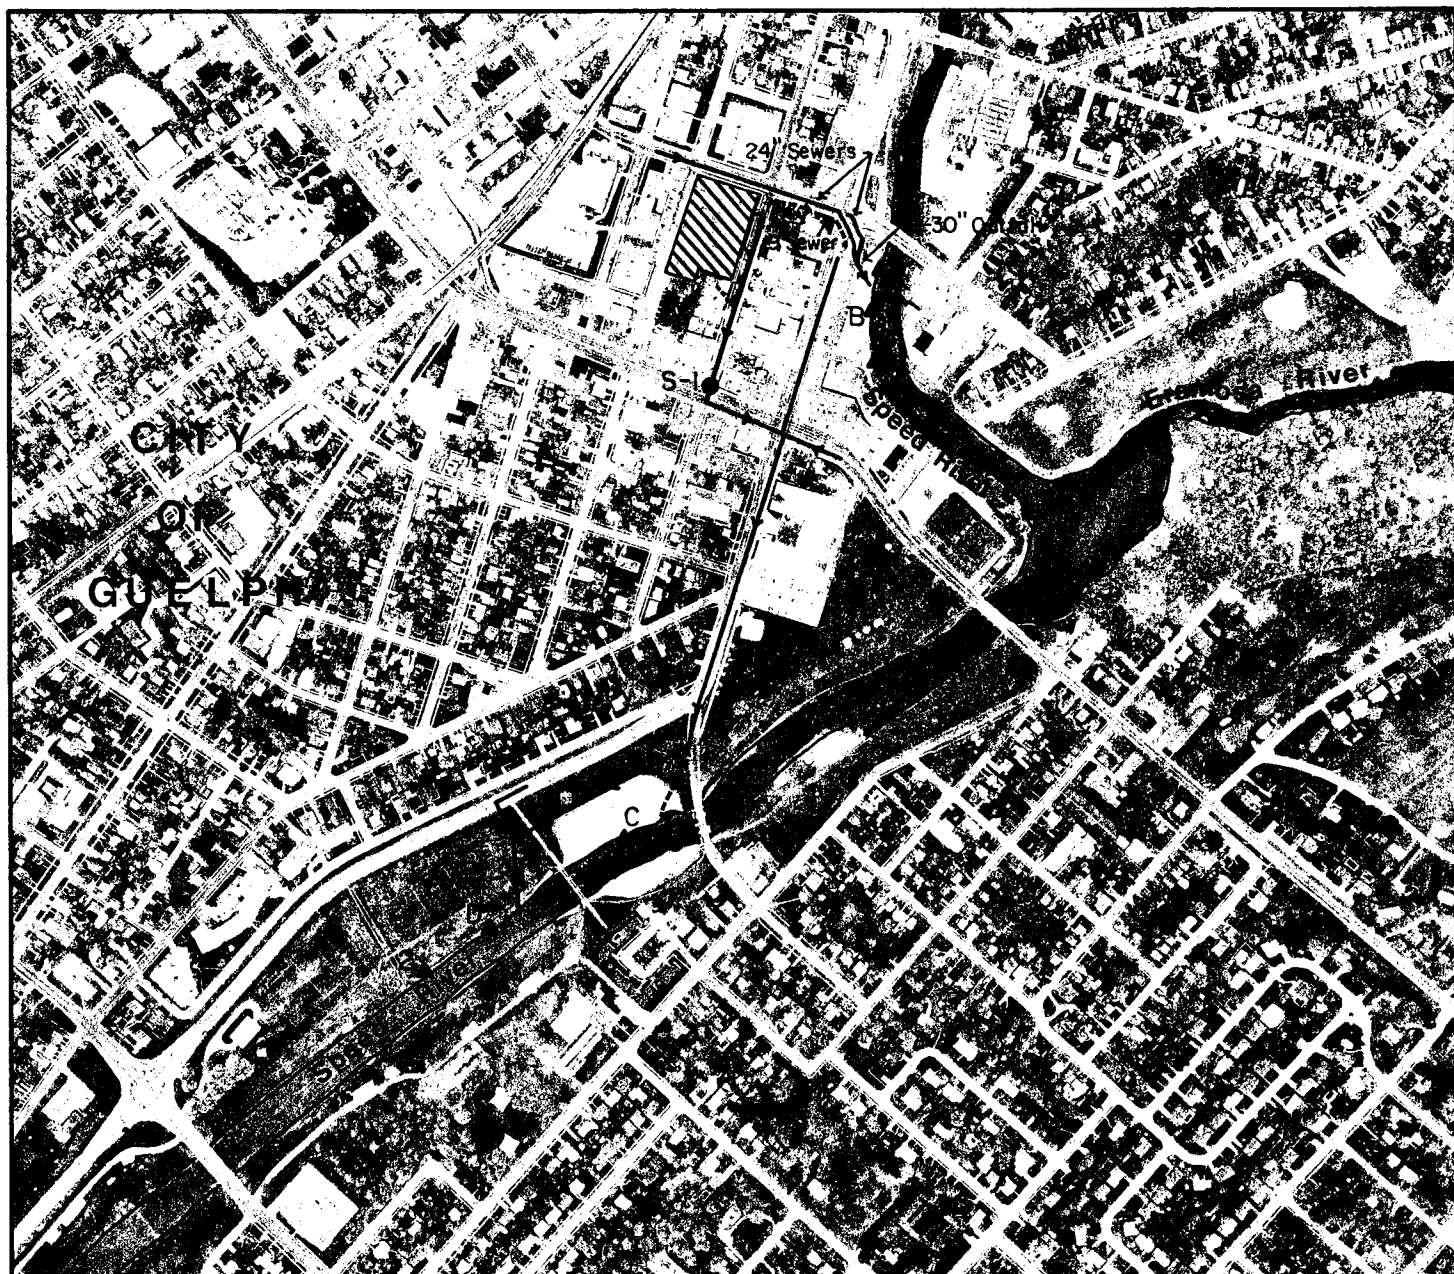
Coal tars were found inside the 9" pipe and in the sewer bedding beneath the 9" and 24" storm sewers in test pit 4 about half way between the plant and the river. The bedding was found to contain coal tar. It is possible that coal tars may be found further southeast along this bedding towards the river. A sanitary sewer running southeast along the centre of Wyndham Street was not investigated.

The other storm sewer serving the gas plant was constructed in 1924 and runs southwest from the plant along Surrey Street. The sewer is still in operation and discharges into the Speed River just downstream from the present McCrae Boulevard Bridge, approximately 700 m southwest of the plant. Former residents in the area report that tarry sediments accumulated near the outfall of this sewer but it is believed they were disturbed and probably removed from the river during a channel improvement project completed by the Grand River Conservation Authority during the 1960's.

During 1986, the City detected coal tar seeping into the Surrey Street sewer from a sewer connection serving the Union Gas portion of the plant site and sealed the connection. Tarry sediments were not found in the Surrey Street sewer during

inspection in the present study. Coal tars were also not found in the sewer bedding of the Surrey Street sewer in test pits 2 and 3. Test pit 2 also exposed the sewer bedding of the sanitary sewer along Surrey Street and did not encounter any coal tar in this bedding.

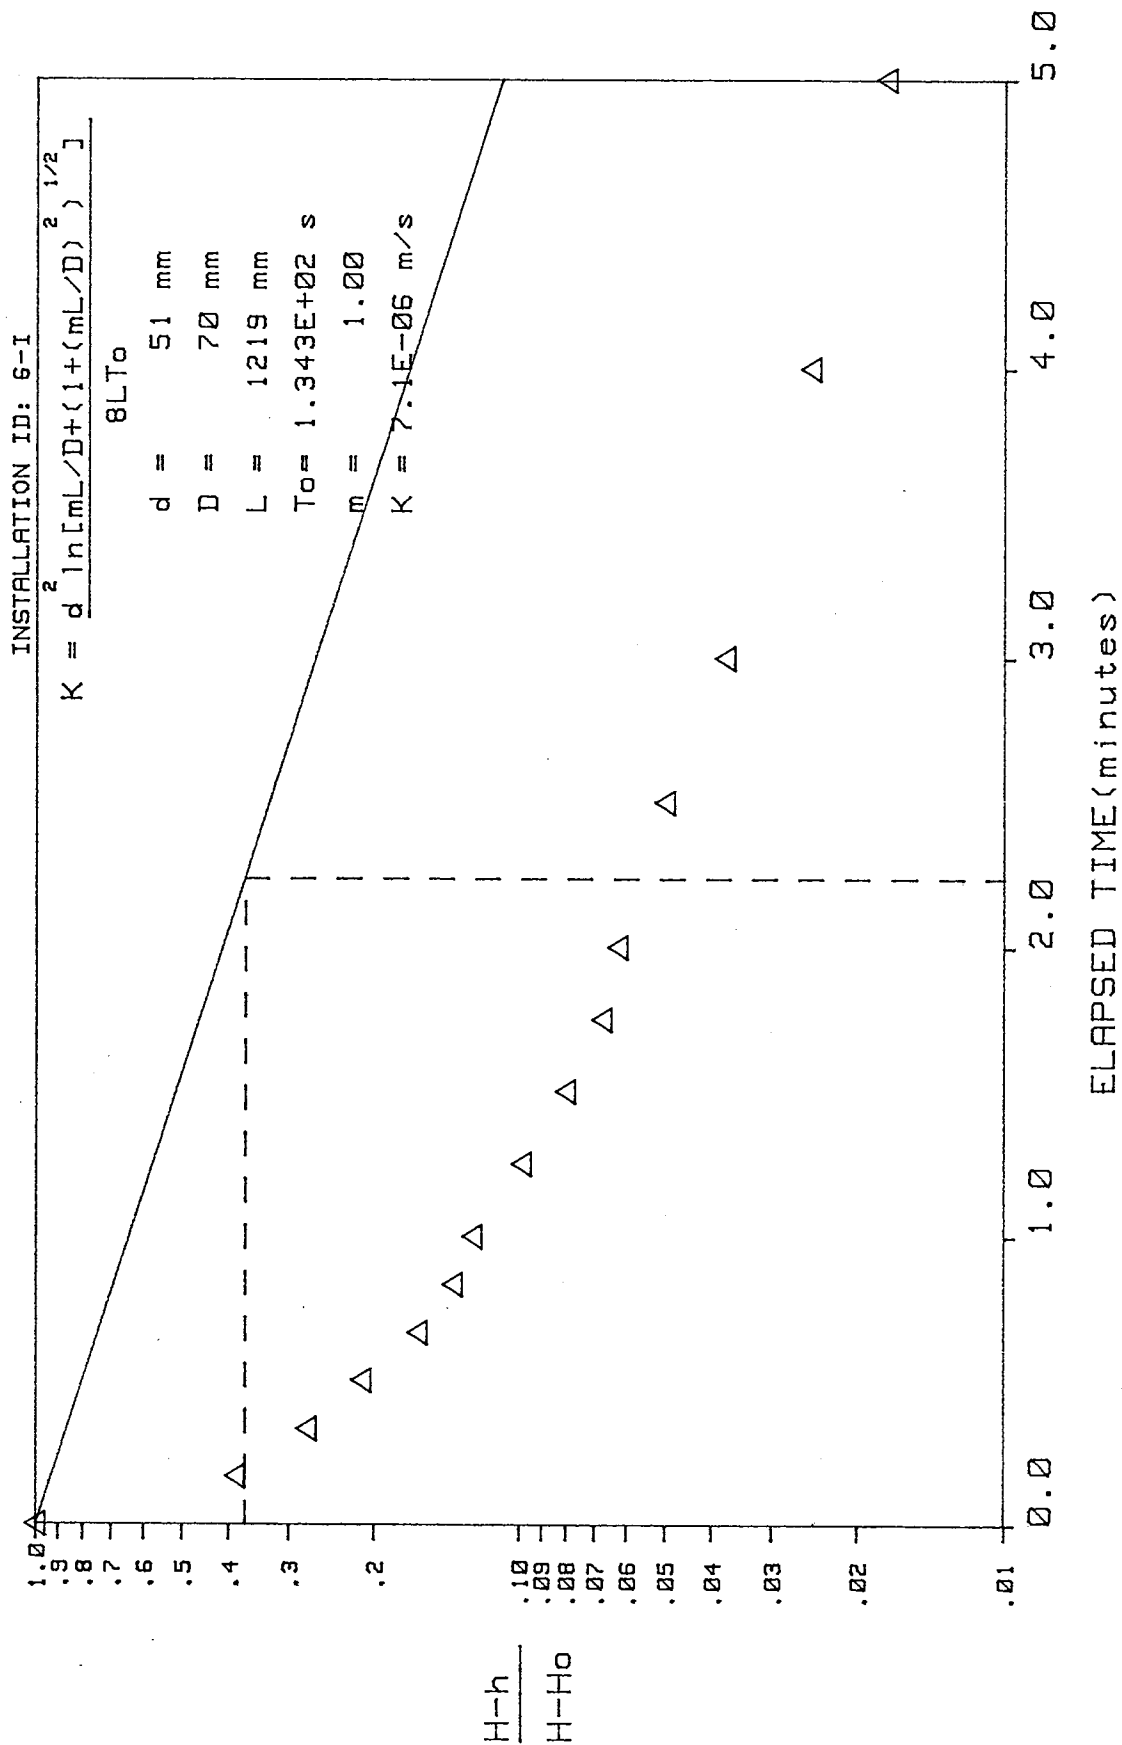
# SLUG TEST ANALYSIS - HVORSLEV'S METHOD

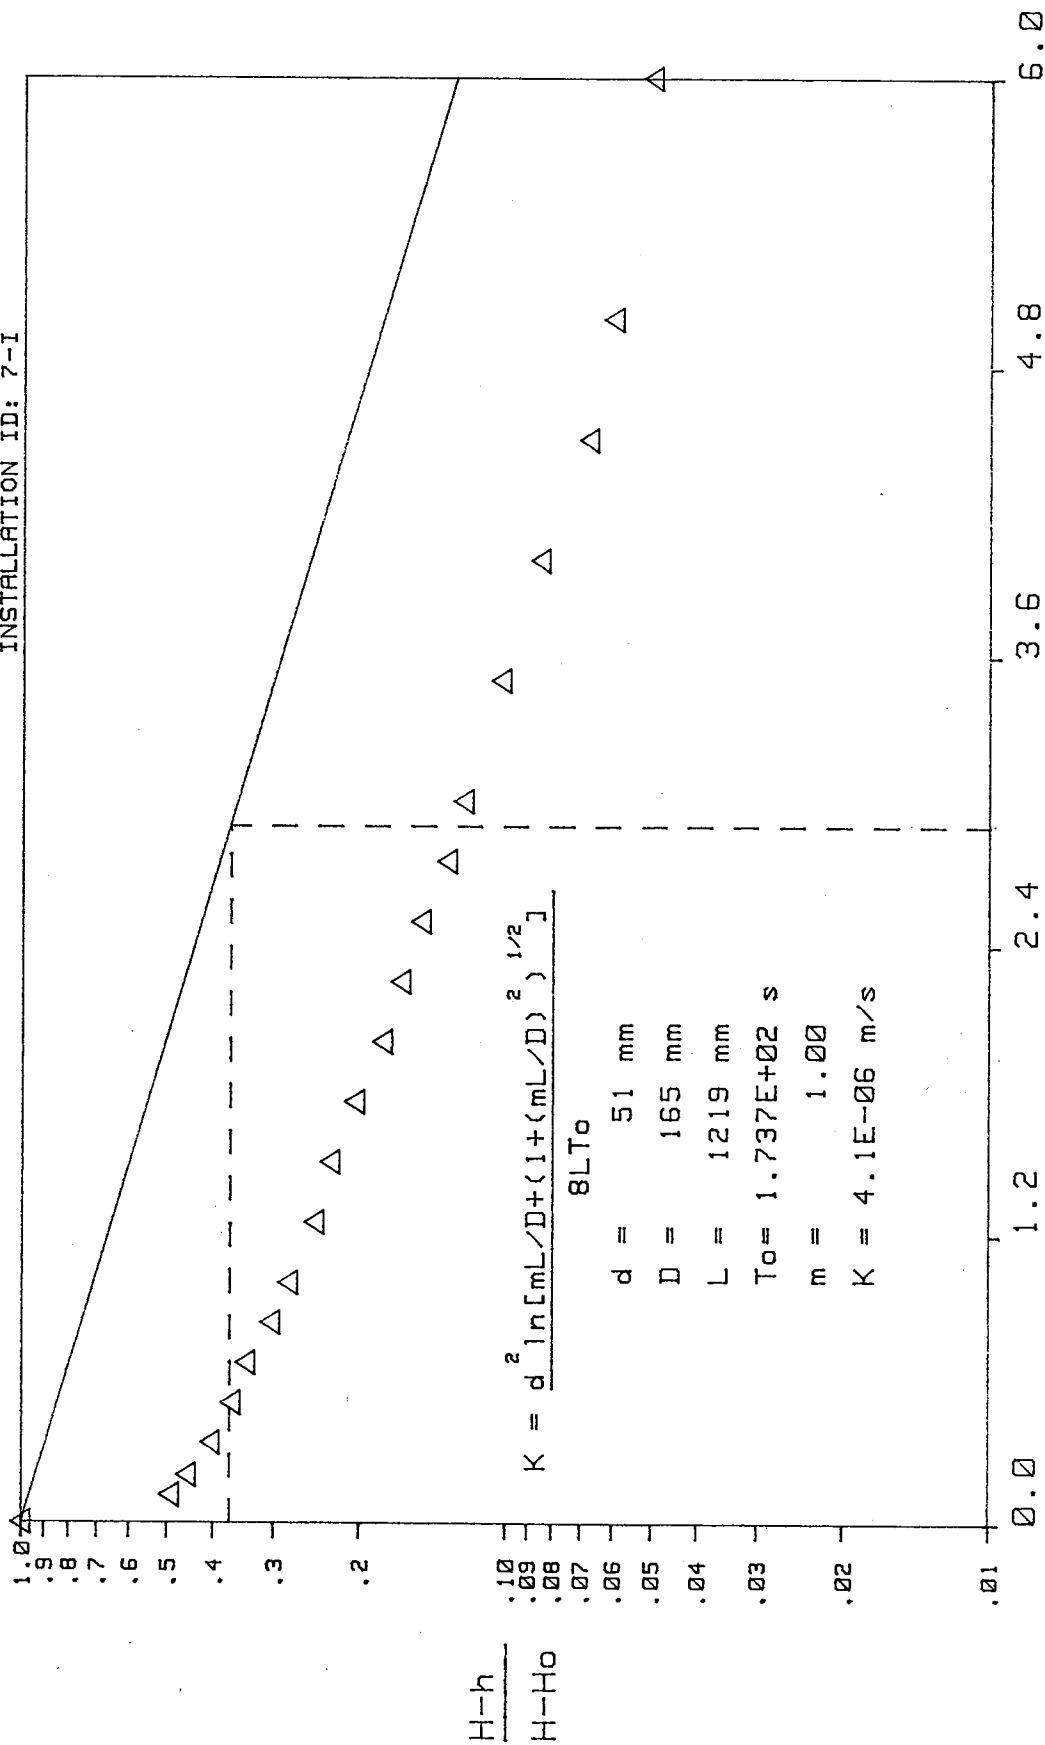
INSTALLATION ID: 7-I

# SLUG TEST ANALYSIS - HVORSLEV'S METHOD

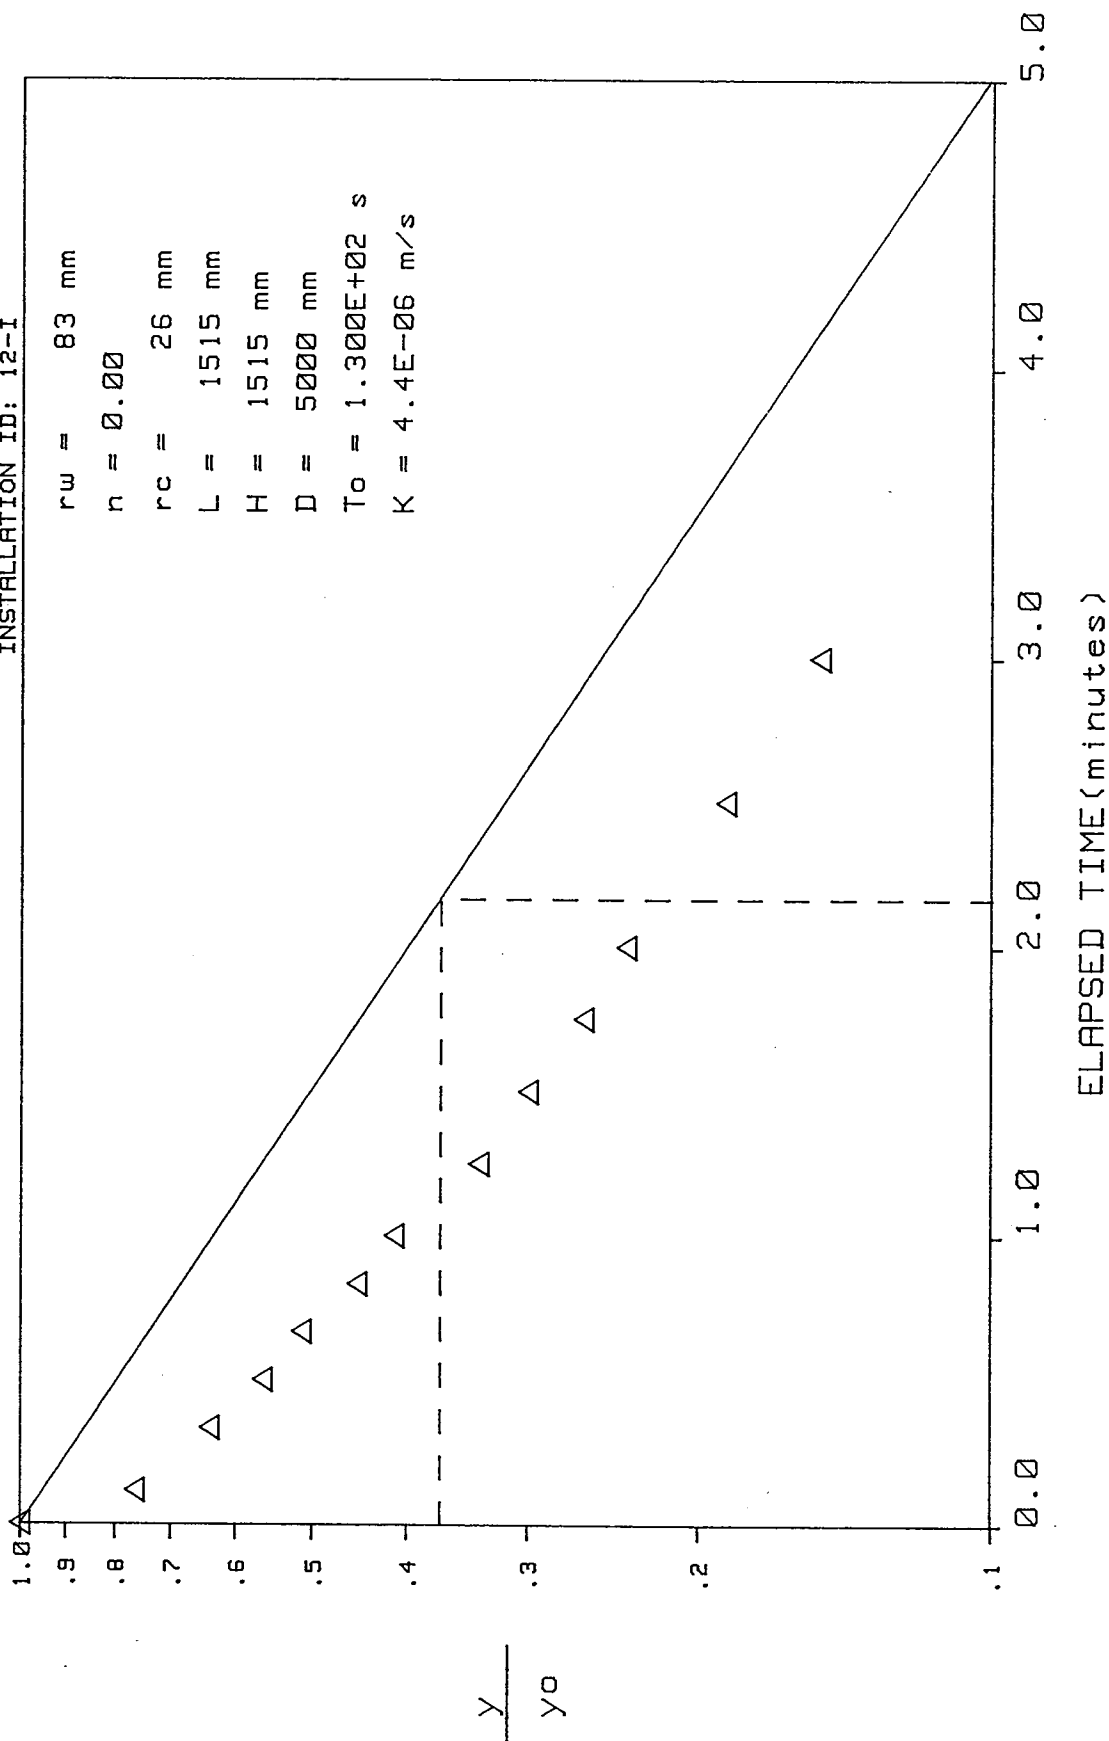
INSTALLATION ID: 12-I

BOUWER AND RICE, WATER RESOURCES RESEARCH, 1976
