Carson Reid Homes Ltd.

Phase One Environmental Site Assessment
Cityview Ridge Subdivision, Guelph, ON

GM BluePlan File: 105172

March 22, 2023

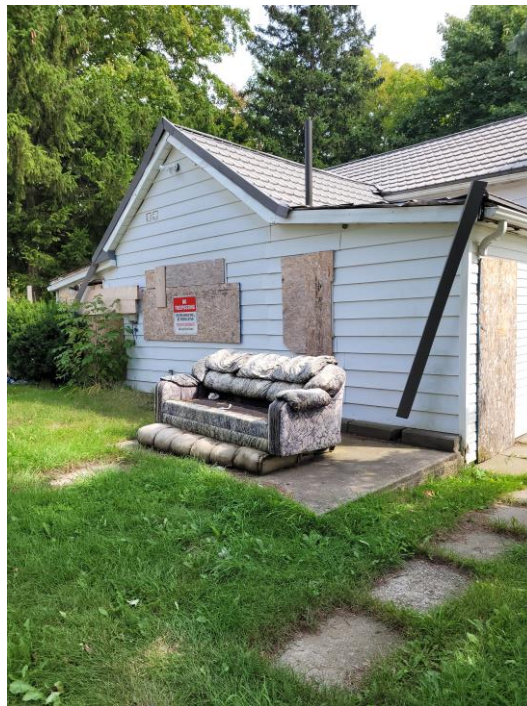
Photograph 4: View of the 20 Cityview Dr. N. residence, looking southwest.

The exterior of the private residential building is clad in vinyl siding with a shingled roof. Due to structural/safety concerns, the inside of the private residence was observed from the exterior of the building (through windows/doors). The residence was observed to contain remnants of domestic items (clothing, furniture and related items).

As reported, in the 2010 Phase One ESA by GM BluePlan, the home was heated with fuel oil historically, however there was no evidence of a fuel oil tank, such as former copper lines or a vent pipe reported at the time of the site visit and the previous Owner at the time of the ESA, reported no knowledge of a fuel oil storage tank on the property under their ownership (GM BluePlan 2011). At the time of the current ESA site visit, no vent pipes were observed on the exterior of the residence.

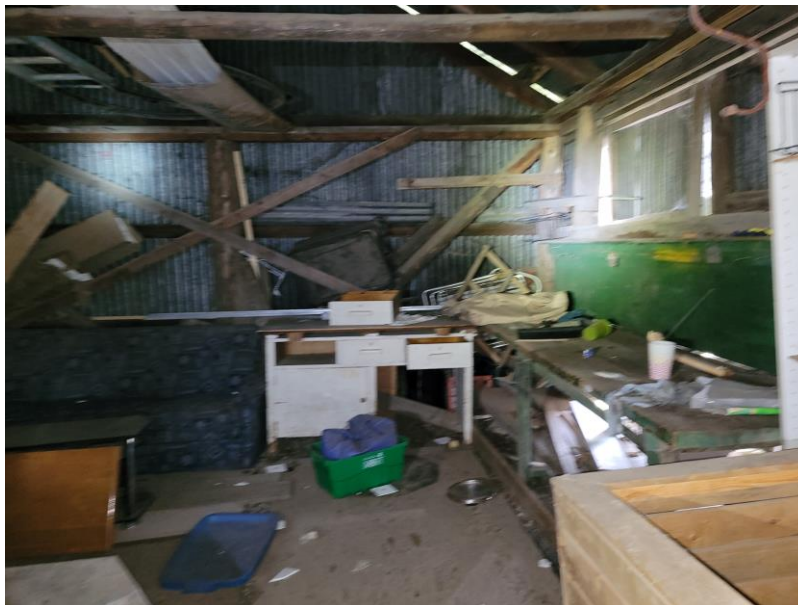
Photograph 6: View inside of the 20 Cityview Dr. N. storage shed.

The barn and the shed were observed to be used for storage of various items such as obsolete furniture (dressers, couch, chairs, tables etc.), bathroom fixtures, lumber, siding, several rolls of snow fence, ladders, scaffolding materials, temporary stairs, windows, window screens, metal fence panels, few 1-gallon containers of paint, various piping, insulation and other items scattered throughout. Some items were also stored on the outside of the barn and shed, mainly lumber, metal pipes and other obsolete items.

Two empty portable fuel containers, "jerry cans", less than 10 L in volume were observed (one on the inside of the shed and one on the exterior). There was no evidence of staining in the vicinity of the containers.

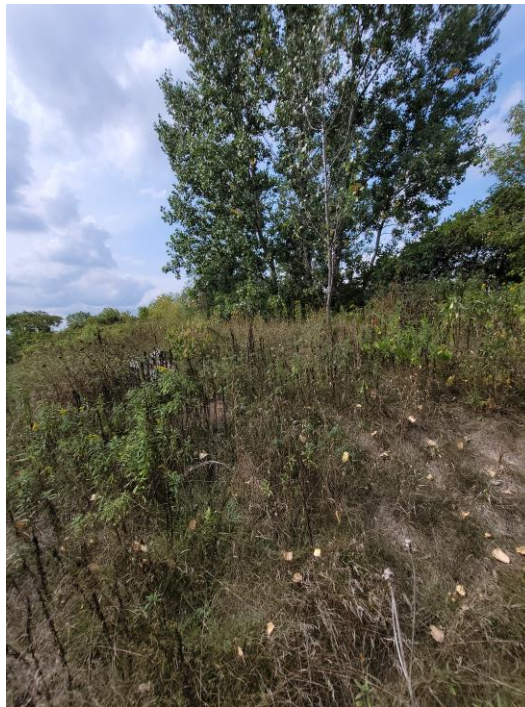
Photograph 8: View of the westerly portion of the 20 Cityview Dr. N. property, looking west.

West of the barn, towards the lower lying area at the rear of the property, was an area where large concrete fragments were observed partially in the ground along with some lumber and metal fragments. This area of the property was filled in 2008 and 2009 and was the subject of the 2011 Phase Two ESA by GM BluePlan and subsequent remediation efforts to remove impacted fill material. As reported by GM BluePlan, based on the 2011 testhole investigation, inert construction materials such as concrete were reported to remain within the silt and clay fill material in some locations at the property.
