# Cityview Ridge Environmental Impact Study

20 and 37 Cityview Drive

Prepared for Carson Reid Homes Ltd.  
February 2012

North-South Environmental Inc.

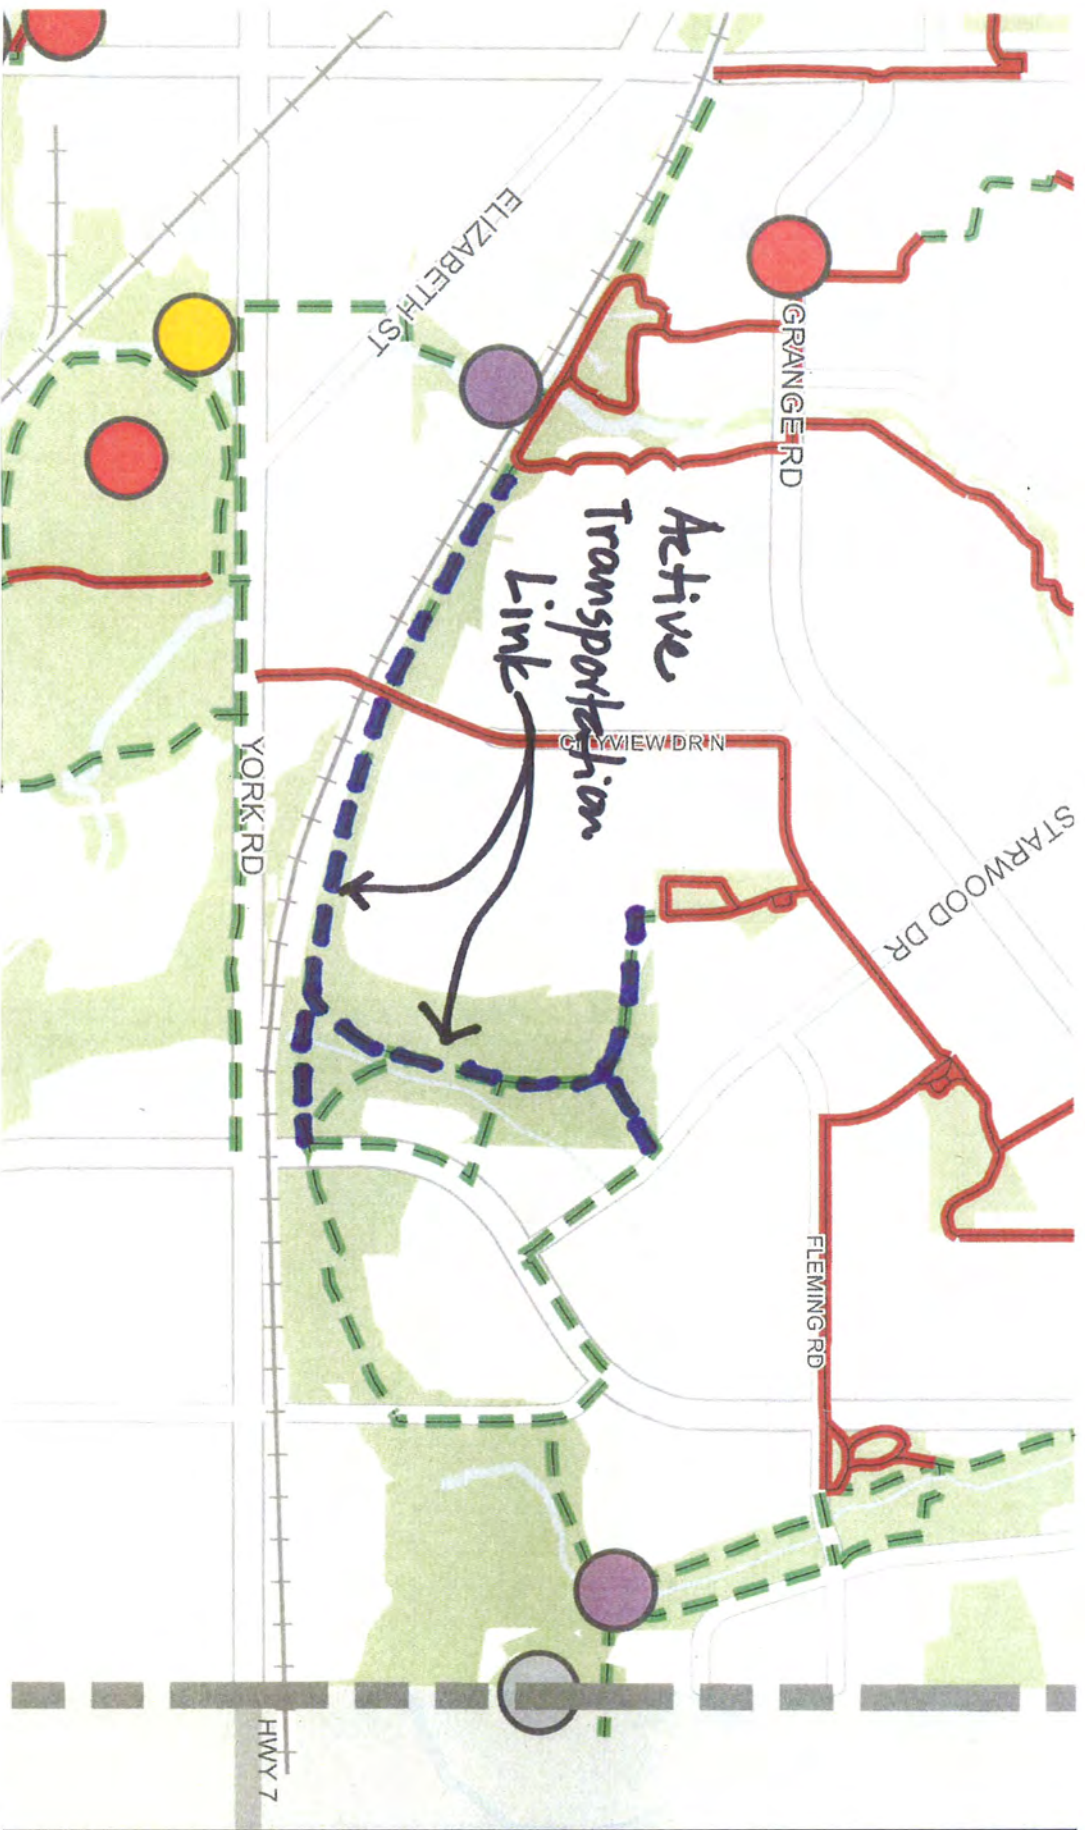
Figure 2: Conceptual Trail Alignment Provided by  
City of Guelph

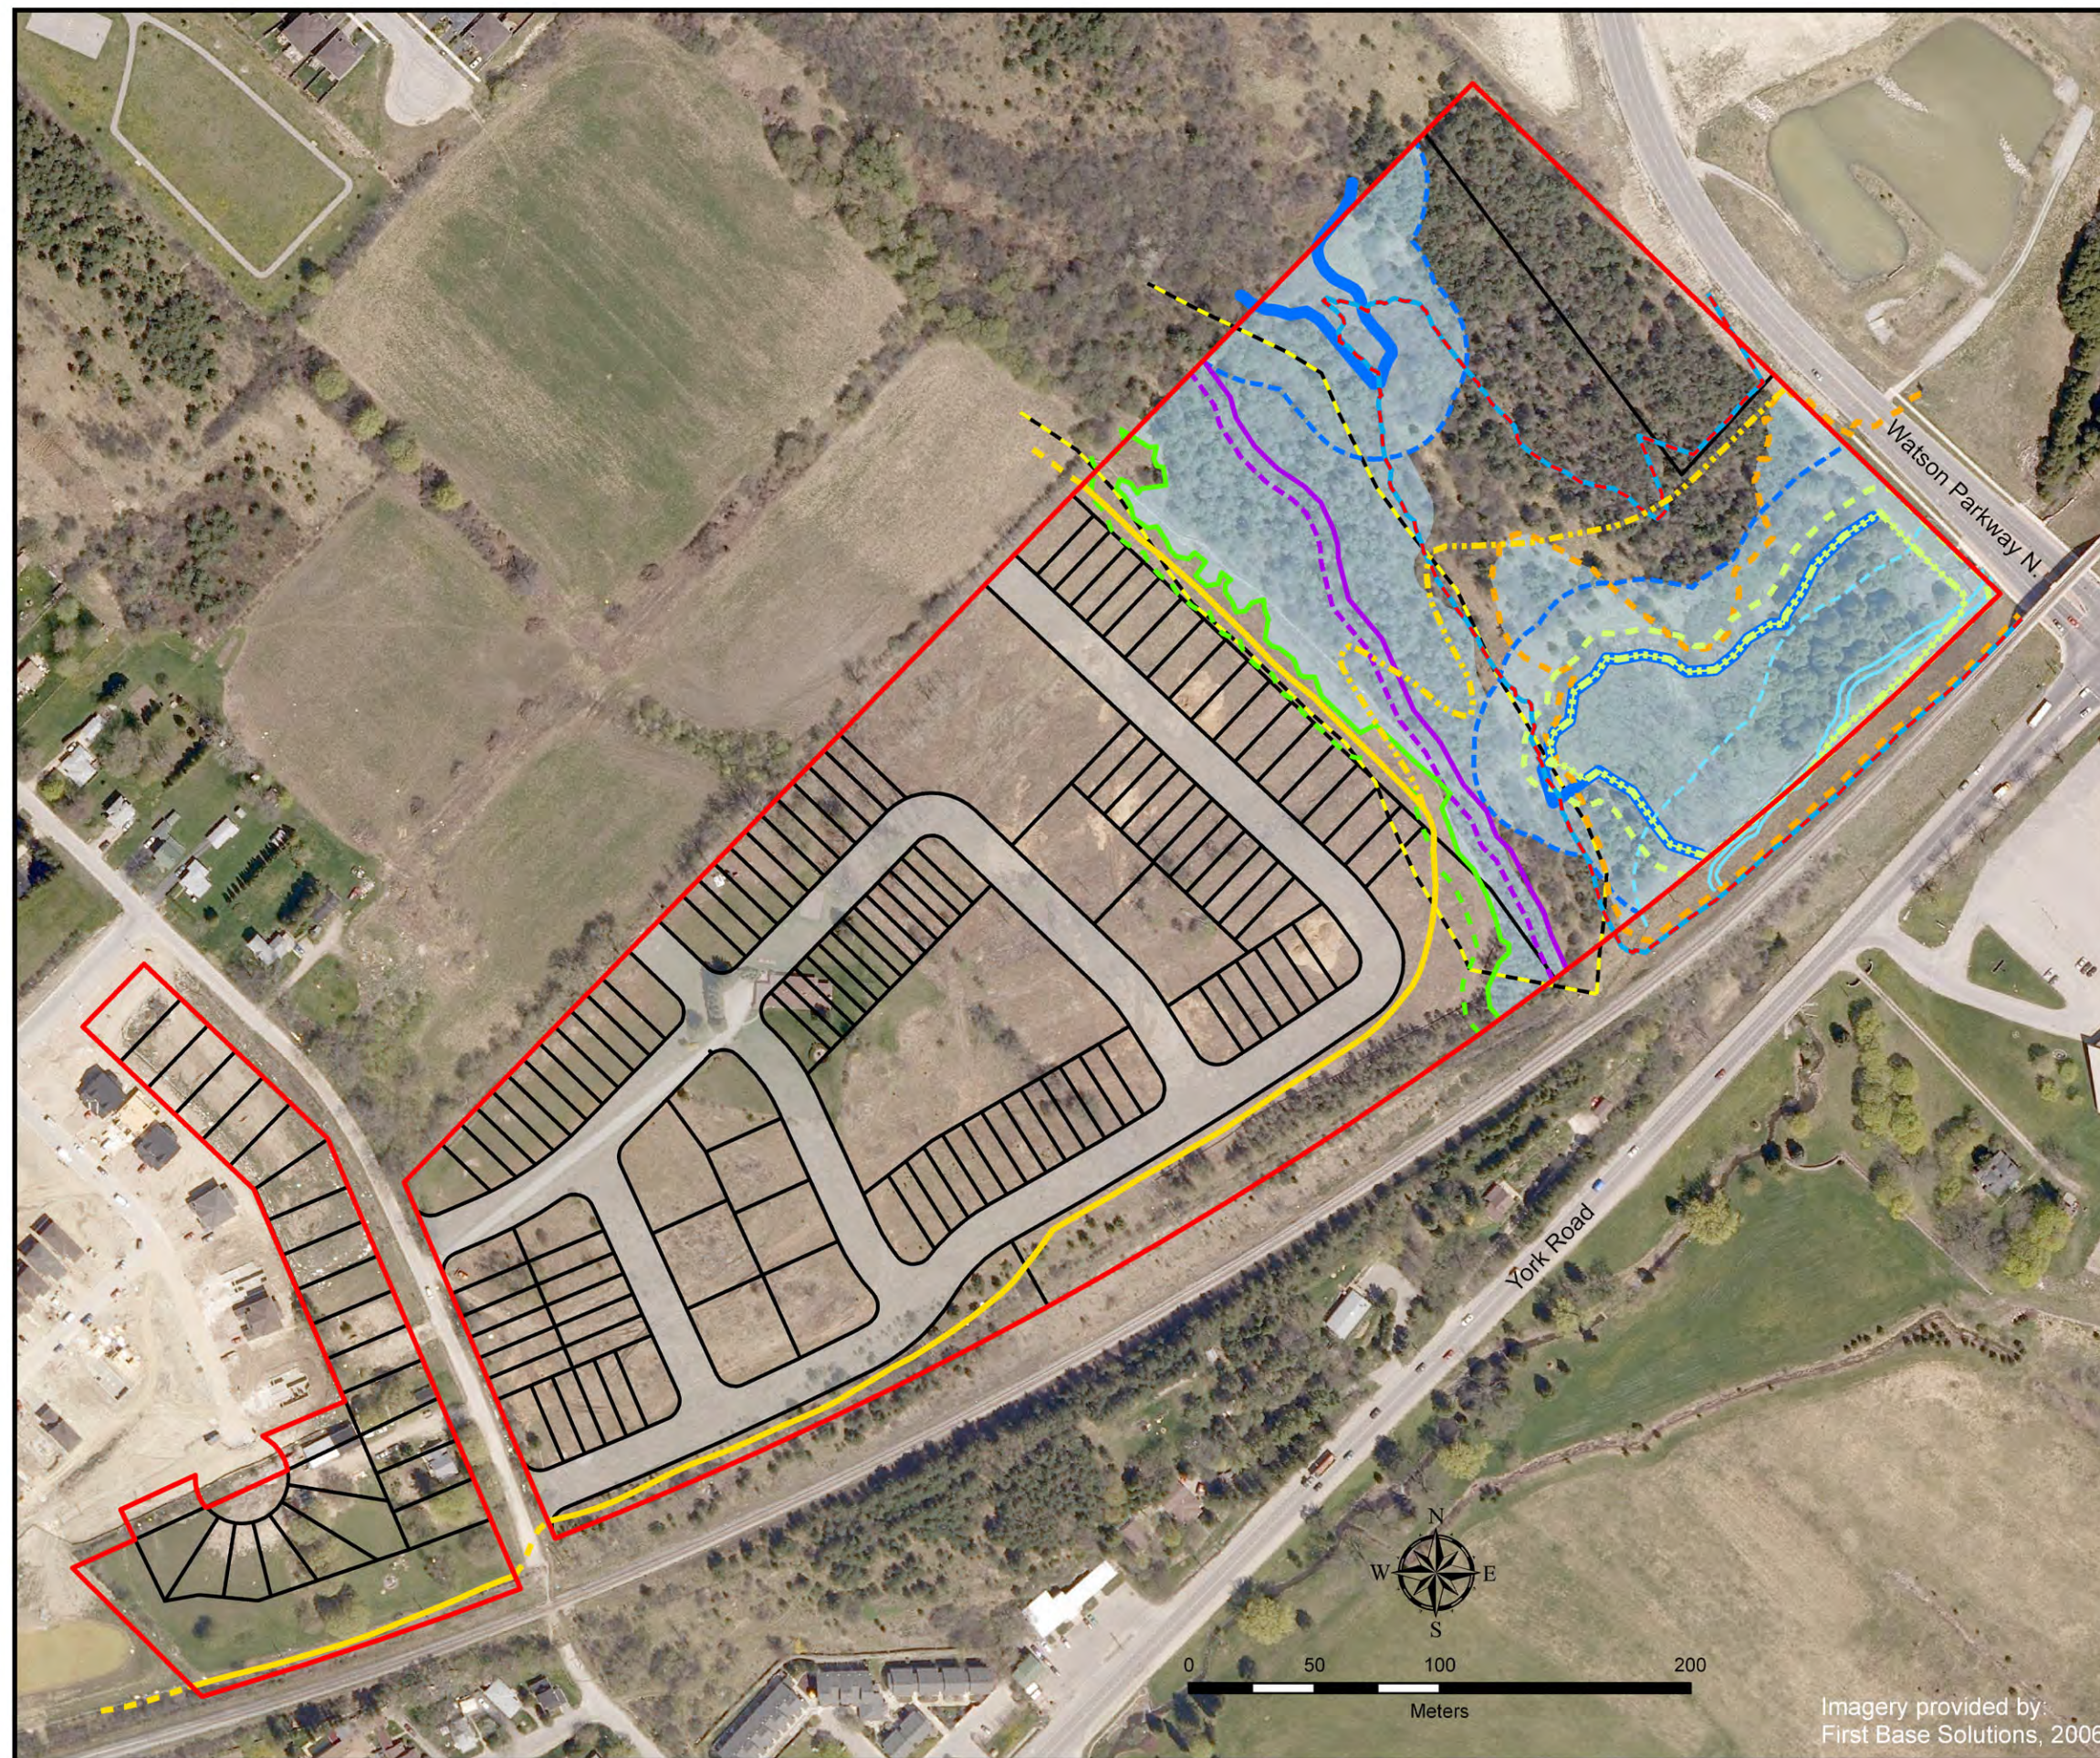
# Cityview Ridge EIS Addendum Figure 3: Proposed Trail Alignment

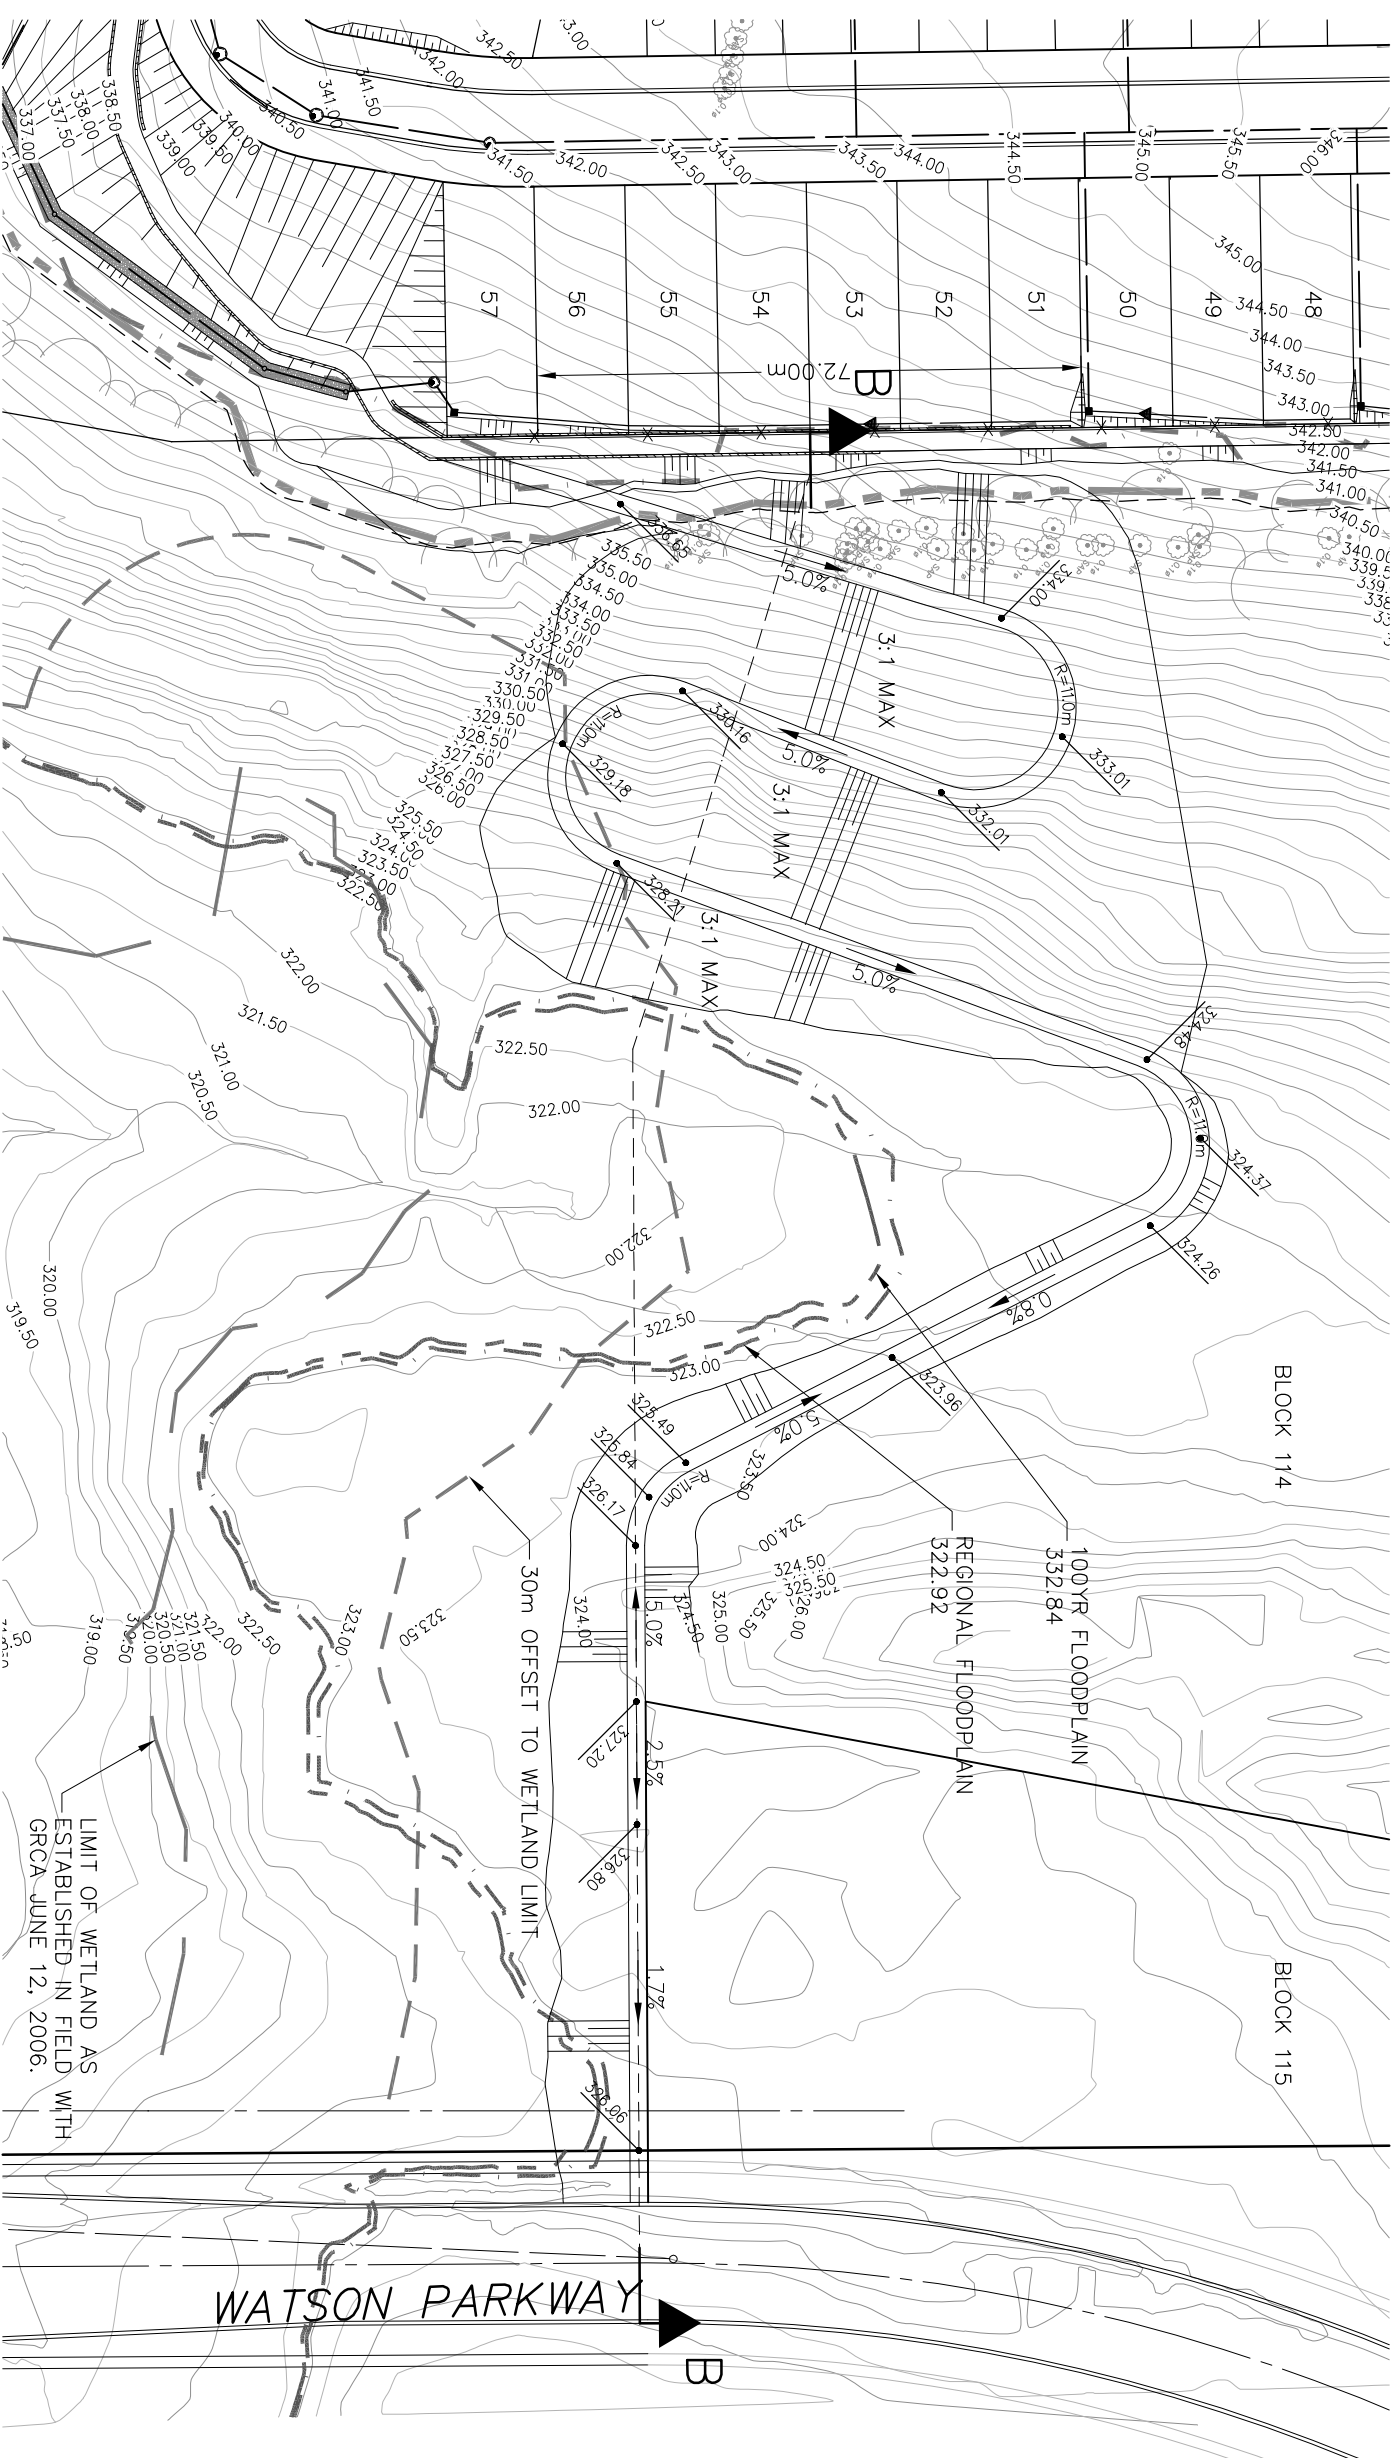
# Figure A

# ALTERNATIVE TRAIL ALIGNMENT AND CONNECTION TO WATSON PARKWAY

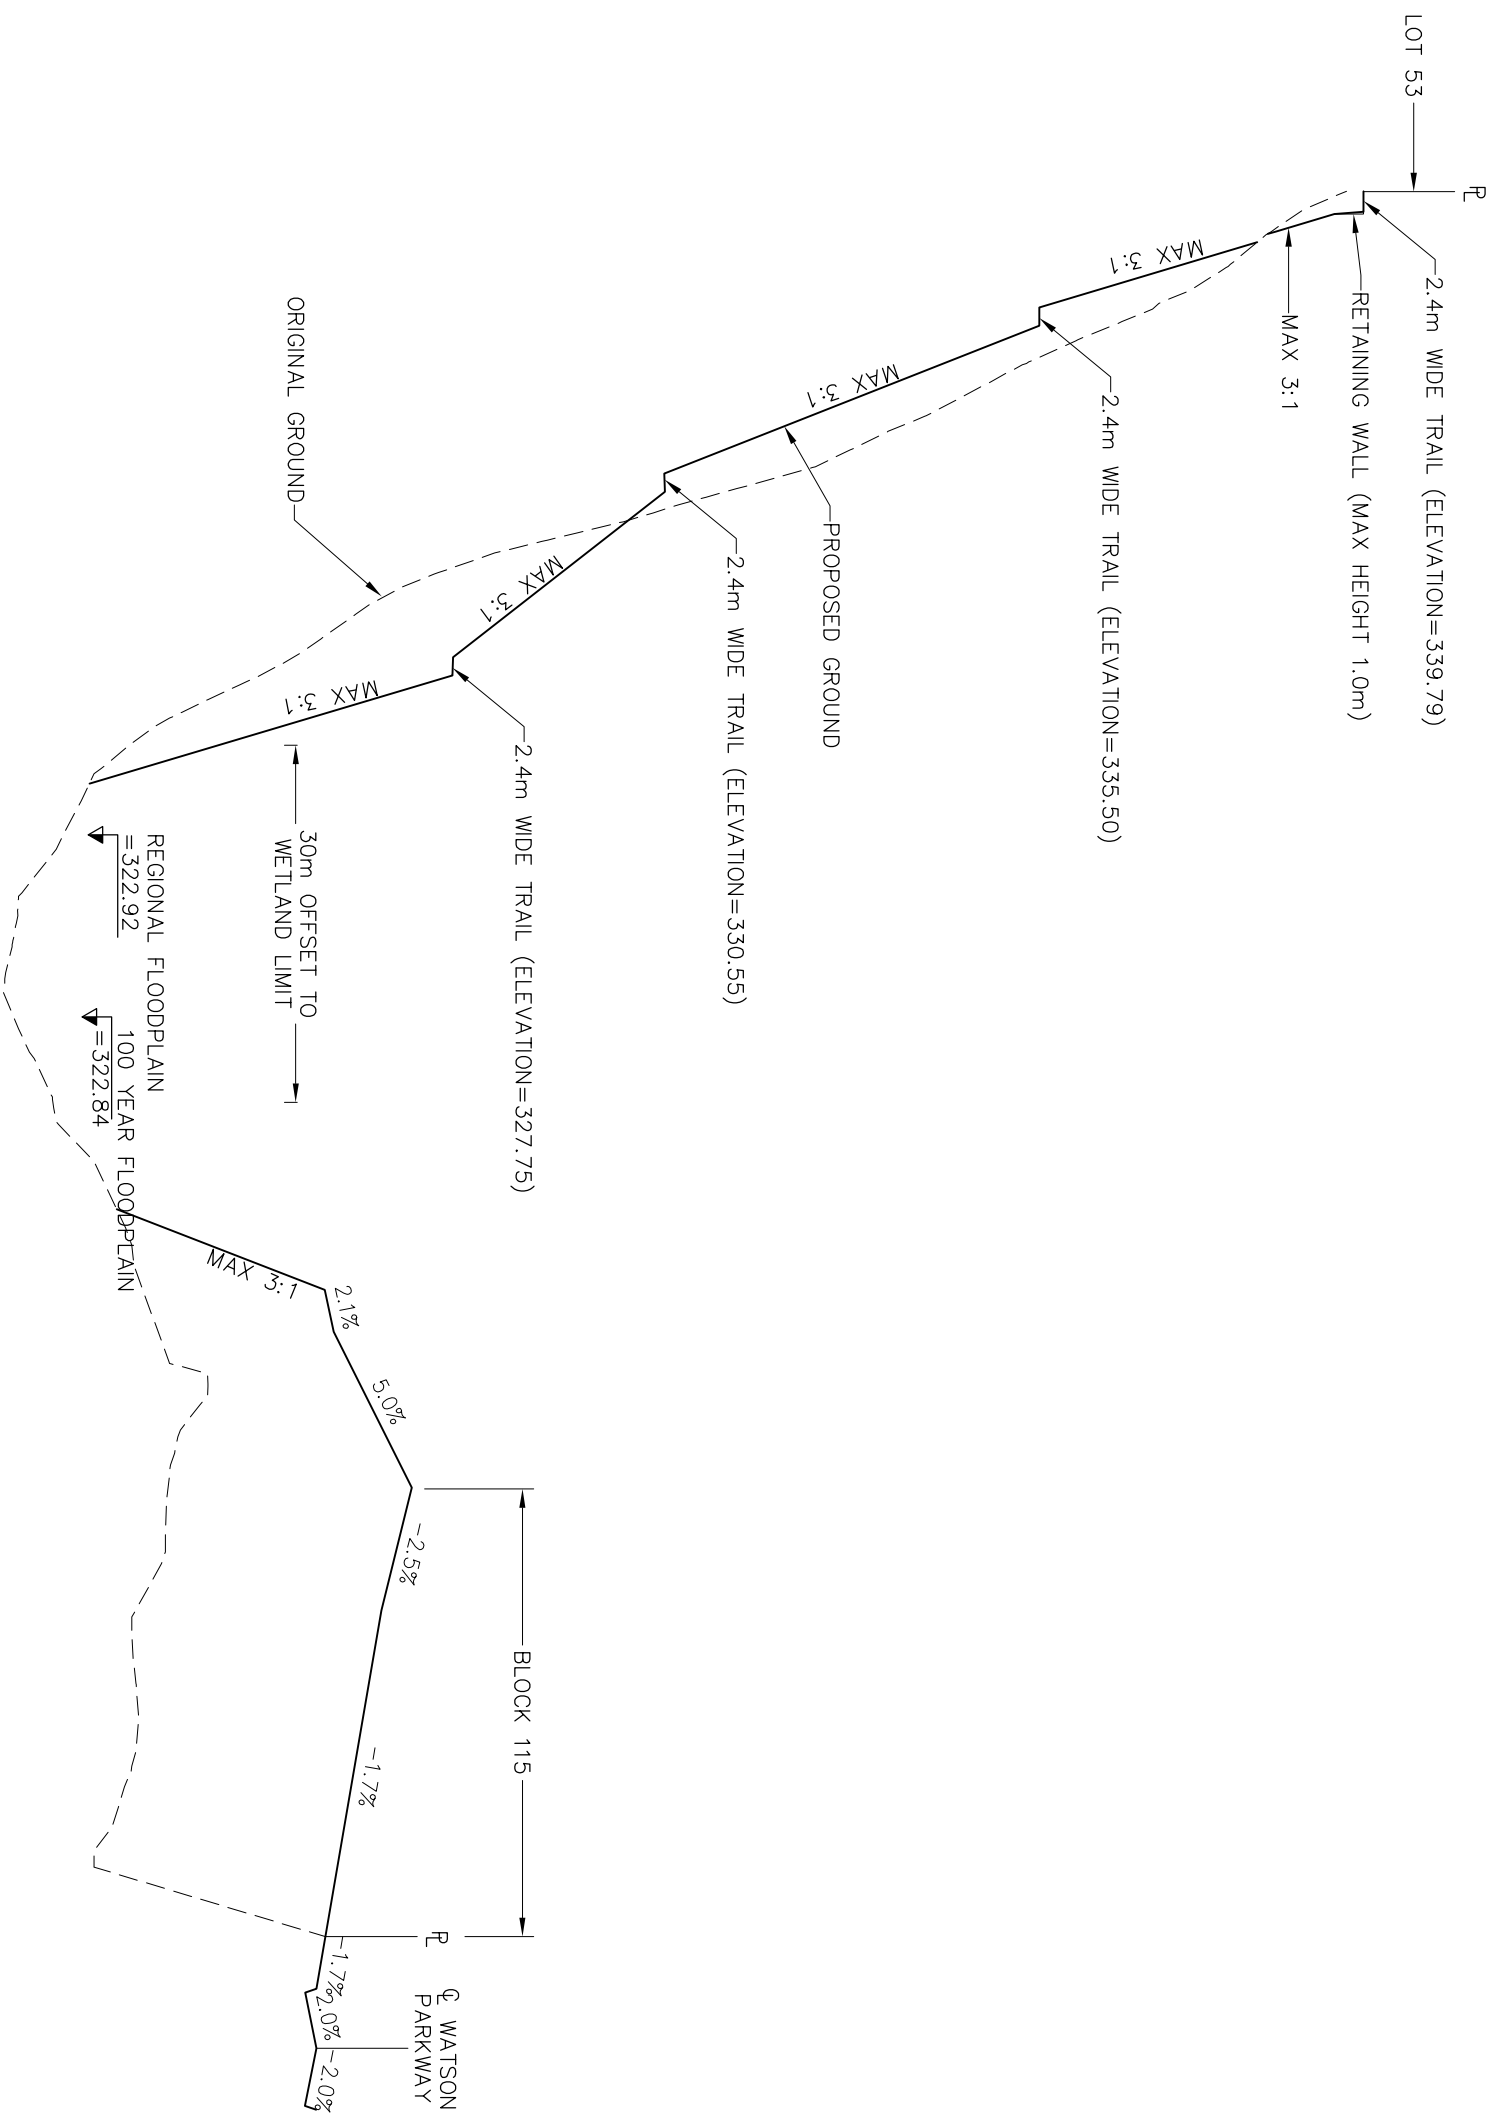
Figure B

SECTION B-B
