**220 Arkell Road, Guelph
Final Phase I Environmental
Site Assessment**

May 28, 2019

Updated April 30, 2021

Project Number: 161423338

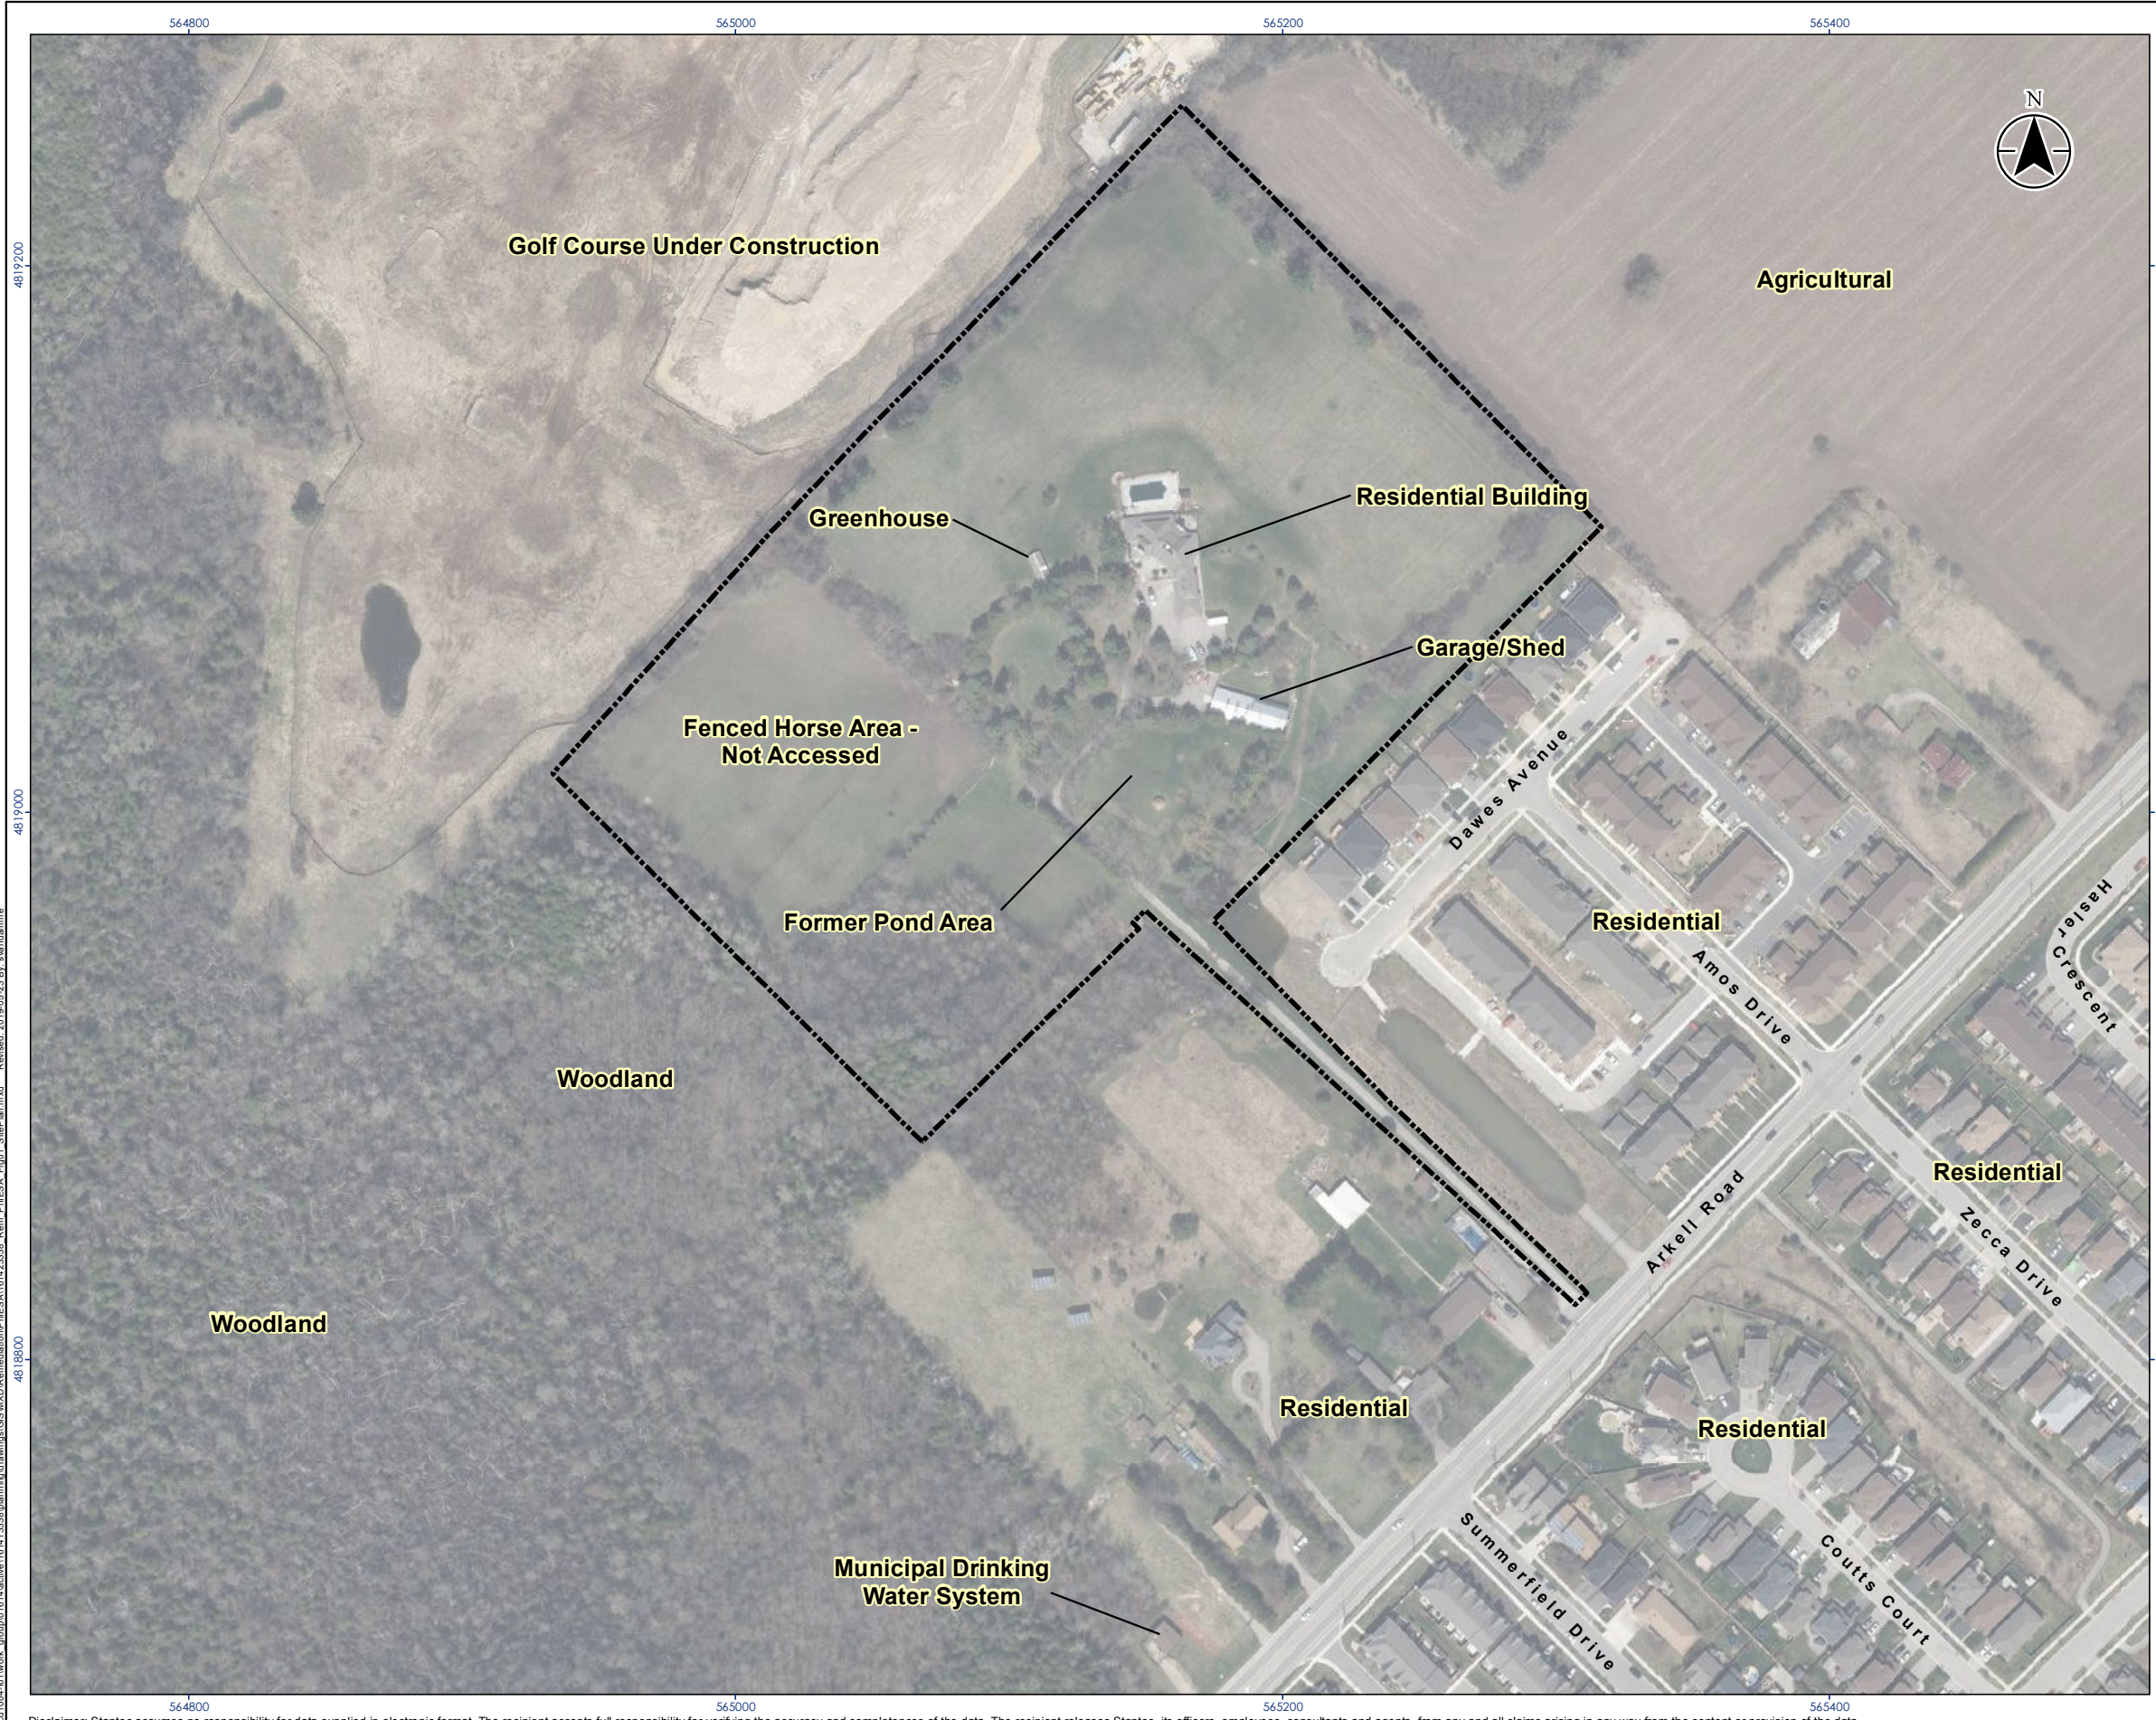
Site Plan

The site buildings consist of a two-storey, irregularly shaped residential building with a basement, as well as a detached garage/shed and a single-story greenhouse located south and west of the residential building, respectively, as shown on Figure No. 1. The general exterior construction of the residential building was observed to be brick/stone masonry with shingle roofing and the general exterior construction of the garage/ shed building was observed to be metal siding.

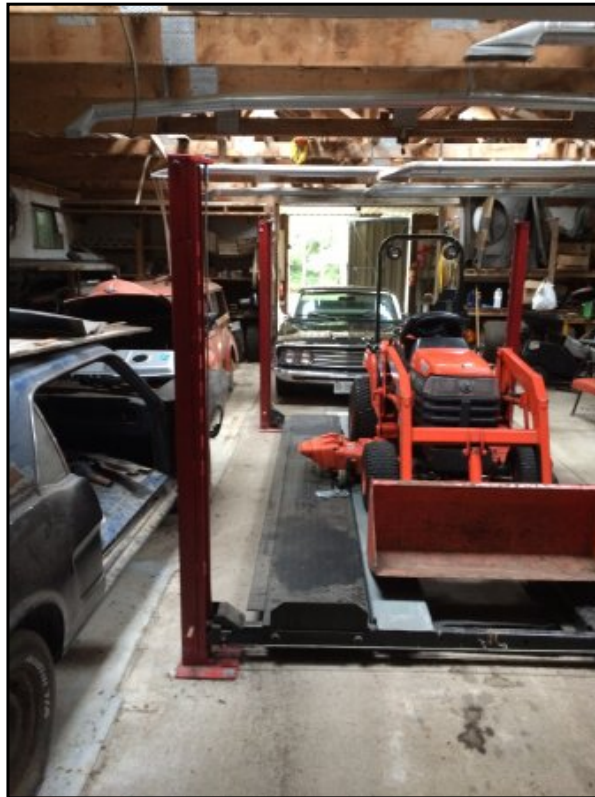
Small quantities of commercially packaged cleaning chemicals, antifreeze coolants, brake fluids, and degreasers were observed to be stored in the garage/ shed building for minor repairs to personal vehicles during the 2018 and 2021 site visits. A portable gasoline tank used for lawn mowers was stored near the garage/shed building during the 2016 site visit. No evidence of spills or leaks was identified associated with the chemical storage.

View of the interior of the garage/shed, located south of the Site in 2016

Based on the unknown age of the detached garage/shed building (possibly built in the mid-1970s), asbestos, PCBs and lead containing materials may be present. A hazardous materials survey should be completed prior to any demolition activities.

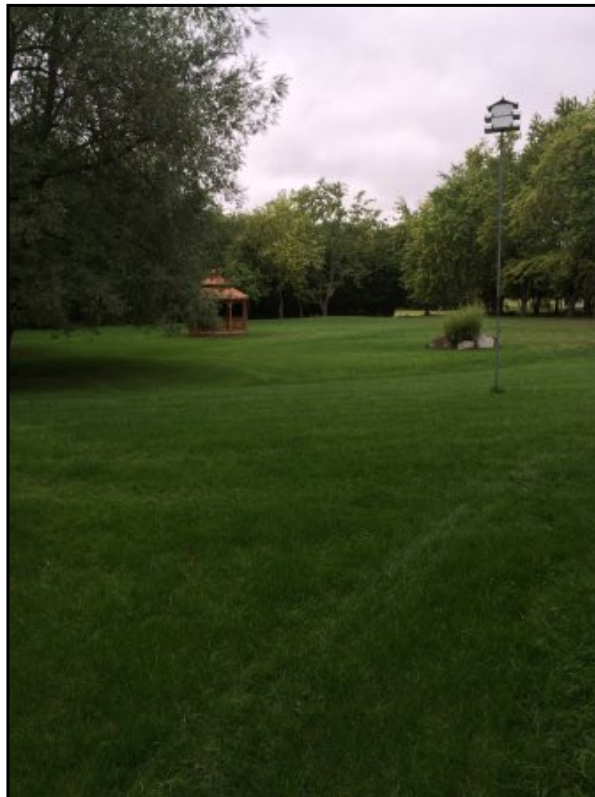
View of the former pond area, facing west in 2016

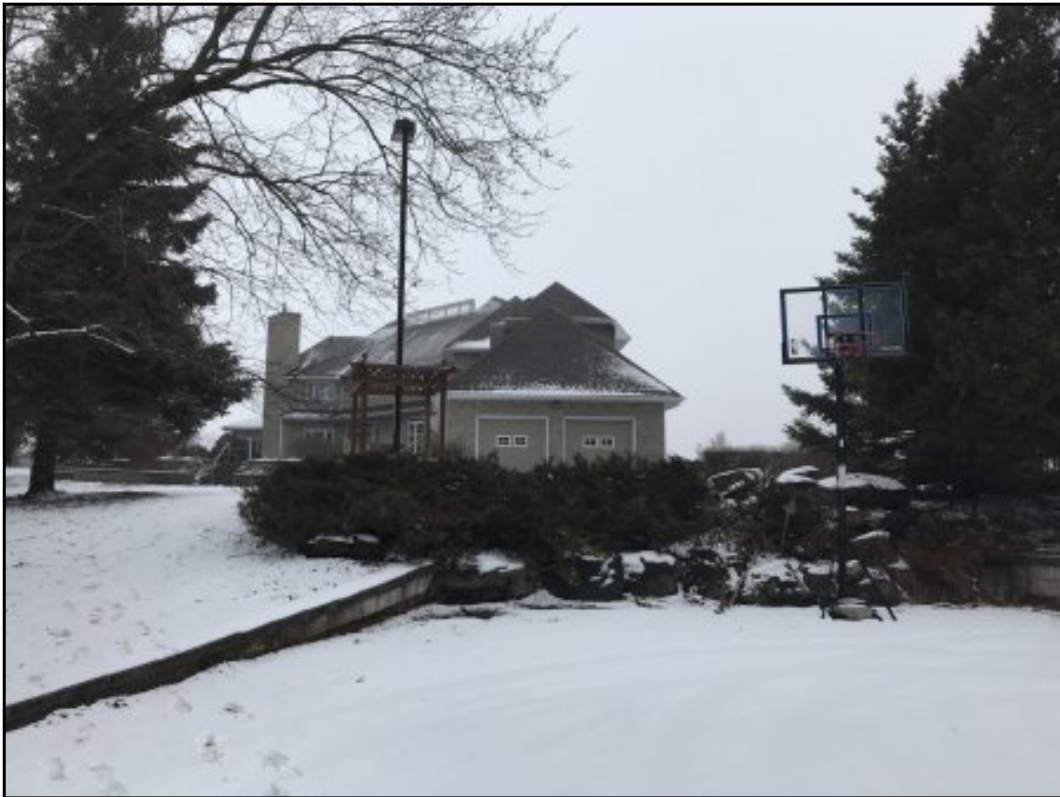
View of the residential building, facing northeast in 2018
