**PHASE ONE ENVIRONMENTAL SITE
ASSESSMENT**

**601 SCOTTSDALE DRIVE
GUELPH, ONTARIO**

FORUM EQUITY PARTNERS

December 2021
Reference No. 21-0006.02

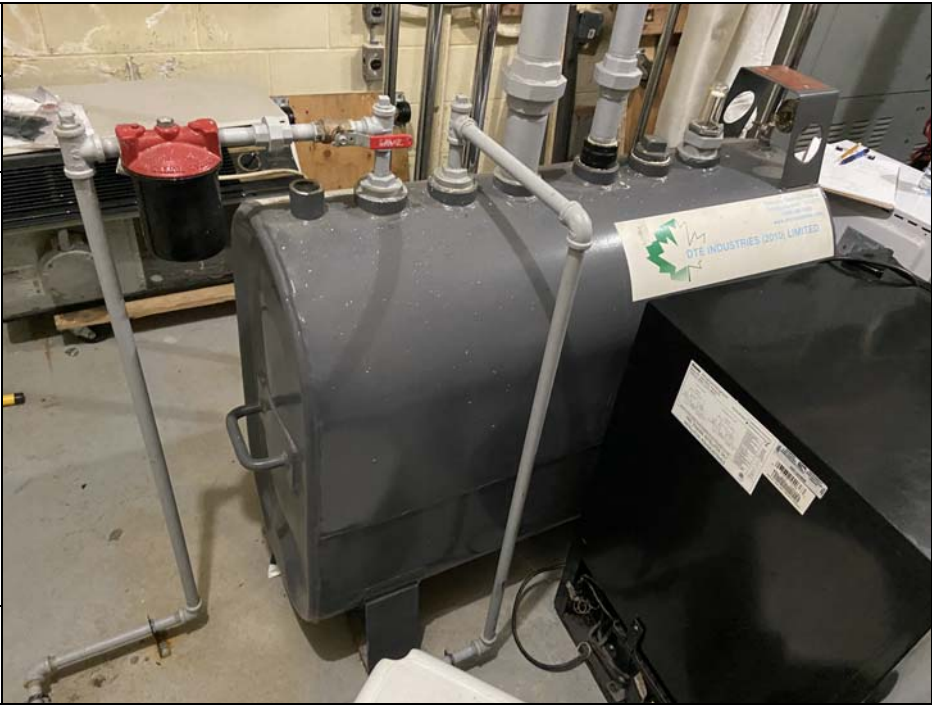
Photograph No. 3

A photograph showing a grey, cylindrical 227-litre diesel AST (Aboveground Storage Tank) located in an electrical room. The tank is mounted on a concrete floor and has several pipes and valves connected to it. A red fire extinguisher is visible in the background. A label on the tank reads "OTE INDUSTRIES (2018) LIMITED".
Date Taken: July 16, 2021	
Description: View showing the 227-litre diesel AST located in the Electrical Room on the Ground Floor. No staining or floor drains were observed in the vicinity of the AST.	
Looking Towards: N/A

- Watters Environmental noted a 227-litre, double-walled diesel AST present within the Electrical Room on the Ground Floor of the Site building. The AST was noted to be installed in 2015 and used to power the on-Site emergency generator. No staining was observed on the concrete floor beneath the AST or on the Site exterior in the vicinity of the remote fill and vent pipes; and

AST Information	AST 1
Active or Inactive	Active
Site Owned or Leased	Owned
Location	Located in the Electrical Room on the Ground Floor of the Site building (see Photograph 3)
Date Installed	According to the information plate on the tank, the AST was installed in 2015.
Construction Material	Steel
Approximate Capacity	227 Litres
Contents	Diesel
Purpose	The AST is used to store diesel used to fuel the on-Site emergency generator
Single or Double-Walled	Double-walled
Secondary Containment	Secondary containment provided by the double-walled construction
Condition	Good (i.e., no visible rust or perforations)
Tanking Filling Location (direct or remote)	Filled remotely from a fill pipe located along the southeastern exterior portion of the Site building (see Photograph 4).
Overfill Alarm System	Unknown
Surface Under the AST	Concrete
Evidence of Spills	No staining was observed beneath the AST.
Floor Drains or Catch Basins Nearby	None

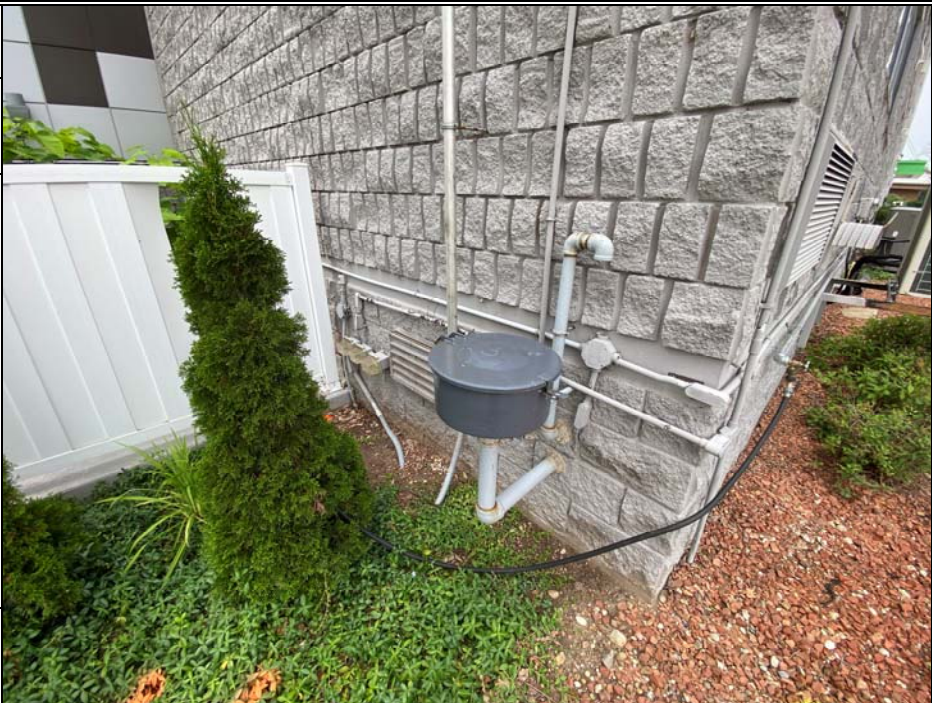
Photograph No. 4

A photograph showing the remote fill and vent pipes for the diesel AST located along the southeastern exterior of the Site building. The pipes are white and run vertically along a grey stone wall. A grey vent cap is visible on the wall. The area is surrounded by greenery and a white fence.
Date Taken: July 16, 2021	
Description: View showing the remote fill and vent pipes for the diesel AST located along the southeastern exterior of the Site building. No staining was observed beneath the pipes.	
Looking Towards: N/A

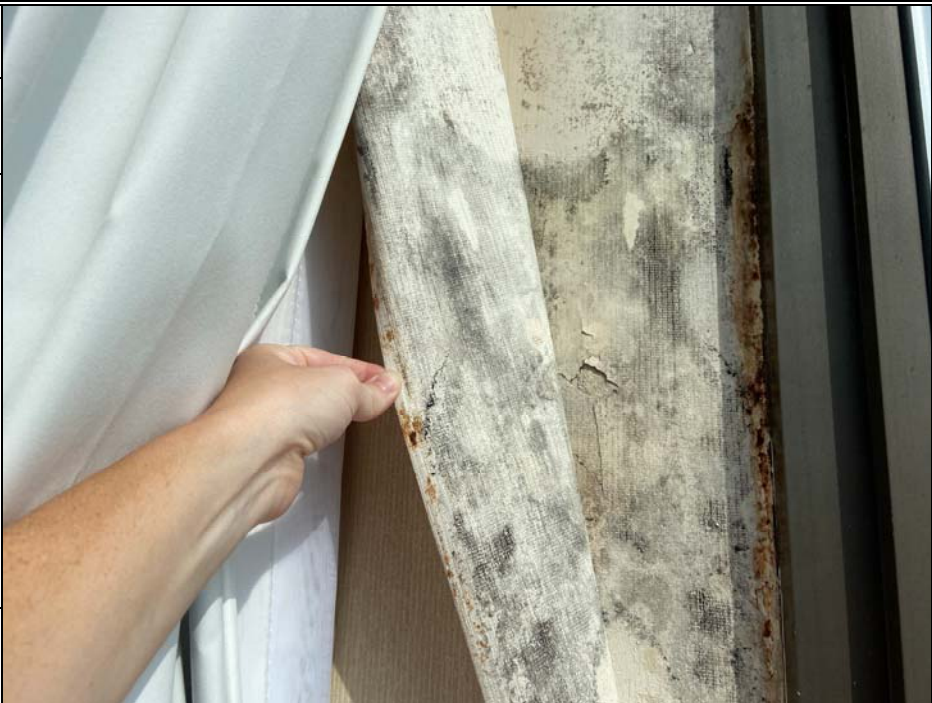
Photograph No. 8

Date Taken: July 16, 2021	
Description: An example of suspected mould growth in the Site building present behind wallpaper near the window 3 rd Floor.	
Looking Towards: N/A

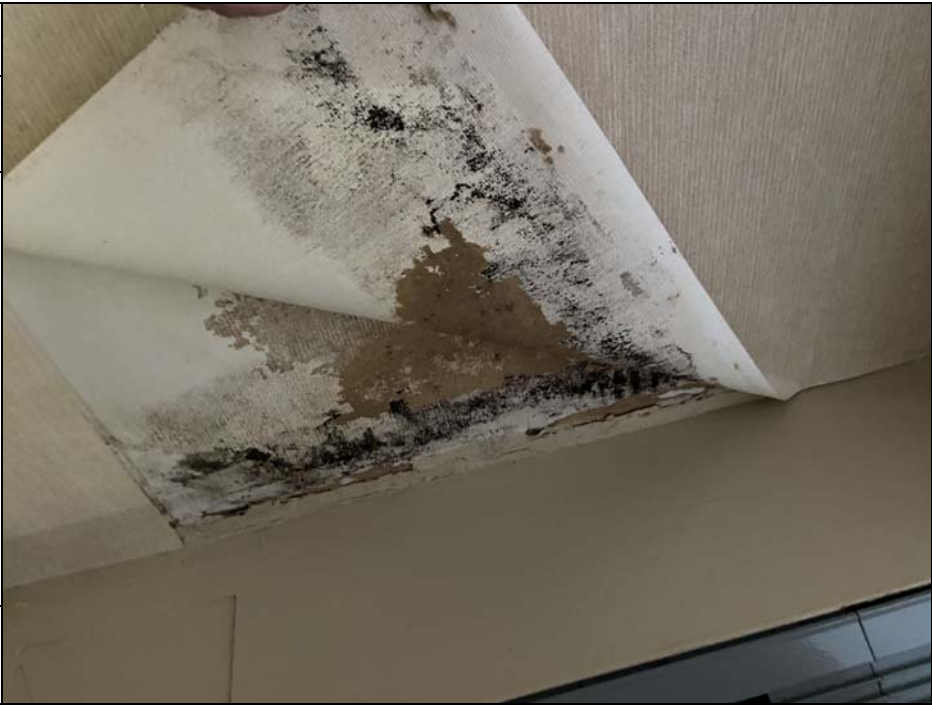
Photograph No. 9

Date Taken: July 16, 2021	
Description: An example of suspected mould growth in the Site building present above packaged terminal air conditioner units 3 rd Floor.	
Looking Towards: N/A
