**PHASE TWO ENVIRONMENTAL  
SITE ASSESSMENT**

**601 SCOTTSDALE DRIVE  
GUELPH, ONTARIO**

December 2021  
Reference No. 21-0006.03

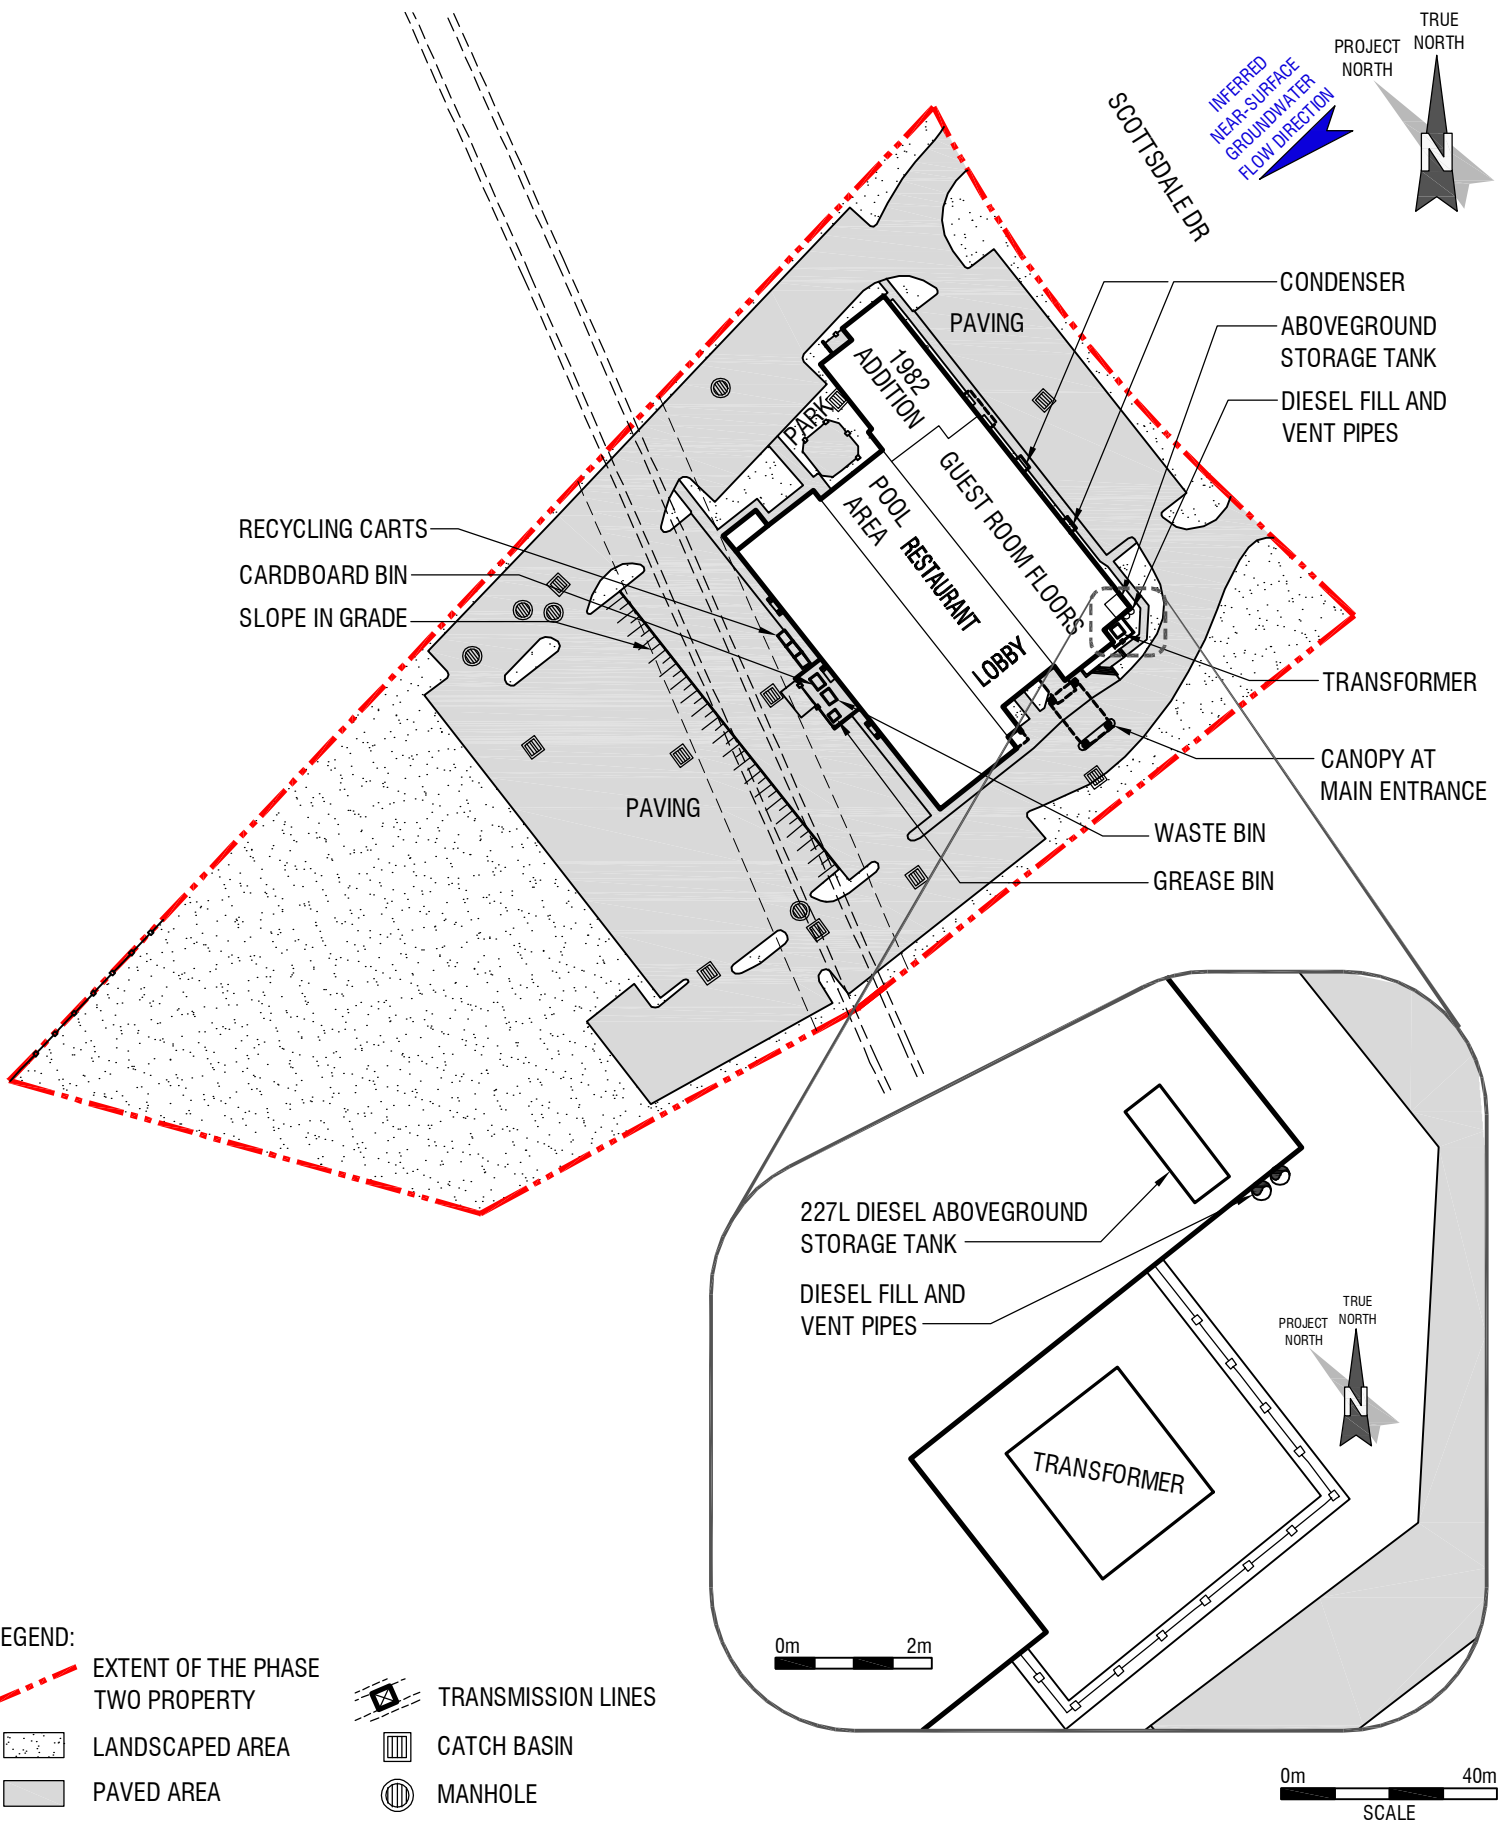
FIGURE NAME:  
**PHASE TWO PROPERTY  
LAYOUT PLAN**  
PROJECT No:  
**21-0006.03**  
FIGURE No:  
**3**

- EXTENT OF THE PHASE TWO PROPERTY
- LANDSCAPED AREA
- PAVED AREA
- TRANSMISSION LINES
- CATCH BASIN
- MANHOLE

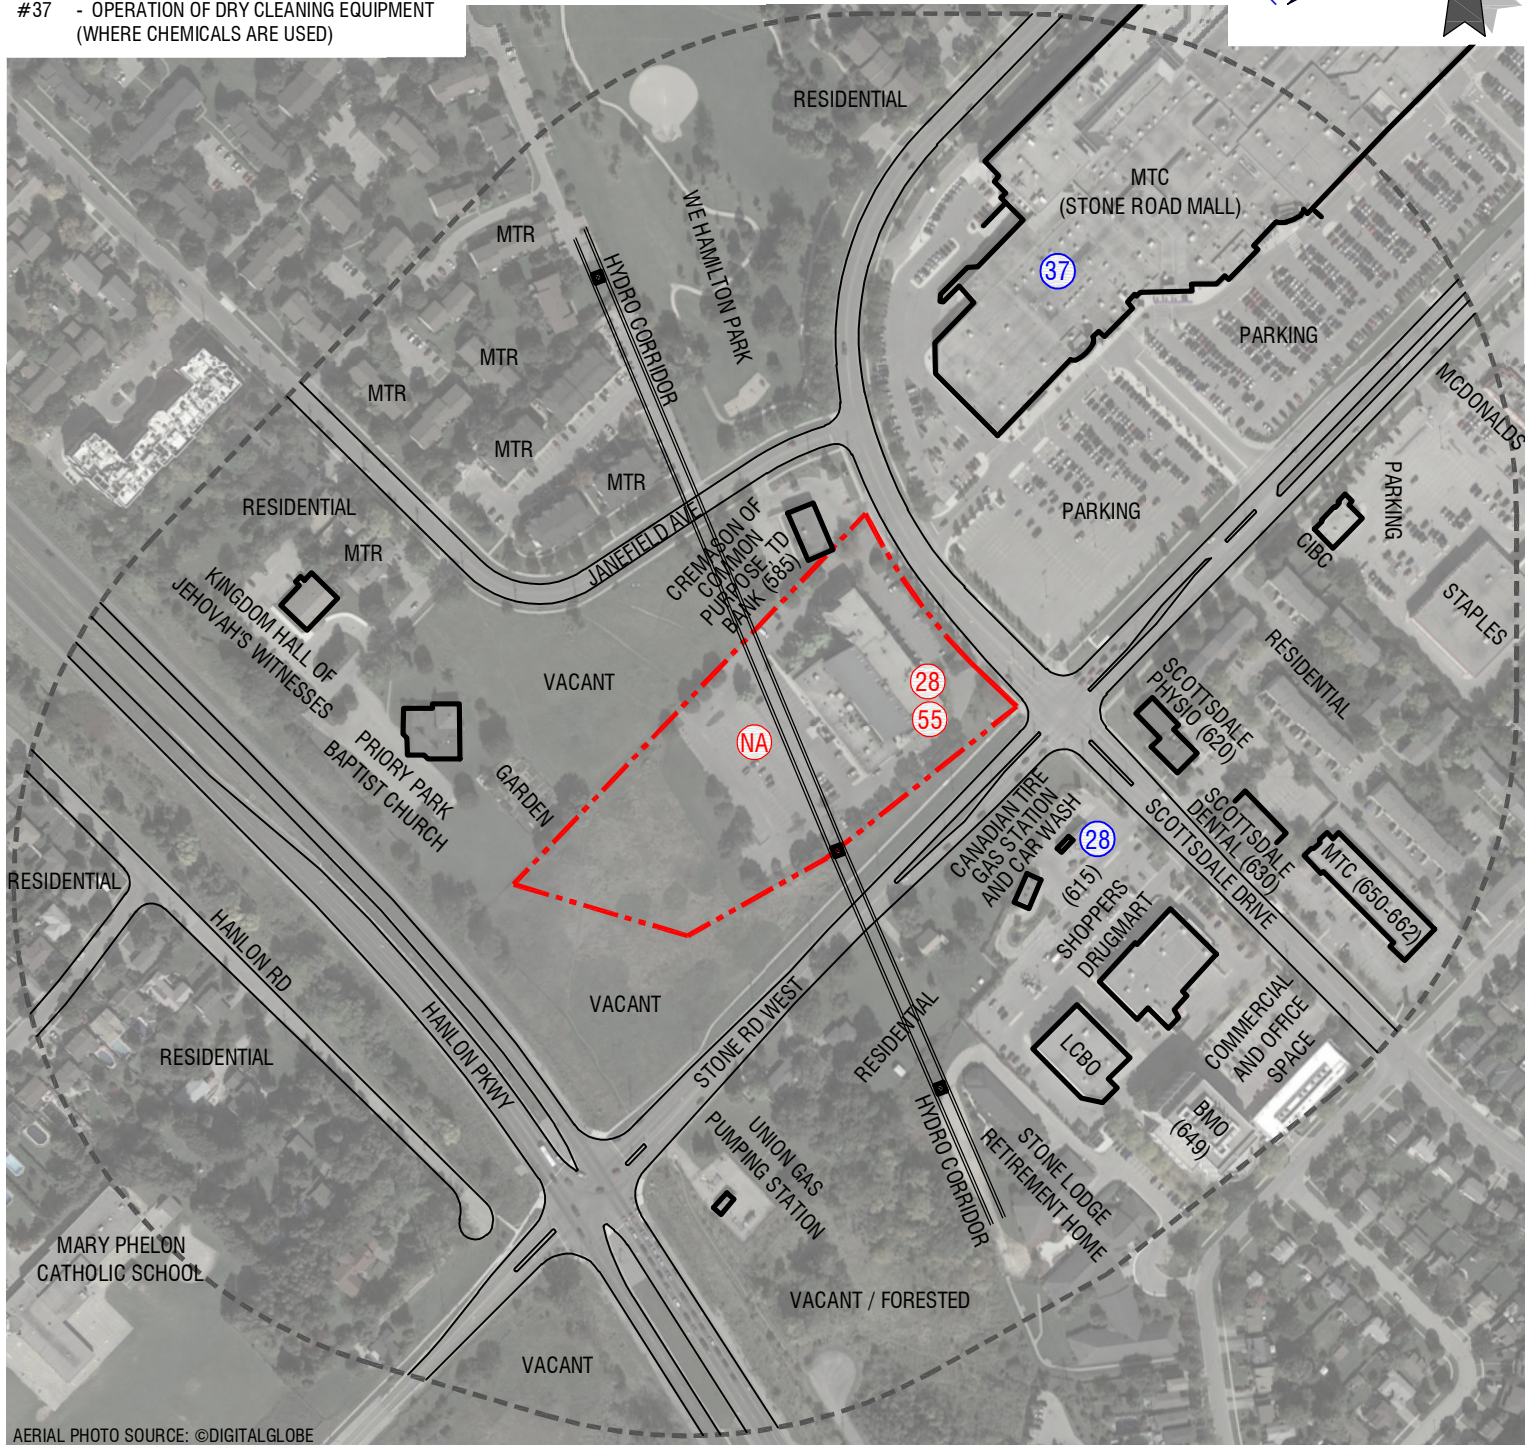
FIGURE NAME:  
**PHASE ONE CONCEPTUAL  
SITE MODEL**  
PROJECT No:  
**21-0006.03**  
FIGURE No:  
**5**

- #55 - TRANSFORMER MANUFACTURING, PROCESSING AND USE
- #28 - GASOLINE AND ASSOCIATED PRODUCTS STORAGE IN FIXED TANKS
- #37 - OPERATION OF DRY CLEANING EQUIPMENT (WHERE CHEMICALS ARE USED)

NA - APPLICATION OF ROAD SALT FOR DE-ICING PURPOSES

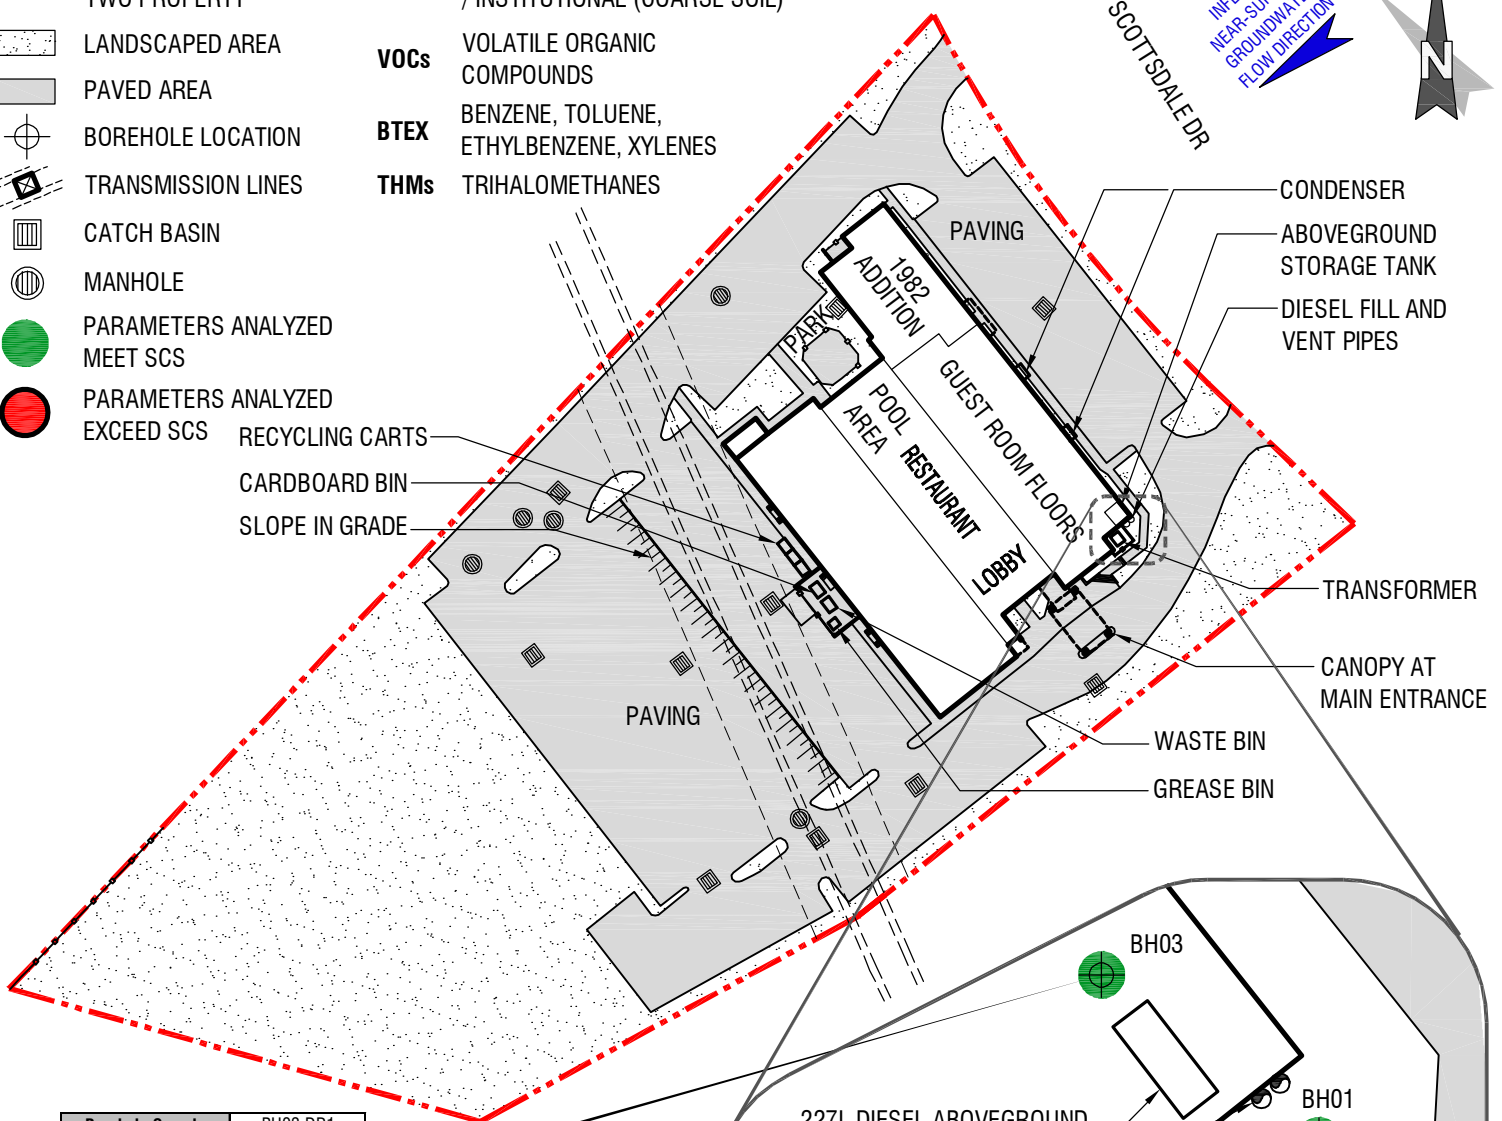
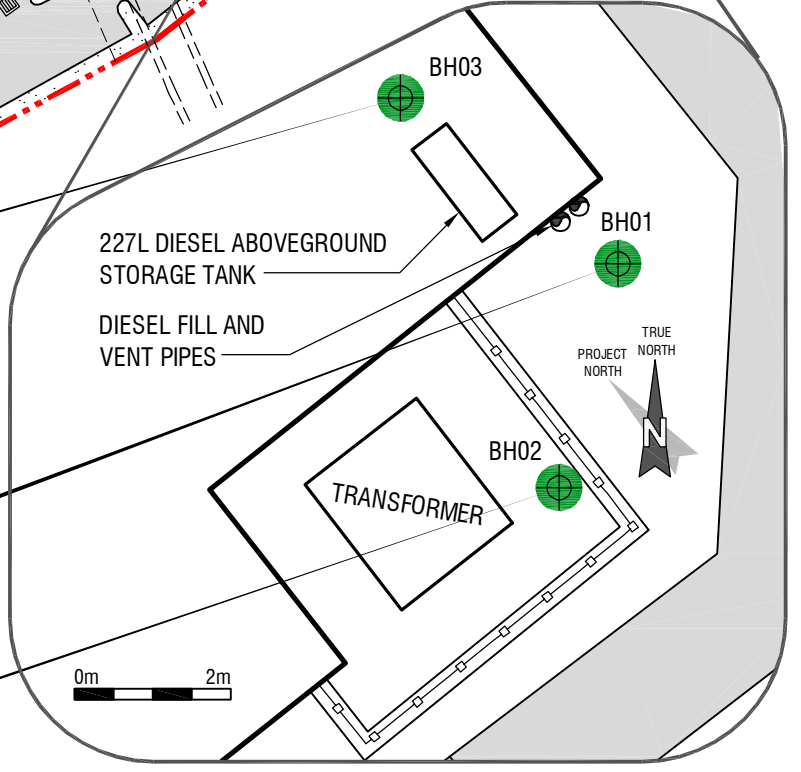
- SCS** TABLE 2 RESIDENTIAL / PARKLAND / INSTITUTIONAL (COARSE SOIL)
- VOCs** VOLATILE ORGANIC COMPOUNDS
- BTEX** BENZENE, TOLUENE, ETHYLBENZENE, XYLENES
- THMs** TRIHALOMETHANES

Borehole Sample	BH03-DP1
Date Sampled	27-Jul-21
Sample Depth (mbgs)	0 - 0.76
All parameters met the Table 2 SCS

Borehole Sample	BH300-DP1
Date Sampled	27-Jul-21
Sample Depth (mbgs)	0 - 0.76
All parameters met the Table 2 SCS

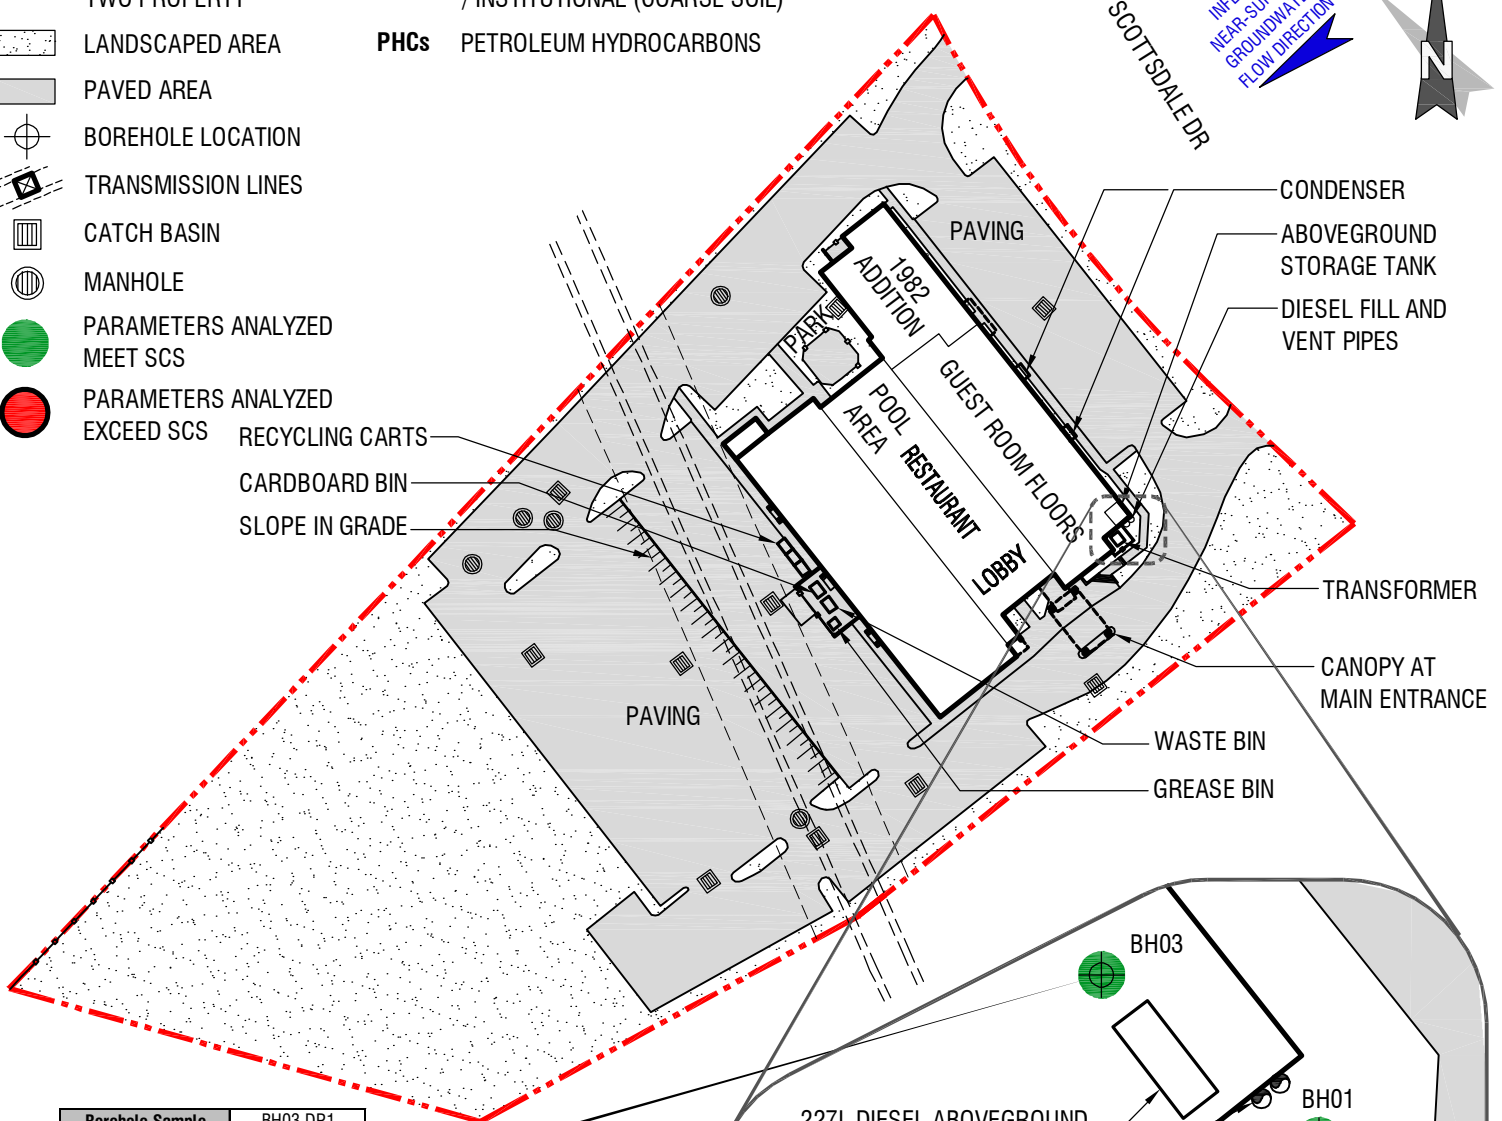
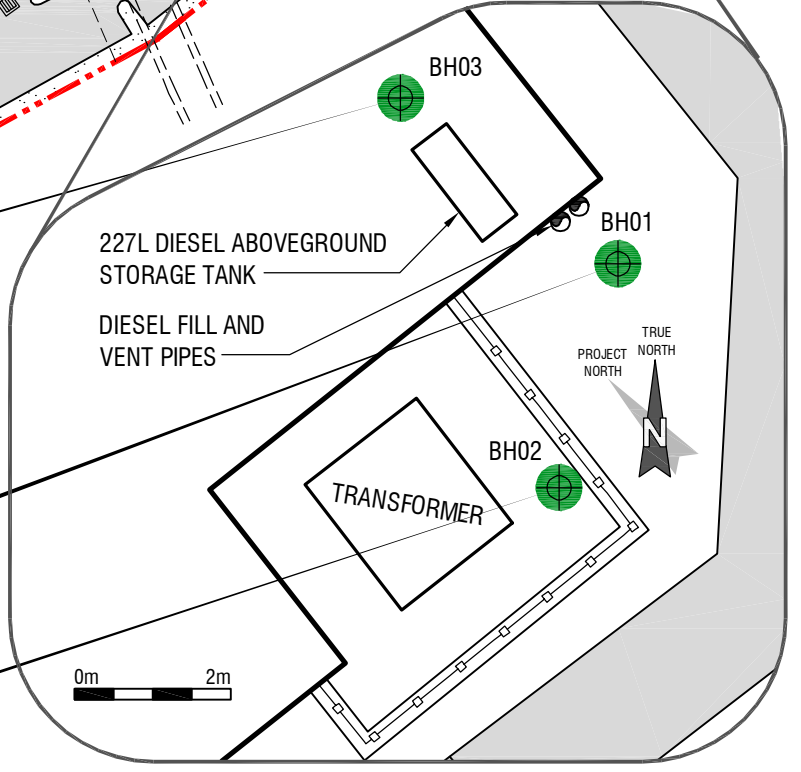
**SCS** TABLE 2 RESIDENTIAL / PARKLAND / INSTITUTIONAL (COARSE SOIL)  
**PHCs** PETROLEUM HYDROCARBONS

Borehole Sample	BH03-DP1
Date Sampled	27-Jul-21
Sample Depth (mbgs)	0 - 0.76
All parameters met the Table 2 SCS

Borehole Sample	BH03-DP3
Date Sampled	27-Jul-21
Sample Depth (mbgs)	0.76 - 1.45
All parameters met the Table 2 SCS

Borehole Sample	BH02-DP1
Date Sampled	27-Jul-21
Sample Depth (mbgs)	0 - 0.76
All parameters met the Table 2 SCS

Borehole Sample	BH02-DP2
Date Sampled	27-Jul-21
Sample Depth (mbgs)	0.76 - 1.45
All parameters met the Table 2 SCS

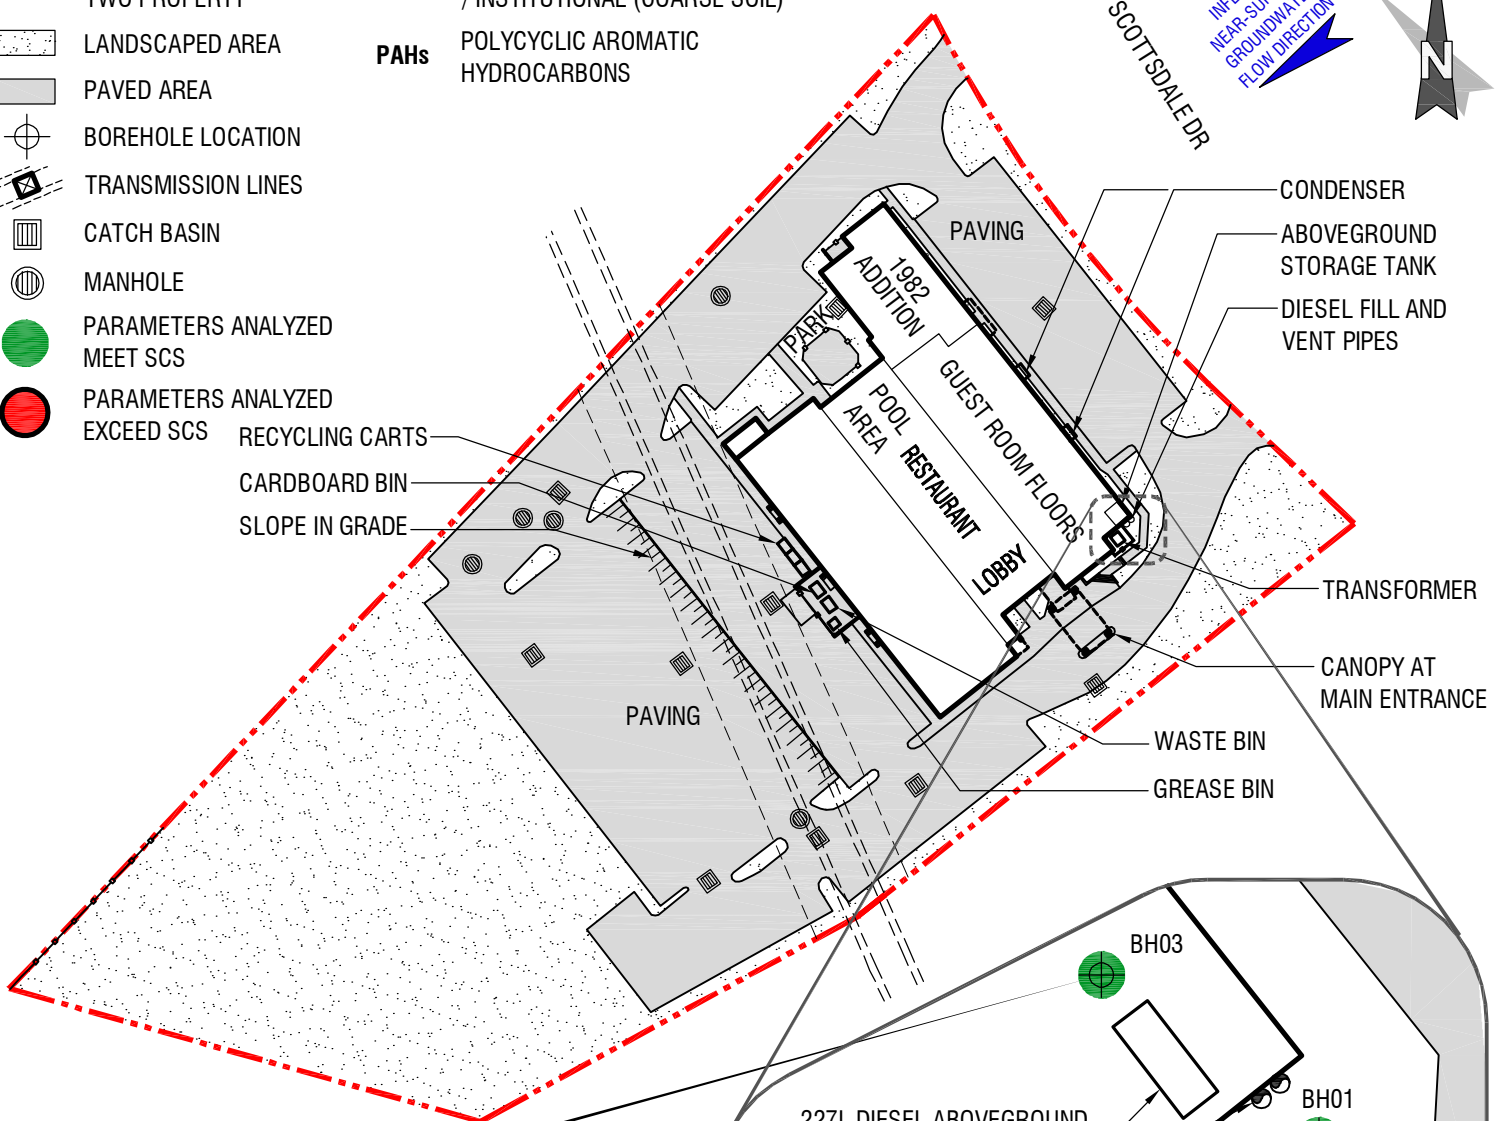
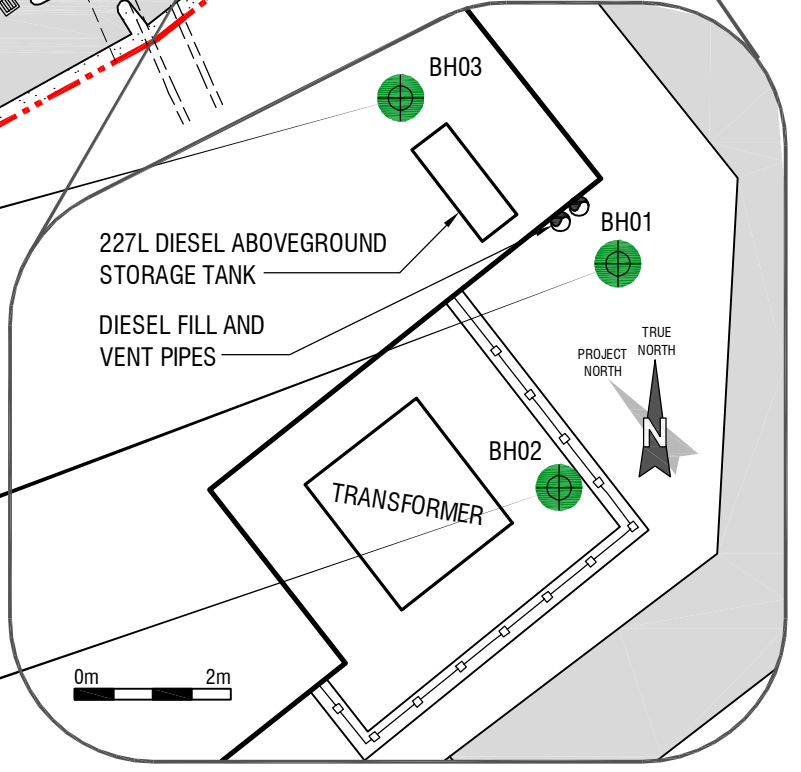
Borehole Sample	BH03-DP1
Date Sampled	27-Jul-21
Sample Depth (mbgs)	0 - 0.76
All parameters met the Table 2 SCS

Borehole Sample	BH03-DP3
Date Sampled	27-Jul-21
Sample Depth (mbgs)	0.76 - 1.45
All parameters met the Table 2 SCS

Borehole Sample	BH100-DP1B (duplicate of BH01-DP1B)
Date Sampled	27-Jul-21
Sample Depth (mbgs)	0.2 - 0.76
All parameters met the Table 2 SCS

Borehole Sample	BH01-DP4
Date Sampled	27-Jul-21
Sample Depth (mbgs)	2.0 - 2.3
All parameters met the Table 2 SCS

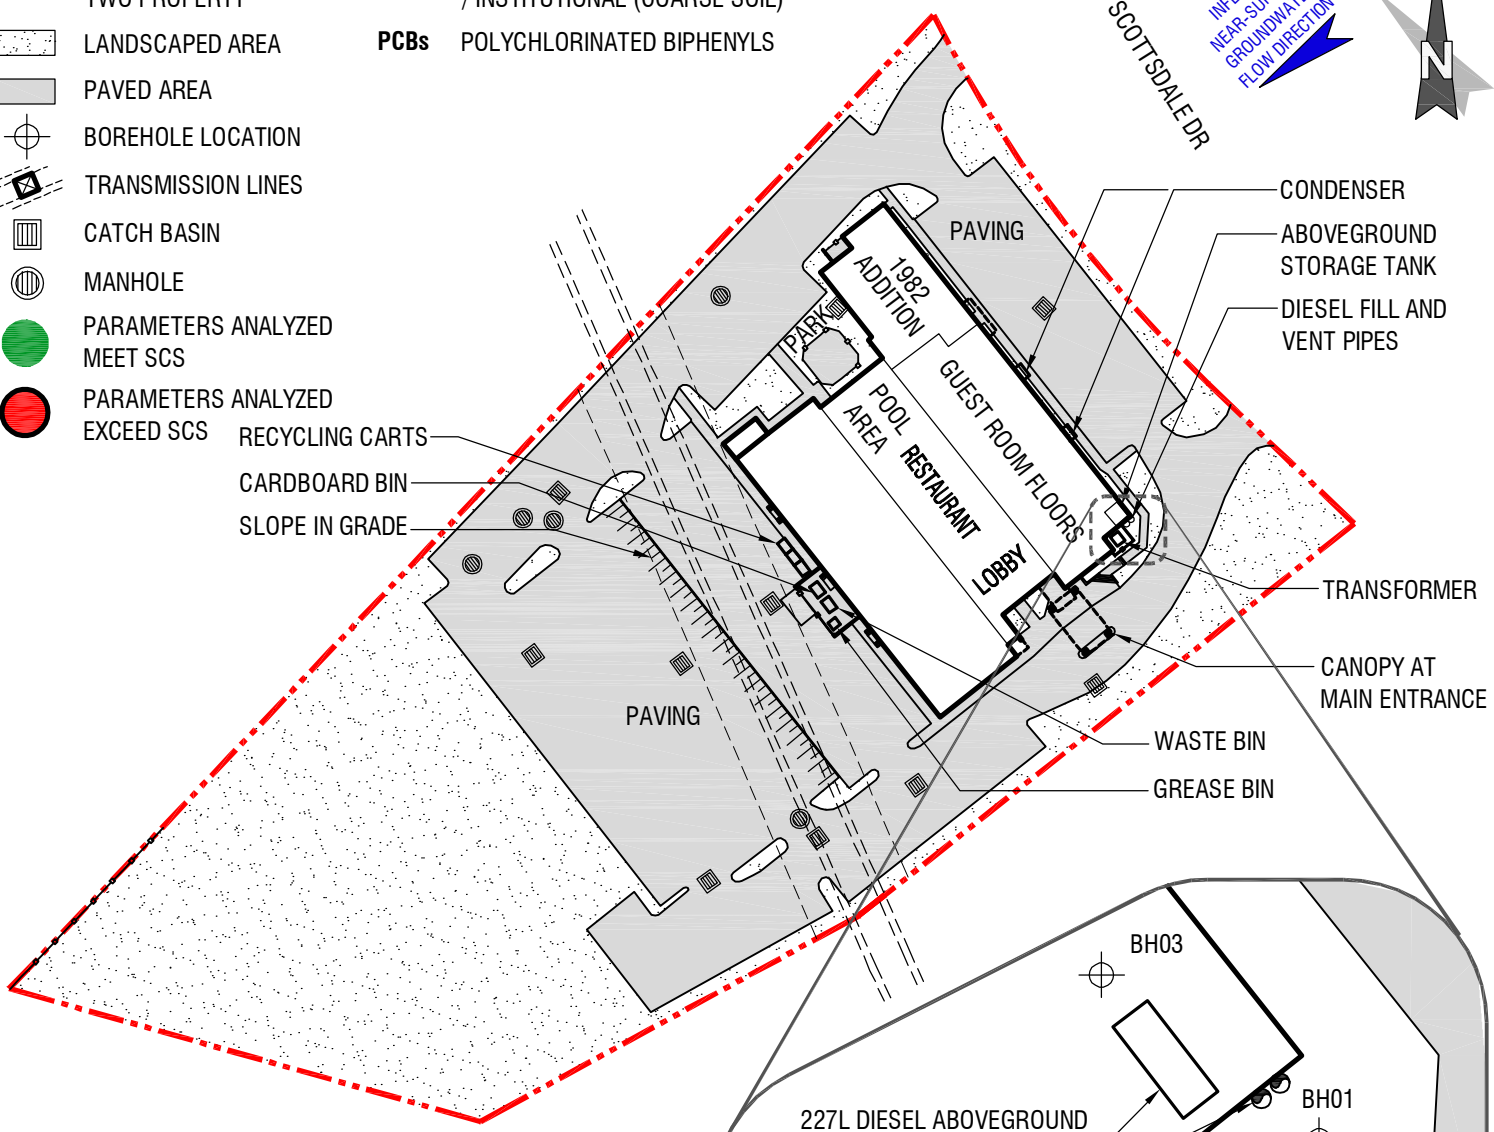
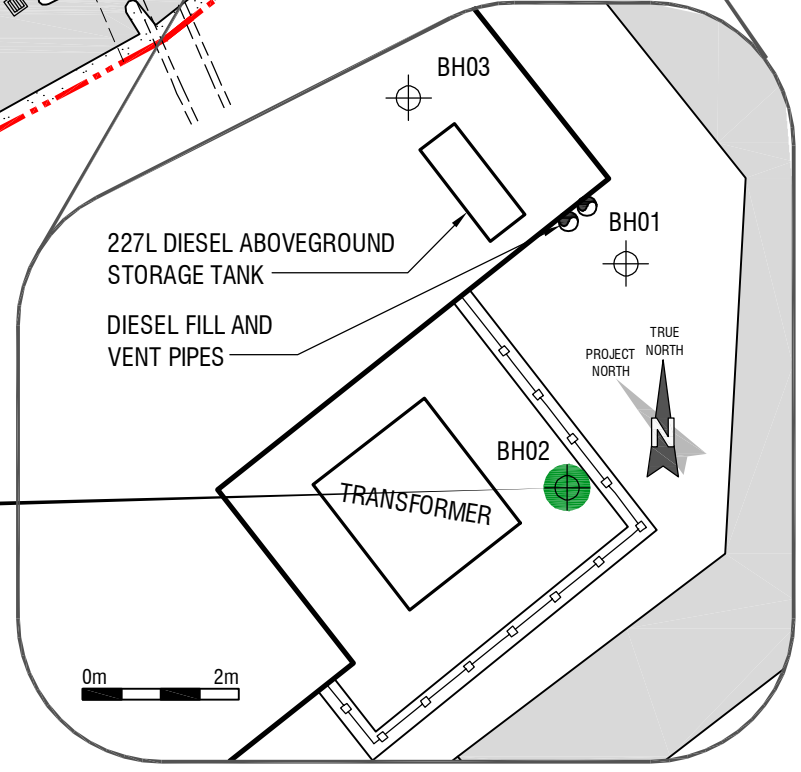
FIGURE NAME:  
**SOIL ANALYTICAL  
 RESULTS (PCBs)**  
 PROJECT No:  
**21-0006.03**  
 FIGURE No:  
**11**

**SCS** TABLE 2 RESIDENTIAL / PARKLAND / INSTITUTIONAL (COARSE SOIL)  
**PCBs** POLYCHLORINATED BIPHENYLS

Borehole Sample	BH02-DP1
Date Sampled	27-Jul-21
Sample Depth (mbgs)	0 - 0.76
All parameters met the Table 2 SCS	
Borehole Sample	BH02-DP2
Date Sampled	27-Jul-21
Sample Depth (mbgs)	0.76 - 1.45
All parameters met the Table 2 SCS	
Borehole Sample	BH200-DP1 (duplicate of BH02-
Date Sampled	27-Jul-21
Sample Depth (mbgs)	0 - 0.76
All parameters met the Table 2 SCS

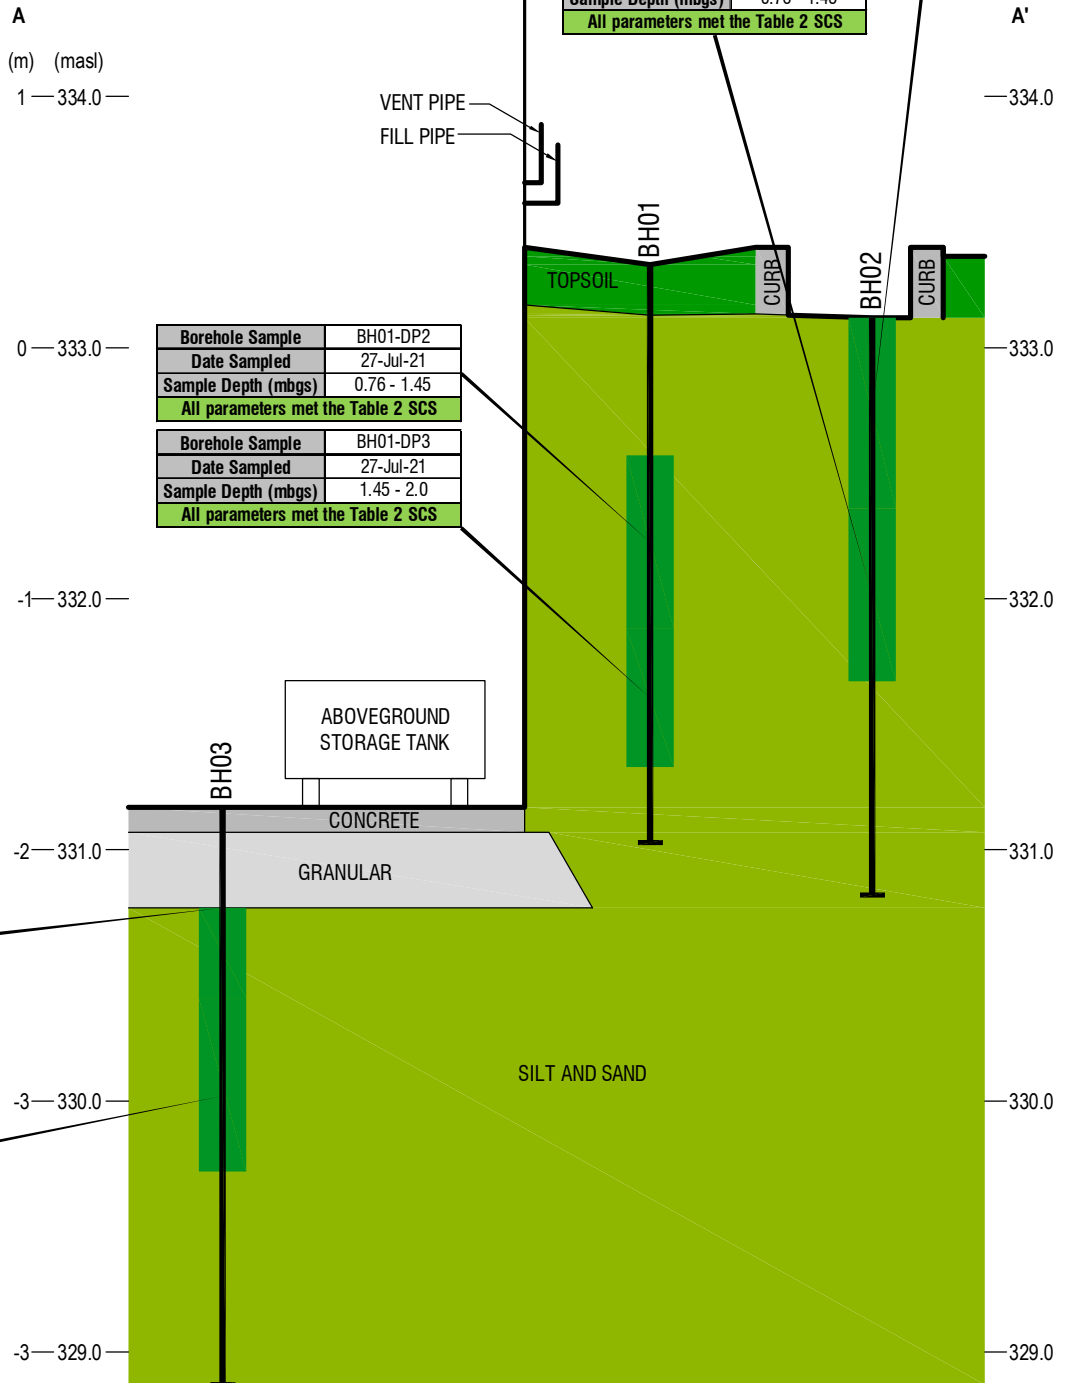
FIGURE NAME: **CROSS SECTION A - A' (VOCs, BTEX, THMs)**  
 PROJECT No: **21-0006.03**  
 FIGURE No: **13A**

Borehole Sample	BH300-DP1
Date Sampled	27-Jul-21
Sample Depth (mbgs)	0 - 0.76
All parameters met the Table 2 SCS

Borehole Sample	BH03-DP3
Date Sampled	27-Jul-21
Sample Depth (mbgs)	0.76 - 1.45
All parameters met the Table 2 SCS

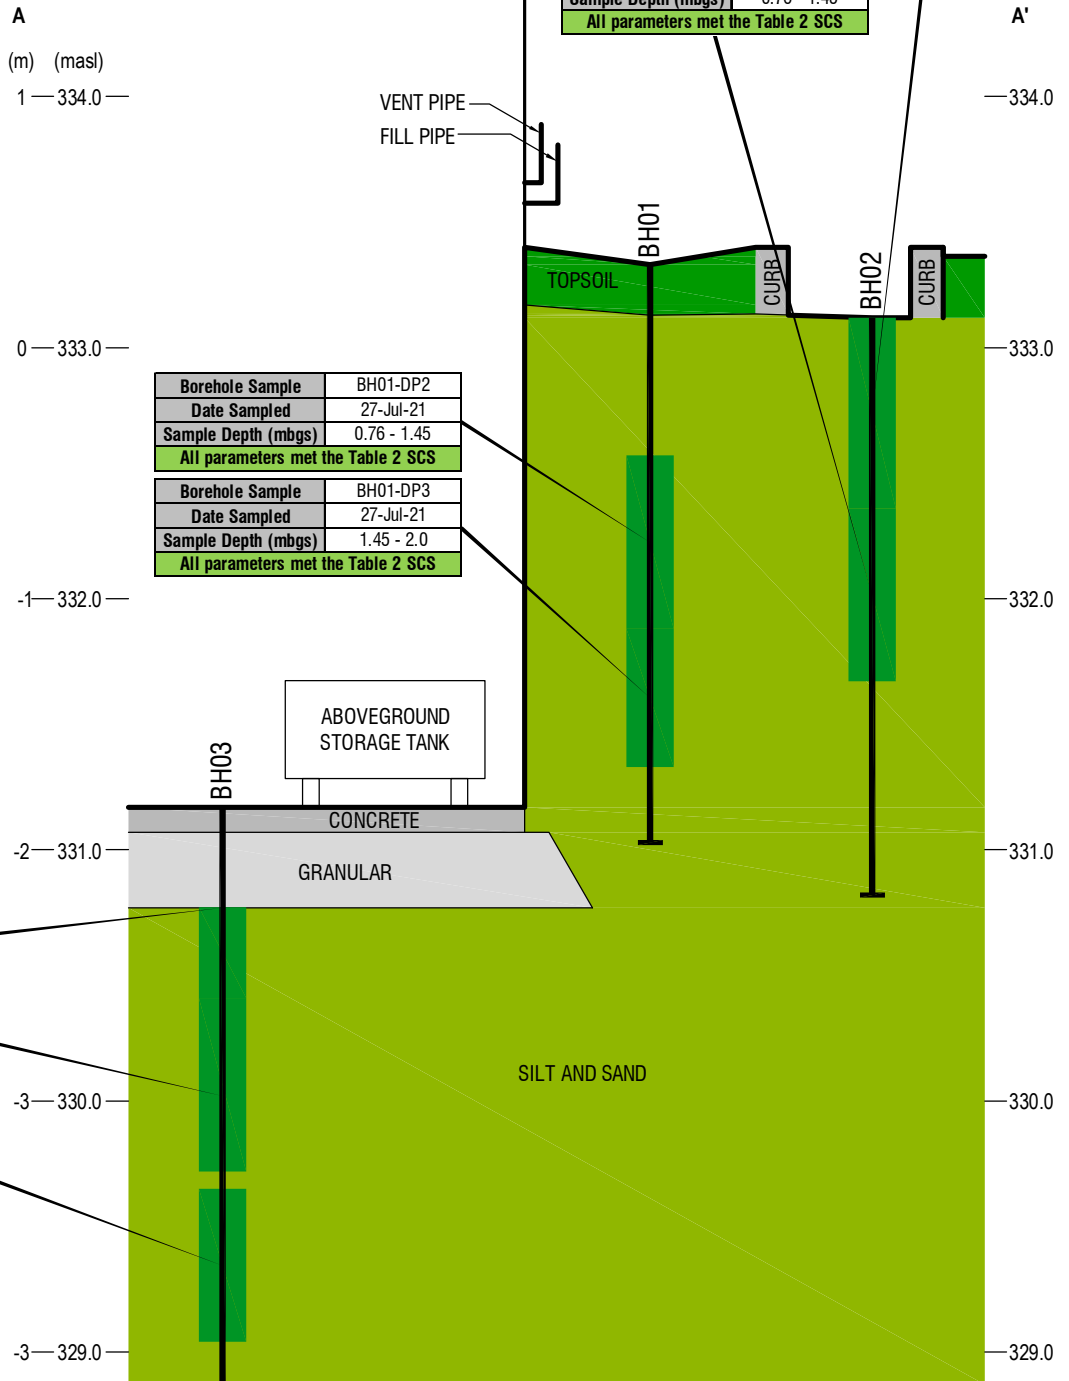
FIGURE NAME:  
**CROSS SECTION A - A'  
(PHCs)**  
PROJECT No:  
**21-0006.03**  
FIGURE No:  
**14A**

Borehole Sample	BH03-DP3
Date Sampled	27-Jul-21
Sample Depth (mbgs)	0.76 - 1.45
All parameters met the Table 2 SCS

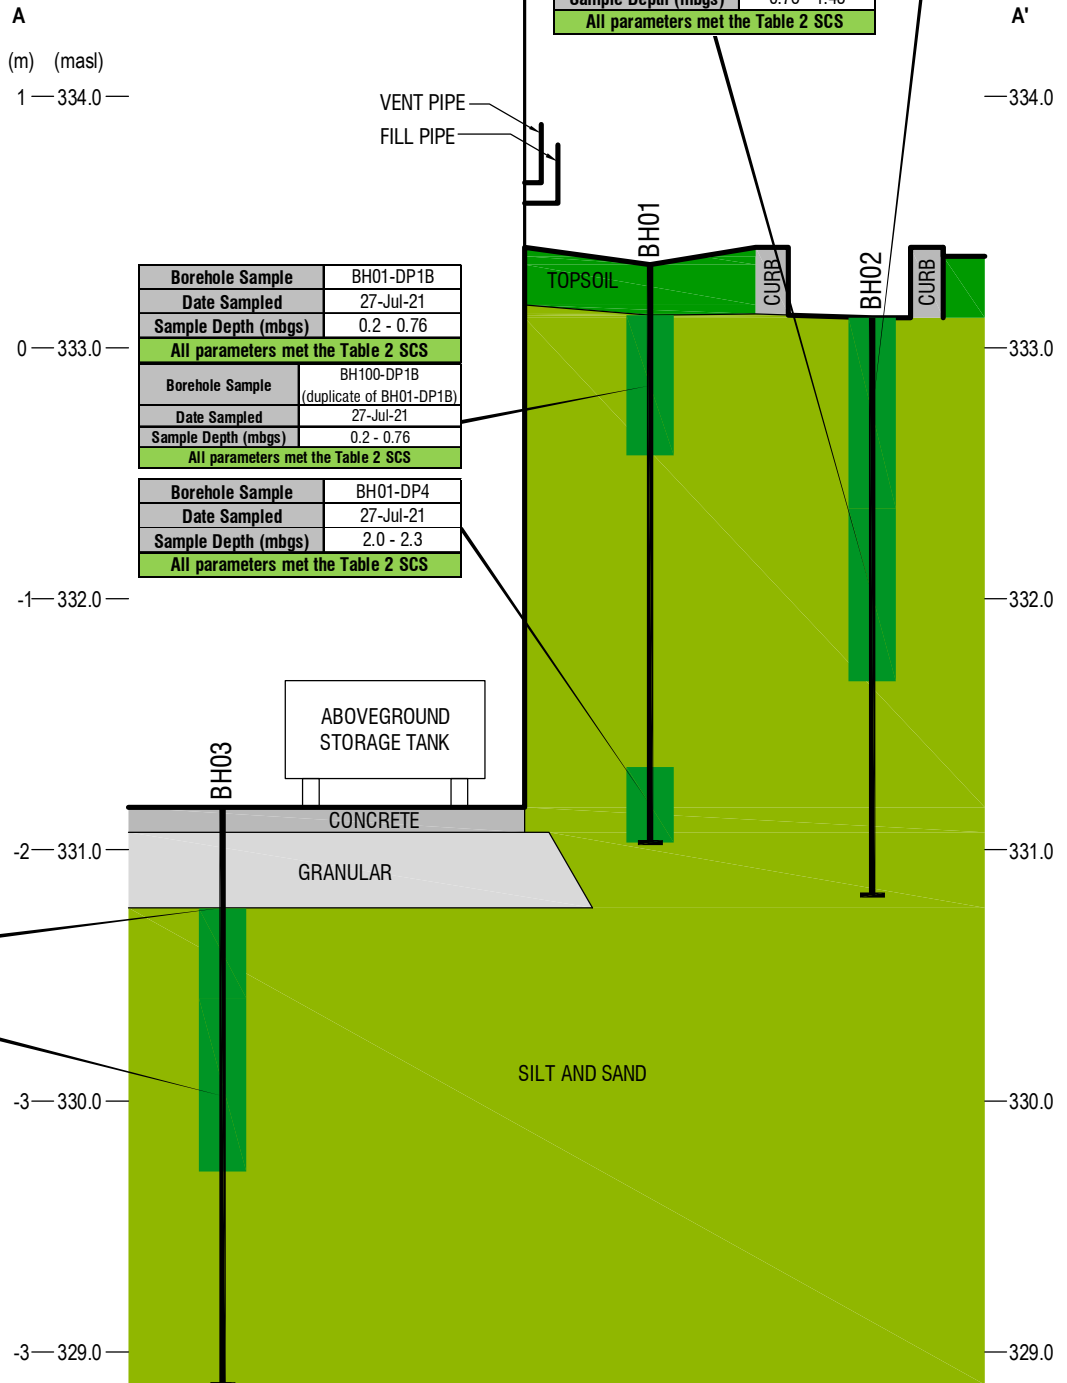
FIGURE NAME:  
**CROSS SECTION A - A'  
 (PAHs)**  
 PROJECT No:  
**21-0006.03**  
 FIGURE No:  
**15A**

Borehole Sample	BH02-DP1
Date Sampled	27-Jul-21
Sample Depth (mbgs)	0 - 0.76
All parameters met the Table 2 SCS

Borehole Sample	BH02-DP2
Date Sampled	27-Jul-21
Sample Depth (mbgs)	0.76 - 1.45
All parameters met the Table 2 SCS
