PHASE I ENVIRONMENTAL SITE ASSESSMENT REPORT

81 COLLEGE AVENUE WEST
GUELPH, ONTARIO

LDS PROJECT NO. GE-01100

NOVEMBER 20, 2023

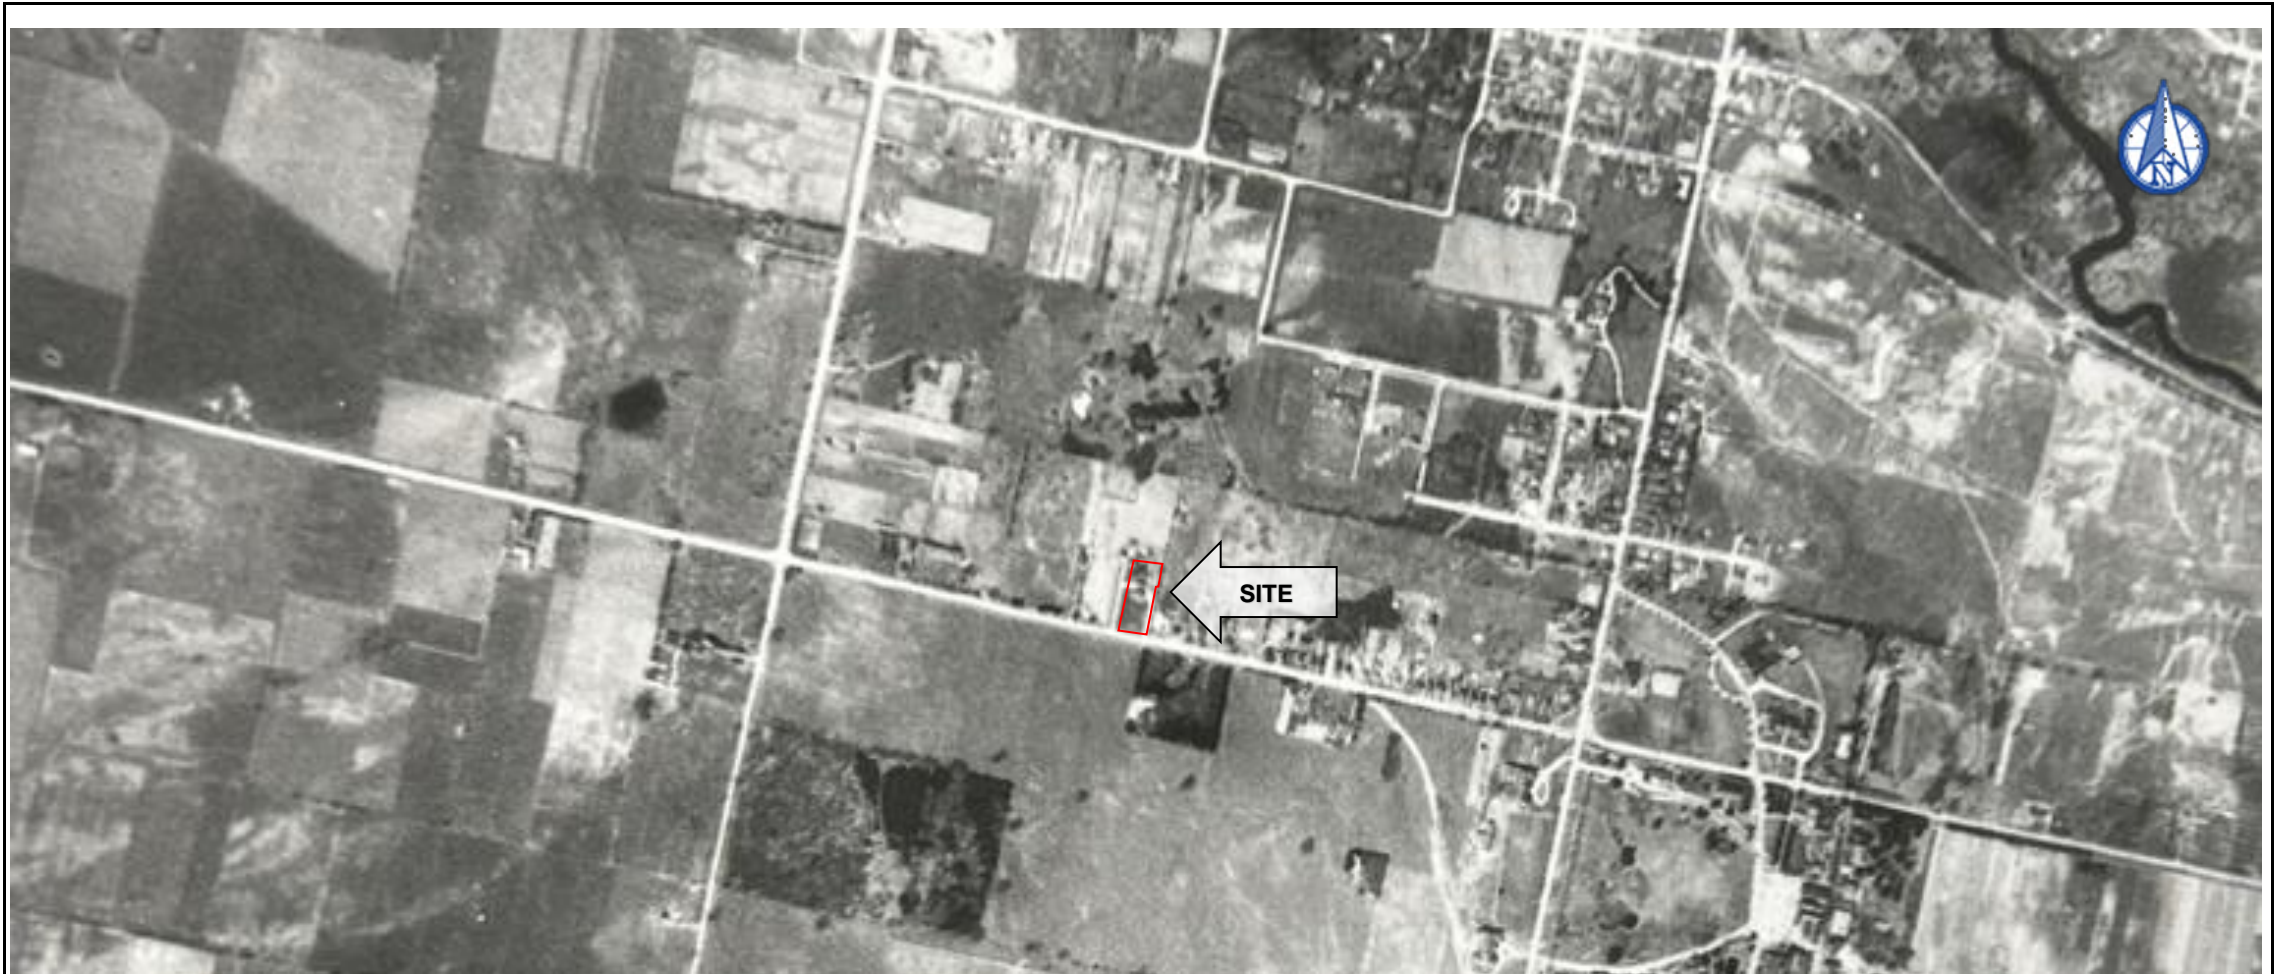
| <p>DRAWING NAME</p> <p>1930 Aerial Photograph</p> | | <p>DATE</p> <p>November 2023</p> | <p>DRAWING NO.</p> <p>A1</p> |

| Year | Site Details | Details of Surrounding Properties |
|---|--|--|
| 1930 | Site appeared to be part of a larger farm/farmstead. Due to the poor quality/resolution of the aerial photograph, specific features could not be determined. | Surrounding land use was predominantly agricultural with some residential dwellings noted along the north side of College Avenue West, west of Gorden Street. |

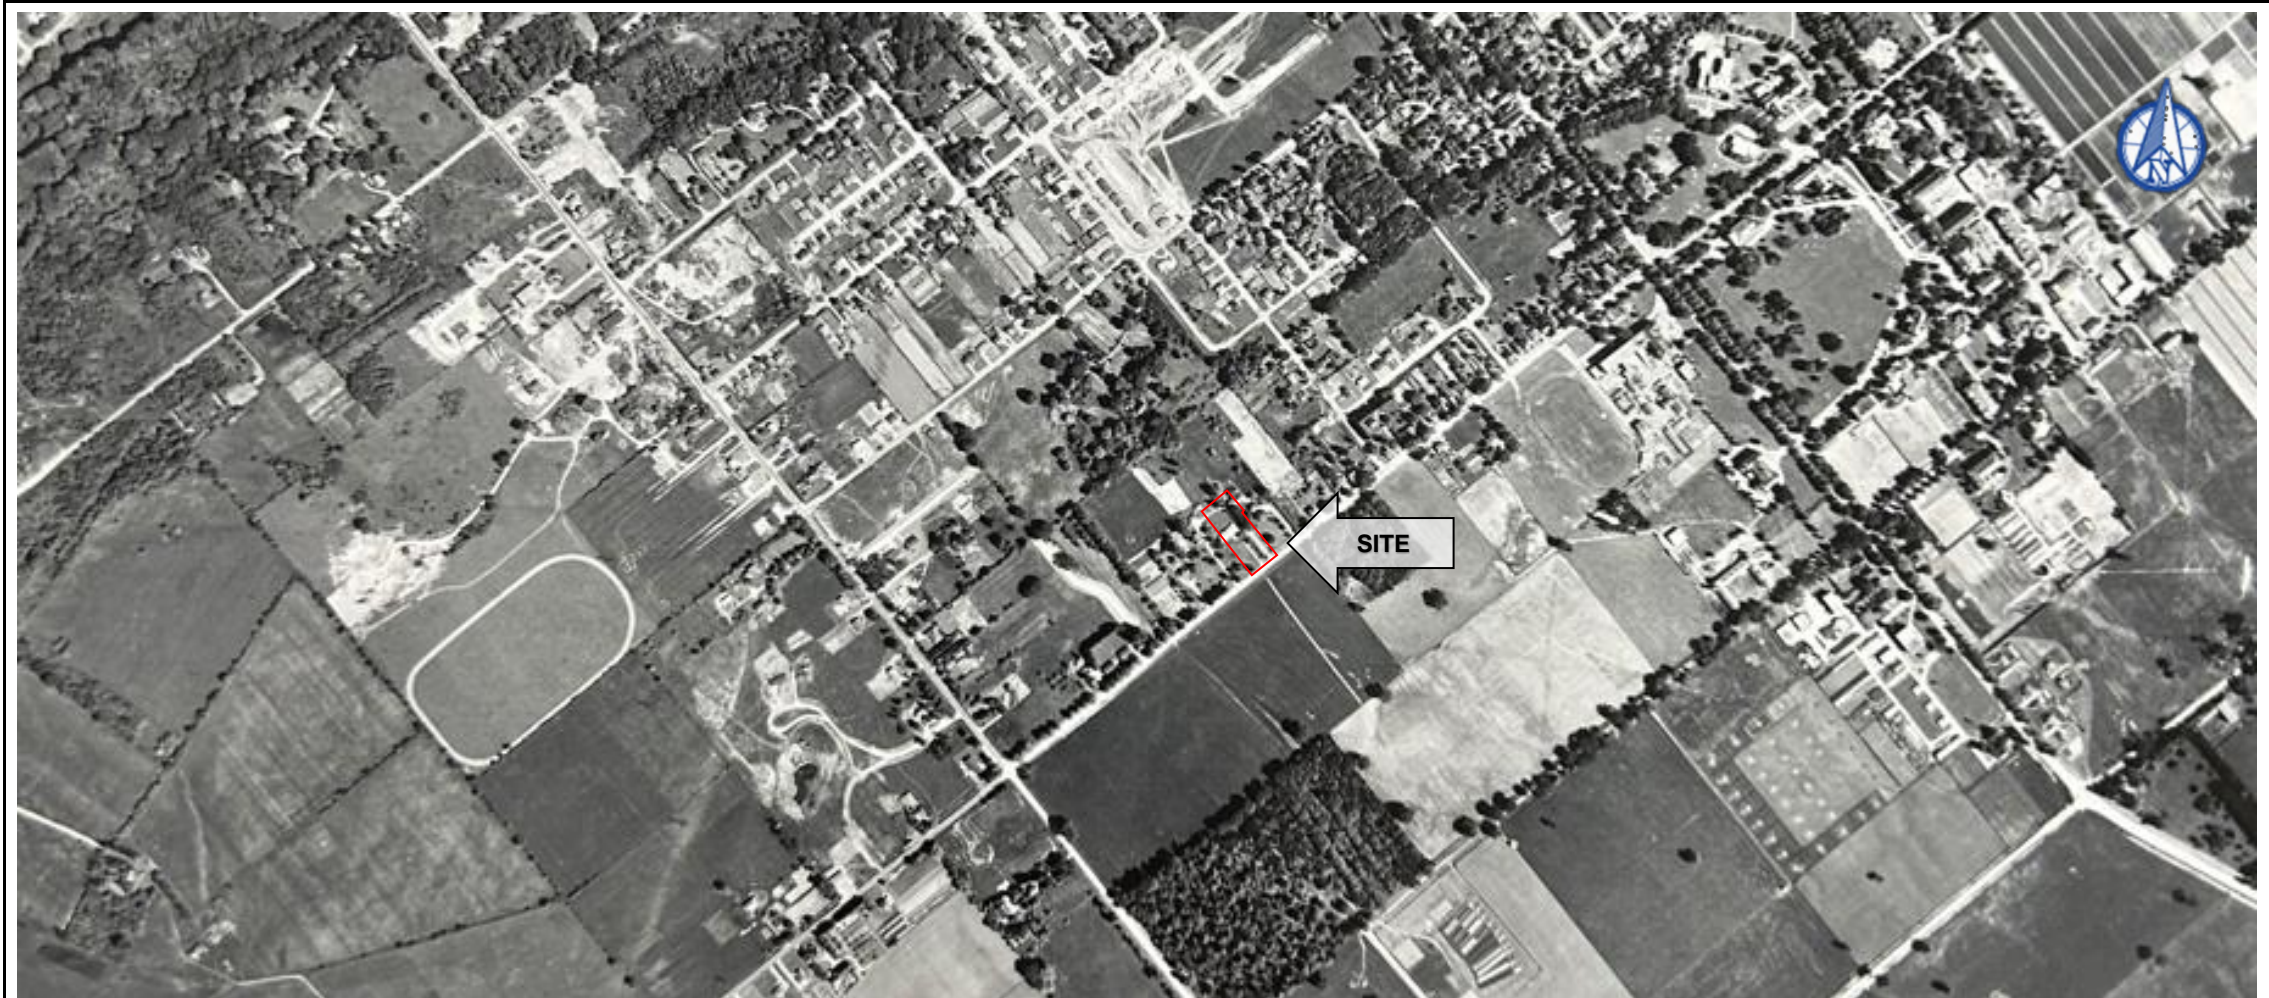
| <p>DRAWING NAME</p> <p>1955 Aerial Photograph</p> | | <p>DATE</p> <p>November 2023</p> | <p>DRAWING NO.</p> <p>A2</p> |

| Year | Site Details | Details of Surrounding Properties |
|---|--|--|
| 1955 | A residential dwelling (inferred to be original portion of the current Site building), based on size, outline, and position within the lot, was observed on the lot. | An increase in residential development was noted along College Avenue West, however, the predominant land use remained agricultural. A larger campus (current University of Guelph) is shown to the far southeast, outside the Phase I Study Area. |

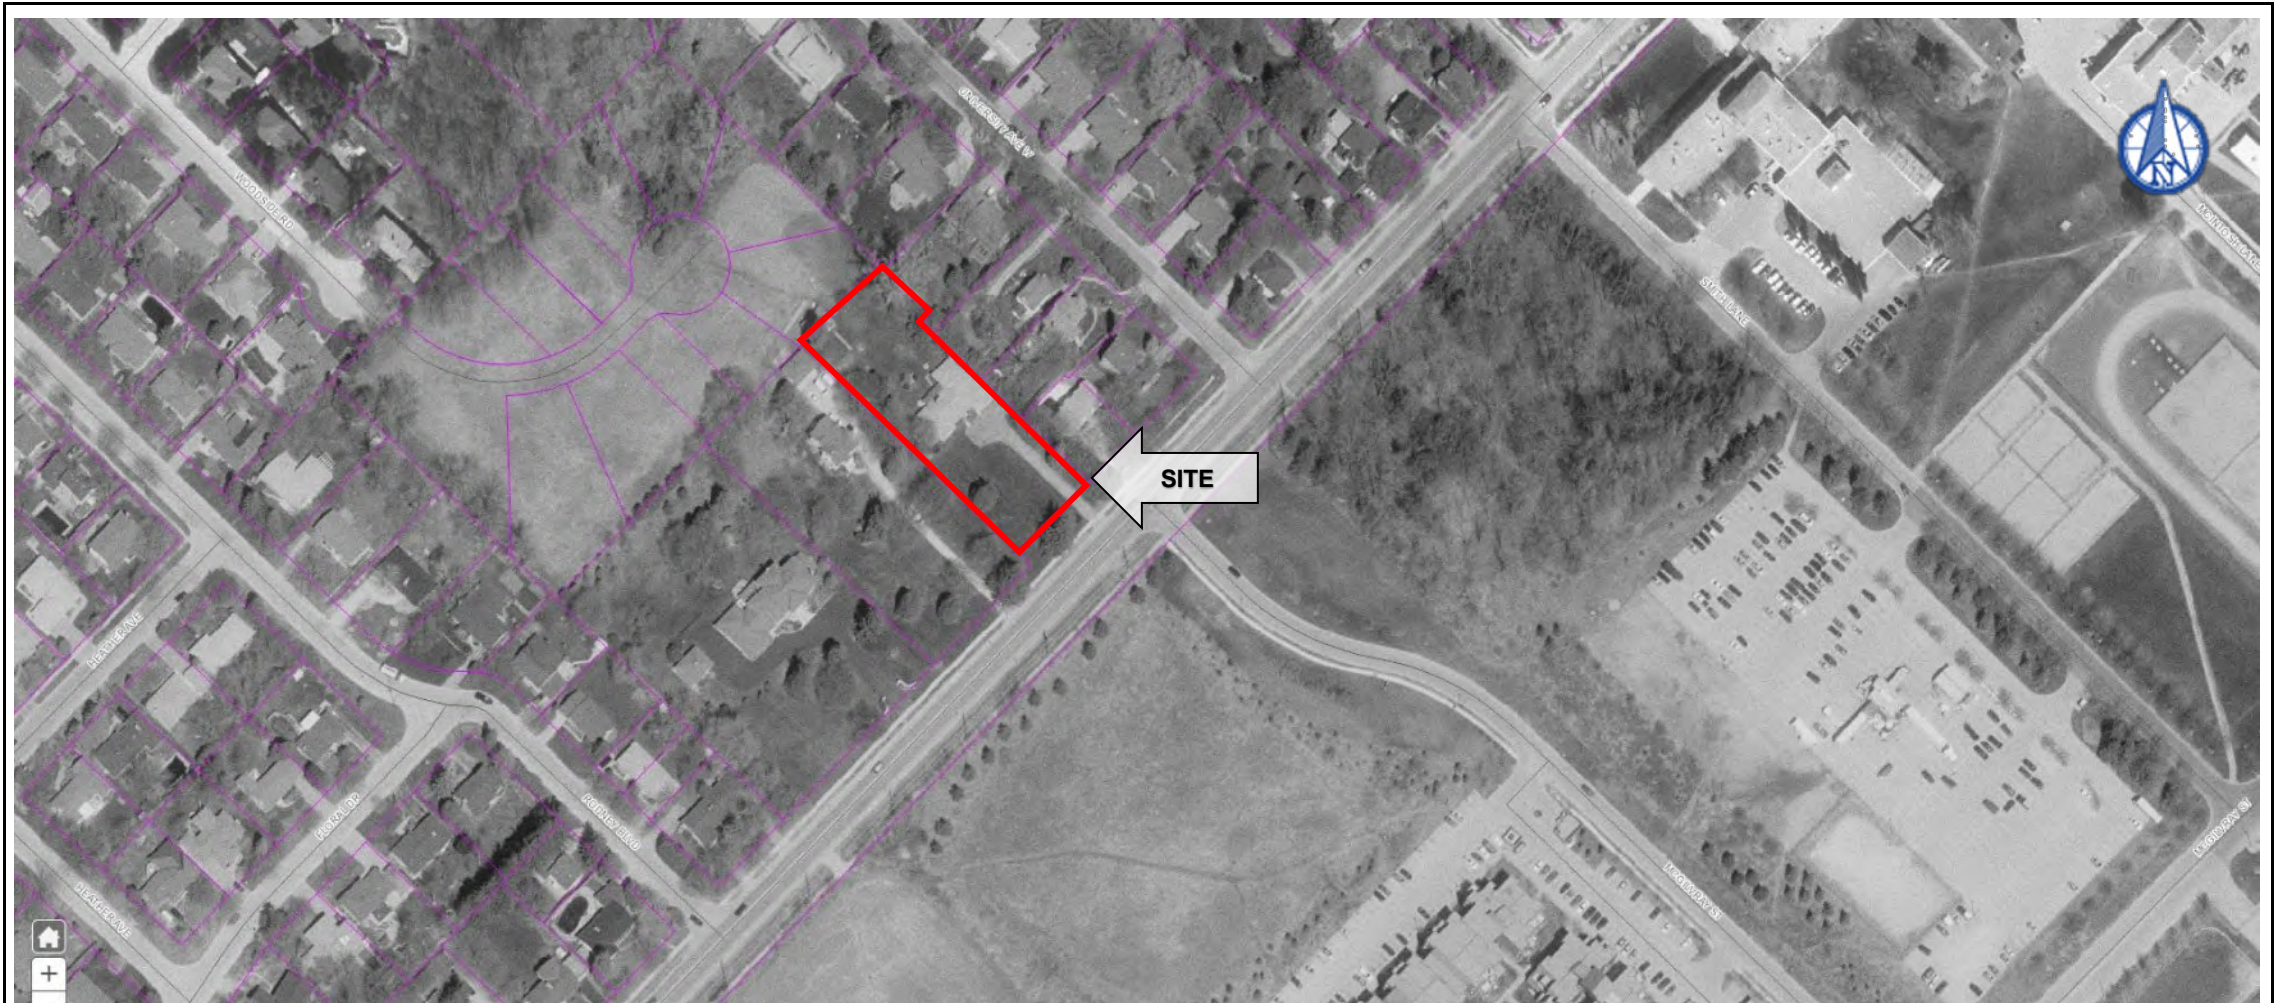
| <p>DRAWING NAME</p> <p>2000 Aerial Photograph</p> | | <p>DATE</p> <p>November 2023</p> | <p>DRAWING NO.</p> <p>A6</p> |

| Year | Site Details | Details of Surrounding Properties |
|---|--|--|
| 2000 | No significant changes were noted on-Site. Land use remains residential. | Current student apartments and parking lot was constructed to the south of the Site. No other significant changes were noted on neighbouring properties when compared to the 1975 aerial photograph. |

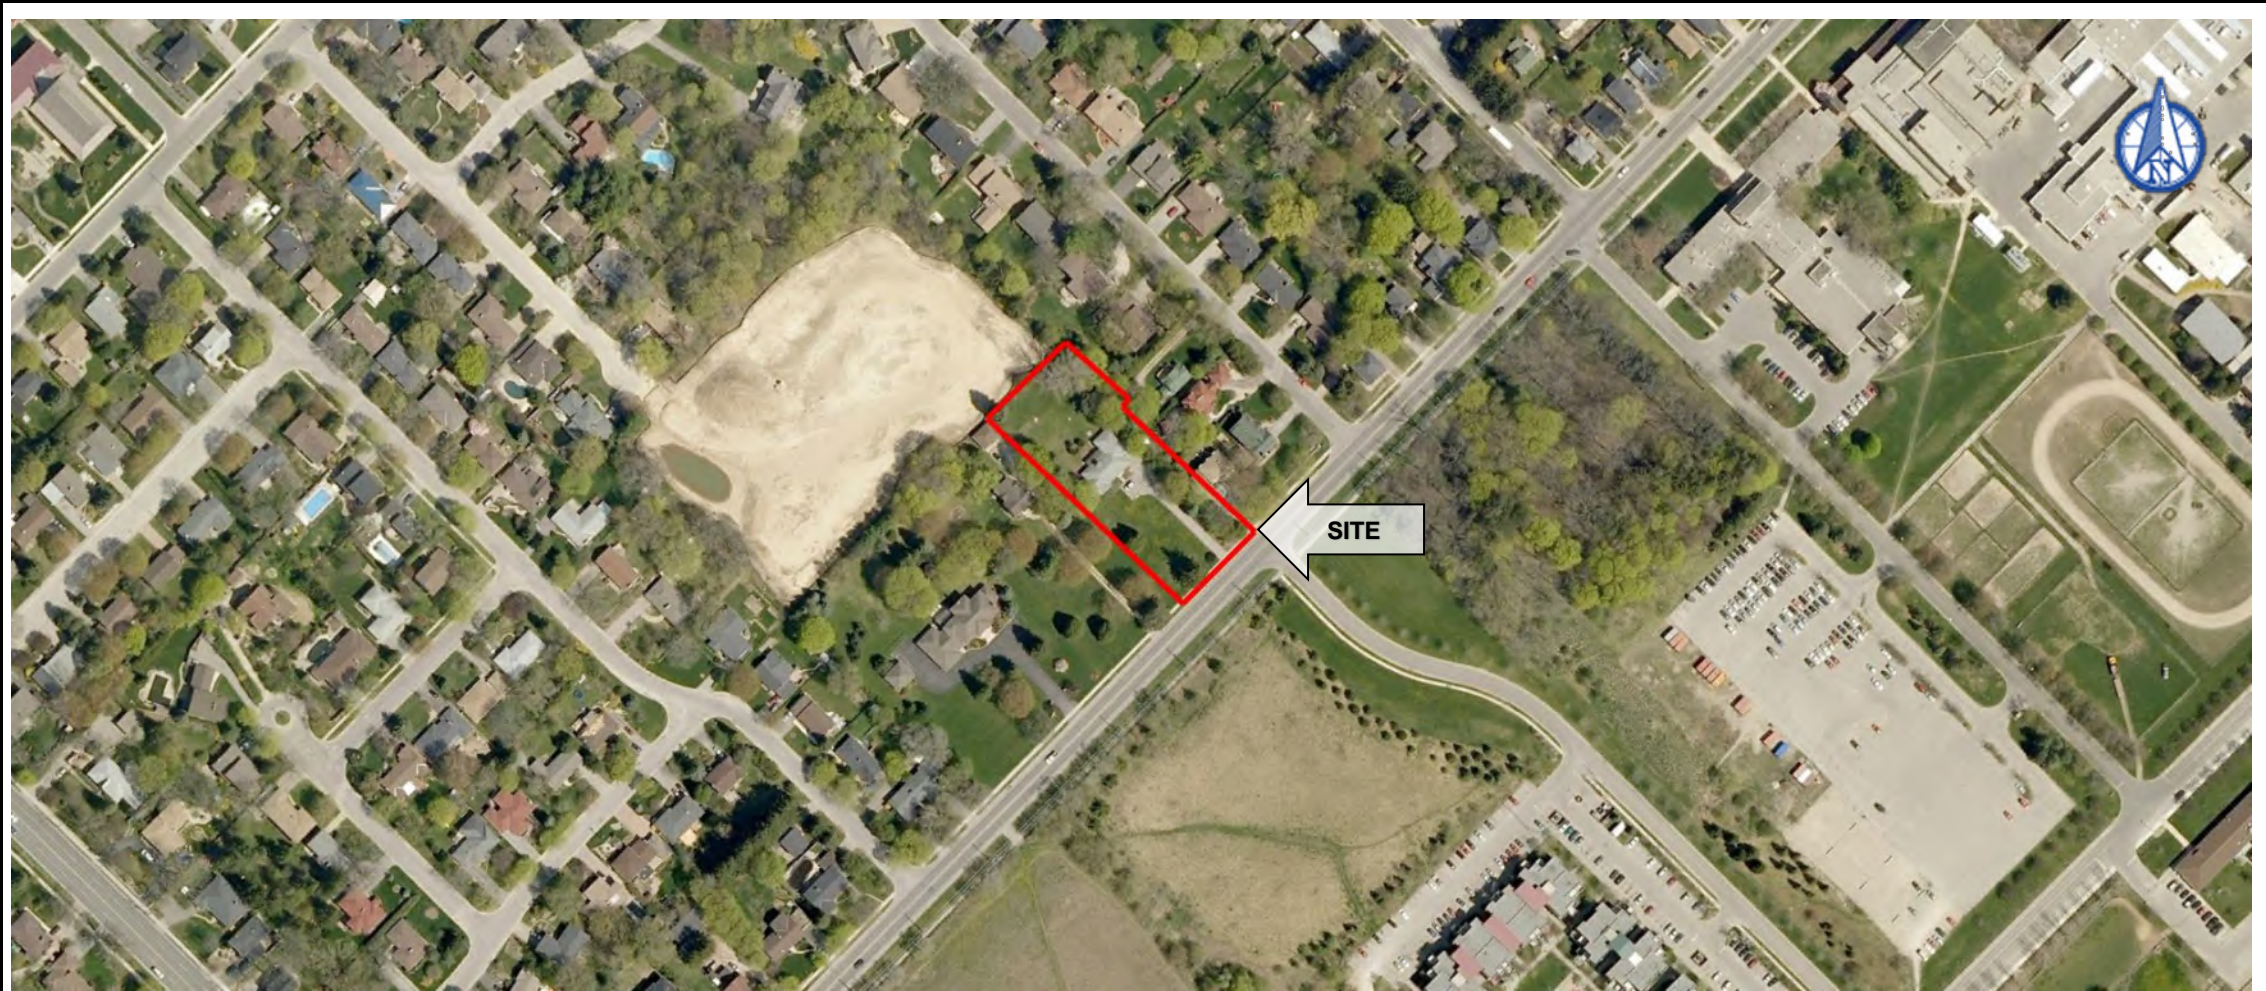
| <p>DRAWING NAME</p> <p>2006 Aerial Photograph</p> | | <p>DATE</p> <p>November 2023</p> | <p>DRAWING NO.</p> <p>A7</p> |

| Year | Site Details | Details of Surrounding Properties |
|---|--|--|
| 2006 | No changes were noted on-Site. | Ground disturbances were noted on the neighbouring parcels to the north, suggesting that the parcel was being prepared for development. |

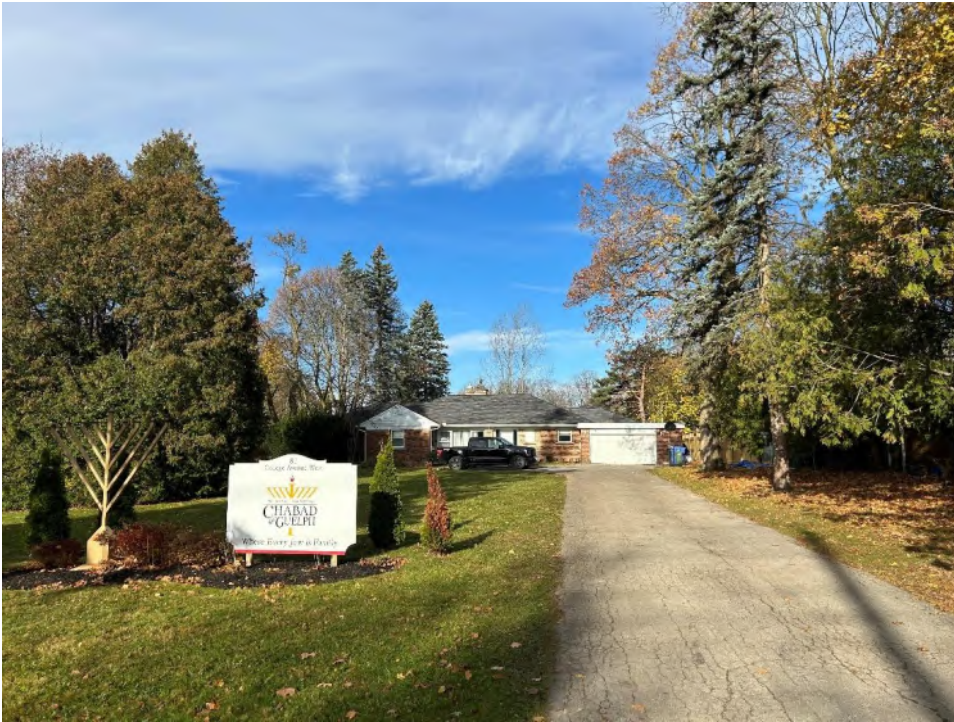
Photograph 1:

Paved entrance driveway and current Site building located at 82 College Avenue West as observed from roadway south of the Site.

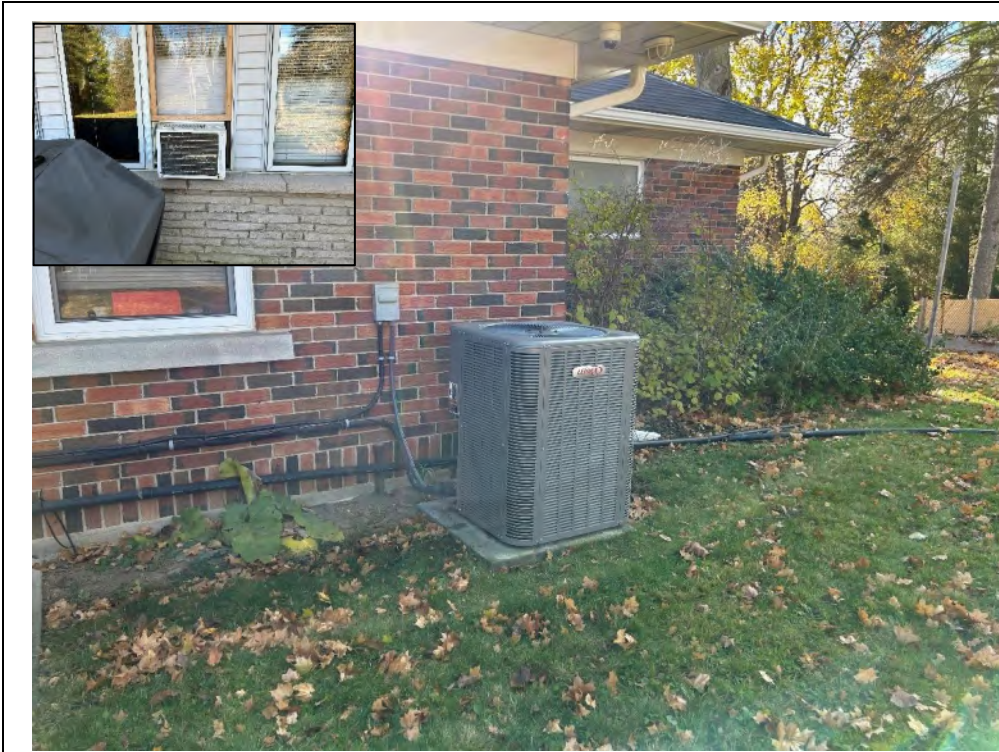
Photograph 5:

Pad-mounted air conditioning unit on north side of Site building as well as window-mounted air conditioning units currently service the Site building.

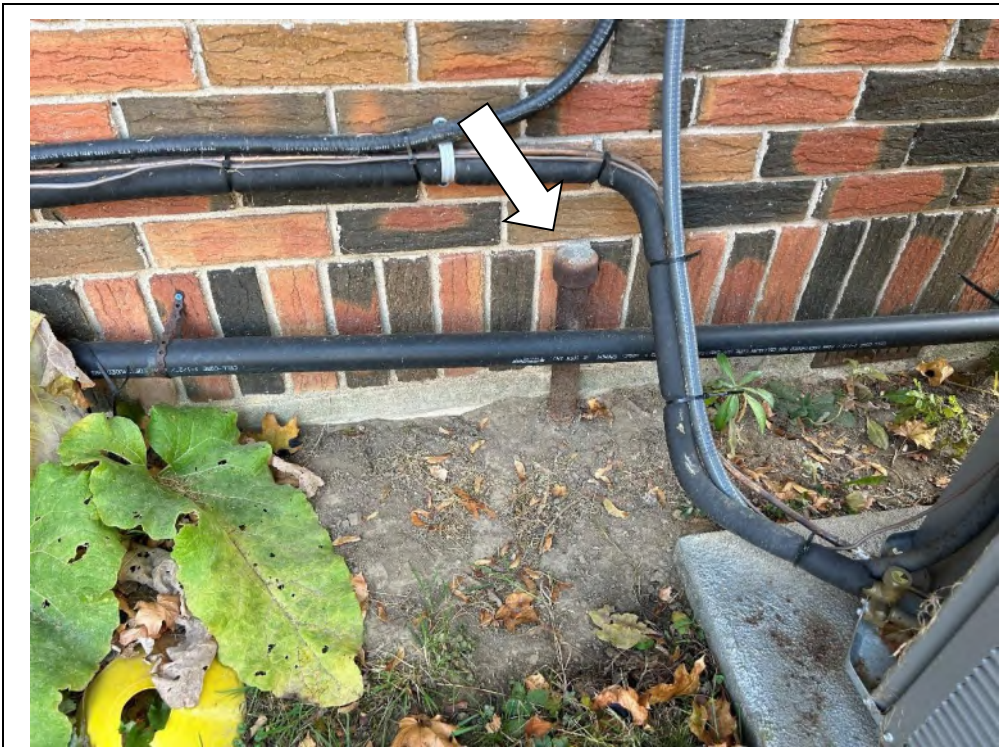
Photograph 6:

It is noted that a capped pipe was noted on the north side of the Site building (see Photograph 6, Appendix C). The location and appearance of this pipe suggests that a furnace oil tank may have formerly been located within the basement of the building (and pipe used as fill pipe). At the time of LDS's Site visit the building was serviced by a natural gas-powered furnace and the concrete flooring was observed throughout the basement.

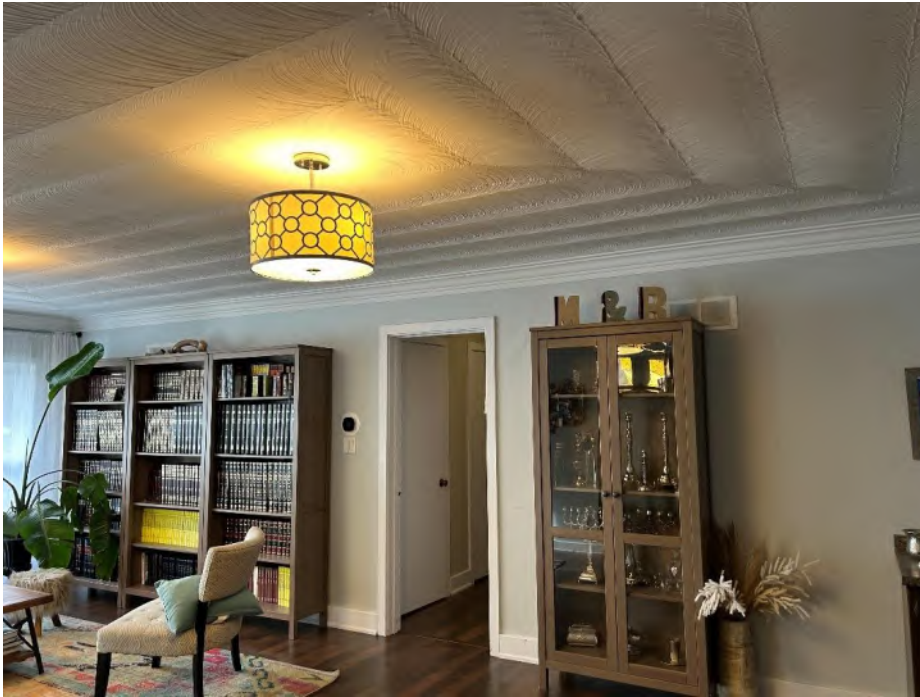
Photograph 7:

Description:
Much of the interior of the current Site building has been significantly renovated in recent years, shown here is the front parlour.

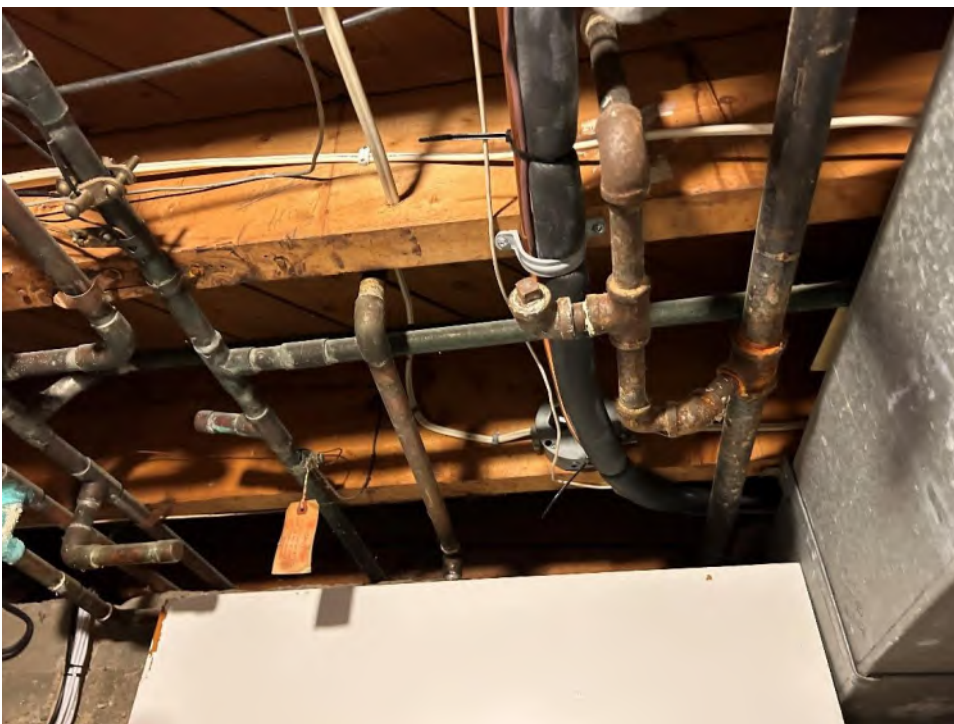
Photograph 12:

Piping within accessible areas of the basement were generally noted as bare/

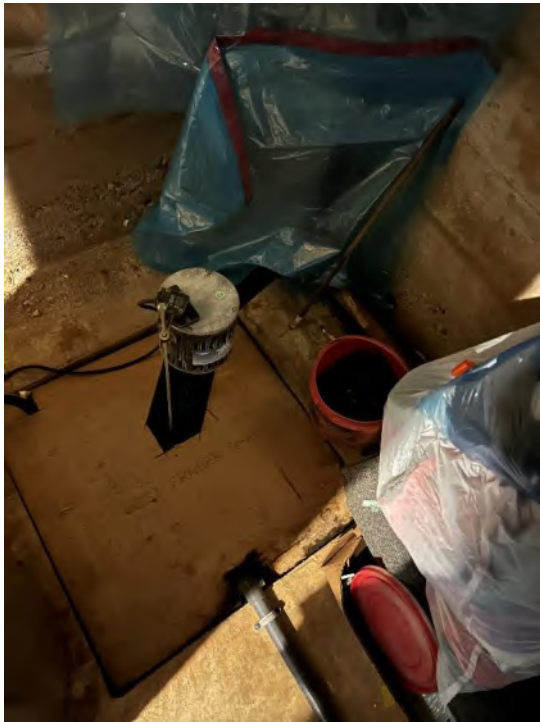
Photograph 13:

A sump pump is located within the basement. No other pits or lagoons were observed at the time of LDS' Site visit.

Description:
A sump pump is located within the basement

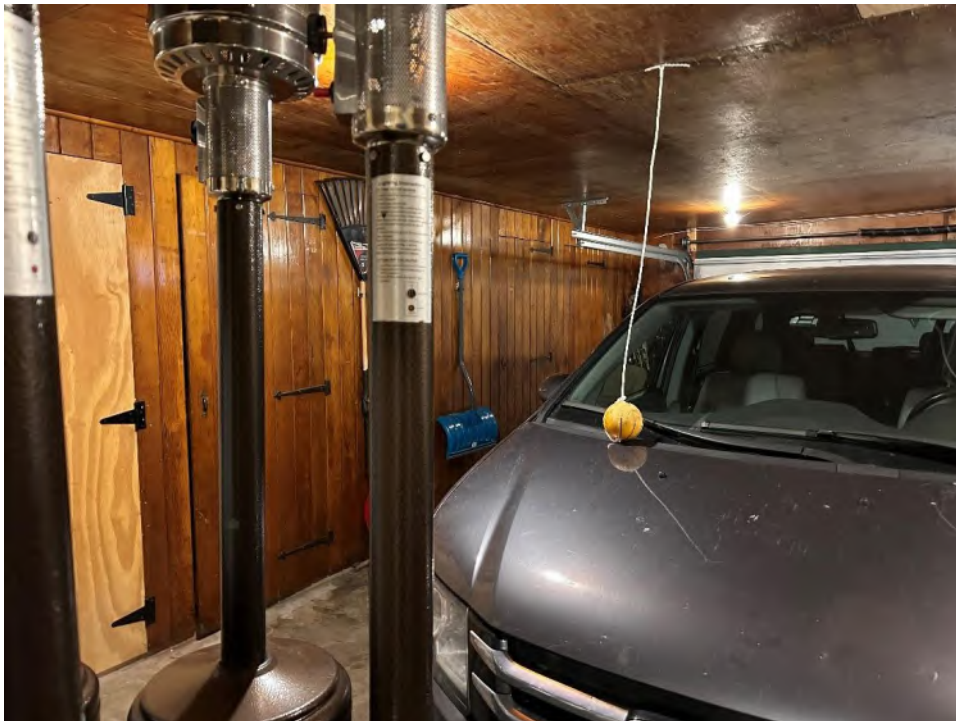
Photograph 14:

Description:
Interior of garage on east side of Site building.
