## PHASE I ENVIRONMENTAL SITE ASSESSMENT

**81 COLLEGE AVENUE WEST, GUELPH, ONTARIO**

PROJECT NO. GE-001100

DECEMBER 1, 2025

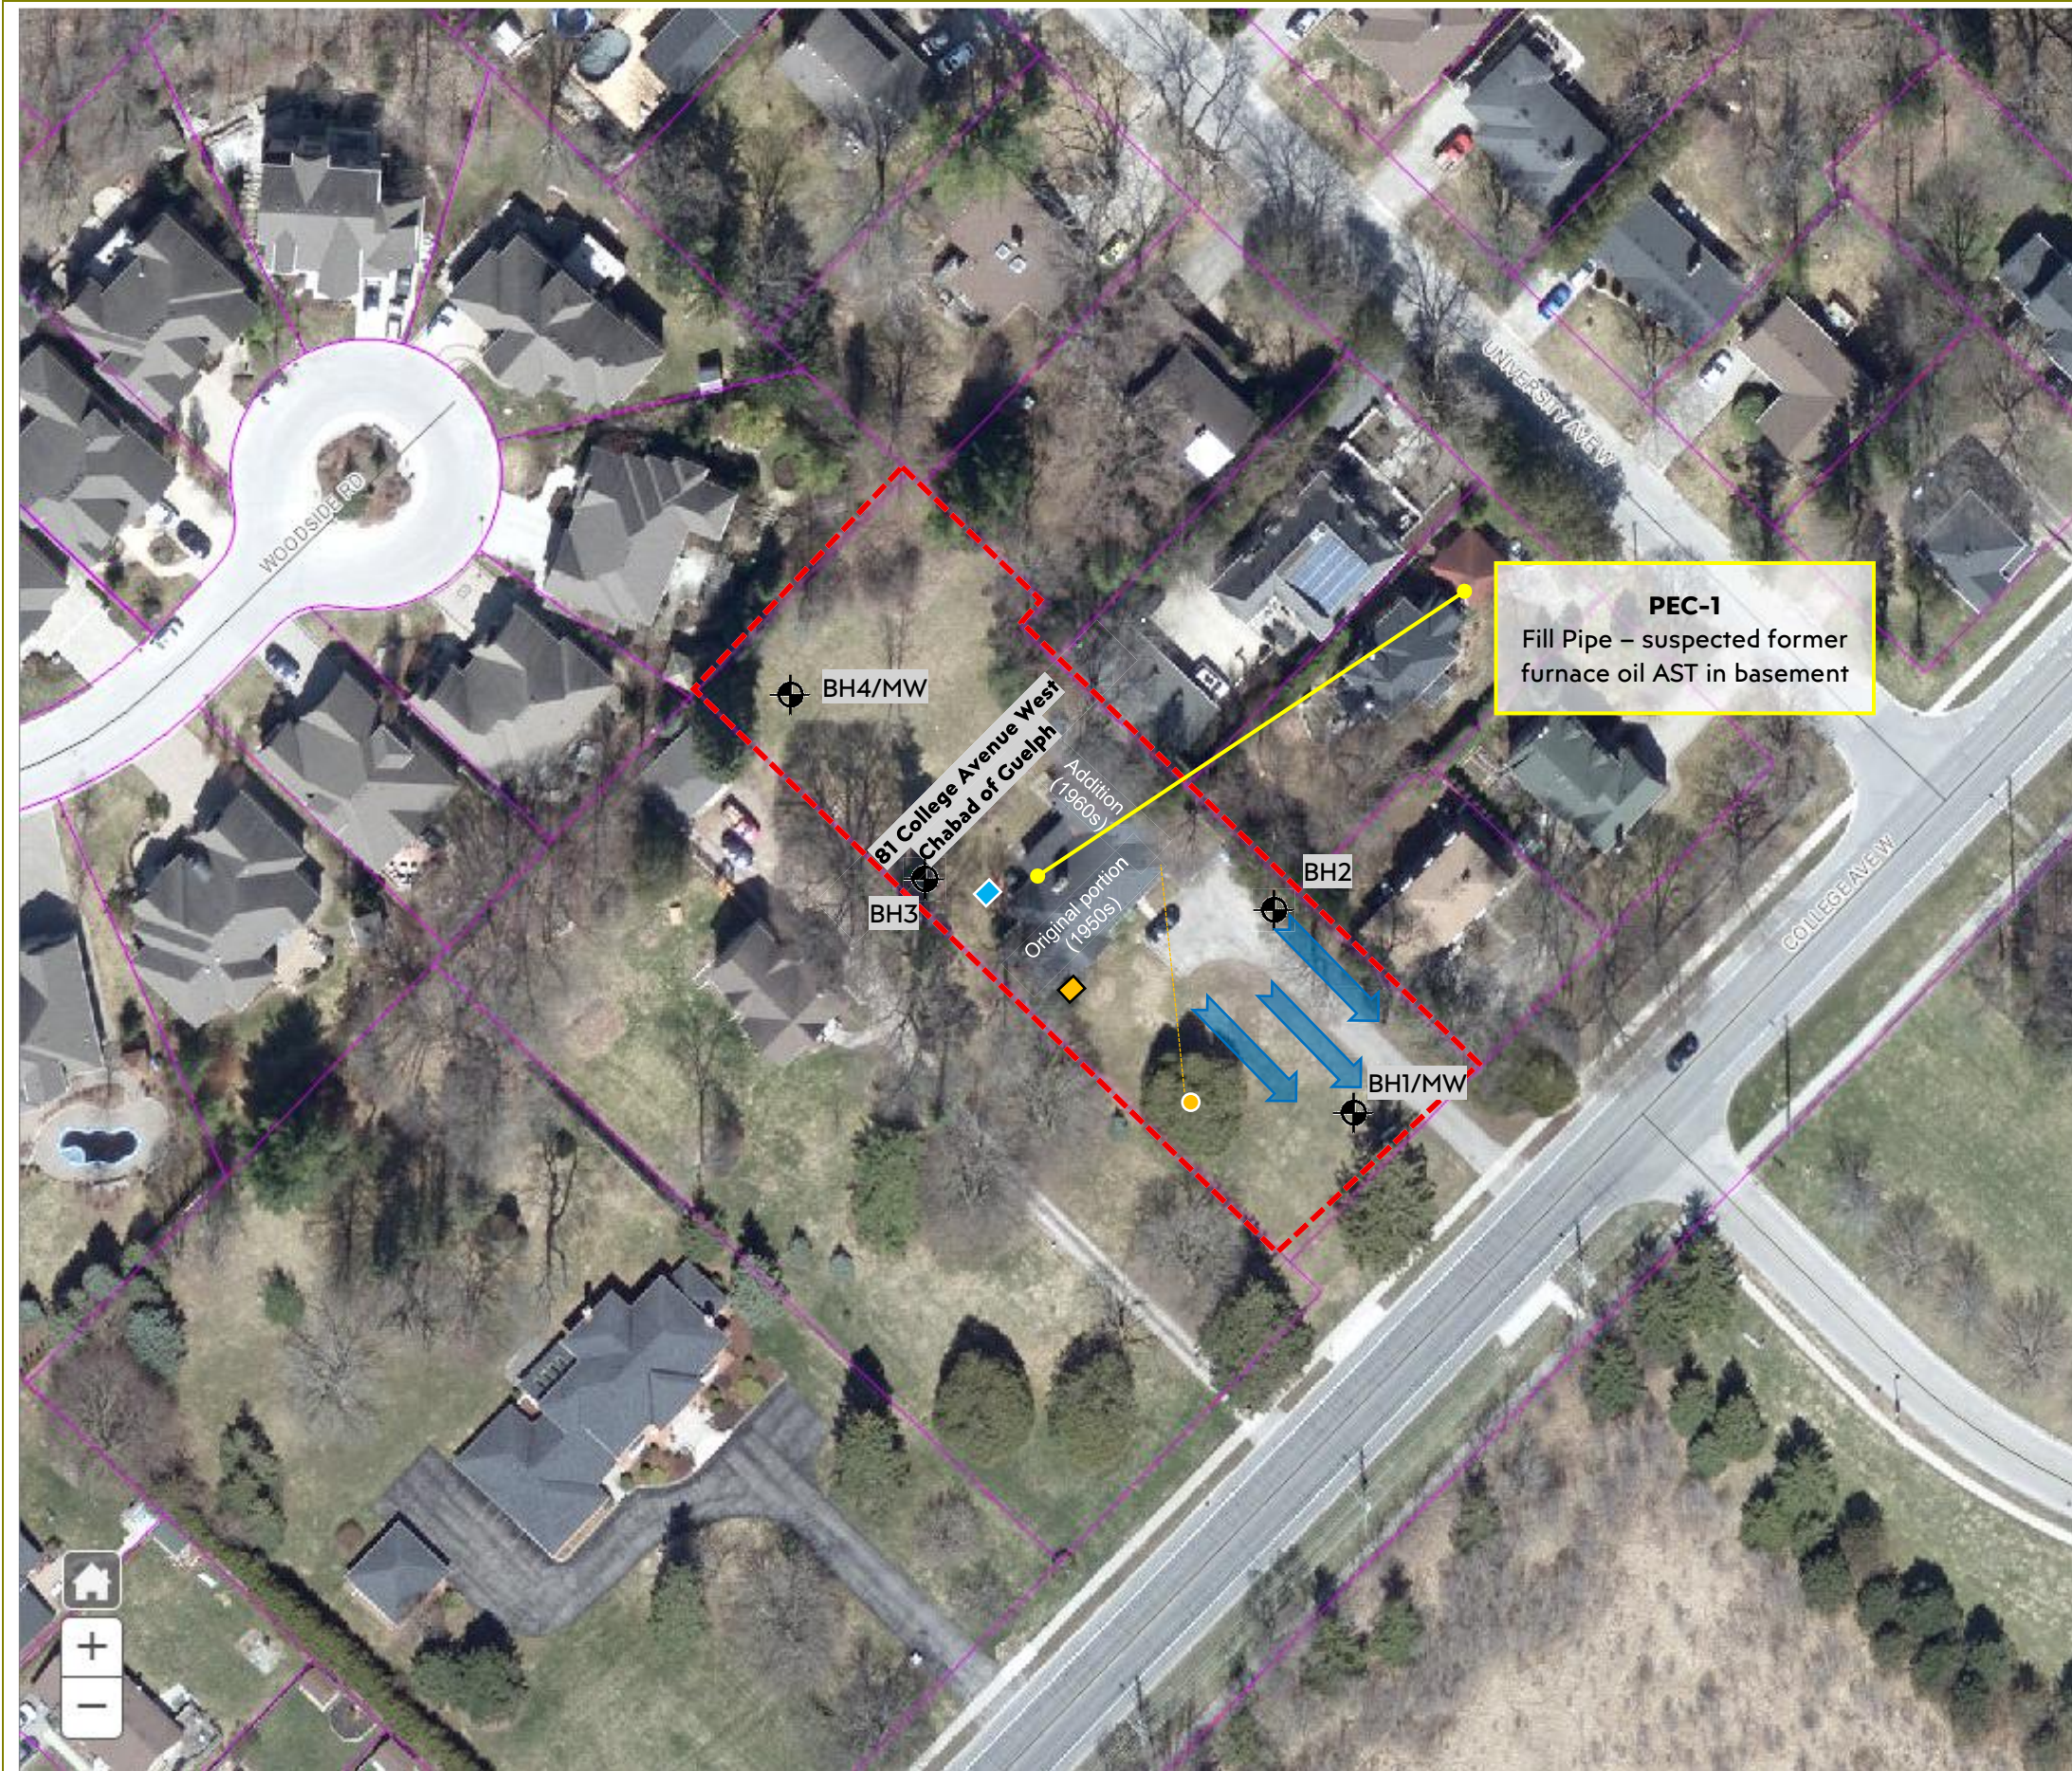
<b>SCALE</b>	<b>PROJECT NO.</b>
NTS	GE-01100
<b>DATE</b>	<b>DRAWING NO.</b>
Dec 2025	2

Site Detail Plan

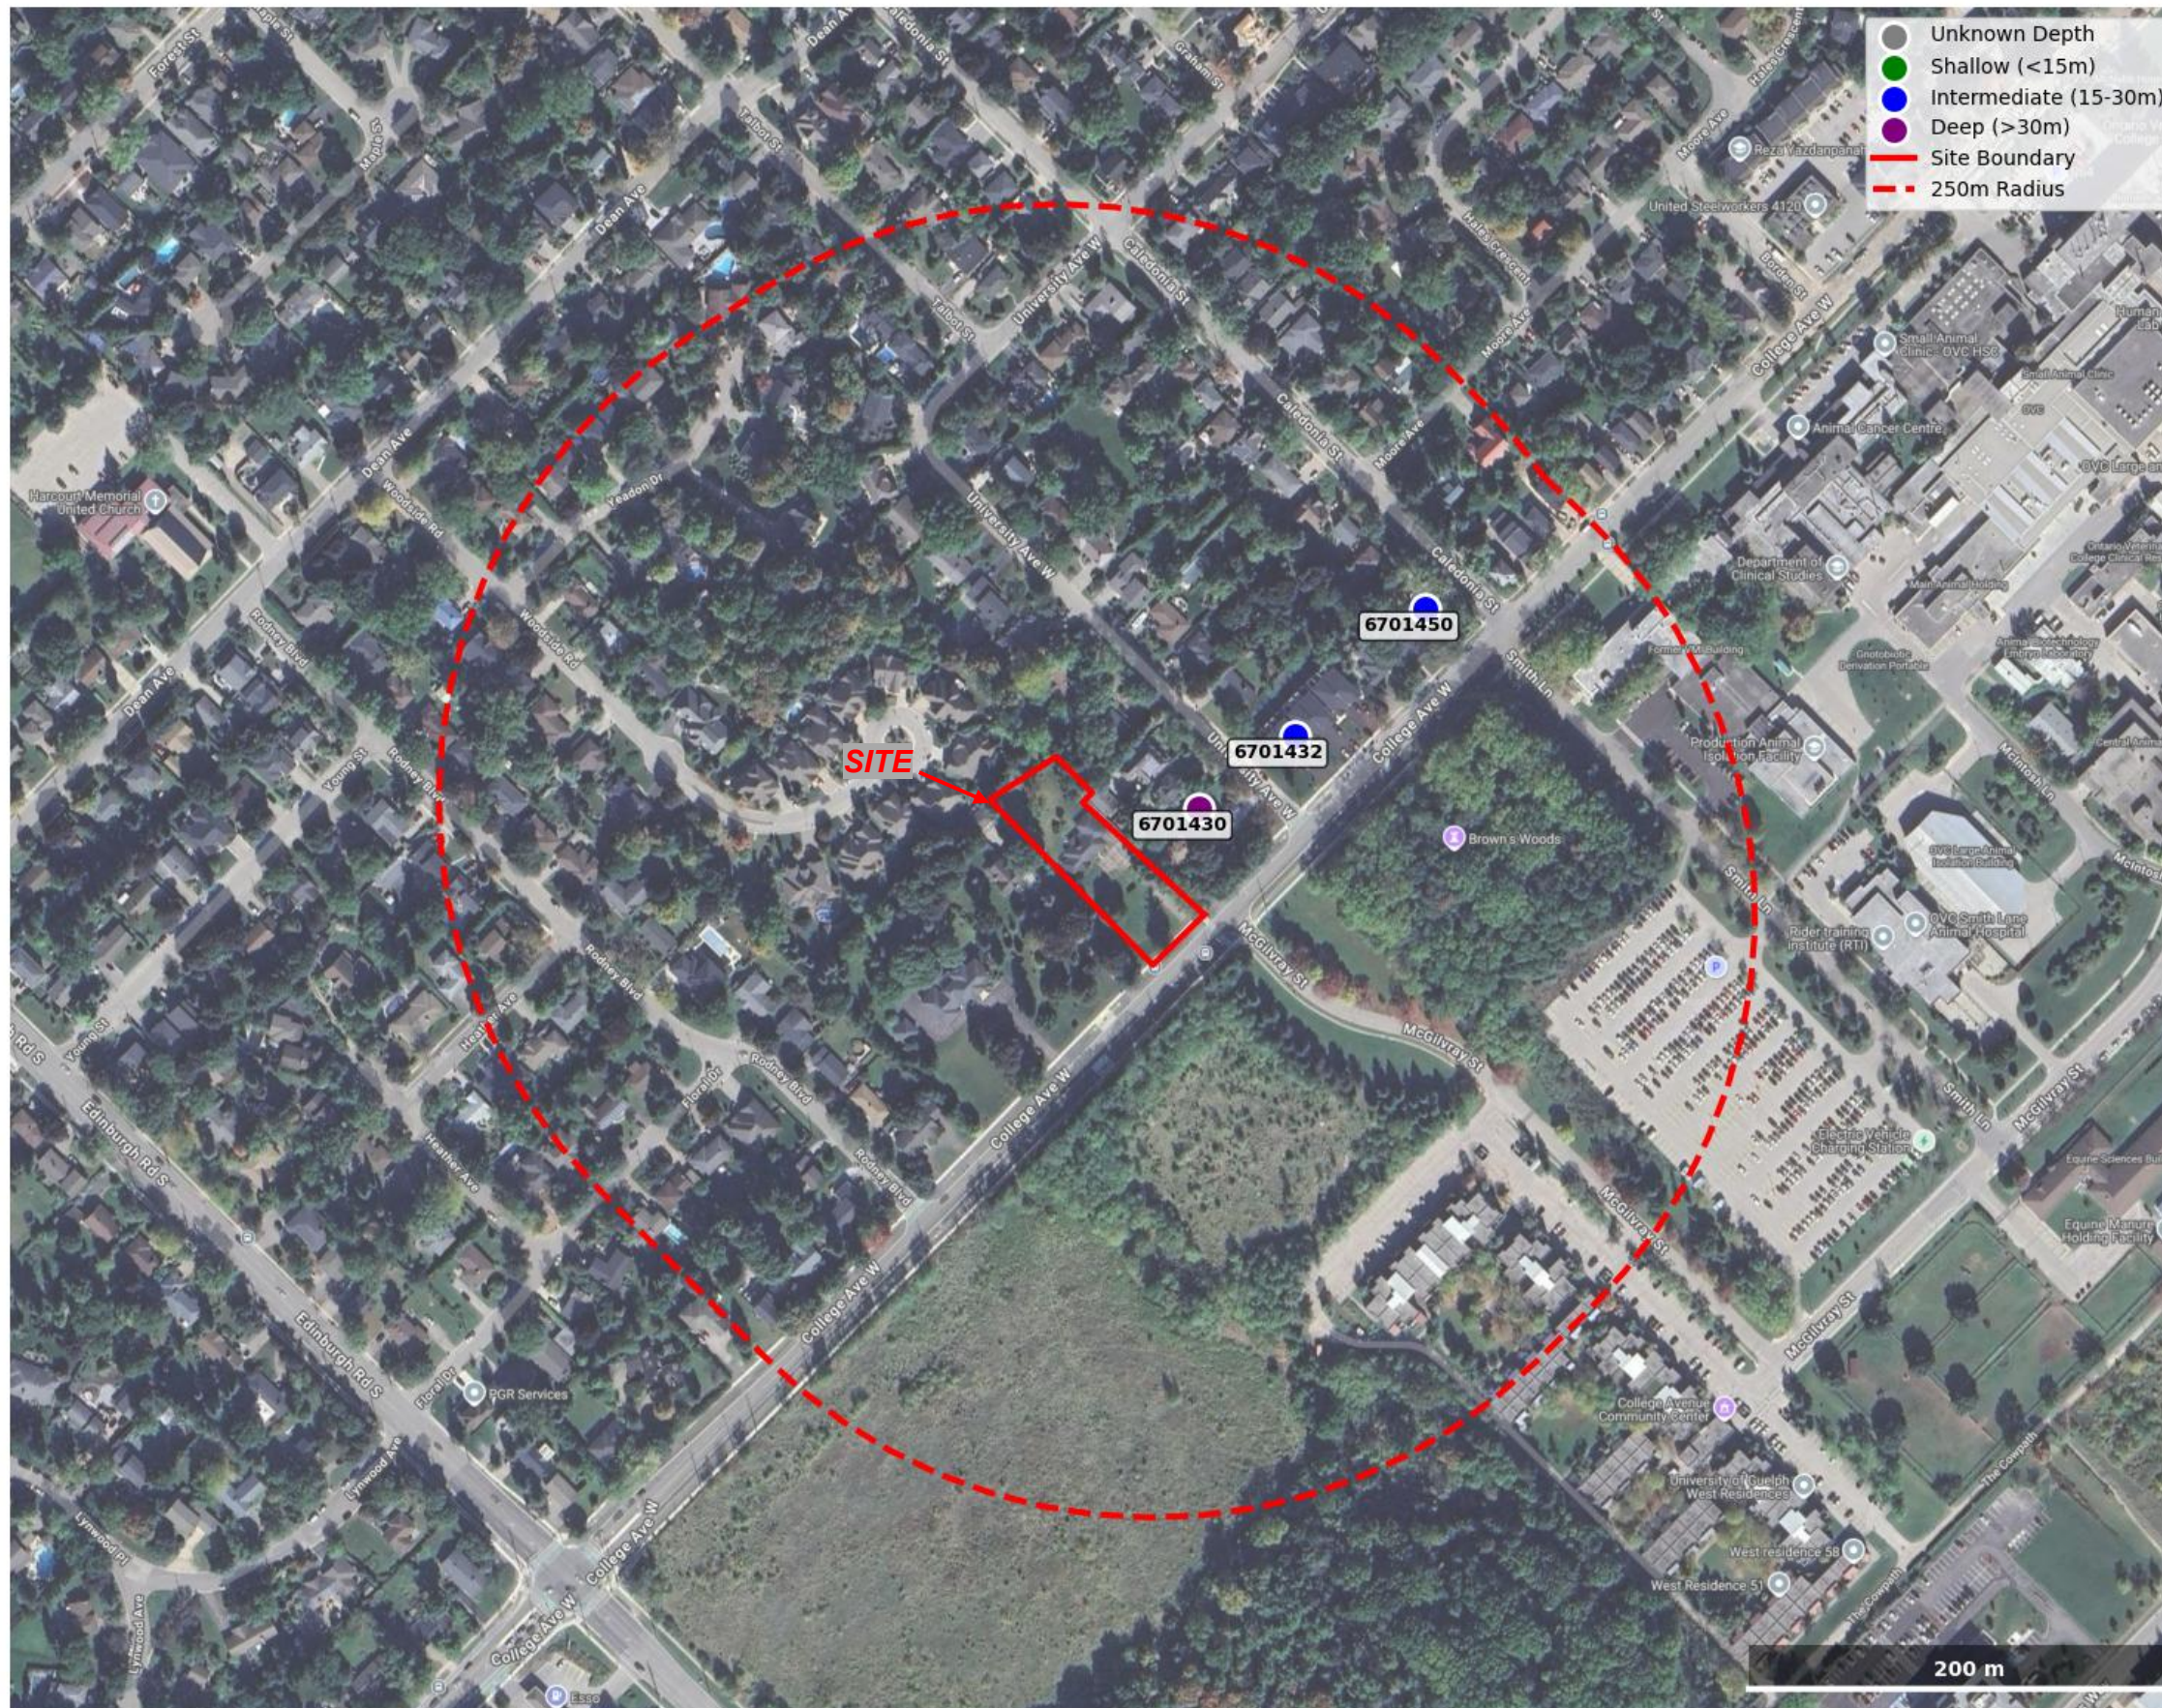
Information regarding wells located within the greater Site area was examined on November 28, 2025. Reference numbers and approximate locations of the wells are shown on Drawing 3, appended, and additional details are provided in the table below. No wells were identified for the Site location, however, as previously noted and shown on Drawing No. 2, two (2) monitoring wells were indeed installed at the subject Site in 2023 as part of a geotechnical investigation.

Base drawing from Google Earth.  
Well data compiled from MECP Online Well Record Database, November 28, 2025.

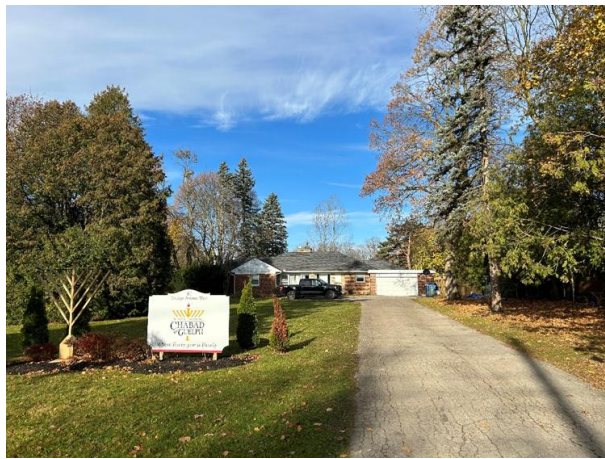
**Photograph 1:**

Paved entrance driveway and current Site building located at 82 College Avenue West as observed from roadway south of the Site.

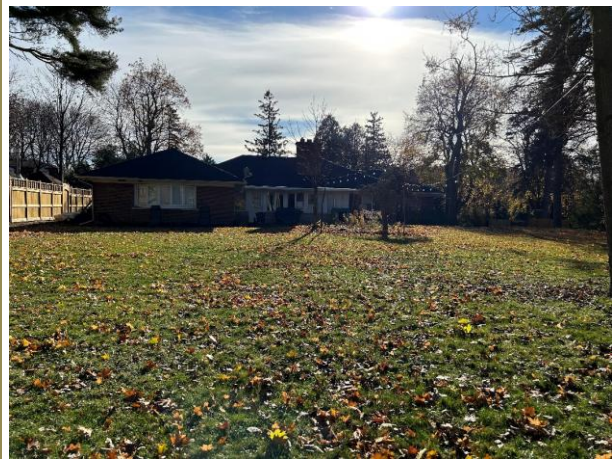
**Photograph 2:**

Rear (north side) of Site building and backyard.

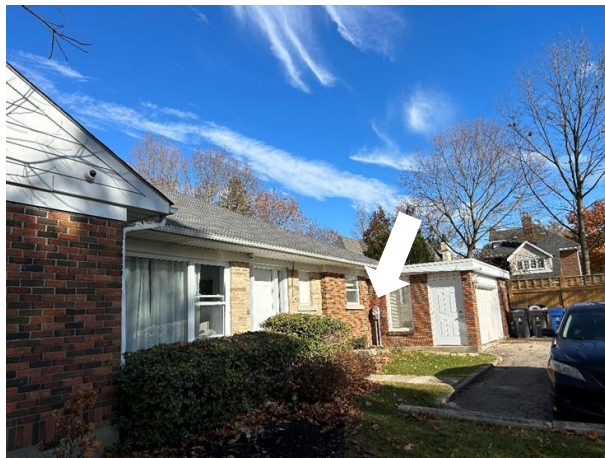
**Photograph 3:**

Hydro-meter located on south side of Site building near garage. Underground hydro cable connects this meter to a hydro-pole that is located within a cedar tree on the southwestern portion of the property.

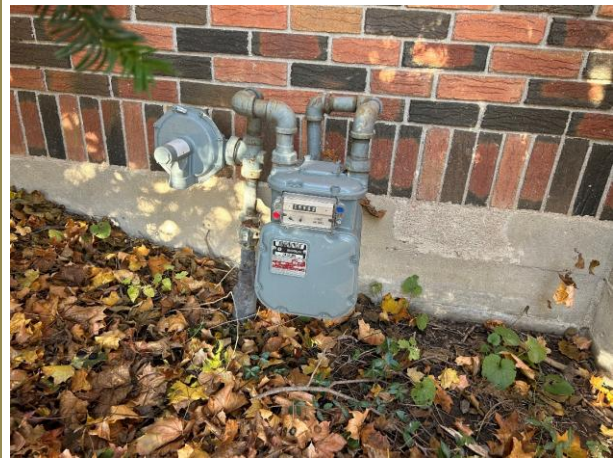
**Photograph 4:**

Gas meter located on southwest corner of Site building.

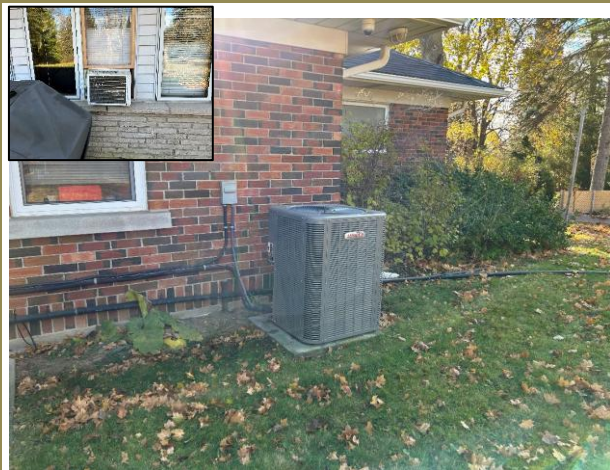
**Photograph 5:**

Pad-mounted air conditioning unit on north side of Site building as well as window-mounted air conditioning units currently service the Site building.

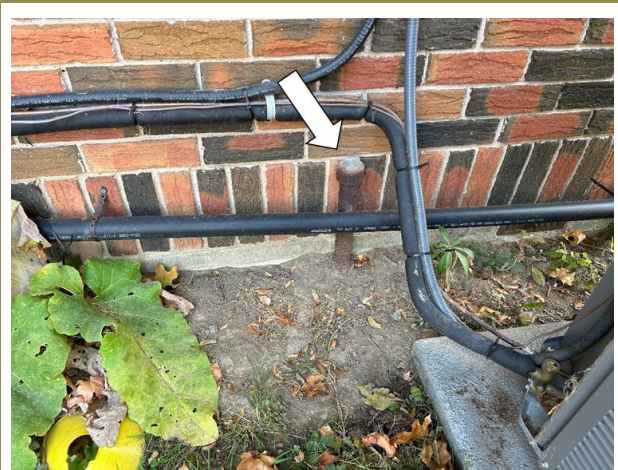
**Photograph 6:**

Capped pipe noted near pad-mounted air conditioner unit on north side of Site building. It was deemed possible that this was a former fill pipe for a furnace oil tank. No fuel tanks were currently noted at the property. The Site building is currently serviced by a natural gas powered forced-air furnace.

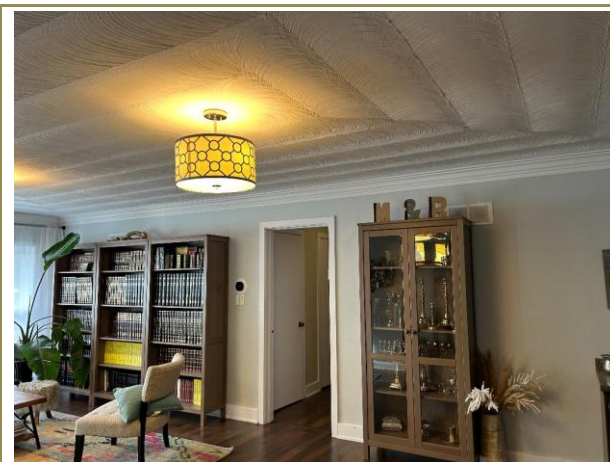
**Photograph 7:**

Much of the interior of the current Site building has been significantly renovated in recent years, shown here is the front parlour.

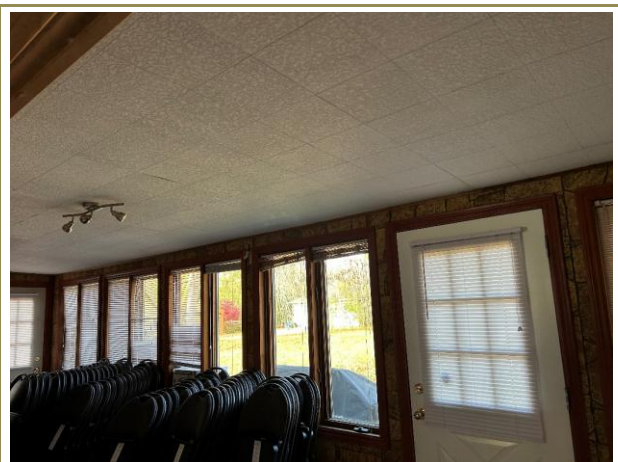
**Photograph 8:**

Back parlour; interior finishes in this room were more dated than much of the rest of the main floor. Older ceiling tiles are observed on the ceiling.

- Based on the age of the on-Site structure (circa 1950s), it was deemed possible that asbestos containing materials (ACM) and/or other designated substances are present within building materials at the Site. Stonecairn notes that the entire Site building was extensively renovated in 2022 and included the removal of many of the original finishes; therefore, significant quantities of ACM are not expected to remain at the Site. However, the presence of hidden ACM within the Site building cannot be ruled out altogether. A Designated Substances/ Hazardous Building Materials Survey (DSS/HMS) of the Site building should be completed prior to any further renovation and/or demolition activities, in accordance with the Occupational Health and Safety Act, particularly O.Reg. 490/09 (as amended), in order to identify possible presence of designated substances and/or hazardous building materials.

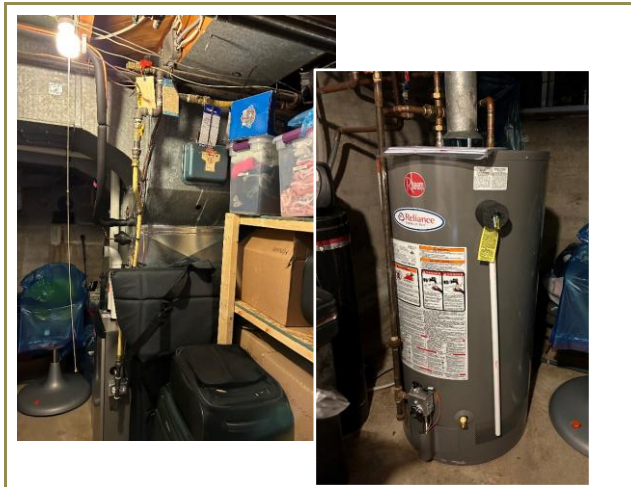
**Photograph 9:**  
Hot water boiler and natural gas forced air furnace in basement of the building.

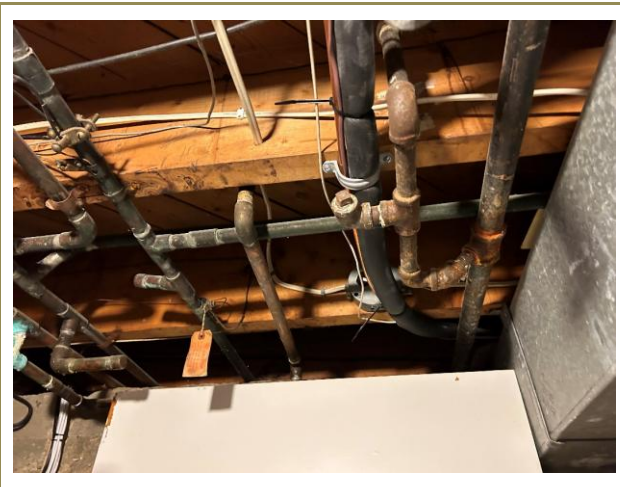
**Photograph 10:**  
Piping within accessible areas of the basement were generally noted as bare (i.e., uninsulated).

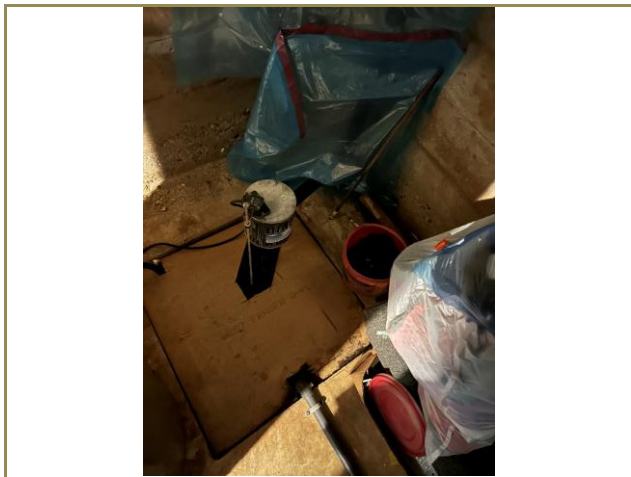
**Photograph 11:**  
A sump pump is located within the basement.

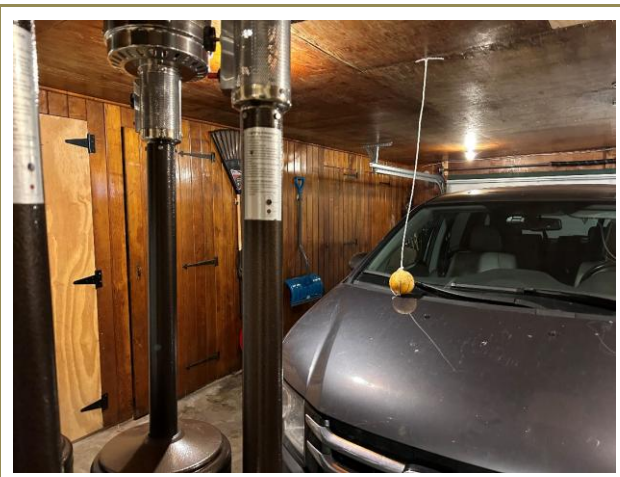
**Photograph 12:**  
Interior of garage on east side of Site building.

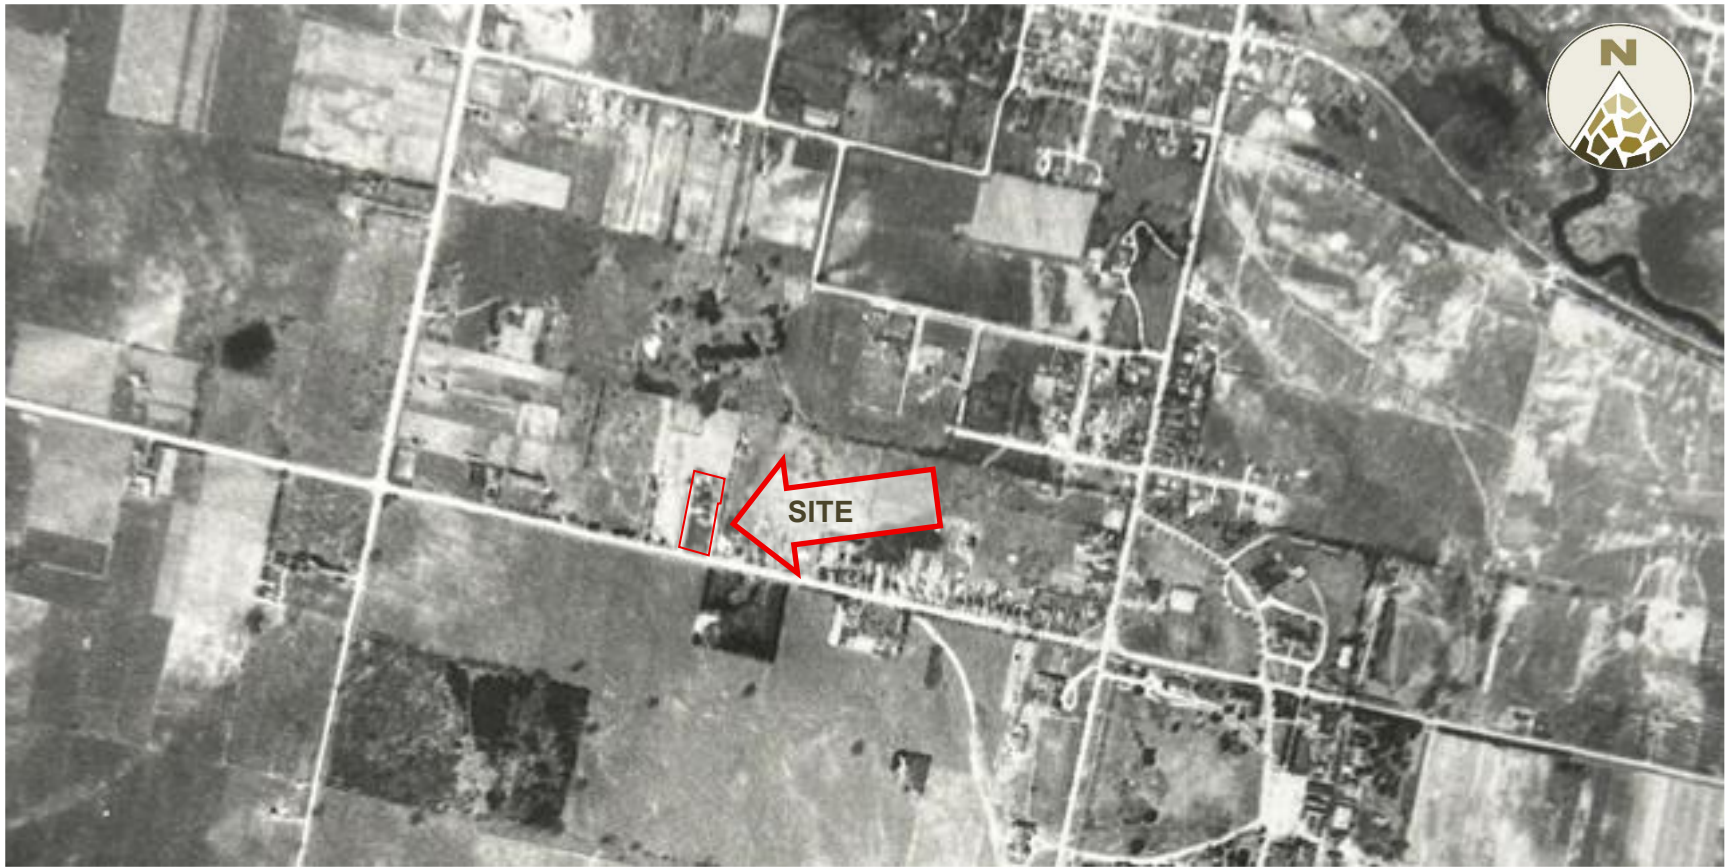
**Source**

University of Western Ontario Aerial Photo Collection.

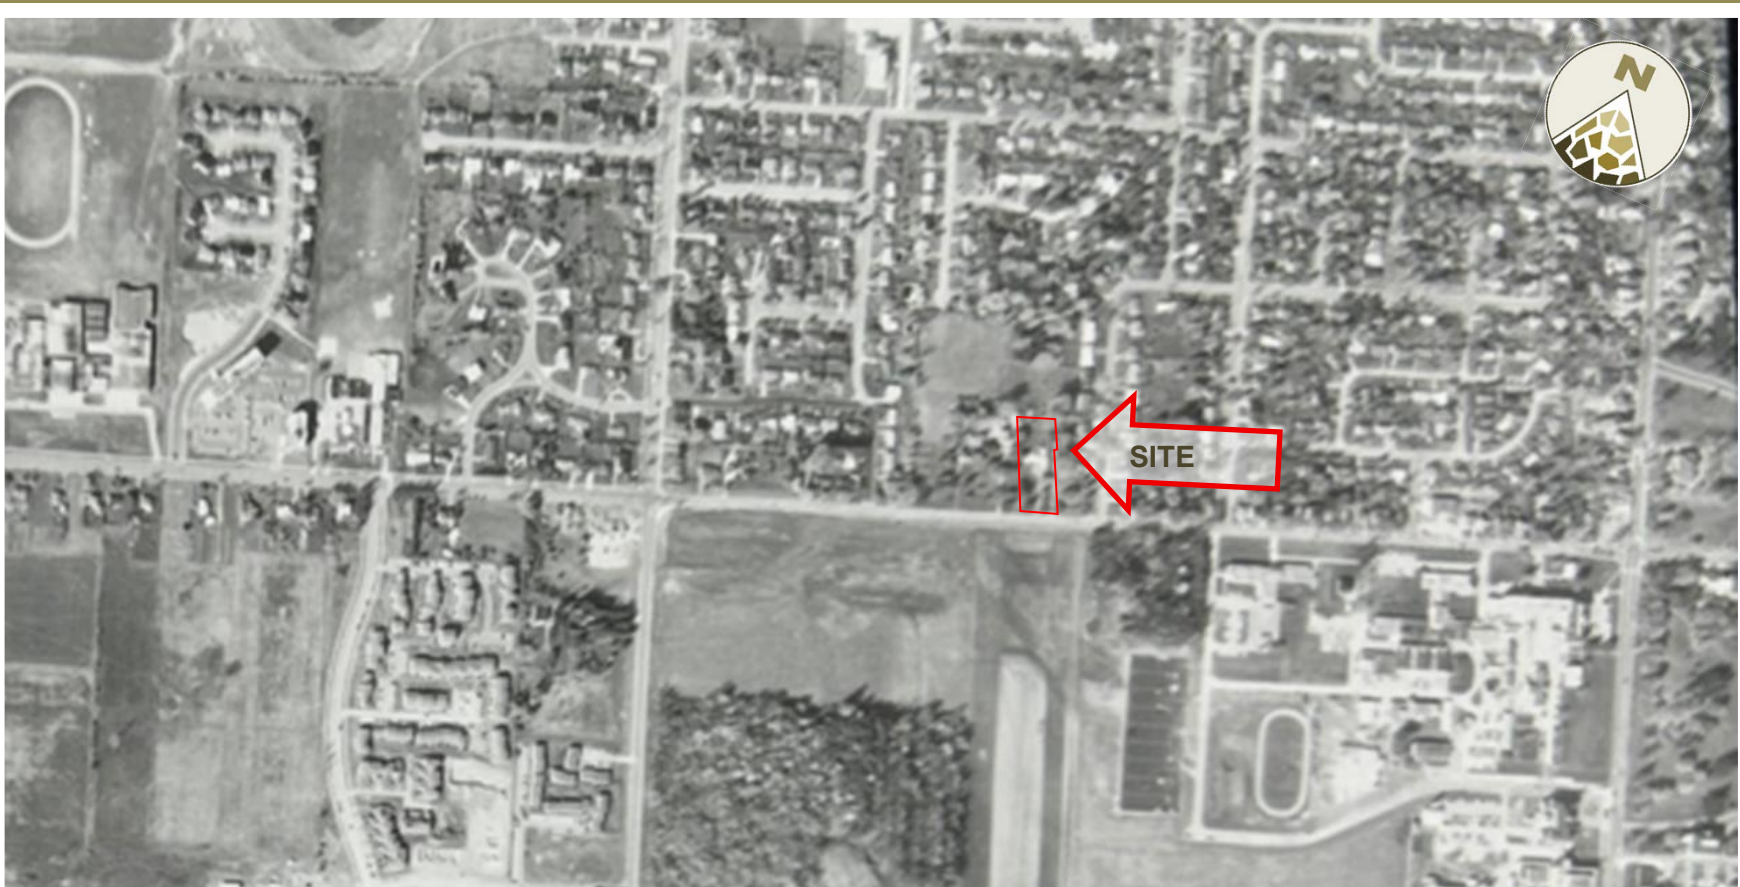
<b>LOCATION</b> 81 College Avenue, Guelph, ON	<b>SCALE</b> NTS	<b>PROJ. NO.</b> GE-01100
	<b>DRAWING NAME</b> 1966 Aerial Photograph	<b>DATE</b> Dec 2025	<b>DWG. NO.</b> B3

**Source**

University of Western Aerial Photo Collection.

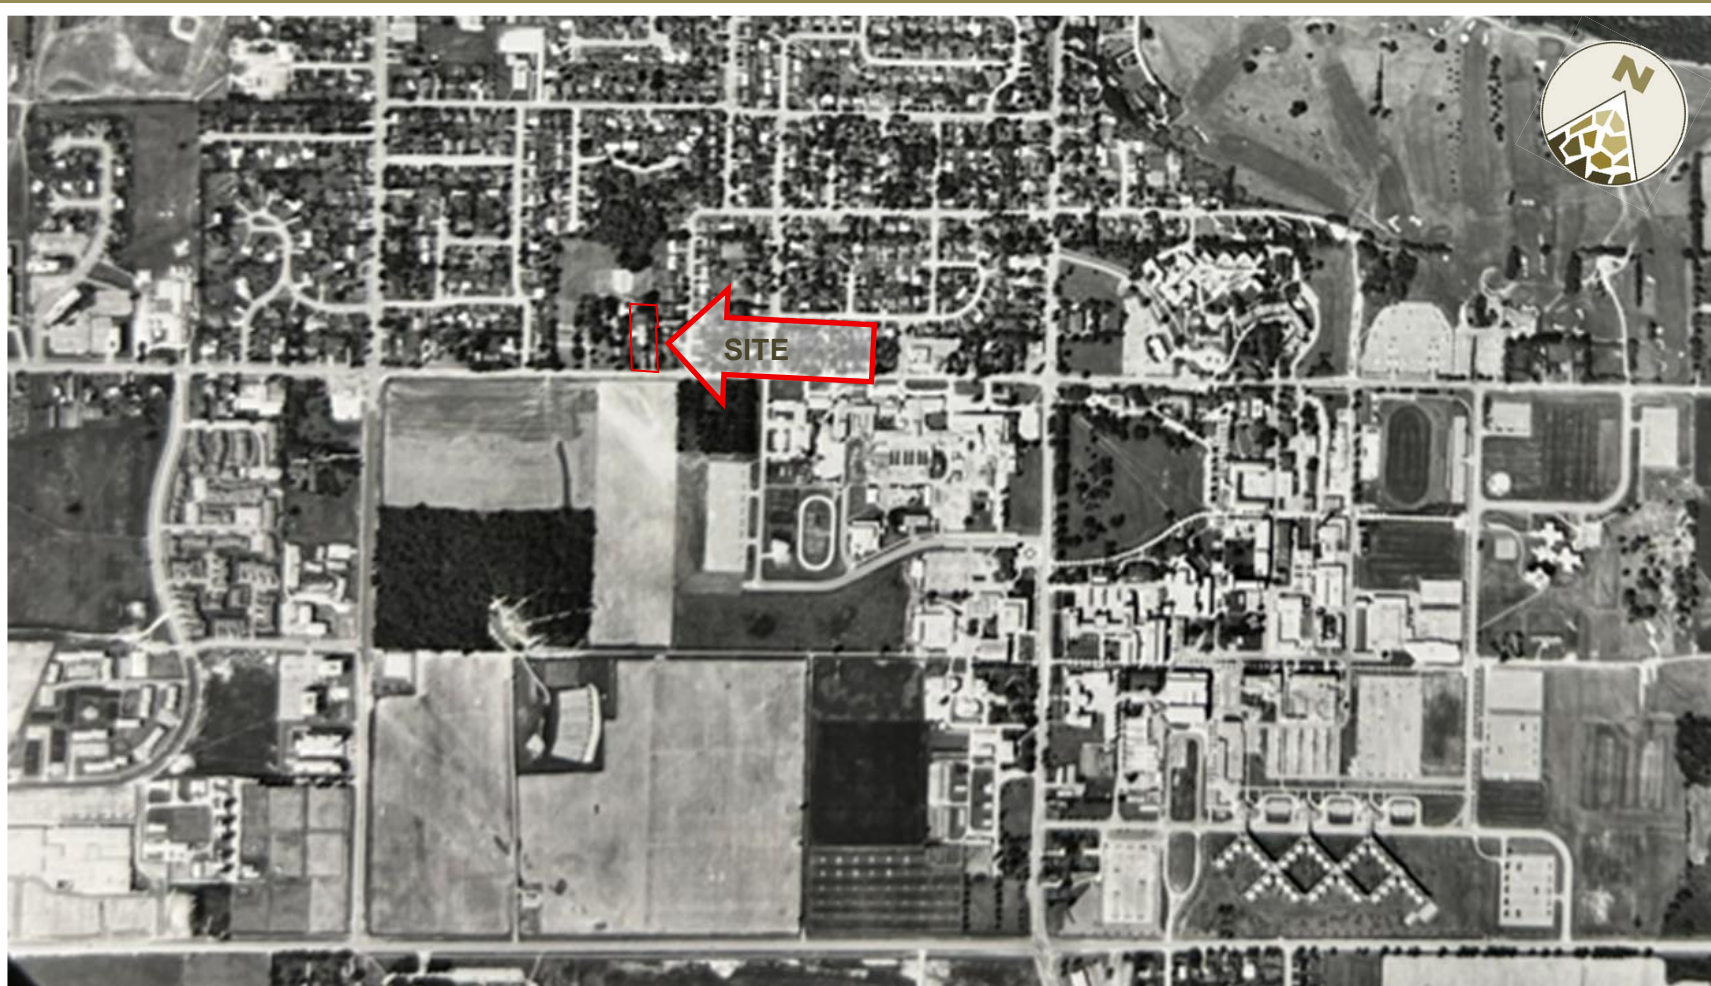
<b>LOCATION</b> 81 College Avenue, Guelph, ON	<b>SCALE</b> NTS	<b>PROJ. NO.</b> GE-01100
	<b>DRAWING NAME</b> 1972 Aerial Photograph	<b>DATE</b> Dec 2025	<b>DWG. NO.</b> B4

**Source**

University of Western Ontario, Map and Data Centre

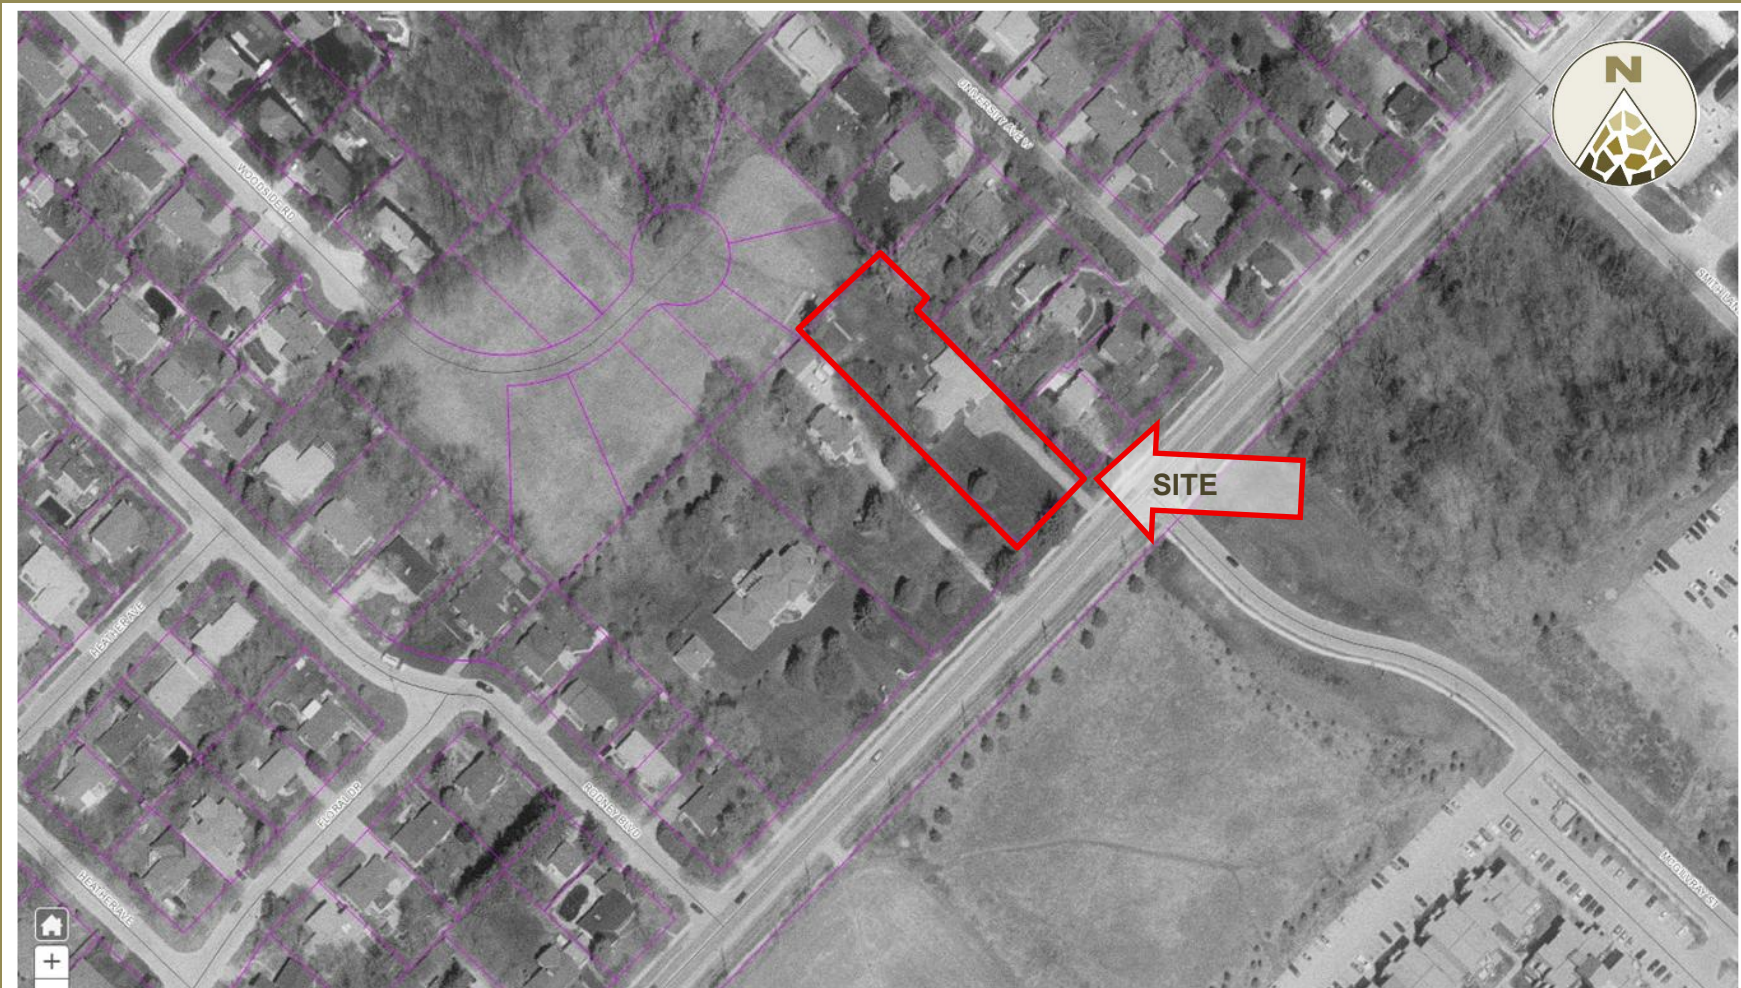
<b>LOCATION</b> 81 College Avenue, Guelph, ON	<b>SCALE</b> NTS	<b>PROJ. NO.</b> GE-01100
	<b>DRAWING NAME</b> 1975 Aerial Photograph	<b>DATE</b> Dec 2025	<b>DWG. NO.</b> B5

**Source**

Grand River Conservation Authority.

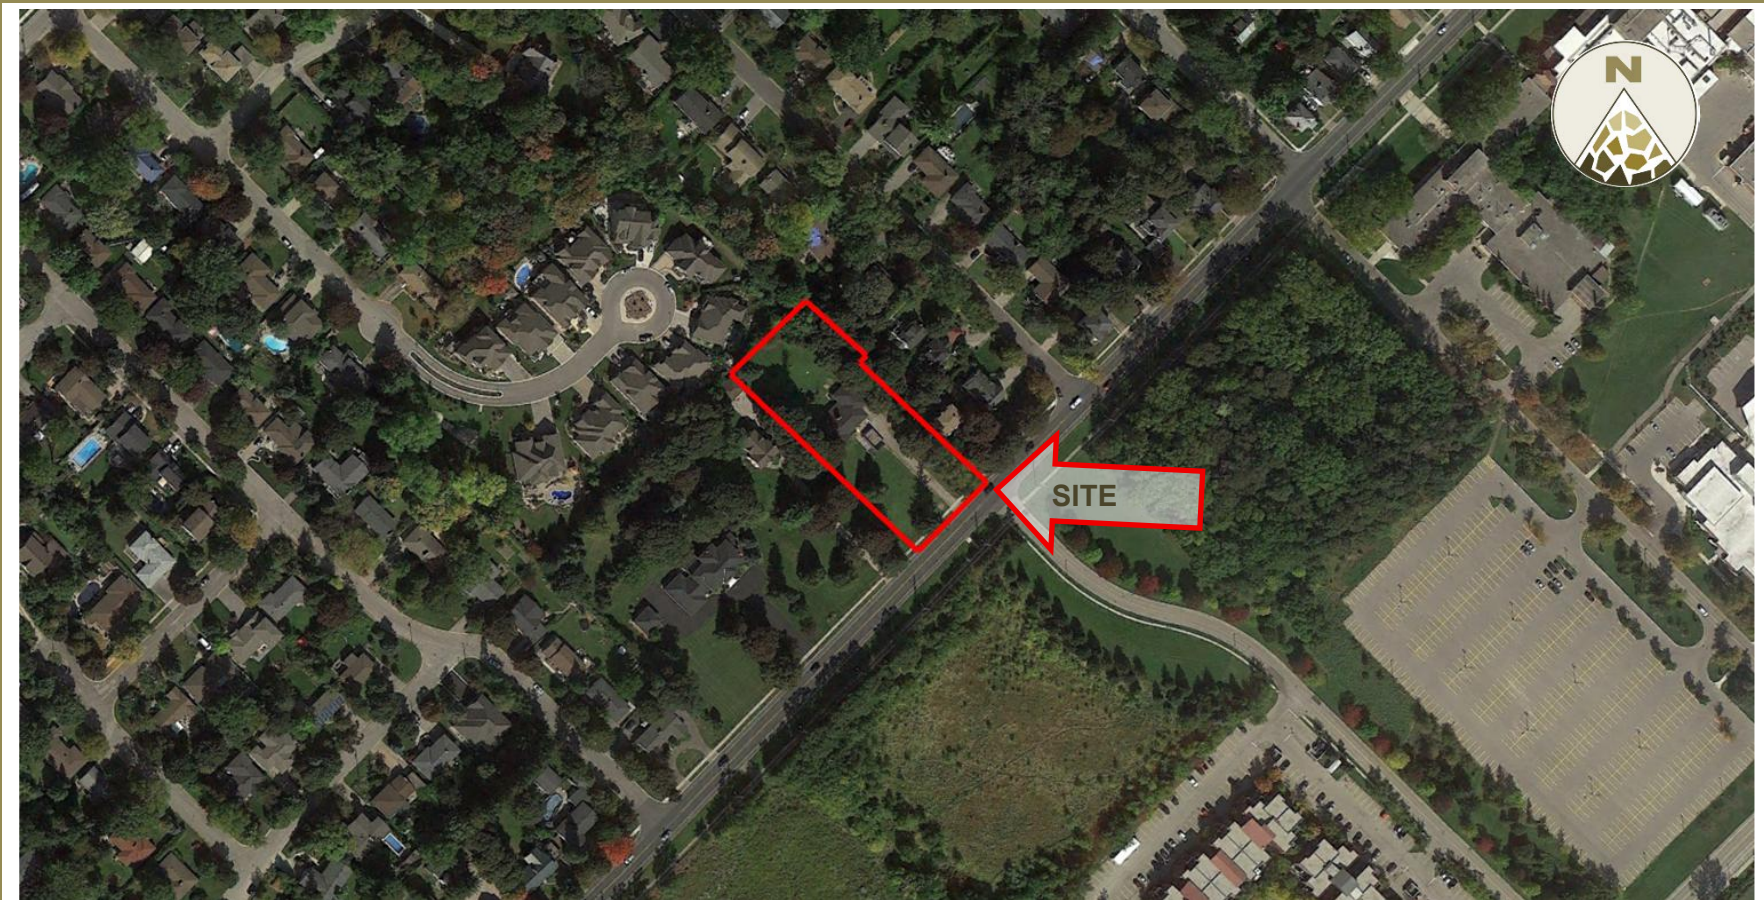
<b>LOCATION</b> 81 College Avenue, Guelph, ON	<b>SCALE</b> NTS	<b>PROJ. NO.</b> GE-01100
	<b>DRAWING NAME</b> 2006 Aerial Photograph	<b>DATE</b> Dec 2025	<b>DWG. NO.</b> B7

**Source**  
Google Earth Pro.

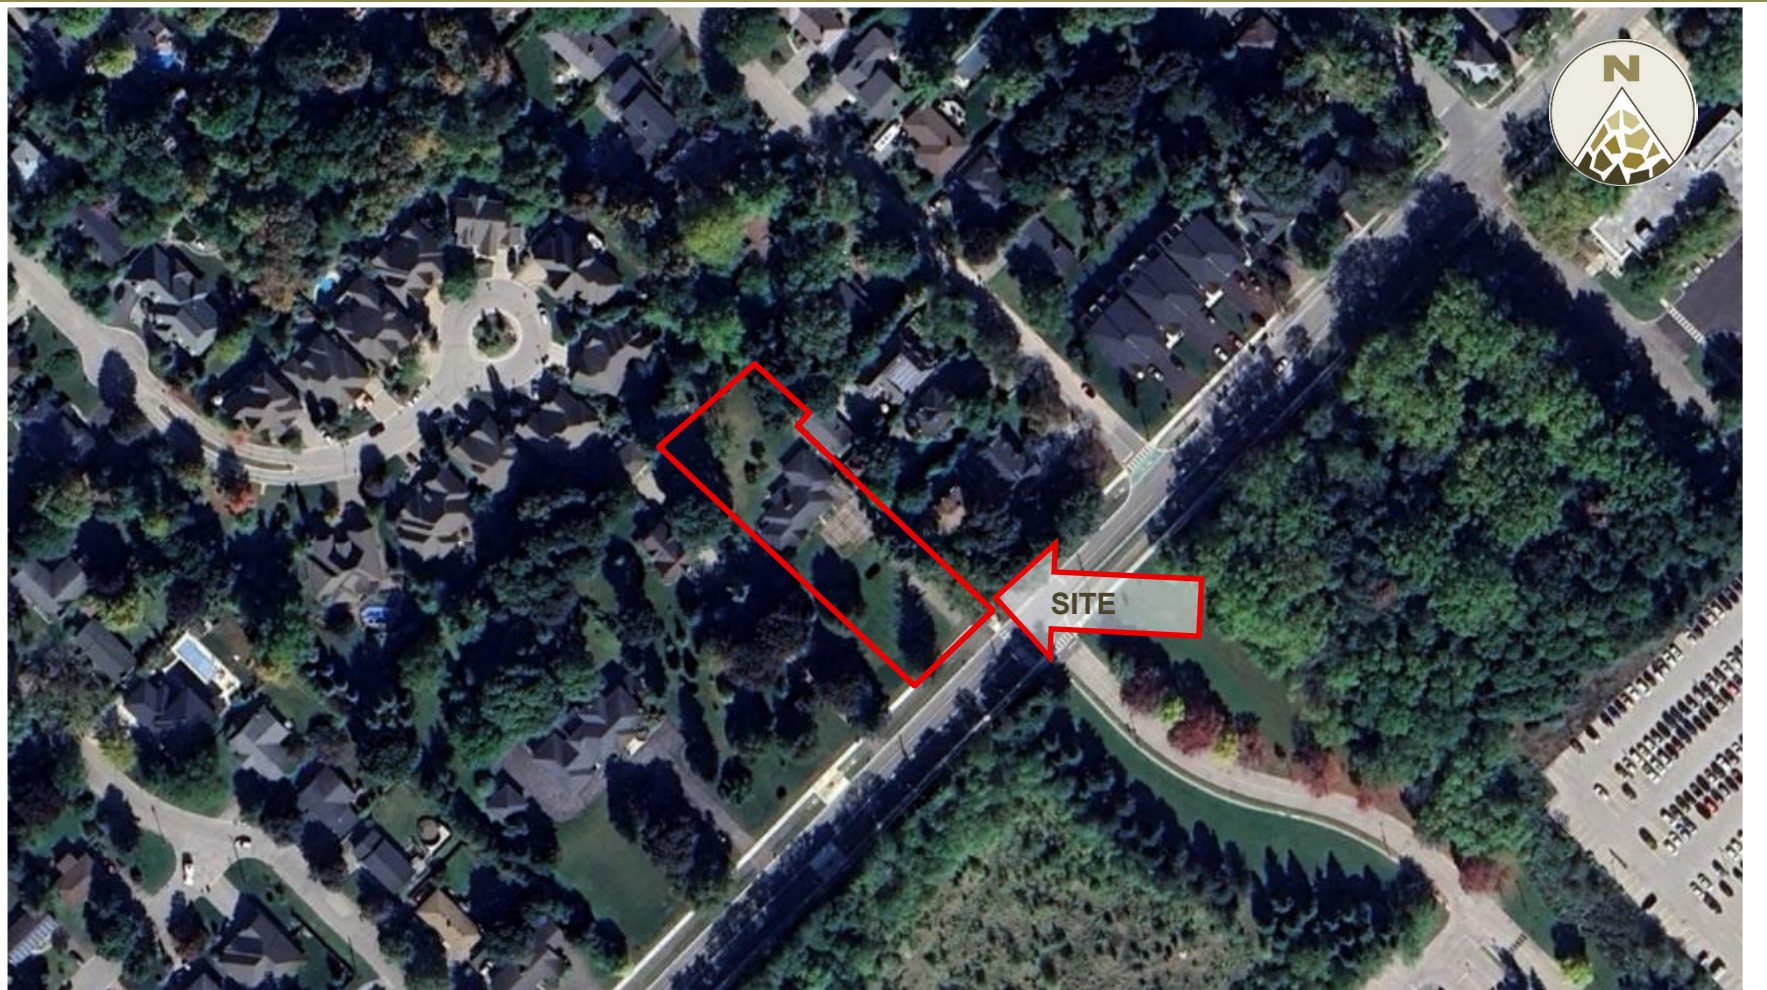
<b>LOCATION</b> 81 College Avenue, Guelph, ON	<b>SCALE</b> NTS	<b>PROJ. NO.</b> GE-01100
	<b>DRAWING NAME</b> 2013 Aerial Photograph	<b>DATE</b> Dec 2025	<b>DWG. NO.</b> B8

**Source**  
Google Earth Pro.
