Cultural Heritage Evaluation Report

Macdonell Street Bridge, Allan's Bridge, Allan's Sluiceway, and Allan's Spillway

Guelph, Ontario

March 2022 (Revised December 2022, March 2025)

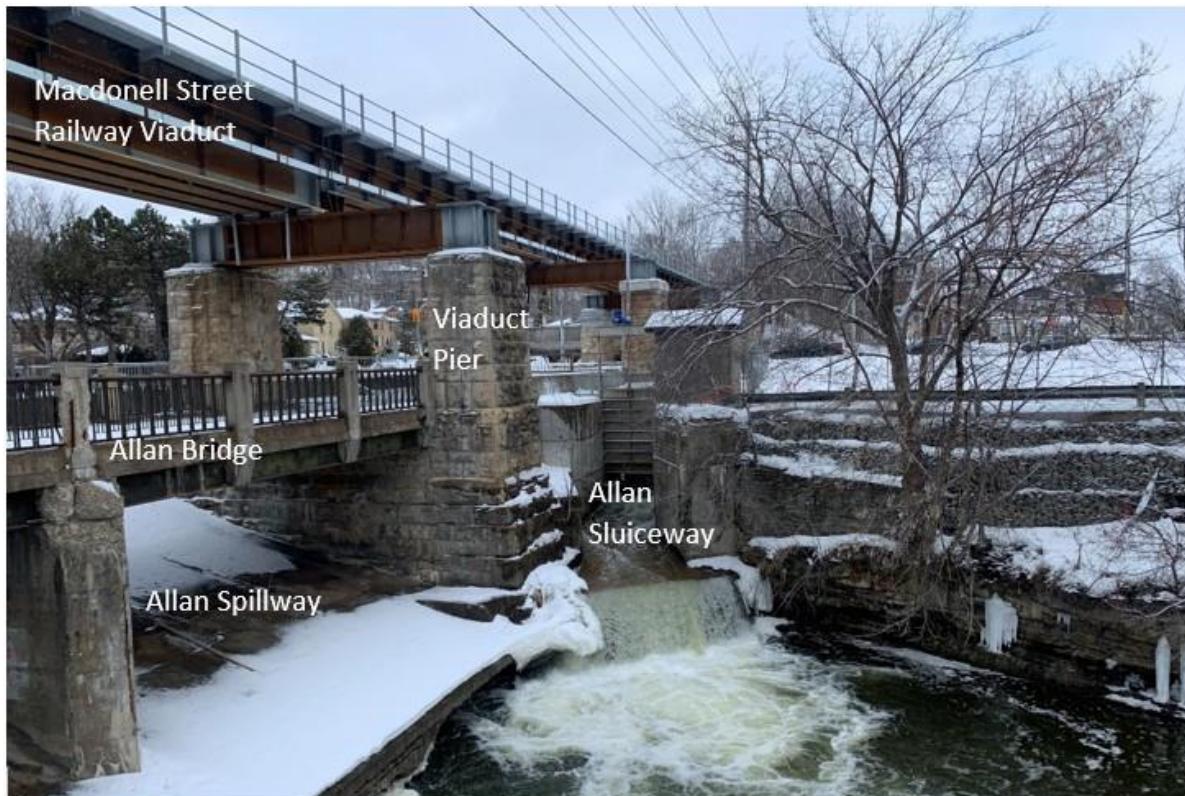
Figure 3: Key structures within the study area. Note that the Macdonell Street Bridge is not depicted in this image, but its location is depicted in Figure 4.

The following images (Figure 3 and Figure 4) and sections provide locations and descriptions of the subject structures and adjacent heritage properties.

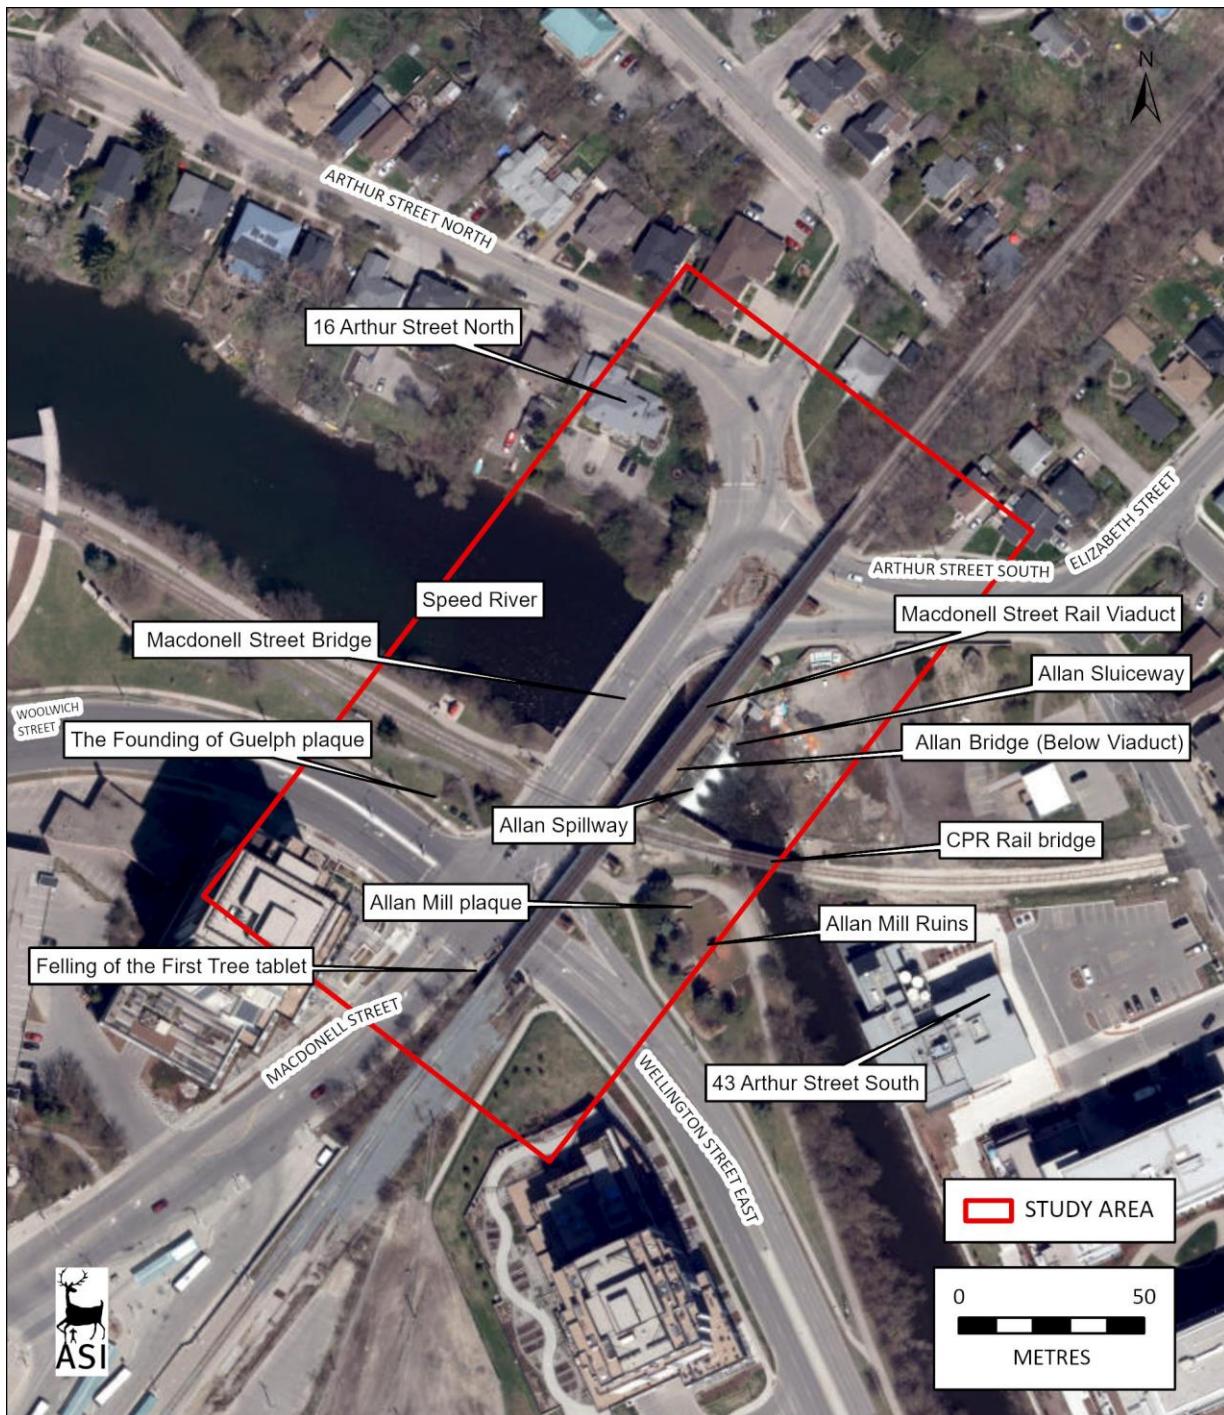
Figure 4: Location Plan showing subject structures and adjacent heritage properties

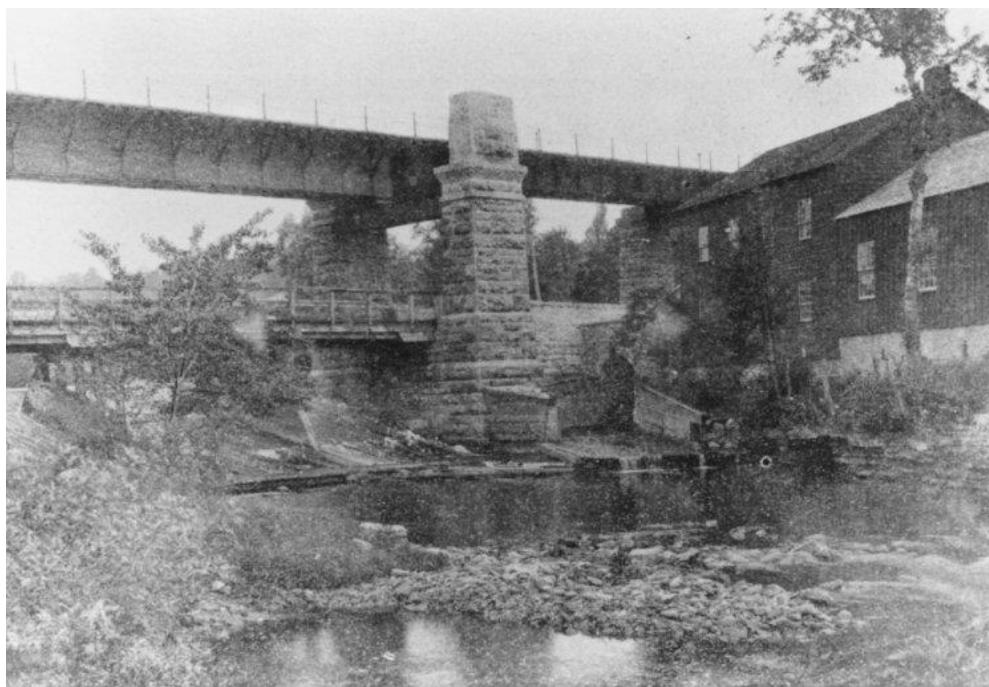
Figure 13: Allan's Spillway, Allan's Sluiceway, and Allan's Bridge, with carding building at right, 1889 (Guelph Public Library, 2022)

(Figure 12). The Allans also had other structures on the east bank. Among them was a water-powered carding operation⁷ which was erected in 1841. This building had a stone foundation and a wood structure above (Figure 13). The building housed an enormous water wheel that was used to power the machinery.

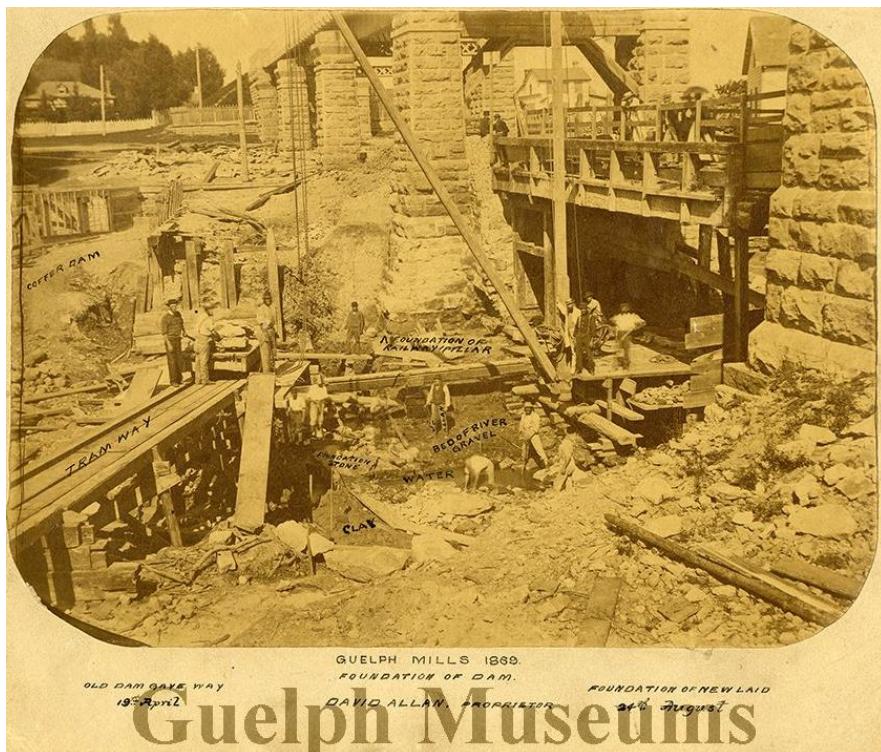
Figure 14: Foundation of dam/spillway and new Allan's Bridge in 1869 (Guelph Museums, n.d.)

This original dam/spillway gave way on 19th April 1869 (Guelph Museums, n.d.). It seems most plausible that this impacted the stability of the Allan's Bridge, which is why they were both replaced that same year. A photograph of the Allan's Bridge, dam/spillway are found below, showing what the site looked like while under construction in the spring of 1869 (Figure 14). Another photograph depicts what the Allan's Bridge looked like upon completion, c. 1870 (Figure 15). Note that the Allan's Bridge is located between the stone piers of the G.T.R.

viaduct, which is located above. The footpath that allowed pedestrians to cross (discussed above) is visible next to the railway track. Given the time period, it seems that the Allan's Bridge also provided pedestrian access as well as a safe, flat surface for horses and/or carriages.

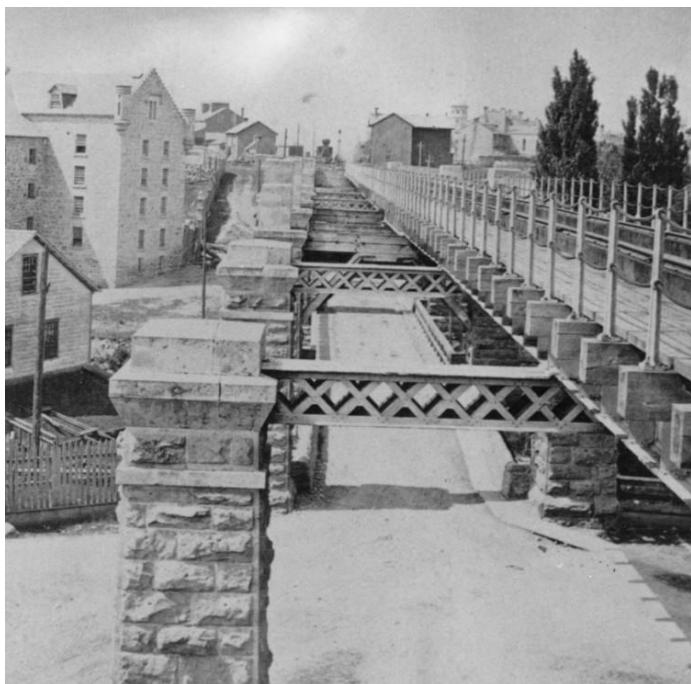
Figure 15: Allan's Bridge following its reconstruction, c. 1870 (Guelph Public Library, 2022)

At some point between 1890 and 1897, the Allan's Bridge was replaced. It appears to be a simple girder structure with wood railings and two slim support piers in the 1870 photograph above and 1890 photograph below. However, by 1897, it is described on the Fire Insurance Plan as an "Iron & Wood Bridge under Viaduct." An undated photograph depicts this pony iron truss road bridge at the same location, matching the language from the F.I.P. Note that this iteration of the Allan's Bridge also appears to use the stone piers that support the railway viaduct as the north and south abutment walls (Figure 19).

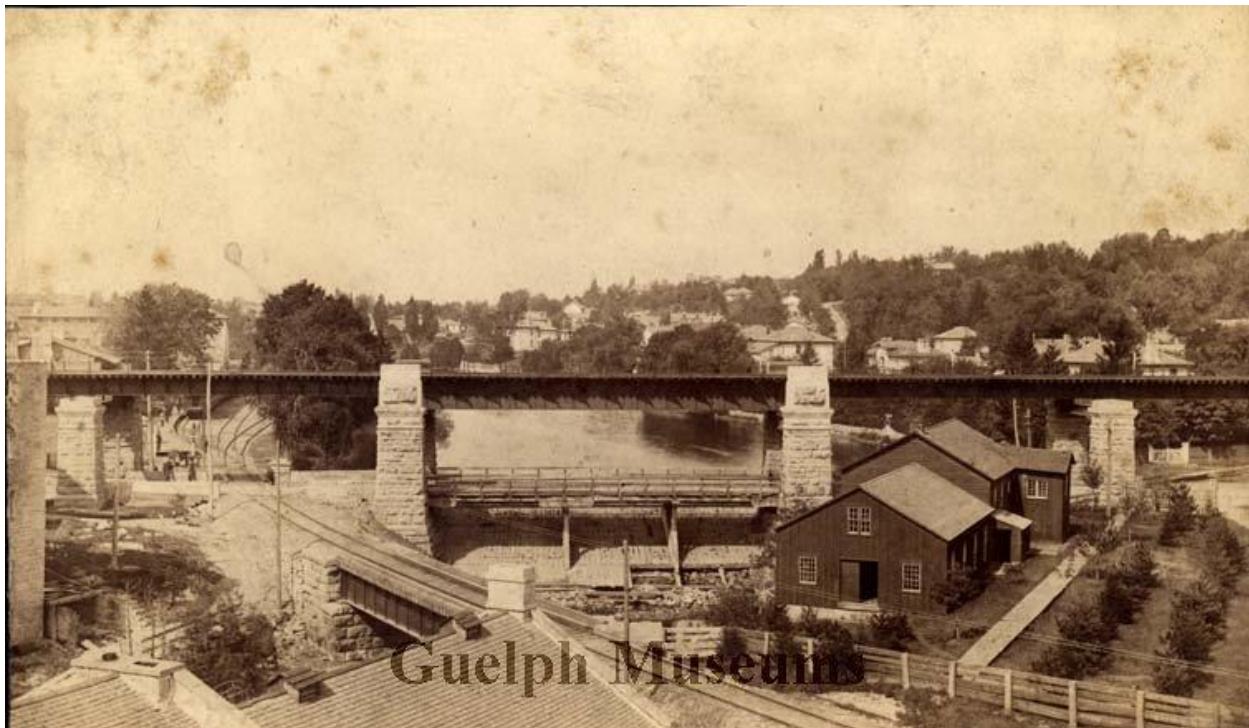
Figure 17: Allan's Bridge c. 1890 (Guelph Museums, n.d.)

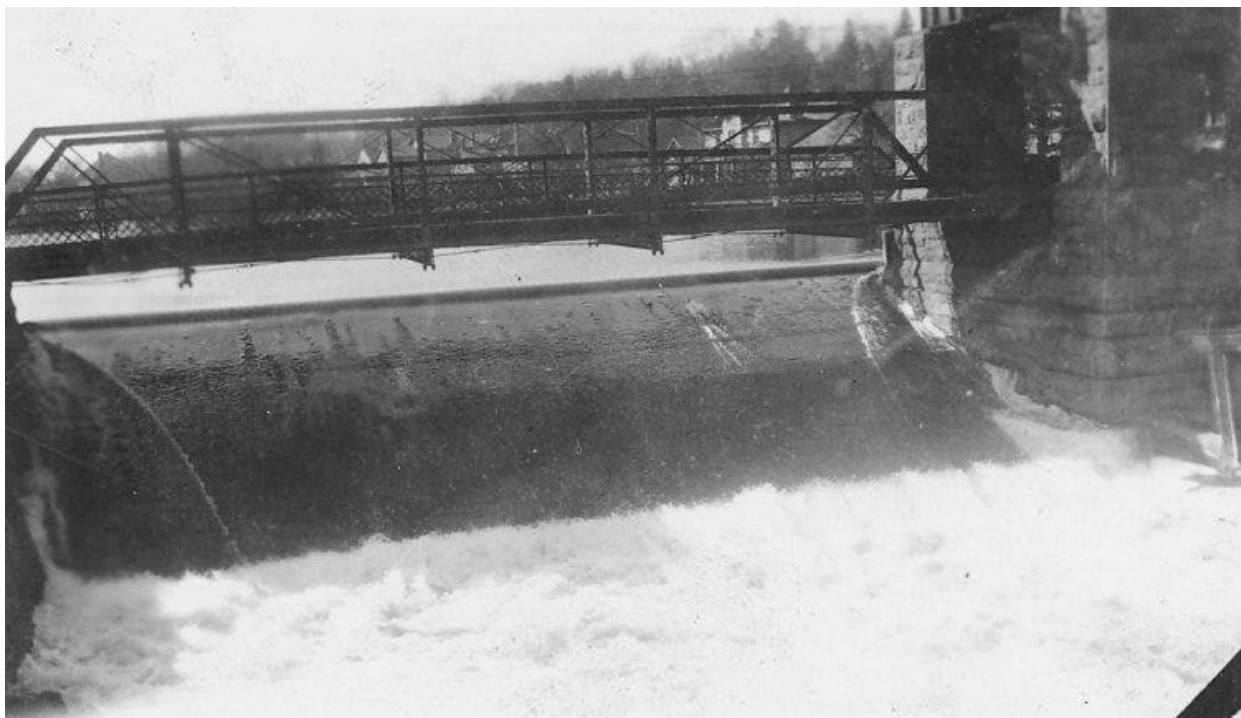
Figure 19: Allan's Bridge as a pony iron truss bridge, undated (Guelph Museums, n.d.)

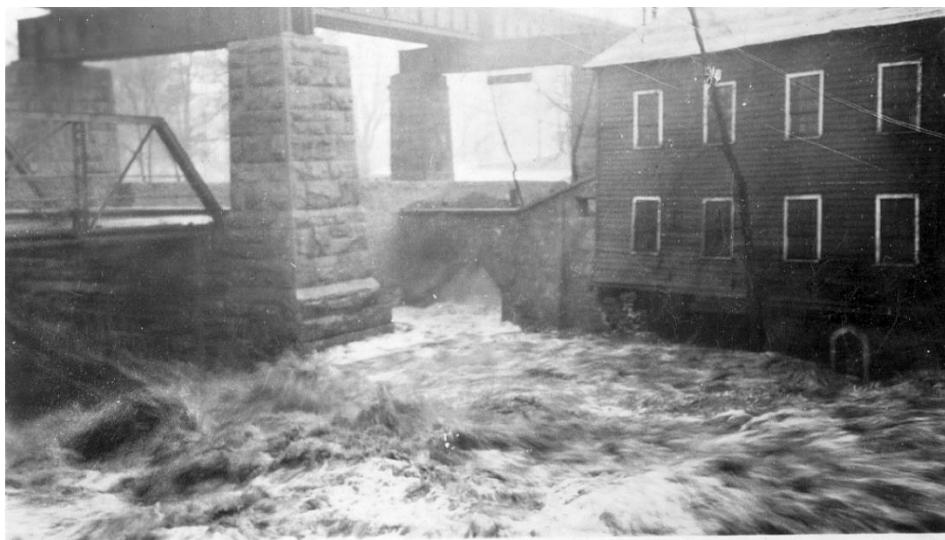
Figure 21: The sluiceway and adjacent storage facility, 1929 (Guelph Public Library, 2022)

A 1929 photograph (Figure 21) of the pipe fitting storage facility shows that the sluiceway separates the building from the Allan's Bridge. An arched opening within a stone or concrete wall is visible, where water could emerge. The spillway is located at the left of the image. By the 1970s, the building and stone or concrete wall with the arched opening had both been demolished, though the sluiceway remained operational (Figure 22).

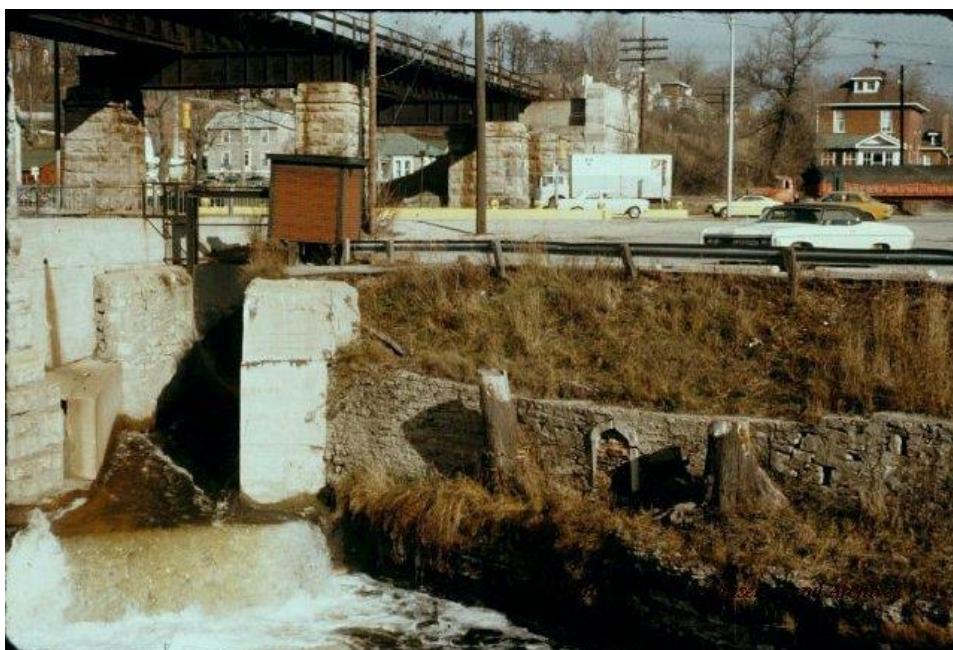
Figure 22: The sluiceway and adjacent parking lot, 1973 (Wellington County Museum and Archives, 2022)

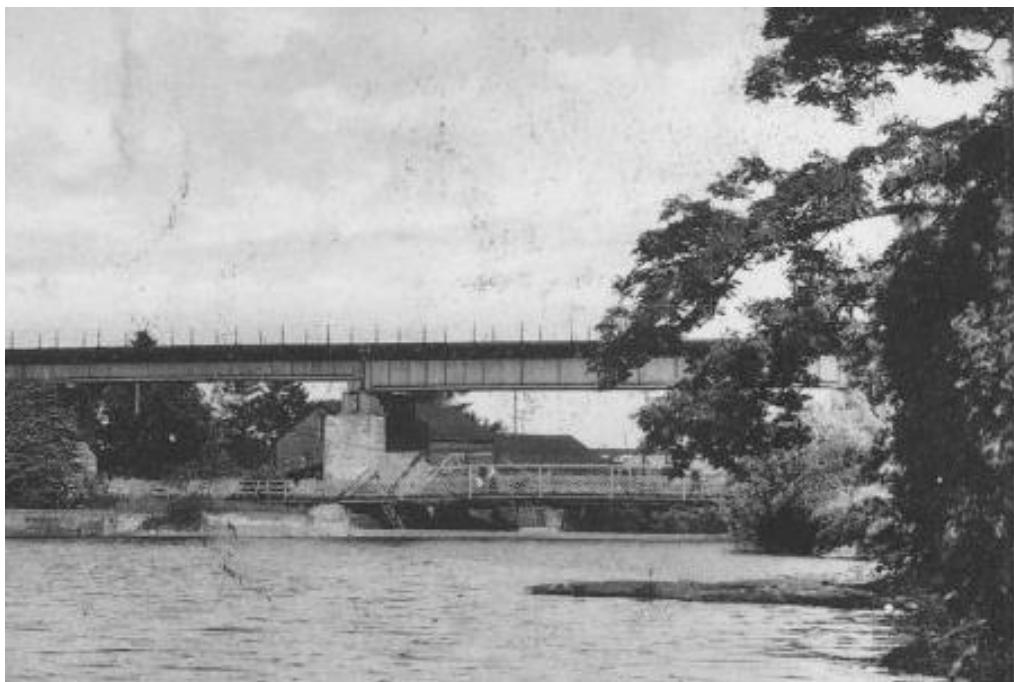
Figure 23: Pedestrian bridge adjacent to west side of Allan's Bridge, 1909
(Guelph Public Library, 2022)

In the early twentieth century, new infrastructure was needed to ensure the safety of those crossing the river. For instance, a steel truss pedestrian bridge was erected adjacent to the west side of Allan's Bridge (Figure 23).

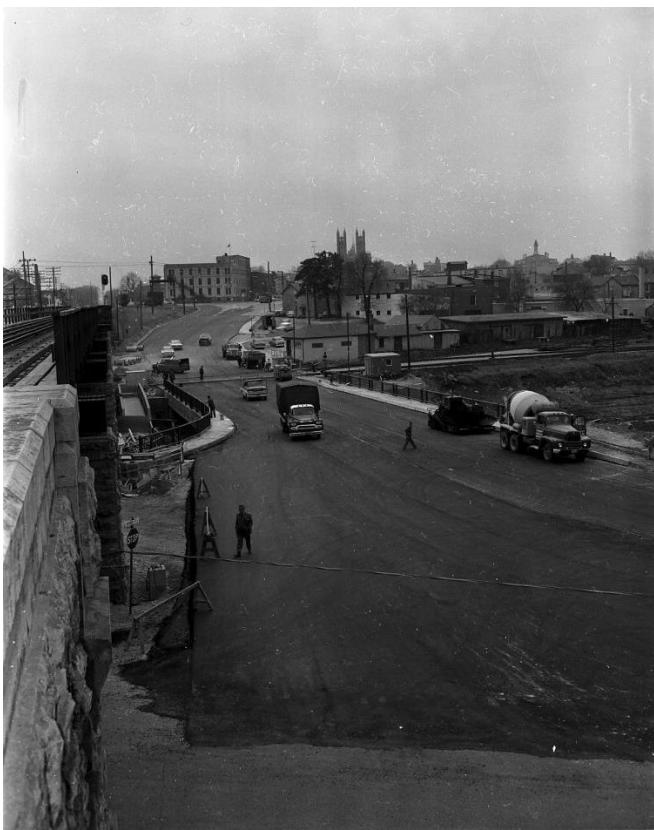
Figure 25: Construction of the Macdonell Street Bridge, 1963 (Guelph Public Library, 2022)

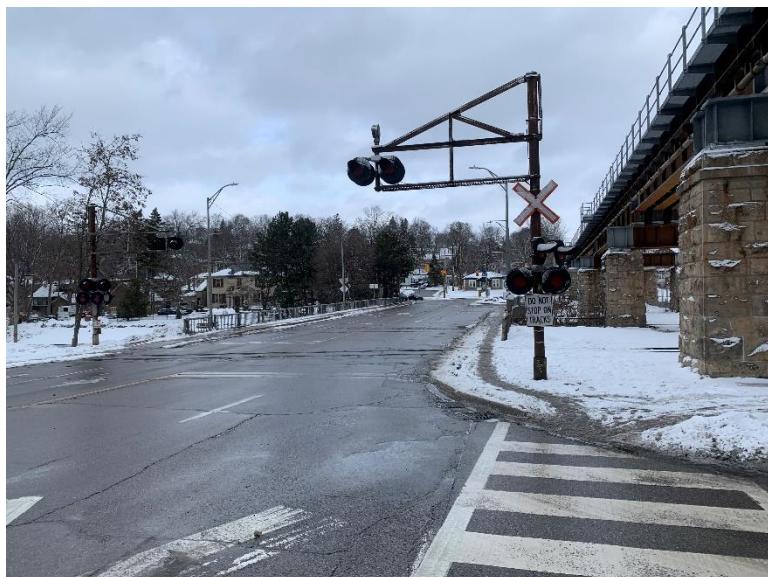
Figure 28: Approach to the Macdonell Street Bridge, looking north (ASI 2022)

The approaches to the bridge are at-grade. The south approach features a perpendicular at-grade railway crossing, now owned by the Guelph Junction Railway with associated warning lights and hazard signs (Figure 28).

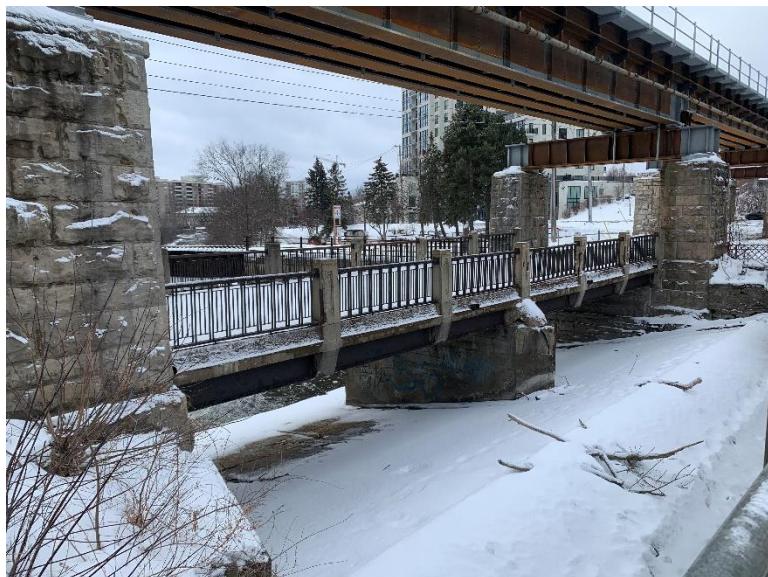
Figure 33: Allan's Bridge, looking southeast (ASI 2022)

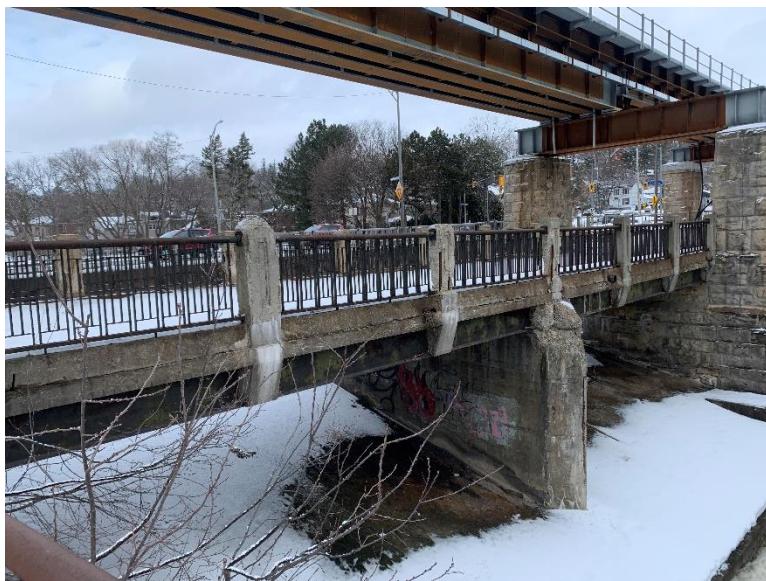
Figure 36: Allan's Bridge, with concrete central pier, looking northwest (ASI 2022)

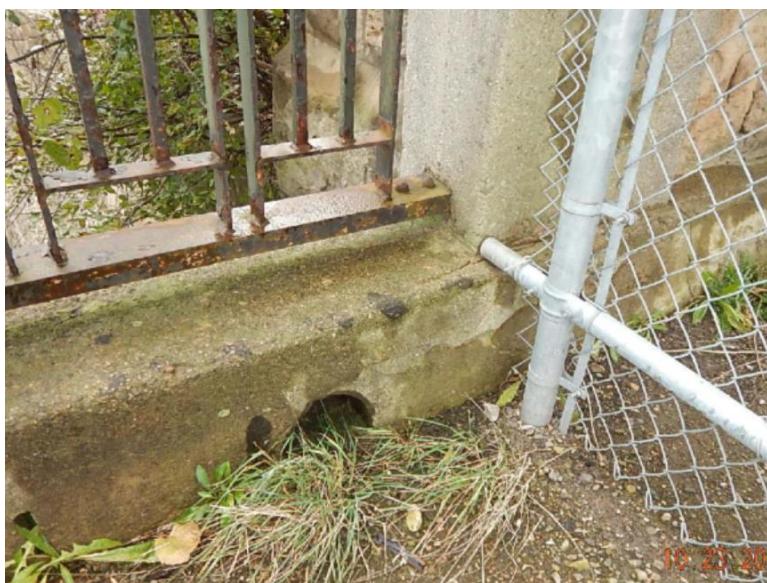
Figure 39: Southwest drain on Allan's Bridge (OSIM, 2018a)

The superstructure features a cast-in-place concrete under-wearing surface along the deck top, with an asphalt wearing surface above. It also features a railing system that includes concrete posts with steel rails. Significant spalling is visible with exposed corroded steel throughout the concrete posts (Figure 38). Eight metal drainpipes were built to allow water to drain off the bridge near the north and south barriers (Figure 39).

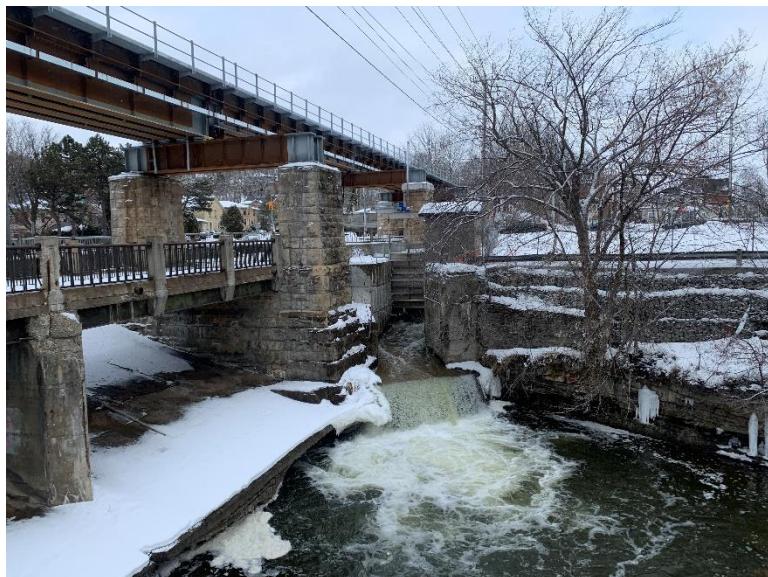
Figure 41: Allan's Sluiceway, looking north, with Allan's Spillway on the left (ASI 2022)

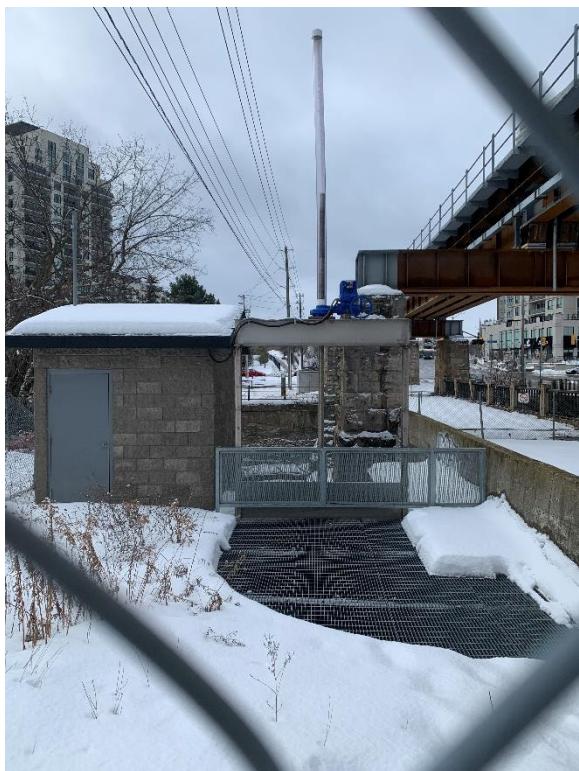
Figure 46: Building, north grate, and sluice gate, looking south (ASI 2022)

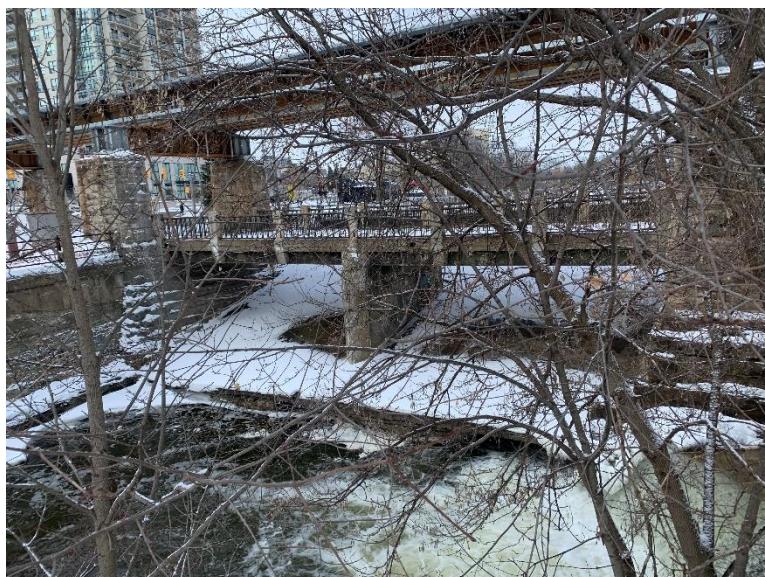
Figure 47: Allan's Spillway, looking southwest (ASI 2022)

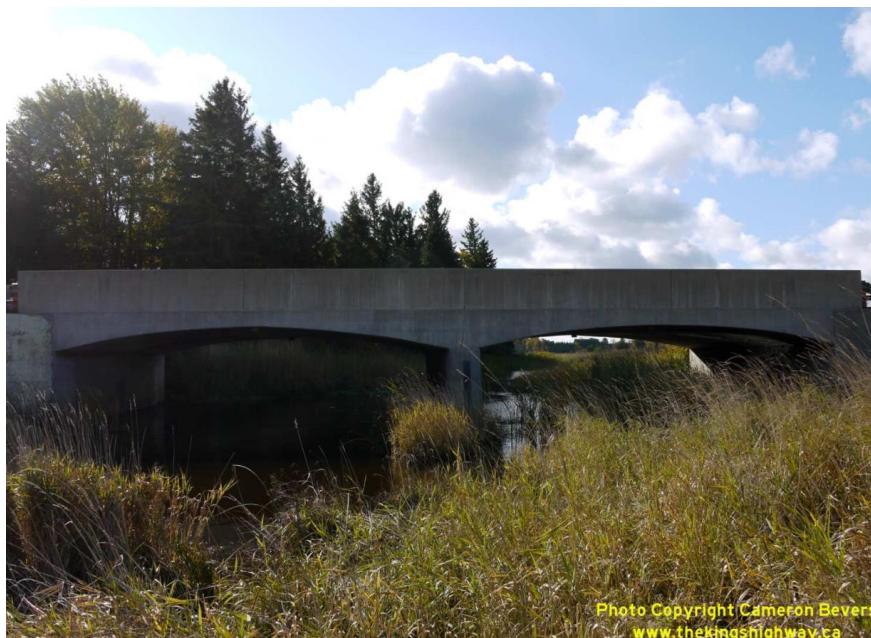
Figure 64: Grand River Bridge at Highway 89, built 1942 (Bevers, 2009)

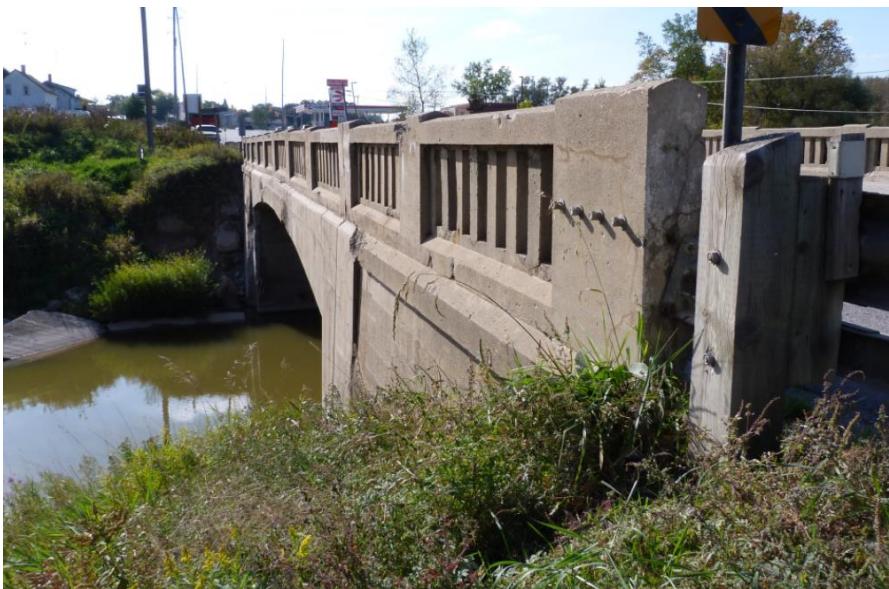
Figure 67: CR-109 West Bridge over Conestogo River in Wellington County, built in 1931 and featuring original concrete balustrade railing (Holth, 2021)

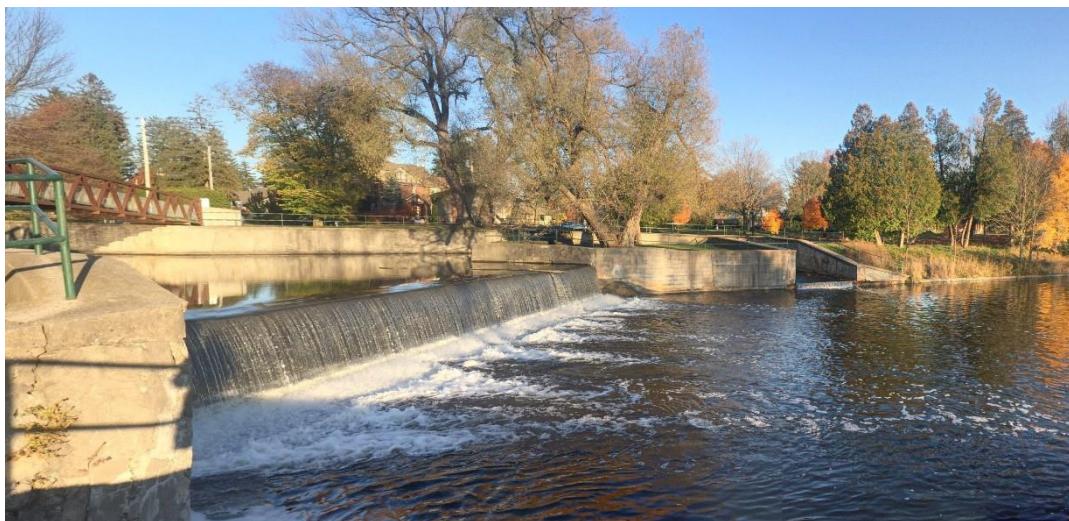
Figure 77: Spillway on the Speed River in Riverside Park in the City of Guelph (Google Maps)

Based on the review of the available data, the Allan's Spillway is built in a similar style and of the same construction material as the other spillways. Therefore, it may be considered to be a representative example of this structural type. The Allan's Spillway is also rare/unique given how it has been integrated with the Allan's Bridge above via a concrete central pier and how it is bounded by the piers of the Macdonell Street Rail Viaduct above.

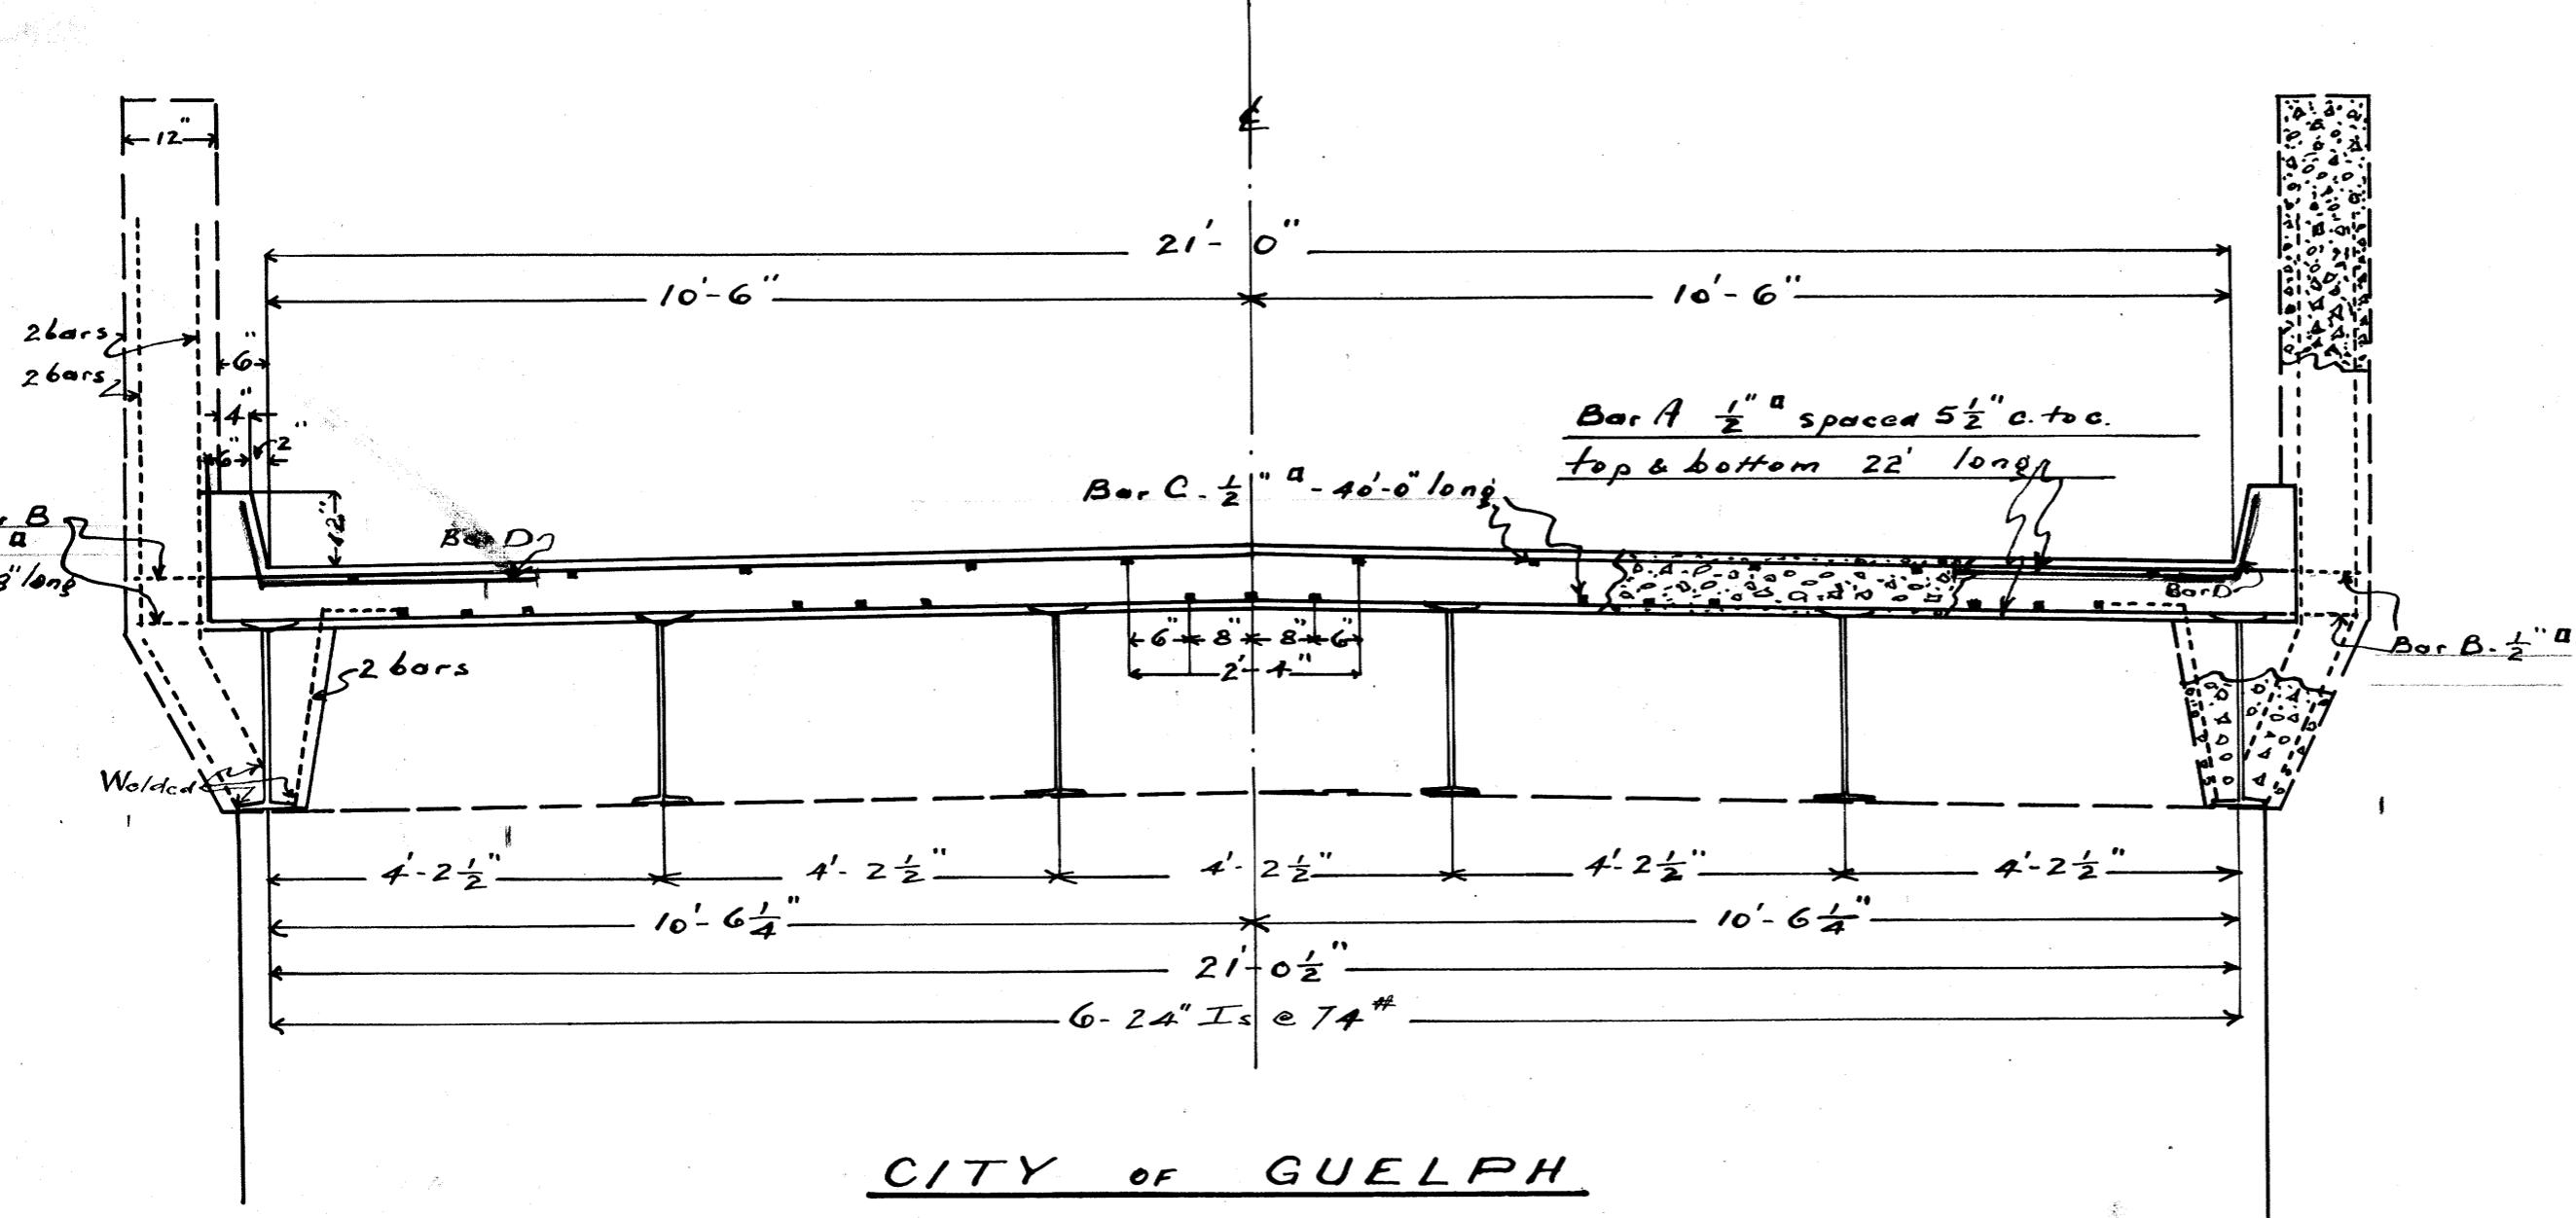
CITY OF GUELPH
RECONSTRUCTION ALLAN'S BRIDGE

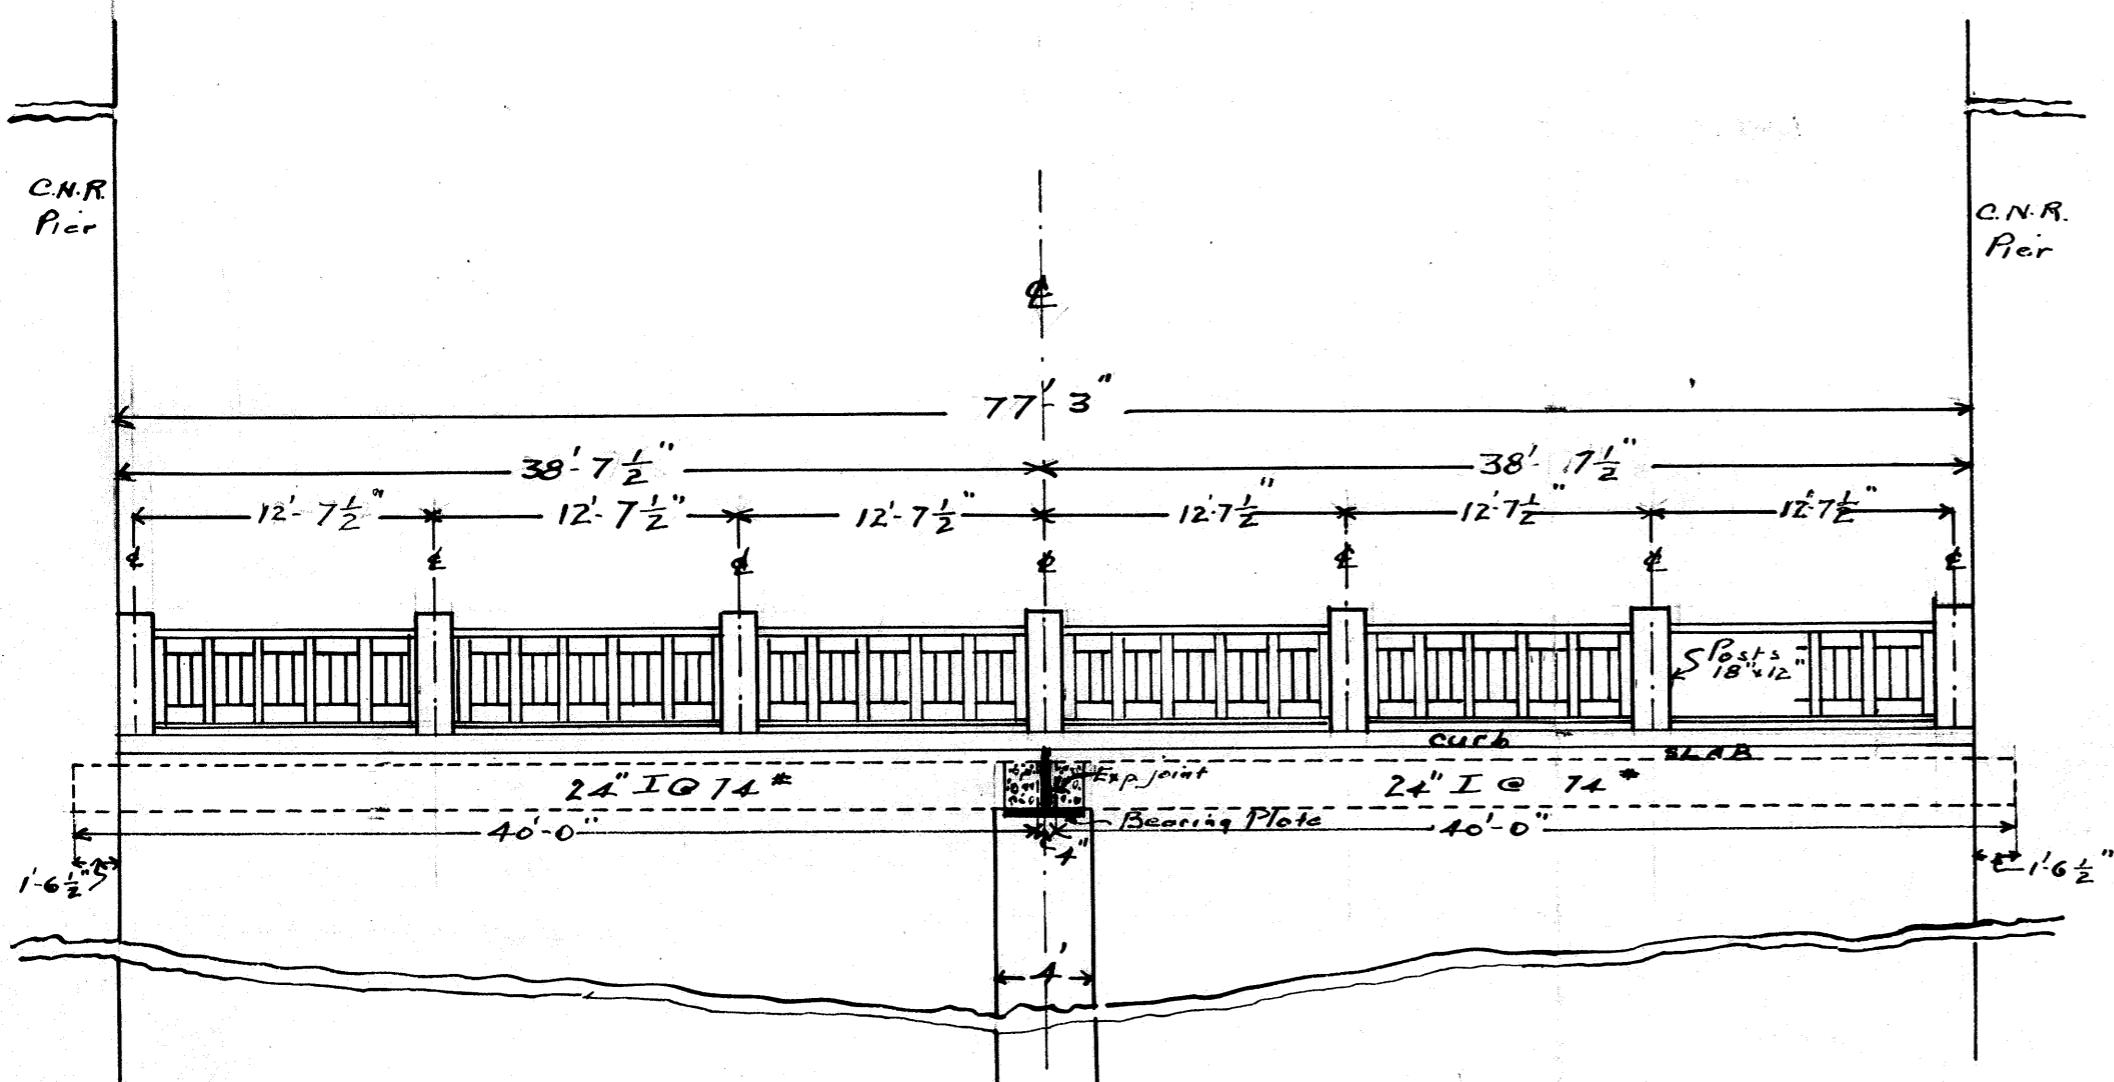
ELEVATION OF ALLAN'S BRIDGE—SHOWING RAILING—
