# Stormwater Management Master Plan

## Appendix O: Identification of Restoration Alternatives and Conceptual Design for Preferred Alternatives

Prepared by:  
**Aquafor Beech Ltd.**

Reference #: 66636  
October 2022  
Final Report

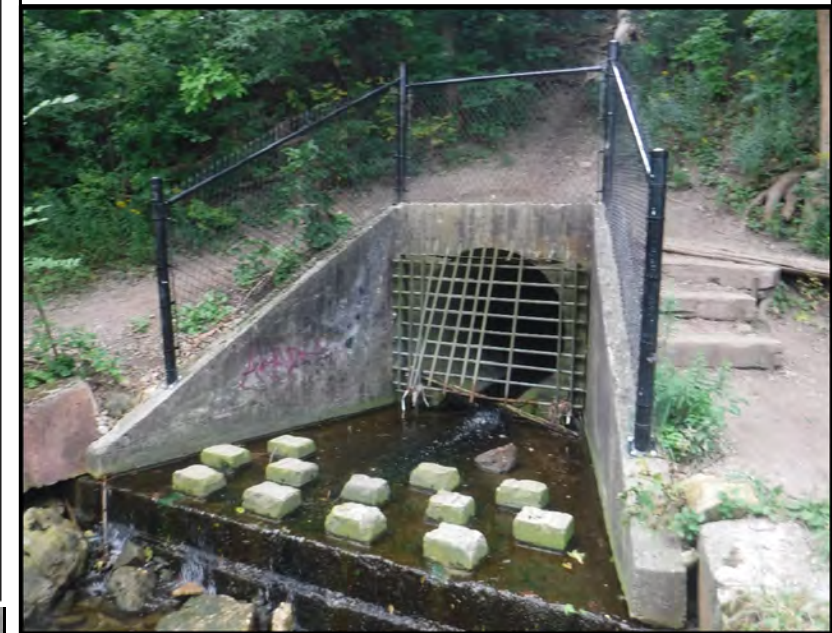
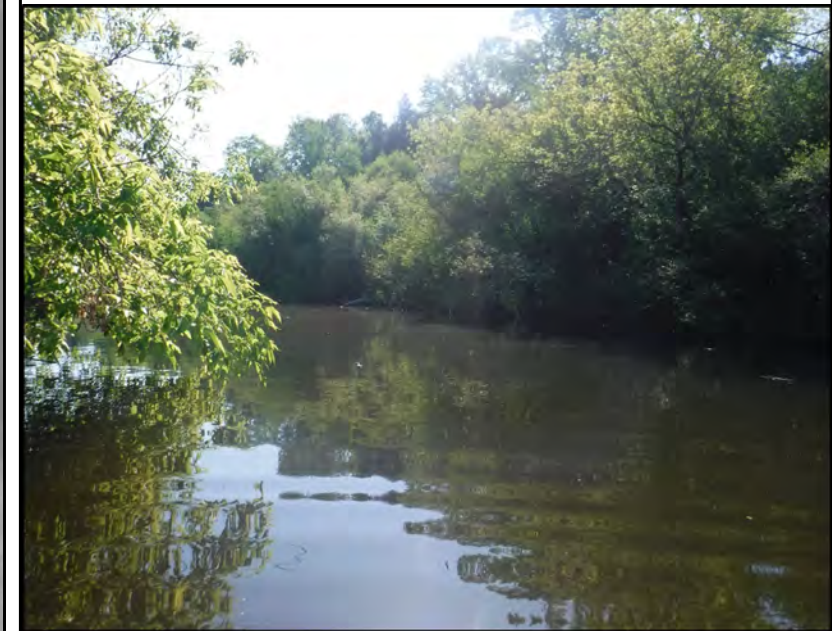
**Location: ES1**  
Local Remove and Replacement Concept Design

**ALTERNATIVE DESCRIPTION:**  
The local remove and replacement works alternative provides a cost-effective approach to stabilize the channel banks and replacement for the failed infrastructure

The components of the Local Replacement Works Alternative would include:

- Removal of the failed armourstone from the outfall channel
- Replacement of the outfall gate
- Restoration and boulder scour protection on the banks and the base of the outfall

The local remove and replacement works alternative provides a cost-effective approach to stabilize the channel banks and replacement for the failed infrastructure. A conceptual design of the Local Remove and Replacement Works alternative is presented below in **Figure 6.1**.

The components of the Local Remove and Replacement Works Alternative would include:

- Removal of the failed armourstone from the outfall channel.
- Replacement of the outfall gate
- Restoration and boulder scour protection on the banks at the base of the outfall channel.

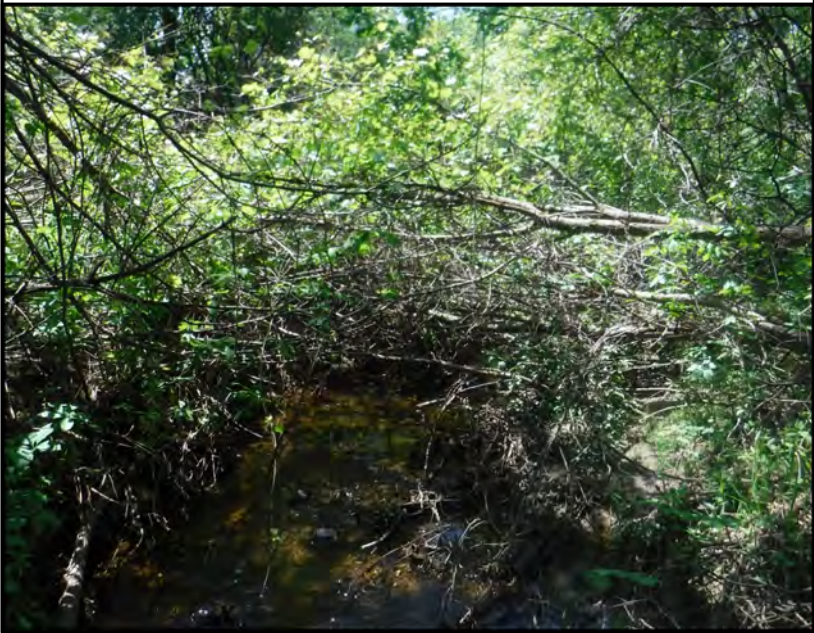
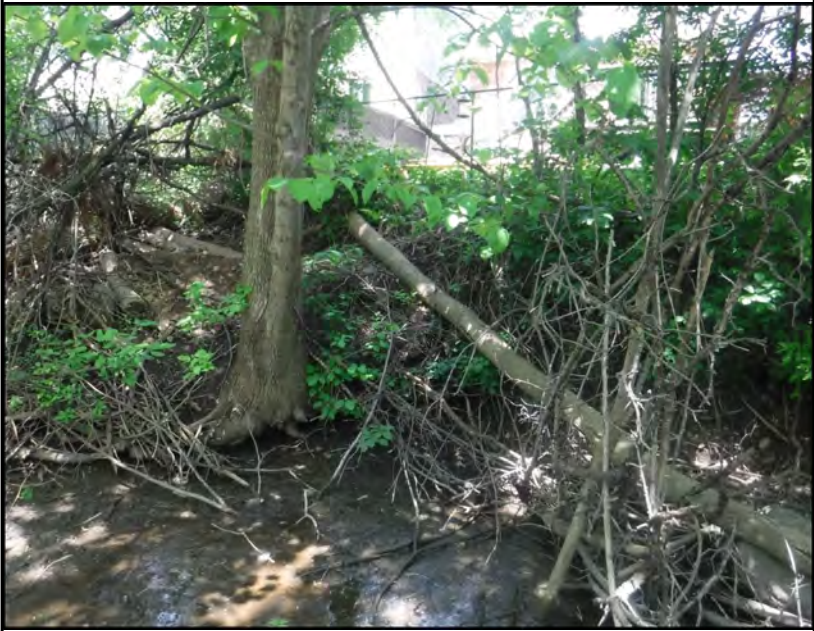
**ALTERNATIVE DESCRIPTION:**  
The local remove and replacement works alternative provides a cost-effective approach to stabilize the channel banks and remove the risk to adjacent properties

- The components of the Local Replacement Works Alternative would include:
- Maintenance and debris removal of channel through the reach
  - Stabilization of the bank with a vegetated boulder and rip rap treatment in the affected meander bend

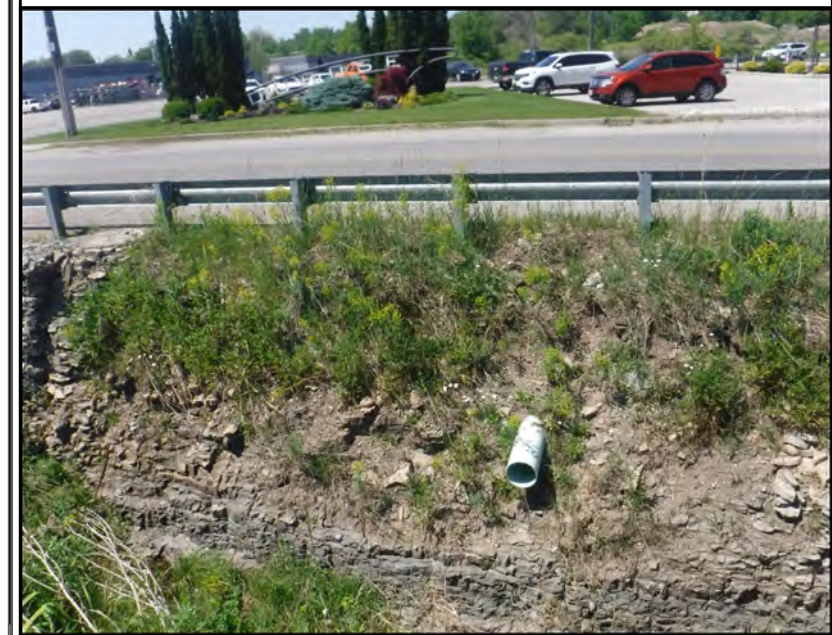
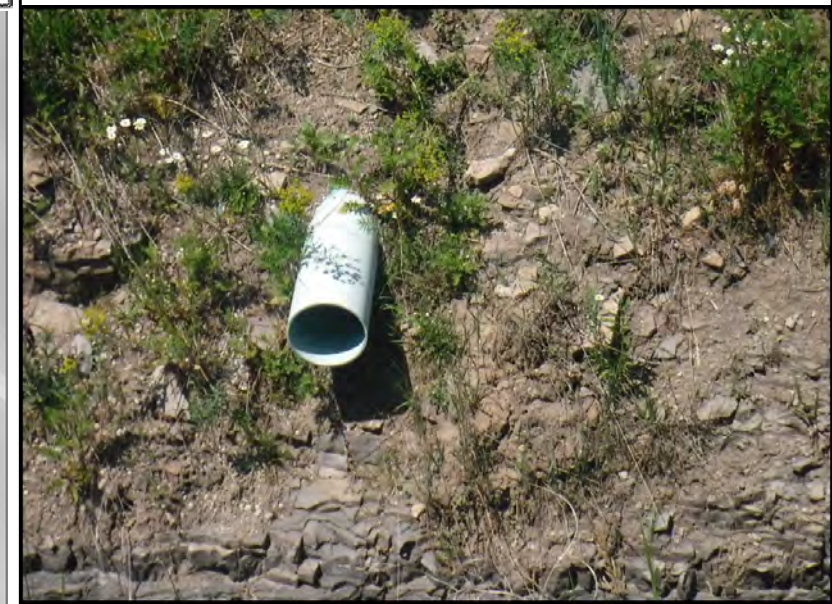
**Location: ES4**  
 Local Remove and Replacement Concept Design

**ALTERNATIVE DESCRIPTION:**  
 The local remove and replacement works alternative provides a cost-effective approach to protect the infrastructure at risk, incorporate structural components into a channelized system, and provide erosion protection

The components of the Local Replacement Works Alternative would include:

- Stabilization of the outfall pipe with a concrete headwall
- Structural reinforcement of the exposed shale roadbed
- Structural support of the compromised guard rail posts over the outfall

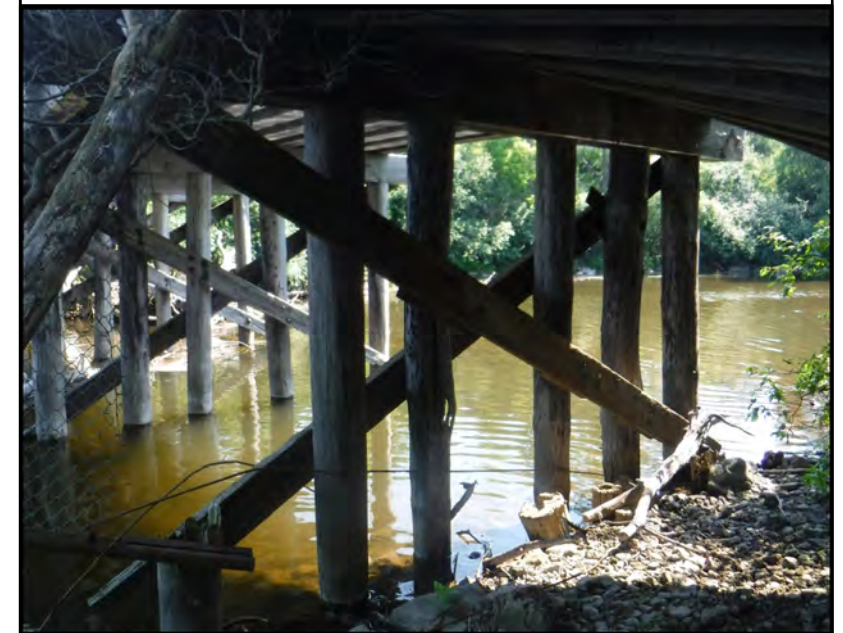
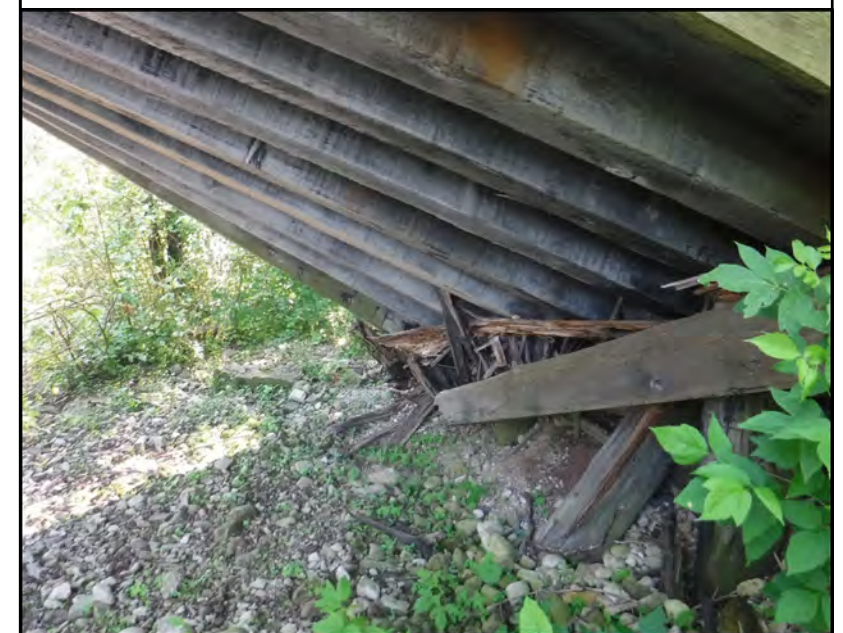
#### ALTERNATIVE DESCRIPTION

The removal of risk alternative provides a cost-effective approach to stabilize the channel banks and removal of the failed bridge.

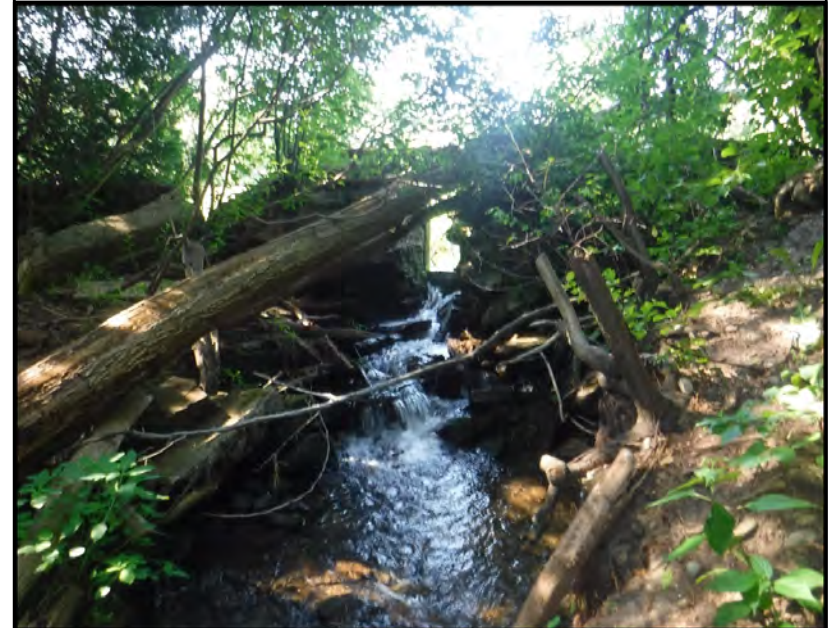
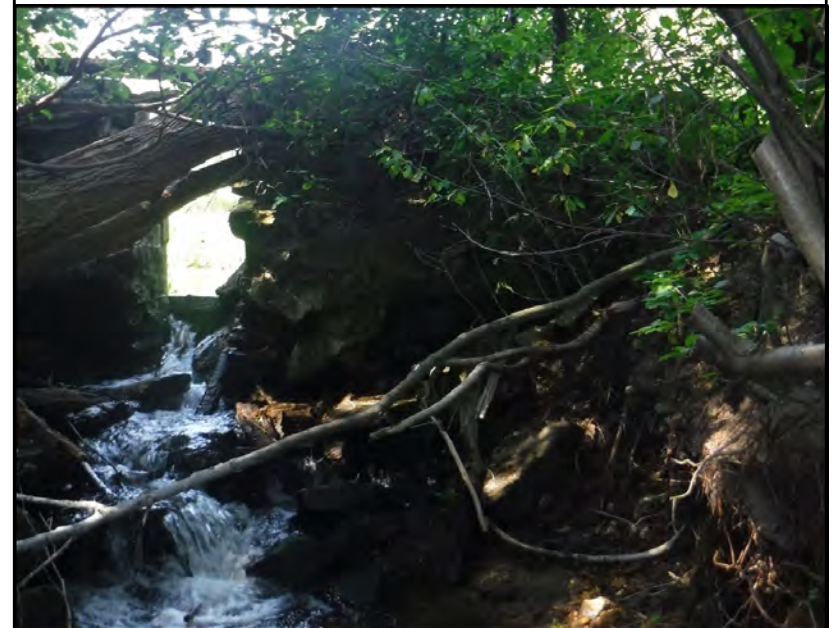
**NOTE:**  
BANK STONE MATERIALS TO BE PLACED IN LIFTS. EACH LIFT TO BE OF ROUNDSTONE FOLLOWING BY TOPSOIL AND VEGETATION AND THEN FOLLOWED BY LAYER OF NEXT LIFT OF ROUNDSTONE. 300MM TOPSOIL SHOULD BE PLACED BETWEEN LIFTS TO ENHANCE THE OPPORTUNITY FOR VEGETATION GROWTH.

### ALTERNATIVE DESCRIPTION:

The local works alternative provides a cost-effective approach to stabilize the channel gradient and restore the banks to a more stable profile

stabilization to the existing conditions. A conceptual design of the Local Works alternative is presented below in **Figure 6.5**.

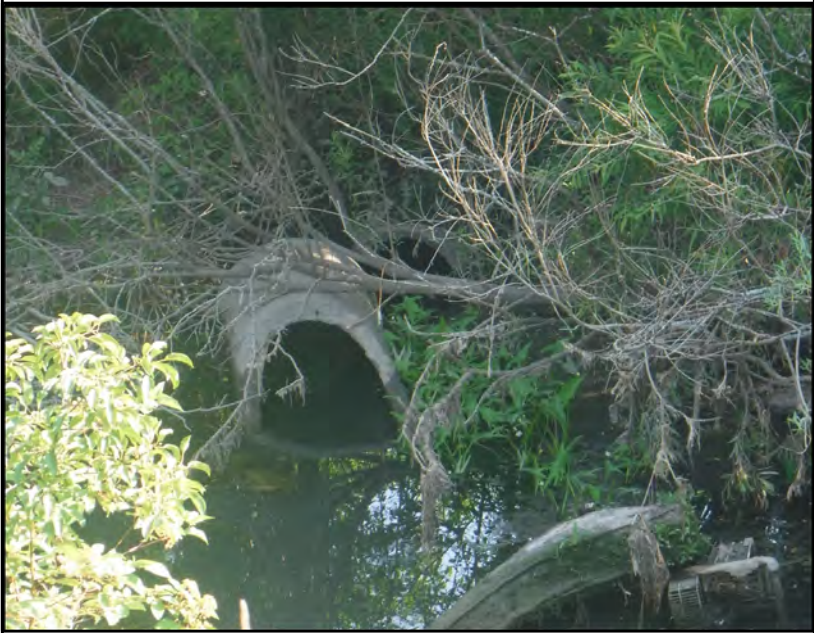
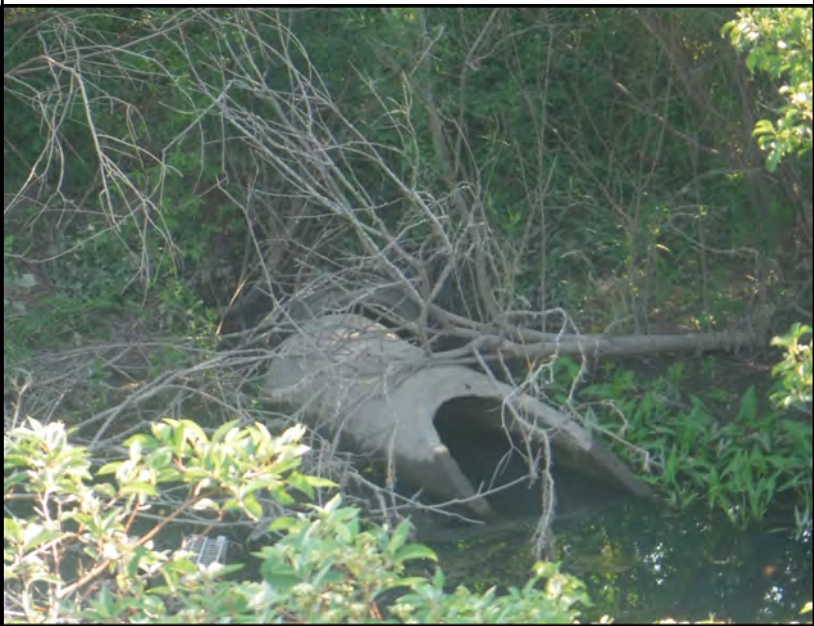
**ALTERNATIVE DESCRIPTION:**

The local stabilization works alternative provides a cost-effective approach to stabilize the channel/infrastructure interaction and remove the risk to the surrounding bank

- Removal of the compromised pipe from the channel.
- Stabilization of the outfall pipe with armourstone.
- Vegetated rip rap bank protection at the banks and slope.

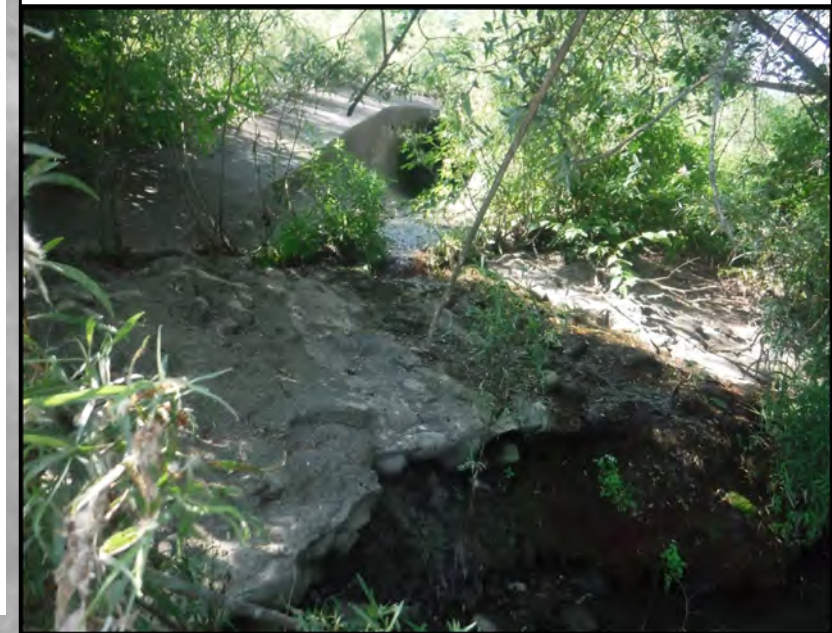
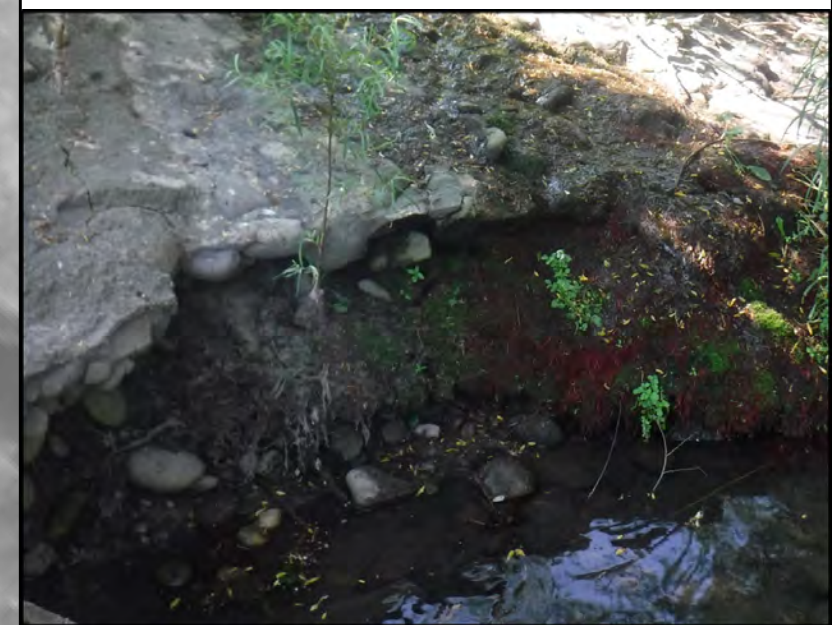
**Location: ES9**  
Local Replacement Works Concept Design

**ALTERNATIVE DESCRIPTION:**  
The local replacement works alternative provides a cost-effective approach to stabilize the channel/infrastructure interaction and remove the risk to the surrounding bank

The components of the Local Replacement Works Alternative would include:

The local replacement works alternative provides a cost-effective approach to stabilize the channel/infrastructure interaction and remove the risk to the surrounding bank. This alternative provides erosion protection and stabilization to the existing concrete outfall and the banks and slopes of the channel corridor. A conceptual design of the Remove and Replace Works alternative is presented below in **Figure 6.7**.

- Removal of the compromised grouted bank treatment from the channel.
- Stabilization of the outfall channel and bank with a vegetated boulder treatment.

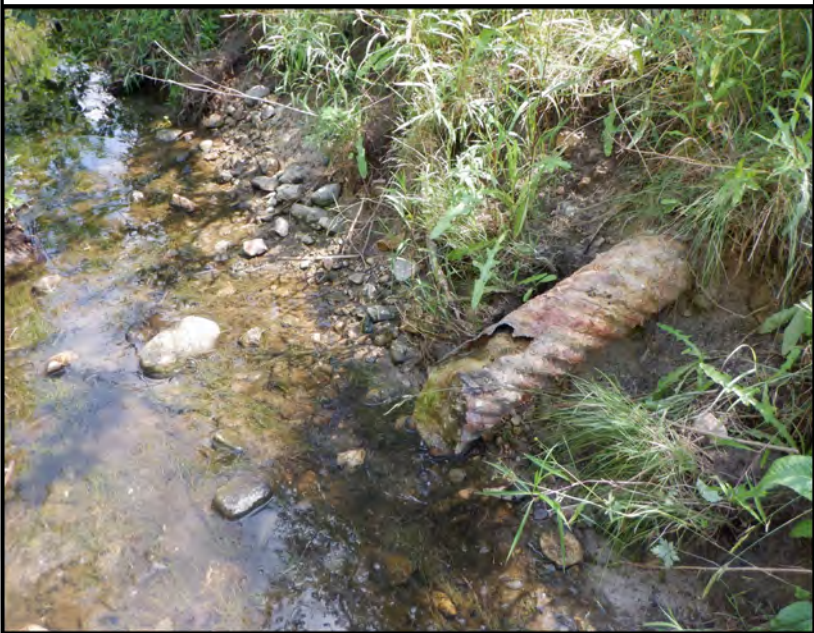
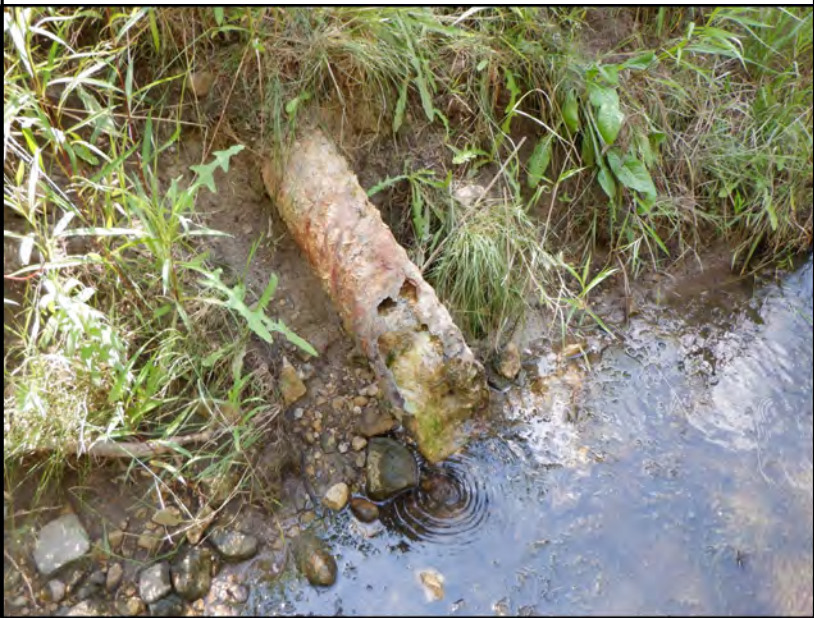
Location: ES10  
Local Repair Works Concept Design

VEGETATED RIP RAP PROTECTION  
WITHIN THE BANKS  
PER DETAIL THIS SHEET

STABILIZATION OF OUTFALL PIPE WITH  
VEGETATED BOULDER TREATMENT

The local replacement works alternative provides a cost-effective approach to stabilize the channel/infrastructure interaction and remove the risk to the surrounding bank

- The components of the Local Repair Works Alternative would include:
- Clearing the obstructed outfall and CCTV inspection of the asset
  - Replacement of pipe will be decided after the CCTV inspection
  - Stabilization of the outfall pipe with a vegetated boulder treatment
  - Rip rap scour protection within the banks

The local repair works alternative provides a cost-effective approach to stabilize the channel/infrastructure interaction and remove the risk to the surrounding bank. Additionally, this alternative provides erosion protection to the private property adjacent to this narrow channel corridor as well as the existing CSP outfall. A conceptual design of the Local Repair Works alternative is presented below in **Figure 6.8**.

- Clearing the obstructed outfall and CCTV inspection of the asset.
- Stabilization of the outfall pipe with a vegetated boulder treatment.
- Rip rap scour protection within the channel.

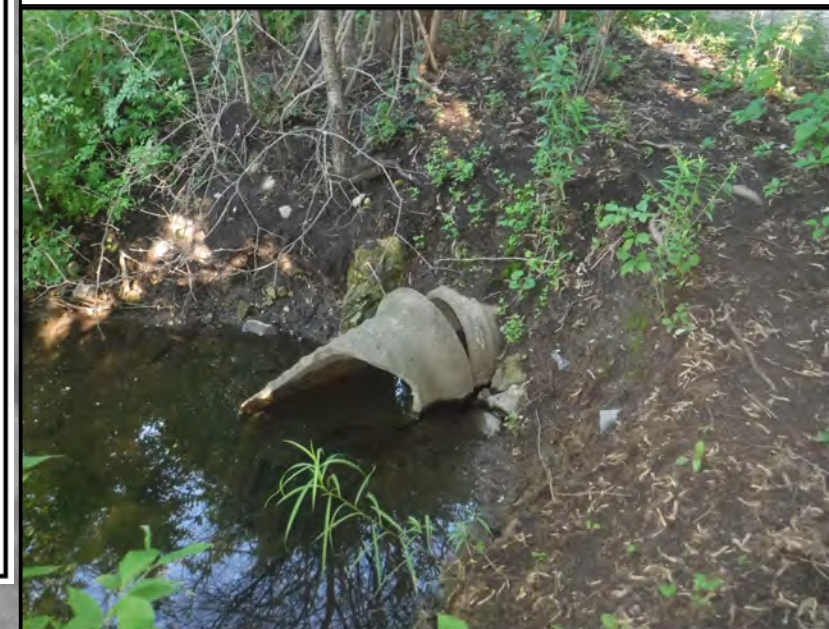
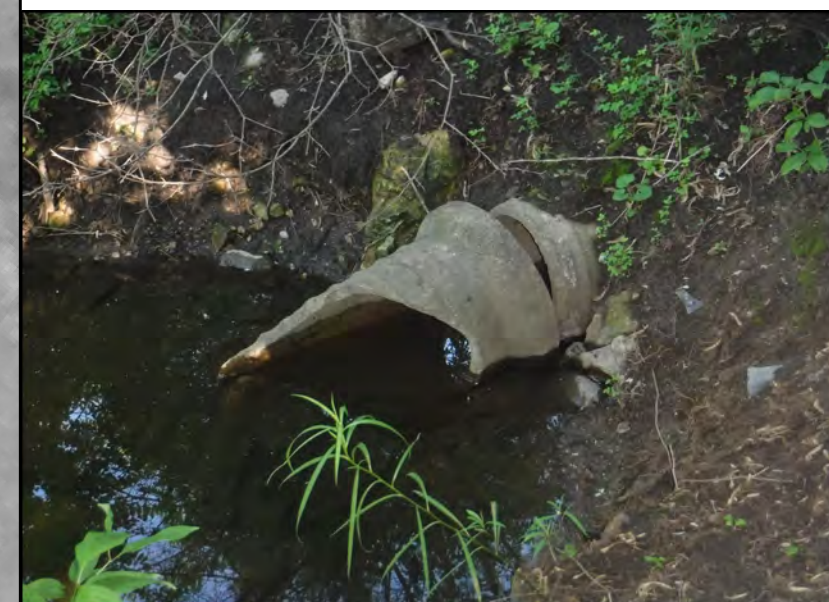
**NOTE:**  
BANK STONE MATERIALS TO BE PLACED IN LIFTS. EACH LIFT TO BE OF ROUNDSTONE FOLLOWING BY TOPSOIL AND VEGETATION AND THEN FOLLOWED BY LAYER OF NEXT LIFT OF ROUNDSTONE. 300MM TOPSOIL SHOULD BE PLACED BETWEEN LIFTS TO ENHANCE THE OPPORTUNITY FOR VEGETATION GROWTH.

### OUTFALL INCORPORATED WITHIN ARMOURSTONE WALL

### ALTERNATIVE DESCRIPTION:

The local stabilization works alternative provides a cost-effective approach to stabilize the channel banks and repair the failed outfall

The local stabilization works alternative provides a cost-effective approach to stabilize the channel banks and repair the failed outfall. This alternative provides erosion protection and bank stabilization to the existing conditions. A conceptual design of the Local Stabilization Works alternative is presented below in **Figure 6.9**.

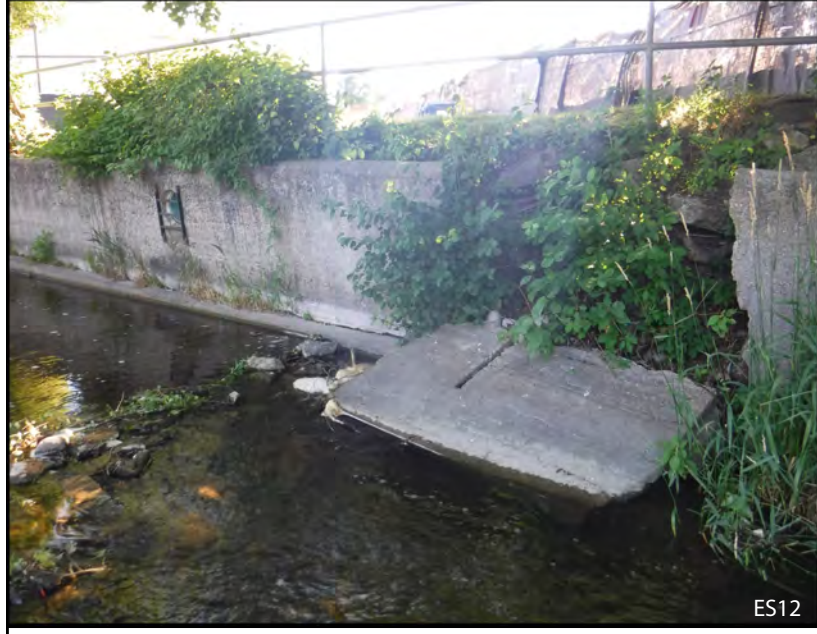
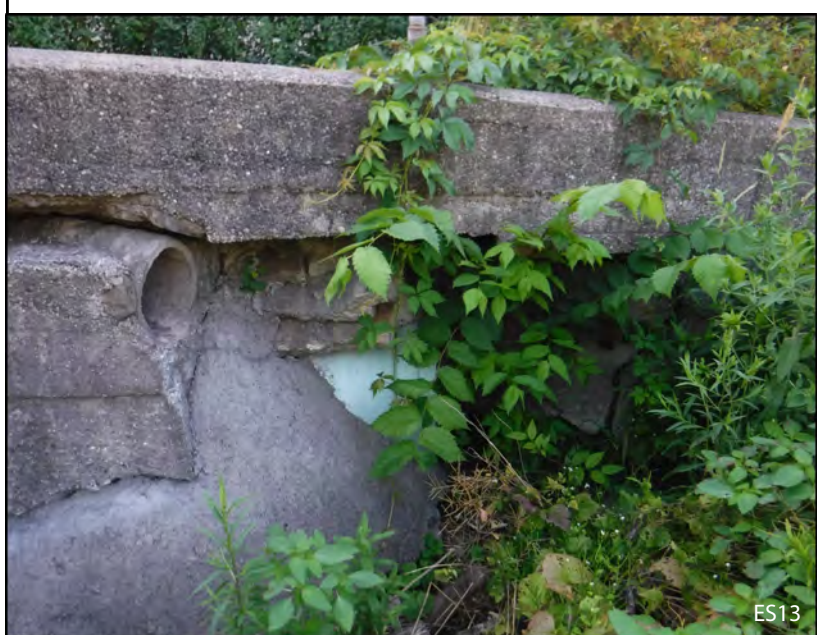
**ALTERNATIVE DESCRIPTION:**

The reach based works alternative provides a cost-effective approach to stabilize the banks and storm sewer outfall infrastructure

- Removal of the failed and deteriorating segments of the unreinforced retaining wall
- Replacing failed segments with armourstone
- Replacement of the outfalls with concrete headwalls, stabilized with armourstone.

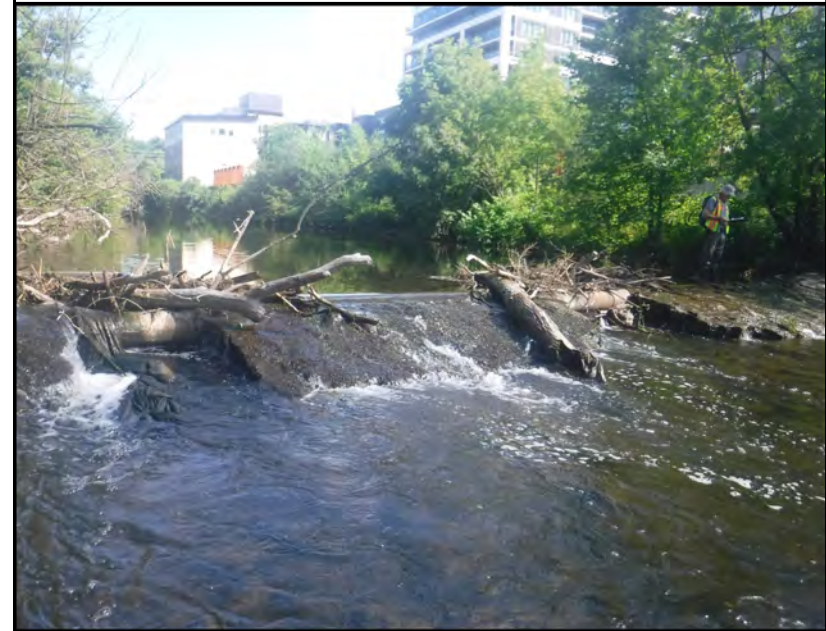
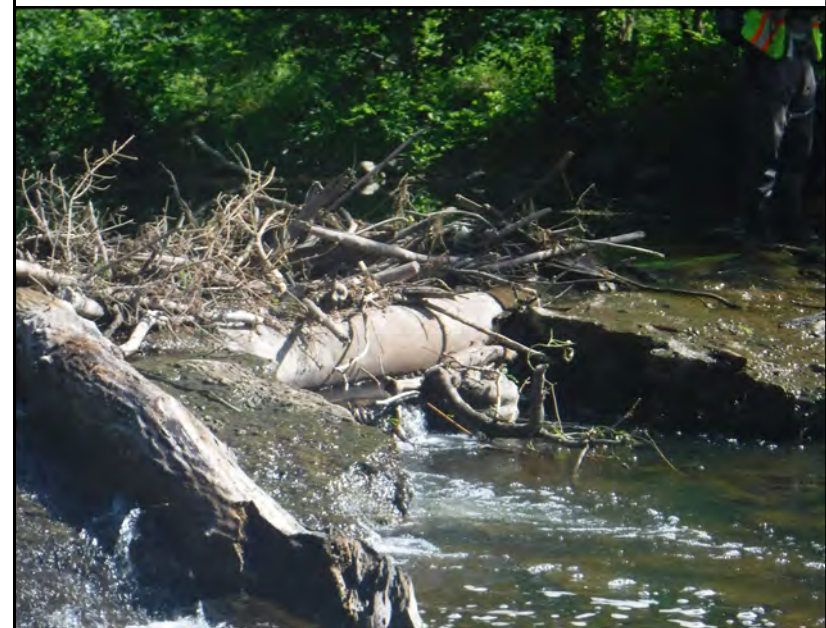
**ALTERNATIVE DESCRIPTION:**  
The removal of risk alternative provides a cost-effective approach to stabilize the channel/infrastructure interaction and remove the risk to the failing infrastructure.

The components of the Removal of Risk Alternative would include:

- Removal of the compromised pipe from the channel.
- Stabilization of the crossing with a fixed riffle over the grade control infrastructure at the site of the crossing.
- Cap the pipe in the banks at an offset equivalent to the 100-yr erosion limit.
- The banks restored with native vegetation and riparian cover.
- Restoration off the banks at the existing crossings.

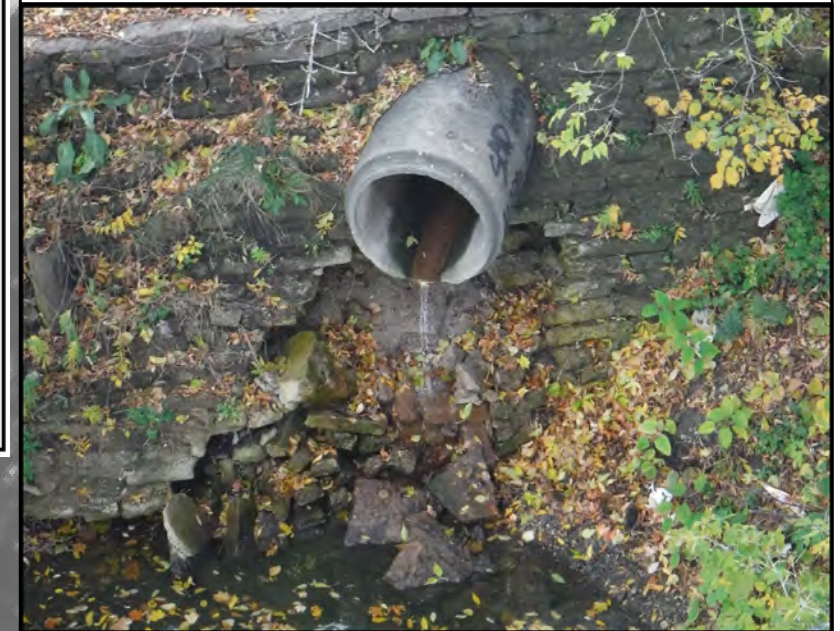
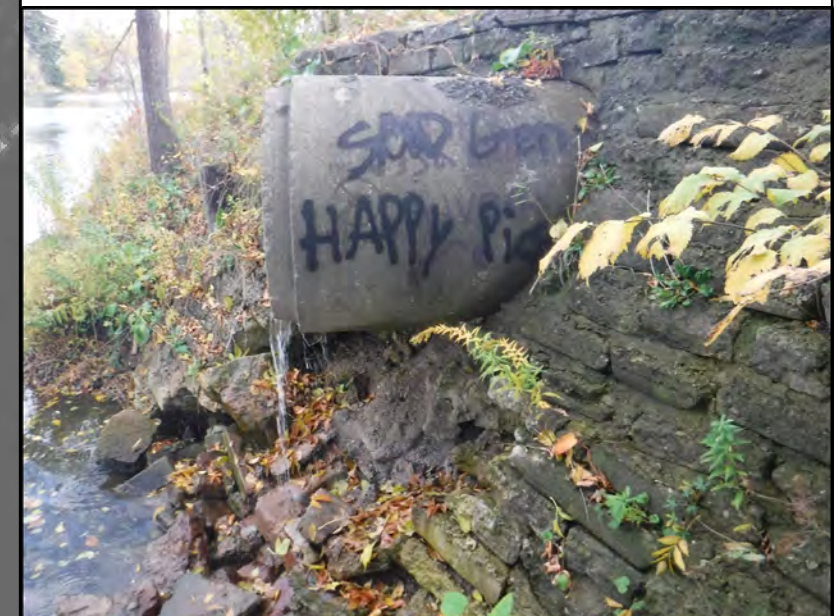
**ALTERNATIVE DESCRIPTION:**

The local replacement works alternative provides a cost-effective approach to stabilize the concrete outfall pipe and repair the failed stone retaining wall.

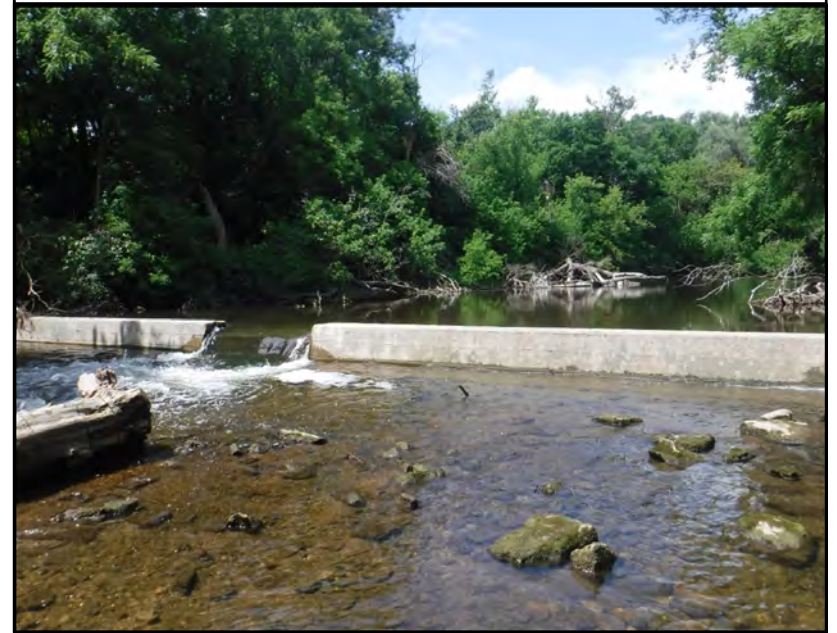
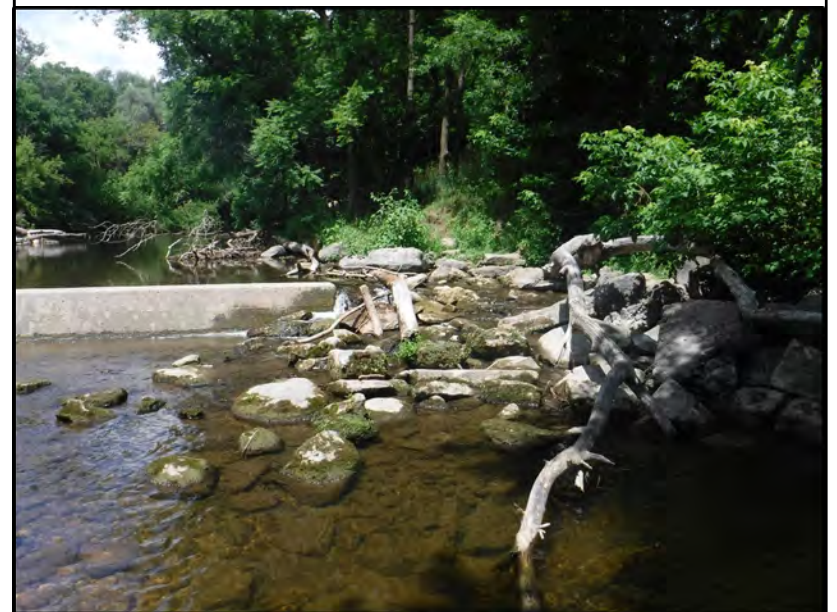
**ALTERNATIVE DESCRIPTION:**

The “Do Nothing” alternative provides a cost-effective solution to the channel/infrastructure interaction.

The “Do Nothing” alternative provides a cost-effective solution to the channel/infrastructure interaction. While this alternative provides no additional erosion protection or stabilization to the existing outfall or banks, the existing scour protection appears stable enough to recommend monitoring the erosion site until the banks show increased risk to the outfall.

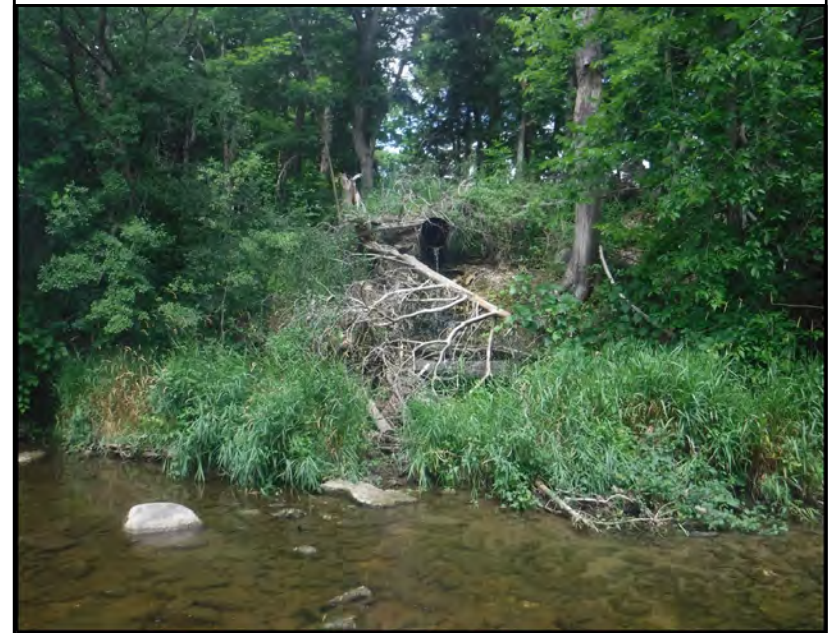
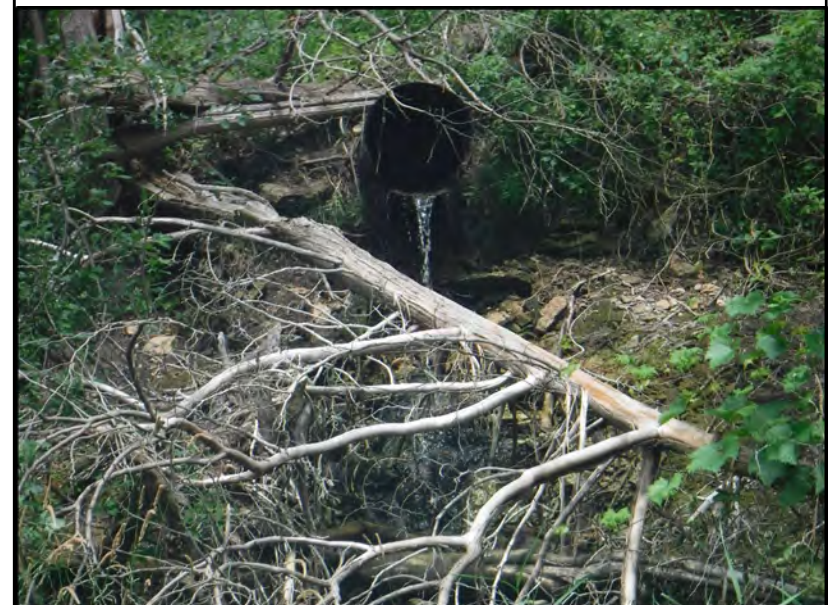
**ALTERNATIVE DESCRIPTION:**

The local stabilization works alternative provides a cost-effective approach to stabilize the channel/infrastructure interaction and remove the risk to the surrounding bank

- Removal of the debris from the channel.
- Rebuilding the undermined bank and stabilization of the outfall pipe with boulders.
- Vegetated rip rap bank protection around the pipe.

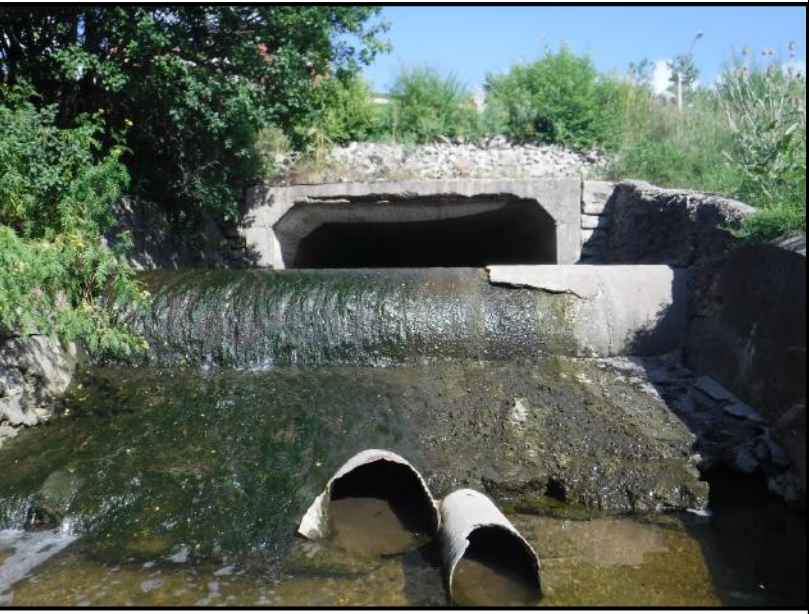
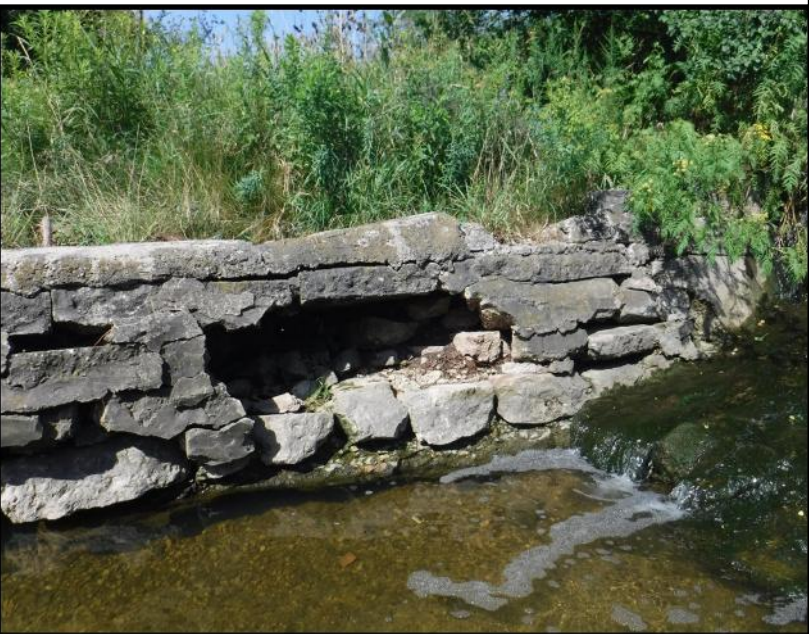
**ALTERNATIVE DESCRIPTION:**

The emergency works alternative provided a cost-effective approach to stabilize the infrastructure and channel banks

- Removal of the existing sanitary sewer between ES#18/20 and the Wastewater Treatment Plant.
- Replace sanitary sewer along this length after lowering it to provide at least 1m of cover over the sewer at both ES#18 and ES#20.
- Rebuilding and stabilizing of the channels.

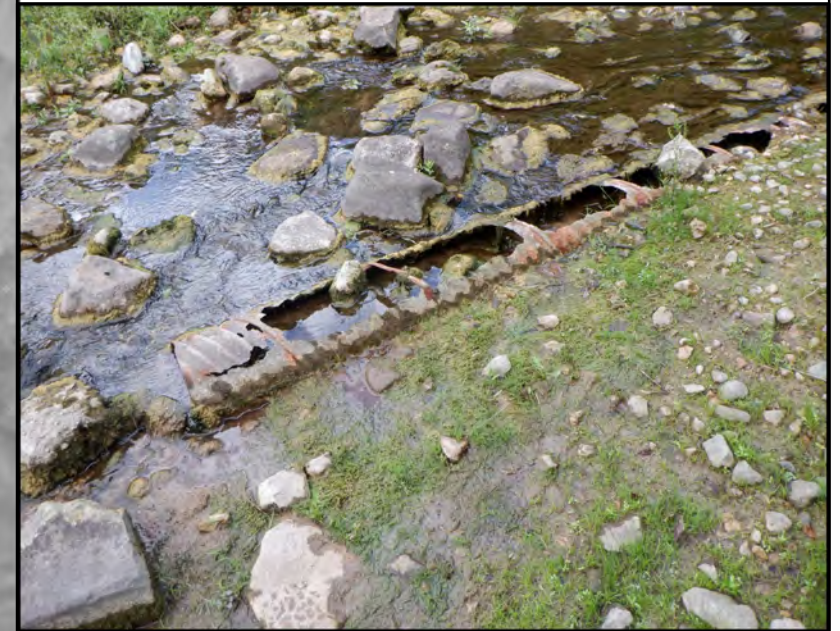
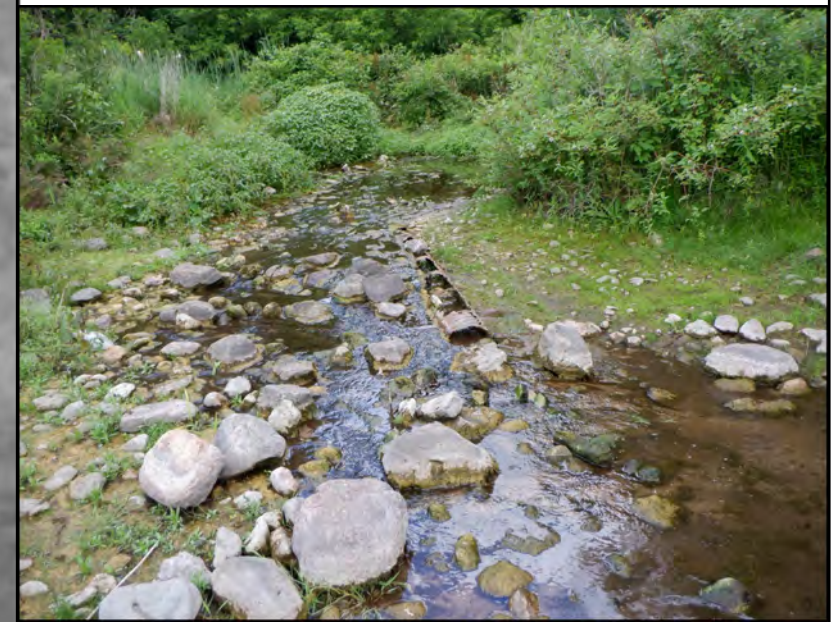
**ALTERNATIVE DESCRIPTION:**

The "Do Nothing" alternative provides a cost-effective solution to the channel/infrastructure interaction.

The “Do Nothing” alternative provides a cost-effective solution to the channel/infrastructure interaction. While this alternative provides no erosion protection or stabilization to the existing outfall or banks, leaving this embedded pipe in the floodplain poses no risk of erosion or barrier to fish passage.

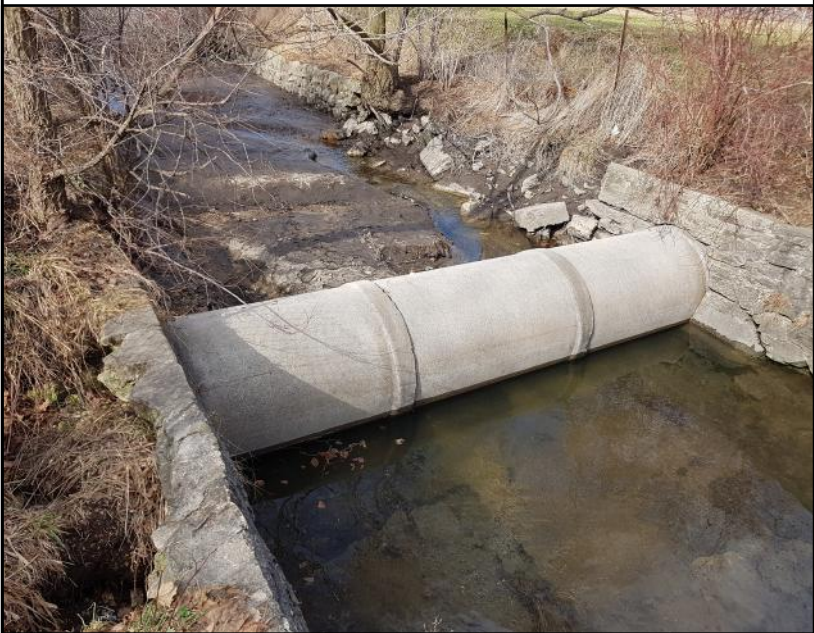
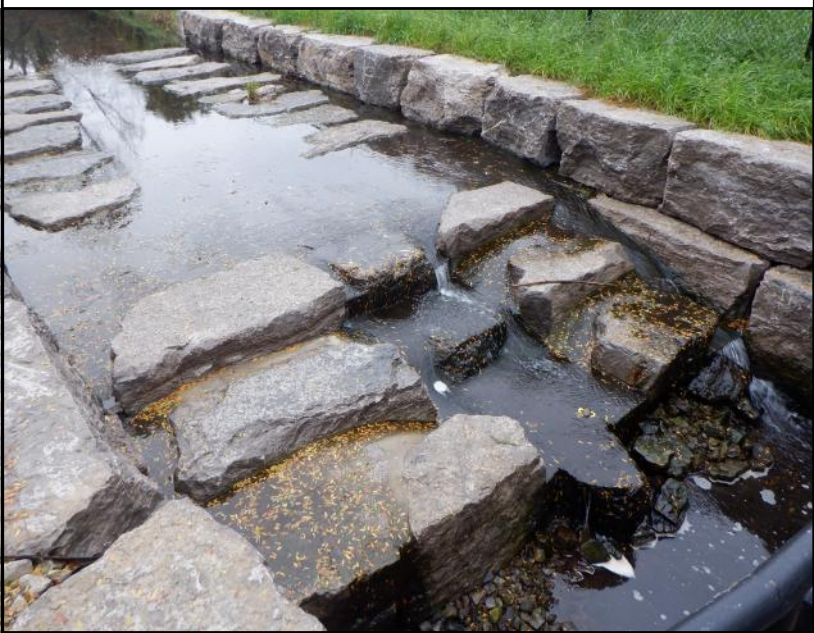
**ALTERNATIVE DESCRIPTION:**

The emergency works alternative provided a cost-effective approach to stabilize the infrastructure and channel banks

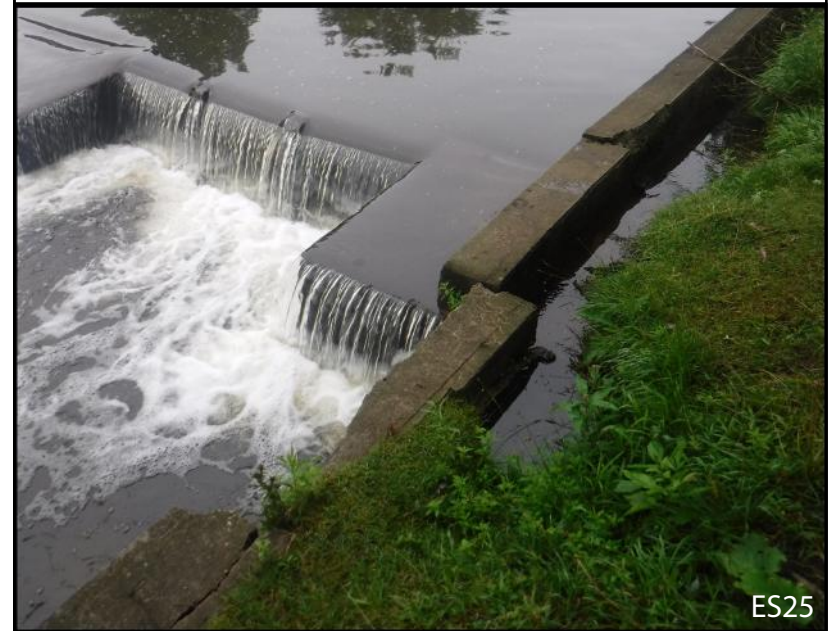
ES25

NOTE:  
VEGETATED BUTTRESS TO BE CONSTRUCTED IN LIFTS. EACH LIFT TO BE OF ROUNDSTONE BOULDERS FOLLOWING BY TOPSOIL AND VEGETATION AND THEN FOLLOWED BY LAYER OF NEXT LIFT OF ROUNDSTONE BOULDERS. 300MM TOPSOIL SHOULD BE PLACED BETWEEN LIFTS TO ENHANCE THE OPPORTUNITY FOR VEGETATION GROWTH.

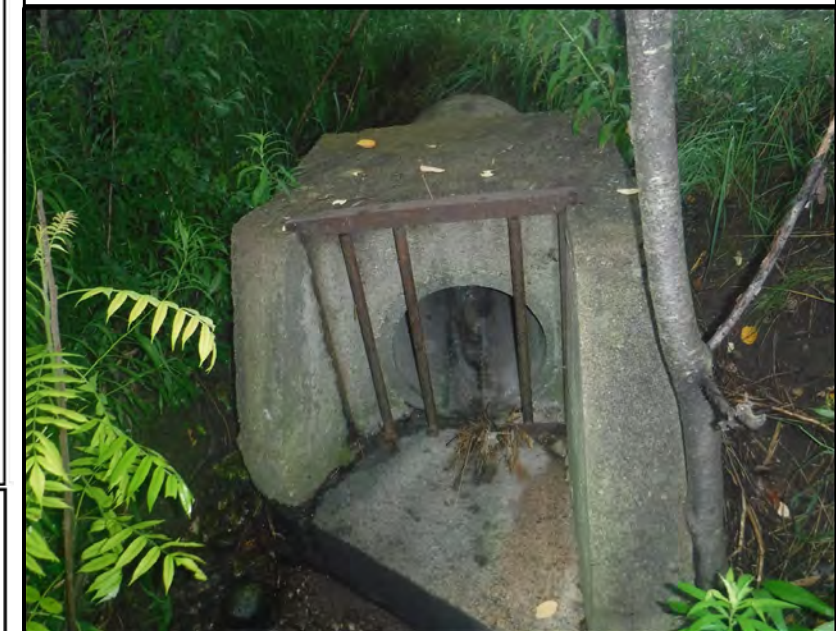
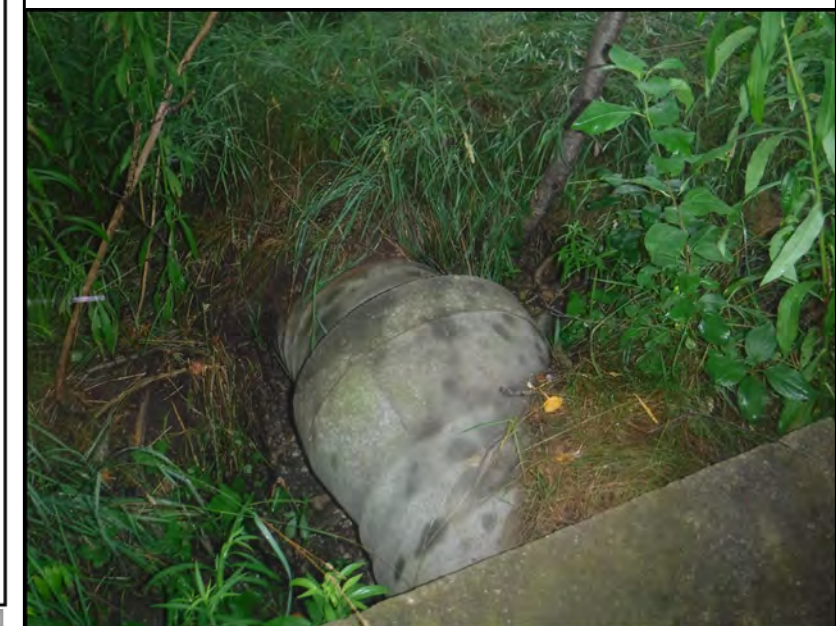
**ALTERNATIVE DESCRIPTION:**

The local replacement works alternative provides a cost-effective approach to stabilize the concrete headwall and restore the eroded bank downstream of Woodlawn Road

- Replacement of the existing headwall.
- Stabilization of the outfall pipe and concrete headwall with embedded armourstone.
- Embedded scour protection on the bank and at the base of the outfall.

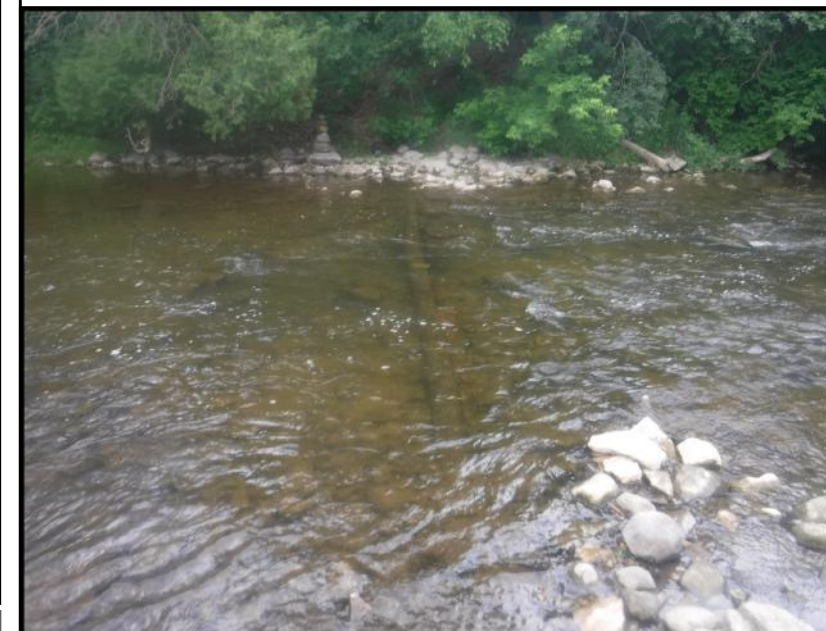
**ALTERNATIVE DESCRIPTION:**

The removal of risk alternative provides a cost-effective approach to stabilize the channel banks and remove the decommissioned infrastructure and low flow fish barrier

- Removal of the pipe from the channel.
- Cap the pipe in the banks at an offset equivalent to the 100-yr erosion limit.
- Restoration off the banks at the existing crossings.
