# Stormwater Management Master Plan

## Appendix O: Identification of Restoration Alternatives and Conceptual Design for Preferred Alternatives

Prepared by:  
**Aquafor Beech Ltd.**

Reference #: 66636  
October 2022  
Final Report

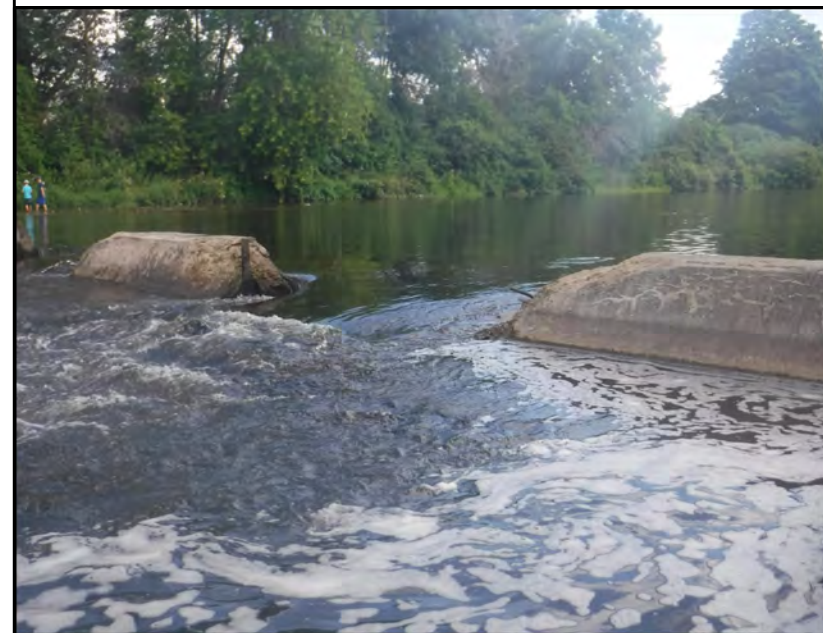
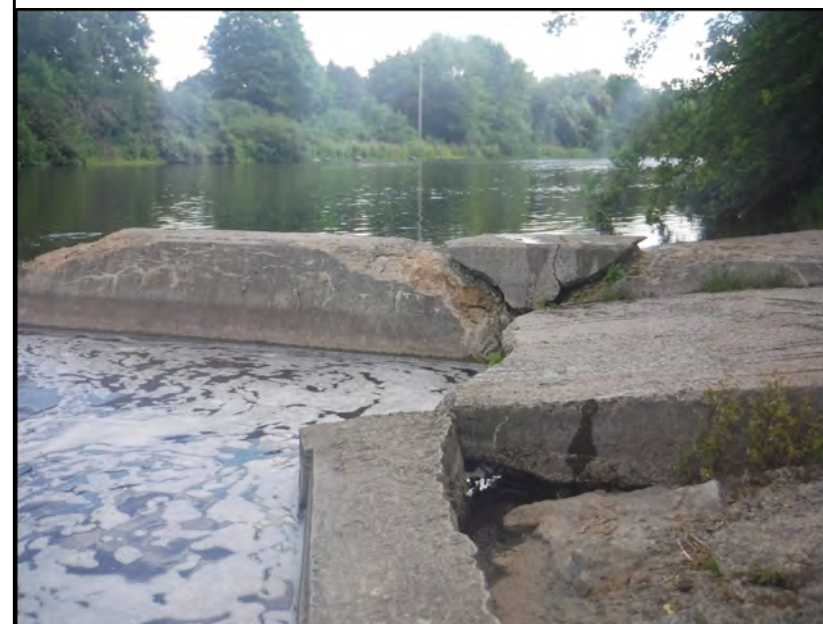
**ALTERNATIVE DESCRIPTION:**  
The local works alternative provides a cost-effective approach to stabilize the channel banks and maintain the channel gradient

- The components of the Local Stabilization Works alternative would include:
- Removal of the failed and deteriorating segments of the weir
  - Replacing failed segments with a fixed boulder riffle, integrated with and stabilizing competent weir sections
  - Restoration and stabilization of the banks at the weir with a combination of boulder, armourstone and bioengineering

- Removal of the failed and deteriorating segments of the weir
- Replacing failed segments with a fixed boulder riffle, integrated with and stabilizing competent weir sections
- Restoration and stabilization of the banks at the weir with a combination of boulder, armourstone and bioengineering

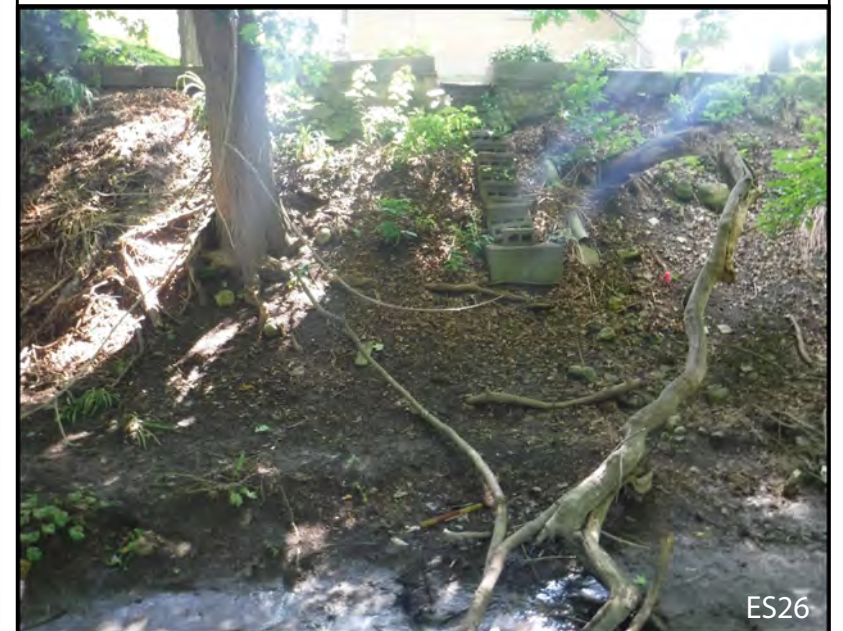
ES27

REMOVAL OF FAILED WEIR AND RETAINING WALL

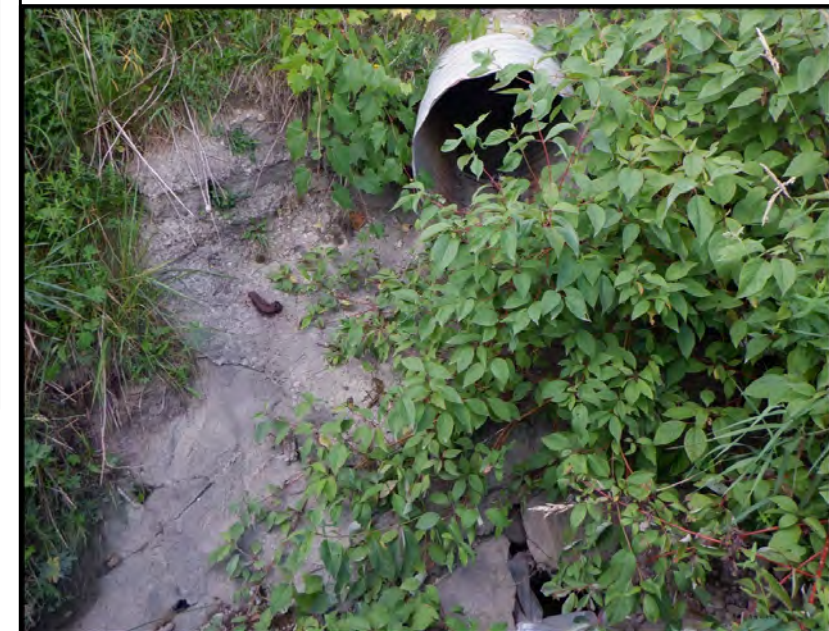
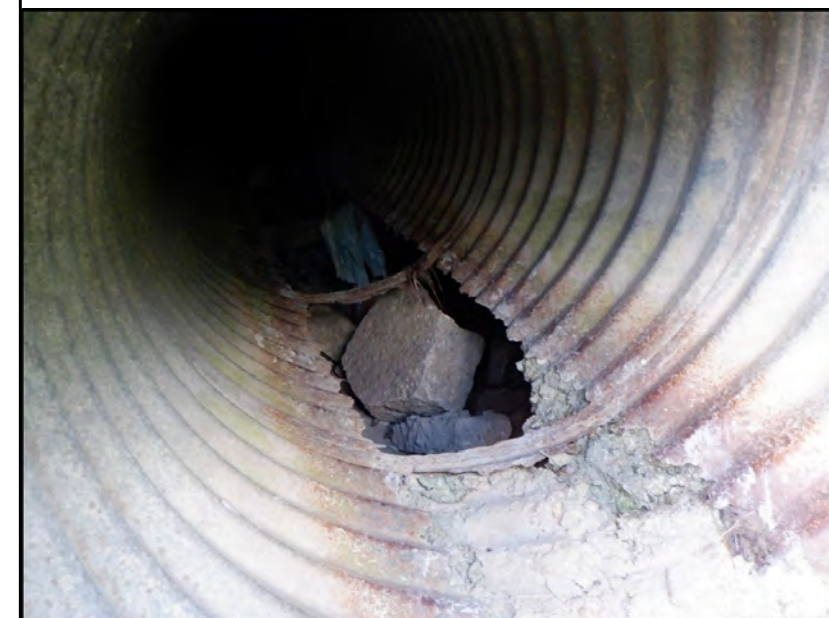
**Location: ES28**  
Local Works Concept Design

#### ALTERNATIVE DESCRIPTION:

The local works alternative provides a cost-effective approach to stabilize the channel/infrastructure interaction and remove the risk to the surrounding bank

- Replacement of the compromised pipe with an HDPE alternative.
- Stabilization of the outfall pipe with a concrete headwall.
- Armourstone bank protections and rip rap scour protection within the channel.

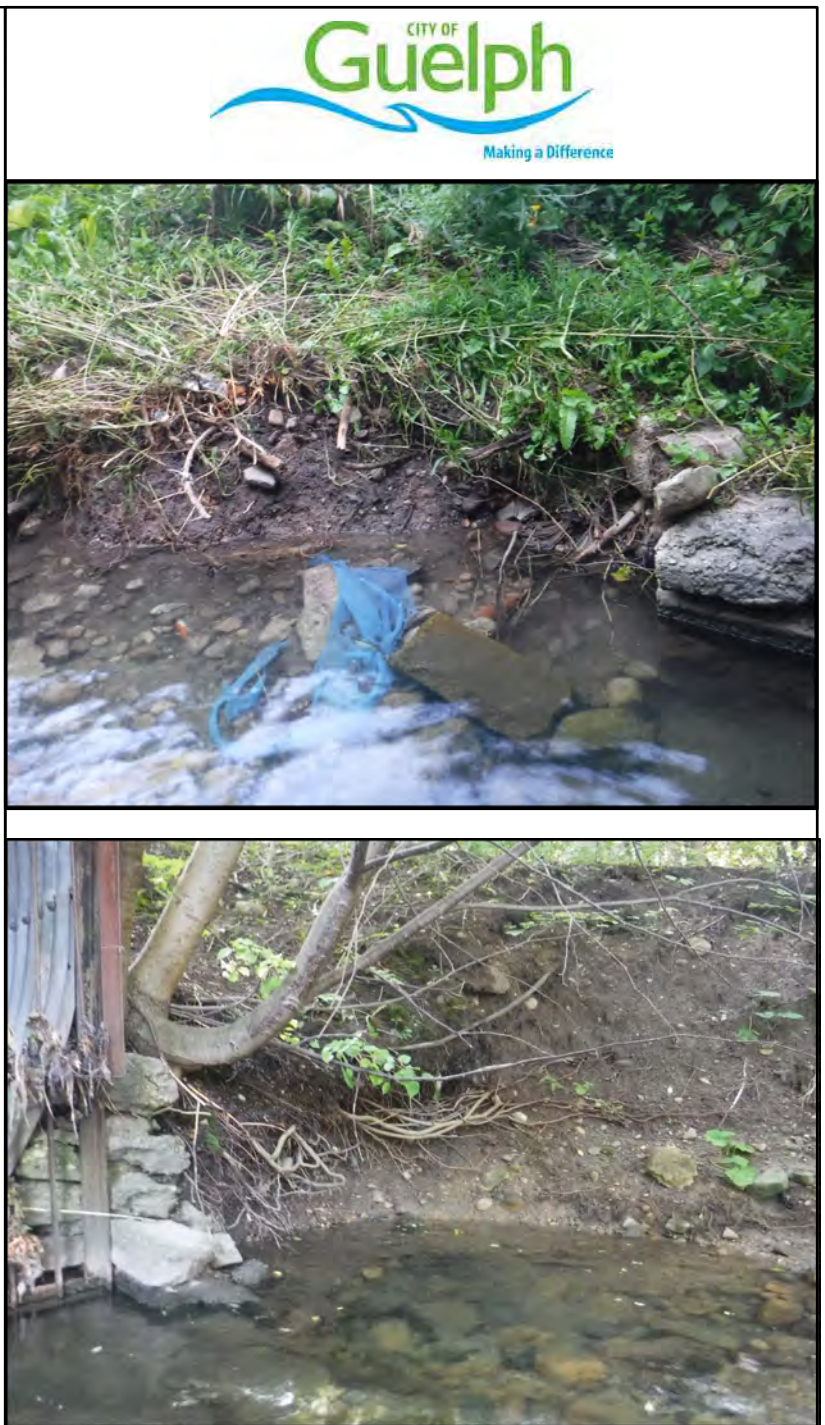
STRUCTURAL SUPPORT OF COMPROMISED CSP OUTFALL WITH ARMOURSTONE WALL PER DETAIL THIS SHEET

EX. 3500mm DIA STM SEWER

**ALTERNATIVE DESCRIPTION:**  
The local works alternative provides a cost-effective approach to stabilize the channel/infrastructure interaction and remove the risk to the surrounding infrastructure

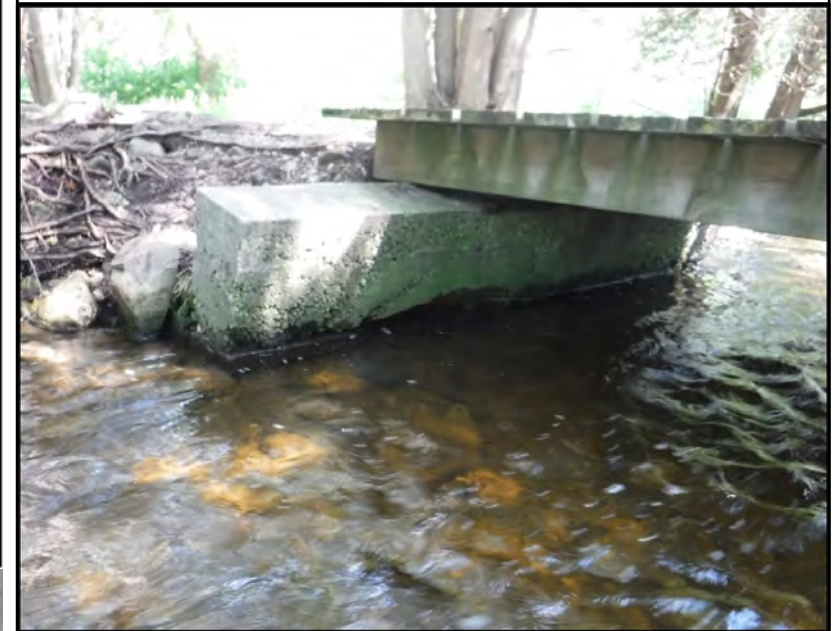
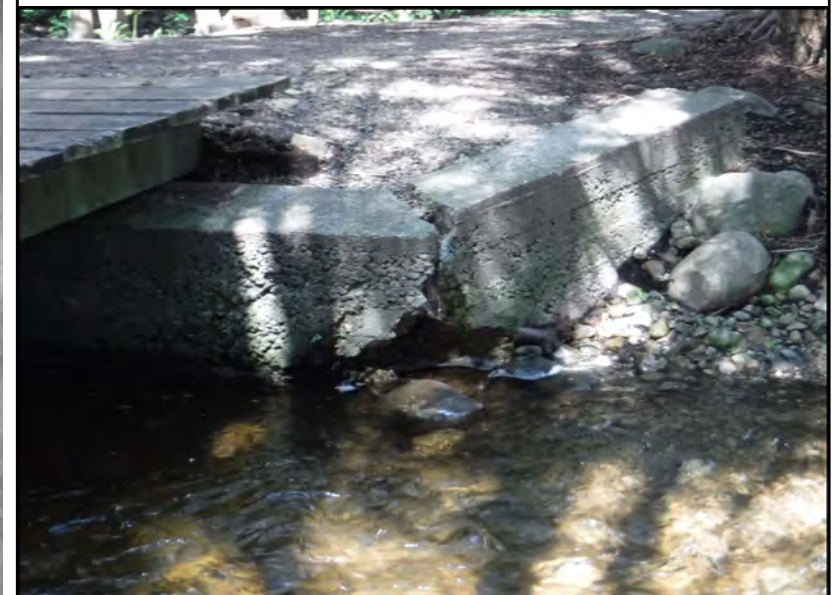
**ALTERNATIVE DESCRIPTION:**

The local replacement works alternative provides a cost-effective approach to stabilize the channel banks and replacement for the failed bridge

- Removal of the existing bridge and abutments
- Replacing the abutments to beyond the 100-yr erosion hazard limit
- Restoration and stabilization of the banks with vegetated rip rap and bioengineering
